Appendix A. River corridor severity scores for impaired sites in the Yellow River Basin, Alabama and Florida

Appendix C. Clear Creek Watershed Focal Area. Sites with orange headings are unpaved road sites. Specific definitions and calculations described for calculating the Sediment Risk Index (SRI) are detailed in Witmer (2009).

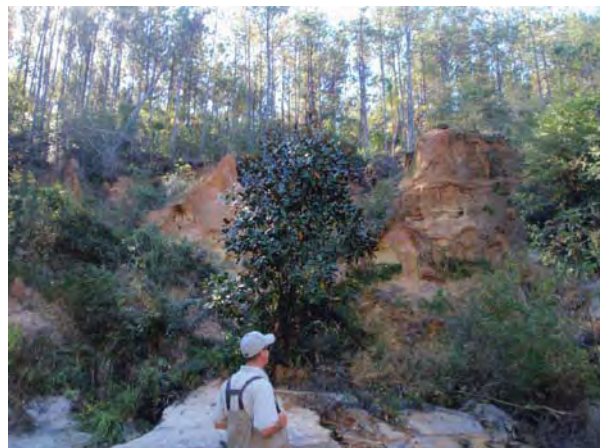
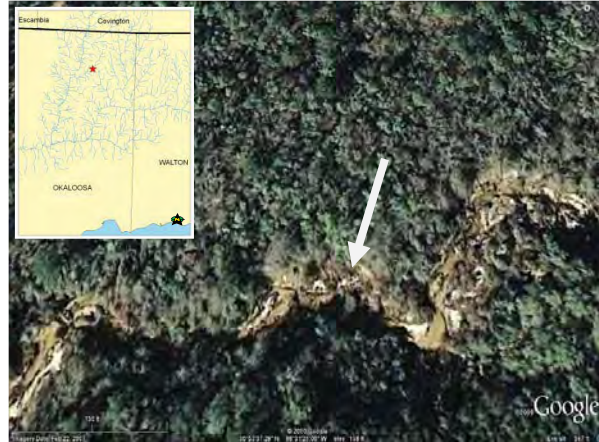
LB

<b>Murder Creek</b>	<b>ok-1105-003</b>	<b>Severity Score</b> <b>4.75</b>
---------------------	--------------------	--------------------------------------

Risk Factor	Ranking	Score	Feature	Within Range	Descriptive Field
<i>Channel Stability</i>	Fair	1	303(d)	Yes	COLIFORMS, DISSOLVED OXYGEN
<i>Channel Alteration</i>	None	0	Wetland Species	No	N/A
<i>Bank Erosion</i>	Active	1	Rare and Imperiled	Yes	BLACKTIP SHINER, IRONCOLOR SHINER
<i>BEHI</i>	High	1	Land Use/Cover	Yes	AGRILCULTURAL/ STREAMS AND WATERWAYS
<i>Local NPSP</i>	No Evidence	0	Candidate Mussels	No	N/A
<i>Shoring Structures</i>	Not Present	0	Sturgeon C.H.	No	N/A
<i>Pipe Discharge</i>	Not Present	0	<b>Additional Site Features</b>		
<i>Water Odors</i>	Not Present	0	<i>Stream Channel Woody Material:</i> Infrequent		
<i>Fish Passage Barrier</i>	Not Present	0	<i>Impoundments:</i> None		
<i>RB: Riparian Buffer</i>	50-99 ft	0.25	<i>Substrate Composition:</i> Medium Sand		
<i>LB: Riparian Buffer</i>	0-29 ft	0.75	<i>Bank Material:</i> Clay		
<i>RB: Floodplain Access</i>	Full	0			
<i>LB: Floodplain Access</i>	None	0.75

<b>River Threat Index:</b>		<b>4.75</b>

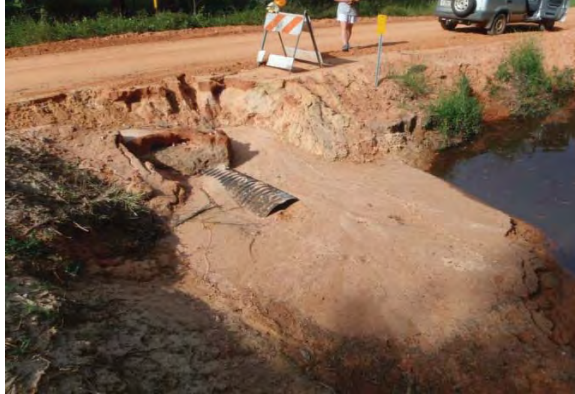
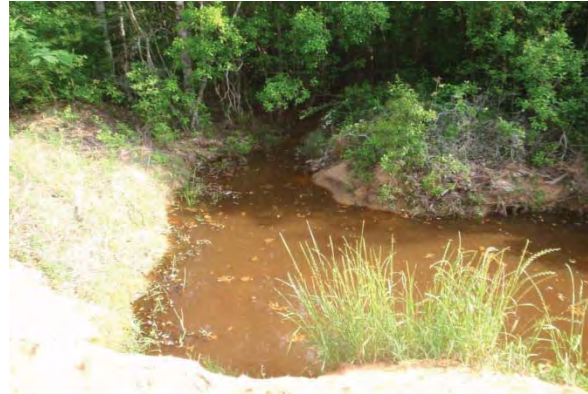
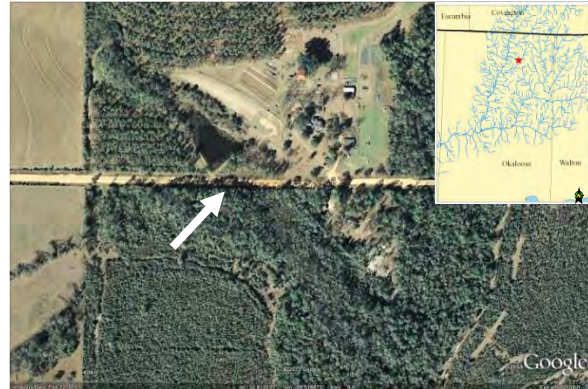
Crossing Structure: DS

Risk Factor	Ranking	Score
<i>US Channel Morph</i>	PONDED	1
<i>DS Channel Morph</i>	PONDED	1
<i>DS Bank Alteration</i>	HIGH	1
<i>Upstream Skew Angle</i>	>30°	1
<i>Crossing fill condition</i>	Poor/Bare soil	1
<i>Inlet/Outlet Condition</i>	Blocked	1
<i>Road Approach Material</i>	All Sand/Clay	3
<i>Potential Eroded Volume Mean</i>	>40 y <sup>3</sup>	1
<i>Approach Slope Mean</i>	2.1-4%	3
<i>Soil K Factor</i>	<0.20	5
<i>Upstream Rt Outlet</i>	Vegetated	1
<i>Upstream Lt Outlet</i>	Vegetated	1
<i>Upstream Rt Ditch</i>	Bare soil	0
<i>Upstream Lt Ditch</i>	Bare soil	0
<i>Downstream Rt Outlet</i>	Bare soil	0
<i>Downstream Lt Outlet</i>	Bare soil	0
<i>Downstream Rt Ditch</i>	Bare soil	0
<i>Downstream Lt Ditch</i>	Bare soil	0
<i>Outlet Total</i>	Partially Improved Outlet System	3
<i>Ditches Total</i>	Unimproved Drainage System	1
<b>SRI Total</b>	<b>High Risk</b>	<b>22</b>

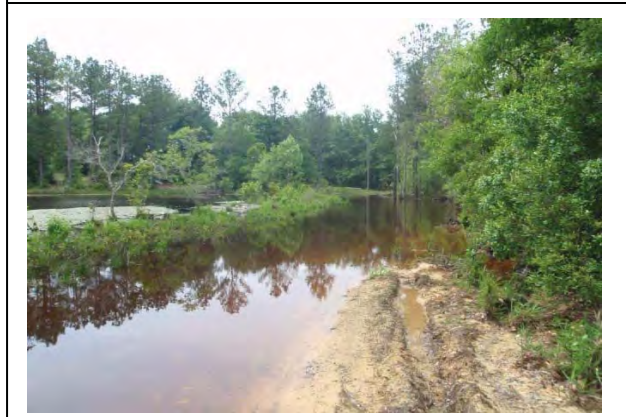
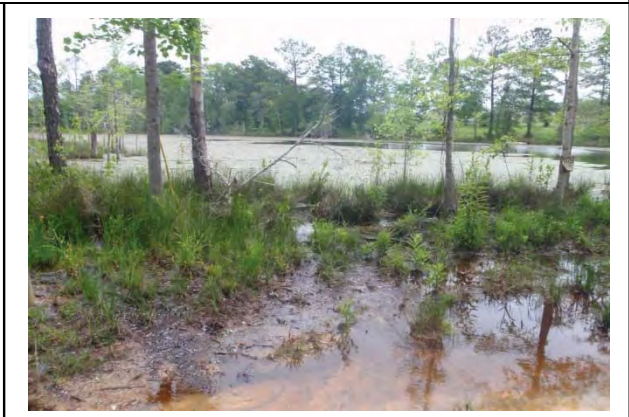
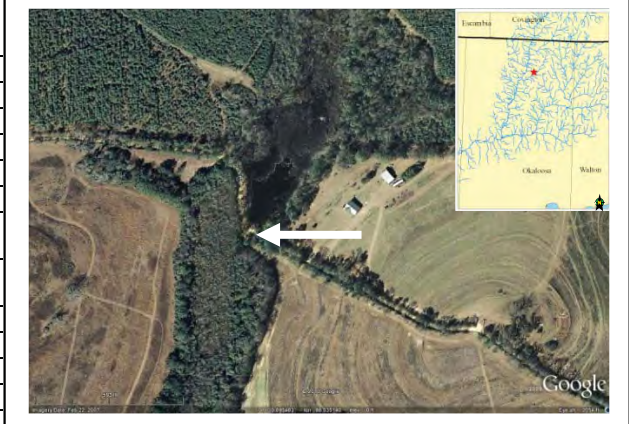
Crossing Structure: From Rt Approach

Risk Factor	Ranking	Score
<i>US Channel Morph</i>	PONDED	1
<i>DS Channel Morph</i>	WETLAND	5
<i>DS Bank Alteration</i>	HIGH	1
<i>Upstream Skew Angle</i>	<5°	5
<i>Crossing fill condition</i>	Poor/Bare soil	1
<i>Inlet/Outlet Condition</i>	Blocked	1
<i>Road Approach Material</i>	All Sand/Clay	3
<i>Potential Eroded Volume Mean</i>	>40 y <sup>3</sup>	1
<i>Approach Slope Mean</i>	>4%	1
<i>Soil K Factor</i>	<0.20	5
<i>Upstream Rt Outlet</i>	Bare soil	0
<i>Upstream Lt Outlet</i>	Bare soil	0
<i>Upstream Rt Ditch</i>	Bare soil	0
<i>Upstream Lt Ditch</i>	Bare soil	0
<i>Downstream Rt Outlet</i>	Bare soil	0
<i>Downstream Lt Outlet</i>	Bare soil	0
<i>Downstream Rt Ditch</i>	Bare soil	0
<i>Downstream Lt Ditch</i>	Bare soil	0
<i>Outlet Total</i>	Unimproved Outlet System	1
<i>Ditches Total</i>	Unimproved Drainage System	1
<b><i>SRI Total</i></b>	<b>High Risk</b>	<b>26</b>
<b>Additional Site Features</b>		
<i>Crossing Type and Quantity:</i>	Culvert?

Notes: Unknown crossing type- Flooded when accessed 2 different days.

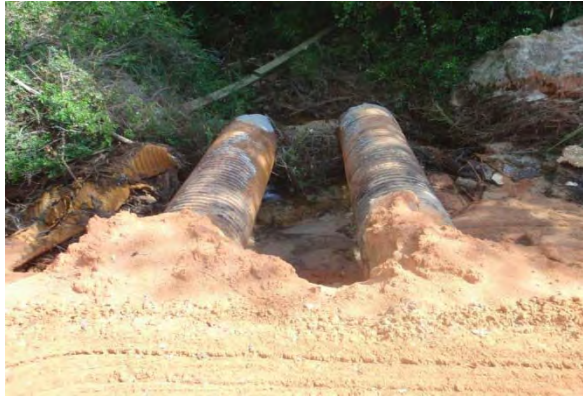
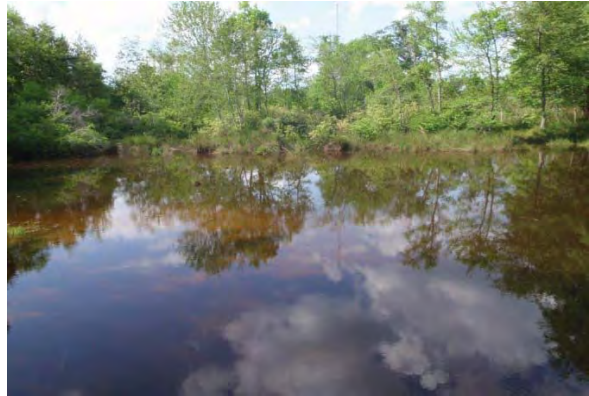
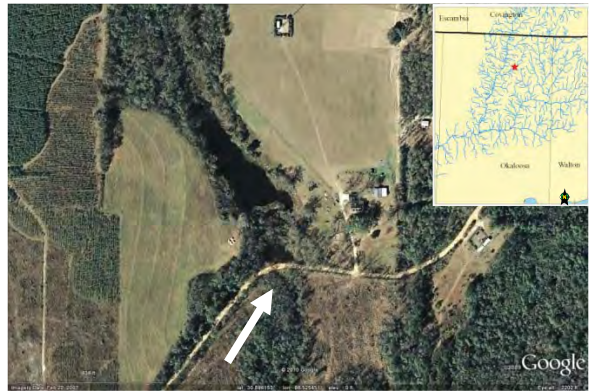
Crossing Structure: DS

Risk Factor	Ranking	Score
<i>US Channel Morph</i>	PONDED	1
<i>DS Channel Morph</i>	DA	3
<i>DS Bank Alteration</i>	HIGH	1
<i>Upstream Skew Angle</i>	5-30°	3
<i>Crossing fill condition</i>	Poor/Bare soil	1
<i>Inlet/Outlet Condition</i>	Sed Islands/Scouring	3
<i>Road Approach Material</i>	All Sand/Clay	3
<i>Potential Eroded Volume Mean</i>	>40 y <sup>3</sup>	1
<i>Approach Slope Mean</i>	2.1-4%	3
<i>Soil K Factor</i>	<0.20	5
<i>Upstream Rt Outlet</i>	Bare soil	0
<i>Upstream Lt Outlet</i>	Bare soil	0
<i>Upstream Rt Ditch</i>	Bare soil	0
<i>Upstream Lt Ditch</i>	Bare soil	0
<i>Downstream Rt Outlet</i>	Bare soil	0
<i>Downstream Lt Outlet</i>	Bare soil	0
<i>Downstream Rt Ditch</i>	Bare soil	0
<i>Downstream Lt Ditch</i>	Bare soil	0
<i>Outlet Total</i>	Unimproved Outlet System	1
<i>Ditches Total</i>	Unimproved Drainage System	1
<b>SRI Total</b>	<b>High Risk</b>	<b>26</b>

Notes: 12ft of each culvert exposed due to road erosion. US openings covered by fencing.

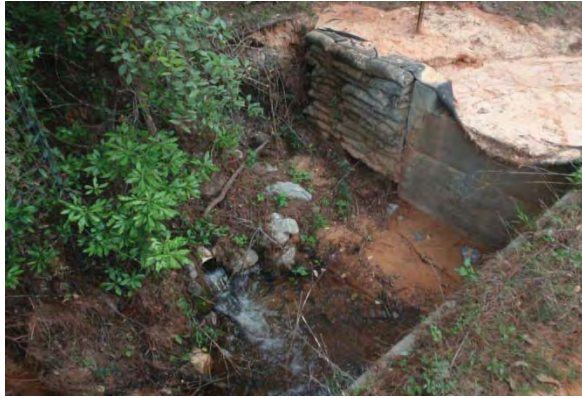
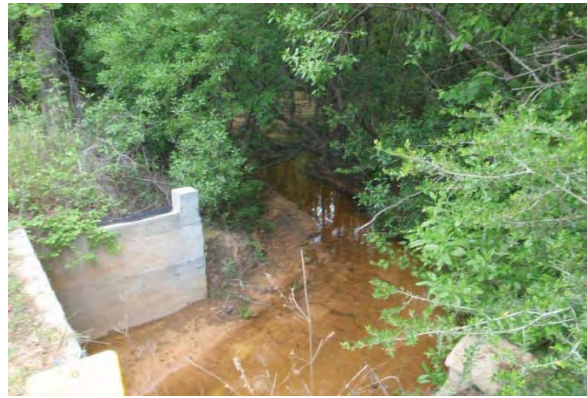
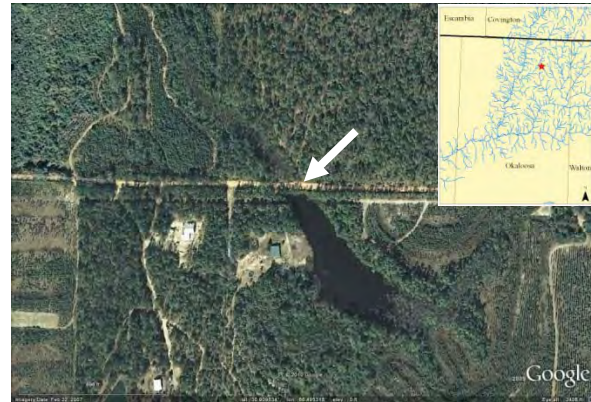
Crossing Structure: US

Risk Factor	Ranking	Score
<i>US Channel Morph</i>	PONDED	1
<i>DS Channel Morph</i>	C	5
<i>DS Bank Alteration</i>	HIGH	1
<i>Upstream Skew Angle</i>	5-30°	3
<i>Crossing fill condition</i>	Poor/Bare soil	1
<i>Inlet/Outlet Condition</i>	No Impairment	5
<i>Road Approach Material</i>	All Sand/Clay	3
<i>Potential Eroded Volume Mean</i>	>40 y <sup>3</sup>	1
<i>Approach Slope Mean</i>	>4%	1
<i>Soil K Factor</i>	<0.20	5
<i>Upstream Rt Outlet</i>	Bare soil	0
<i>Upstream Lt Outlet</i>	Bare soil	0
<i>Upstream Rt Ditch</i>	Bare soil	0
<i>Upstream Lt Ditch</i>	Bare soil	0
<i>Downstream Rt Outlet</i>	Bare soil	0
<i>Downstream Lt Outlet</i>	Vegetated	1
<i>Downstream Rt Ditch</i>	Bare soil	0
<i>Downstream Lt Ditch</i>	Bare soil	0
<i>Outlet Total</i>	Partially Improved Outlet System	3
<i>Ditches Total</i>	Unimproved Drainage System	1
<b>SRI Total</b>	<b>High Risk</b>	<b>30</b>
<b>Additional Site Features</b>		
<u>Crossing Type and Quantity:</u>	Culvert, 2

Notes: Culvert w/outfall draining pond. High levels of sedimentation DS.

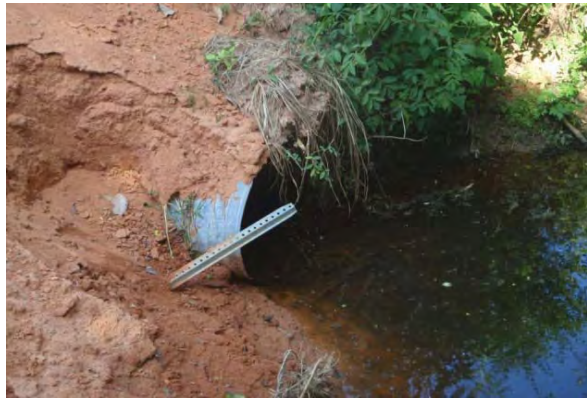
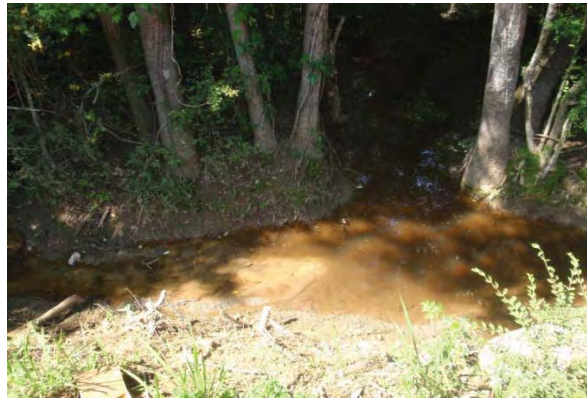
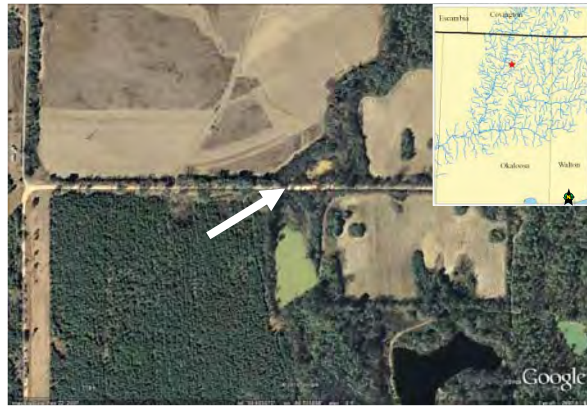
Crossing Structure: DS

Risk Factor	Ranking	Score
US Channel Morph	DA	3
DS Channel Morph	PONDED	1
DS Bank Alteration	MINOR/PARTIAL	3
Upstream Skew Angle	>30°	1
Crossing fill condition	Poor/Bare soil	1
Inlet/Outlet Condition	No Impairment	5
Road Approach Material	All Sand/Clay	3
Potential Eroded Volume Mean	21-40 y <sup>3</sup>	3
Approach Slope Mean	>4%	1
Soil K Factor	<0.20	5
Upstream Rt Outlet	Bare soil	0
Upstream Lt Outlet	Bare soil	0
Upstream Rt Ditch	Bare soil	0
Upstream Lt Ditch	Bare soil	0
Downstream Rt Outlet	Bare soil	0
Downstream Lt Outlet	Bare soil	0
Downstream Rt Ditch	Bare soil	0
Downstream Lt Ditch	Bare soil	0
Outlet Total	Unimproved Outlet System	1
Ditches Total	Unimproved Drainage System	1
<b>SRI Total</b>	<b>High Risk</b>	<b>28</b>

Notes: Undersized culvert draining agricultural land. Loose sediment over culvert

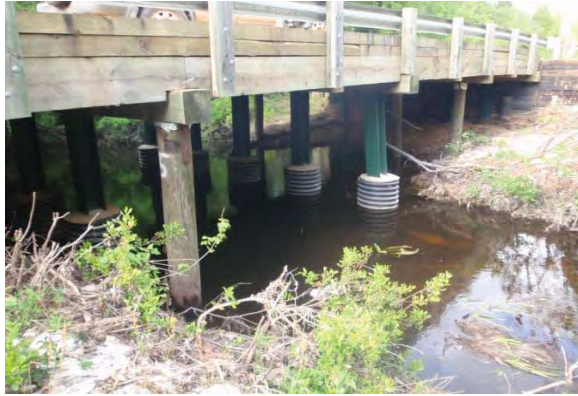
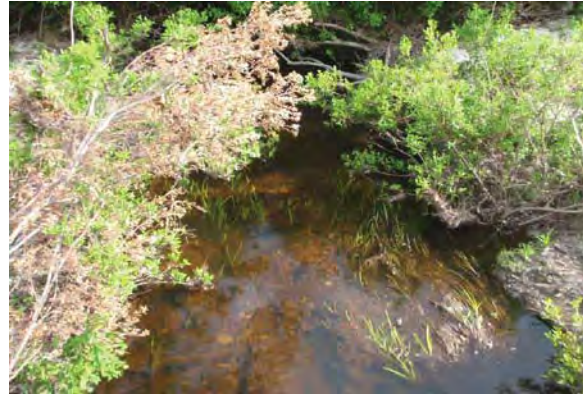
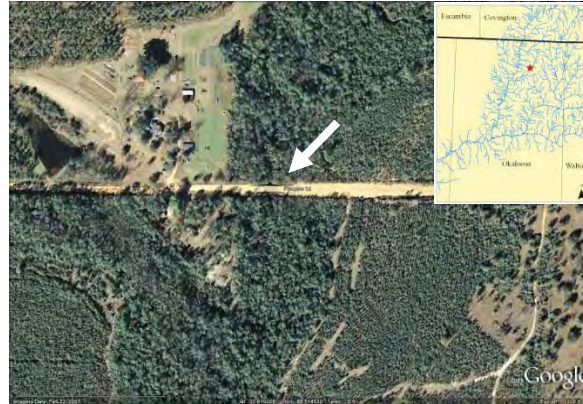
Crossing Structure: DS

Risk Factor	Ranking	Score
<i>US Channel Morph</i>	E	5
<i>DS Channel Morph</i>	C	5
<i>DS Bank Alteration</i>	MINOR/PARTIAL	3
<i>Upstream Skew Angle</i>	<5°	5
<i>Crossing fill condition</i>	Good/Vegetated	5
<i>Inlet/Outlet Condition</i>	Sed Islands/Scouring	3
<i>Road Approach Material</i>	All Sand/Clay	3
<i>Potential Eroded Volume Mean</i>	>40 y <sup>3</sup>	1
<i>Approach Slope Mean</i>	>4%	1
<i>Soil K Factor</i>	<0.20	5
<i>Upstream Rt Outlet</i>	Vegetated	1
<i>Upstream Lt Outlet</i>	Vegetated	1
<i>Upstream Rt Ditch</i>	Bare soil	0
<i>Upstream Lt Ditch</i>	Bare soil	0
<i>Downstream Rt Outlet</i>	Vegetated	1
<i>Downstream Lt Outlet</i>	Bare soil	0
<i>Downstream Rt Ditch</i>	Bare soil	0
<i>Downstream Lt Ditch</i>	Bare soil	0
<i>Outlet Total</i>	Partially Improved Outlet System	3
<i>Ditches Total</i>	Unimproved Drainage System	1
<b>SRI Total</b>	<b>Medium Risk</b>	<b>40</b>
<b>Additional Site Features</b>		
<i>Crossing Type and Quantity:</i>	Bridge,1

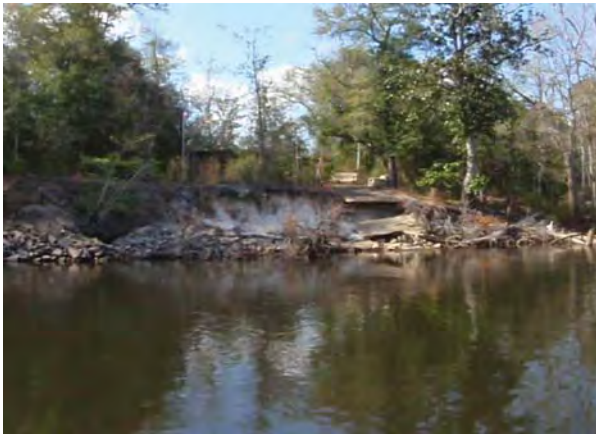
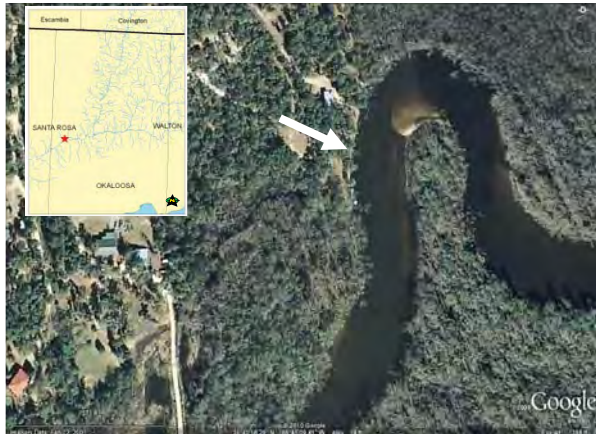
<b>RB</b>																																																																
<table border="1"> <thead> <tr> <th>Risk Factor</th> <th>Ranking</th> <th>Score</th> </tr> </thead> <tbody> <tr> <td><i>Channel Stability</i></td> <td>Good</td> <td>0.5</td> </tr> <tr> <td><i>Channel Alteration</i></td> <td>None</td> <td>0</td> </tr> <tr> <td><i>Bank Erosion</i></td> <td>Historic</td> <td>0.5</td> </tr> <tr> <td><i>BEHI</i></td> <td>High</td> <td>1</td> </tr> <tr> <td><i>Local NPSP</i></td> <td>Obvious Sources</td> <td>1.5</td> </tr> <tr> <td><i>Shoring Structures</i></td> <td>Present</td> <td>1.5</td> </tr> <tr> <td><i>Pipe Discharge</i></td> <td>Present</td> <td>1.5</td> </tr> <tr> <td><i>Water Odors</i></td> <td>Not Present</td> <td>0</td> </tr> <tr> <td><i>Fish Passage Barrier</i></td> <td>Not Present</td> <td>0</td> </tr> <tr> <td><i>RB: Riparian Buffer</i></td> <td>0-29 ft</td> <td>0.75</td> </tr> <tr> <td><i>LB: Riparian Buffer</i></td> <td>100+ ft</td> <td>0</td> </tr> <tr> <td><i>RB: Floodplain Access</i></td> <td>None</td> <td>0.75</td> </tr> <tr> <td><i>LB: Floodplain Access</i></td> <td>Full</td> <td>0</td> </tr> <tr> <td colspan="2"><b>River Threat Index:</b></td> <td><b>8</b></td> </tr> </tbody> </table>	Risk Factor	Ranking	Score	<i>Channel Stability</i>	Good	0.5	<i>Channel Alteration</i>	None	0	<i>Bank Erosion</i>	Historic	0.5	<i>BEHI</i>	High	1	<i>Local NPSP</i>	Obvious Sources	1.5	<i>Shoring Structures</i>	Present	1.5	<i>Pipe Discharge</i>	Present	1.5	<i>Water Odors</i>	Not Present	0	<i>Fish Passage Barrier</i>	Not Present	0	<i>RB: Riparian Buffer</i>	0-29 ft	0.75	<i>LB: Riparian Buffer</i>	100+ ft	0	<i>RB: Floodplain Access</i>	None	0.75	<i>LB: Floodplain Access</i>	Full	0	<b>River Threat Index:</b>		<b>8</b>	<table border="1"> <thead> <tr> <th>Feature</th> <th>Within Range</th> <th>Descriptive Field</th> </tr> </thead> <tbody> <tr> <td>303(d)</td> <td>No</td> <td>N/A</td> </tr> <tr> <td>Wetland Species Rare and Imperiled</td> <td>Yes</td> <td>1-3 FOCAL SPECIES IN UPLAND AREAS ALBAMA SHAD, ALLIGATOR GAR, BLUE NOSE SHINER, GULF STURGEON, SPECKLED CHUB, IRONCOLOR SHINER, SPOTTED BULLHEAD, SPECKLED DARTER</td> </tr> <tr> <td>Land Use/Cover</td> <td>Yes</td> <td>N/A/ STREAMS AND WATERWAYS</td> </tr> <tr> <td>Candidate Mussels</td> <td>No</td> <td>N/A</td> </tr> <tr> <td>Sturgeon C.H.</td> <td>Yes</td> <td>N/A</td> </tr> </tbody> </table>	Feature	Within Range	Descriptive Field	303(d)	No	N/A	Wetland Species Rare and Imperiled	Yes	1-3 FOCAL SPECIES IN UPLAND AREAS ALBAMA SHAD, ALLIGATOR GAR, BLUE NOSE SHINER, GULF STURGEON, SPECKLED CHUB, IRONCOLOR SHINER, SPOTTED BULLHEAD, SPECKLED DARTER	Land Use/Cover	Yes	N/A/ STREAMS AND WATERWAYS	Candidate Mussels	No	N/A	Sturgeon C.H.	Yes	N/A

Notes: Pipe discharge coming from a small PVC pipe on right bank boat launch. Approx. 100 yards of brick and concrete shoring structure present. "Easy Street" leads to house on right bank.

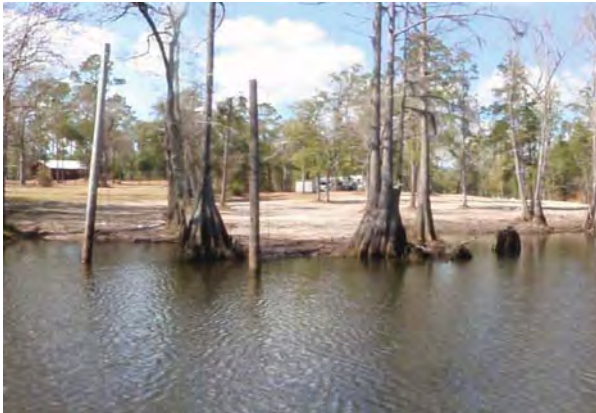
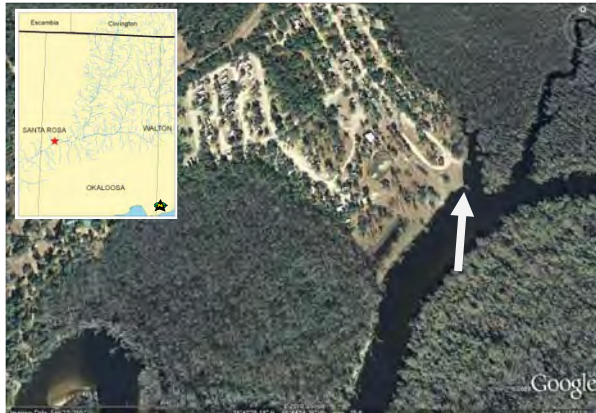
<p><b>RB</b></p>																																																																																							
<table border="1"> <thead> <tr> <th>Risk Factor</th> <th>Ranking</th> <th>Score</th> </tr> </thead> <tbody> <tr> <td><i>Channel Stability</i></td> <td>Good</td> <td>0.5</td> </tr> <tr> <td><i>Channel Alteration</i></td> <td>None</td> <td>0</td> </tr> <tr> <td><i>Bank Erosion</i></td> <td>Historic</td> <td>0.5</td> </tr> <tr> <td><i>BEHI</i></td> <td>Moderate</td> <td>0.5</td> </tr> <tr> <td><i>Local NPSP</i></td> <td>Obvious Sources</td> <td>1.5</td> </tr> <tr> <td><i>Shoring Structures</i></td> <td>Present</td> <td>1.5</td> </tr> <tr> <td><i>Pipe Discharge</i></td> <td>Present</td> <td>1.5</td> </tr> <tr> <td><i>Water Odors</i></td> <td>Not Present</td> <td>0</td> </tr> <tr> <td><i>Fish Passage Barrier</i></td> <td>Not Present</td> <td>0</td> </tr> <tr> <td><i>RB: Riparian Buffer</i></td> <td>0-29 ft</td> <td>0.75</td> </tr> <tr> <td><i>LB: Riparian Buffer</i></td> <td>100+ ft</td> <td>0</td> </tr> <tr> <td><i>RB: Floodplain Access</i></td> <td>Full</td> <td>0</td> </tr> <tr> <td><i>LB: Floodplain Access</i></td> <td>Full</td> <td>0</td> </tr> <tr> <td colspan="2" style="text-align: right;"><b>River Threat Index:</b></td> <td><b>6.75</b></td> </tr> </tbody> </table>			Risk Factor	Ranking	Score	<i>Channel Stability</i>	Good	0.5	<i>Channel Alteration</i>	None	0	<i>Bank Erosion</i>	Historic	0.5	<i>BEHI</i>	Moderate	0.5	<i>Local NPSP</i>	Obvious Sources	1.5	<i>Shoring Structures</i>	Present	1.5	<i>Pipe Discharge</i>	Present	1.5	<i>Water Odors</i>	Not Present	0	<i>Fish Passage Barrier</i>	Not Present	0	<i>RB: Riparian Buffer</i>	0-29 ft	0.75	<i>LB: Riparian Buffer</i>	100+ ft	0	<i>RB: Floodplain Access</i>	Full	0	<i>LB: Floodplain Access</i>	Full	0	<b>River Threat Index:</b>		<b>6.75</b>	<table border="1"> <thead> <tr> <th>Feature</th> <th>Within Range</th> <th>Descriptive Field</th> </tr> </thead> <tbody> <tr> <td>303(d)</td> <td>No</td> <td>N/A</td> </tr> <tr> <td>Wetland Species</td> <td>Yes</td> <td>1-3 FOCAL SPECIES IN WETLAND AREAS</td> </tr> <tr> <td>Rare and Imperiled</td> <td>Yes</td> <td>ALABAMA SHAD, ALLIGATOR GAR, BLUENOSE SHINER, GULF STURGEON, SPECKLED CHUB, IRONCOLOR SHINER, SPOTTED BULLHEAD, SPECKLED DARTER</td> </tr> <tr> <td>Land Use/Cover</td> <td>Yes</td> <td>N/A/ STREAMS AND WATERWAYS</td> </tr> <tr> <td>Candidate Mussels</td> <td>No</td> <td>N/A</td> </tr> <tr> <td>Sturgeon C.H.</td> <td>Yes</td> <td>N/A</td> </tr> <tr> <td colspan="3"><b>Additional Site Features</b></td> </tr> <tr> <td colspan="2"><i>Stream Channel Woody Material:</i></td> <td>Infrequent</td> </tr> <tr> <td colspan="2"><i>Impoundments:</i></td> <td>None</td> </tr> <tr> <td colspan="2"><i>Substrate Composition:</i></td> <td>Medium Sand, Silt</td> </tr> <tr> <td colspan="2"><i>Bank Material:</i></td> <td>Sand</td> </tr> </tbody> </table>				Feature	Within Range	Descriptive Field	303(d)	No	N/A	Wetland Species	Yes	1-3 FOCAL SPECIES IN WETLAND AREAS	Rare and Imperiled	Yes	ALABAMA SHAD, ALLIGATOR GAR, BLUENOSE SHINER, GULF STURGEON, SPECKLED CHUB, IRONCOLOR SHINER, SPOTTED BULLHEAD, SPECKLED DARTER	Land Use/Cover	Yes	N/A/ STREAMS AND WATERWAYS	Candidate Mussels	No	N/A	Sturgeon C.H.	Yes	N/A	<b>Additional Site Features</b>			<i>Stream Channel Woody Material:</i>		Infrequent	<i>Impoundments:</i>		None	<i>Substrate Composition:</i>		Medium Sand, Silt	<i>Bank Material:</i>		Sand

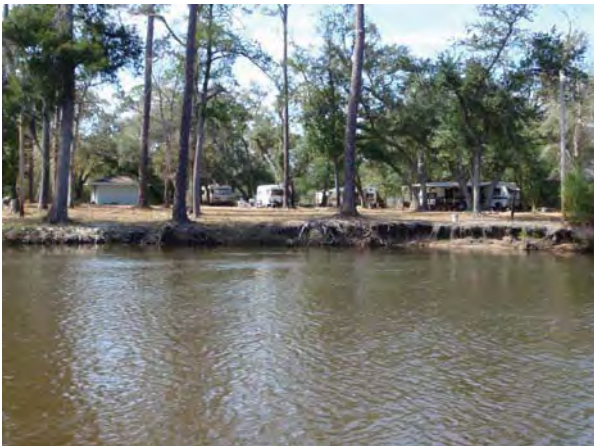
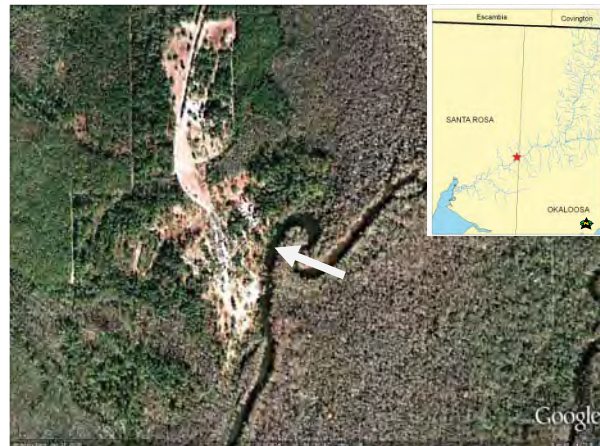
RB

Risk Factor	Ranking	Score	Feature	Within Range	Descriptive Field
<i>Channel Stability</i>	Fair	1	303(d)	No	N/A
<i>Channel Alteration</i>	None	0	<b>Wetland Species</b>	Yes	1-3 FOCAL SPECIES IN WETLAND AREAS
<i>Bank Erosion</i>	Active	1	<b>Rare and Imperiled</b>	Yes	GOLDSTRIPE DARTER, SPECKLED CHUB, IRONCOLOR SHINER, GULF STURGEON, ALABAMA SHAD, ALLIGATOR GAR, SPECKLED DARTER, SPOTTED BULLHEAD
<i>BEHI</i>	Moderate	0.5	<b>Land Use/ Cover</b>	Yes	N/A/ STREAMS AND WATERWAYS
<i>Local NPSP</i>	Obvious Sources	1.5	<b>Candidate Mussels</b>	No	N/A
<i>Shoring Structures</i>	Present	1.5	<b>Sturgeon C.H.</b>	No	N/A
<i>Pipe Discharge</i>	Not Present	0	<b>Additional Site Features</b>		
<i>Water Odors</i>	Not Present	0	<i>Stream Channel Woody Material:</i> Moderate		
<i>Fish Passage Barrier</i>	Not Present	0	<i>Impoundments:</i> None		
<i>RB: Riparian Buffer</i>	0-29 ft	0.75	<i>Substrate Composition:</i> Medium Sand

Notes: Concrete shoring structure and two boat launches present. Road leading down is Garner Landing Rd

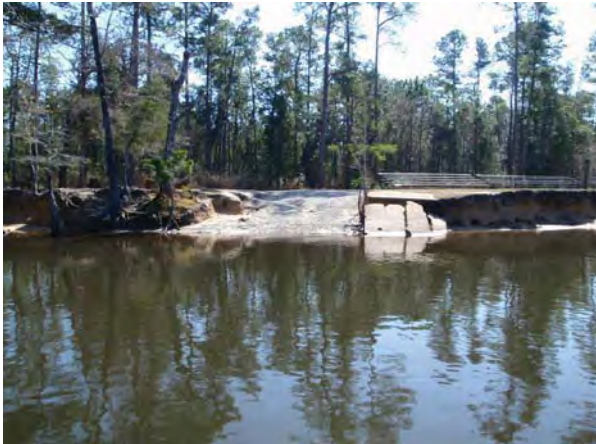
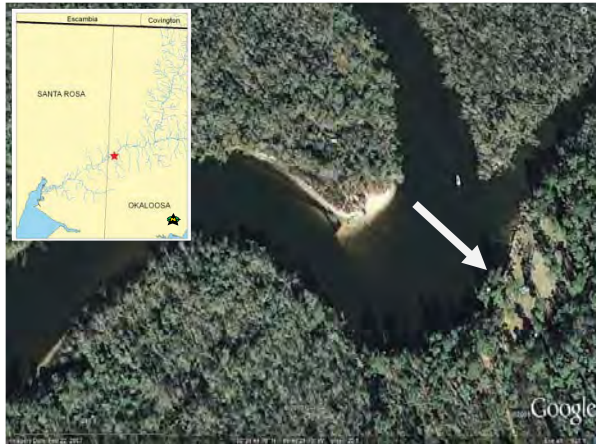
<b>LB</b>																																																																			
<table border="1"> <thead> <tr> <th>Risk Factor</th> <th>Ranking</th> <th>Score</th> </tr> </thead> <tbody> <tr> <td>Channel Stability</td> <td>Good</td> <td>0.5</td> </tr> <tr> <td>Channel Alteration</td> <td>None</td> <td>0</td> </tr> <tr> <td>Bank Erosion</td> <td>Historic</td> <td>1</td> </tr> <tr> <td>BEHI</td> <td>High</td> <td>1</td> </tr> <tr> <td>Local NPSP</td> <td>Moderate Potential</td> <td>1</td> </tr> <tr> <td>Shoring Structures</td> <td>Present</td> <td>1.5</td> </tr> <tr> <td>Pipe Discharge</td> <td>Not Present</td> <td>0</td> </tr> <tr> <td>Water Odors</td> <td>Not Present</td> <td>0</td> </tr> <tr> <td>Fish Passage Barrier</td> <td>Not Present</td> <td>0</td> </tr> <tr> <td>RB: Riparian Buffer</td> <td>100+ ft</td> <td>0</td> </tr> <tr> <td>LB: Riparian Buffer</td> <td>0-29 ft</td> <td>0.75</td> </tr> <tr> <td>RB: Floodplain Access</td> <td>Full</td> <td>0</td> </tr> <tr> <td>LB: Floodplain Access</td> <td>Full</td> <td>0</td> </tr> <tr> <td colspan="2"><b>River Threat Index:</b></td> <td><b>5.75</b></td> </tr> </tbody> </table>	Risk Factor	Ranking	Score	Channel Stability	Good	0.5	Channel Alteration	None	0	Bank Erosion	Historic	1	BEHI	High	1	Local NPSP	Moderate Potential	1	Shoring Structures	Present	1.5	Pipe Discharge	Not Present	0	Water Odors	Not Present	0	Fish Passage Barrier	Not Present	0	RB: Riparian Buffer	100+ ft	0	LB: Riparian Buffer	0-29 ft	0.75	RB: Floodplain Access	Full	0	LB: Floodplain Access	Full	0	<b>River Threat Index:</b>		<b>5.75</b>	<table border="1"> <thead> <tr> <th>Feature</th> <th>Within Range</th> <th>Descriptive Field</th> </tr> </thead> <tbody> <tr> <td>303(d)</td> <td>No</td> <td>N/A</td> </tr> <tr> <td>Wetland Species</td> <td>Yes</td> <td>4-6 FOCAL SPECIES IN WETLAND AREAS</td> </tr> <tr> <td>Rare and Imperiled</td> <td>Yes</td> <td>ALABAMA SHAD, ALLIGATOR GAR, BLUENOSE SHINER, GULF STURGEON, SPECKLED CHUB, IRONCOLOR SHINER, SPOTTED BULLHEAD, SPECKLED DARTER</td> </tr> <tr> <td>Land Use/Cover</td> <td>Yes</td> <td>N/A/ STREAMS AND WATERWAYS</td> </tr> <tr> <td>Candidate Mussels</td> <td>No</td> <td>N/A</td> </tr> <tr> <td>Sturgeon C.H.</td> <td>Yes</td> <td>N/A</td> </tr> </tbody> </table>	Feature	Within Range	Descriptive Field	303(d)	No	N/A	Wetland Species	Yes	4-6 FOCAL SPECIES IN WETLAND AREAS	Rare and Imperiled	Yes	ALABAMA SHAD, ALLIGATOR GAR, BLUENOSE SHINER, GULF STURGEON, SPECKLED CHUB, IRONCOLOR SHINER, SPOTTED BULLHEAD, SPECKLED DARTER	Land Use/Cover	Yes	N/A/ STREAMS AND WATERWAYS	Candidate Mussels	No	N/A	Sturgeon C.H.	Yes	N/A

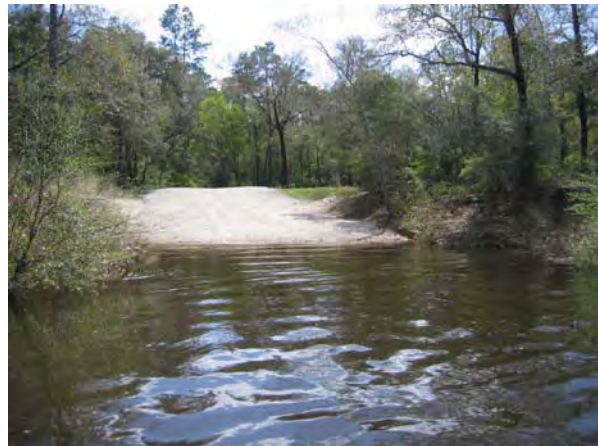
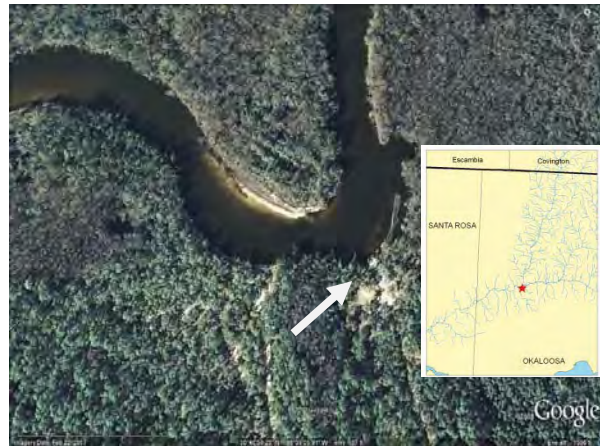
LB

Risk Factor	Ranking	Score	Feature	Within Range	Descriptive Field
<i>Channel Stability</i>	Good	0.5	303(d)	No	N/A
<i>Channel Alteration</i>	None	0	<b>Wetland Species</b>	Yes	1-3 FOCAL SPECIES IN WETLAND AREAS
<i>Bank Erosion</i>	Active	1	<b>Rare and Imperiled</b>	Yes	ALABAMA SHAD, ALLIGATOR GAR, BLUENOSE SHINER, GULF STURGEON, SPECKLED CHUB, IRONCOLOR SHINER, SPOTTED BULLHEAD, SPECKLED DARTER
<i>BEHI</i>	Moderate	0.5	<b>Land Use/ Cover</b>	Yes	N/A/ STREAMS AND WATERWAYS & UPLAND AND CONIFEROUS FORESTS
<i>Local NPSP</i>	Moderate Potential	1	<b>Candidate Mussels</b>	Yes	NARROW PIGTOE
<i>Shoring Structures</i>	Present	1.5	<b>Sturgeon C.H.</b>	Yes	N/A
<i>Pipe Discharge</i>	Not Present	0	<b>Additional Site Features</b>		
<i>Water Odors</i>	Not Present	0	<i>Stream Channel Woody Material:</i> Infrequent		
<i>Fish Passage Barrier</i>	Not Present	0	<i>Impoundments:</i> None		
<i>RB: Riparian Buffer</i>	100+ ft	0	<i>Substrate Composition:</i> Medium Sand and Gravel

<i>LB: Riparian Buffer</i>	0-29 ft	0.75	<i>Bank Material:</i> Sand		
<i>RB: Floodplain Access</i>	Full	0			
<i>LB: Floodplain Access</i>	Full	0			
<b>River Threat Index:</b>		<b>5.25</b>

Notes: A gravel road leads to this recreational site. Little Gin Hole Landing.

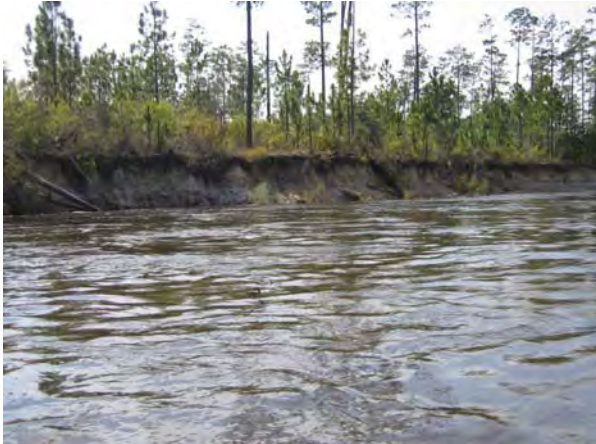
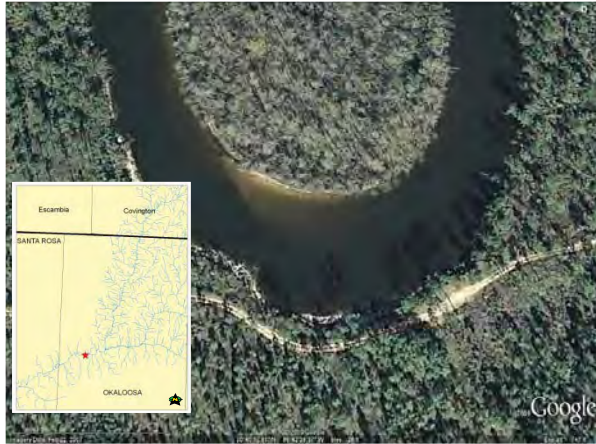
Yellow River		ok-0319-006	Severity Score 4.75
<u>Common:</u> 10.3mi SW of Crestview <u>Drainage:</u> Blackwater Bay <u>GPS:</u> 30.670433, -86.709917 <u>Land owner:</u> RB: NFWFMD/ LB: USA		<u>County:</u> Okaloosa <u>State:</u> Florida <u>PLSS(T-R-S):</u> 2N-25W-14 <u>Parcel No.:</u> 1/2

LB			
<b>Risk Factor</b>	<b>Ranking</b>	<b>Score</b>	
<i>Channel Stability</i>	Poor	1.5	
<i>Channel Alteration</i>	None	0	
<i>Bank Erosion</i>	Mass Wasting	1.5	
<i>BEHI</i>	High	1	
<i>Local NPSP</i>	No Evidence	0	
<i>Shoring Structures</i>	Not Present	0	
<i>Pipe Discharge</i>	Not Present	0	
<i>Water Odors</i>	Not Present	0	
<i>Fish Passage Barrier</i>	Not Present	0	
<i>RB: Riparian Buffer</i>	100+ ft	0	
<i>LB: Riparian Buffer</i>	30-49 ft	0.5	
<i>RB: Floodplain Access</i>	Full	0	
<i>LB: Floodplain Access</i>	Partial	0.25	
<b>River Threat Index:</b>		<b>4.75</b>	
<b>Feature</b>	<b>Within Range</b>	<b>Descriptive Field</b>

Notes: Roots and new trees showing recent repair of riparian buffer, but bare banks. Logging road 33ft from rivers edge on the left bank. Former clear cut evident in historical aerial (1994).

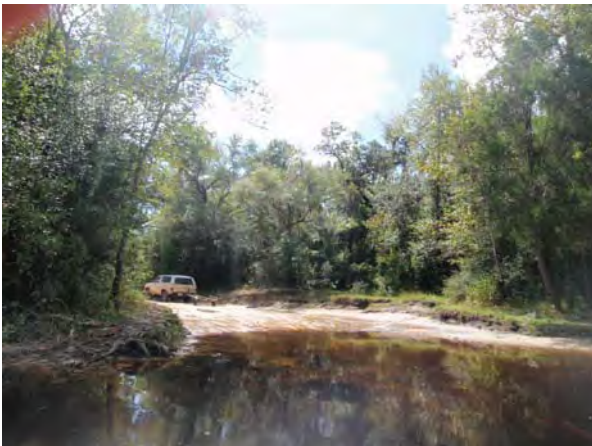
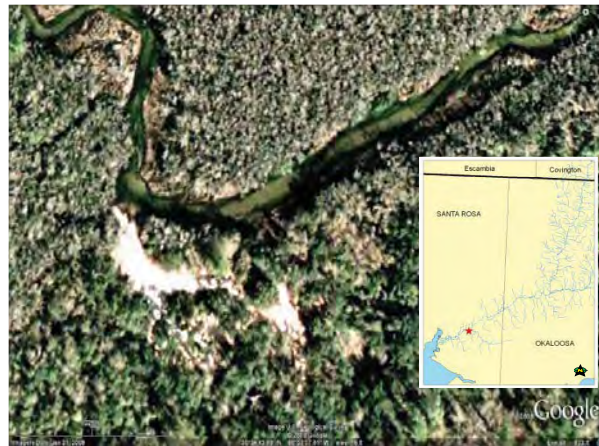
<b>Boiling Creek</b>	<b>sr-1006-001</b>	<i>Severity Score</i> <b>4.25</b>
----------------------	--------------------	--------------------------------------

Risk Factor	Ranking	Score	Feature	Within Range	Descriptive Field
<i>Channel Stability</i>	Good	0.5	303(d)	No	N/A
<i>Channel Alteration</i>	None	0	Wetland Species	Yes	1-3 FOCAL SPECIES IN UPLAND AREAS
<i>Bank Erosion</i>	Not Eroding	0	Rare and Imperiled	Yes	BLUENOSE SHINER, IRONCOLOR SHINER
<i>BEHI</i>	Moderate	0.5	Land Use/Cover	Yes	N/A/ WETLAND FORESTED MIXED
<i>Local NPSP</i>	Moderate Potential	1	Candidate Mussels	Yes	NARROW PIGTOE
<i>Shoring Structures</i>	Present	1.5	Sturgeon C.H.	No	N/A
<i>Pipe Discharge</i>	Not Present	0	<b>Additional Site Features</b>		
<i>Water Odors</i>	Not Present	0	<i>Stream Channel Woody Material:</i> Infrequent		
<i>Fish Passage Barrier</i>	Not Present	0	<i>Impoundments:</i> None		
<i>RB: Riparian Buffer</i>	100+ ft	0	<i>Substrate Composition:</i> Medium Sand		
<i>LB: Riparian Buffer</i>	0-29 ft	0.75	<i>Bank Material:</i> Sand		
<i>RB: Floodplain Access</i>	Full	0			
<i>LB: Floodplain Access</i>	Full	0

Notes: The public boat launch is frequented for AFB training. Team observed multiple Hummers at launch as well as witnessed closing of the road for the final mission for Ranger School. Boat launch is composed of about five percent concrete. Road leading to boat launch is within the flood plain and frequently flooded. Difficult to drive.

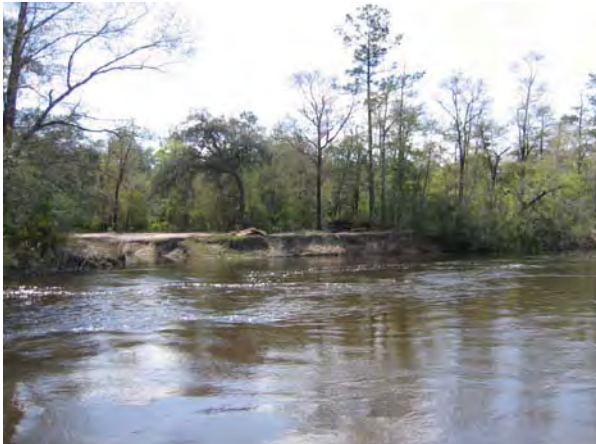
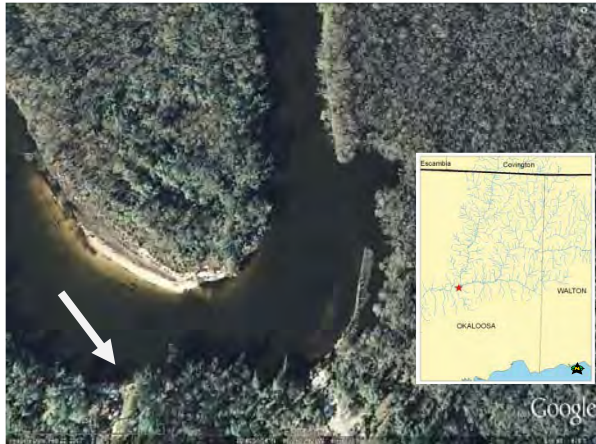
Yellow River		ok-0319-002	Severity Score 3.75	
<u>Common:</u> 7.4mi SW of Crestview <u>Drainage:</u> Blackwater Bay <u>GPS:</u> 30.680552, -86.651965 <u>Land owner:</u> USA- Eglin AFB		<u>County:</u> Okaloosa <u>State:</u> Florida <u>PLSS(T-R-S):</u> 2N-16W-16 <u>Parcel No.:</u> 1

LB				
Risk Factor	Ranking	Score	Feature Within Range Descriptive Field	
<i>Channel Stability</i>	Good	0.5	303(d) No N/A	
<i>Channel Alteration</i>	None	0	Wetland Species Yes 1-3 FOCAL SPECIES IN UPLAND AREAS	
<i>Bank Erosion</i>	Historic	1	Rare and Imperiled Yes ALABAMA SHAD, ALLIGATOR GAR, BLUENOSE SHINER, GULF STURGEON, SPECKLED CHUB, IRONCOLOR SHINER, SPOTTED BULLHEAD, SPECKLED DARTER	
<i>BEHI</i>	Moderate	0.5	Sturgeon Spawning No N/A/ STREAMS AND WATERWAYS	
<i>Local NPSP</i>	Moderate Potential	1	Candidate Mussels Yes NARROW PIGTOE	
<i>Shoring Structures</i>	Not Present	0	Sturgeon C.H. Yes N/A	
<i>Pipe Discharge</i>	Not Present	0	<b>Additional Site Features</b>

<i>Water Odors</i>	Not Present	0	<i>Stream Channel Woody Material:</i> Moderate	
<i>Fish Passage Barrier</i>	Not Present	0	<i>Impoundments:</i> None	
<i>RB: Riparian Buffer</i>	100+ ft	0	<i>Substrate Composition:</i> Medium Sand	
<i>LB: Riparian Buffer</i>	0-29 ft	0.75	<i>Bank Material:</i> Sand	
<i>RB: Floodplain Access</i>	Full	0		
<i>LB: Floodplain Access</i>	Full	0		
<b>River Threat Index:</b>		<b>3.75</b>

Notes: Eglin AFB Gin Hole Landing recreational site. Found shotgun shells on the bank. Scar of improvised boat launch? Evidence of camp fires. Top of LB is clear.

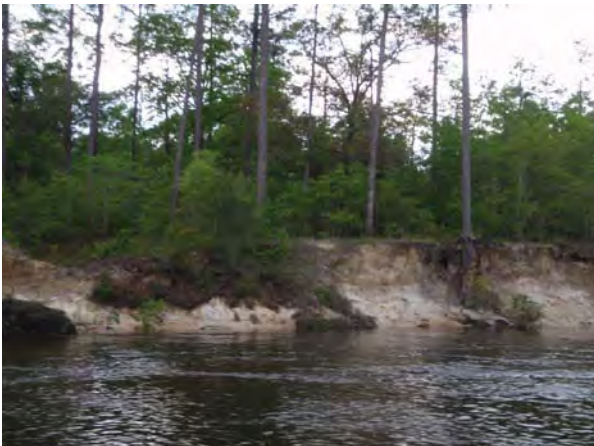
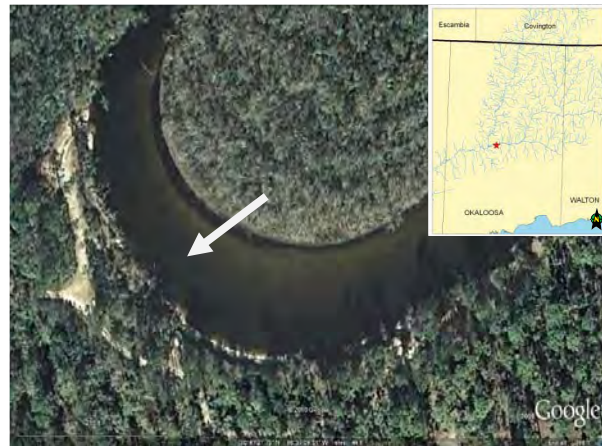
<b>Shoal River</b>	<b>ok-0421-003</b>	<i>Severity Score</i> <b>3.5</b>
--------------------	--------------------	-------------------------------------

Risk Factor	Ranking	Score	Feature	Within Range	Descriptive Field
<i>Channel Stability</i>	Fair	1	303(d)	No	N/A
<i>Channel Alteration</i>	None	0	<b>Wetland Species</b>	Yes	1-3 FOCAL SPECIES IN UPLAND AREAS
<i>Bank Erosion</i>	Not eroding	0	<b>Rare and Imperiled</b>	Yes	GOLDSTRIPE DARTER, IRONCOLOR SHINER, SPECKLED CHUB
<i>BEHI</i>	High	1	<b>Land Use/Cover</b>	Yes	N/A/ STREAMS AND WATERWAYS
<i>Local NPSP</i>	No Evidence	0	<b>Candidate Mussels</b>	No	N/A
<i>Shoring Structures</i>	Not Present	0	<b>Sturgeon C.H.</b>	Yes	N/A
<i>Pipe Discharge</i>	Not Present	0	<b>Additional Site Features</b>		
<i>Water Odors</i>	Not Present	0	<i>Stream Channel Woody Material:</i> Moderate		
<i>Fish Passage Barrier</i>	Not Present	0	<i>Impoundments:</i> None		
<i>RB: Riparian Buffer</i>	100+ ft	0	<i>Substrate Composition:</i> Medium Sand		
<i>LB: Riparian Buffer</i>	0-29 ft	0.75	<i>Bank Material:</i> Sand		
<i>RB: Floodplain Access</i>	Full	0

<i>LB: Floodplain Access</i>	None	0.75			
<b>River Threat Index:</b>		<b>3.5</b>

Notes: Road adjacent to eroded bank, contributing

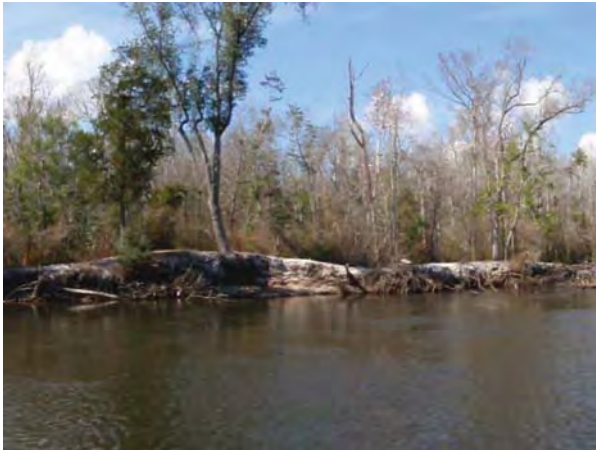
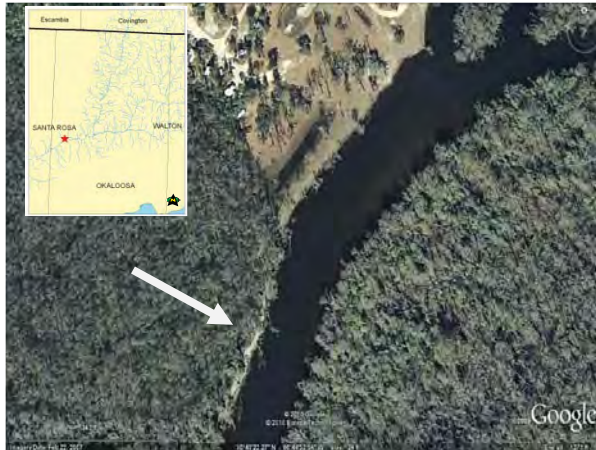
<p>RB</p>					
Risk Factor	Ranking	Score	Feature	Within Range	Descriptive Field
Channel Stability	Fair	1	303(d)	No	N/A
Channel Alteration	None	0	Wetland Species	Yes	1-3 FOCAL SPECIES IN UPLAND AREAS
Bank Erosion	Active	1	Rare and Imperiled	Yes	ALABAMA SHAD, ALLIGATOR GAR, BLUENOSE SHINER, GULF STURGEON, SPECKLED CHUB, IRONCOLOR SHINER, SPOTTED BULLHEAD, SPECKLED DARTER
BEHI	High	1	Land Use/ Cover	Yes	N/A/ STREAMS AND WATERWAYS
Local NPSP	Slight	0.5	Candidate Mussels	No	N/A
Shoring Structures	Not Present	0	Sturgeon C.H.	Yes	N/A

Pipe Discharge	Not Present	0	<b>Additional Site Features</b>		
Water Odors	Not Present	0	<u>Stream Channel Woody Material:</u> Moderate		
Fish Passage Barrier	Not Present	0	<u>Impoundments:</u> None		
RB: Riparian Buffer	100+ ft	0	<u>Substrate Composition:</u> Medium Sand		
LB: Riparian Buffer	100+ ft	0	<u>Bank Material:</u> Sand		
RB: Floodplain Access	Full	0			
LB: Floodplain Access	Full	0			
		<b>River Threat Index:</b>	<b>3.5</b>

Notes: This site is the south end of a foot path coming from the River's Edge Campground, pictured in the northeast corner of the aerial photo.

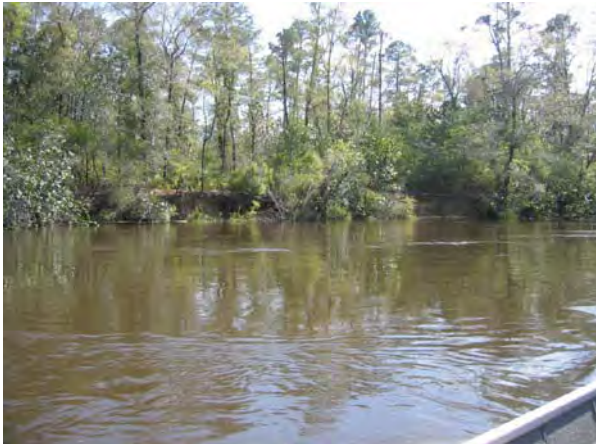
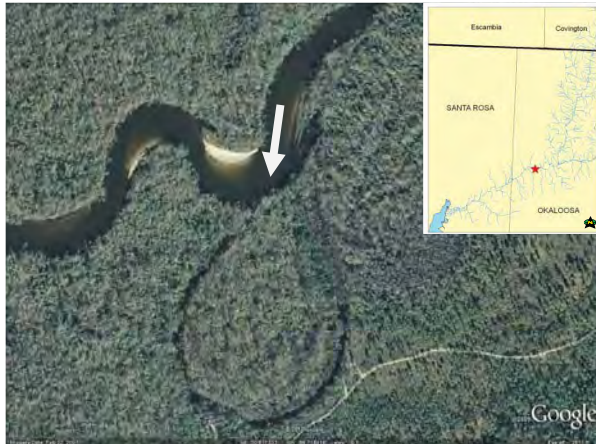
Yellow River		ok-0319-007	Severity Score 2.5
<i>Common:</i> 7.4mi SW of Crestview		<i>County:</i> Okaloosa	<i>State:</i> Florida
<i>Drainage:</i> Blackwater Bay <i>GPS:</i> 30.672025, -86.719466		<i>PLSS:</i> 2N-25W-14	
<i>Land owner:</i> RB: NFWFMD / LB: USA		<i>Parcel No.:</i> 1 / 2

LB			
Risk Factor	Ranking	Score	Feature Within Range Descriptive Field
<i>Channel Stability</i>	Fair	1	303(d) No N/A
<i>Channel Alteration</i>	None	0	Wetland Species Yes 1-3 FOCAL SPECIES IN UPLAND AREAS
<i>Bank Erosion</i>	Active	1	Rare and Imperiled Yes ALABAMA SHAD, ALLIGATOR GAR, BLUENOSE SHINER, GULF STURGEON, SPECKLED CHUB, IRONCOLOR SHINER, SPOTTED BULLHEAD, SPECKLED DARTER
<i>BEHI</i>	Moderate	0.5	Land Use/Cover Yes N/A/ STREAMS AND WATERWAYS
<i>Local NPSP</i>	No Evidence	0	Candidate Mussels No N/A
<i>Shoring Structures</i>	Not Present	0	Sturgeon C.H. Yes N/A
<i>Pipe Discharge</i>	Not Present	0	<b>Additional Site Features</b>

<i>Water Odors</i>	Not Present	0	<i>Stream Channel Woody Material:</i> Moderate
<i>Fish Passage Barrier</i>	Not Present	0	<i>Impoundments:</i> None
<i>RB: Riparian Buffer</i>	100+ ft	0	<i>Substrate Composition:</i> Clay Marl
<i>LB: Riparian Buffer</i>	100+ ft	0	<i>Bank Material:</i> Clay Marl
<i>RB: Floodplain Access</i>	Full	0	
<i>LB: Floodplain Access</i>	Full	0	
<b>River Threat Index:</b>		<b>2.5</b>

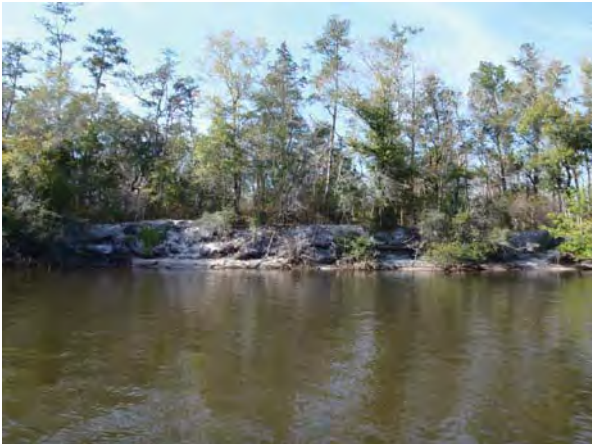
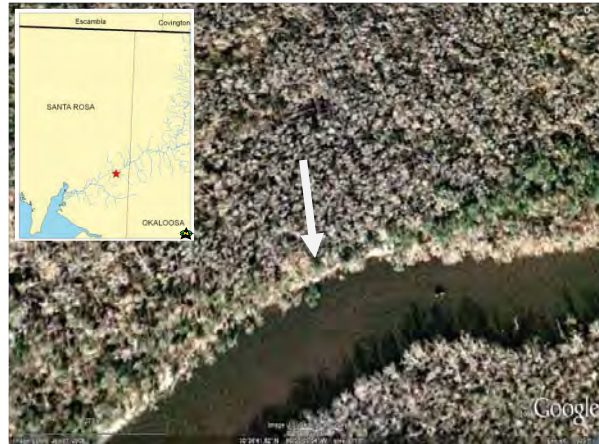
<b>Yellow River</b>	<b>sr-0305-005</b>	<i>Severity Score</i> <b>2</b>
---------------------	--------------------	-----------------------------------

Risk Factor	Ranking	Score	Feature	Within Range	Descriptive Field
<i>Channel Stability</i>	Fair	1	303(d)	No	N/A
<i>Channel Alteration</i>	None	0	<b>Wetland Species</b>	Yes	1-3 FOCAL SPECIES IN UPLAND AREAS
<i>Bank Erosion</i>	Historic	0.5	<b>Rare and Imperiled</b>	Yes	ALABAMA SHAD, GULF STURGEON, ALLIGATOR GAR, SPOTTED BULLHEAD, BLUENOSE SHINER, GOLDSTRIPE DARTER, IRONCOLOR SHINER, SPECKLED CHUB
<i>BEHI</i>	Moderate	0.5	<b>Land Use/Cover</b>	Yes	N/A/ STREAMS AND WATERWAYS
<i>Local NPSP</i>	No Evidence	0	<b>Candidate Mussels</b>	No	N/A
<i>Shoring Structures</i>	Not Present	0	<b>Sturgeon C.H.</b>	Yes	N/A
<i>Pipe Discharge</i>	Not Present	0	<b>Additional Site Features</b>		
<i>Water Odors</i>	Not Present	0	<i>Stream Channel Woody Material:</i> Moderate		
<i>Fish Passage Barrier</i>	Not Present	0	<i>Impoundments:</i> None		
<i>RB: Riparian Buffer</i>	100+ ft	0	<i>Substrate Composition:</i> Medium Sand

<i>LB: Riparian Buffer</i>	100+ ft	0	<i>Bank Material:</i> Sand		
<i>RB: Floodplain Access</i>	Full	0			
<i>LB: Floodplain Access</i>	Full	0			
<b>River Threat Index:</b>		<b>2</b>

Notes: Natural feature

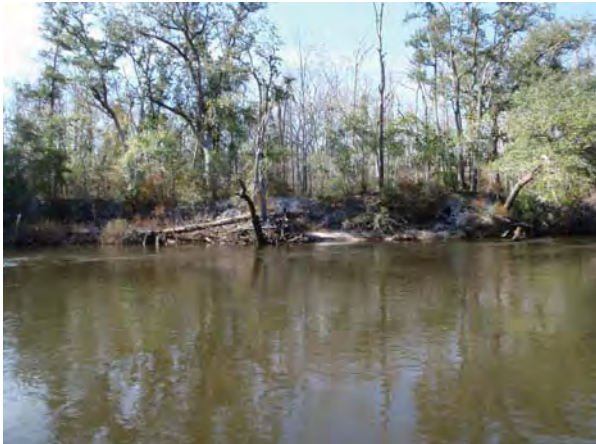
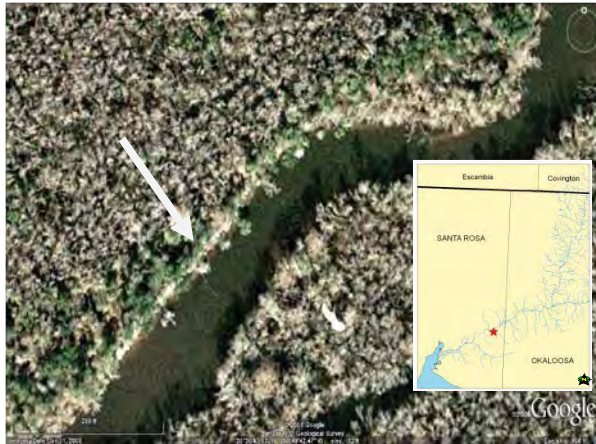
<b>RB</b>																																																																																		
<table border="1"> <thead> <tr> <th>Risk Factor</th> <th>Ranking</th> <th>Score</th> </tr> </thead> <tbody> <tr> <td><i>Channel Stability</i></td> <td>Fair</td> <td>1</td> </tr> <tr> <td><i>Channel Alteration</i></td> <td>None</td> <td>0</td> </tr> <tr> <td><i>Bank Erosion</i></td> <td>Historic</td> <td>0.5</td> </tr> <tr> <td><i>BEHI</i></td> <td>Low-Very Low</td> <td>0</td> </tr> <tr> <td><i>Local NPSP</i></td> <td>No Evidence</td> <td>0</td> </tr> <tr> <td><i>Shoring Structures</i></td> <td>Not Present</td> <td>0</td> </tr> <tr> <td><i>Pipe Discharge</i></td> <td>Not Present</td> <td>0</td> </tr> <tr> <td><i>Water Odors</i></td> <td>Not Present</td> <td>0</td> </tr> <tr> <td><i>Fish Passage Barrier</i></td> <td>Not Present</td> <td>0</td> </tr> <tr> <td><i>RB: Riparian Buffer</i></td> <td>100+ ft</td> <td>0</td> </tr> <tr> <td><i>LB: Riparian Buffer</i></td> <td>100+ ft</td> <td>0</td> </tr> <tr> <td><i>RB: Floodplain Access</i></td> <td>Full</td> <td>0</td> </tr> <tr> <td><i>LB: Floodplain Access</i></td> <td>Full</td> <td>0</td> </tr> <tr> <td colspan="2"><b>River Threat Index:</b></td> <td><b>1.5</b></td> </tr> </tbody> </table>	Risk Factor	Ranking	Score	<i>Channel Stability</i>	Fair	1	<i>Channel Alteration</i>	None	0	<i>Bank Erosion</i>	Historic	0.5	<i>BEHI</i>	Low-Very Low	0	<i>Local NPSP</i>	No Evidence	0	<i>Shoring Structures</i>	Not Present	0	<i>Pipe Discharge</i>	Not Present	0	<i>Water Odors</i>	Not Present	0	<i>Fish Passage Barrier</i>	Not Present	0	<i>RB: Riparian Buffer</i>	100+ ft	0	<i>LB: Riparian Buffer</i>	100+ ft	0	<i>RB: Floodplain Access</i>	Full	0	<i>LB: Floodplain Access</i>	Full	0	<b>River Threat Index:</b>		<b>1.5</b>	<table border="1"> <thead> <tr> <th>Feature</th> <th>Within Range</th> <th>Descriptive Field</th> </tr> </thead> <tbody> <tr> <td>303(d)</td> <td>No</td> <td>N/A</td> </tr> <tr> <td>Wetland Species</td> <td>Yes</td> <td>1-3 FOCAL SPECIES IN UPLAND AREAS</td> </tr> <tr> <td>Rare and Imperiled</td> <td>Yes</td> <td>ALABAMA SHAD, GULF STURGEON, ALLIGATOR GAR, SPOTTED BULLHEAD, BLUENOSE SHINER, GOLDSTRIPE DARTER, IRONCOLOR SHINER, SPECKLED CHUB</td> </tr> <tr> <td>Land Use/Cover</td> <td>Yes</td> <td>N/A/ STREAMS AND WATERWAYS</td> </tr> <tr> <td>Candidate Mussels</td> <td>No</td> <td>N/A</td> </tr> <tr> <td>Sturgeon C.H.</td> <td>Yes</td> <td>N/A</td> </tr> <tr> <td colspan="3"><b>Additional Site Features</b></td> </tr> <tr> <td colspan="2"><i>Stream Channel Woody Material:</i></td> <td>Numerous</td> </tr> <tr> <td colspan="2"><i>Impoundments:</i></td> <td>None</td> </tr> <tr> <td colspan="2"><i>Substrate Composition:</i></td> <td>Medium Sand</td> </tr> <tr> <td colspan="2"><i>Bank Material:</i></td> <td>Sand</td> </tr> </tbody> </table>	Feature	Within Range	Descriptive Field	303(d)	No	N/A	Wetland Species	Yes	1-3 FOCAL SPECIES IN UPLAND AREAS	Rare and Imperiled	Yes	ALABAMA SHAD, GULF STURGEON, ALLIGATOR GAR, SPOTTED BULLHEAD, BLUENOSE SHINER, GOLDSTRIPE DARTER, IRONCOLOR SHINER, SPECKLED CHUB	Land Use/Cover	Yes	N/A/ STREAMS AND WATERWAYS	Candidate Mussels	No	N/A	Sturgeon C.H.	Yes	N/A	<b>Additional Site Features</b>			<i>Stream Channel Woody Material:</i>		Numerous	<i>Impoundments:</i>		None	<i>Substrate Composition:</i>		Medium Sand	<i>Bank Material:</i>		Sand

Notes: Natural feature.

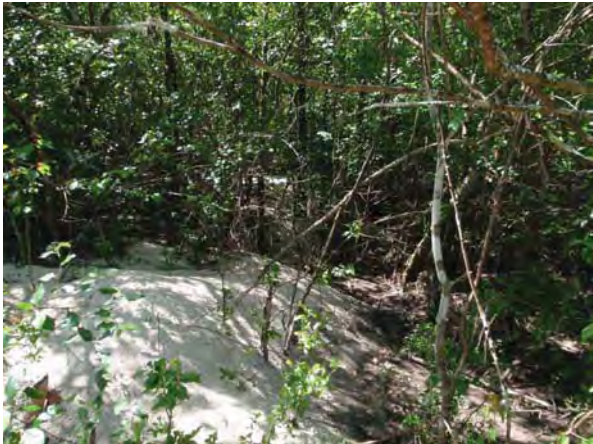
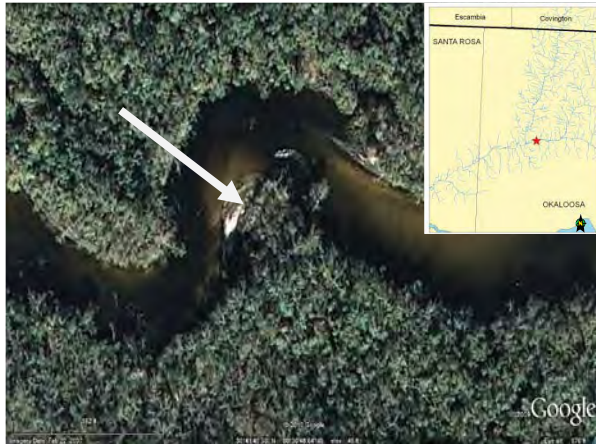
Shoal River		ok-0422-001		Severity Score 1.5	
<u>Common:</u> 5.3mi SW of Crestview		<u>County:</u> Okaloosa		<u>State:</u> Florida	
<u>Drainage:</u> Yellow River		<u>PLSS:</u> 2N-24W-11			
<u>Land owner:</u> USA		<u>Parcel No.:</u> 1

<b>LB</b>					
Risk Factor	Ranking	Score	Feature	Within Range	Descriptive Field
<i>Channel Stability</i>	Poor	1.5	303(d)	No	N/A
<i>Channel Alteration</i>	None	0	Wetland Species	Yes	1-3 FOCAL SPECIES IN UPLAND AREAS
<i>Bank Erosion</i>	Not eroding	0	Rare and Imperiled	Yes	GOLDSTRIPE DARTER, IRONCOLOR SHINER, SPECKLED CHUB
<i>BEHI</i>	Low-Very Low	0	Land Use/Cover	Yes	N/A/ STREAMS AND WATERWAYS
<i>Local NPSP</i>	No Evidence	0	Candidate Mussels	No	N/A
<i>Shoring Structures</i>	Not Present	0	Sturgeon C.H.	Yes	N/A
<i>Pipe Discharge</i>	Not Present	0	<b>Additional Site Features</b>		
<i>Water Odors</i>	Not Present	0	<i>Stream Channel Woody Material:</i> Numerous

<i>Fish Passage Barrier</i>	Not Present	0	<i>Impoundments:</i> None		
<i>RB: Riparian Buffer</i>	100+ ft	0	<i>Substrate Composition:</i> Coarse Sand		
<i>LB: Riparian Buffer</i>	100+ ft	0	<i>Bank Material:</i> Sand		
<i>RB: Floodplain Access</i>	Full	0			
<i>LB: Floodplain Access</i>	Full	0			
<b>River Threat Index:</b>		<b>1.5</b>

Notes: Aggradational Site: Large, fresh deposit extended into forest- 4 in of fine sand and about 1 inch of coarse sand result of recent heavy rains and flooding.

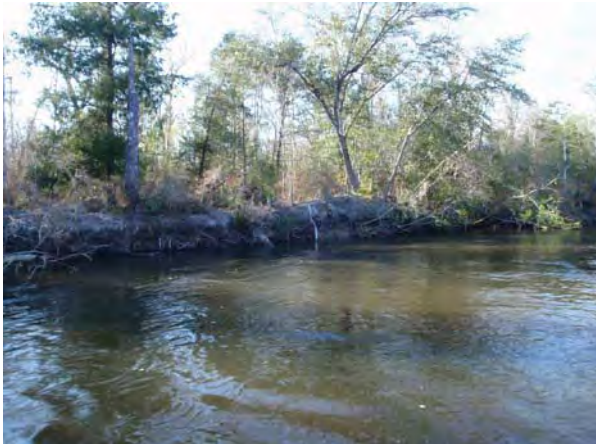
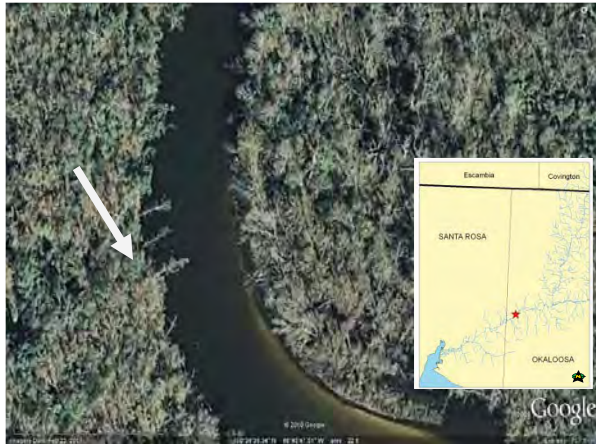
Yellow River		ok-0224-002	Severity Score 1.5
<u>Common:</u> 16.6mi NE of Bagdad <u>Drainage:</u> Blackwater Bay <u>GPS:</u> 30.658450, -86.763867 <u>Land owner:</u> RB: NFWFMD / LB: USA- Eglin AFB		<u>County:</u> Okaloosa <u>State:</u> Florida <u>PLSS:</u> 2N-25W-20 <u>Parcel No.:</u> 1.001/ 3

<b>RB</b>			
Risk Factor	Ranking	Score	Feature Within Range Descriptive Field
<i>Channel Stability</i>	Good	0.5	303(d) No N/A
<i>Channel Alteration</i>	None	0	Wetland Species Yes 1-3 FOCAL SPECIES IN UPLAND AREAS
<i>Bank Erosion</i>	Historic	0.5	Rare and Imperiled Yes ALABAMA SHAD, ALLIGATOR GAR, BLUENOSE SHINER, GULF STURGEON, SPECKLED CHUB, IRONCOLOR SHINER, SPOTTED BULLHEAD, SPECKLED DARTER
<i>BEHI</i>	Moderate	0.5	
<i>Local NPSP</i>	No Evidence	0	
<i>Shoring Structures</i>	Not Present	0	Land Use/ Cover Yes N/A/ STREAMS AND LAKE SWAMPS (BOTTOMLAND)
<i>Pipe Discharge</i>	Not Present	0	
<i>Water Odors</i>	Not Present	0	Candidate Mussels No N/A

<i>Fish Passage Barrier</i>	Not Present	0	Sturgeon C.H. Yes N/A
<i>RB: Riparian Buffer</i>	100+ ft	0	
<i>LB: Riparian Buffer</i>	100+ ft	0	
<i>RB: Floodplain Access</i>	Full	0	
<i>LB: Floodplain Access</i>	Full	0	
<b>River Threat Index:</b>		<b>1.5</b>	<b>Additional Site Features</b> <i>Stream Channel Woody Material:</i> Moderate <i>Impoundments:</i> None <i>Substrate Composition:</i> Medium Sand <i>Bank Material:</i> Sand, Mud, and Roots
