Appendix A. River corridor severity scores for impaired sites in the Yellow River Basin, Alabama and Florida

Appendix C. Clear Creek Watershed Focal Area. Sites with orange headings are unpaved road sites. Specific definitions and calculations described for calculating the Sediment Risk Index (SRI) are detailed in Witmer (2009).

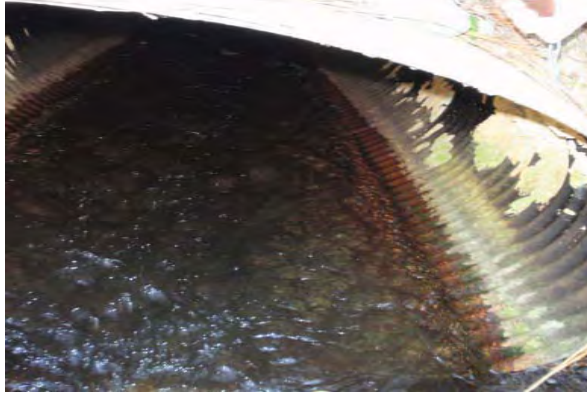
<b>Camp Creek</b>	<b>ok-0407-r-007</b>	<b>Sedimentation Risk Index</b> <b>34</b>
-------------------	----------------------	--

Risk Factor	Ranking	Score
<i>US Channel Morph</i>	PONDED	1
<i>DS Channel Morph</i>	E	5
<i>DS Bank Alteration</i>	HIGH	1
<i>Upstream Skew Angle</i>	>30°	1
<i>Crossing fill condition</i>	Good/Vegetated	5
<i>Inlet/Outlet Condition</i>	No Impairment	5
<i>Road Approach Material</i>	All Sand/Clay	3
<i>Potential Eroded Volume Mean</i>	>40 y <sup>3</sup>	1
<i>Approach Slope Mean</i>	2.1-4%	3
<i>Soil K Factor</i>	<0.20	5
<i>Upstream Rt Outlet</i>	Bare soil	0
<i>Upstream Lt Outlet</i>	Bare soil	0
<i>Upstream Rt Ditch</i>	Bare soil	0
<i>Upstream Lt Ditch</i>	Bare soil	0
<i>Downstream Rt Outlet</i>	Vegetated	1
<i>Downstream Lt Outlet</i>	Vegetated	1
<i>Downstream Rt Ditch</i>	Bare soil	0
<i>Downstream Lt Ditch</i>	Bare soil	0
<i>Outlet Total</i>	Partially Improved Outlet System	3
<i>Ditches Total</i>	Unimproved Drainage System	1
<b>SRI Total</b>	<b>High Risk</b>	<b>34</b>

Notes: Failing BMPs installed DS. Unnaturally ponded as a result of undersized

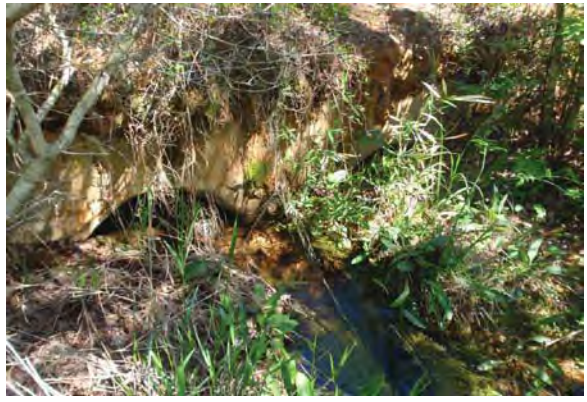
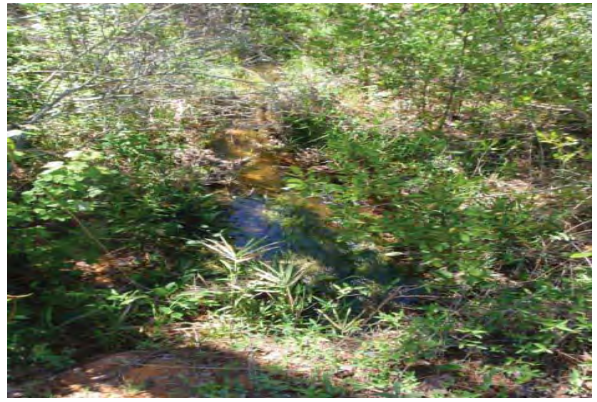
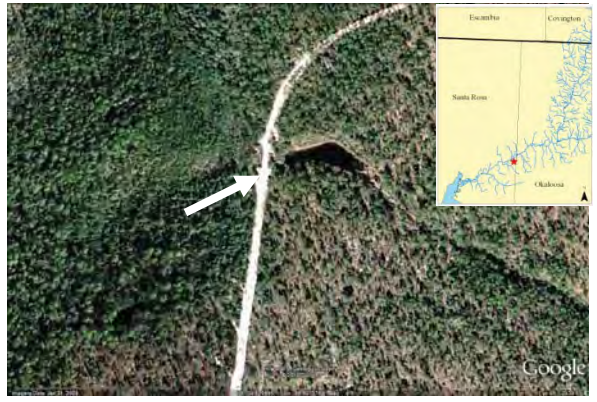
Crossing Structure: DS

Risk Factor	Ranking	Score
<i>US Channel Morph</i>	PONDED	1
<i>DS Channel Morph</i>	E	5
<i>DS Bank Alteration</i>	MINOR/PARTIAL	3
<i>Upstream Skew Angle</i>	<5°	5
<i>Crossing fill condition</i>	Poor/Bare soil	1
<i>Inlet/Outlet Condition</i>	Blocked	1
<i>Road Approach Material</i>	All Sand/Clay	3
<i>Potential Eroded Volume Mean</i>	>40 y <sup>3</sup>	1
<i>Approach Slope Mean</i>	2.1-4%	3
<i>Soil K Factor</i>	<0.20	5
<i>Upstream Rt Outlet</i>	Bare soil	0
<i>Upstream Lt Outlet</i>	Bare soil	0
<i>Upstream Rt Ditch</i>	Bare soil	0
<i>Upstream Lt Ditch</i>	Bare soil	0
<i>Downstream Rt Outlet</i>	Bare soil	0
<i>Downstream Lt Outlet</i>	Bare soil	0
<i>Downstream Rt Ditch</i>	Bare soil	0
<i>Downstream Lt Ditch</i>	Bare soil	0
<i>Outlet Total</i>	Unimproved Outlet System	1
<i>Ditches Total</i>	Unimproved Drainage System	1
<b>SRI Total</b>	<b>High Risk</b>	<b>30</b>

Notes: Failing BMPs installed. 1 culvert blocked 1 clear

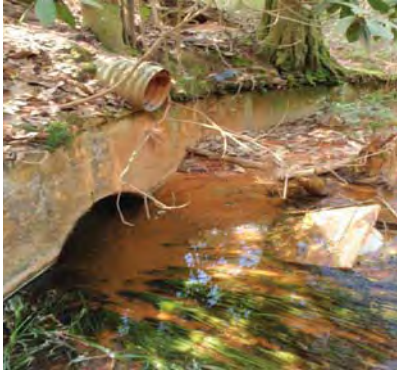
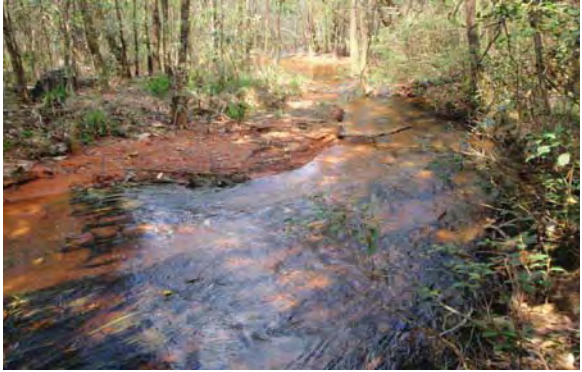
Crossing Structure: DS		DS																						
<b>Risk Factor</b>	<b>Ranking</b>	<b>Score</b>																						
<i>US Channel Morph</i>	E	5																						
<i>DS Channel Morph</i>	DA	3																						
<i>DS Bank Alteration</i>	MINOR/PARTIAL	3																						
<i>Upstream Skew Angle</i>	<5°	5																						
<i>Crossing fill condition</i>	Good/Vegetated	5																						
<i>Inlet/Outlet Condition</i>	Sed Islands/Scouring	3																						
<i>Road Approach Material</i>	All Sand/Clay	3																						
<i>Potential Eroded Volume Mean</i>	>40 y <sup>3</sup>	1																						
<i>Approach Slope Mean</i>	>4%	1																						
<i>Soil K Factor</i>	<0.20	5																						
<i>Upstream Rt Outlet</i>	Bare soil	0																						
<i>Upstream Lt Outlet</i>	Bare soil	0																						
<i>Upstream Rt Ditch</i>	Bare soil	0																						
<i>Upstream Lt Ditch</i>	Bare soil	0																						
<i>Downstream Rt Outlet</i>	Bare soil	0																						
<i>Downstream Lt Outlet</i>	Bare soil	0																						
<i>Downstream Rt Ditch</i>	Bare soil	0																						
<i>Downstream Lt Ditch</i>	Bare soil	0																						
<i>Outlet Total</i>	Unimproved Outlet System	1																						
<i>Ditches Total</i>	Unimproved Drainage System	1																						
<i>SRI Total</i>	<b>High Risk</b>	<b>36</b>																						
<b>Additional Site Features</b>

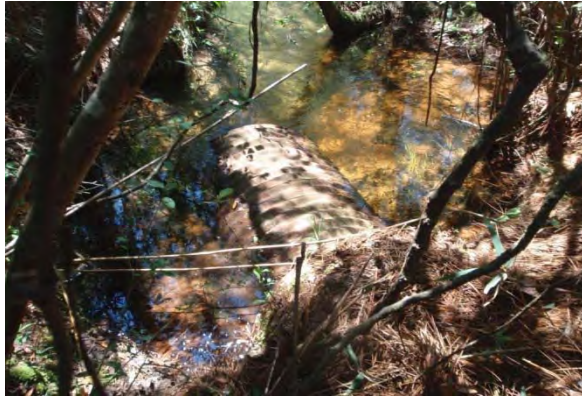
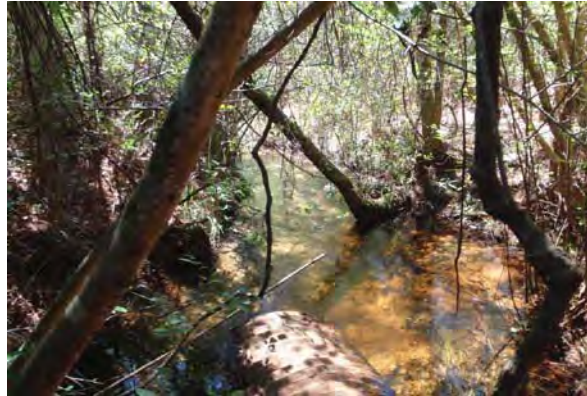
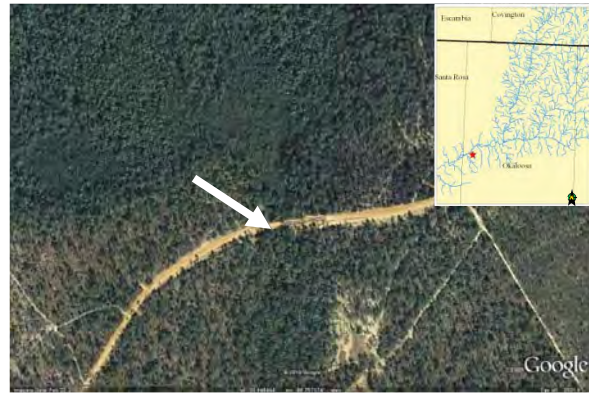
Crossing Structure: US

Risk Factor	Ranking	Score
<i>US Channel Morph</i>	E	5
<i>DS Channel Morph</i>	E	5
<i>DS Bank Alteration</i>	MINOR/PARTIAL	3
<i>Upstream Skew Angle</i>	5-30°	3
<i>Crossing fill condition</i>	Good/Vegetated	5
<i>Inlet/Outlet Condition</i>	No Impairment	5
<i>Road Approach Material</i>	All Sand/Clay	3
<i>Potential Eroded Volume Mean</i>	>40 y <sup>3</sup>	1
<i>Approach Slope Mean</i>	>4%	1
<i>Soil K Factor</i>	<0.20	5
<i>Upstream Rt Outlet</i>	Vegetated	1
<i>Upstream Lt Outlet</i>	Bare soil	0
<i>Upstream Rt Ditch</i>	Bare soil	0
<i>Upstream Lt Ditch</i>	Bare soil	0
<i>Downstream Rt Outlet</i>	Bare soil	0
<i>Downstream Lt Outlet</i>	Vegetated	1
<i>Downstream Rt Ditch</i>	Bare soil	0
<i>Downstream Lt Ditch</i>	Bare soil	0
<i>Outlet Total</i>	Partially Improved Outlet System	3
<i>Ditches Total</i>	Unimproved Drainage System	1
<b>SRI Total</b>	<b>Medium Risk</b>	<b>40</b>
<b>Additional Site Features</b>		
<i>Crossing Type and Quantity:</i>	Culvert, 1

Notes: Failing BMPs installed. Culvert undersized for flow affecting skew angle.

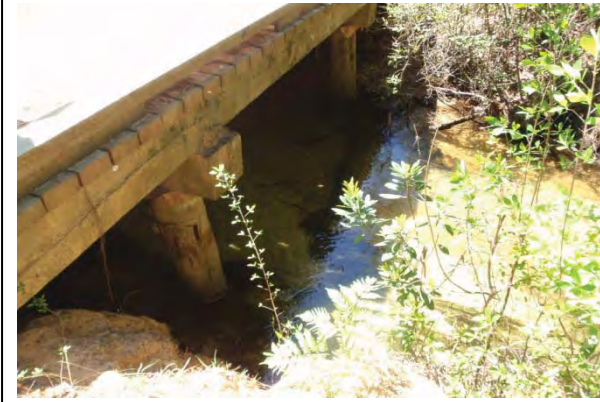
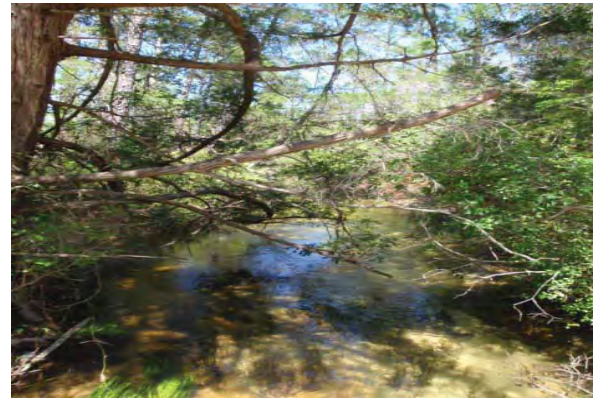
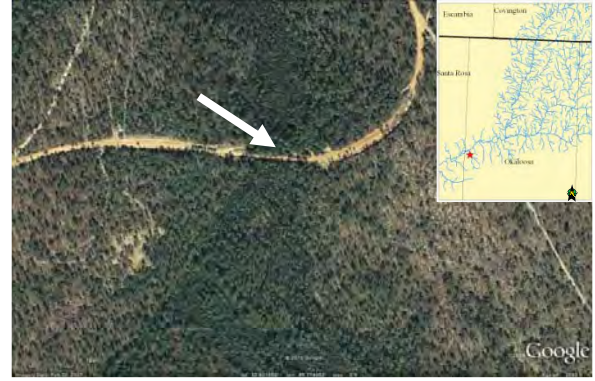
Crossing Structure: US

Risk Factor	Ranking	Score
<i>US Channel Morph</i>	E	5
<i>DS Channel Morph</i>	E	5
<i>DS Bank Alteration</i>	NATURAL	5
<i>Upstream Skew Angle</i>	<5°	5
<i>Crossing fill condition</i>	Poor/Bare soil	1
<i>Inlet/Outlet Condition</i>	No Impairment	5
<i>Road Approach Material</i>	All Sand/Clay	3
<i>Potential Eroded Volume Mean</i>	>40 y <sup>3</sup>	1
<i>Approach Slope Mean</i>	>4%	1
<i>Soil K Factor</i>	<0.20	5
<i>Upstream Rt Outlet</i>	Vegetated	1
<i>Upstream Lt Outlet</i>	Bare soil	0
<i>Upstream Rt Ditch</i>	Bare soil	0
<i>Upstream Lt Ditch</i>	Bare soil	0
<i>Downstream Rt Outlet</i>	Bare soil	0
<i>Downstream Lt Outlet</i>	Bare soil	0
<i>Downstream Rt Ditch</i>	Bare soil	0
<i>Downstream Lt Ditch</i>	Bare soil	0
<i>Outlet Total</i>	Partially Improved Outlet System	3
<i>Ditches Total</i>	Unimproved Drainage System	1
<b>SRI Total</b>	<b>Medium Risk</b>	<b>40</b>

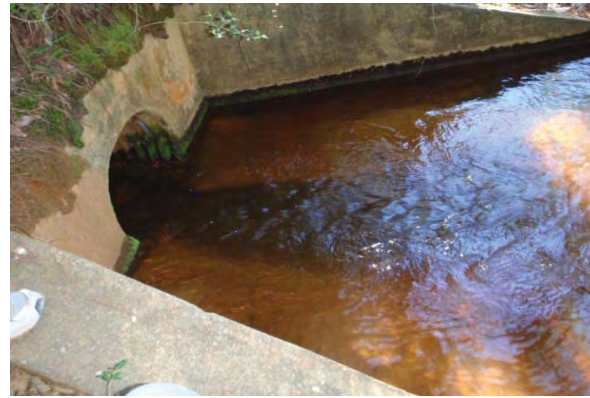
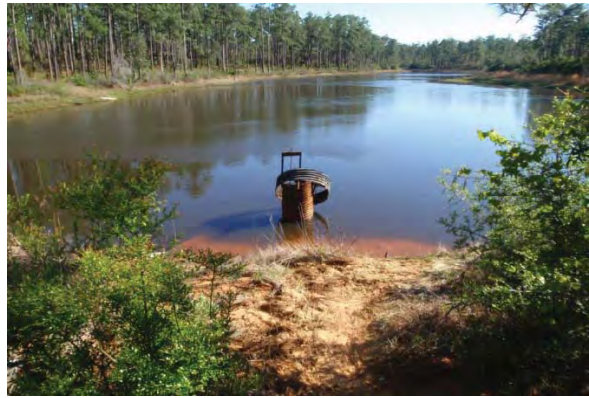
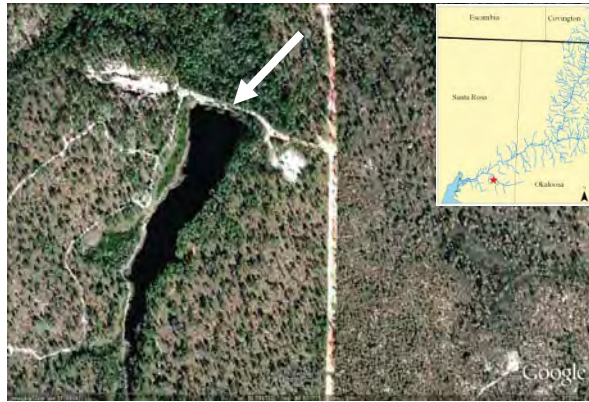
Crossing Structure: DS

Risk Factor	Ranking	Score
<i>US Channel Morph</i>	PONDED	1
<i>DS Channel Morph</i>	E	5
<i>DS Bank Alteration</i>	MINOR/PARTIAL	3
<i>Upstream Skew Angle</i>	<5°	5
<i>Crossing fill condition</i>	Good/Vegetated	5
<i>Inlet/Outlet Condition</i>	No Impairment	5
<i>Road Approach Material</i>	All Sand/Clay	3
<i>Potential Eroded Volume Mean</i>	>40 y <sup>3</sup>	1
<i>Approach Slope Mean</i>	<2%	5
<i>Soil K Factor</i>	<0.20	5
<i>Upstream Rt Outlet</i>	Bare soil	0
<i>Upstream Lt Outlet</i>	Bare soil	0
<i>Upstream Rt Ditch</i>	Bare soil	0
<i>Upstream Lt Ditch</i>	Bare soil	0
<i>Downstream Rt Outlet</i>	Bare soil	0
<i>Downstream Lt Outlet</i>	Bare soil	0
<i>Downstream Rt Ditch</i>	Bare soil	0
<i>Downstream Lt Ditch</i>	Bare soil	0
<i>Outlet Total</i>	Unimproved Outlet System	1
<i>Ditches Total</i>	Unimproved Drainage System	1
<b><i>SRI Total</i></b>	<b>Medium Risk</b>	<b>40</b>

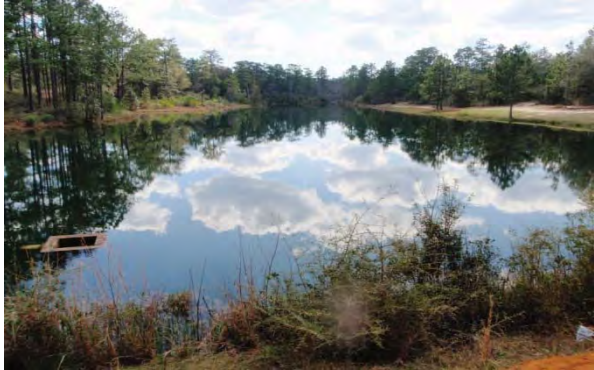
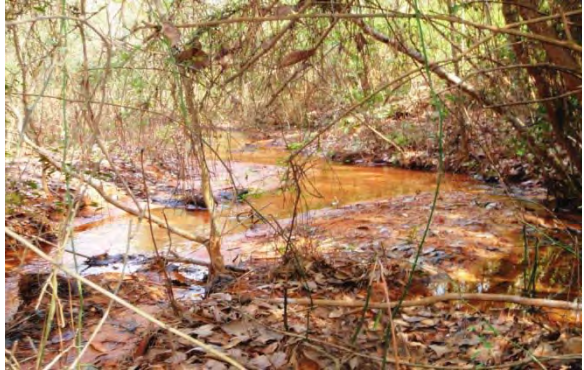
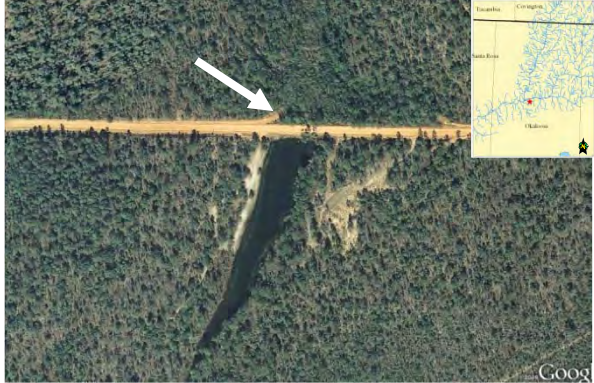
<b>Crossing Structure- US</b>		<b>DS</b>																																																																			
<table border="1"> <thead> <tr> <th>Risk Factor</th> <th>Ranking</th> <th>Score</th> </tr> </thead> <tbody> <tr><td>US Channel Morph</td><td>PONDED</td><td>1</td></tr> <tr><td>DS Channel Morph</td><td>C</td><td>5</td></tr> <tr><td>DS Bank Alteration</td><td>MINOR/PARTIAL</td><td>3</td></tr> <tr><td>Upstream Skew Angle</td><td>5-30°</td><td>3</td></tr> <tr><td>Crossing fill condition</td><td>Good/Vegetated</td><td>5</td></tr> <tr><td>Inlet/Outlet Condition</td><td>No Impairment</td><td>5</td></tr> <tr><td>Road Approach Material</td><td>All Sand/Clay</td><td>3</td></tr> <tr><td>Potential Eroded Volume Mean</td><td>&gt;40 y<sup>3</sup></td><td>1</td></tr> <tr><td>Approach Slope Mean</td><td>&lt;2%</td><td>5</td></tr> <tr><td>Soil K Factor</td><td>&lt;0.20</td><td>5</td></tr> <tr><td>Upstream Rt Outlet</td><td>Vegetated</td><td>1</td></tr> <tr><td>Upstream Lt Outlet</td><td>Vegetated</td><td>1</td></tr> <tr><td>Upstream Rt Ditch</td><td>Bare soil</td><td>0</td></tr> <tr><td>Upstream Lt Ditch</td><td>Bare soil</td><td>0</td></tr> <tr><td>Downstream Rt Outlet</td><td>Vegetated</td><td>1</td></tr> <tr><td>Downstream Lt Outlet</td><td>Vegetated</td><td>1</td></tr> <tr><td>Downstream Rt Ditch</td><td>Bare soil</td><td>0</td></tr> <tr><td>Downstream Lt Ditch</td><td>Bare soil</td><td>0</td></tr> <tr><td>Outlet Total</td><td>Improved Outlet System</td><td>5</td></tr> <tr><td>Ditches Total</td><td>Unimproved Drainage System</td><td>1</td></tr> <tr><td><b>SRI Total</b></td><td><b>Medium Risk</b></td><td><b>42</b></td></tr> </tbody> </table>		Risk Factor	Ranking	Score	US Channel Morph	PONDED	1	DS Channel Morph	C	5	DS Bank Alteration	MINOR/PARTIAL	3	Upstream Skew Angle	5-30°	3	Crossing fill condition	Good/Vegetated	5	Inlet/Outlet Condition	No Impairment	5	Road Approach Material	All Sand/Clay	3	Potential Eroded Volume Mean	>40 y <sup>3</sup>	1	Approach Slope Mean	<2%	5	Soil K Factor	<0.20	5	Upstream Rt Outlet	Vegetated	1	Upstream Lt Outlet	Vegetated	1	Upstream Rt Ditch	Bare soil	0	Upstream Lt Ditch	Bare soil	0	Downstream Rt Outlet	Vegetated	1	Downstream Lt Outlet	Vegetated	1	Downstream Rt Ditch	Bare soil	0	Downstream Lt Ditch	Bare soil	0	Outlet Total	Improved Outlet System	5	Ditches Total	Unimproved Drainage System	1	<b>SRI Total</b>	<b>Medium Risk</b>	<b>42</b>

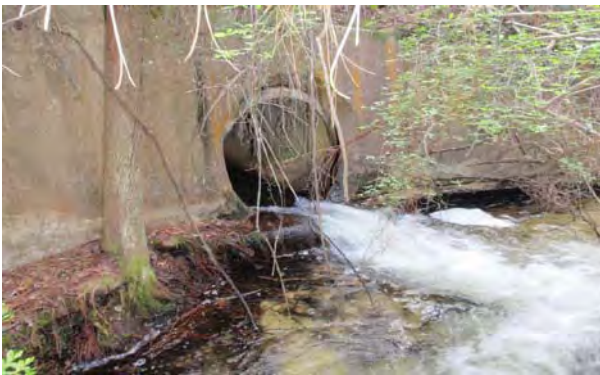
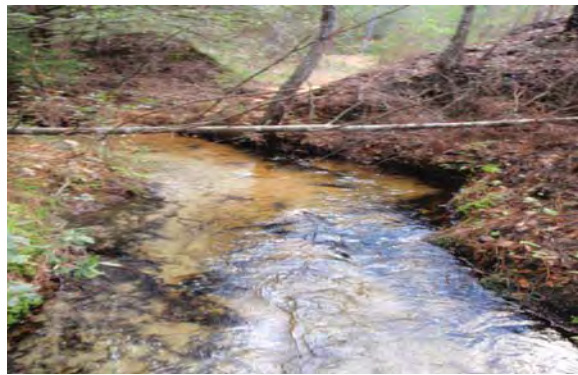
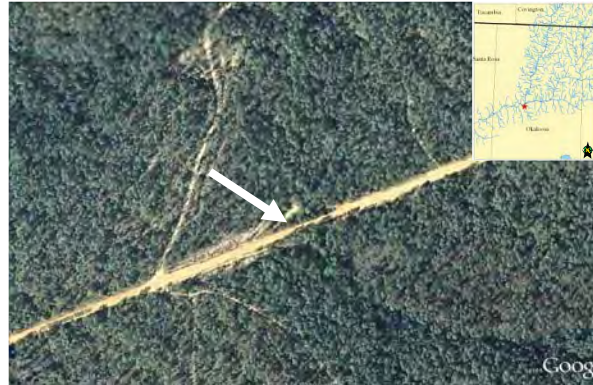
Crossing Structure: DS

Risk Factor	Ranking	Score
<i>US Channel Morph</i>	E	5
<i>DS Channel Morph</i>	C	5
<i>DS Bank Alteration</i>	MINOR/PARTIAL	3
<i>Upstream Skew Angle</i>	5-30°	3
<i>Crossing fill condition</i>	Fair/Riprap	3
<i>Inlet/Outlet Condition</i>	No Impairment	5
<i>Road Approach Material</i>	All Sand/Clay	3
<i>Potential Eroded Volume Mean</i>	>40 y <sup>3</sup>	1
<i>Approach Slope Mean</i>	2.1-4%	3
<i>Soil K Factor</i>	<0.20	5
<i>Upstream Rt Outlet</i>	Vegetated	1
<i>Upstream Lt Outlet</i>	Vegetated	1
<i>Upstream Rt Ditch</i>	Bare soil	0
<i>Upstream Lt Ditch</i>	Bare soil	0
<i>Downstream Rt Outlet</i>	Bare soil	0
<i>Downstream Lt Outlet</i>	Bare soil	0
<i>Downstream Rt Ditch</i>	Vegetated	1
<i>Downstream Lt Ditch</i>	Vegetated	1
<i>Outlet Total</i>	Partially Improved Outlet System	3
<i>Ditches Total</i>	Partially Improved Drainage System	3
<b>SRI Total</b>	<b>Medium Risk</b>	<b>42</b>

Notes: Fish passage barrier due to DS drop off. Located between two lateral roads Gin Hole/Little Gin Hole.

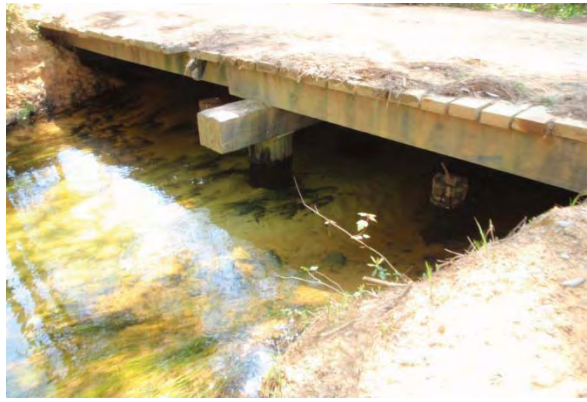
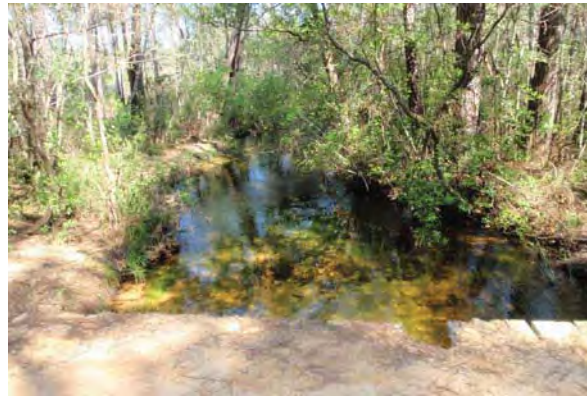
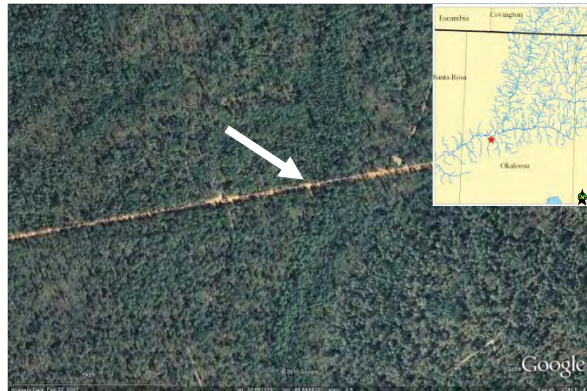
Crossing Structure: DS

Risk Factor	Ranking	Score
<i>US Channel Morph</i>	E	5
<i>DS Channel Morph</i>	E	5
<i>DS Bank Alteration</i>	NATURAL	5
<i>Upstream Skew Angle</i>	<5°	5
<i>Crossing fill condition</i>	Poor/Bare soil	1
<i>Inlet/Outlet Condition</i>	No Impairment	5
<i>Road Approach Material</i>	All Sand/Clay	3
<i>Potential Eroded Volume Mean</i>	>40 y <sup>3</sup>	1
<i>Approach Slope Mean</i>	<2%	5
<i>Soil K Factor</i>	<0.20	5
<i>Upstream Rt Outlet</i>	Bare soil	0
<i>Upstream Lt Outlet</i>	Vegetated	1
<i>Upstream Rt Ditch</i>	Bare soil	0
<i>Upstream Lt Ditch</i>	Bare soil	0
<i>Downstream Rt Outlet</i>	Bare soil	0
<i>Downstream Lt Outlet</i>	Vegetated	1
<i>Downstream Rt Ditch</i>	Bare soil	0
<i>Downstream Lt Ditch</i>	Bare soil	0
<i>Outlet Total</i>	Partially Improved Outlet System	3
<i>Ditches Total</i>	Unimproved Drainage System	1
<b>SRI Total</b>	<b>Medium Risk</b>	<b>44</b>

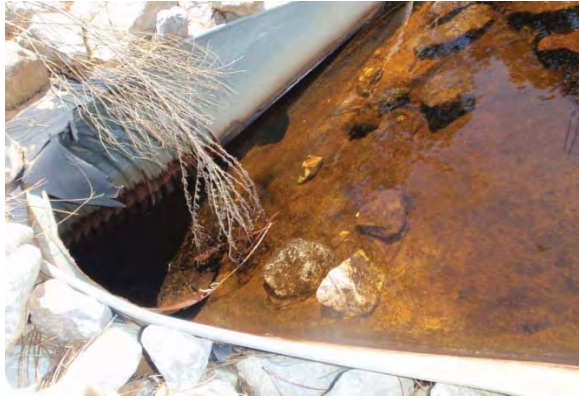
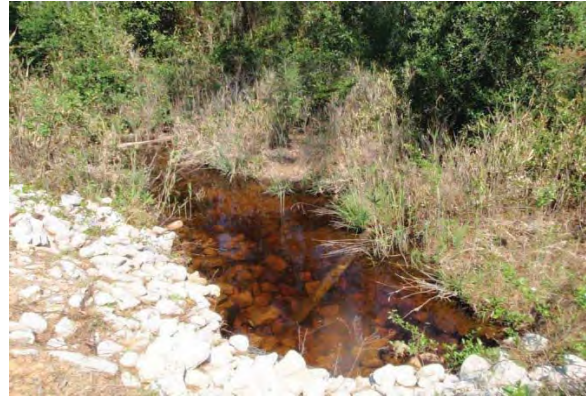
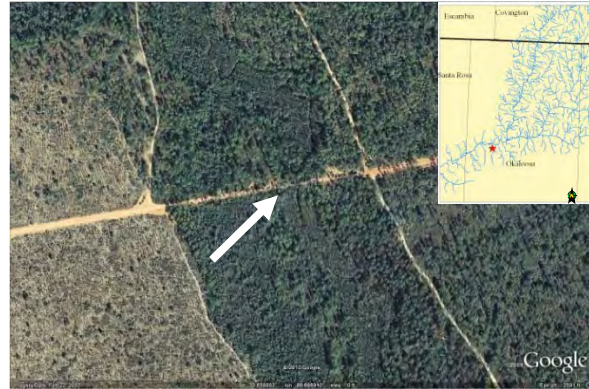
Crossing Structure: DS

Risk Factor	Ranking	Score
<i>US Channel Morph</i>	WETLAND	5
<i>DS Channel Morph</i>	E	5
<i>DS Bank Alteration</i>	NATURAL	5
<i>Upstream Skew Angle</i>	5-30°	3
<i>Crossing fill condition</i>	Fair/Riprap	3
<i>Inlet/Outlet Condition</i>	Blocked	1
<i>Road Approach Material</i>	All Sand/Clay	3
<i>Potential Eroded Volume Mean</i>	21-40 y <sup>3</sup>	3
<i>Approach Slope Mean</i>	<2%	5
<i>Soil K Factor</i>	<0.20	5
<i>Upstream Rt Outlet</i>	Vegetated	1
<i>Upstream Lt Outlet</i>	Vegetated	1
<i>Upstream Rt Ditch</i>	Bare soil	0
<i>Upstream Lt Ditch</i>	Bare soil	0
<i>Downstream Rt Outlet</i>	Vegetated	1
<i>Downstream Lt Outlet</i>	Rip Rap	1
<i>Downstream Rt Ditch</i>	Bare soil	0
<i>Downstream Lt Ditch</i>	Bare soil	0
<i>Outlet Total</i>	Improved Outlet System	5
<i>Ditches Total</i>	Unimproved Drainage System	1
<b>SRI Total</b>	<b>Medium Risk</b>	<b>44</b>

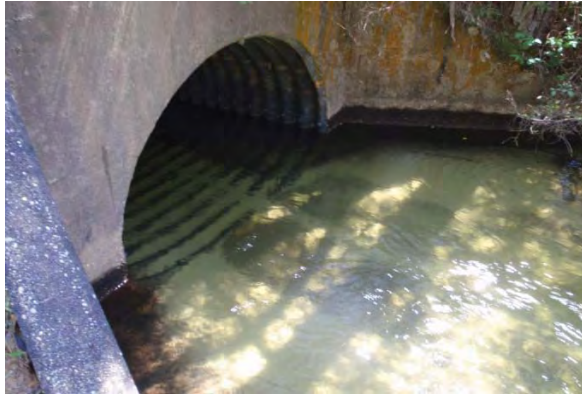
Crossing Structure: DS

Risk Factor	Ranking	Score
<i>US Channel Morph</i>	C	5
<i>DS Channel Morph</i>	C	5
<i>DS Bank Alteration</i>	NATURAL	5
<i>Upstream Skew Angle</i>	<5°	5
<i>Crossing fill condition</i>	Poor/Bare soil	1
<i>Inlet/Outlet Condition</i>	No Impairment	5
<i>Road Approach Material</i>	All Sand/Clay	3
<i>Potential Eroded Volume Mean</i>	21-40 y <sup>3</sup>	3
<i>Approach Slope Mean</i>	2.1-4%	3
<i>Soil K Factor</i>	<0.20	5
<i>Upstream Rt Outlet</i>	Bare soil	0
<i>Upstream Lt Outlet</i>	Bare soil	0
<i>Upstream Rt Ditch</i>	Bare soil	0
<i>Upstream Lt Ditch</i>	Bare soil	0
<i>Downstream Rt Outlet</i>	Vegetated	1
<i>Downstream Lt Outlet</i>	Vegetated	1
<i>Downstream Rt Ditch</i>	Bare soil	0
<i>Downstream Lt Ditch</i>	Bare soil	0
<i>Outlet Total</i>	Partially Improved Outlet System	3
<i>Ditches Total</i>	Unimproved Drainage System	1
<b><i>SRI Total</i></b>	<b>Medium Risk</b>	<b>44</b>

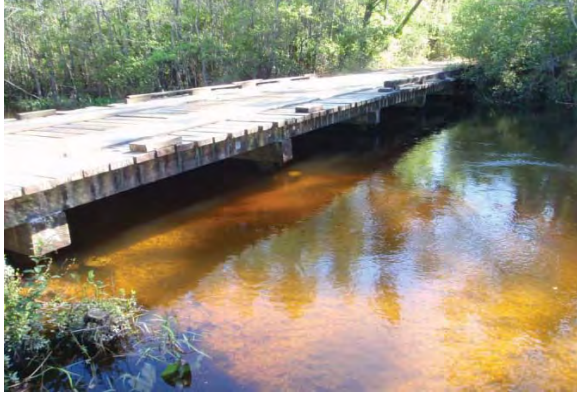
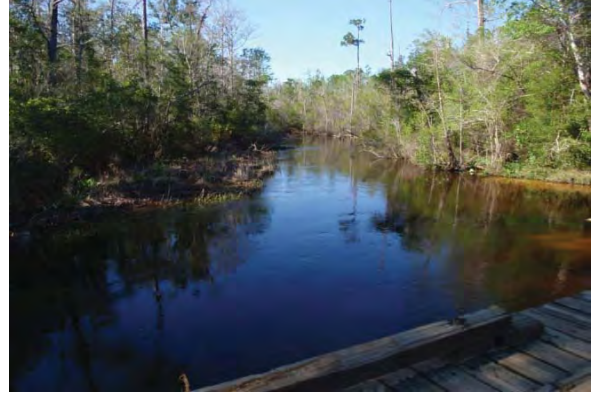
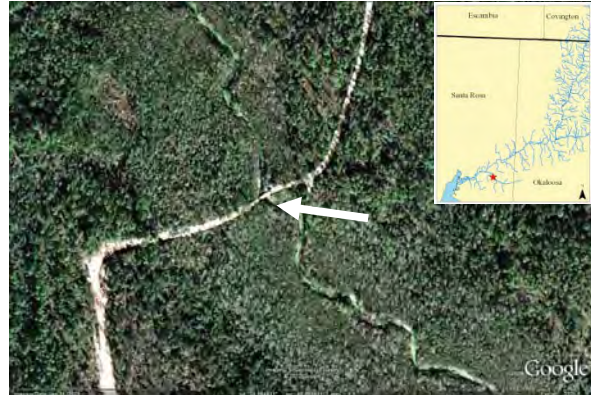
<b>Boiling Creek</b>	<b>sr-0414-r-004</b>	<i>Sedimentation Risk Index</i> <b>44</b>
----------------------	----------------------	--

Risk Factor	Ranking	Score
<i>US Channel Morph</i>	C	5
<i>DS Channel Morph</i>	C	5
<i>DS Bank Alteration</i>	NATURAL	5
<i>Upstream Skew Angle</i>	<5°	5
<i>Crossing fill condition</i>	Poor/Bare soil	1
<i>Inlet/Outlet Condition</i>	No Impairment	5
<i>Road Approach Material</i>	All Sand/Clay	3
<i>Potential Eroded Volume Mean</i>	>40 y <sup>3</sup>	1
<i>Approach Slope Mean</i>	<2%	5
<i>Soil K Factor</i>	<0.20	5
<i>Upstream Rt Outlet</i>	Bare soil	0
<i>Upstream Lt Outlet</i>	Bare soil	0
<i>Upstream Rt Ditch</i>	Bare soil	0
<i>Upstream Lt Ditch</i>	Bare soil	0
<i>Downstream Rt Outlet</i>	Bare soil	0
<i>Downstream Lt Outlet</i>	Vegetated	1
<i>Downstream Rt Ditch</i>	Bare soil	0
<i>Downstream Lt Ditch</i>	Bare soil	0
<i>Outlet Total</i>	Partially Improved Outlet System	3
<i>Ditches Total</i>	Unimproved Drainage System	1
<b>SRI Total</b>	<b>Medium Risk</b>	<b>44</b>

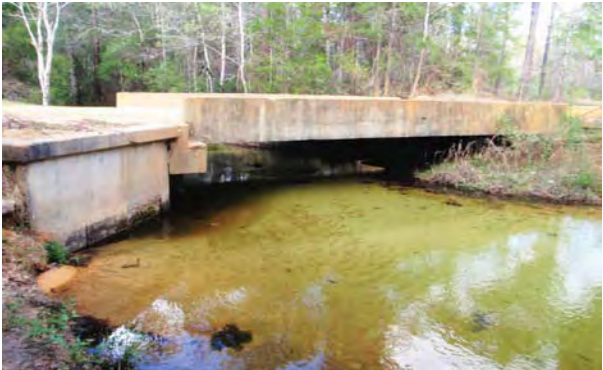
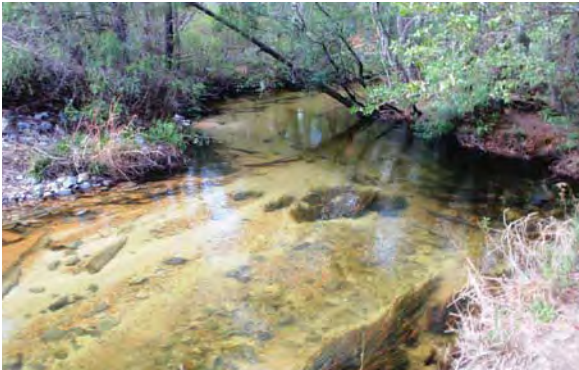
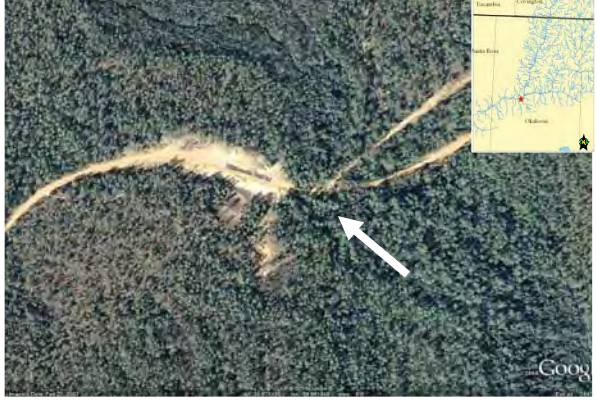
<h1>Turkey Gobbler Creek</h1>	<h2>ok-0318-r-004</h2>	<i>Sedimentation Risk Index</i> <h1>46</h1>
-------------------------------	------------------------	--

Risk Factor	Ranking	Score
<i>US Channel Morph</i>	C	5
<i>DS Channel Morph</i>	C	5
<i>DS Bank Alteration</i>	NATURAL	5
<i>Upstream Skew Angle</i>	<5°	5
<i>Crossing fill condition</i>	Good/Vegetated	5
<i>Inlet/Outlet Condition</i>	No Impairment	5
<i>Road Approach Material</i>	All Sand/Clay	3
<i>Potential Eroded Volume Mean</i>	>40 y <sup>3</sup>	1
<i>Approach Slope Mean</i>	<2%	5
<i>Soil K Factor</i>	<0.20	5
<i>Upstream Rt Outlet</i>	Bare soil	0
<i>Upstream Lt Outlet</i>	Bare soil	0
<i>Upstream Rt Ditch</i>	Bare soil	0
<i>Upstream Lt Ditch</i>	Bare soil	0
<i>Downstream Rt Outlet</i>	Bare soil	0
<i>Downstream Lt Outlet</i>	Bare soil	0
<i>Downstream Rt Ditch</i>	Bare soil	0
<i>Downstream Lt Ditch</i>	Bare soil	0
<i>Outlet Total</i>	Unimproved Outlet System	1
<i>Ditches Total</i>	Unimproved Drainage System	1
<b><i>SRI Total</i></b>	<b>Low Risk</b>	<b>46</b>

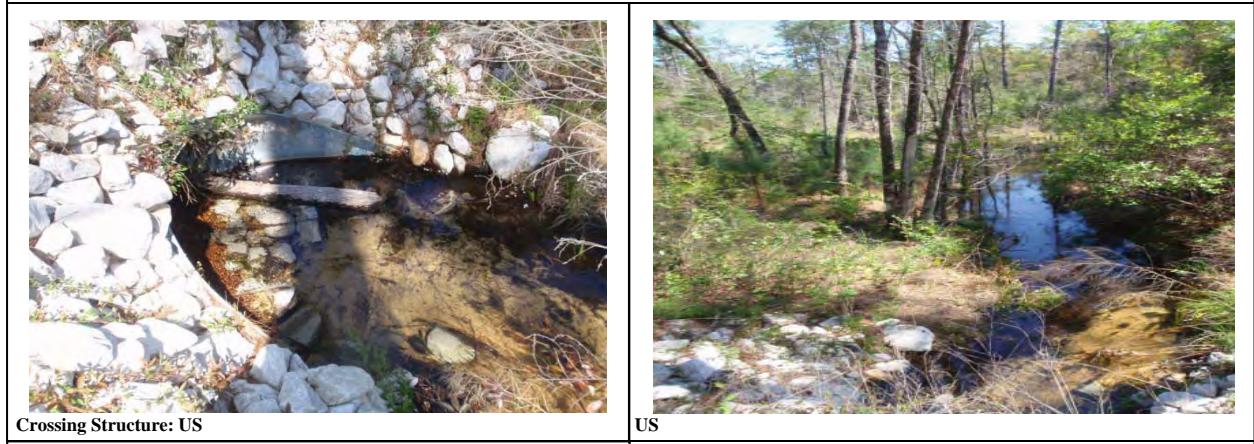
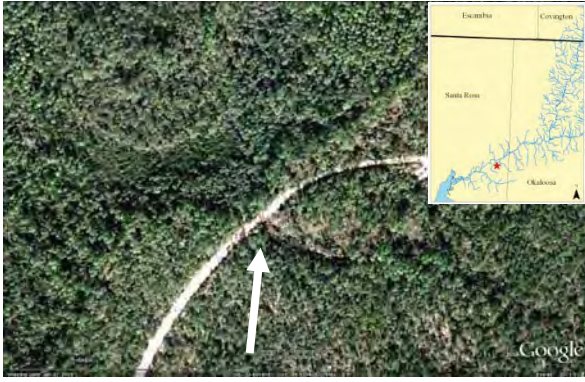
<h1 style="margin:0;">Broxon Branch</h1>	<h2 style="margin:0;">sr-0407-r-010</h2>	<i>Sedimentation Risk Index</i> <b style="font-size: 1.5em;">46</b>
--	--	--

Risk Factor	Ranking	Score	
<i>US Channel Morph</i>	C	5	
<i>DS Channel Morph</i>	C	5	
<i>DS Bank Alteration</i>	MINOR/PARTIAL	3	
<i>Upstream Skew Angle</i>	5-30°	3	
<i>Crossing fill condition</i>	Fair/Rip Rap	3	
<i>Inlet/Outlet Condition</i>	No Impairment	5	
<i>Road Approach Material</i>	All Sand/Clay	3	
<i>Potential Eroded Volume Mean</i>	21-40 y <sup>3</sup>	3	
<i>Approach Slope Mean</i>	<2%	5	
<i>Soil K Factor</i>	<0.20	5	
<i>Upstream Rt Outlet</i>	Vegetated	1	
<i>Upstream Lt Outlet</i>	Vegetated	1	
<i>Upstream Rt Ditch</i>	Bare soil	0	
<i>Upstream Lt Ditch</i>	Bare soil	0	
<i>Downstream Rt Outlet</i>	Vegetated	1	
<i>Downstream Lt Outlet</i>	Vegetated	1	
<i>Downstream Rt Ditch</i>	Bare soil	0	
<i>Downstream Lt Ditch</i>	Bare soil	0	
<i>Outlet Total</i>	Improved Outlet System	5	
<i>Ditches Total</i>	Unimproved Drainage System	1	
<b><i>SRI Total</i></b>	<b>Low Risk</b>	<b>46</b>

Notes: Rip rap in stream bed

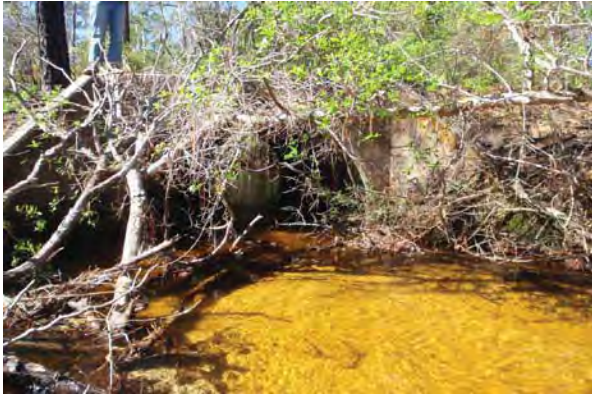
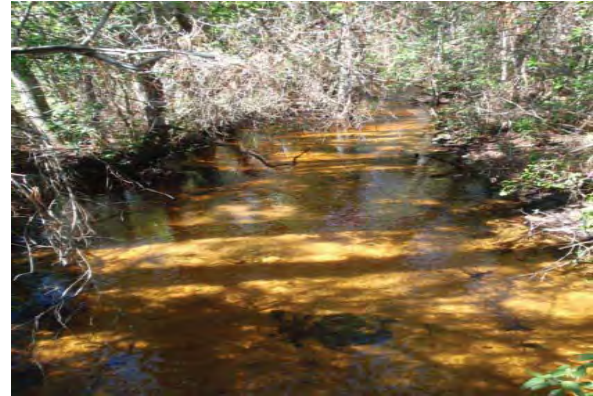
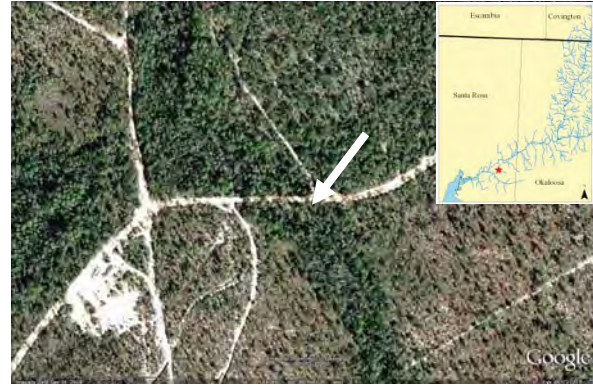
<h1 style="margin:0;">Bear Creek</h1>	<h2 style="margin:0;">sr-0414-r-002</h2>	<i>Sedimentation Risk Index</i> <h1 style="margin:0;">46</h1>
---------------------------------------	--	--

Risk Factor	Ranking	Score
<i>US Channel Morph</i>	E	5
<i>DS Channel Morph</i>	C	5
<i>DS Bank Alteration</i>	NATURAL	5
<i>Upstream Skew Angle</i>	5-30°	3
<i>Crossing fill condition</i>	Good/Vegetated	5
<i>Inlet/Outlet Condition</i>	No Impairment	5
<i>Road Approach Material</i>	All Sand/Clay	3
<i>Potential Eroded Volume Mean</i>	>40 y <sup>3</sup>	1
<i>Approach Slope Mean</i>	2.1-4%	3
<i>Soil K Factor</i>	<0.20	5
<i>Upstream Rt Outlet</i>	Vegetated	1
<i>Upstream Lt Outlet</i>	Vegetated	1
<i>Upstream Rt Ditch</i>	Bare soil	0
<i>Upstream Lt Ditch</i>	Bare soil	0
<i>Downstream Rt Outlet</i>	Vegetated	1
<i>Downstream Lt Outlet</i>	Vegetated	1
<i>Downstream Rt Ditch</i>	Bare soil	0
<i>Downstream Lt Ditch</i>	Bare soil	0
<i>Outlet Total</i>	Improved Outlet System	5
<i>Ditches Total</i>	Unimproved Drainage System	1
<b><i>SRI Total</i></b>	<b>Low Risk</b>	<b>46</b>
<b>Additional Site Features</b>		
<i>Crossing Type and Quantity:</i>	Culvert,1

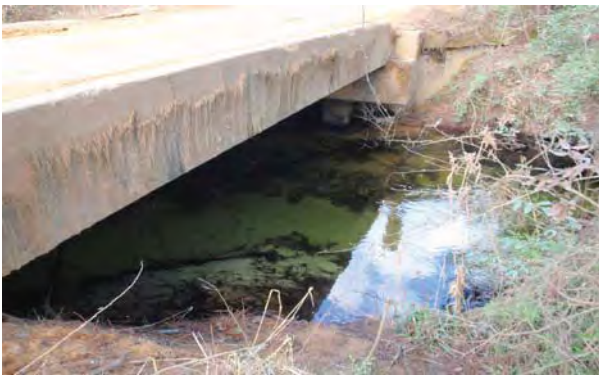
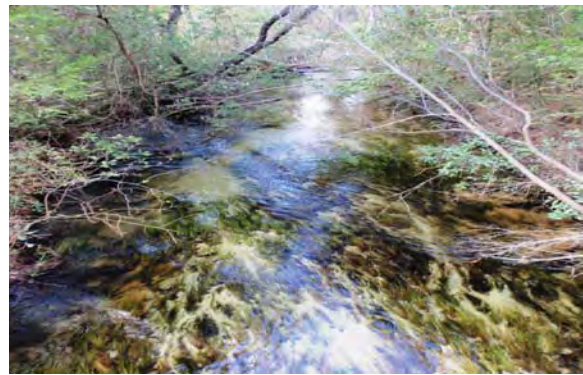
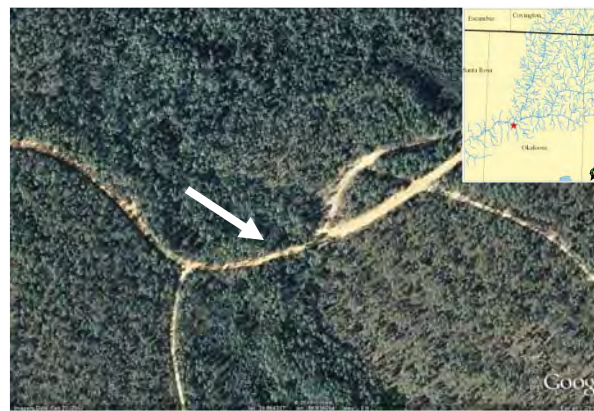
Risk Factor	Ranking	Score
<i>US Channel Morph</i>	C	5
<i>DS Channel Morph</i>	E	5
<i>DS Bank Alteration</i>	NATURAL	5
<i>Upstream Skew Angle</i>	<5°	5
<i>Crossing fill condition</i>	Fair/Riprap	3
<i>Inlet/Outlet Condition</i>	No Impairment	5
<i>Road Approach Material</i>	All Sand/Clay	3
<i>Potential Eroded Volume Mean</i>	21-40 y <sup>3</sup>	3
<i>Approach Slope Mean</i>	2.1-4%	3
<i>Soil K Factor</i>	<0.20	5
<i>Upstream Rt Outlet</i>	Vegetated	1
<i>Upstream Lt Outlet</i>	Vegetated	1
<i>Upstream Rt Ditch</i>	Bare soil	0
<i>Upstream Lt Ditch</i>	Bare soil	0
<i>Downstream Rt Outlet</i>	Vegetated	1
<i>Downstream Lt Outlet</i>	Vegetated	1
<i>Downstream Rt Ditch</i>	Bare soil	0
<i>Downstream Lt Ditch</i>	Bare soil	0
<i>Outlet Total</i>	Improved Outlet System	5
<i>Ditches Total</i>	Unimproved Drainage System	1
<b>SRI Total</b>	<b>Low Risk</b>	<b>48</b>

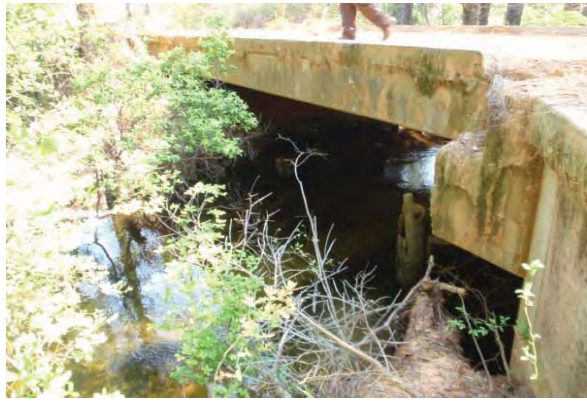
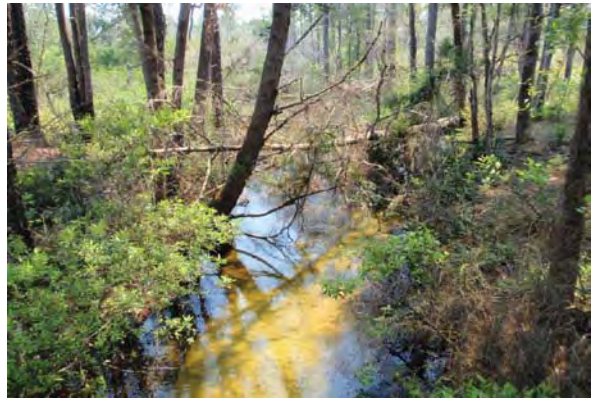
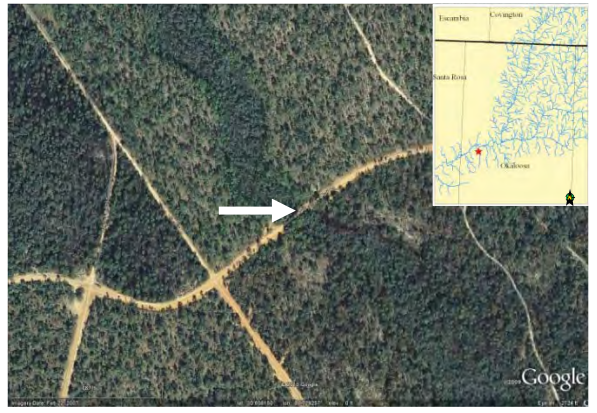
<b>Metts Creek</b>	<b>ok-0407-r-005</b>	<i>Sedimentation Risk Index</i> <b>50</b>
--------------------	----------------------	--

Risk Factor	Ranking	Score
<i>US Channel Morph</i>	E	5
<i>DS Channel Morph</i>	C	5
<i>DS Bank Alteration</i>	NATURAL	5
<i>Upstream Skew Angle</i>	<5°	5
<i>Crossing fill condition</i>	Good/Vegetated	5
<i>Inlet/Outlet Condition</i>	No Impairment	5
<i>Road Approach Material</i>	All Sand/Clay	3
<i>Potential Eroded Volume Mean</i>	>40 y <sup>3</sup>	1
<i>Approach Slope Mean</i>	<2%	5
<i>Soil K Factor</i>	<0.20	5
<i>Upstream Rt Outlet</i>	Vegetated	1
<i>Upstream Lt Outlet</i>	Vegetated	1
<i>Upstream Rt Ditch</i>	Bare soil	0
<i>Upstream Lt Ditch</i>	Bare soil	0
<i>Downstream Rt Outlet</i>	Vegetated	1
<i>Downstream Lt Outlet</i>	Vegetated	1
<i>Downstream Rt Ditch</i>	Bare soil	0
<i>Downstream Lt Ditch</i>	Bare soil	0
<i>Outlet Total</i>	Improved Outlet System	5
<i>Ditches Total</i>	Unimproved Drainage System	1
<b>SRI Total</b>	<b>Low Risk</b>	<b>50</b>

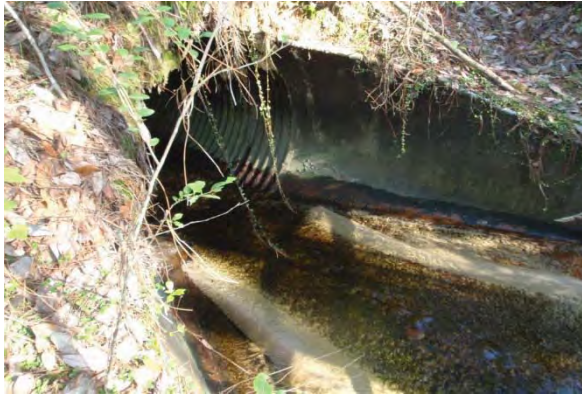
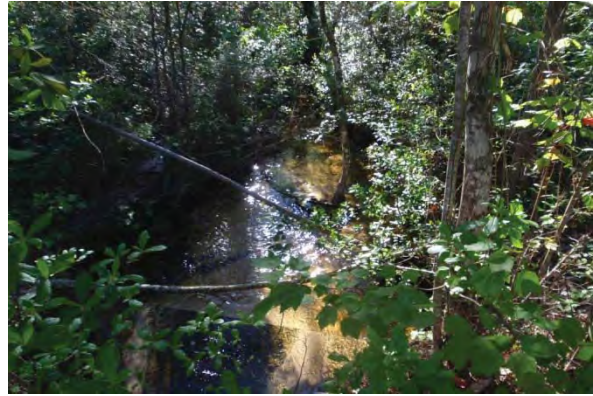
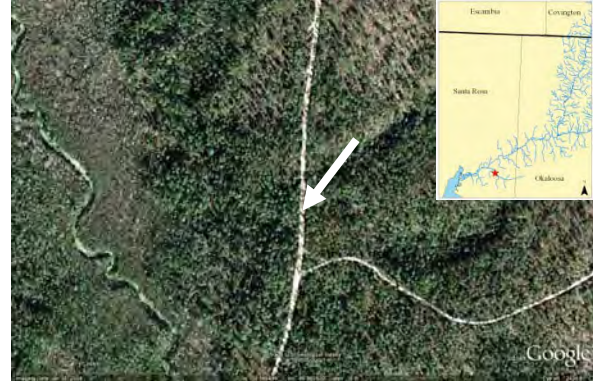
<h1>Loon Branch</h1>	<h2>sr-0414-r-006</h2>	<i>Sedimentation Risk Index</i> <h1>52</h1>
----------------------	------------------------	--

Risk Factor	Ranking	Score
<i>US Channel Morph</i>	C	5
<i>DS Channel Morph</i>	E	5
<i>DS Bank Alteration</i>	MINOR/PARTIAL	3
<i>Upstream Skew Angle</i>	<5°	5
<i>Crossing fill condition</i>	Good/Vegetated	5
<i>Inlet/Outlet Condition</i>	No Impairment	5
<i>Road Approach Material</i>	All Sand/Clay	3
<i>Potential Eroded Volume Mean</i>	<21 y <sup>3</sup>	5
<i>Approach Slope Mean</i>	<2%	5
<i>Soil K Factor</i>	<0.20	5
<i>Upstream Rt Outlet</i>	Vegetated	1
<i>Upstream Lt Outlet</i>	Vegetated	1
<i>Upstream Rt Ditch</i>	Bare soil	0
<i>Upstream Lt Ditch</i>	Bare soil	0
<i>Downstream Rt Outlet</i>	Vegetated	1
<i>Downstream Lt Outlet</i>	Vegetated	1
<i>Downstream Rt Ditch</i>	Bare soil	0
<i>Downstream Lt Ditch</i>	Bare soil	0
<i>Outlet Total</i>	Improved Outlet System	5
<i>Ditches Total</i>	Unimproved Drainage System	1
<b>SRI Total</b>	<b>Low Risk</b>	<b>52</b>
<b>Additional Site Features</b>		
<i>Crossing Type and Quantity:</i>	Culvert, 1

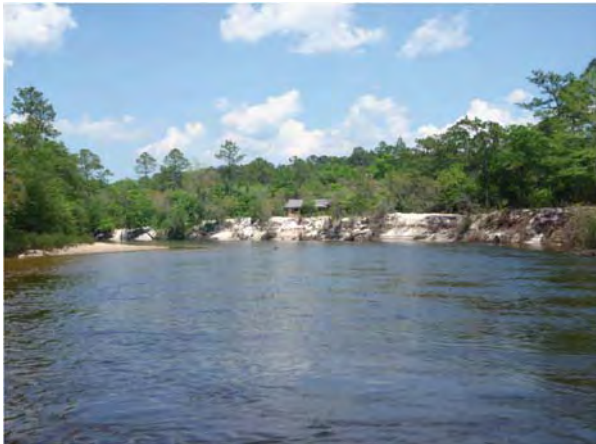
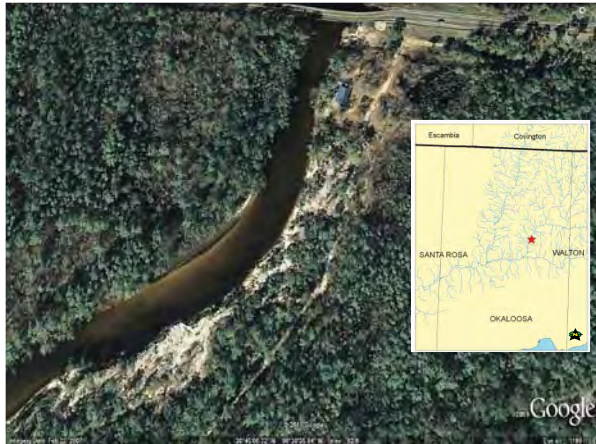
RB					
Risk Factor	Ranking	Score	Feature	Within Range	Descriptive Field
<i>Channel Stability</i>	Poor	1.5	303(d)	No	N/A
<i>Channel Alteration</i>	In Recovery	1	Wetland Species	Yes	1-3 FOCAL SPECIES IN UPLAND AREAS
<i>Bank Erosion</i>	Mass-wasting	1.5	Rare and Imperiled	Yes	GOLDSTRIPE DARTER SPECKLED CHUB, IRONCOLOR SHINER
<i>BEHI</i>	Extreme-Very High	1	Land Use/ Cover	Yes	NA/ MDC-LOW DENSITY FIXED UNITS(FIXED&MOBILE)
<i>Local NPSP</i>	Obvious Sources	1.5	Candidate Mussels	No	N/A

<i>Shoring Structures</i>	Present	1.5	Sturgeon C.H.	No	N/A
<i>Pipe Discharge</i>	Present	1.5	<b>Additional Site Features</b>		
<i>Water Odors</i>	Not Present	0	<i>Stream Channel Woody Material:</i> Numerous		
<i>Fish Passage Barrier</i>	Not Present	0	<i>Impoundments:</i> None		
<i>RB: Riparian Buffer</i>	100+ft	0	<i>Substrate Composition:</i> Medium Sand		
<i>LB: Riparian Buffer</i>	0-29 ft	0.75	<i>Bank Material:</i> Sand		
<i>RB: Floodplain Access</i>	Full	0			
<i>LB: Floodplain Access</i>	None	0.75			
<b>River Threat Index:</b>		<b>11</b>

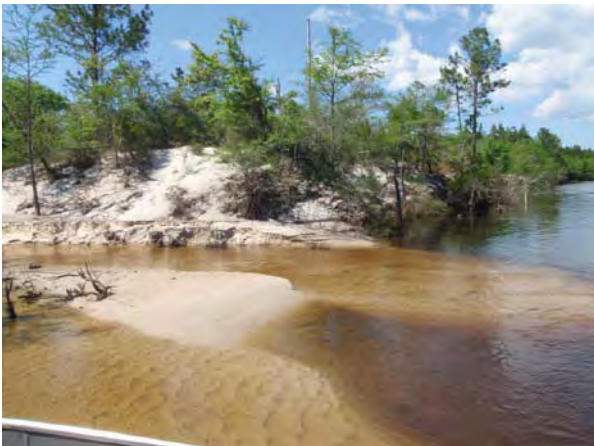
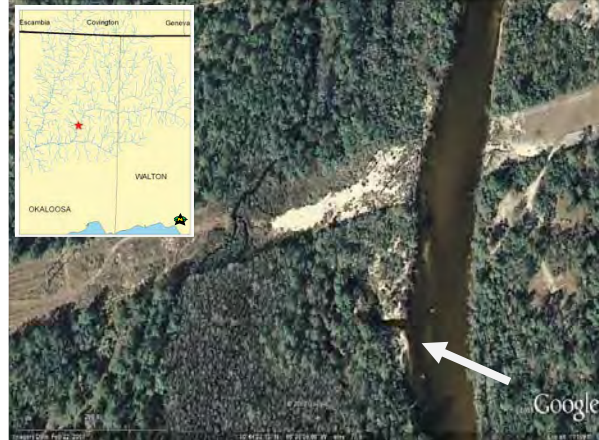
Risk Factor	Ranking	Score	Feature	Within Range	Descriptive Field
<i>Channel Stability</i>	Fair	1	303d	No	N/A
<i>Channel Alteration</i>	In Recovery	1	Wetland Species	Yes	1-3 FOCAL SPECIES IN UPLAND AREAS
<i>Bank Erosion</i>	Active	1	Rare and Imperiled	Yes	GOLDSTRIPE DARTER, SPECKLED CHUB IRONCOLOR SHINER
<i>BEHI</i>	High	1	Land Use/Cover	Yes	NA/ PINE FLATWOODS
<i>Local NPSP</i>	Moderate Potential	1	Candidate Mussels	No	N/A
<i>Shoring Structures</i>	Not Present	0	Sturgeon C.H.	No	N/A
<i>Pipe Discharge</i>	Not Present	0	<b>Additional Site Features</b>		
<i>Water Odors</i>	Not Present	0	<i>Stream Channel Woody Material:</i> Moderate		
<i>Fish Passage Barrier</i>	Not Present	0	<i>Impoundments:</i> None		
<i>RB: Riparian Buffer</i>	0-29 ft	0.75	<i>Substrate Composition:</i> Medium Sand and Coarse Sand		
<i>LB: Riparian Buffer</i>	0-29 ft	0.75	<i>Bank Material:</i> Sand		
<i>RB: Floodplain Access</i>	Partial	0.25

Notes: Residence on left bank across from site. Site adjacent to power line crossing and below Hwy 90. Dead mussels found at this site. Live corbiculla also found.

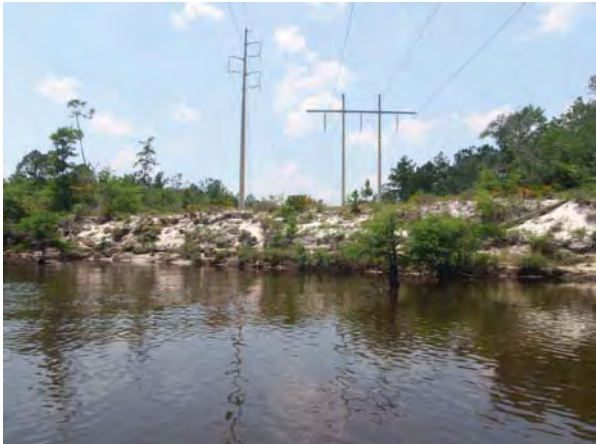
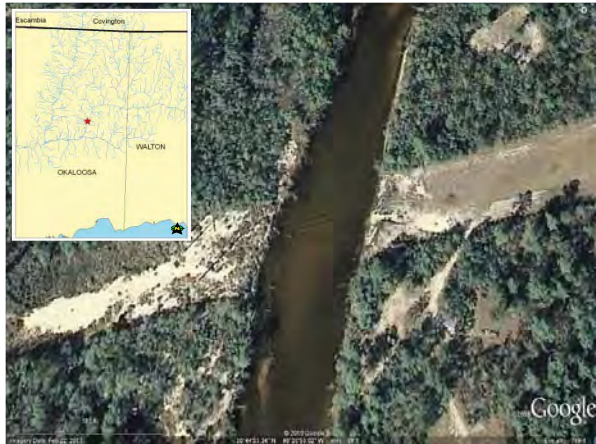
RB					
Risk Factor	Ranking	Score	Feature	Within Range	Descriptive Field
<i>Channel Stability</i>	Fair	1	303(d)	No	N/A
<i>Channel Alteration</i>	None	0	Wetland Species	Yes	1-3 FOCAL SPECIES IN UPLAND AREAS
<i>Bank Erosion</i>	Historic	0.5	Rare and Imperiled	Yes	GOLDSTRIPE DARTER,SPECKLED CHUB,IRONCOLOR SHINER
<i>BEHI</i>	High	1	Land Use/Cover	Yes	N/A/ STREAMS AND WATERWAYS
<i>Local NPSP</i>	No Evidence	0	Candidate Mussels	Yes	SOUTHERN SANDSHELL
<i>Shoring Structures</i>	Not Present	0	Sturgeon C.H.	No	N/A
<i>Pipe Discharge</i>	Not Present	0	<b>Additional Site Features</b>		
<i>Water Odors</i>	Not Present	0	<i>Stream Channel Woody Material:</i> Moderate

<i>Fish Passage Barrier</i>	Not Present	0	<i>Impoundments:</i> None		
<i>RB: Riparian Buffer</i>	0-29 ft	0.75	<i>Substrate Composition:</i> Medium Sand		
<i>LB: Riparian Buffer</i>	0-29 ft	0.75	<i>Bank Material:</i> Sand		
<i>RB: Floodplain Access</i>	Partial	0.25			
<i>LB: Floodplain Access</i>	Partial	0.25			
<b>River Threat Index:</b>		<b>4.5</b>

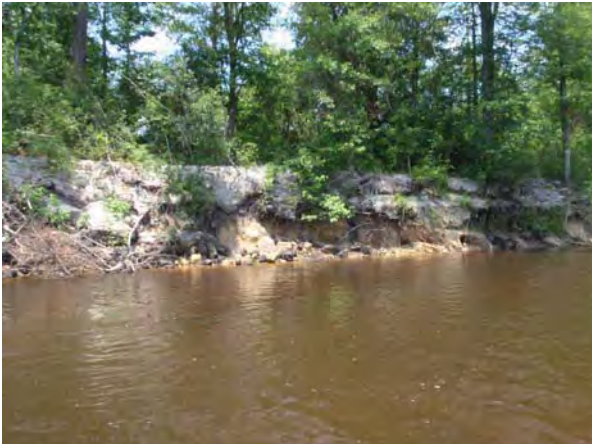
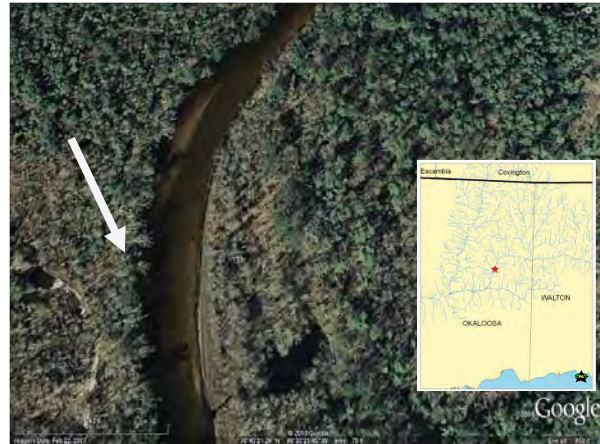
Risk Factor	Ranking	Score	Feature	Within Range	Descriptive Field
<i>Channel Stability</i>	Poor	1.5	303(d)	No	N/A
<i>Channel Alteration</i>	None	0	Wetland Species	Yes	1-3 FOCAL SPECIES IN UPLAND AREAS
<i>Bank Erosion</i>	Mass Wasting	1.5	Rare and Imperiled	Yes	GOLDSTRIPE DARTER, SPECKLED CHUB IRONCOLOR SHINER
<i>BEHI</i>	High	1	Land Use/Cover	Yes	N/A/ STREAMS AND WATERWAYS
<i>Local NPSP</i>	No Evidence	0	Candidate Mussels	Yes	SOUTHERN SANDSHELL
<i>Shoring Structures</i>	Not Present	0	Sturgeon C.H.	No	N/A
<i>Pipe Discharge</i>	Not Present	0	<b>Additional Site Features</b>		
<i>Water Odors</i>	Not Present	0	<i>Stream Channel Woody Material:</i> Moderate		
<i>Fish Passage Barrier</i>	Not Present	0	<i>Impoundments:</i> None		
<i>RB: Riparian Buffer</i>	100+ ft	0	<i>Substrate Composition:</i> Medium Sand		
<i>LB: Riparian Buffer</i>	100 + ft	0	<i>Bank Material:</i> Sand and Clay		
<i>RB: Floodplain Access</i>	Partial	0.25

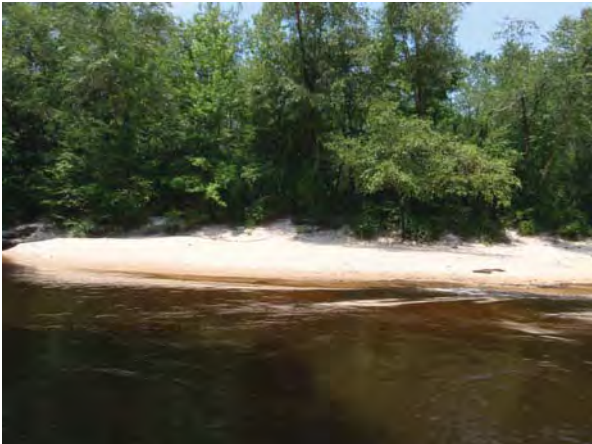
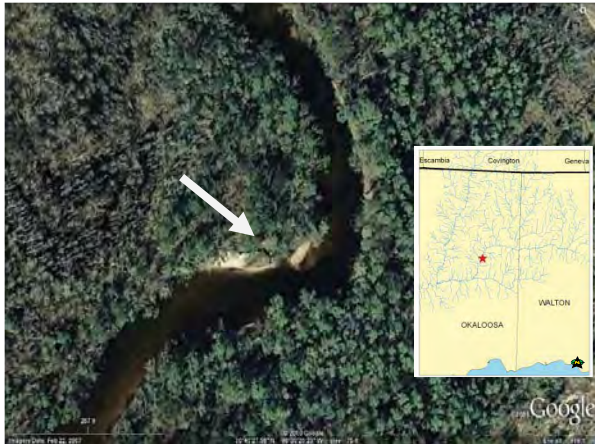
Risk Factor	Ranking	Score	Feature	Within Range	Descriptive Field
<i>Channel Stability</i>	Good	0.5	303(d)	No	N/A
<i>Channel Alteration</i>	None	0	Wetland Species	Yes	1-3 FOCAL SPECIES IN UPLAND AREAS
<i>Bank Erosion</i>	Historic	0.5	Rare and Imperiled	Yes	GOLDSTRIPE DARTER, IRONCOLOR SHINER, SPECKLED CHUB
<i>BEHI</i>	Moderate	0.5	Land Use/Cover	Yes	N/A/ STREAMS AND WATERWAYS
<i>Local NPSP</i>	Slight	0.5	Candidate Mussels	No	N/A
<i>Shoring Structures</i>	Not Present	0	Sturgeon C.H.	No	N/A
<i>Pipe Discharge</i>	Not Present	0	<b>Additional Site Features</b>		
<i>Water Odors</i>	Not Present	0	<i>Stream Channel Woody Material:</i> Moderate		
<i>Fish Passage Barrier</i>	Not Present	0	<i>Impoundments:</i> None		
<i>RB: Riparian Buffer</i>	100+ ft	0	<i>Substrate Composition:</i> Medium Sand		
<i>LB: Riparian Buffer</i>	100+ ft	0	<i>Bank Material:</i> Sand		
<i>RB: Floodplain Access</i>	Partial	0.25			
<i>LB: Floodplain Access</i>	Partial	0.25

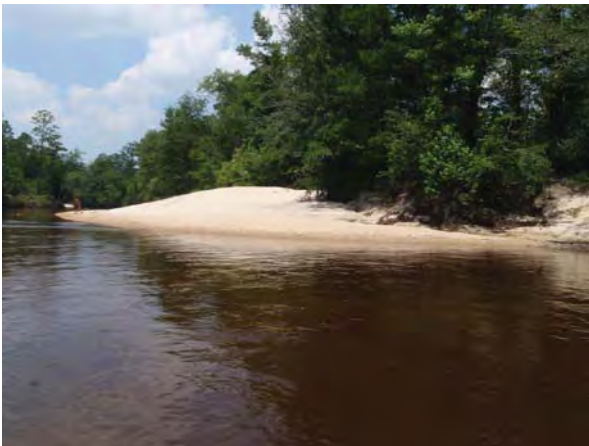
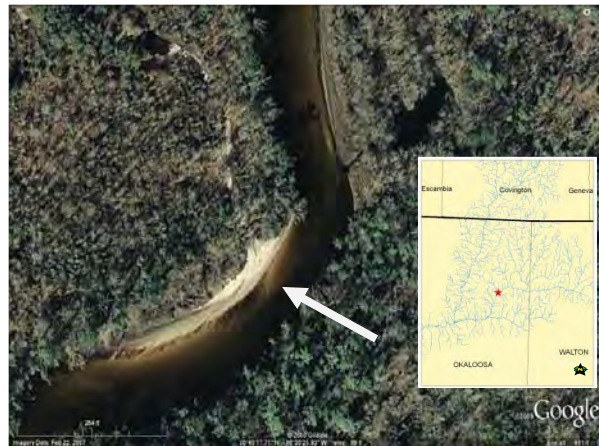
Risk Factor	Ranking	Score	Feature	Within Range	Descriptive Field
<i>Channel Stability</i>	Fair	1	303(d)	No	N/A
<i>Channel Alteration</i>	Not Eroding	0	Wetland Species	Yes	1-3 FOCAL SPECIES IN UPLAND AREAS
<i>Bank Erosion</i>	Historic	0.5	Rare and Imperiled	Yes	GOLDSTRIPE DARTER, IRONCOLOR SHINER, SPECKLED CHUB
<i>BEHI</i>	High	1	Land Use/Cover	Yes	N/A/ STREAMS AND WATERWAYS
<i>Local NPSP</i>	Slight	0.5	Candidate Mussels	Yes	SOUTHERN SANDSHELL
<i>Shoring Structures</i>	Not Present	0	Sturgeon C.H.	No	N/A
<i>Pipe Discharge</i>	Not Present	0	<b>Additional Site Features</b>		
<i>Water Odors</i>	Not Present	0	<i>Stream Channel Woody Material:</i> Moderate		
<i>Fish Passage Barrier</i>	Not Present	0	<i>Impoundments:</i> None		
<i>RB: Riparian Buffer</i>	100+ ft	0	<i>Substrate Composition:</i> Medium Sand		
<i>LB: Riparian Buffer</i>	100+ ft	0	<i>Bank Material:</i> Sand		
<i>RB: Floodplain Access</i>	Full	0

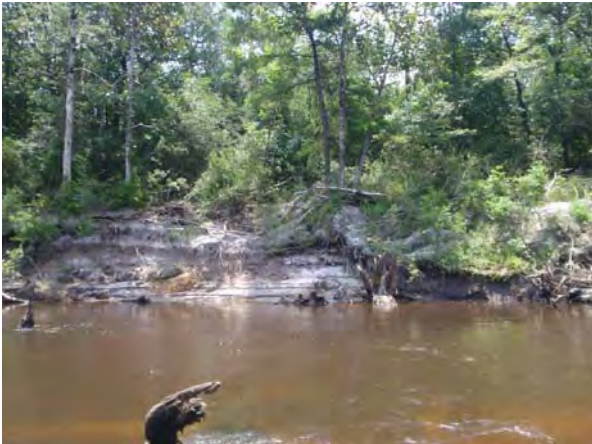
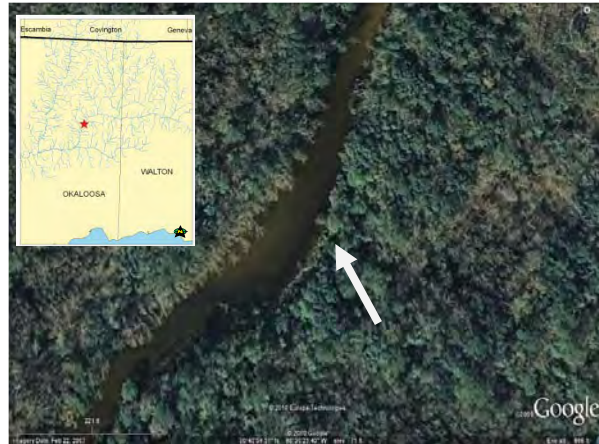
Risk Factor	Ranking	Score	Feature	Within Range	Descriptive Field
<i>Channel Stability</i>	Fair	1	303(d)	No	N/A
<i>Channel Alteration</i>	None	0	<b>Wetland Species</b>	Yes	1-3 FOCAL SPECIES IN UPLAND AREAS
<i>Bank Erosion</i>	Historic	0.5	<b>Rare and Imperiled</b>	Yes	GOLDSTRIPE DARTER, IRONCOLOR SHINER, SPECKLED CHUB
<i>BEHI</i>	Moderate	0.5	<b>Land Use/Cover</b>	Yes	N/A/ STREAMS AND WATERWAYS
<i>Local NPSP</i>	No Evidence	0	<b>Candidate Mussels</b>	No	N/A
<i>Shoring Structures</i>	Not Present	0	<b>Sturgeon C.H.</b>	No	N/A
<i>Pipe Discharge</i>	Not Present	0	<b>Additional Site Features</b>		
<i>Water Odors</i>	Not Present	0	<i>Stream Channel Woody Material:</i> Moderate		
<i>Fish Passage Barrier</i>	Not Present	0	<i>Impoundments:</i> None		
<i>RB: Riparian Buffer</i>	100+ ft	0	<i>Substrate Composition:</i> Medium Sand		
<i>LB: Riparian Buffer</i>	100+ ft	0	<i>Bank Material:</i> Sand		
<i>RB: Floodplain Access</i>	Partial	0.25

<i>LB: Floodplain Access</i>	Partial	0.25			
<b>River Threat Index:</b>		<b>2.5</b>
