Appendix A. River corridor severity scores for impaired sites in the Yellow River Basin, Alabama and Florida

Appendix C. Clear Creek Watershed Focal Area. Sites with orange headings are unpaved road sites. Specific definitions and calculations described for calculating the Sediment Risk Index (SRI) are detailed in Witmer (2009).

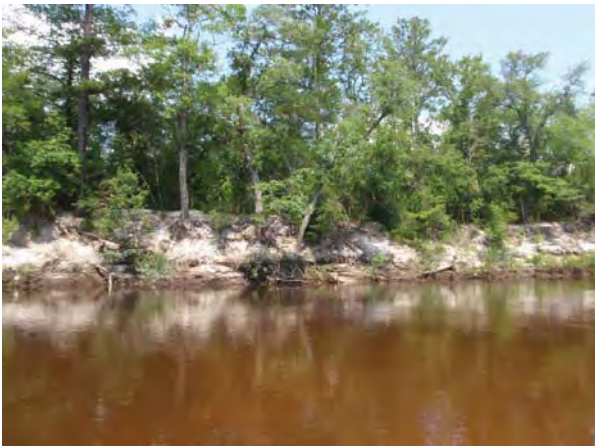
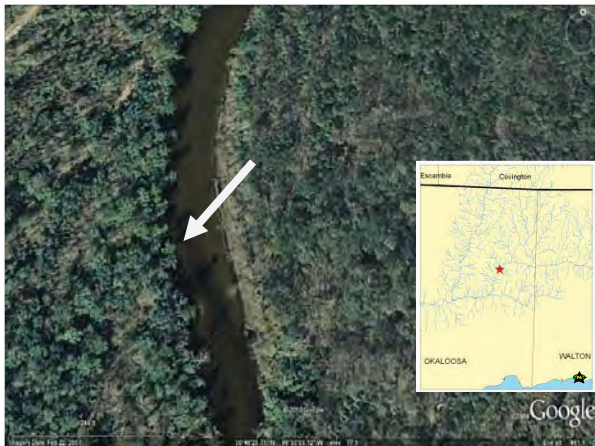
Risk Factor	Ranking	Score	Feature	Within Range	Descriptive Field
<i>Channel Stability</i>	Good	0.5	303(d)	No	N/A
<i>Channel Alteration</i>	None	0	Wetland Species	Yes	1-3 FOCAL SPECIES IN UPLAND AREAS
<i>Bank Erosion</i>	Historic	0.5	Rare and Imperiled	Yes	GOLDSTRIPE DARTER, IRONCOLOR SHINER, SPECKLED CHUB
<i>BEHI</i>	Moderate	0.5	Land Use/Cover	Yes	N/A/ STREAMS AND WATERWAYS
<i>Local NPSP</i>	No Evidence	0	Candidate Mussels	No	N/A
<i>Shoring Structures</i>	Not Present	0	Sturgeon C.H.	No	N/A
<i>Pipe Discharge</i>	Not Present	0	<b>Additional Site Features</b>		
<i>Water Odors</i>	Not Present	0	<i>Stream Channel Woody Material:</i> Moderate		
<i>Fish Passage Barrier</i>	Not Present	0	<i>Impoundments:</i> None		
<i>RB: Riparian Buffer</i>	100+ ft	0	<i>Substrate Composition:</i> Medium Sand		
<i>LB: Riparian Buffer</i>	100+ ft	0	<i>Bank Material:</i> Sand		
<i>RB: Floodplain Access</i>	Partial	0.25			
<i>LB: Floodplain Access</i>	Partial	0.25

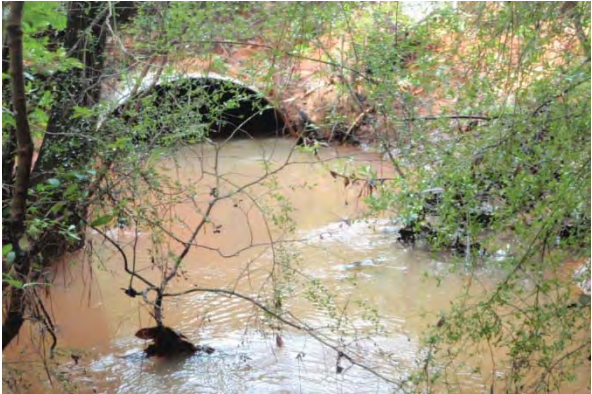
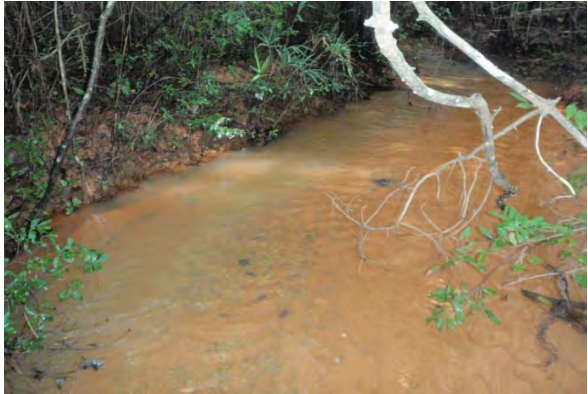
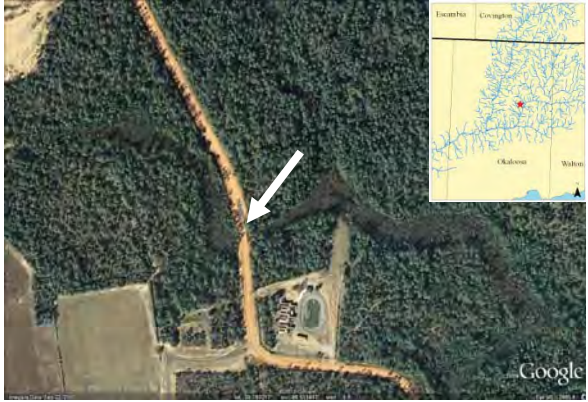
Crossing Structure: DS

Risk Factor	Ranking	Score
<i>US Channel Morph</i>	DA	3
<i>DS Channel Morph</i>	C	5
<i>DS Bank Alteration</i>	HIGH	1
<i>Upstream Skew Angle</i>	>30°	1
<i>Crossing fill condition</i>	Poor/Bare soil	1
<i>Inlet/Outlet Condition</i>	Sed Islands/Scouring	3
<i>Road Approach Material</i>	All Sand/Clay	3
<i>Potential Eroded Volume Mean</i>	>40 y <sup>3</sup>	1
<i>Approach Slope Mean</i>	>4%	1
<i>Soil K Factor</i>	0.21-0.40	3
<i>Upstream Rt Outlet</i>	Bare soil	0
<i>Upstream Lt Outlet</i>	Bare soil	0
<i>Upstream Rt Ditch</i>	Bare soil	0
<i>Upstream Lt Ditch</i>	Bare soil	0
<i>Downstream Rt Outlet</i>	Bare soil	0
<i>Downstream Lt Outlet</i>	Bare soil	0
<i>Downstream Rt Ditch</i>	Bare soil	0
<i>Downstream Lt Ditch</i>	Bare soil	0
<i>Outlet Total</i>	Unimproved Outlet System	1
<i>Ditches Total</i>	Unimproved Drainage System	1
<b><i>SRI Total</i></b>	<b>High Risk</b>	<b>24</b>
<b>Additional Site Features</b>		
<i>Crossing Type and Quantity:</i>	Culvert, 1

Notes: Excessive sediment loading and erosion coming from the road and outlets. Fence across US channel.

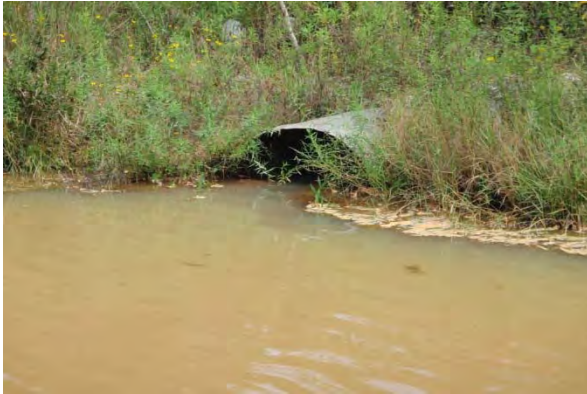
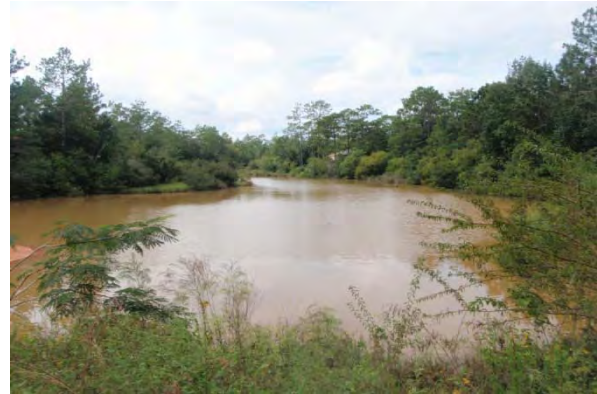
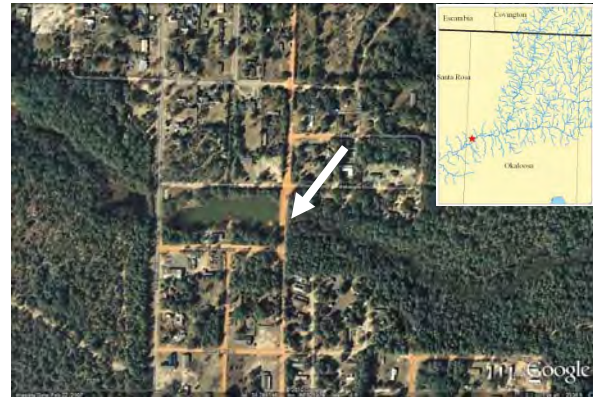
Crossing Structure: US

Risk Factor	Ranking	Score
<i>US Channel Morph</i>	PONDED	1
<i>DS Channel Morph</i>	D	1
<i>DS Bank Alteration</i>	HIGH	1
<i>Upstream Skew Angle</i>	5-30°	3
<i>Crossing fill condition</i>	Fair/Rip Rap	3
<i>Inlet/Outlet Condition</i>	Sed Islands/Scouring	3
<i>Road Approach Material</i>	All Sand/Clay	3
<i>Potential Eroded Volume Mean</i>	21-40 y <sup>3</sup>	3
<i>Approach Slope Mean</i>	2.1-4%	3
<i>Soil K Factor</i>	<0.20	5
<i>Upstream Rt Outlet</i>	Vegetated	1
<i>Upstream Lt Outlet</i>	Vegetated	1
<i>Upstream Rt Ditch</i>	Bare soil	0
<i>Upstream Lt Ditch</i>	Bare soil	0
<i>Downstream Rt Outlet</i>	Bare soil	0
<i>Downstream Lt Outlet</i>	Vegetated	1
<i>Downstream Rt Ditch</i>	Bare soil	0
<i>Downstream Lt Ditch</i>	Bare soil	0
<i>Outlet Total</i>	Partially Improved Outlet System	3
<i>Ditches Total</i>	Unimproved Drainage System	1
<b>SRI Total</b>	<b>High Risk</b>	<b>30</b>
<b>Additional Site Features</b>		
<i>Crossing Type and Quantity:</i>	Culvert, 1

Notes: DS drop off. US RT outlet contributing excessive sedimentation, also seen in aerial photo.

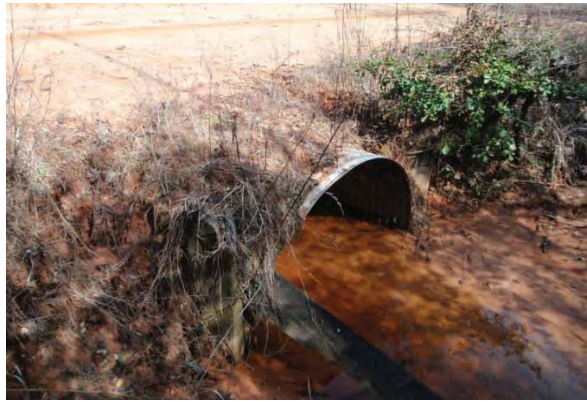
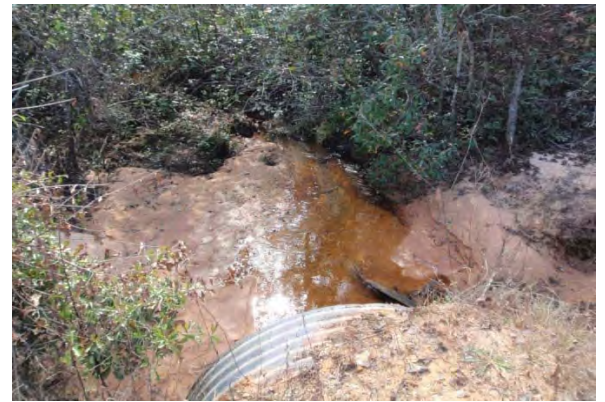
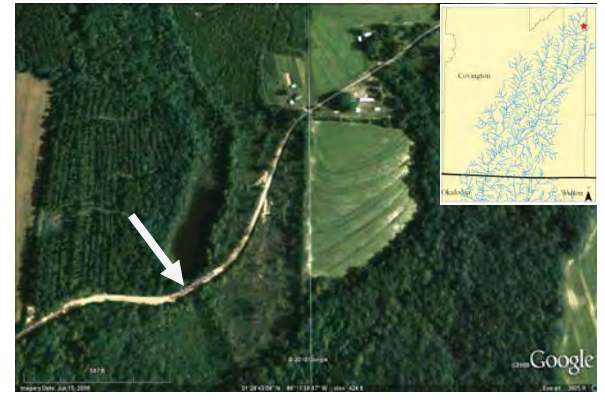
Crossing Structure: DS

Risk Factor	Ranking	Score
<i>US Channel Morph</i>	PONDED	1
<i>DS Channel Morph</i>	E	5
<i>DS Bank Alteration</i>	HIGH	1
<i>Upstream Skew Angle</i>	5-30°	3
<i>Crossing fill condition</i>	Poor/Bare soil	1
<i>Inlet/Outlet Condition</i>	Sed Islands/Scouring	3
<i>Road Approach Material</i>	All Sand/Clay	3
<i>Potential Eroded Volume Mean</i>	21-40 y <sup>3</sup>	3
<i>Approach Slope Mean</i>	>4%	1
<i>Soil K Factor</i>	0.21-0.40	3
<i>Upstream Rt Outlet</i>	Bare soil	0
<i>Upstream Lt Outlet</i>	Bare soil	0
<i>Upstream Rt Ditch</i>	Bare soil	0
<i>Upstream Lt Ditch</i>	Bare soil	0
<i>Downstream Rt Outlet</i>	Bare soil	0
<i>Downstream Lt Outlet</i>	Bare soil	0
<i>Downstream Rt Ditch</i>	Bare soil	0
<i>Downstream Lt Ditch</i>	Bare soil	0
<b>Outlet Total</b>	Unimproved Outlet System	1
<b>Ditches Total</b>	Unimproved Drainage System	1
<b>SRI Total</b>	<b>High Risk</b>	<b>26</b>

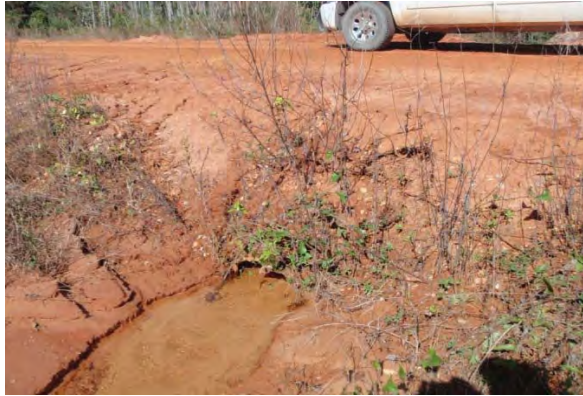
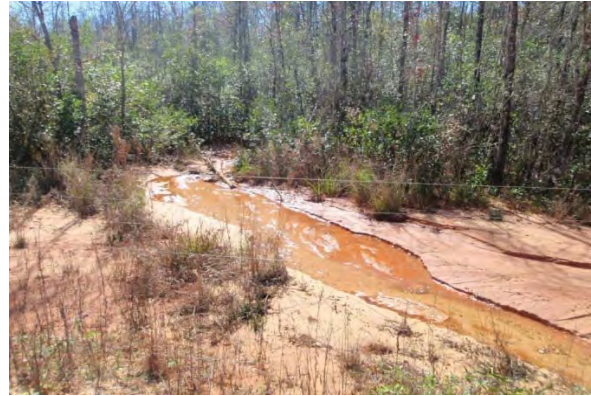
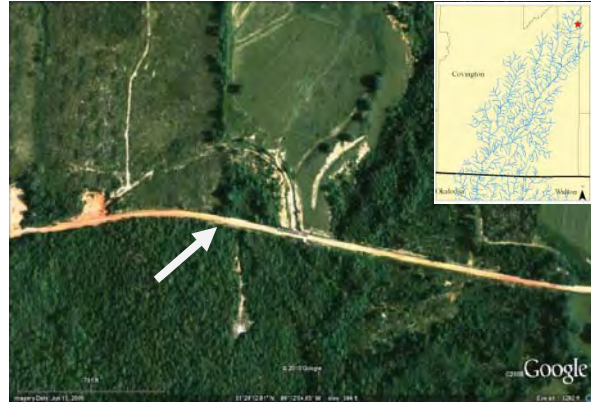
Crossing Structure: US

Risk Factor	Ranking	Score
<i>US Channel Morph</i>	WETLAND	5
<i>DS Channel Morph</i>	C	5
<i>DS Bank Alteration</i>	HIGH	1
<i>Upstream Skew Angle</i>	5-30°	3
<i>Crossing fill condition</i>	Poor/Bare soil	1
<i>Inlet/Outlet Condition</i>	Sed Islands/Scouring	3
<i>Road Approach Material</i>	All Sand/Clay	3
<i>Potential Eroded Volume Mean</i>	<21 y <sup>3</sup>	5
<i>Approach Slope Mean</i>	2.1-4%	3
<i>Soil K Factor</i>	0.21-0.40	3
<i>Upstream Rt Outlet</i>	Bare soil	0
<i>Upstream Lt Outlet</i>	Bare soil	0
<i>Upstream Rt Ditch</i>	Bare soil	0
<i>Upstream Lt Ditch</i>	Bare soil	0
<i>Downstream Rt Outlet</i>	Bare soil	0
<i>Downstream Lt Outlet</i>	Bare soil	0
<i>Downstream Rt Ditch</i>	Bare soil	0
<i>Downstream Lt Ditch</i>	Bare soil	0
<i>Outlet Total</i>	Unimproved Outlet System	1
<i>Ditches Total</i>	Unimproved Drainage System	1
<b><i>SRI Total</i></b>	<b>High Risk</b>	<b>34</b>

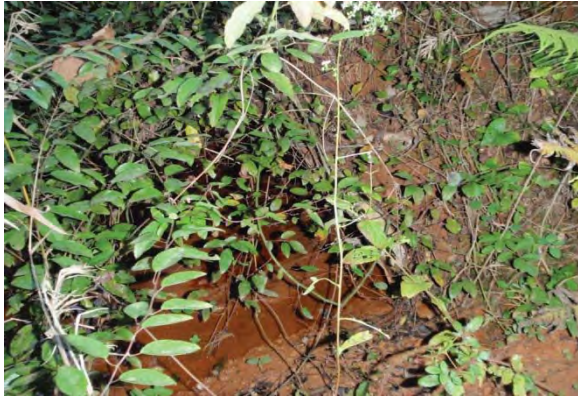
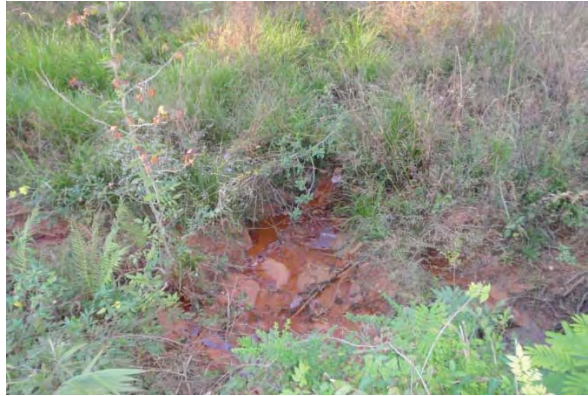
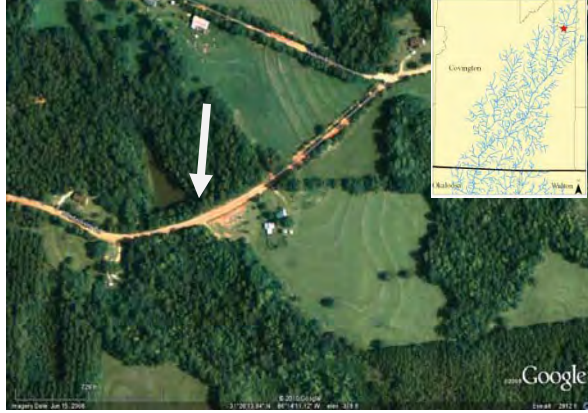
Crossing Structure: DS

Risk Factor	Ranking	Score
<i>US Channel Morph</i>	PONDED	1
<i>DS Channel Morph</i>	E	5
<i>DS Bank Alteration</i>	HIGH	1
<i>Upstream Skew Angle</i>	5-30°	3
<i>Crossing fill condition</i>	Good/Vegetated	5
<i>Inlet/Outlet Condition</i>	Sed Islands/Scouring	3
<i>Road Approach Material</i>	All Sand/Clay	3
<i>Potential Eroded Volume Mean</i>	<21 y <sup>3</sup>	5
<i>Approach Slope Mean</i>	2.1-4%	3
<i>Soil K Factor</i>	<0.20	5
<i>Upstream Rt Outlet</i>	Bare soil	0
<i>Upstream Lt Outlet</i>	Bare soil	0
<i>Upstream Rt Ditch</i>	Bare soil	0
<i>Upstream Lt Ditch</i>	Bare soil	0
<i>Downstream Rt Outlet</i>	Bare soil	0
<i>Downstream Lt Outlet</i>	Bare soil	0
<i>Downstream Rt Ditch</i>	Bare soil	0
<i>Downstream Lt Ditch</i>	Bare soil	0
<i>Outlet Total</i>	Unimproved Outlet System	1
<i>Ditches Total</i>	Unimproved Drainage System	1
<b>SRI Total</b>	<b>High Risk</b>	<b>36</b>

Notes: Pond US, not visible from road. Bare soil ditches and outlets influencing score.

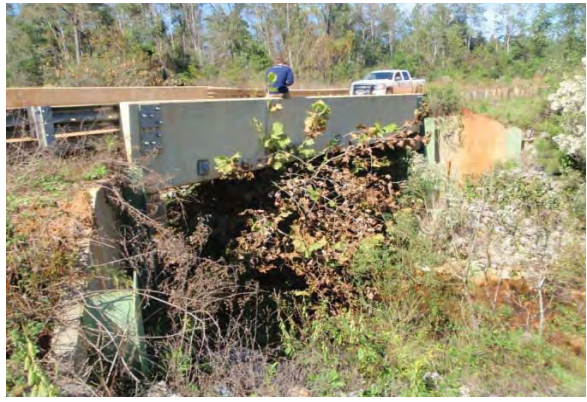
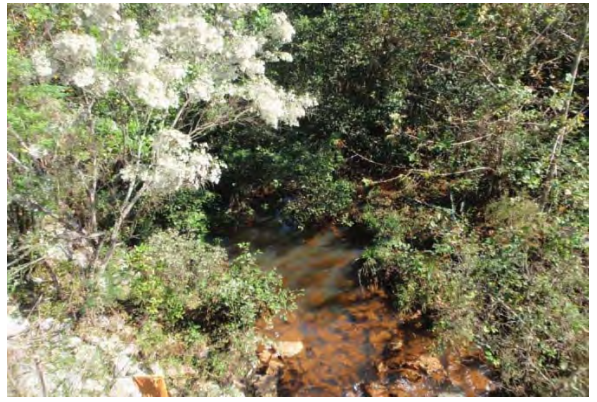
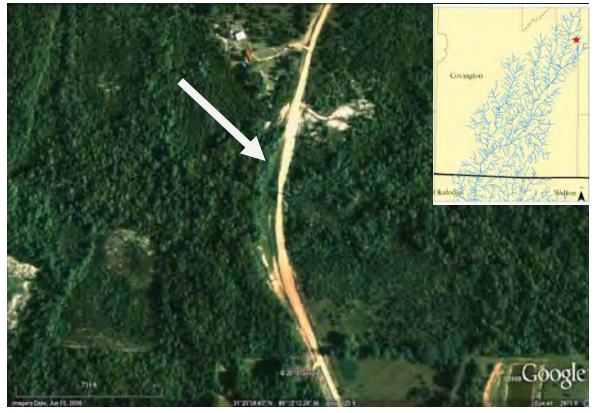
Crossing Structure: US

Risk Factor	Ranking	Score
<i>US Channel Morph</i>	F	1
<i>DS Channel Morph</i>	F	1
<i>DS Bank Alteration</i>	MINOR/PARTIAL	3
<i>Upstream Skew Angle</i>	<5°	5
<i>Crossing fill condition</i>	Fair/Rip Rap	3
<i>Inlet/Outlet Condition</i>	No Impairment	5
<i>Road Approach Material</i>	All Sand/Clay	3
<i>Potential Eroded Volume Mean</i>	<21 y <sup>3</sup>	5
<i>Approach Slope Mean</i>	2.1-4%	3
<i>Soil K Factor</i>	0.21-0.40	3
<i>Upstream Rt Outlet</i>	Vegetated	1
<i>Upstream Lt Outlet</i>	Vegetated	1
<i>Upstream Rt Ditch</i>	Bare soil	0
<i>Upstream Lt Ditch</i>	Bare soil	0
<i>Downstream Rt Outlet</i>	Concrete	0
<i>Downstream Lt Outlet</i>	Vegetated	1
<i>Downstream Rt Ditch</i>	Bare soil	0
<i>Downstream Lt Ditch</i>	Bare soil	0
<i>Outlet Total</i>	Partially Improved Outlet System	3
<i>Ditches Total</i>	Unimproved Drainage System	1
<b><i>SRI Total</i></b>	<b>High Risk</b>	<b>36</b>

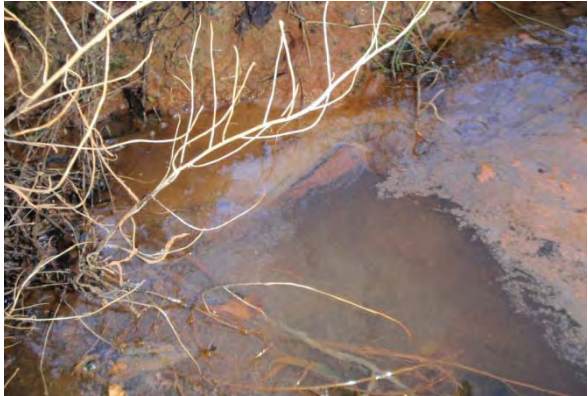
Crossing Structure: US

Risk Factor	Ranking	Score
<i>US Channel Morph</i>	WETLAND	5
<i>DS Channel Morph</i>	E	5
<i>DS Bank Alteration</i>	MINOR/PARTIAL	3
<i>Upstream Skew Angle</i>	<5°	5
<i>Crossing fill condition</i>	Poor/Bare soil	1
<i>Inlet/Outlet Condition</i>	Blocked	1
<i>Road Approach Material</i>	All Sand/Clay	3
<i>Potential Eroded Volume Mean</i>	<21 y <sup>3</sup>	5
<i>Approach Slope Mean</i>	2.1-4%	3
<i>Soil K Factor</i>	0.21-0.40	3
<i>Upstream Rt Outlet</i>	Bare soil	0
<i>Upstream Lt Outlet</i>	Bare soil	0
<i>Upstream Rt Ditch</i>	Bare soil	0
<i>Upstream Lt Ditch</i>	Bare soil	0
<i>Downstream Rt Outlet</i>	Bare soil	0
<i>Downstream Lt Outlet</i>	Bare soil	0
<i>Downstream Rt Ditch</i>	Bare soil	0
<i>Downstream Lt Ditch</i>	Bare soil	0
<b>Outlet Total</b>	Unimproved Outlet System	1
<b>Ditches Total</b>	Unimproved Drainage System	1
<b>SRI Total</b>	<b>High Risk</b>	<b>36</b>

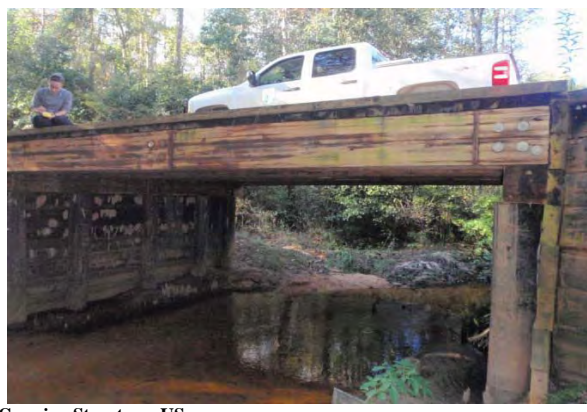
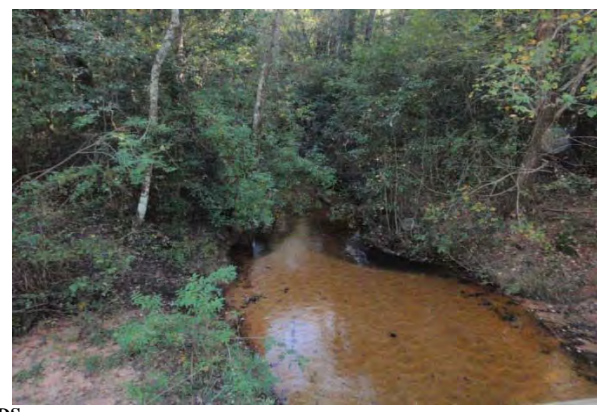
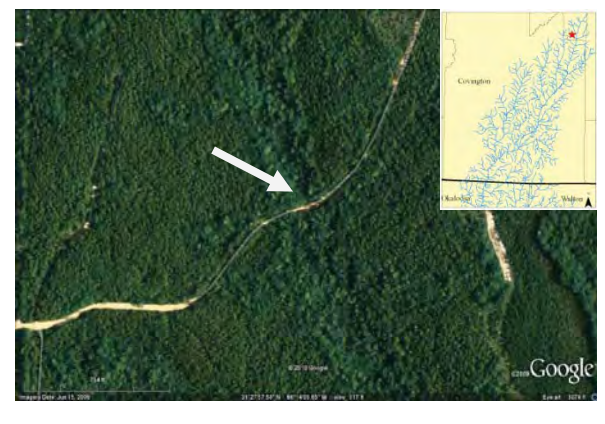
<h1>Parker Creek</h1>	<h2>cr-1102-r-011</h2>	<i>Sedimentation Risk Index</i> <h1>36</h1>
-----------------------	------------------------	--

Risk Factor	Ranking	Score
<i>US Channel Morph</i>	DA	3
<i>DS Channel Morph</i>	C	5
<i>DS Bank Alteration</i>	MINOR/PARTIAL	3
<i>Upstream Skew Angle</i>	<5°	5
<i>Crossing fill condition</i>	Poor/Bare soil	1
<i>Inlet/Outlet Condition</i>	No Impairment	5
<i>Road Approach Material</i>	All Sand/Clay	3
<i>Potential Eroded Volume Mean</i>	>40 y <sup>3</sup>	1
<i>Approach Slope Mean</i>	>4%	1
<i>Soil K Factor</i>	<0.20	5
<i>Upstream Rt Outlet</i>	Bare soil	0
<i>Upstream Lt Outlet</i>	Vegetated	1
<i>Upstream Rt Ditch</i>	Bare soil	0
<i>Upstream Lt Ditch</i>	Bare soil	0
<i>Downstream Rt Outlet</i>	Bare soil	0
<i>Downstream Lt Outlet</i>	Bare soil	0
<i>Downstream Rt Ditch</i>	Bare soil	0
<i>Downstream Lt Ditch</i>	Bare soil	0
<i>Outlet Total</i>	Partially Improved Outlet System	3
<i>Ditches Total</i>	Unimproved Drainage System	1
<b><i>SRI Total</i></b>	<b>High Risk</b>	<b>36</b>

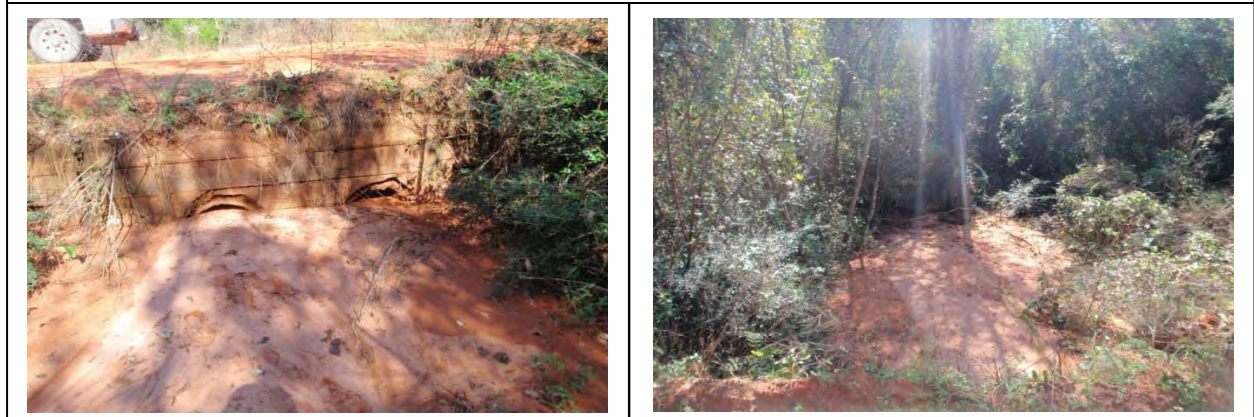
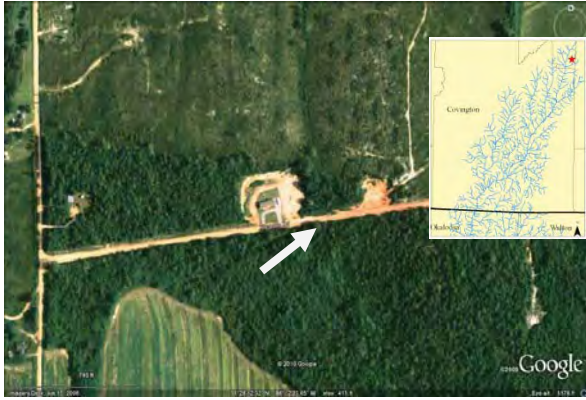
<h1 style="margin:0;">Blaze Branch</h1>	<h2 style="margin:0;">cr-1103-r-005</h2>	<b style="font-size: small;">Sedimentation Risk Index</b> <h1 style="margin:0;">36</h1>
---	--	--

Risk Factor	Ranking	Score	
<i>US Channel Morph</i>	A	5	
<i>DS Channel Morph</i>	B	5	
<i>DS Bank Alteration</i>	HIGH	1	
<i>Upstream Skew Angle</i>	<5°	5	
<i>Crossing fill condition</i>	Poor/Bare soil	1	
<i>Inlet/Outlet Condition</i>	Blocked	1	
<i>Road Approach Material</i>	All Sand/Clay	3	
<i>Potential Eroded Volume Mean</i>	<21 y <sup>3</sup>	5	
<i>Approach Slope Mean</i>	2.1-4%	3	
<i>Soil K Factor</i>	<0.20	5	
<i>Upstream Rt Outlet</i>	Bare soil	0	
<i>Upstream Lt Outlet</i>	Bare soil	0	
<i>Upstream Rt Ditch</i>	Bare soil	0	
<i>Upstream Lt Ditch</i>	Bare soil	0	
<i>Downstream Rt Outlet</i>	Bare soil	0	
<i>Downstream Lt Outlet</i>	Bare soil	0	
<i>Downstream Rt Ditch</i>	Bare soil	0	
<i>Downstream Lt Ditch</i>	Bare soil	0	
<i>Outlet Total</i>	Unimproved Outlet System	1	
<i>Ditches Total</i>	Unimproved Drainage System	1	
<b><i>SRI Total</i></b>	<b>High Risk</b>	<b>36</b>	
<b>Additional Site Features</b>			
<i>Crossing Type and Quantity:</i>	Culvert,2

Notes: Eroding slope Lt approach. Blocked culverts from bare soil and ditches influencing score.

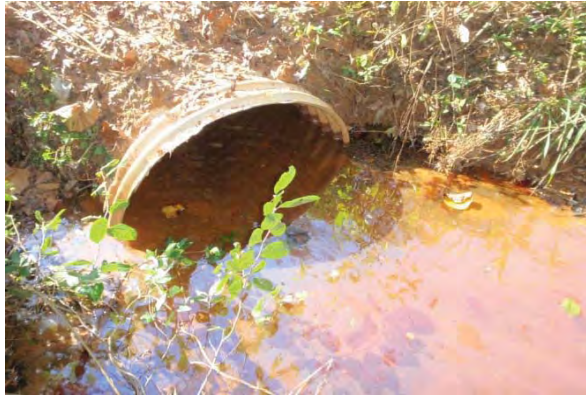
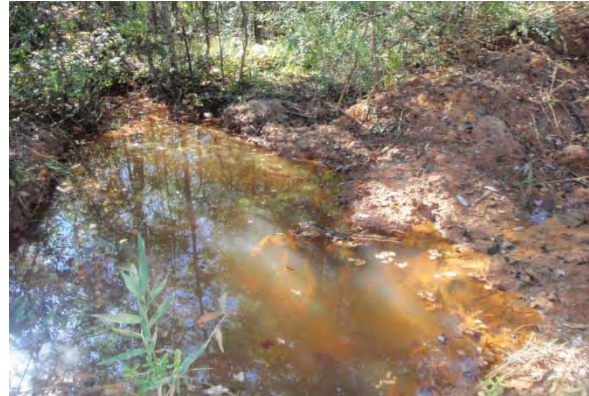
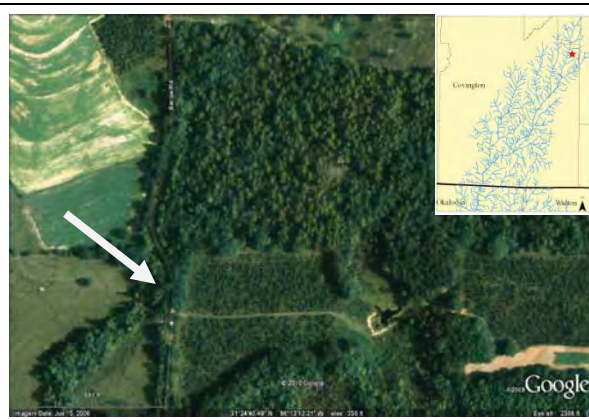
County: Covington  
PLSS (T-R-S): 5N-18E-14  
Parcel No.: 1,2  
Road Name: Barlow Rd

Risk Factor	Ranking	Score
<i>US Channel Morph</i>	DA	3
<i>DS Channel Morph</i>	DA	3
<i>DS Bank Alteration</i>	HIGH	1
<i>Upstream Skew Angle</i>	5-30°	3
<i>Crossing fill condition</i>	Poor/Bare soil	1
<i>Inlet/Outlet Condition</i>	No Impairment	5
<i>Road Approach Material</i>	All Sand/Clay	3
<i>Potential Eroded Volume Mean</i>	<21 y <sup>3</sup>	5
<i>Approach Slope Mean</i>	<2%	5
<i>Soil K Factor</i>	0.21-0.40	3
<i>Upstream Rt Outlet</i>	Bare soil	0
<i>Upstream Lt Outlet</i>	Vegetated	1
<i>Upstream Rt Ditch</i>	Bare soil	0
<i>Upstream Lt Ditch</i>	Vegetated	1
<i>Downstream Rt Outlet</i>	Bare soil	0
<i>Downstream Lt Outlet</i>	Bare soil	0
<i>Downstream Rt Ditch</i>	Bare soil	0
<i>Downstream Lt Ditch</i>	Bare soil	0
<i>Outlet Total</i>	Partially Improved Outlet System	3
<i>Ditches Total</i>	Partially Improved Drainage System	3
<b>SRI Total</b>	<b>Medium Risk</b>	<b>38</b>

Notes: Bare fill, mostly bare ditches and outlets influencing score.

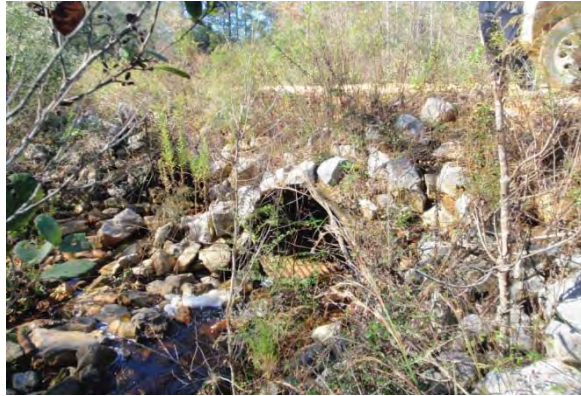
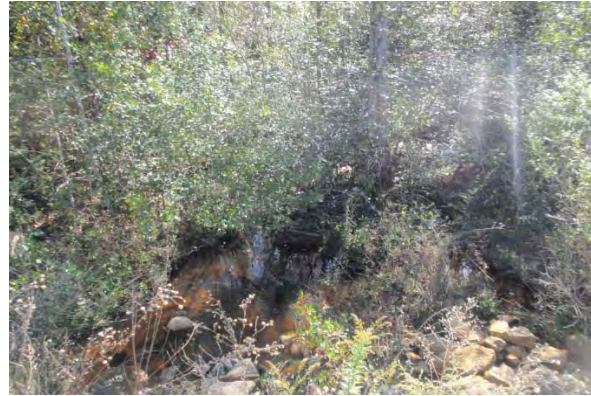
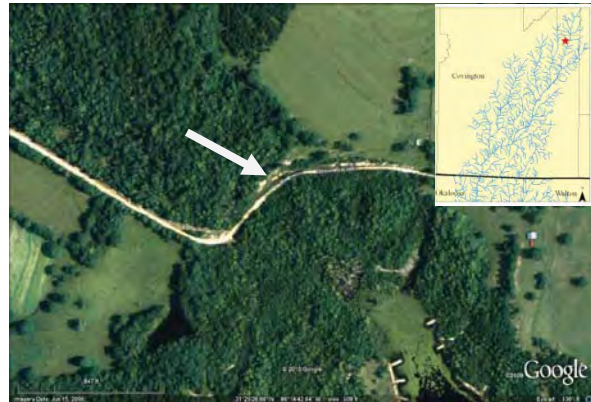
<b>Unnamed tributary</b>	<b>co-1104-r-004</b>	<i>Sedimentation Risk Index</i> <b>38</b>
--------------------------	----------------------	--

Risk Factor	Ranking	Score
US Channel Morph	DA	3
DS Channel Morph	DA	3
DS Bank Alteration	MINOR/PARTIAL	3
Upstream Skew Angle	<5°	5
Crossing fill condition	Fair/Rip Rap	3
Inlet/Outlet Condition	Blocked	1
Road Approach Material	All Sand/Clay	3
Potential Eroded Volume Mean	<21 y <sup>3</sup>	5
Approach Slope Mean	<2%	5
Soil K Factor	<0.20	5
Upstream Rt Outlet	Bare soil	0
Upstream Lt Outlet	Bare soil	0
Upstream Rt Ditch	Bare soil	0
Upstream Lt Ditch	Bare soil	0
Downstream Rt Outlet	Bare soil	0
Downstream Lt Outlet	Bare soil	0
Downstream Rt Ditch	Bare soil	0
Downstream Lt Ditch	Bare soil	0
Outlet Total	Unimproved Outlet System	1
Ditches Total	Unimproved Drainage System	1
<b>SRI Total</b>	<b>Medium Risk</b>	<b>38</b>

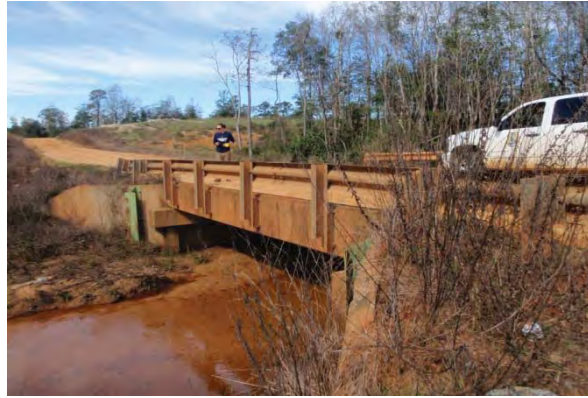
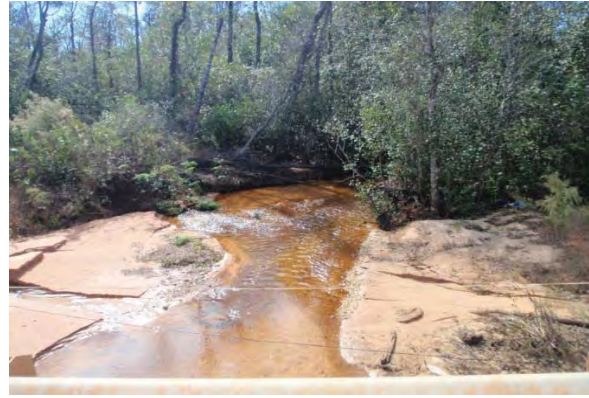
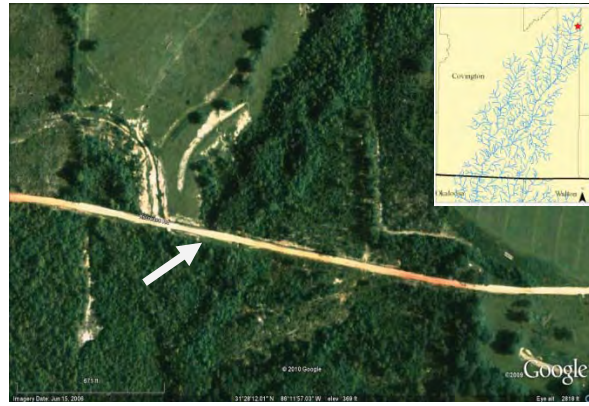
<b>Blaze Branch</b>	<b>cr-1103-r-003</b>	<i>Sedimentation Risk Index</i> <b>38</b>
---------------------	----------------------	--

Risk Factor	Ranking	Score
<i>US Channel Morph</i>	DA	3
<i>DS Channel Morph</i>	E	5
<i>DS Bank Alteration</i>	MINOR/PARTIAL	3
<i>Upstream Skew Angle</i>	5-30°	3
<i>Crossing fill condition</i>	Poor/Bare soil	1
<i>Inlet/Outlet Condition</i>	Sed Islands/Scouring	3
<i>Road Approach Material</i>	All Sand/Clay	3
<i>Potential Eroded Volume Mean</i>	<21 y <sup>3</sup>	5
<i>Approach Slope Mean</i>	2.1-4%	3
<i>Soil K Factor</i>	0.21-0.40	3
<i>Upstream Rt Outlet</i>	Bare soil	0
<i>Upstream Lt Outlet</i>	Rip Rap	1
<i>Upstream Rt Ditch</i>	Rip Rap	1
<i>Upstream Lt Ditch</i>	Bare soil	0
<i>Downstream Rt Outlet</i>	Bare soil	0
<i>Downstream Lt Outlet</i>	Rip Rap	1
<i>Downstream Rt Ditch</i>	Bare soil	0
<i>Downstream Lt Ditch</i>	Rip Rap	1
<i>Outlet Total</i>	Partially Improved Outlet System	3
<i>Ditches Total</i>	Partially Improved Drainage System	3
<b>SRI Total</b>	<b>Medium Risk</b>	<b>38</b>

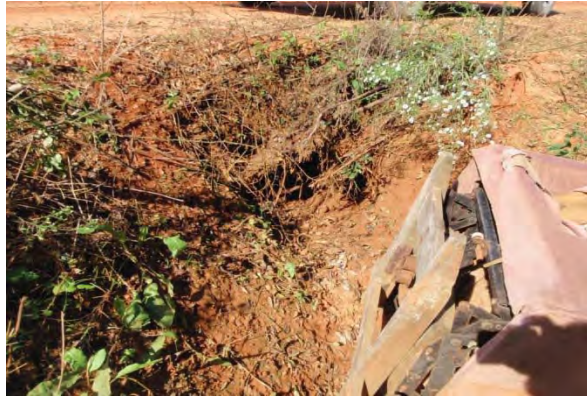
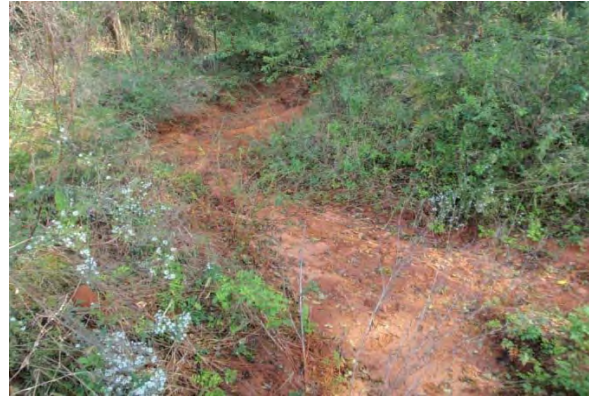
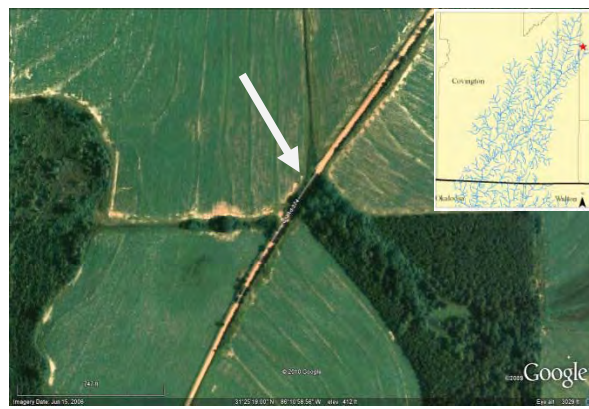
Unnamed tributary	cf-1103-r-008	Sedimentation Risk Index <b>40</b>
-------------------	---------------	---------------------------------------

Risk Factor	Ranking	Score
<i>US Channel Morph</i>	DA	3
<i>DS Channel Morph</i>	C	5
<i>DS Bank Alteration</i>	MINOR/PARTIAL	3
<i>Upstream Skew Angle</i>	<5°	5
<i>Crossing fill condition</i>	Good/Vegetated	5
<i>Inlet/Outlet Condition</i>	No Impairment	5
<i>Road Approach Material</i>	All Sand/Clay	3
<i>Potential Eroded Volume Mean</i>	21-40 y <sup>3</sup>	3
<i>Approach Slope Mean</i>	2.1-4%	3
<i>Soil K Factor</i>	0.21-0.40	3
<i>Upstream Rt Outlet</i>	Vegetated	1
<i>Upstream Lt Outlet</i>	Vegetated	1
<i>Upstream Rt Ditch</i>	Bare soil	0
<i>Upstream Lt Ditch</i>	Bare soil	0
<i>Downstream Rt Outlet</i>	Vegetated	1
<i>Downstream Lt Outlet</i>	Vegetated	1
<i>Downstream Rt Ditch</i>	Bare soil	0
<i>Downstream Lt Ditch</i>	Bare soil	0
<i>Outlet Total</i>	Improved Outlet System	5
<i>Ditches Total</i>	Unimproved Drainage System	1
<b>SRI Total</b>	<b>Medium Risk</b>	<b>44</b>

Restoration Recommendations: TBD

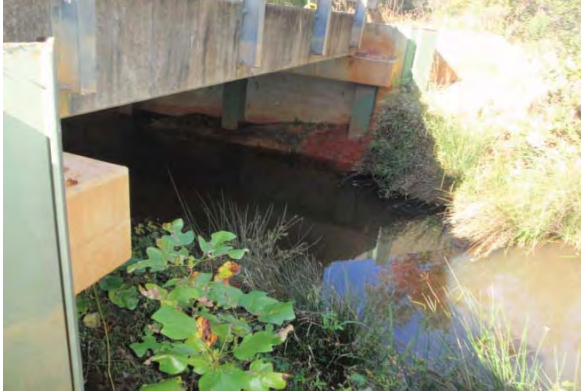
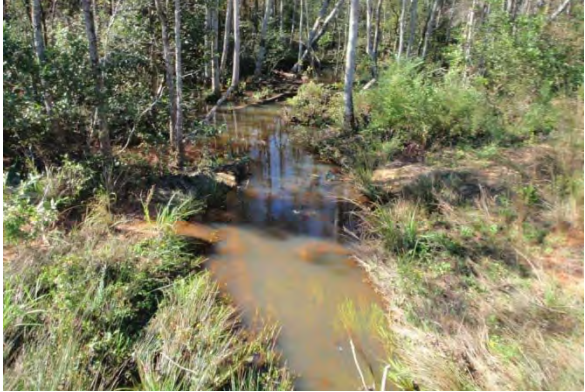
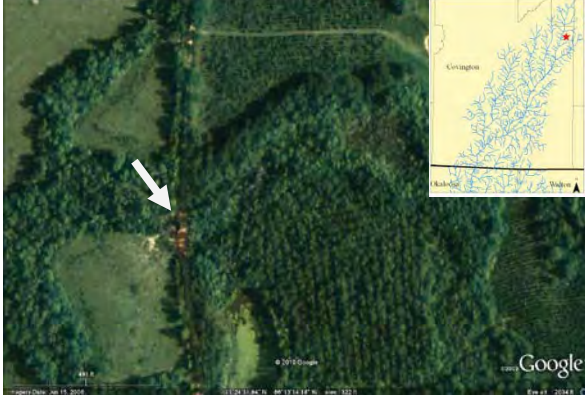
Crossing Structure: US		DS																						
<b>Risk Factor</b>	<b>Ranking</b>	<b>Score</b>																						
<i>US Channel Morph</i>	DA	3																						
<i>DS Channel Morph</i>	DA	3																						
<i>DS Bank Alteration</i>	HIGH	1																						
<i>Upstream Skew Angle</i>	<5°	5																						
<i>Crossing fill condition</i>	Good/Vegetated	5																						
<i>Inlet/Outlet Condition</i>	No Impairment	5																						
<i>Road Approach Material</i>	All Sand/Clay	3																						
<i>Potential Eroded Volume Mean</i>	21-40 y <sup>3</sup>	3																						
<i>Approach Slope Mean</i>	2.1-4%	3																						
<i>Soil K Factor</i>	<0.20	5																						
<i>Upstream Rt Outlet</i>	Vegetated	1																						
<i>Upstream Lt Outlet</i>	Vegetated	1																						
<i>Upstream Rt Ditch</i>	Bare soil	0																						
<i>Upstream Lt Ditch</i>	Bare soil	0																						
<i>Downstream Rt Outlet</i>	Bare soil	0																						
<i>Downstream Lt Outlet</i>	Bare soil	0																						
<i>Downstream Rt Ditch</i>	Bare soil	0																						
<i>Downstream Lt Ditch</i>	Bare soil	0																						
<i>Outlet Total</i>	Partially Improved Outlet System	3																						
<i>Ditches Total</i>	Unimproved Drainage System	1																						
<b>SRI Total</b>	<b>Medium Risk</b>	<b>40</b>

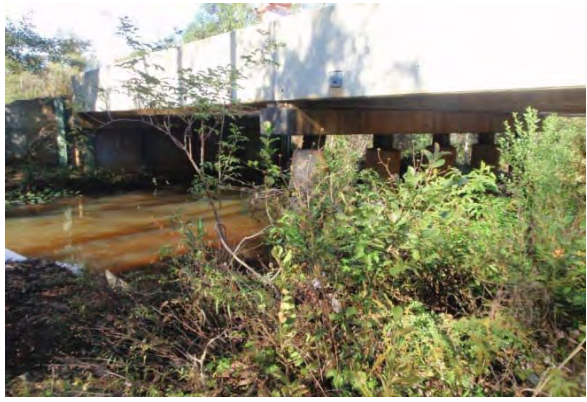
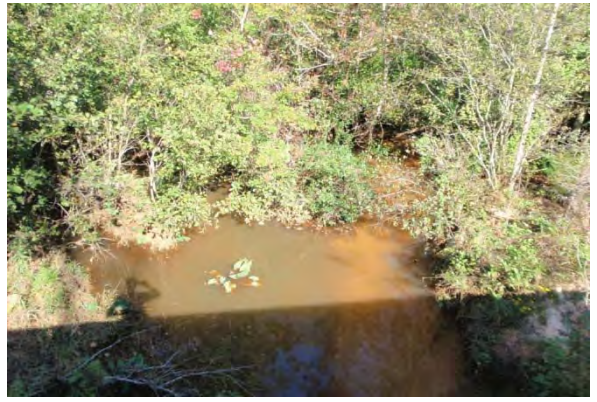
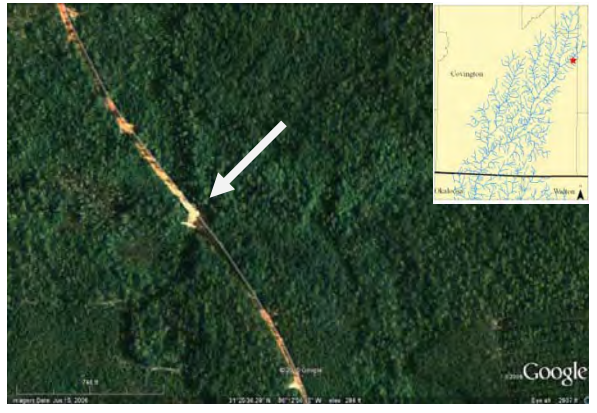
<b>Mill Creek</b>	<b>co-1103-r-011</b>	<i>Sedimentation Risk Index</i> <b>40</b>
-------------------	----------------------	--

Risk Factor	Ranking	Score
<i>US Channel Morph</i>	C	5
<i>DS Channel Morph</i>	C	5
<i>DS Bank Alteration</i>	MINOR/PARTIAL	3
<i>Upstream Skew Angle</i>	<5°	5
<i>Crossing fill condition</i>	Good/Vegetated	5
<i>Inlet/Outlet Condition</i>	No Impairment	5
<i>Road Approach Material</i>	All Sand/Clay	3
<i>Potential Eroded Volume Mean</i>	>40 y <sup>3</sup>	1
<i>Approach Slope Mean</i>	>4%	1
<i>Soil K Factor</i>	0.21-0.40	3
<i>Upstream Rt Outlet</i>	Vegetated	1
<i>Upstream Lt Outlet</i>	Bare soil	0
<i>Upstream Rt Ditch</i>	Bare soil	0
<i>Upstream Lt Ditch</i>	Bare soil	0
<i>Downstream Rt Outlet</i>	Vegetated	1
<i>Downstream Lt Outlet</i>	Bare soil	0
<i>Downstream Rt Ditch</i>	Bare soil	0
<i>Downstream Lt Ditch</i>	Bare soil	0
<i>Outlet Total</i>	Partially Improved Outlet System	3
<i>Ditches Total</i>	Unimproved Drainage System	1
<b>SRI Total</b>	<b>Medium Risk</b>	<b>40</b>

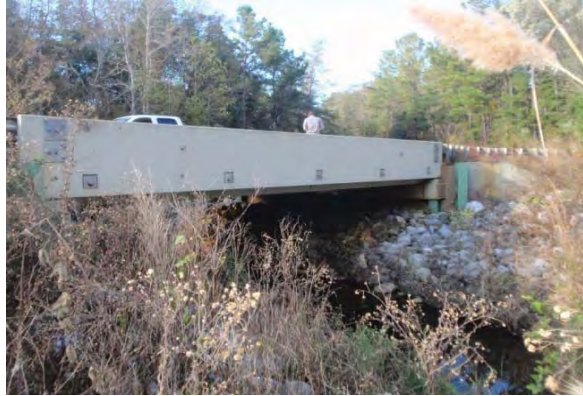
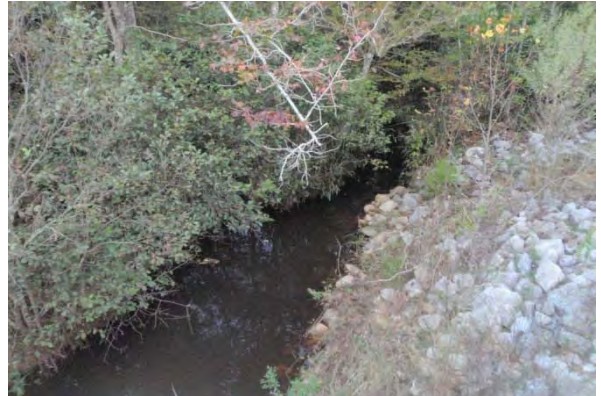
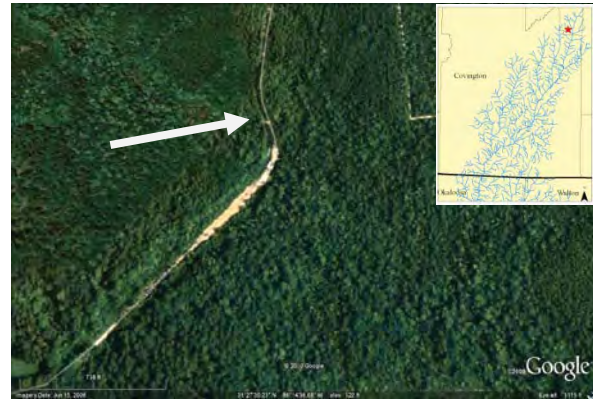
<h1 style="margin:0;">Pigpen Creek</h1>	<h2 style="margin:0;">cr-1102-r-012</h2>	<i>Sedimentation Risk Index</i> <h1 style="margin:0;">42</h1>
---	--	--

Risk Factor	Ranking	Score
<i>US Channel Morph</i>	DA	3
<i>DS Channel Morph</i>	C	5
<i>DS Bank Alteration</i>	MINOR/PARTIAL	3
<i>Upstream Skew Angle</i>	<5°	5
<i>Crossing fill condition</i>	Fair/Rip Rap	3
<i>Inlet/Outlet Condition</i>	No Impairment	5
<i>Road Approach Material</i>	All Sand/Clay	3
<i>Potential Eroded Volume Mean</i>	21-40 y <sup>3</sup>	3
<i>Approach Slope Mean</i>	>4%	1
<i>Soil K Factor</i>	<0.20	5
<i>Upstream Rt Outlet</i>	Bare soil	0
<i>Upstream Lt Outlet</i>	Rip Rap	1
<i>Upstream Rt Ditch</i>	Rip Rap	1
<i>Upstream Lt Ditch</i>	Rip Rap	1
<i>Downstream Rt Outlet</i>	Vegetated	1
<i>Downstream Lt Outlet</i>	Rip Rap	1
<i>Downstream Rt Ditch</i>	Bare soil	0
<i>Downstream Lt Ditch</i>	Rip Rap	1
<i>Outlet Total</i>	Partially Improved Outlet System	3
<i>Ditches Total</i>	Partially Improved Drainage System	3
<b><i>SRI Total</i></b>	<b>Medium Risk</b>	<b>42</b>

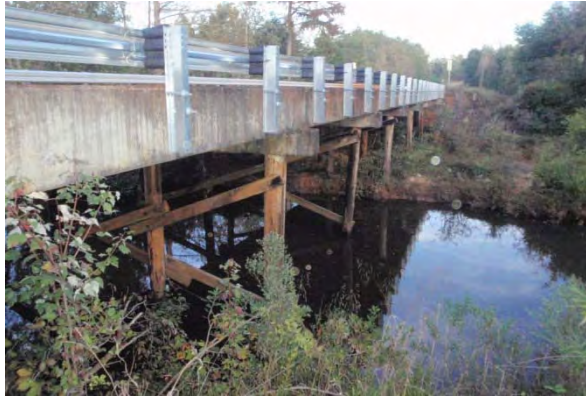
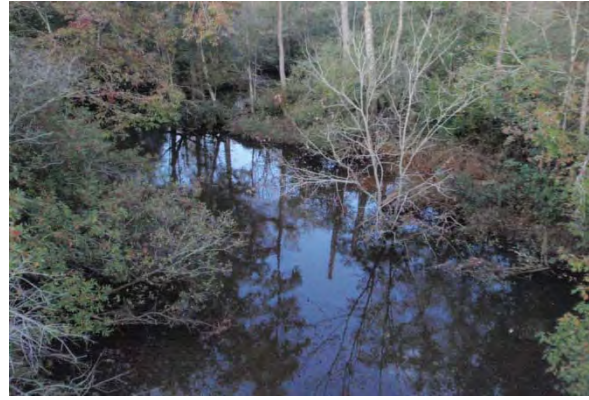
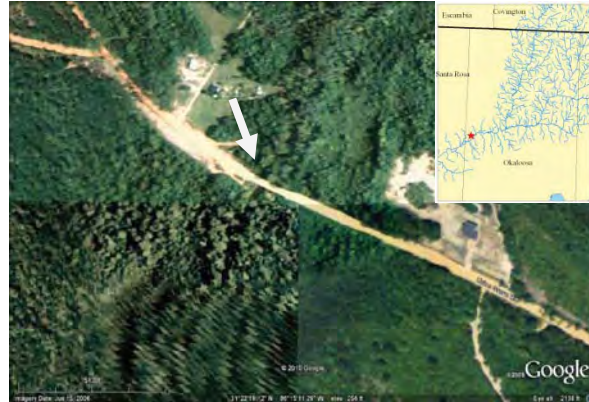
County: Covington  
PLSS (T-R-S): 5N-18E-28  
Parcel No.: 1.04, 1  
Road Name: Union Grove Rd

Risk Factor	Ranking	Score
<i>US Channel Morph</i>	C	5
<i>DS Channel Morph</i>	C	5
<i>DS Bank Alteration</i>	NATURAL	5
<i>Upstream Skew Angle</i>	<5°	5
<i>Crossing fill condition</i>	Good/Vegetated	5
<i>Inlet/Outlet Condition</i>	No Impairment	5
<i>Road Approach Material</i>	All Aggregate	5
<i>Potential Eroded Volume Mean</i>	>40 y <sup>3</sup>	1
<i>Approach Slope Mean</i>	>4%	1
<i>Soil K Factor</i>	0.21-0.40	3
<i>Upstream Rt Outlet</i>	Vegetated	1
<i>Upstream Lt Outlet</i>	Vegetated	1
<i>Upstream Rt Ditch</i>	Bare soil	0
<i>Upstream Lt Ditch</i>	Bare soil	0
<i>Downstream Rt Outlet</i>	Vegetated	1
<i>Downstream Lt Outlet</i>	Bare soil	0
<i>Downstream Rt Ditch</i>	Bare soil	0
<i>Downstream Lt Ditch</i>	Bare soil	0
<i>Outlet Total</i>	Partially Improved Outlet System	3
<i>Ditches Total</i>	Unimproved Drainage System	1
<b><i>SRI Total</i></b>	<b>Medium Risk</b>	<b>44</b>

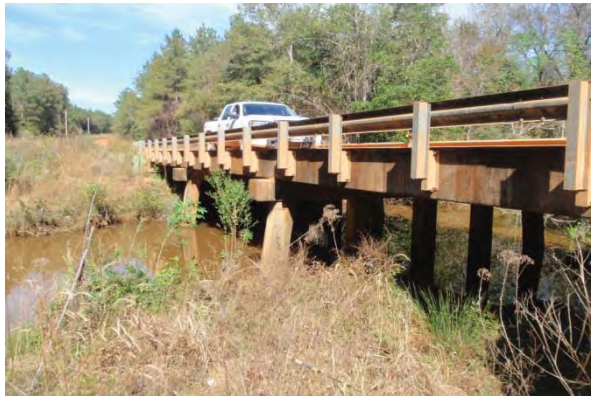
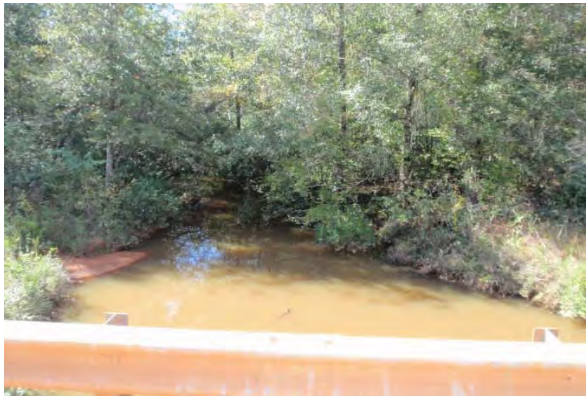
<h1 style="margin:0;">Blaze Branch</h1>	<h2 style="margin:0;">cr-1103-r-006</h2>	<i>Sedimentation Risk Index</i> <b style="font-size: 1.5em;">44</b>
---	--	--

Risk Factor	Ranking	Score
<i>US Channel Morph</i>	DA	3
<i>DS Channel Morph</i>	C	5
<i>DS Bank Alteration</i>	MINOR/PARTIAL	3
<i>Upstream Skew Angle</i>	<5°	5
<i>Crossing fill condition</i>	Good/Vegetated	5
<i>Inlet/Outlet Condition</i>	No Impairment	5
<i>Road Approach Material</i>	All Sand/Clay	3
<i>Potential Eroded Volume Mean</i>	21-40 y <sup>3</sup>	3
<i>Approach Slope Mean</i>	2.1-4%	3
<i>Soil K Factor</i>	0.21-0.40	3
<i>Upstream Rt Outlet</i>	Vegetated	1
<i>Upstream Lt Outlet</i>	Vegetated	1
<i>Upstream Rt Ditch</i>	Bare soil	0
<i>Upstream Lt Ditch</i>	Bare soil	0
<i>Downstream Rt Outlet</i>	Vegetated	1
<i>Downstream Lt Outlet</i>	Vegetated	1
<i>Downstream Rt Ditch</i>	Bare soil	0
<i>Downstream Lt Ditch</i>	Bare soil	0
<i>Outlet Total</i>	Improved Outlet System	5
<i>Ditches Total</i>	Unimproved Drainage System	1
<b><i>SRI Total</i></b>	<b>Medium Risk</b>	<b>44</b>

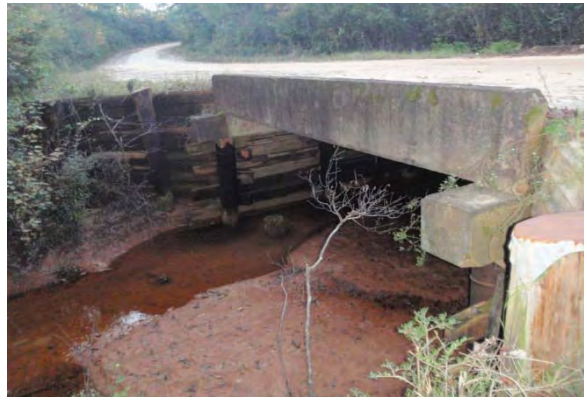
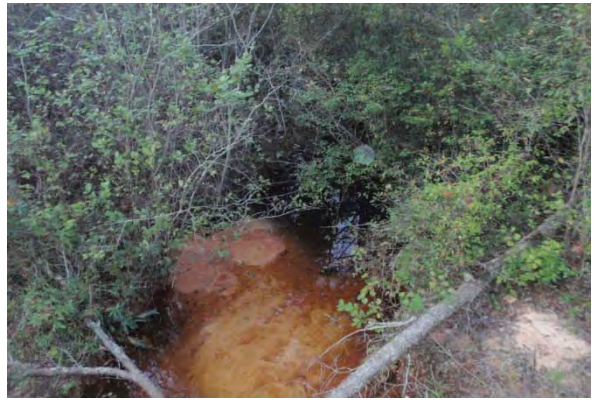
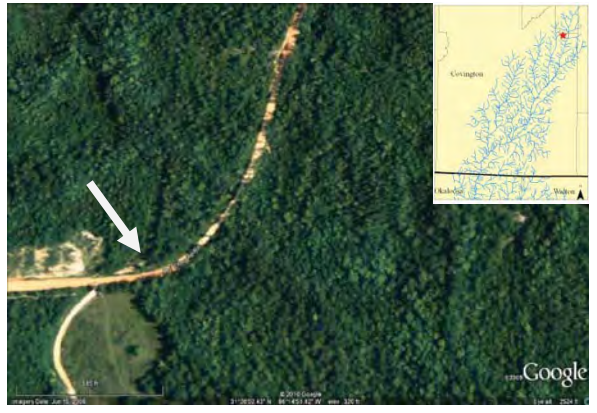
<b>Jolly Creek</b>	<b>co-1102-r-015</b>	<i>Sedimentation Risk Index</i> <b>46</b>
--------------------	----------------------	--

Risk Factor	Ranking	Score
<i>US Channel Morph</i>	C	5
<i>DS Channel Morph</i>	B	5
<i>DS Bank Alteration</i>	MINOR/PARTIAL	3
<i>Upstream Skew Angle</i>	<5°	5
<i>Crossing fill condition</i>	Good/Vegetated	5
<i>Inlet/Outlet Condition</i>	Sed Islands/Scouring	3
<i>Road Approach Material</i>	All Sand/Clay	3
<i>Potential Eroded Volume Mean</i>	<21 y <sup>3</sup>	5
<i>Approach Slope Mean</i>	2.1-4%	3
<i>Soil K Factor</i>	<0.20	5
<i>Upstream Rt Outlet</i>	Bare soil	0
<i>Upstream Lt Outlet</i>	Bare soil	0
<i>Upstream Rt Ditch</i>	Bare soil	0
<i>Upstream Lt Ditch</i>	Bare soil	0
<i>Downstream Rt Outlet</i>	Bare soil	0
<i>Downstream Lt Outlet</i>	Vegetated	1
<i>Downstream Rt Ditch</i>	Bare soil	0
<i>Downstream Lt Ditch</i>	Bare soil	0
<i>Outlet Total</i>	Partially Improved Outlet System	3
<i>Ditches Total</i>	Unimproved Drainage System	1
<b>SRI Total</b>	<b>Low Risk</b>	<b>46</b>

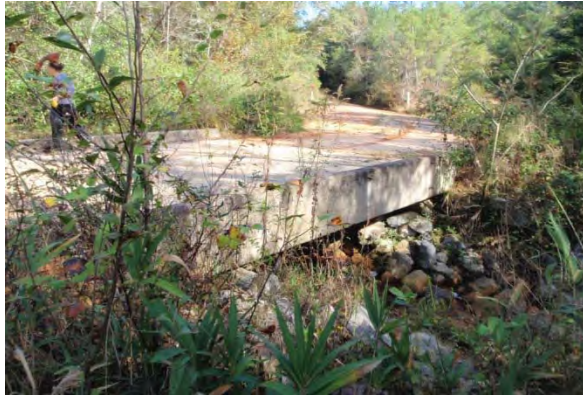
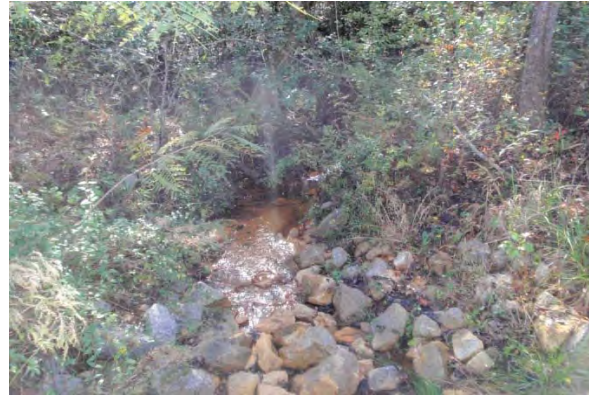
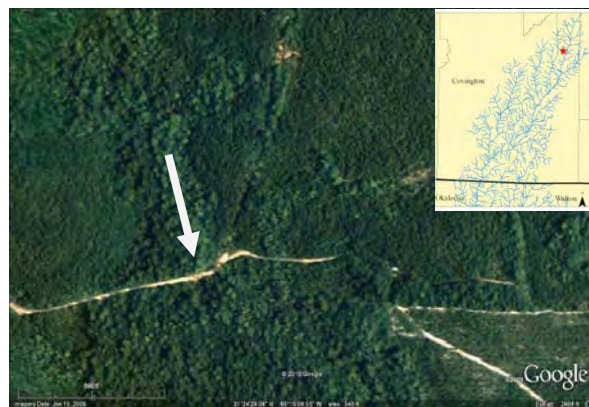
Unnamed tributary	co-1104-r-002	Sedimentation Risk Index <b>46</b>
-------------------	---------------	---------------------------------------

Risk Factor	Ranking	Score
<i>US Channel Morph</i>	E	5
<i>DS Channel Morph</i>	E	5
<i>DS Bank Alteration</i>	MINOR/PARTIAL	3
<i>Upstream Skew Angle</i>	<5°	5
<i>Crossing fill condition</i>	Fair/Rip Rap	3
<i>Inlet/Outlet Condition</i>	No Impairment	5
<i>Road Approach Material</i>	All Sand/Clay	3
<i>Potential Eroded Volume Mean</i>	<21 y <sup>3</sup>	5
<i>Approach Slope Mean</i>	2.1-4%	3
<i>Soil K Factor</i>	<0.20	5
<i>Upstream Rt Outlet</i>	Vegetated	1
<i>Upstream Lt Outlet</i>	Vegetated	1
<i>Upstream Rt Ditch</i>	Bare soil	0
<i>Upstream Lt Ditch</i>	Bare soil	0
<i>Downstream Rt Outlet</i>	Bare soil	0
<i>Downstream Lt Outlet</i>	Bare soil	0
<i>Downstream Rt Ditch</i>	Bare soil	0
<i>Downstream Lt Ditch</i>	Bare soil	0
<i>Outlet Total</i>	Partially Improved Outlet System	3
<i>Ditches Total</i>	Unimproved Drainage System	1
<b>SRI Total</b>	<b>Low Risk</b>	<b>46</b>

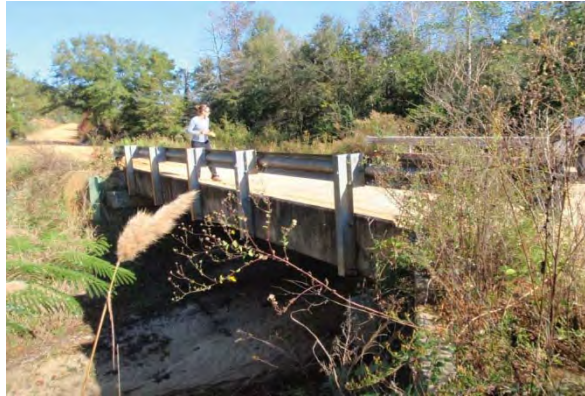
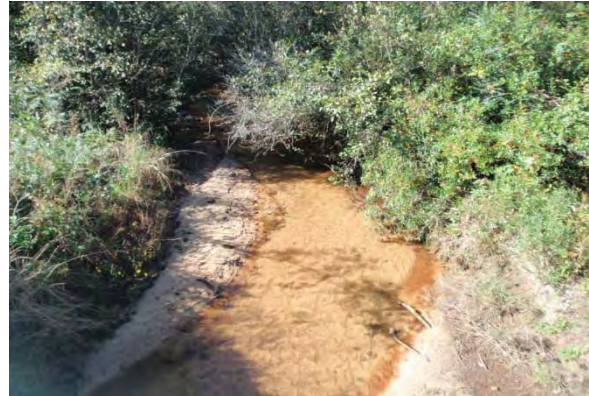
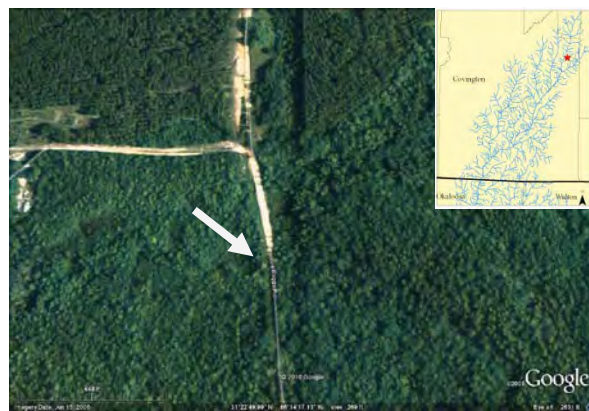
Unnamed tributary	co-1104-r-001	Sedimentation Risk Index <b>48</b>
-------------------	---------------	---------------------------------------

Risk Factor	Ranking	Score
<i>US Channel Morph</i>	DA	3
<i>DS Channel Morph</i>	C	5
<i>DS Bank Alteration</i>	MINOR/PARTIAL	3
<i>Upstream Skew Angle</i>	<5°	5
<i>Crossing fill condition</i>	Good/Vegetated	5
<i>Inlet/Outlet Condition</i>	No Impairment	5
<i>Road Approach Material</i>	All Sand/Clay	3
<i>Potential Eroded Volume Mean</i>	21-40 y <sup>3</sup>	3
<i>Approach Slope Mean</i>	2.1-4%	3
<i>Soil K Factor</i>	<0.20	5
<i>Upstream Rt Outlet</i>	Vegetated	1
<i>Upstream Lt Outlet</i>	Vegetated	1
<i>Upstream Rt Ditch</i>	Bare soil	0
<i>Upstream Lt Ditch</i>	Vegetated	1
<i>Downstream Rt Outlet</i>	Vegetated	1
<i>Downstream Lt Outlet</i>	Vegetated	1
<i>Downstream Rt Ditch</i>	Vegetated	1
<i>Downstream Lt Ditch</i>	Bare soil	0
<i>Outlet Total</i>	Improved Outlet System	5
<i>Ditches Total</i>	Partially Improved Drainage System	3
<b>SRI Total</b>	<b>Low Risk</b>	<b>48</b>

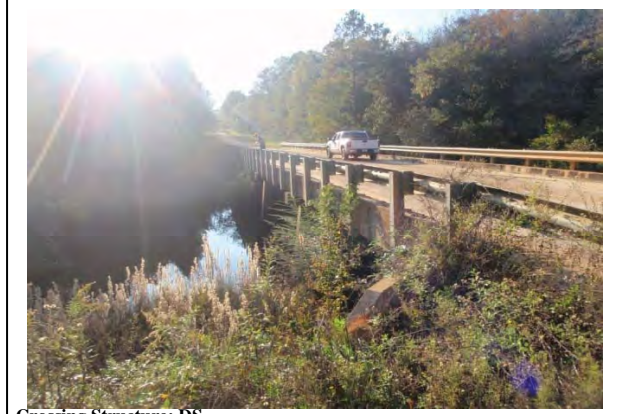
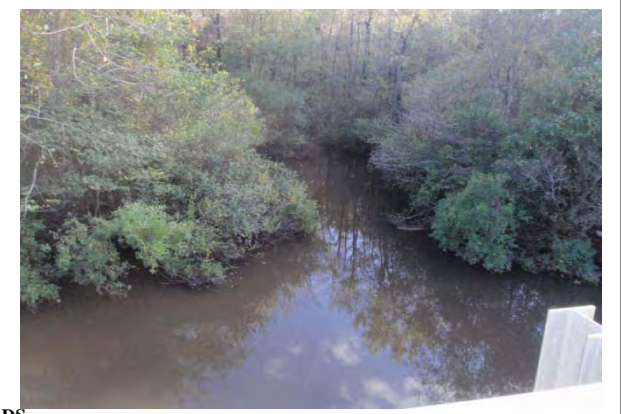
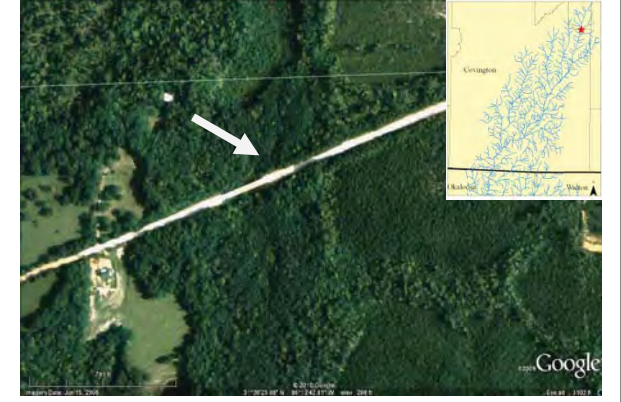
<h1 style="margin:0;">Lightwood Knot Creek</h1>	<h2 style="margin:0;">co-1102-r-013</h2>	<i>Sedimentation Risk Index</i> <b>50</b>
---	--	--

Risk Factor	Ranking	Score
<i>US Channel Morph</i>	WETLAND	5
<i>DS Channel Morph</i>	WETLAND	5
<i>DS Bank Alteration</i>	MINOR/PARTIAL	3
<i>Upstream Skew Angle</i>	<5°	5
<i>Crossing fill condition</i>	Fair/Rip Rap	3
<i>Inlet/Outlet Condition</i>	No Impairment	5
<i>Road Approach Material</i>	All Aggregate	5
<i>Potential Eroded Volume Mean</i>	>40 y <sup>3</sup>	1
<i>Approach Slope Mean</i>	2.1-4%	3
<i>Soil K Factor</i>	<0.20	5
<i>Upstream Rt Outlet</i>	Vegetated	1
<i>Upstream Lt Outlet</i>	Vegetated	1
<i>Upstream Rt Ditch</i>	Vegetated	1
<i>Upstream Lt Ditch</i>	Vegetated	1
<i>Downstream Rt Outlet</i>	Vegetated	1
<i>Downstream Lt Outlet</i>	Vegetated	1
<i>Downstream Rt Ditch</i>	Vegetated	1
<i>Downstream Lt Ditch</i>	Vegetated	1
<i>Outlet Total</i>	Improved Outlet System	5
<i>Ditches Total</i>	Improved Drainage System	5
<b><i>SRI Total</i></b>	<b>Low Risk</b>	<b>50</b>
