Appendix A. River corridor severity scores for impaired sites in the Yellow River Basin, Alabama and Florida

Appendix C. Clear Creek Watershed Focal Area. Sites with orange headings are unpaved road sites. Specific definitions and calculations described for calculating the Sediment Risk Index (SRI) are detailed in Witmer (2009).

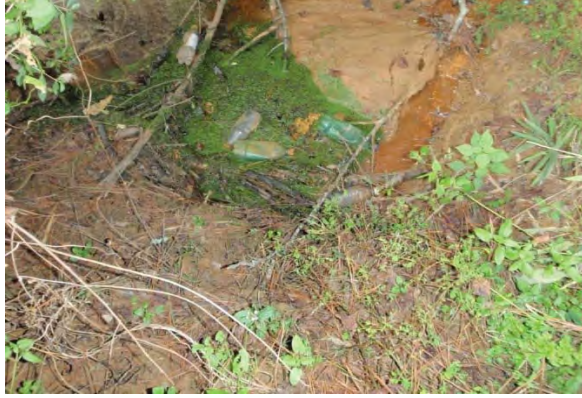
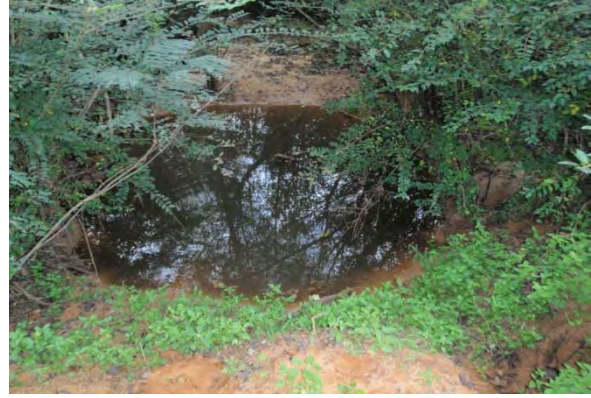
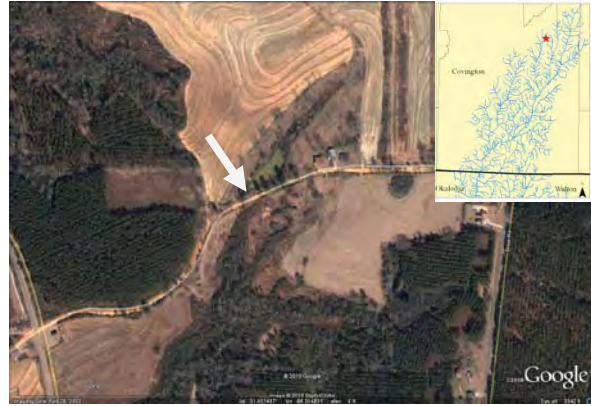
<b>Unnamed tributary</b>	<b>co-1029-r-010</b>	<i>Sedimentation Risk Index</i> <b>24</b>
--------------------------	----------------------	--

Risk Factor	Ranking	Score
<i>US Channel Morph</i>	PONDED	1
<i>DS Channel Morph</i>	E	5
<i>DS Bank Alteration</i>	HIGH	1
<i>Upstream Skew Angle</i>	>30°	1
<i>Crossing fill condition</i>	Poor/Bare soil	1
<i>Inlet/Outlet Condition</i>	Blocked	1
<i>Road Approach Material</i>	All Sand/Clay	3
<i>Potential Eroded Volume Mean</i>	<21 y <sup>3</sup>	5
<i>Approach Slope Mean</i>	>4%	1
<i>Soil K Factor</i>	0.21-0.40	3
<i>Upstream Rt Outlet</i>	Bare soil	0
<i>Upstream Lt Outlet</i>	Bare soil	0
<i>Upstream Rt Ditch</i>	Bare soil	0
<i>Upstream Lt Ditch</i>	Bare soil	0
<i>Downstream Rt Outlet</i>	Bare soil	0
<i>Downstream Lt Outlet</i>	Bare soil	0
<i>Downstream Rt Ditch</i>	Bare soil	0
<i>Downstream Lt Ditch</i>	Bare soil	0
<i>Outlet Total</i>	Unimproved Outlet System	1
<i>Ditches Total</i>	Unimproved Drainage System	1
<b><i>SRI Total</i></b>	<b>High Risk</b>	<b>24</b>

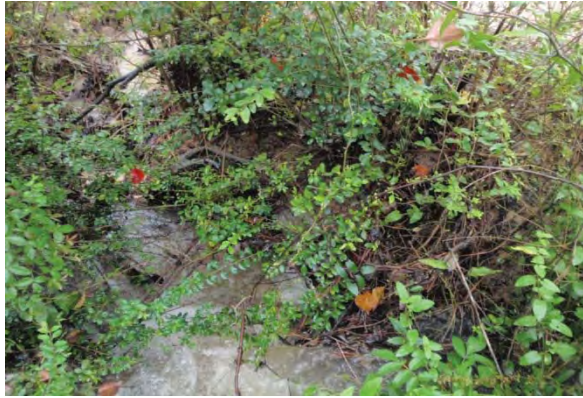
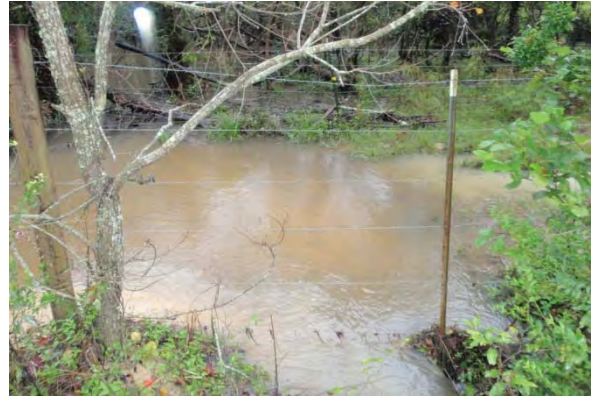
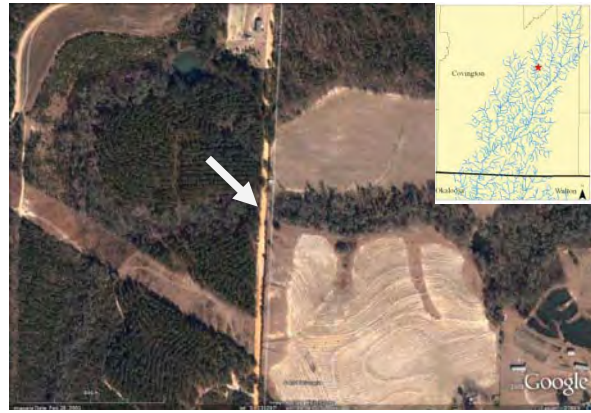
<b>Sasser Branch</b>	<b>co-1027-r-003</b>	<b>Sedimentation Risk Index</b> <b>30</b>
----------------------	----------------------	--

Risk Factor	Ranking	Score
<i>US Channel Morph</i>	WETLAND	5
<i>DS Channel Morph</i>	DA	3
<i>DS Bank Alteration</i>	HIGH	1
<i>Upstream Skew Angle</i>	<5°	5
<i>Crossing fill condition</i>	Poor/Bare soil	1
<i>Inlet/Outlet Condition</i>	Sed Islands/Scouring	3
<i>Road Approach Material</i>	All Sand/Clay	3
<i>Potential Eroded Volume Mean</i>	>40 y <sup>3</sup>	1
<i>Approach Slope Mean</i>	>4%	1
<i>Soil K Factor</i>	<0.20	5
<i>Upstream Rt Outlet</i>	Bare soil	0
<i>Upstream Lt Outlet</i>	Bare soil	0
<i>Upstream Rt Ditch</i>	Bare soil	0
<i>Upstream Lt Ditch</i>	Bare soil	0
<i>Downstream Rt Outlet</i>	Bare soil	0
<i>Downstream Lt Outlet</i>	Bare soil	0
<i>Downstream Rt Ditch</i>	Bare soil	0
<i>Downstream Lt Ditch</i>	Bare soil	0
<i>Outlet Total</i>	Unimproved Outlet System	1
<i>Ditches Total</i>	Unimproved Drainage System	1
<b>SRI Total</b>	<b>High Risk</b>	<b>30</b>

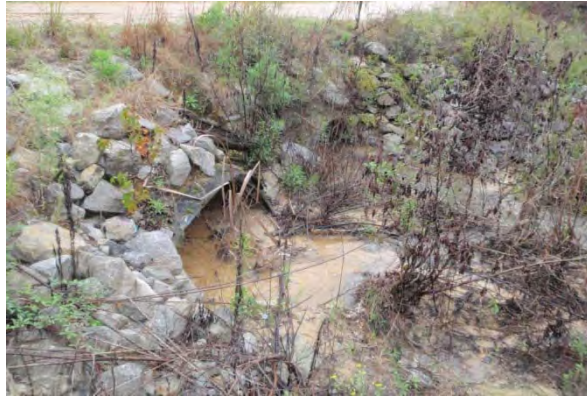
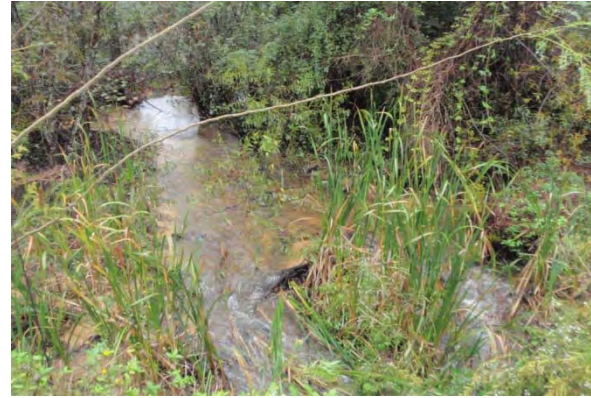
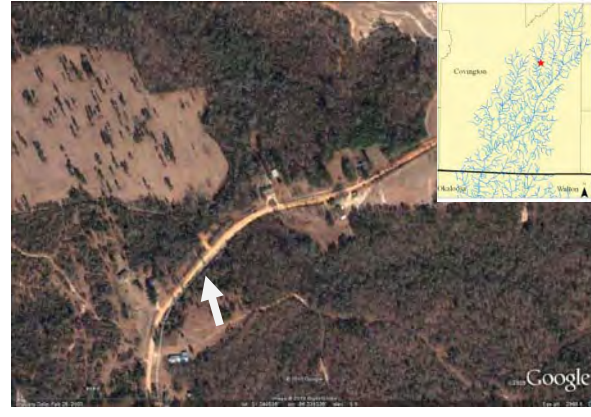
Unnamed tributary	co-1027-r-004	Sedimentation Risk Index <b>32</b>
-------------------	---------------	---------------------------------------

Risk Factor	Ranking	Score
<i>US Channel Morph</i>	PONDED	1
<i>DS Channel Morph</i>	E	5
<i>DS Bank Alteration</i>	HIGH	1
<i>Upstream Skew Angle</i>	<5°	5
<i>Crossing fill condition</i>	Fair/Rip Rap	3
<i>Inlet/Outlet Condition</i>	Sed Islands/Scouring	3
<i>Road Approach Material</i>	All Sand/Clay	3
<i>Potential Eroded Volume Mean</i>	21-40 y <sup>3</sup>	3
<i>Approach Slope Mean</i>	>4%	1
<i>Soil K Factor</i>	<0.20	5
<i>Upstream Rt Outlet</i>	Bare soil	0
<i>Upstream Lt Outlet</i>	Bare soil	0
<i>Upstream Rt Ditch</i>	Bare soil	0
<i>Upstream Lt Ditch</i>	Bare soil	0
<i>Downstream Rt Outlet</i>	Bare soil	0
<i>Downstream Lt Outlet</i>	Bare soil	0
<i>Downstream Rt Ditch</i>	Bare soil	0
<i>Downstream Lt Ditch</i>	Bare soil	0
<i>Outlet Total</i>	Unimproved Outlet System	1
<i>Ditches Total</i>	Unimproved Drainage System	1
<b>SRI Total</b>	<b>High Risk</b>	<b>32</b>

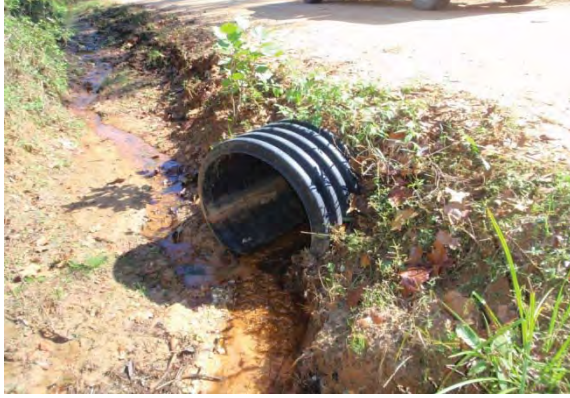
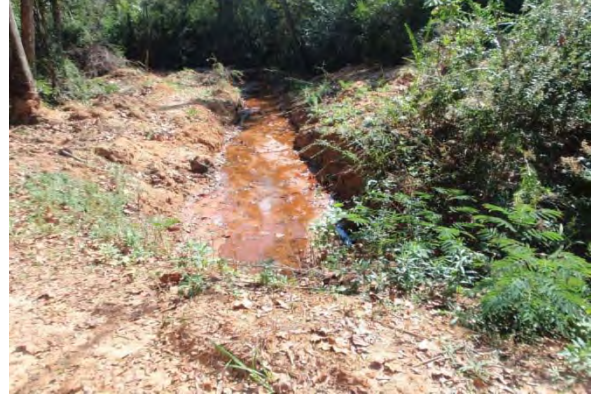
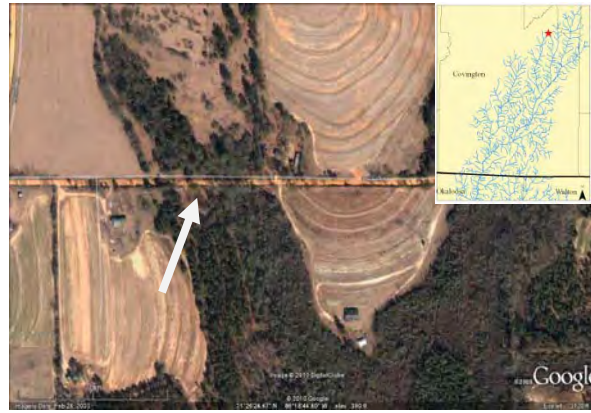
Unnamed tributary	co-1102-r-002	Sedimentation Risk Index <b>32</b>
-------------------	---------------	---------------------------------------

Risk Factor	Ranking	Score
US Channel Morph	E	5
DS Channel Morph	F	1
DS Bank Alteration	HIGH	1
Upstream Skew Angle	5-30°	3
Crossing fill condition	Poor/Bare soil	1
Inlet/Outlet Condition	Sed Islands/Scouring	3
Road Approach Material	All Sand/Clay	3
Potential Eroded Volume Mean	<21 y <sup>3</sup>	5
Approach Slope Mean	2.1-4%	3
Soil K Factor	<0.20	5
Upstream Rt Outlet	Bare soil	0
Upstream Lt Outlet	Bare soil	0
Upstream Rt Ditch	Bare soil	0
Upstream Lt Ditch	Bare soil	0
Downstream Rt Outlet	Bare soil	0
Downstream Lt Outlet	Bare soil	0
Downstream Rt Ditch	Bare soil	0
Downstream Lt Ditch	Bare soil	0
Outlet Total	Unimproved Outlet System	1
Ditches Total	Unimproved Drainage System	1
<b>SRI Total</b>	<b>High Risk</b>	<b>32</b>

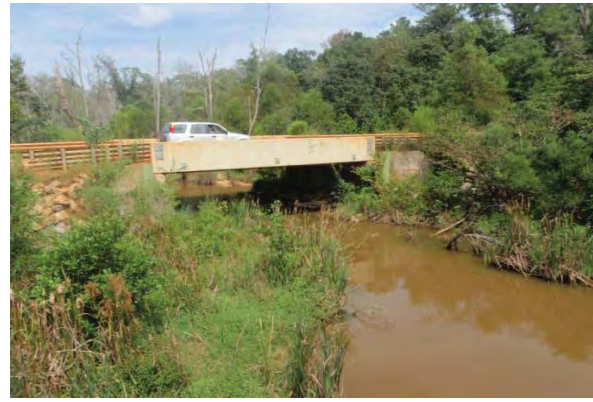
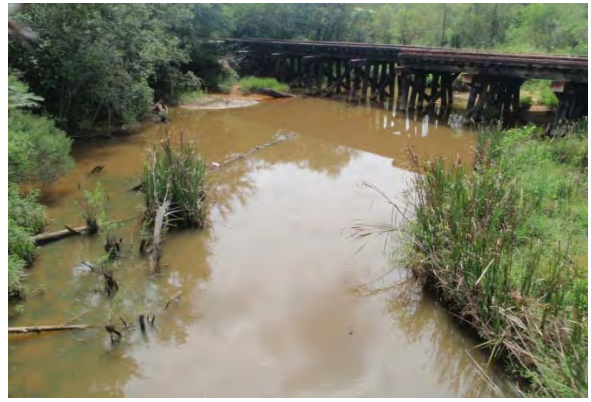
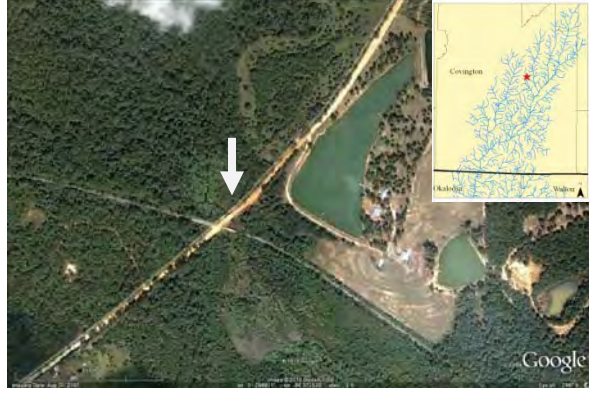
<h1>Hollis Creek</h1>	<h2>co-0907-r-001</h2>	<i>Sedimentation Risk Index</i> <b>36</b>
-----------------------	------------------------	--

Risk Factor	Ranking	Score
<i>US Channel Morph</i>	DA	3
<i>DS Channel Morph</i>	DA	3
<i>DS Bank Alteration</i>	HIGH	1
<i>Upstream Skew Angle</i>	<5°	5
<i>Crossing fill condition</i>	Good/Vegetated	5
<i>Inlet/Outlet Condition</i>	Sed Islands/Scouring	3
<i>Road Approach Material</i>	All Sand/Clay	3
<i>Potential Eroded Volume Mean</i>	>40 y <sup>3</sup>	1
<i>Approach Slope Mean</i>	2.1-4%	3
<i>Soil K Factor</i>	<0.20	5
<i>Upstream Rt Outlet</i>	Bare soil	0
<i>Upstream Lt Outlet</i>	Rip Rap	1
<i>Upstream Rt Ditch</i>	Bare soil	0
<i>Upstream Lt Ditch</i>	Bare soil	0
<i>Downstream Rt Outlet</i>	Vegetated	1
<i>Downstream Lt Outlet</i>	Bare soil	0
<i>Downstream Rt Ditch</i>	Bare soil	0
<i>Downstream Lt Ditch</i>	Bare soil	0
<i>Outlet Total</i>	Partially Improved Outlet System	3
<i>Ditches Total</i>	Unimproved Drainage System	1
<b><i>SRI Total</i></b>	<b>High Risk</b>	<b>36</b>
<b>Additional Site Features</b>		
<i>Crossing Type and Quantity:</i>	Bridge, 1

Notes: Railroad crossing directly DS

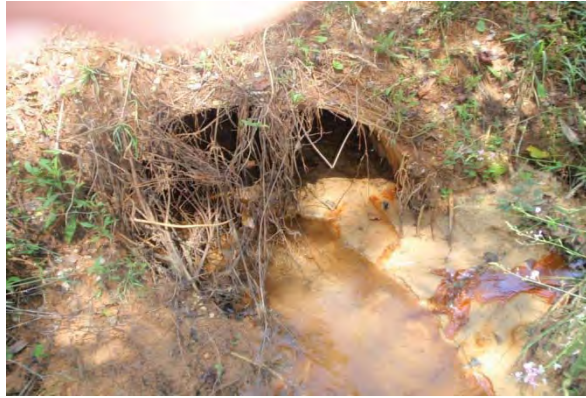
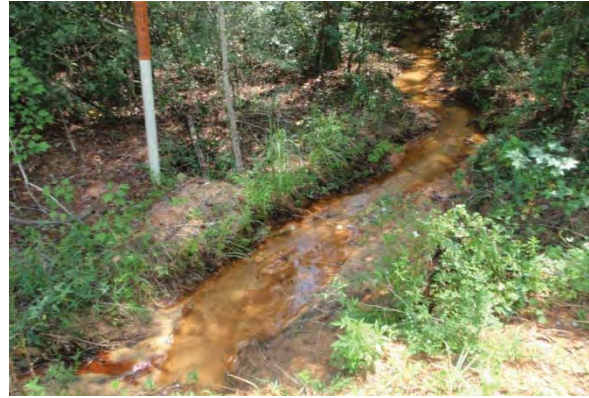
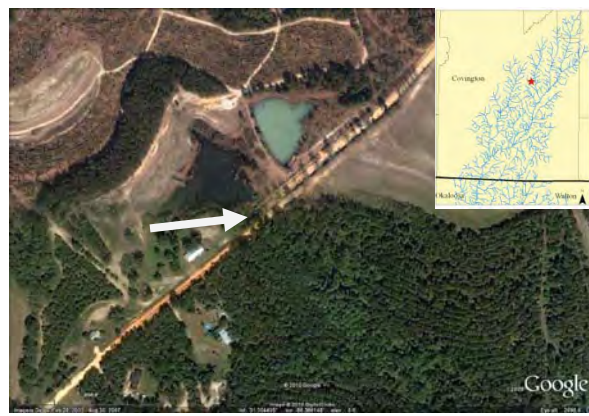
Unnamed tributary	co-0907-r-002	Sedimentation Risk Index <b>36</b>
-------------------	---------------	---------------------------------------

Risk Factor	Ranking	Score
<i>US Channel Morph</i>	PONDED	1
<i>DS Channel Morph</i>	A	5
<i>DS Bank Alteration</i>	HIGH	1
<i>Upstream Skew Angle</i>	<5°	5
<i>Crossing fill condition</i>	Poor/Bare soil	1
<i>Inlet/Outlet Condition</i>	Sed Islands/Scouring	3
<i>Road Approach Material</i>	All Sand/Clay	3
<i>Potential Eroded Volume Mean</i>	<21 y <sup>3</sup>	5
<i>Approach Slope Mean</i>	<2%	5
<i>Soil K Factor</i>	<0.20	5
<i>Upstream Rt Outlet</i>	Bare soil	0
<i>Upstream Lt Outlet</i>	Bare soil	0
<i>Upstream Rt Ditch</i>	Bare soil	0
<i>Upstream Lt Ditch</i>	Bare soil	0
<i>Downstream Rt Outlet</i>	Bare soil	0
<i>Downstream Lt Outlet</i>	Bare soil	0
<i>Downstream Rt Ditch</i>	Bare soil	0
<i>Downstream Lt Ditch</i>	Bare soil	0
<i>Outlet Total</i>	Unimproved Outlet System	1
<i>Ditches Total</i>	Unimproved Drainage System	1
<b>SRI Total</b>	<b>High Risk</b>	<b>36</b>

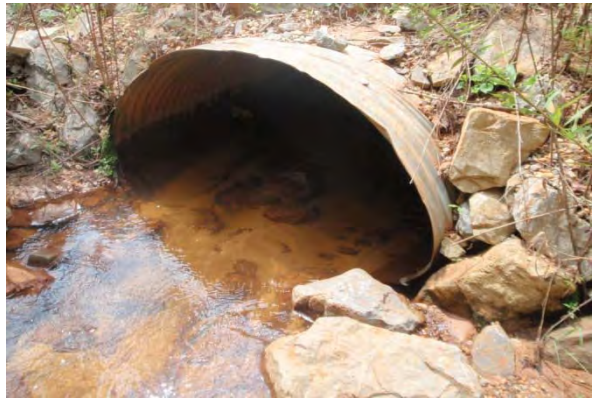
<b>Bear Branch</b>	<b>co-0907-r-005</b>	<b>Sedimentation Risk Index</b> <b>38</b>
--------------------	----------------------	--

Risk Factor	Ranking	Score
<i>US Channel Morph</i>	DA	3
<i>DS Channel Morph</i>	E	5
<i>DS Bank Alteration</i>	HIGH	1
<i>Upstream Skew Angle</i>	<5°	5
<i>Crossing fill condition</i>	Fair/Rip Rap	3
<i>Inlet/Outlet Condition</i>	Sed Islands/Scouring	3
<i>Road Approach Material</i>	All Sand/Clay	3
<i>Potential Eroded Volume Mean</i>	<21 y <sup>3</sup>	5
<i>Approach Slope Mean</i>	2.1-4%	3
<i>Soil K Factor</i>	<0.20	5
<i>Upstream Rt Outlet</i>	Bare soil	0
<i>Upstream Lt Outlet</i>	Bare soil	0
<i>Upstream Rt Ditch</i>	Bare soil	0
<i>Upstream Lt Ditch</i>	Bare soil	0
<i>Downstream Rt Outlet</i>	Bare soil	0
<i>Downstream Lt Outlet</i>	Bare soil	0
<i>Downstream Rt Ditch</i>	Bare soil	0
<i>Downstream Lt Ditch</i>	Bare soil	0
<i>Outlet Total</i>	Unimproved Outlet System	1
<i>Ditches Total</i>	Unimproved Drainage System	1
<b>SRI Total</b>	<b>Medium Risk</b>	<b>38</b>

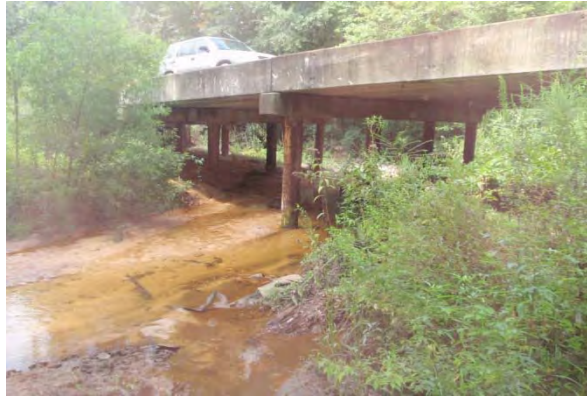
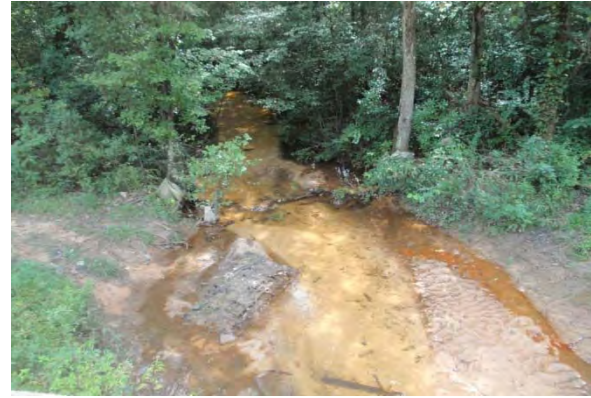
<b>Unnamed tributary</b>	<b>co-0907-r-004</b>	<b>Sedimentation Risk Index</b> <b>40</b>
--------------------------	----------------------	--

Risk Factor	Ranking	Score
<i>US Channel Morph</i>	C	5
<i>DS Channel Morph</i>	E	5
<i>DS Bank Alteration</i>	MINOR/PARTIAL	3
<i>Upstream Skew Angle</i>	<5°	5
<i>Crossing fill condition</i>	Good/Vegetated	5
<i>Inlet/Outlet Condition</i>	Sed Islands/Scouring	3
<i>Road Approach Material</i>	All Sand/Clay	3
<i>Potential Eroded Volume Mean</i>	>40 y <sup>3</sup>	1
<i>Approach Slope Mean</i>	>4%	1
<i>Soil K Factor</i>	<0.20	5
<i>Upstream Rt Outlet</i>	Vegetated	1
<i>Upstream Lt Outlet</i>	Vegetated	1
<i>Upstream Rt Ditch</i>	Bare soil	0
<i>Upstream Lt Ditch</i>	Bare soil	0
<i>Downstream Rt Outlet</i>	Bare soil	0
<i>Downstream Lt Outlet</i>	Bare soil	0
<i>Downstream Rt Ditch</i>	Bare soil	0
<i>Downstream Lt Ditch</i>	Bare soil	0
<i>Outlet Total</i>	Partially Improved Outlet System	3
<i>Ditches Total</i>	Unimproved Drainage System	1
<b>SRI Total</b>	<b>Medium Risk</b>	<b>40</b>

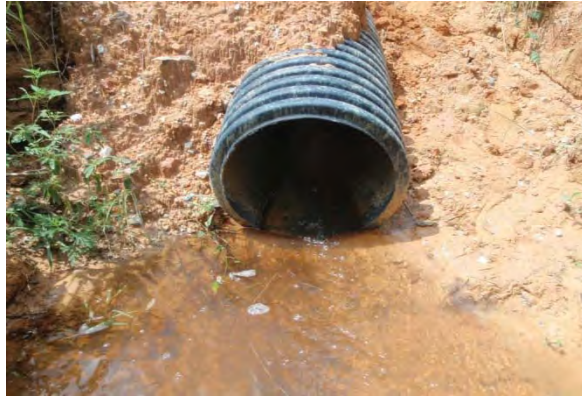
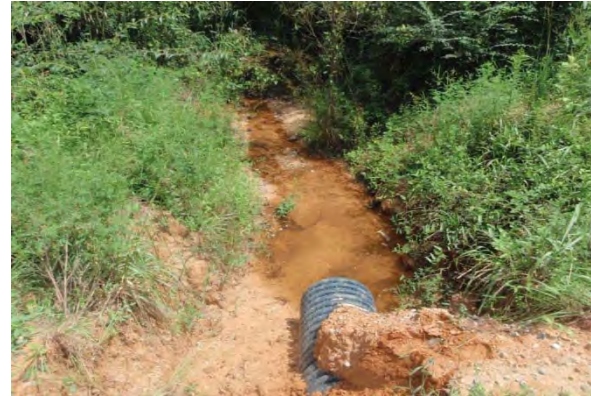
Unnamed tributary	co-0907-r-003	Sedimentation Risk Index <b>42</b>
-------------------	---------------	---------------------------------------

Risk Factor	Ranking	Score
<i>US Channel Morph</i>	WETLAND	5
<i>DS Channel Morph</i>	B	5
<i>DS Bank Alteration</i>	MINOR/PARTIAL	3
<i>Upstream Skew Angle</i>	<5°	5
<i>Crossing fill condition</i>	Poor/Bare soil	1
<i>Inlet/Outlet Condition</i>	Sed Islands/Scouring	3
<i>Road Approach Material</i>	All Sand/Clay	3
<i>Potential Eroded Volume Mean</i>	<21 y <sup>3</sup>	5
<i>Approach Slope Mean</i>	2.1-4%	3
<i>Soil K Factor</i>	<0.20	5
<i>Upstream Rt Outlet</i>	Bare soil	0
<i>Upstream Lt Outlet</i>	Bare soil	0
<i>Upstream Rt Ditch</i>	Bare soil	0
<i>Upstream Lt Ditch</i>	Bare soil	0
<i>Downstream Rt Outlet</i>	Vegetated	1
<i>Downstream Lt Outlet</i>	Vegetated	1
<i>Downstream Rt Ditch</i>	Bare soil	0
<i>Downstream Lt Ditch</i>	Bare soil	0
<i>Outlet Total</i>	Partially Improved Outlet System	3
<i>Ditches Total</i>	Unimproved Drainage System	1
<b>SRI Total</b>	<b>Medium Risk</b>	<b>42</b>

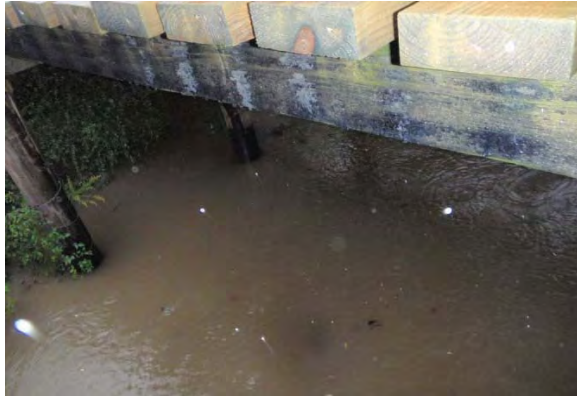
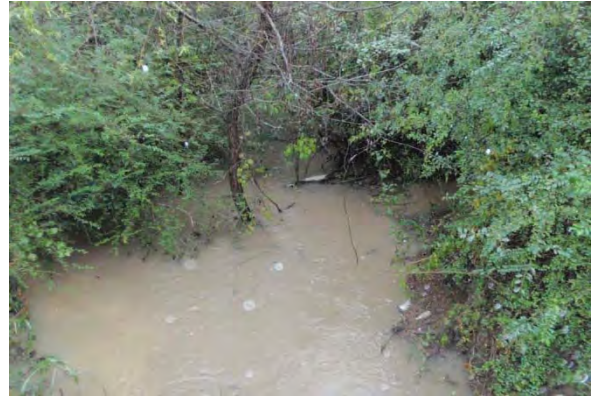
Unnamed tributary	co-1027-r-002	Sedimentation Risk Index <b>42</b>
-------------------	---------------	---------------------------------------

Risk Factor	Ranking	Score
US Channel Morph	E	5
DS Channel Morph	E	5
DS Bank Alteration	MINOR/PARTIAL	3
Upstream Skew Angle	<5°	5
Crossing fill condition	Good/Vegetated	5
Inlet/Outlet Condition	No Impairment	5
Road Approach Material	All Sand/Clay	3
Potential Eroded Volume Mean	>40 y <sup>3</sup>	1
Approach Slope Mean	>4%	1
Soil K Factor	<0.20	5
Upstream Rt Outlet	Bare soil	0
Upstream Lt Outlet	Vegetated	1
Upstream Rt Ditch	Bare soil	0
Upstream Lt Ditch	Bare soil	0
Downstream Rt Outlet	Bare soil	0
Downstream Lt Outlet	Vegetated	1
Downstream Rt Ditch	Bare soil	0
Downstream Lt Ditch	Bare soil	0
Outlet Total	Partially Improved Outlet System	3
Ditches Total	Unimproved Drainage System	1
<b>SRI Total</b>	<b>Medium Risk</b>	<b>42</b>

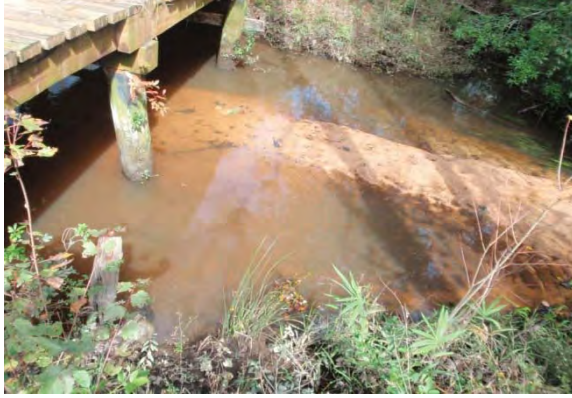
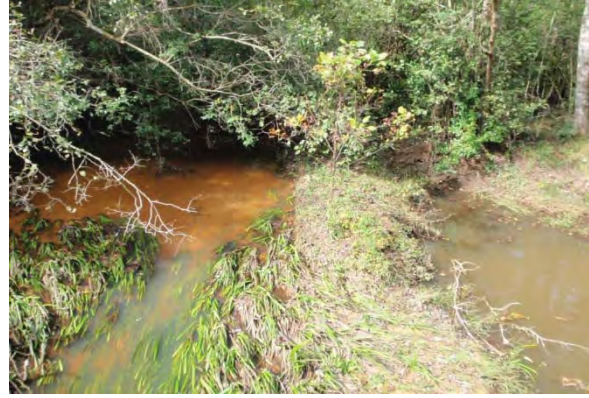
<h1 style="margin:0;">Faegins Creek</h1>	<h2 style="margin:0;">co-1029-r-003</h2>	<b>Sedimentation Risk Index</b> <h1 style="margin:0;">42</h1>
--	--	--

Risk Factor	Ranking	Score
<i>US Channel Morph</i>	D	1
<i>DS Channel Morph</i>	D	1
<i>DS Bank Alteration</i>	MINOR/PARTIAL	3
<i>Upstream Skew Angle</i>	<5°	5
<i>Crossing fill condition</i>	Good/Vegetated	5
<i>Inlet/Outlet Condition</i>	Sed Islands/Scouring	3
<i>Road Approach Material</i>	All Aggregate	5
<i>Potential Eroded Volume Mean</i>	<21 y <sup>3</sup>	5
<i>Approach Slope Mean</i>	2.1-4%	3
<i>Soil K Factor</i>	<0.20	5
<i>Upstream Rt Outlet</i>	Vegetated	1
<i>Upstream Lt Outlet</i>	Vegetated	1
<i>Upstream Rt Ditch</i>	Bare soil	0
<i>Upstream Lt Ditch</i>	Bare soil	0
<i>Downstream Rt Outlet</i>	Vegetated	1
<i>Downstream Lt Outlet</i>	Vegetated	1
<i>Downstream Rt Ditch</i>	Bare soil	0
<i>Downstream Lt Ditch</i>	Bare soil	0
<i>Outlet Total</i>	Improved Outlet System	5
<i>Ditches Total</i>	Unimproved Drainage System	1
<b><i>SRI Total</i></b>	<b>Medium Risk</b>	<b>42</b>

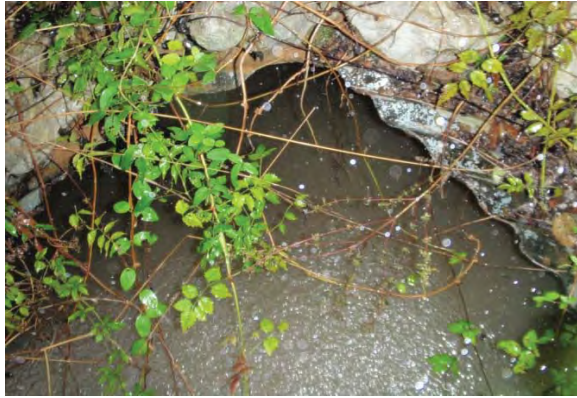
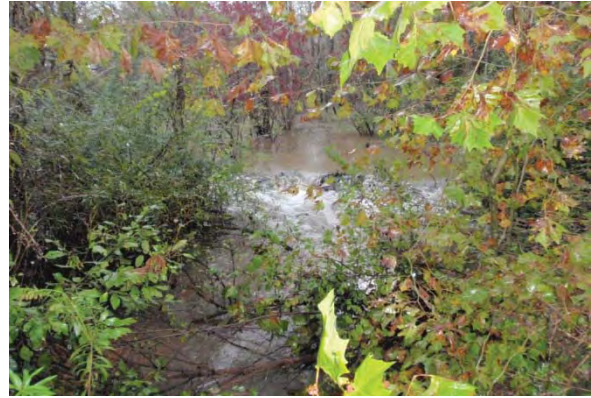
Unnamed tributary	co-1027-r-001	Sedimentation Risk Index <b>42</b>
-------------------	---------------	---------------------------------------

Risk Factor	Ranking	Score
<i>US Channel Morph</i>	BEAVER DAM	3
<i>DS Channel Morph</i>	PONDED	1
<i>DS Bank Alteration</i>	MINOR/PARTIAL	3
<i>Upstream Skew Angle</i>	<5°	5
<i>Crossing fill condition</i>	Good/Vegetated	5
<i>Inlet/Outlet Condition</i>	No Impairment	5
<i>Road Approach Material</i>	All Aggregate	5
<i>Potential Eroded Volume Mean</i>	<21 y <sup>3</sup>	5
<i>Approach Slope Mean</i>	>4%	1
<i>Soil K Factor</i>	<0.20	5
<i>Upstream Rt Outlet</i>	Bare soil	0
<i>Upstream Lt Outlet</i>	Bare soil	0
<i>Upstream Rt Ditch</i>	Bare soil	0
<i>Upstream Lt Ditch</i>	Bare soil	0
<i>Downstream Rt Outlet</i>	Vegetated	1
<i>Downstream Lt Outlet</i>	Vegetated	1
<i>Downstream Rt Ditch</i>	Bare soil	0
<i>Downstream Lt Ditch</i>	Bare soil	0
<i>Outlet Total</i>	Partially Improved Outlet System	3
<i>Ditches Total</i>	Unimproved Drainage System	1
<b>SRI Total</b>	<b>Medium Risk</b>	<b>42</b>

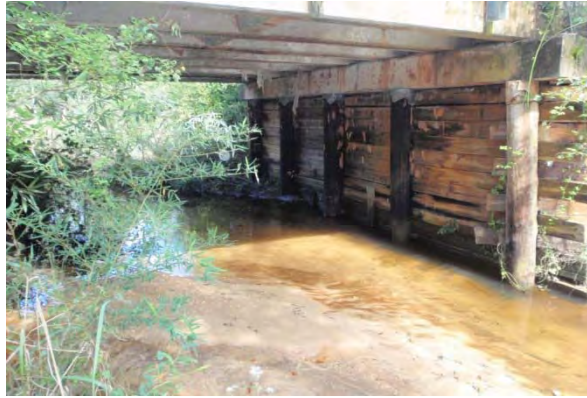
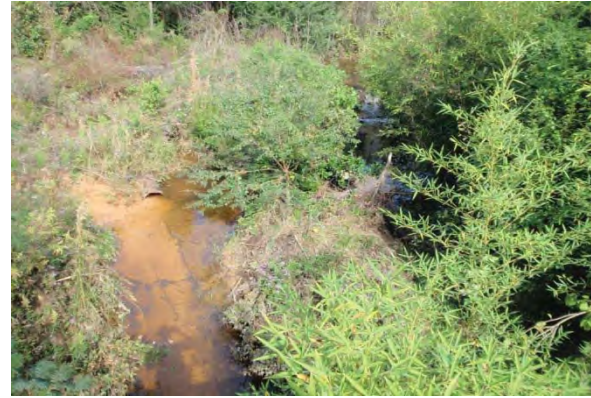
Unnamed tributary	co-1029-r-002	Sedimentation Risk Index <b>44</b>
-------------------	---------------	---------------------------------------

Risk Factor	Ranking	Score
US Channel Morph	E	5
DS Channel Morph	E	5
DS Bank Alteration	HIGH	1
Upstream Skew Angle	5-30°	3
Crossing fill condition	Good/Vegetated	5
Inlet/Outlet Condition	No Impairment	5
Road Approach Material	All Aggregate	5
Potential Eroded Volume Mean	<21 y <sup>3</sup>	5
Approach Slope Mean	>4%	1
Soil K Factor	<0.20	5
Upstream Rt Outlet	Bare soil	0
Upstream Lt Outlet	Vegetated	1
Upstream Rt Ditch	Bare soil	0
Upstream Lt Ditch	Bare soil	0
Downstream Rt Outlet	Vegetated	1
Downstream Lt Outlet	Vegetated	1
Downstream Rt Ditch	Bare soil	0
Downstream Lt Ditch	Bare soil	0
<b>Outlet Total</b>	Partially Improved Outlet System	<b>3</b>
<b>Ditches Total</b>	Unimproved Drainage System	<b>1</b>
<b>SRI Total</b>	<b>Medium Risk</b>	<b>44</b>

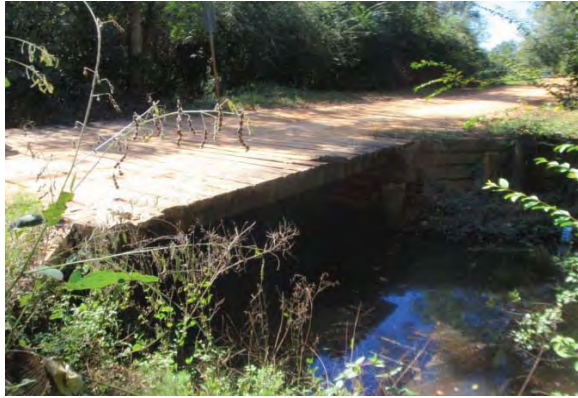
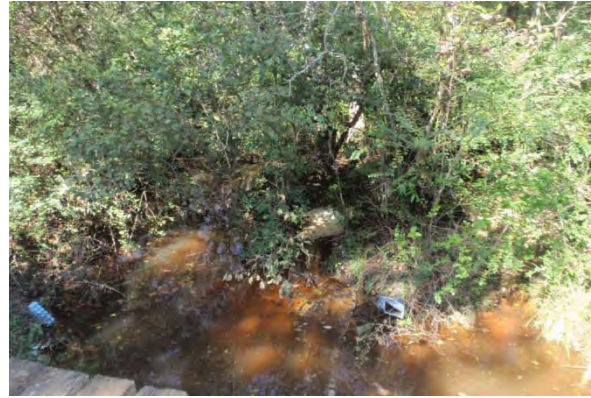
<b>Unnamed tributary</b>	<b>co-1102-r-003</b>	<i>Sedimentation Risk Index</i> <b>46</b>
--------------------------	----------------------	--

Risk Factor	Ranking	Score
<i>US Channel Morph</i>	DA	3
<i>DS Channel Morph</i>	C	5
<i>DS Bank Alteration</i>	MINOR/PARTIAL	3
<i>Upstream Skew Angle</i>	<5°	5
<i>Crossing fill condition</i>	Good/Vegetated	5
<i>Inlet/Outlet Condition</i>	No Impairment	5
<i>Road Approach Material</i>	All Sand/Clay	3
<i>Potential Eroded Volume Mean</i>	<21 y <sup>3</sup>	5
<i>Approach Slope Mean</i>	2.1-4%	3
<i>Soil K Factor</i>	<0.20	5
<i>Upstream Rt Outlet</i>	Bare soil	0
<i>Upstream Lt Outlet</i>	Bare soil	0
<i>Upstream Rt Ditch</i>	Bare soil	0
<i>Upstream Lt Ditch</i>	Bare soil	0
<i>Downstream Rt Outlet</i>	Vegetated	1
<i>Downstream Lt Outlet</i>	Vegetated	1
<i>Downstream Rt Ditch</i>	Bare soil	0
<i>Downstream Lt Ditch</i>	Bare soil	0
<i>Outlet Total</i>	Partially Improved Outlet System	3
<i>Ditches Total</i>	Unimproved Drainage System	1
<b>SRI Total</b>	<b>Low Risk</b>	<b>46</b>

Notes: Surface oils and anaerobic smell

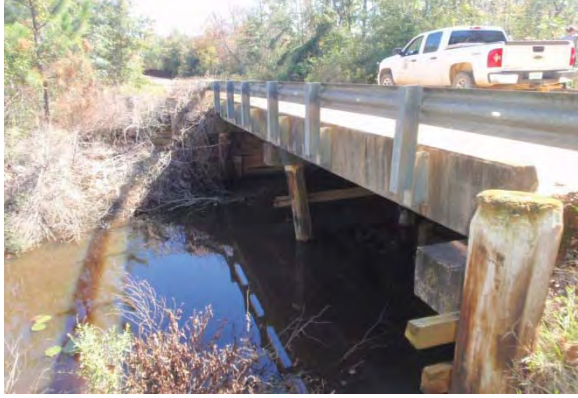
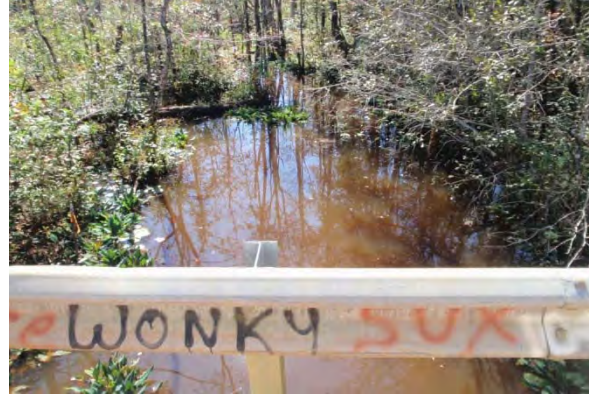
<b>Yellow River</b>	<b>co-1102-r-001</b>	<b>Sedimentation Risk Index</b> <b>48</b>
---------------------	----------------------	--

Risk Factor	Ranking	Score
<i>US Channel Morph</i>	BEAVER DAM	3
<i>DS Channel Morph</i>	WETLAND	5
<i>DS Bank Alteration</i>	MINOR/PARTIAL	3
<i>Upstream Skew Angle</i>	<5°	5
<i>Crossing fill condition</i>	Fair/Rip Rap	3
<i>Inlet/Outlet Condition</i>	No Impairment	5
<i>Road Approach Material</i>	All Sand/Clay	3
<i>Potential Eroded Volume Mean</i>	21-40 y <sup>3</sup>	3
<i>Approach Slope Mean</i>	<2%	5
<i>Soil K Factor</i>	<0.20	5
<i>Upstream Rt Outlet</i>	Vegetated	1
<i>Upstream Lt Outlet</i>	Vegetated	1
<i>Upstream Rt Ditch</i>	Bare soil	0
<i>Upstream Lt Ditch</i>	Vegetated	1
<i>Downstream Rt Outlet</i>	Vegetated	1
<i>Downstream Lt Outlet</i>	Vegetated	1
<i>Downstream Rt Ditch</i>	Bare soil	0
<i>Downstream Lt Ditch</i>	Bare soil	0
<i>Outlet Total</i>	Improved Outlet System	5
<i>Ditches Total</i>	Partially Improved Drainage System	3
<b>SRI Total</b>	<b>Low Risk</b>	<b>48</b>

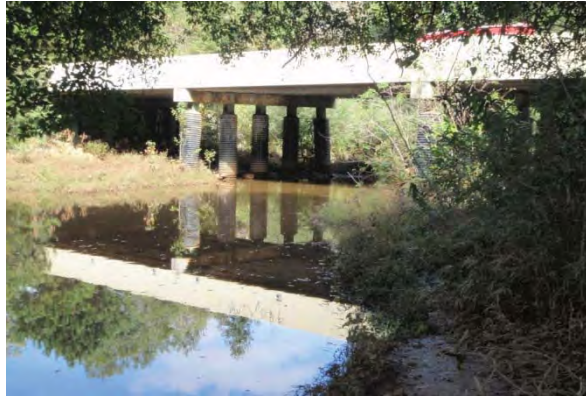
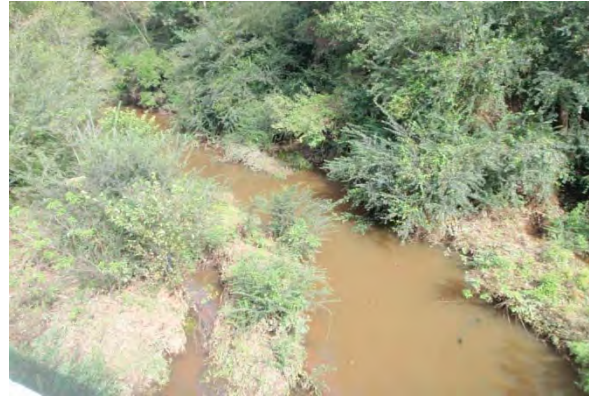
<b>Yellow River</b>	<b>co-1029-r-001</b>	<i>Sedimentation Risk Index</i> <b>50</b>
---------------------	----------------------	--

Risk Factor	Ranking	Score
<i>US Channel Morph</i>	C	5
<i>DS Channel Morph</i>	C	5
<i>DS Bank Alteration</i>	MINOR/PARTIAL	3
<i>Upstream Skew Angle</i>	<5°	5
<i>Crossing fill condition</i>	Fair/Rip Rap	3
<i>Inlet/Outlet Condition</i>	No Impairment	5
<i>Road Approach Material</i>	All Aggregate	5
<i>Potential Eroded Volume Mean</i>	21-40 y <sup>3</sup>	3
<i>Approach Slope Mean</i>	2.1-4%	3
<i>Soil K Factor</i>	<0.20	5
<i>Upstream Rt Outlet</i>	Vegetated	1
<i>Upstream Lt Outlet</i>	Vegetated	1
<i>Upstream Rt Ditch</i>	Vegetated	1
<i>Upstream Lt Ditch</i>	Vegetated	1
<i>Downstream Rt Outlet</i>	Vegetated	1
<i>Downstream Lt Outlet</i>	Bare soil	0
<i>Downstream Rt Ditch</i>	Vegetated	1
<i>Downstream Lt Ditch</i>	Vegetated	1
<i>Outlet Total</i>	Partially Improved Outlet System	3
<i>Ditches Total</i>	Improved Drainage System	5
<b>SRI Total</b>	<b>Low Risk</b>	<b>50</b>

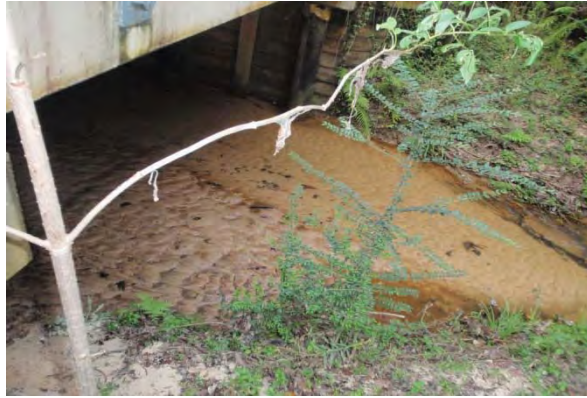
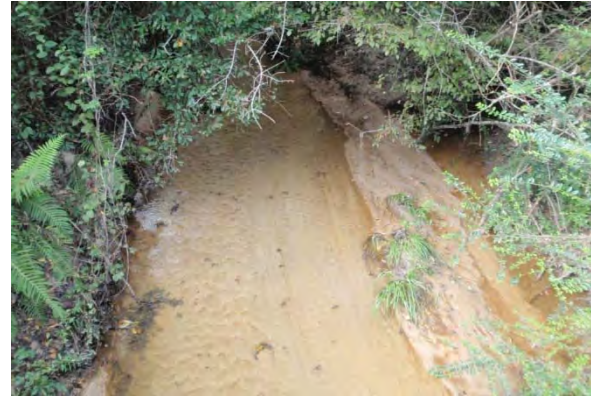
<b>Unnamed tributary</b>	<b>co-1029-r-005</b>	<i>Sedimentation Risk Index</i> <b>50</b>
--------------------------	----------------------	--

Risk Factor	Ranking	Score
<i>US Channel Morph</i>	E	5
<i>DS Channel Morph</i>	E	5
<i>DS Bank Alteration</i>	MINOR/PARTIAL	3
<i>Upstream Skew Angle</i>	<5°	5
<i>Crossing fill condition</i>	Good/Vegetated	5
<i>Inlet/Outlet Condition</i>	No Impairment	5
<i>Road Approach Material</i>	All Aggregate	5
<i>Potential Eroded Volume Mean</i>	<21 y <sup>3</sup>	5
<i>Approach Slope Mean</i>	>4%	1
<i>Soil K Factor</i>	<0.20	5
<i>Upstream Rt Outlet</i>	Vegetated	1
<i>Upstream Lt Outlet</i>	Vegetated	1
<i>Upstream Rt Ditch</i>	Bare soil	0
<i>Upstream Lt Ditch</i>	Bare soil	0
<i>Downstream Rt Outlet</i>	Vegetated	1
<i>Downstream Lt Outlet</i>	Vegetated	1
<i>Downstream Rt Ditch</i>	Bare soil	0
<i>Downstream Lt Ditch</i>	Bare soil	0
<i>Outlet Total</i>	Improved Outlet System	5
<i>Ditches Total</i>	Unimproved Drainage System	1
<b>SRI Total</b>	<b>Low Risk</b>	<b>50</b>

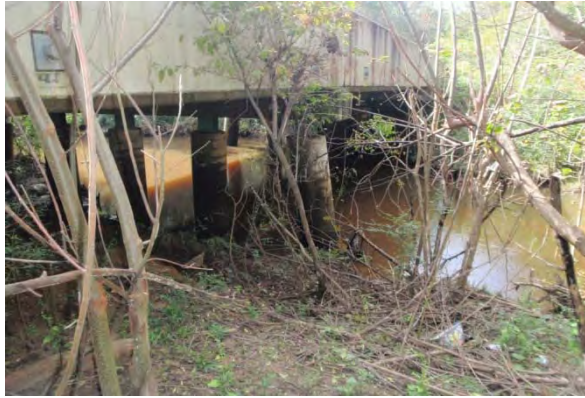
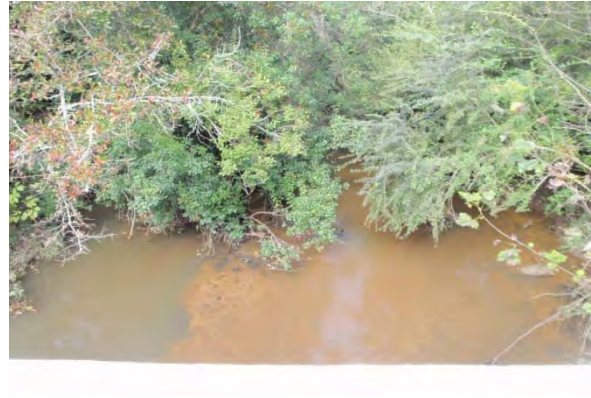
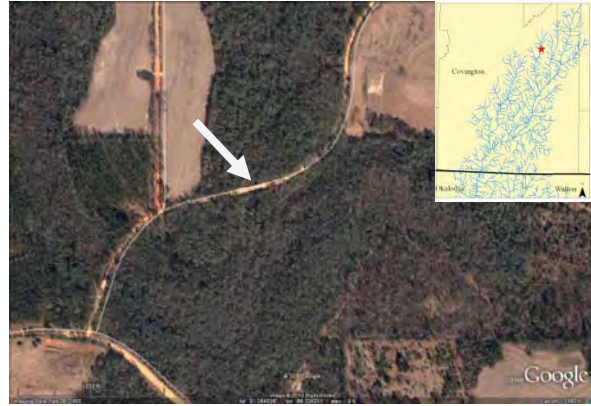
<h1>Yellow River</h1>	<h2>co-1029-r-004</h2>	<i>Sedimentation Risk Index</i> <h1>52</h1>
-----------------------	------------------------	--

Risk Factor	Ranking	Score
<i>US Channel Morph</i>	C	5
<i>DS Channel Morph</i>	C	5
<i>DS Bank Alteration</i>	MINOR/PARTIAL	3
<i>Upstream Skew Angle</i>	<5°	5
<i>Crossing fill condition</i>	Good/Vegetated	5
<i>Inlet/Outlet Condition</i>	No Impairment	5
<i>Road Approach Material</i>	All Sand/Clay	3
<i>Potential Eroded Volume Mean</i>	<21 y <sup>3</sup>	5
<i>Approach Slope Mean</i>	<2%	5
<i>Soil K Factor</i>	<0.20	5
<i>Upstream Rt Outlet</i>	Vegetated	1
<i>Upstream Lt Outlet</i>	Vegetated	1
<i>Upstream Rt Ditch</i>	Bare soil	0
<i>Upstream Lt Ditch</i>	Bare soil	0
<i>Downstream Rt Outlet</i>	Vegetated	1
<i>Downstream Lt Outlet</i>	Vegetated	1
<i>Downstream Rt Ditch</i>	Bare soil	0
<i>Downstream Lt Ditch</i>	Bare soil	0
<i>Outlet Total</i>	Improved Outlet System	5
<i>Ditches Total</i>	Unimproved Drainage System	1
<b><i>SRI Total</i></b>	<b>Low Risk</b>	<b>52</b>

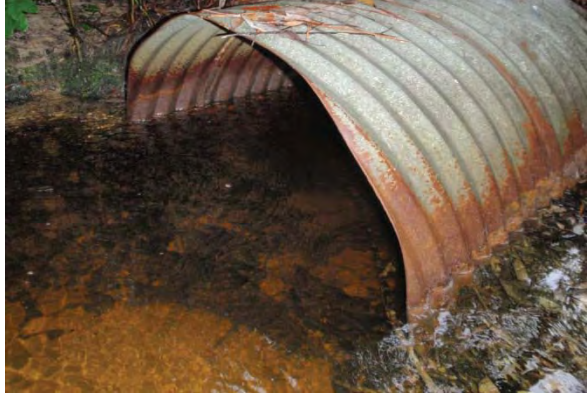
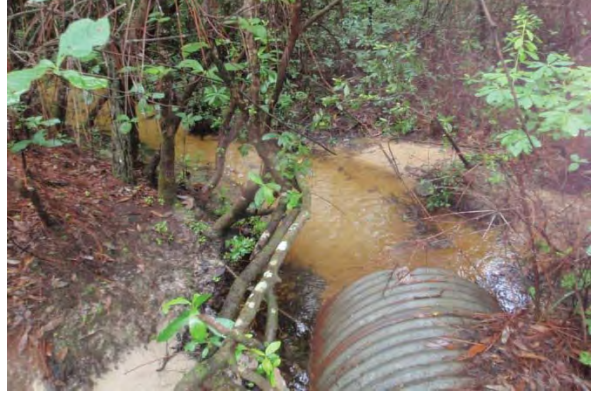
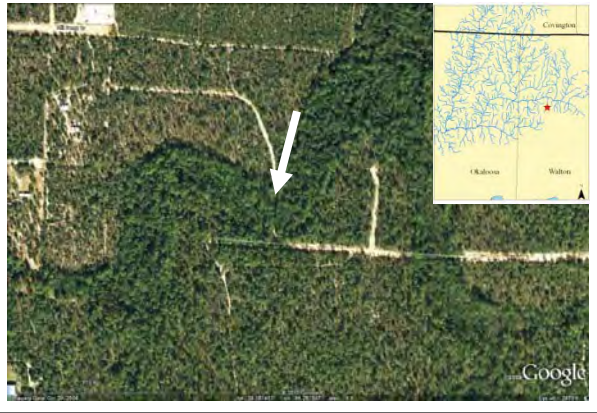
<h1>Battle Creek</h1>	<h2>wa-0707-r-002</h2>	<b>Sedimentation Risk Index</b> <h1>22</h1>
-----------------------	------------------------	--

Risk Factor	Ranking	Score
<i>US Channel Morph</i>	D	1
<i>DS Channel Morph</i>	D	1
<i>DS Bank Alteration</i>	NATURAL	5
<i>Upstream Skew Angle</i>	>30°	1
<i>Crossing fill condition</i>	Poor/Bare soil	1
<i>Inlet/Outlet Condition</i>	Sed Islands/Scouring	3
<i>Road Approach Material</i>	All Native Soil	1
<i>Potential Eroded Volume Mean</i>	>40 y <sup>3</sup>	1
<i>Approach Slope Mean</i>	>4%	1
<i>Soil K Factor</i>	<0.20	5
<i>Upstream Rt Outlet</i>	Bare soil	0
<i>Upstream Lt Outlet</i>	Bare soil	0
<i>Upstream Rt Ditch</i>	Bare soil	0
<i>Upstream Lt Ditch</i>	Bare soil	0
<i>Downstream Rt Outlet</i>	Bare soil	0
<i>Downstream Lt Outlet</i>	Bare soil	0
<i>Downstream Rt Ditch</i>	Bare soil	0
<i>Downstream Lt Ditch</i>	Bare soil	0
<i>Outlet Total</i>	Unimproved Outlet System	1
<i>Ditches Total</i>	Unimproved Drainage System	1
<b><i>SRI Total</i></b>	<b>High Risk</b>	<b>22</b>
<b>Additional Site Features</b>		
<i>Crossing Type and Quantity:</i>	Culvert, 1

Notes: Not sure if this is a county maintained road.

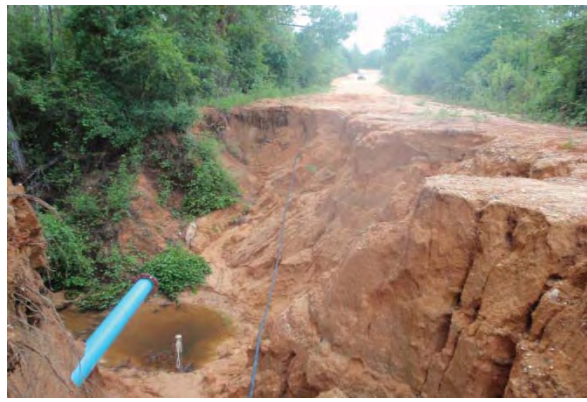
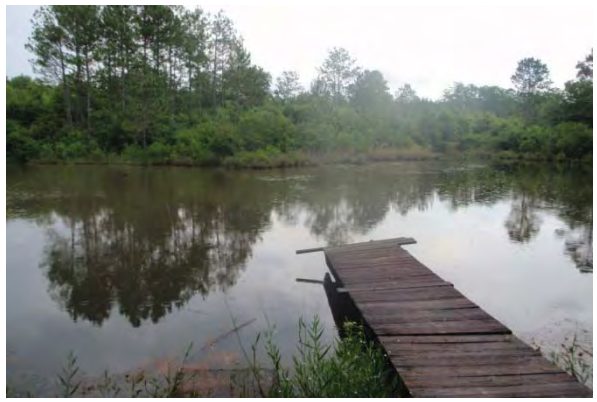
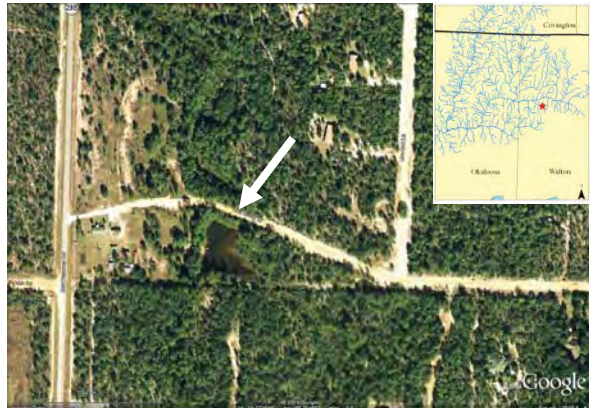
<h1>Unnamed tributary</h1>	<h2>wa-0707-r-005</h2>	<b>Sedimentation Risk Index</b> <h1>22</h1>
----------------------------	------------------------	--

Risk Factor	Ranking	Score
<i>US Channel Morph</i>	PONDED	1
<i>DS Channel Morph</i>	F	1
<i>DS Bank Alteration</i>	HIGH	1
<i>Upstream Skew Angle</i>	>30°	1
<i>Crossing fill condition</i>	Poor/Bare soil	1
<i>Inlet/Outlet Condition</i>	Blocked	1
<i>Road Approach Material</i>	All Sand/Clay	3
<i>Potential Eroded Volume Mean</i>	>40 y <sup>3</sup>	1
<i>Approach Slope Mean</i>	>4%	1
<i>Soil K Factor</i>	<0.20	5
<i>Upstream Rt Outlet</i>	Vegetated	1
<i>Upstream Lt Outlet</i>	Vegetated	1
<i>Upstream Rt Ditch</i>	Bare soil	0
<i>Upstream Lt Ditch</i>	Bare soil	0
<i>Downstream Rt Outlet</i>	Vegetated	1
<i>Downstream Lt Outlet</i>	Vegetated	1
<i>Downstream Rt Ditch</i>	Bare soil	0
<i>Downstream Lt Ditch</i>	Bare soil	0
<i>Outlet Total</i>	Improved Outlet System	5
<i>Ditches Total</i>	Unimproved Drainage System	1
<b>SRI Total</b>	<b>High Risk</b>	<b>22</b>

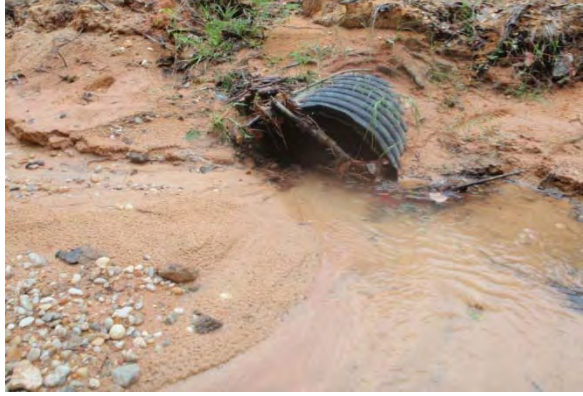
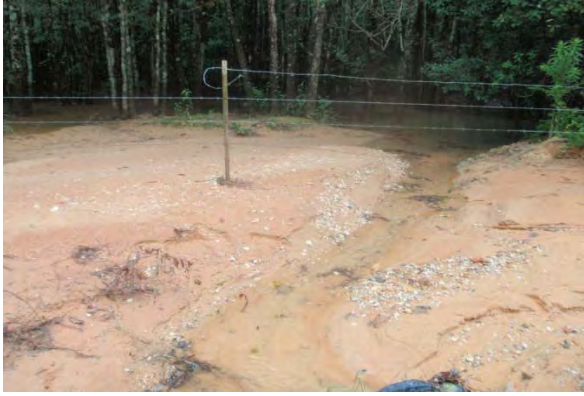
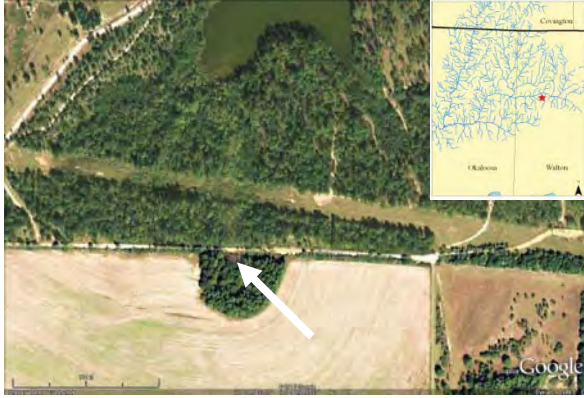
<b>Unnamed tributary</b>	<b>wa-0707-r-007</b>	<b>Sedimentation Risk Index</b> <b>30</b>
--------------------------	----------------------	--

Risk Factor	Ranking	Score
<i>US Channel Morph</i>	WETLAND	5
<i>DS Channel Morph</i>	DA	3
<i>DS Bank Alteration</i>	MINOR/PARTIAL	3
<i>Upstream Skew Angle</i>	<5°	5
<i>Crossing fill condition</i>	Poor/Bare soil	1
<i>Inlet/Outlet Condition</i>	Blocked	1
<i>Road Approach Material</i>	All Native Soil	1
<i>Potential Eroded Volume Mean</i>	>40 y <sup>3</sup>	1
<i>Approach Slope Mean</i>	>4%	1
<i>Soil K Factor</i>	<0.20	5
<i>Upstream Rt Outlet</i>	Bare soil	0
<i>Upstream Lt Outlet</i>	Bare soil	0
<i>Upstream Rt Ditch</i>	Bare soil	0
<i>Upstream Lt Ditch</i>	Bare soil	0
<i>Downstream Rt Outlet</i>	Vegetated	1
<i>Downstream Lt Outlet</i>	Vegetated	1
<i>Downstream Rt Ditch</i>	Bare soil	0
<i>Downstream Lt Ditch</i>	Bare soil	0
<i>Outlet Total</i>	Partially Improved Outlet System	3
<i>Ditches Total</i>	Unimproved Drainage System	1
<b><i>SRI Total</i></b>	<b>High Risk</b>	<b>30</b>
<b>Additional Site Features</b>		
<i>Crossing Type and Quantity:</i>	Culvert, 1

Notes: Fencing across US.

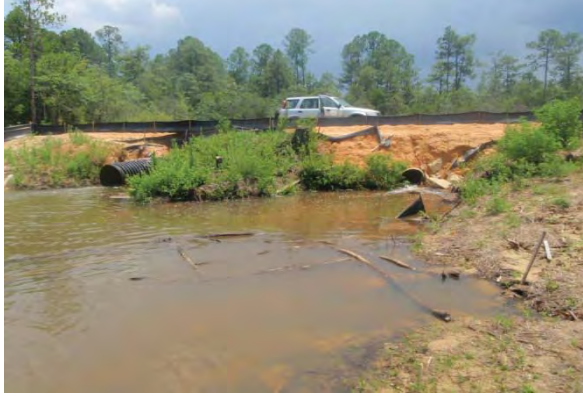
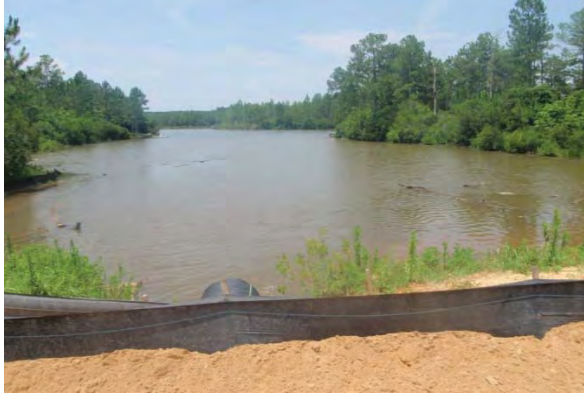
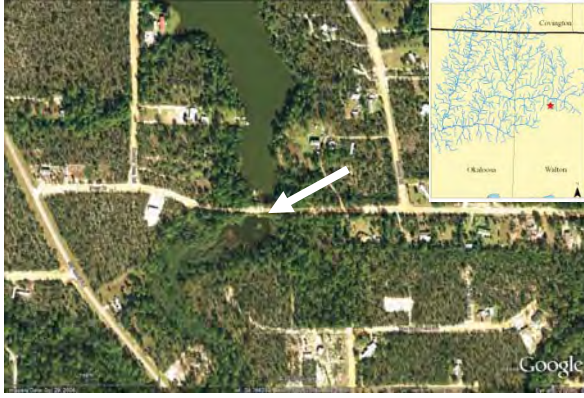
<h1>Unnamed tributary</h1>	<h2>wa-0716-r-009</h2>	<b>Sedimentation Risk Index</b> <h1>26</h1>
----------------------------	------------------------	--

Risk Factor	Ranking	Score
<i>US Channel Morph</i>	PONDED	1
<i>DS Channel Morph</i>	PONDED	1
<i>DS Bank Alteration</i>	HIGH	1
<i>Upstream Skew Angle</i>	<5°	5
<i>Crossing fill condition</i>	Poor/Bare soil	1
<i>Inlet/Outlet Condition</i>	No Impairment	5
<i>Road Approach Material</i>	All Sand/Clay	3
<i>Potential Eroded Volume Mean</i>	>40 y <sup>3</sup>	1
<i>Approach Slope Mean</i>	>4%	1
<i>Soil K Factor</i>	<0.20	5
<i>Upstream Rt Outlet</i>	Bare soil	0
<i>Upstream Lt Outlet</i>	Bare soil	0
<i>Upstream Rt Ditch</i>	Bare soil	0
<i>Upstream Lt Ditch</i>	Bare soil	0
<i>Downstream Rt Outlet</i>	Bare soil	0
<i>Downstream Lt Outlet</i>	Bare soil	0
<i>Downstream Rt Ditch</i>	Bare soil	0
<i>Downstream Lt Ditch</i>	Bare soil	0
<i>Outlet Total</i>	Unimproved Outlet System	1
<i>Ditches Total</i>	Unimproved Drainage System	1
<b>SRI Total</b>	<b>High Risk</b>	<b>26</b>

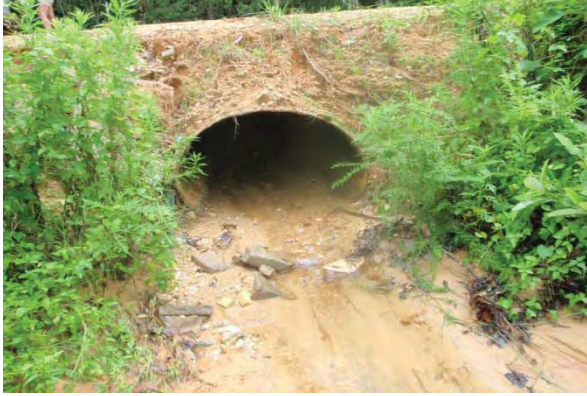
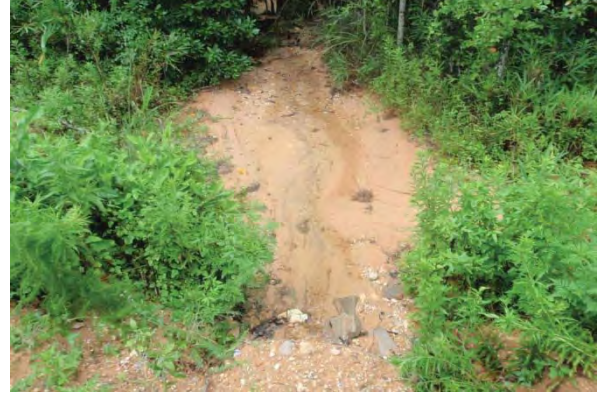
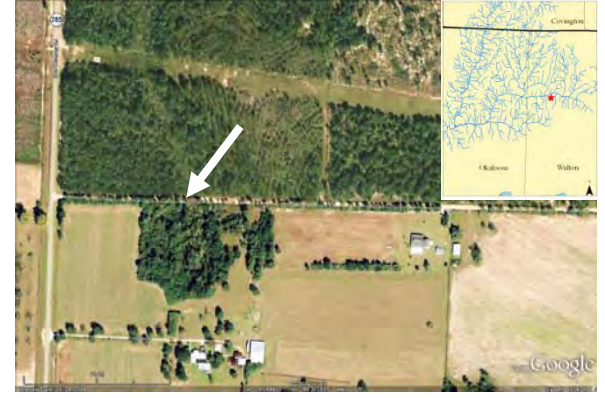
Unnamed tributary	wa-0707-r-006	Sedimentation Risk Index <b>30</b>
-------------------	---------------	---------------------------------------

Risk Factor	Ranking	Score
<i>US Channel Morph</i>	D	1
<i>DS Channel Morph</i>	D	1
<i>DS Bank Alteration</i>	HIGH	1
<i>Upstream Skew Angle</i>	<5°	5
<i>Crossing fill condition</i>	Poor/Bare soil	1
<i>Inlet/Outlet Condition</i>	Sed Islands/Scouring	3
<i>Road Approach Material</i>	All Sand/Clay	3
<i>Potential Eroded Volume Mean</i>	<21 y <sup>3</sup>	5
<i>Approach Slope Mean</i>	>4%	1
<i>Soil K Factor</i>	<0.20	5
<i>Upstream Rt Outlet</i>	Bare soil	0
<i>Upstream Lt Outlet</i>	Bare soil	0
<i>Upstream Rt Ditch</i>	Bare soil	0
<i>Upstream Lt Ditch</i>	Bare soil	0
<i>Downstream Rt Outlet</i>	Vegetated	1
<i>Downstream Lt Outlet</i>	Vegetated	1
<i>Downstream Rt Ditch</i>	Bare soil	0
<i>Downstream Lt Ditch</i>	Bare soil	0
<i>Outlet Total</i>	Partially Improved Outlet System	3
<i>Ditches Total</i>	Unimproved Drainage System	1
<b>SRI Total</b>	<b>High Risk</b>	<b>30</b>

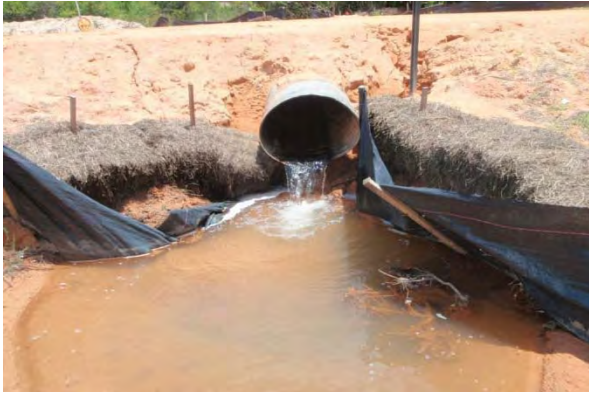
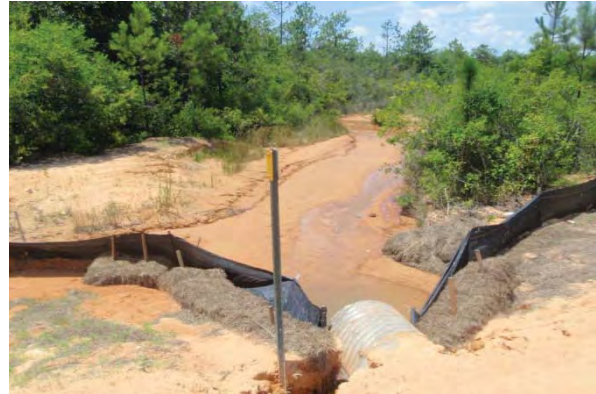
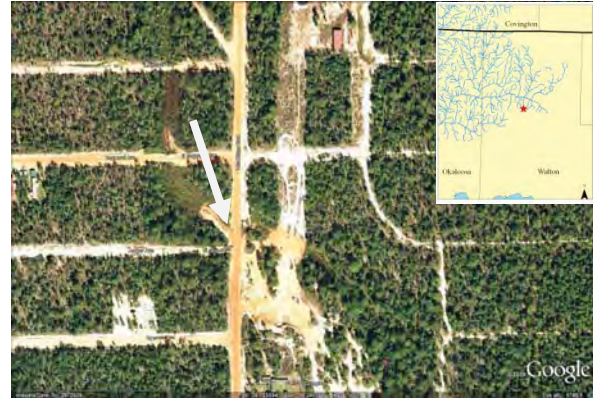
<h1 style="margin:0;">Gum Creek</h1>	<h2 style="margin:0;">wa-0727-r-006</h2>	<b>Sedimentation Risk Index</b> <h1 style="margin:0;">32</h1>
--------------------------------------	--	--

Risk Factor	Ranking	Score
<i>US Channel Morph</i>	DA	3
<i>DS Channel Morph</i>	DA	3
<i>DS Bank Alteration</i>	HIGH	1
<i>Upstream Skew Angle</i>	<5°	5
<i>Crossing fill condition</i>	Poor/Bare soil	1
<i>Inlet/Outlet Condition</i>	Sed Islands/Scouring	3
<i>Road Approach Material</i>	All Sand/Clay	3
<i>Potential Eroded Volume Mean</i>	<21 y <sup>3</sup>	5
<i>Approach Slope Mean</i>	>4%	1
<i>Soil K Factor</i>	<0.20	5
<i>Upstream Rt Outlet</i>	Other	0
<i>Upstream Lt Outlet</i>	Other	0
<i>Upstream Rt Ditch</i>	Bare soil	0
<i>Upstream Lt Ditch</i>	Bare soil	0
<i>Downstream Rt Outlet</i>	Other	0
<i>Downstream Lt Outlet</i>	Other	0
<i>Downstream Rt Ditch</i>	Bare soil	0
<i>Downstream Lt Ditch</i>	Bare soil	0
<b>Outlet Total</b>	Unimproved Outlet System	1
<b>Ditches Total</b>	Unimproved Drainage System	1
<b>SRI Total</b>	<b>High Risk</b>	<b>32</b>

Notes: Failing BMPs DS. DS Drop off.

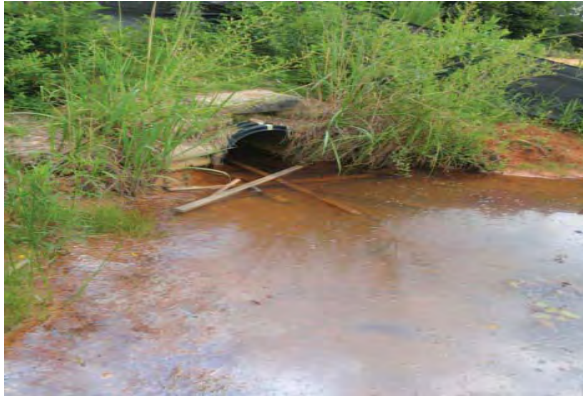
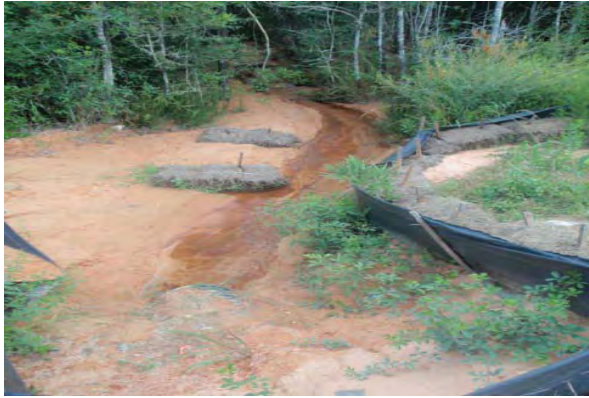
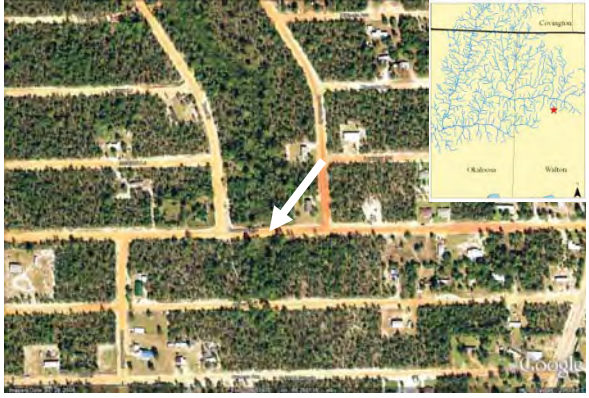
<h1>Unnamed tributary</h1>	<h2>wa-0716-r-002</h2>	<i>Sedimentation Risk Index</i> <b>32</b>
----------------------------	------------------------	--

Risk Factor	Ranking	Score
<i>US Channel Morph</i>	PONDED	1
<i>DS Channel Morph</i>	C	5
<i>DS Bank Alteration</i>	HIGH	1
<i>Upstream Skew Angle</i>	5-30°	3
<i>Crossing fill condition</i>	Fair/Rip Rap	3
<i>Inlet/Outlet Condition</i>	Sed Islands/Scouring	3
<i>Road Approach Material</i>	All Sand/Clay	3
<i>Potential Eroded Volume Mean</i>	<21 y <sup>3</sup>	5
<i>Approach Slope Mean</i>	2.1-4%	3
<i>Soil K Factor</i>	0.21-0.40	3
<i>Upstream Rt Outlet</i>	Other	0
<i>Upstream Lt Outlet</i>	Other	0
<i>Upstream Rt Ditch</i>	Bare soil	0
<i>Upstream Lt Ditch</i>	Bare soil	0
<i>Downstream Rt Outlet</i>	Other	0
<i>Downstream Lt Outlet</i>	Other	0
<i>Downstream Rt Ditch</i>	Bare soil	0
<i>Downstream Lt Ditch</i>	Bare soil	0
<i>Outlet Total</i>	Unimproved Outlet System	1
<i>Ditches Total</i>	Unimproved Drainage System	1
<b>SRI Total</b>	<b>High Risk</b>	<b>32</b>
