Appendix A. River corridor severity scores for impaired sites in the Yellow River Basin, Alabama and Florida

Appendix C. Clear Creek Watershed Focal Area. Sites with orange headings are unpaved road sites. Specific definitions and calculations described for calculating the Sediment Risk Index (SRI) are detailed in Witmer (2009).

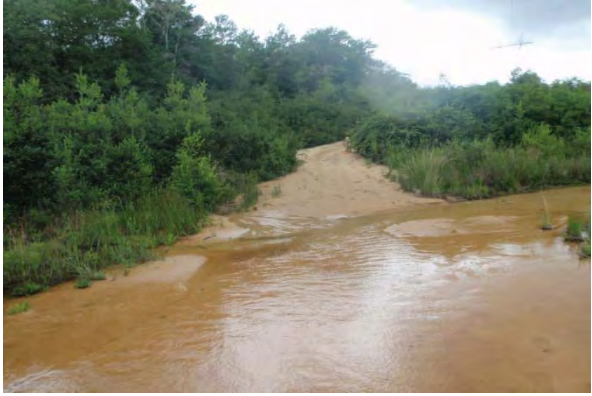
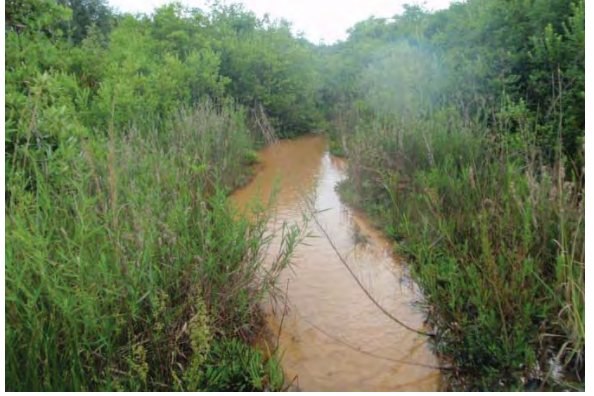
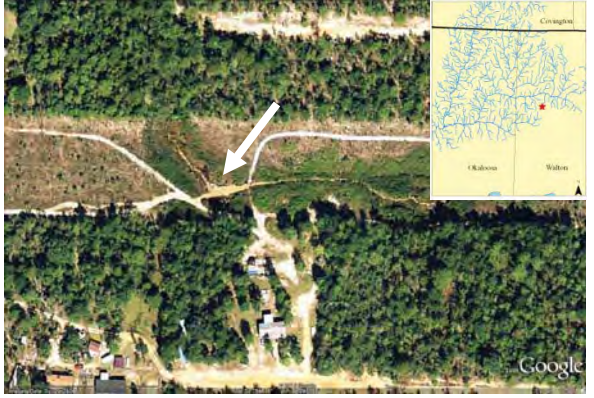
<b>Unnamed tributary</b>	<b>wa-0707-r-004</b>	<i>Sedimentation Risk Index</i> <b>40</b>
--------------------------	----------------------	--

Risk Factor	Ranking	Score
<i>US Channel Morph</i>	E	5
<i>DS Channel Morph</i>	E	5
<i>DS Bank Alteration</i>	MINOR/PARTIAL	3
<i>Upstream Skew Angle</i>	<5°	5
<i>Crossing fill condition</i>	Good/Vegetated	5
<i>Inlet/Outlet Condition</i>	Sed Islands/Scouring	3
<i>Road Approach Material</i>	All Native Soil	1
<i>Potential Eroded Volume Mean</i>	<21 y <sup>3</sup>	5
<i>Approach Slope Mean</i>	>4%	1
<i>Soil K Factor</i>	<0.20	5
<i>Upstream Rt Outlet</i>	Bare soil	0
<i>Upstream Lt Outlet</i>	Bare soil	0
<i>Upstream Rt Ditch</i>	Bare soil	0
<i>Upstream Lt Ditch</i>	Bare soil	0
<i>Downstream Rt Outlet</i>	Bare soil	0
<i>Downstream Lt Outlet</i>	Bare soil	0
<i>Downstream Rt Ditch</i>	Bare soil	0
<i>Downstream Lt Ditch</i>	Bare soil	0
<i>Outlet Total</i>	Unimproved Outlet System	1
<i>Ditches Total</i>	Unimproved Drainage System	1
<b>SRI Total</b>	<b>Medium Risk</b>	<b>40</b>
<b>Additional Site Features</b>		
<i>Crossing Type and Quantity:</i>	Ford, 1

Notes: ATV trail

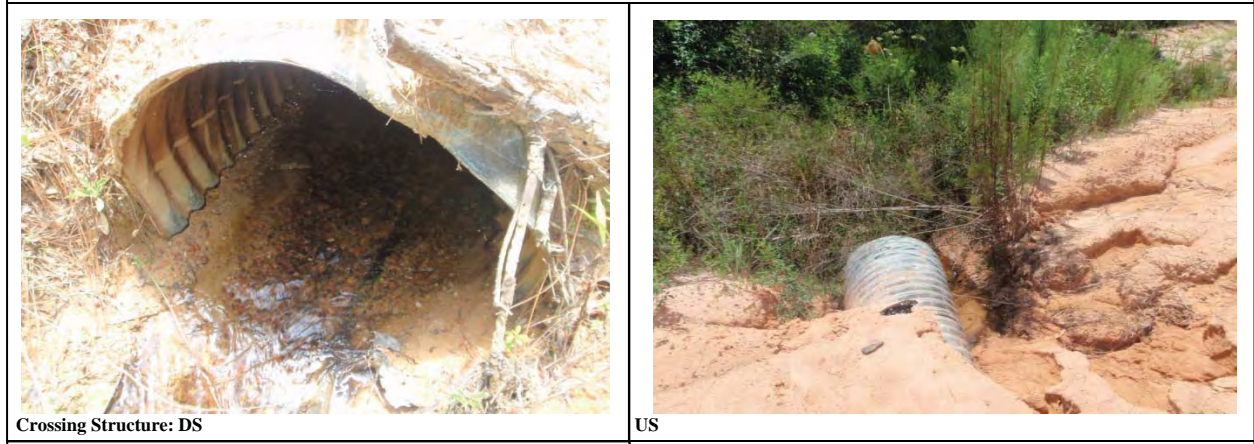
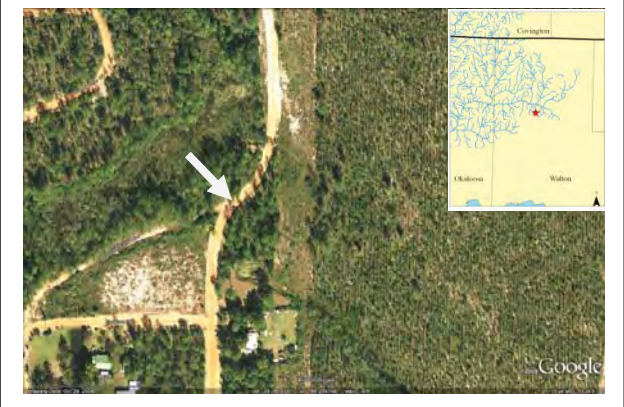
<b>Unnamed tributary</b>	<b>wa-0727-r-002</b>	<b>Sedimentation Risk Index</b> <b>32</b>
--------------------------	----------------------	--

Risk Factor	Ranking	Score
<i>US Channel Morph</i>	PONDED	1
<i>DS Channel Morph</i>	DA	3
<i>DS Bank Alteration</i>	HIGH	1
<i>Upstream Skew Angle</i>	<5°	5
<i>Crossing fill condition</i>	Poor/Bare soil	1
<i>Inlet/Outlet Condition</i>	Sed Islands/Scouring	3
<i>Road Approach Material</i>	All Sand/Clay	3
<i>Potential Eroded Volume Mean</i>	<21 y <sup>3</sup>	5
<i>Approach Slope Mean</i>	2.1-4%	3
<i>Soil K Factor</i>	<0.20	5
<i>Upstream Rt Outlet</i>	Bare soil	0
<i>Upstream Lt Outlet</i>	Bare soil	0
<i>Upstream Rt Ditch</i>	Bare soil	0
<i>Upstream Lt Ditch</i>	Bare soil	0
<i>Downstream Rt Outlet</i>	Bare soil	0
<i>Downstream Lt Outlet</i>	Bare soil	0
<i>Downstream Rt Ditch</i>	Bare soil	0
<i>Downstream Lt Ditch</i>	Bare soil	0
<i>Outlet Total</i>	Unimproved Outlet System	1
<i>Ditches Total</i>	Unimproved Drainage System	1
<b><i>SRI Total</i></b>	<b>High Risk</b>	<b>32</b>

Notes: US culvert too high- all flow cannot reach its inlet.

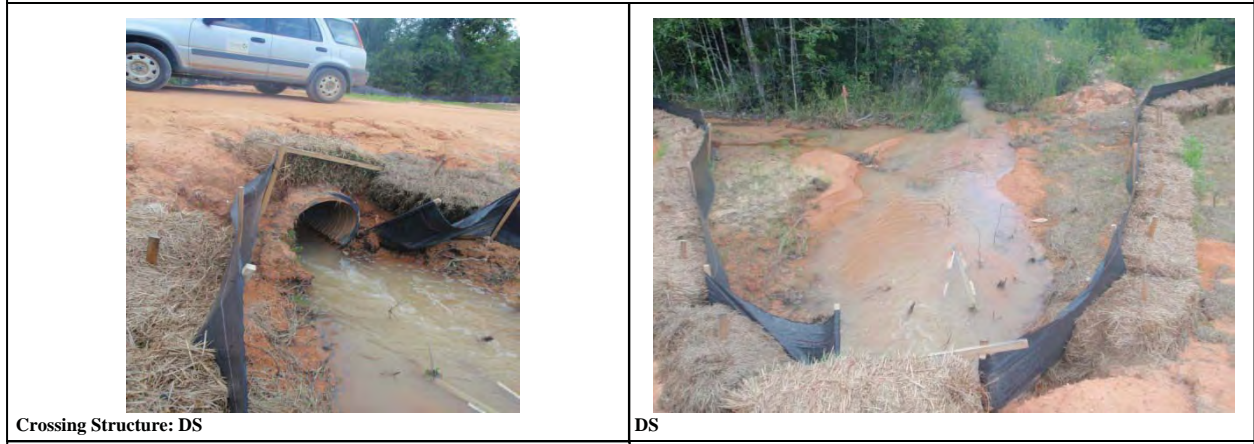
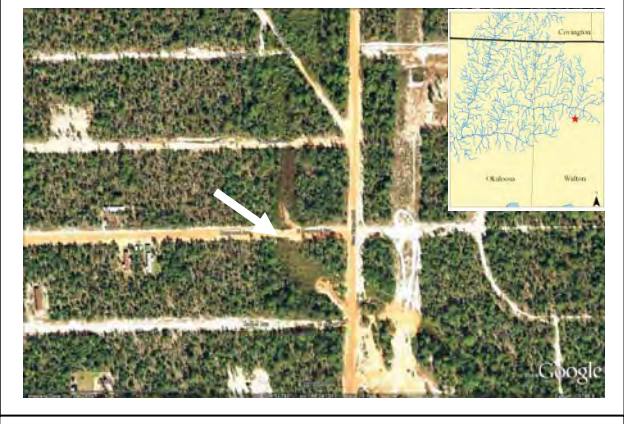
<h1>Gum Creek</h1>	<h2>wa-0716-r-010</h2>	<b>Sedimentation Risk Index</b> <h1>26</h1>
--------------------	------------------------	--

Risk Factor	Ranking	Score
<i>US Channel Morph</i>	DA	3
<i>DS Channel Morph</i>	DA	3
<i>DS Bank Alteration</i>	HIGH	1
<i>Upstream Skew Angle</i>	<5°	5
<i>Crossing fill condition</i>	Poor/Bare soil	1
<i>Inlet/Outlet Condition</i>	Sed Islands/Scouring	3
<i>Road Approach Material</i>	All Sand/Clay	3
<i>Potential Eroded Volume Mean</i>	<21 y <sup>3</sup>	5
<i>Approach Slope Mean</i>	>4%	1
<i>Soil K Factor</i>	<0.20	5
<i>Upstream Rt Outlet</i>	Other	0
<i>Upstream Lt Outlet</i>	Other	0
<i>Upstream Rt Ditch</i>	Bare soil	0
<i>Upstream Lt Ditch</i>	Bare soil	0
<i>Downstream Rt Outlet</i>	Other	0
<i>Downstream Lt Outlet</i>	Other	0
<i>Downstream Rt Ditch</i>	Vegetated	1
<i>Downstream Lt Ditch</i>	Vegetated	1
<b>Outlet Total</b>	Unimproved Outlet System	1
<b>Ditches Total</b>	Partially Improved Drainage System	3
<b>SRI Total</b>	<b>High Risk</b>	<b>34</b>
<b>Additional Site Features</b>		
<i>Crossing Type and Quantity:</i>	Culvert, 1

Notes: BMPs

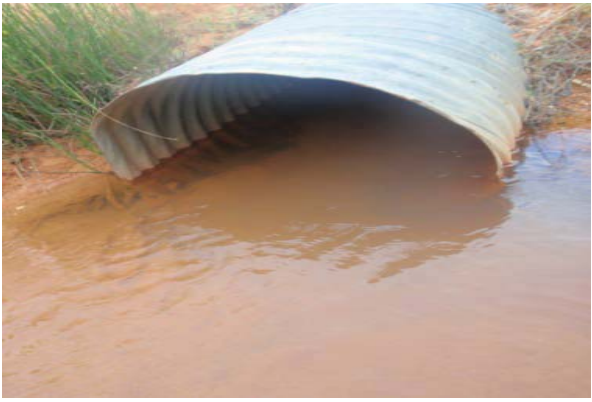
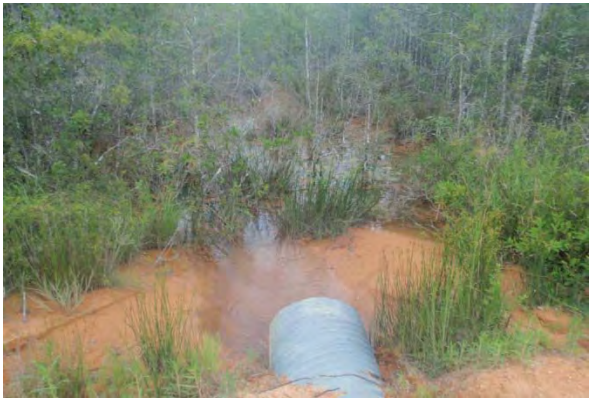
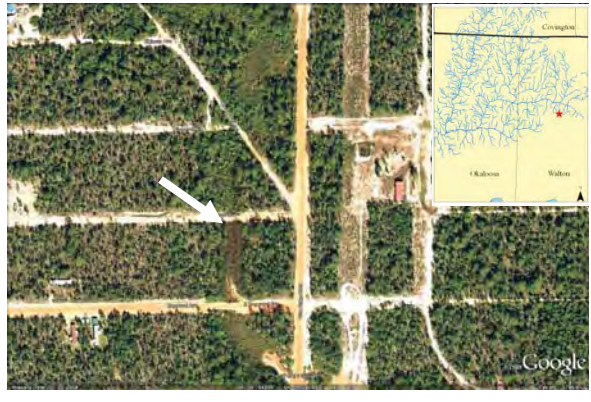
<h1>Gum Creek</h1>	<h2>wa-0716-r-011</h2>	<b>Sedimentation Risk Index</b> <h1>36</h1>
--------------------	------------------------	--

Risk Factor	Ranking	Score
<i>US Channel Morph</i>	WETLAND	5
<i>DS Channel Morph</i>	E	5
<i>DS Bank Alteration</i>	HIGH	1
<i>Upstream Skew Angle</i>	<5°	5
<i>Crossing fill condition</i>	Poor/Bare soil	1
<i>Inlet/Outlet Condition</i>	Sed Islands/Scouring	3
<i>Road Approach Material</i>	All Sand/Clay	3
<i>Potential Eroded Volume Mean</i>	<21 y <sup>3</sup>	5
<i>Approach Slope Mean</i>	>4%	1
<i>Soil K Factor</i>	<0.20	5
<i>Upstream Rt Outlet</i>	Bare soil	0
<i>Upstream Lt Outlet</i>	Bare soil	0
<i>Upstream Rt Ditch</i>	Bare soil	0
<i>Upstream Lt Ditch</i>	Bare soil	0
<i>Downstream Rt Outlet</i>	Bare soil	0
<i>Downstream Lt Outlet</i>	Bare soil	0
<i>Downstream Rt Ditch</i>	Bare soil	0
<i>Downstream Lt Ditch</i>	Bare soil	0
<i>Outlet Total</i>	Unimproved Outlet System	1
<i>Ditches Total</i>	Unimproved Drainage System	1
<b>SRI Total</b>	<b>High Risk</b>	<b>36</b>

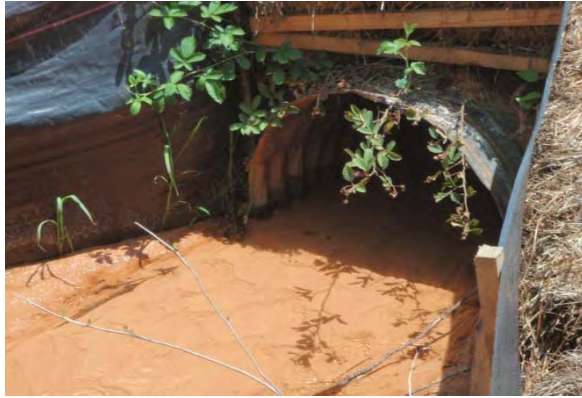
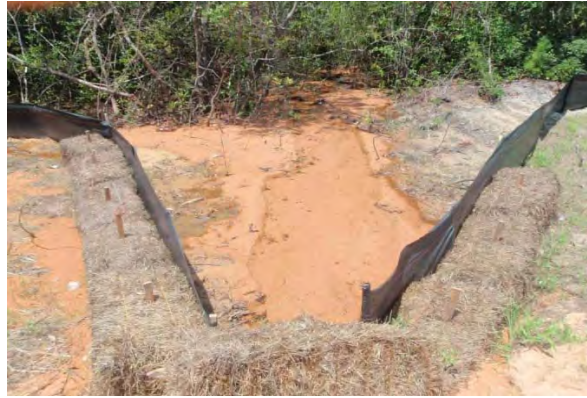
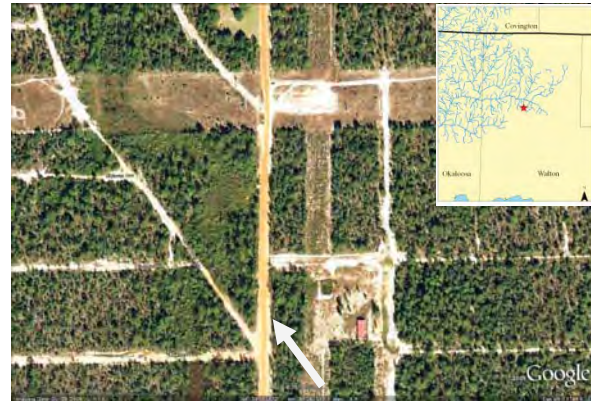
<b>Unnamed tributary</b>	<b>wa-0727-r-004b</b>	<i>Sedimentation Risk Index</i> <b>34</b>
--------------------------	-----------------------	--

Risk Factor	Ranking	Score
<i>US Channel Morph</i>	DA	3
<i>DS Channel Morph</i>	DA	3
<i>DS Bank Alteration</i>	HIGH	1
<i>Upstream Skew Angle</i>	<5°	5
<i>Crossing fill condition</i>	Poor/Bare soil	1
<i>Inlet/Outlet Condition</i>	Sed Islands/Scouring	3
<i>Road Approach Material</i>	All Sand/Clay	3
<i>Potential Eroded Volume Mean</i>	<21 y <sup>3</sup>	5
<i>Approach Slope Mean</i>	2.1-4%	3
<i>Soil K Factor</i>	<0.20	5
<i>Upstream Rt Outlet</i>	Bare soil	0
<i>Upstream Lt Outlet</i>	Bare soil	0
<i>Upstream Rt Ditch</i>	Bare soil	0
<i>Upstream Lt Ditch</i>	Bare soil	0
<i>Downstream Rt Outlet</i>	Other	0
<i>Downstream Lt Outlet</i>	Other	0
<i>Downstream Rt Ditch</i>	Bare soil	0
<i>Downstream Lt Ditch</i>	Bare soil	0
<i>Outlet Total</i>	Unimproved Outlet System	1
<i>Ditches Total</i>	Unimproved Drainage System	1
<b><i>SRI Total</i></b>	<b>High Risk</b>	<b>34</b>

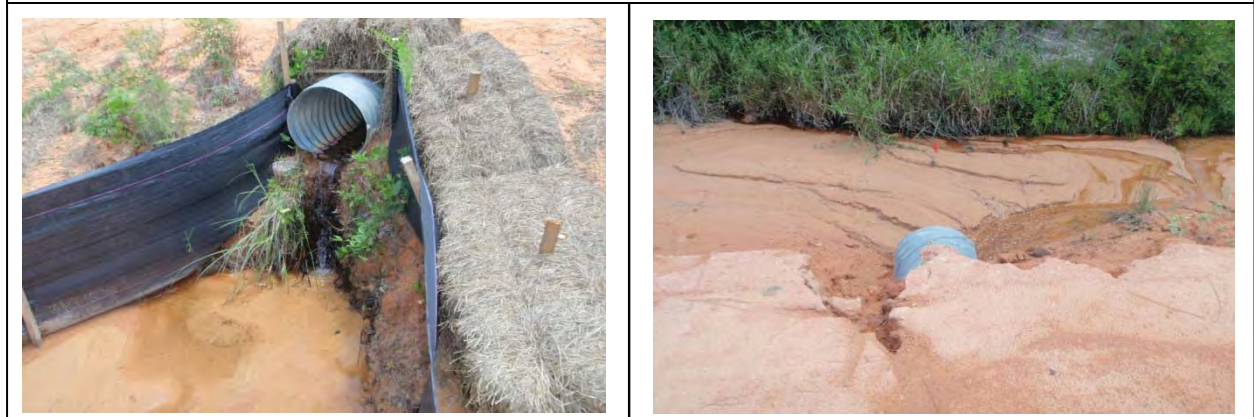
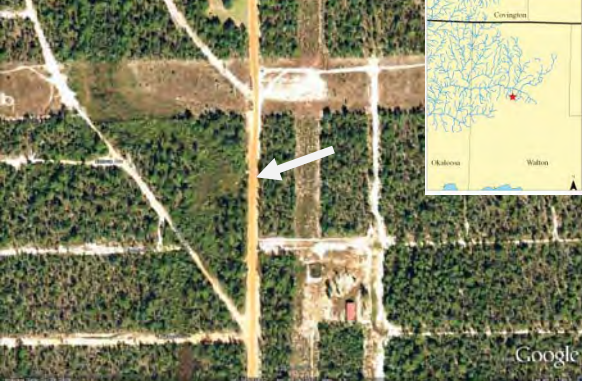
<h1>Unnamed tributary</h1>	<h2>wa-0727-r-004a</h2>	<b>Sedimentation Risk Index</b> <h1>34</h1>
----------------------------	-------------------------	--

Risk Factor	Ranking	Score	
<i>US Channel Morph</i>	DA	3	
<i>DS Channel Morph</i>	E	5	
<i>DS Bank Alteration</i>	HIGH	1	
<i>Upstream Skew Angle</i>	>30°	1	
<i>Crossing fill condition</i>	Poor/Bare soil	1	
<i>Inlet/Outlet Condition</i>	No Impairment	5	
<i>Road Approach Material</i>	All Sand/Clay	3	
<i>Potential Eroded Volume Mean</i>	<21 y <sup>3</sup>	5	
<i>Approach Slope Mean</i>	2.1-4%	3	
<i>Soil K Factor</i>	<0.20	5	
<i>Upstream Rt Outlet</i>	Bare soil	0	
<i>Upstream Lt Outlet</i>	Bare soil	0	
<i>Upstream Rt Ditch</i>	Bare soil	0	
<i>Upstream Lt Ditch</i>	Bare soil	0	
<i>Downstream Rt Outlet</i>	Other	0	
<i>Downstream Lt Outlet</i>	Other	0	
<i>Downstream Rt Ditch</i>	Bare soil	0	
<i>Downstream Lt Ditch</i>	Bare soil	0	
<i>Outlet Total</i>	Unimproved Outlet System	1	
<i>Ditches Total</i>	Unimproved Drainage System	1	
<b><i>SRI Total</i></b>	<b>High Risk</b>	<b>34</b>

Notes: DS drop off. BMPs installed.

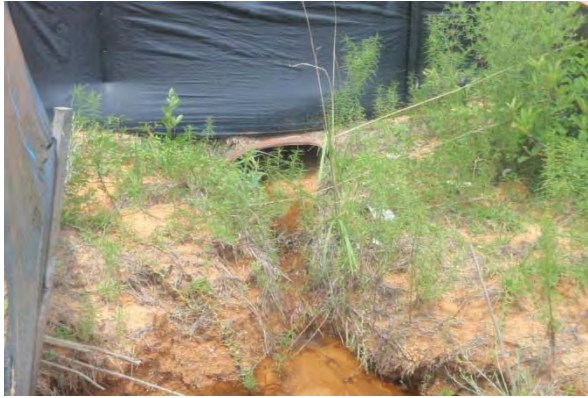
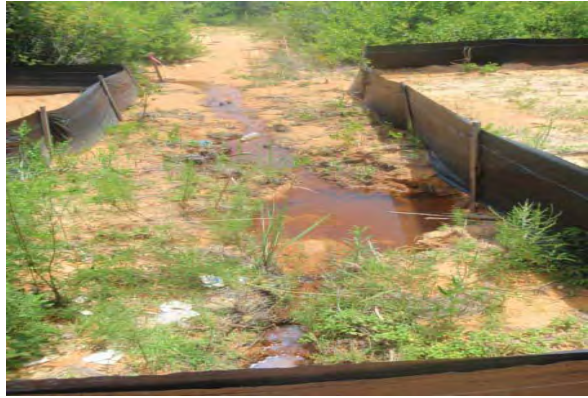
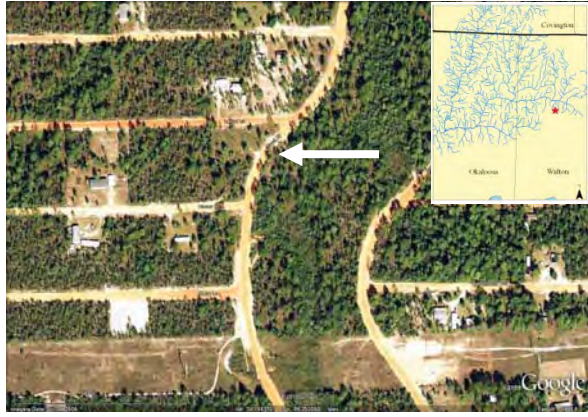
Unnamed tributary	wa-0716-r-004	Sedimentation Risk Index <b>36</b>
-------------------	---------------	---------------------------------------

Risk Factor	Ranking	Score
US Channel Morph	WETLAND	5
DS Channel Morph	DA	3
DS Bank Alteration	HIGH	1
Upstream Skew Angle	5-30°	3
Crossing fill condition	Poor/Bare soil	1
Inlet/Outlet Condition	Sed Islands/Scouring	3
Road Approach Material	All Sand/Clay	3
Potential Eroded Volume Mean	<21 y <sup>3</sup>	5
Approach Slope Mean	<2%	5
Soil K Factor	<0.20	5
Upstream Rt Outlet	Bare soil	0
Upstream Lt Outlet	Bare soil	0
Upstream Rt Ditch	Bare soil	0
Upstream Lt Ditch	Bare soil	0
Downstream Rt Outlet	Other	0
Downstream Lt Outlet	Other	0
Downstream Rt Ditch	Bare soil	0
Downstream Lt Ditch	Bare soil	0
Outlet Total	Unimproved Outlet System	1
Ditches Total	Unimproved Drainage System	1
<b>SRI Total</b>	<b>High Risk</b>	<b>36</b>

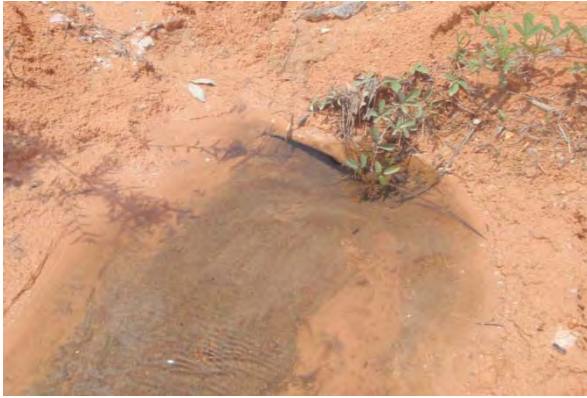
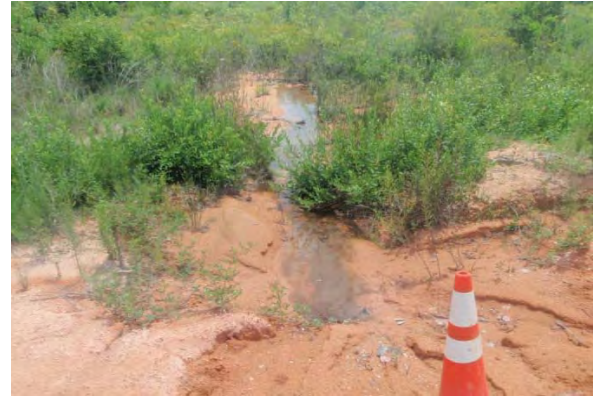
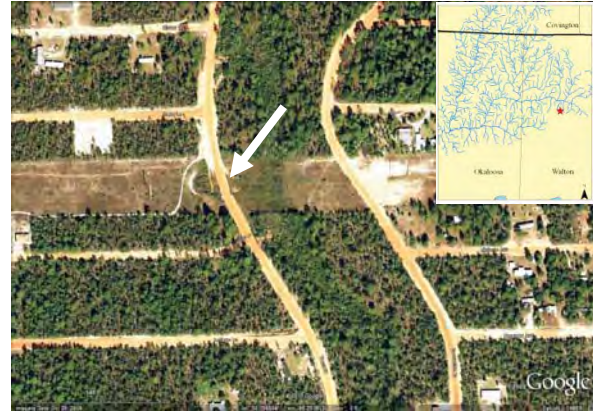
Unnamed tributary	wa-0716-r-003b	Sedimentation Risk Index <b>34</b>
-------------------	----------------	---------------------------------------

Risk Factor	Ranking	Score
<i>US Channel Morph</i>	DA	3
<i>DS Channel Morph</i>	DA	3
<i>DS Bank Alteration</i>	HIGH	1
<i>Upstream Skew Angle</i>	<5°	5
<i>Crossing fill condition</i>	Poor/Bare soil	1
<i>Inlet/Outlet Condition</i>	Sed Islands/Scouring	3
<i>Road Approach Material</i>	All Sand/Clay	3
<i>Potential Eroded Volume Mean</i>	<21 y <sup>3</sup>	5
<i>Approach Slope Mean</i>	2.1-4%	3
<i>Soil K Factor</i>	<0.20	5
<i>Upstream Rt Outlet</i>	Bare soil	0
<i>Upstream Lt Outlet</i>	Bare soil	0
<i>Upstream Rt Ditch</i>	Bare soil	0
<i>Upstream Lt Ditch</i>	Bare soil	0
<i>Downstream Rt Outlet</i>	Bare soil	0
<i>Downstream Lt Outlet</i>	Bare soil	0
<i>Downstream Rt Ditch</i>	Bare soil	0
<i>Downstream Lt Ditch</i>	Bare soil	0
<i>Outlet Total</i>	Unimproved Outlet System	1
<i>Ditches Total</i>	Unimproved Drainage System	1
<b>SRI Total</b>	<b>High Risk</b>	<b>34</b>

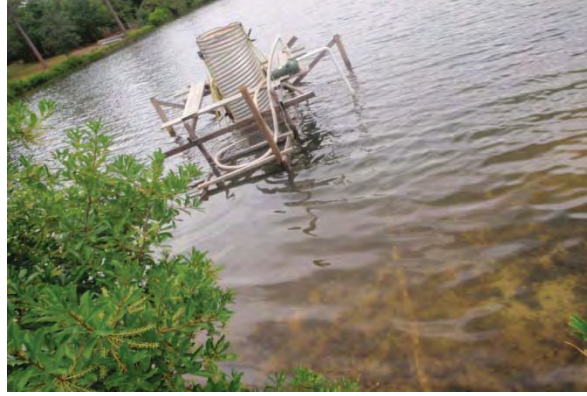
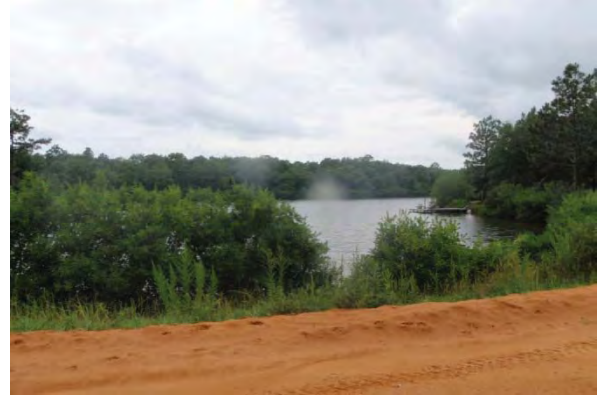
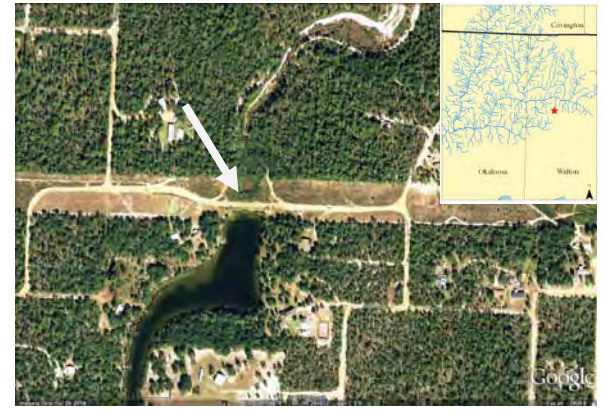
<b>Unnamed tributary</b>	<b>wa-0707-r-003</b>	<i>Sedimentation Risk Index</i> <b>34</b>
--------------------------	----------------------	--

Risk Factor	Ranking	Score
<i>US Channel Morph</i>	PONDED	1
<i>DS Channel Morph</i>	DA	3
<i>DS Bank Alteration</i>	NATURAL	5
<i>Upstream Skew Angle</i>	5-30°	3
<i>Crossing fill condition</i>	Poor/Bare soil	1
<i>Inlet/Outlet Condition</i>	No Impairment	5
<i>Road Approach Material</i>	All Native Soil	1
<i>Potential Eroded Volume Mean</i>	>40 y <sup>3</sup>	1
<i>Approach Slope Mean</i>	>4%	1
<i>Soil K Factor</i>	<0.20	5
<i>Upstream Rt Outlet</i>	Vegetated	1
<i>Upstream Lt Outlet</i>	Vegetated	1
<i>Upstream Rt Ditch</i>	Vegetated	1
<i>Upstream Lt Ditch</i>	Bare soil	0
<i>Downstream Rt Outlet</i>	Vegetated	1
<i>Downstream Lt Outlet</i>	Vegetated	1
<i>Downstream Rt Ditch</i>	Vegetated	1
<i>Downstream Lt Ditch</i>	Bare soil	0
<i>Outlet Total</i>	Improved Outlet System	5
<i>Ditches Total</i>	Partially Improved Drainage System	3
<b><i>SRI Total</i></b>	<b>High Risk</b>	<b>34</b>

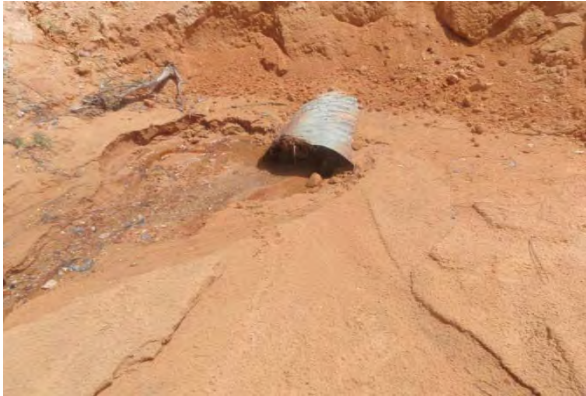
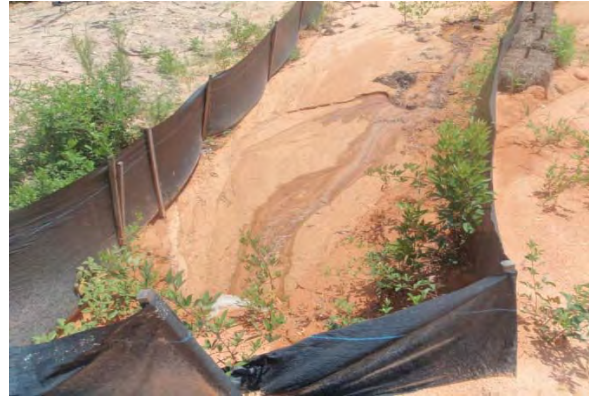
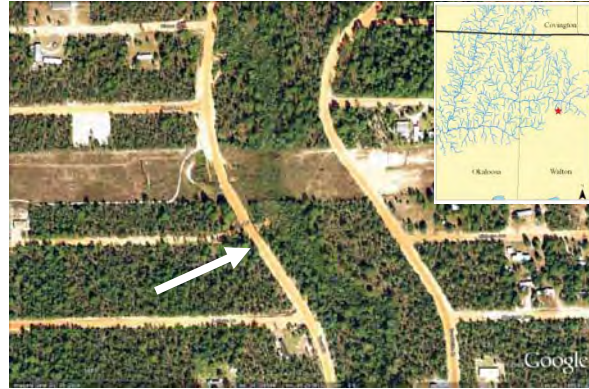
<b>Unnamed tributary</b>	<b>wa-0716-r-003a</b>	<i>Sedimentation Risk Index</i> <b>38</b>
--------------------------	-----------------------	--

Risk Factor	Ranking	Score
<i>US Channel Morph</i>	E	5
<i>DS Channel Morph</i>	E	5
<i>DS Bank Alteration</i>	HIGH	1
<i>Upstream Skew Angle</i>	<5°	5
<i>Crossing fill condition</i>	Poor/Bare soil	1
<i>Inlet/Outlet Condition</i>	Sed Islands/Scouring	3
<i>Road Approach Material</i>	All Sand/Clay	3
<i>Potential Eroded Volume Mean</i>	<21 y <sup>3</sup>	5
<i>Approach Slope Mean</i>	2.1-4%	3
<i>Soil K Factor</i>	<0.20	5
<i>Upstream Rt Outlet</i>	Bare soil	0
<i>Upstream Lt Outlet</i>	Bare soil	0
<i>Upstream Rt Ditch</i>	Bare soil	0
<i>Upstream Lt Ditch</i>	Bare soil	0
<i>Downstream Rt Outlet</i>	Bare soil	0
<i>Downstream Lt Outlet</i>	Other	0
<i>Downstream Rt Ditch</i>	Bare soil	0
<i>Downstream Lt Ditch</i>	Bare soil	0
<i>Outlet Total</i>	Unimproved Outlet System	1
<i>Ditches Total</i>	Unimproved Drainage System	1
<b>SRI Total</b>	<b>Medium Risk</b>	<b>38</b>
<b>Additional Site Features</b>		
<u>Crossing Type and Quantity:</u>	Culvert, 1

Notes: BMPs installed

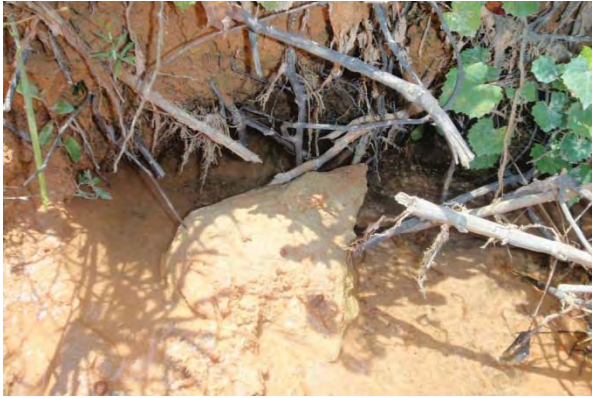
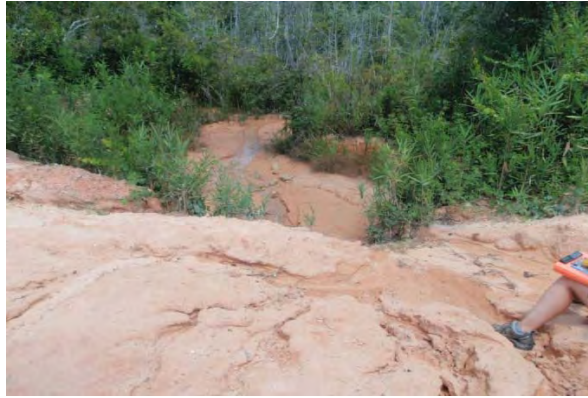
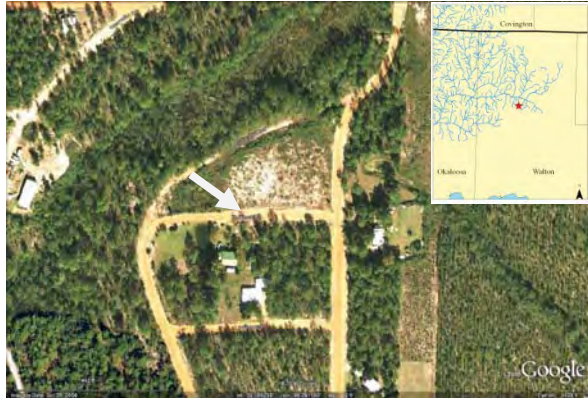
<h1>Unnamed tributary</h1>	<h2>wa-0727-r-003</h2>	<b>Sedimentation Risk Index</b> <h1>34</h1>
----------------------------	------------------------	--

Risk Factor	Ranking	Score
<i>US Channel Morph</i>	PONDED	1
<i>DS Channel Morph</i>	E	5
<i>DS Bank Alteration</i>	HIGH	1
<i>Upstream Skew Angle</i>	<5°	5
<i>Crossing fill condition</i>	Poor/Bare soil	1
<i>Inlet/Outlet Condition</i>	Blocked	1
<i>Road Approach Material</i>	All Sand/Clay	3
<i>Potential Eroded Volume Mean</i>	<21 y <sup>3</sup>	5
<i>Approach Slope Mean</i>	<2%	5
<i>Soil K Factor</i>	<0.20	5
<i>Upstream Rt Outlet</i>	Bare soil	0
<i>Upstream Lt Outlet</i>	Bare soil	0
<i>Upstream Rt Ditch</i>	Bare soil	0
<i>Upstream Lt Ditch</i>	Bare soil	0
<i>Downstream Rt Outlet</i>	Bare soil	0
<i>Downstream Lt Outlet</i>	Bare soil	0
<i>Downstream Rt Ditch</i>	Bare soil	0
<i>Downstream Lt Ditch</i>	Bare soil	0
<i>Outlet Total</i>	Unimproved Outlet System	1
<i>Ditches Total</i>	Unimproved Drainage System	1
<b><i>SRI Total</i></b>	<b>High Risk</b>	<b>34</b>
<b>Additional Site Features</b>		
<i>Crossing Type and Quantity:</i>	Culvert, 1

Notes: Cannot see DS outlet. US pond is full of algal growth.

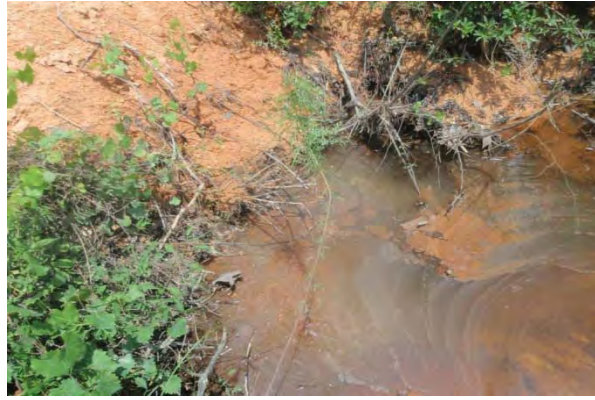
Unnamed tributary	wa-0716-r-006	Sedimentation Risk Index <b>34</b>
-------------------	---------------	---------------------------------------

Risk Factor	Ranking	Score
US Channel Morph	WETLAND	5
DS Channel Morph	PONDED	1
DS Bank Alteration	HIGH	1
Upstream Skew Angle	<5°	5
Crossing fill condition	Poor/Bare soil	1
Inlet/Outlet Condition	Blocked	1
Road Approach Material	All Sand/Clay	3
Potential Eroded Volume Mean	<21 y <sup>3</sup>	5
Approach Slope Mean	2.1-4%	3
Soil K Factor	<0.20	5
Upstream Rt Outlet	Bare soil	0
Upstream Lt Outlet	Vegetated	1
Upstream Rt Ditch	Bare soil	0
Upstream Lt Ditch	Bare soil	0
Downstream Rt Outlet	Bare soil	0
Downstream Lt Outlet	Bare soil	0
Downstream Rt Ditch	Bare soil	0
Downstream Lt Ditch	Bare soil	0
Outlet Total	Partially Improved Outlet System	3
Ditches Total	Unimproved Drainage System	1
<b>SRI Total</b>	<b>High Risk</b>	<b>34</b>
<b>Additional Site Features</b>		
<u>Crossing Type and Quantity:</u>	Unknown	
<u>Crossing Materials:</u>	Unknown	
<u>Soil Types:</u>	8,17,18,33	
<u>Rt Approach Prism Fill:</u>	0.5in	
<u>Lt Approach Prism Fill:</u>	0.15in

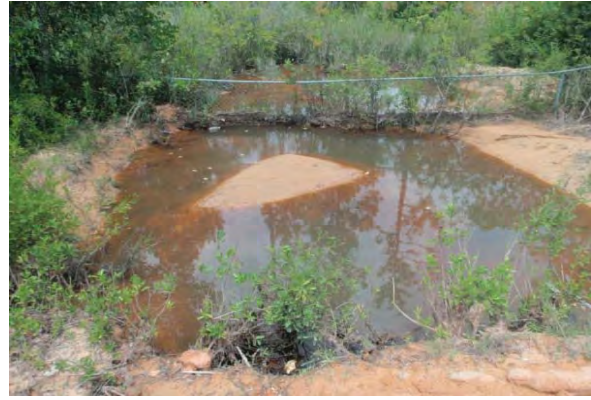
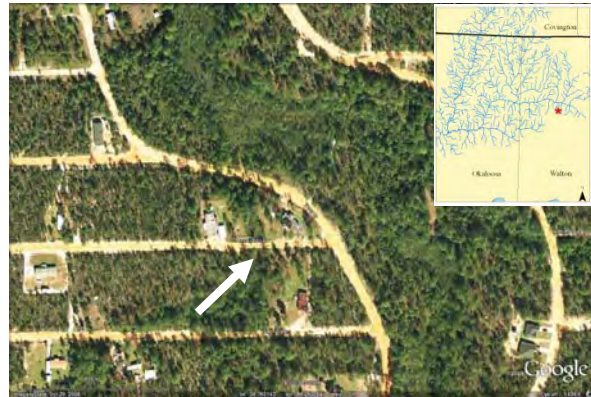
Crossing Structure: US

Notes: Buried crossing structure- unknown. Fence across DS.

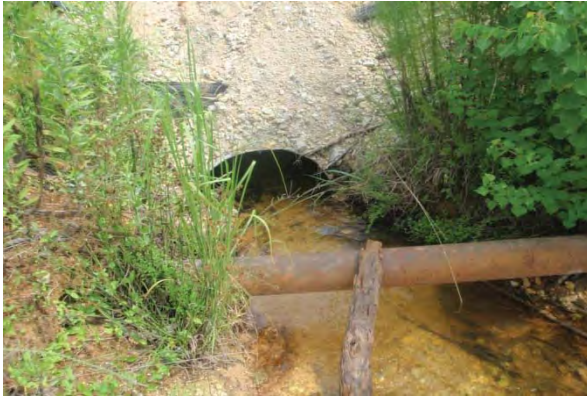
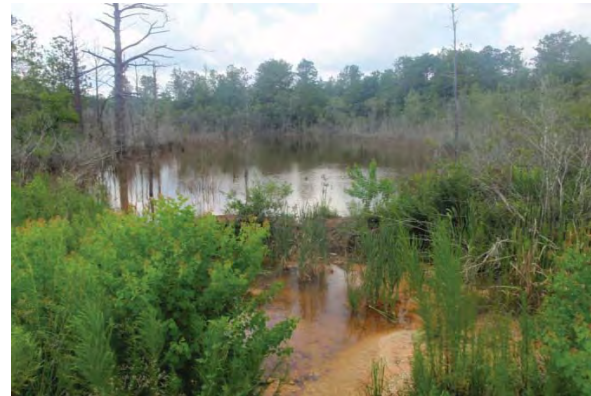
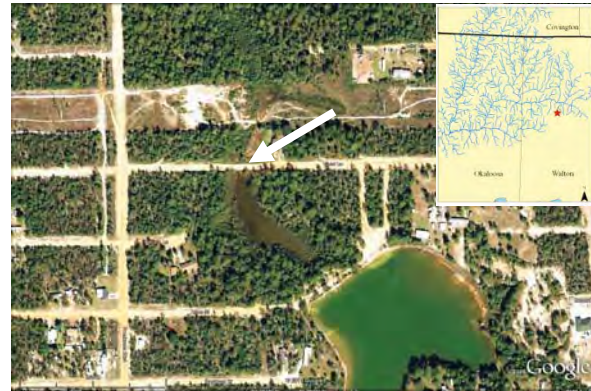
Crossing Structure: DS

Notes: Failing BMPs installed.

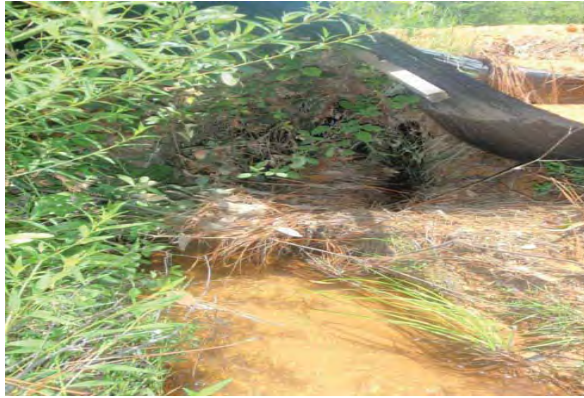
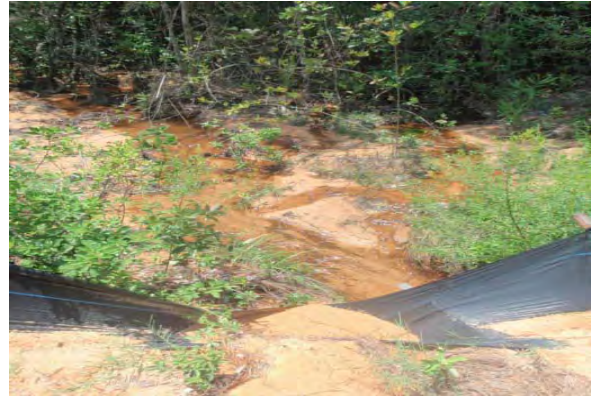
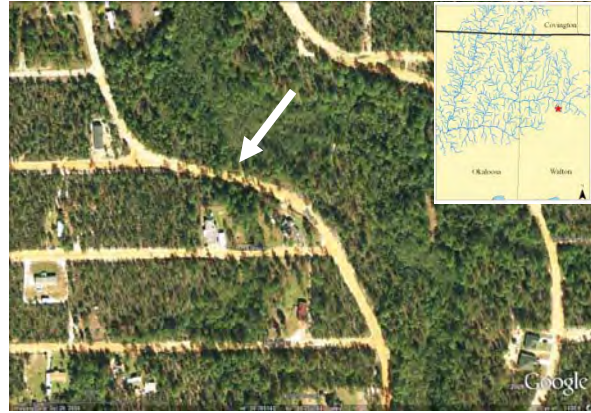
Crossing Structure: US

Notes: BMPs for fill and outlets-- failing. Outlets running over.

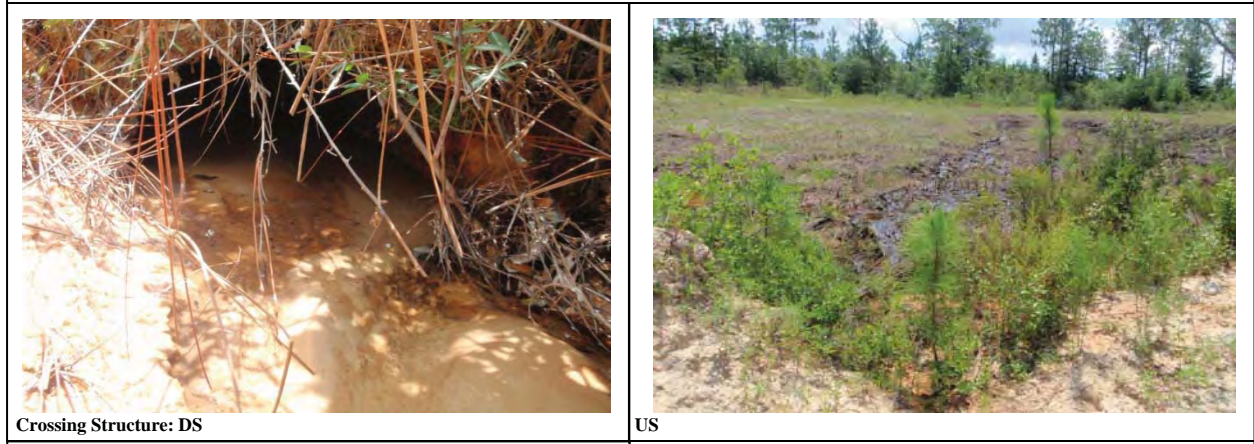
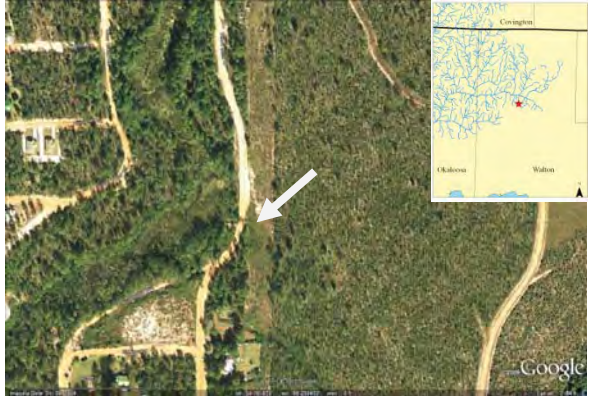
Notes: High gradient US

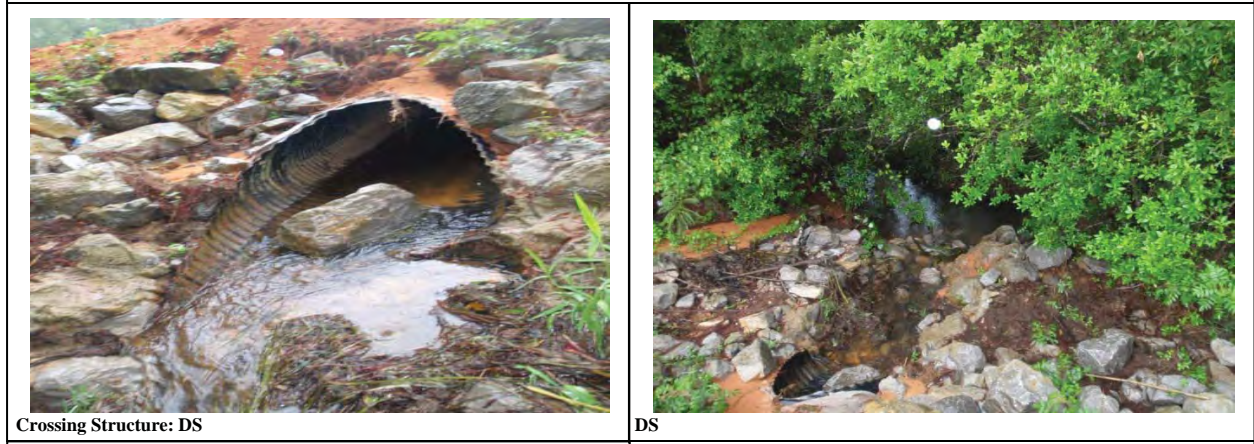
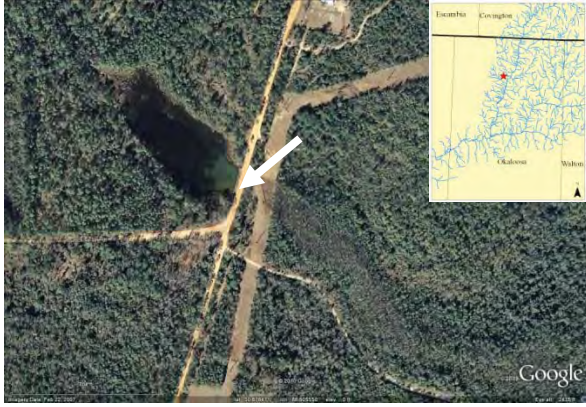
Notes: DS outfall drop, rip rap in stream bed. Fencing across US inlet. Fish passage barrier.

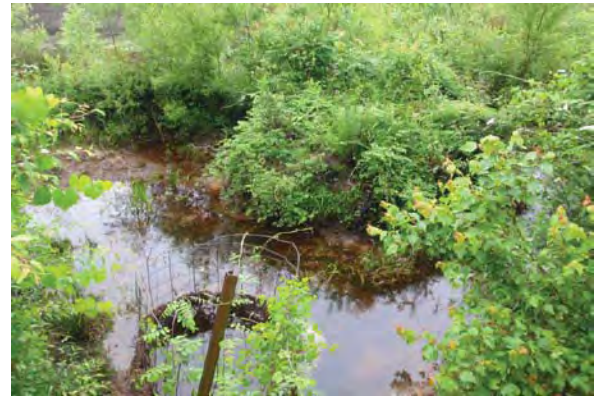
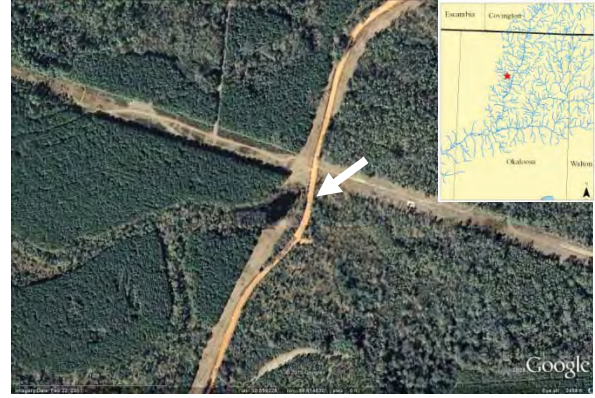
Crossing Structure: DS

Risk Factor	Ranking	Score
<i>US Channel Morph</i>	DA	3
<i>DS Channel Morph</i>	DA	3
<i>DS Bank Alteration</i>	MINOR/PARTIAL	3
<i>Upstream Skew Angle</i>	5-30°	3
<i>Crossing fill condition</i>	Poor/Bare soil	1
<i>Inlet/Outlet Condition</i>	Sed Islands/Scouring	3
<i>Road Approach Material</i>	All Sand/Clay	3
<i>Potential Eroded Volume Mean</i>	>40 y <sup>3</sup>	1
<i>Approach Slope Mean</i>	<2%	5
<i>Soil K Factor</i>	<0.20	5
<i>Upstream Rt Outlet</i>	Bare soil	0
<i>Upstream Lt Outlet</i>	Bare soil	0
<i>Upstream Rt Ditch</i>	Bare soil	0
<i>Upstream Lt Ditch</i>	Bare soil	0
<i>Downstream Rt Outlet</i>	Bare soil	0
<i>Downstream Lt Outlet</i>	Bare soil	0
<i>Downstream Rt Ditch</i>	Bare soil	0
<i>Downstream Lt Ditch</i>	Bare soil	0
<i>Outlet Total</i>	Unimproved Outlet System	1
<i>Ditches Total</i>	Unimproved Drainage System	1
<b>SRI Total</b>	<b>High Risk</b>	<b>32</b>

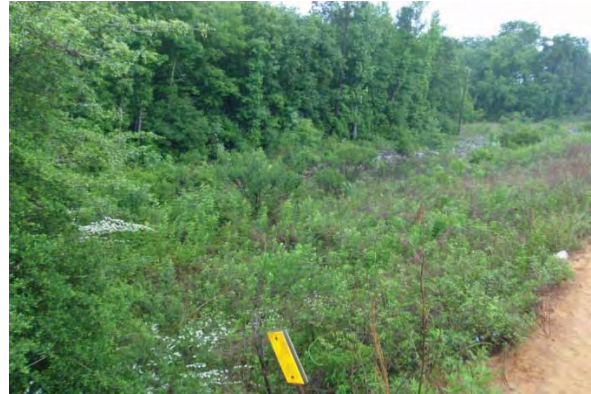
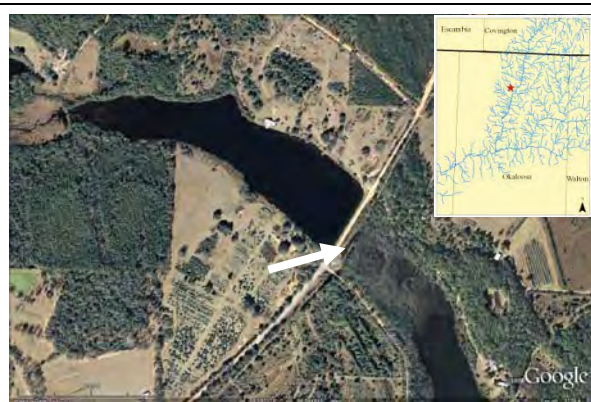
Crossing Structure: US

Risk Factor	Ranking	Score
<i>US Channel Morph</i>	PONDED	1
<i>DS Channel Morph</i>	PONDED	1
<i>DS Bank Alteration</i>	HIGH	1
<i>Upstream Skew Angle</i>	<5°	5
<i>Crossing fill condition</i>	Good/Vegetated	5
<i>Inlet/Outlet Condition</i>	No Impairment	5
<i>Road Approach Material</i>	All Sand/Clay	3
<i>Potential Eroded Volume Mean</i>	>40 y <sup>3</sup>	1
<i>Approach Slope Mean</i>	>4%	1
<i>Soil K Factor</i>	<0.20	5
<i>Upstream Rt Outlet</i>	Vegetated	1
<i>Upstream Lt Outlet</i>	Vegetated	1
<i>Upstream Rt Ditch</i>	Bare soil	0
<i>Upstream Lt Ditch</i>	Bare soil	0
<i>Downstream Rt Outlet</i>	Rip Rap	1
<i>Downstream Lt Outlet</i>	Vegetated	1
<i>Downstream Rt Ditch</i>	Bare soil	0
<i>Downstream Lt Ditch</i>	Bare soil	0
<i>Outlet Total</i>	Improved Outlet System	5
<i>Ditches Total</i>	Unimproved Drainage System	1
<b><i>SRI Total</i></b>	<b>High Risk</b>	<b>34</b>

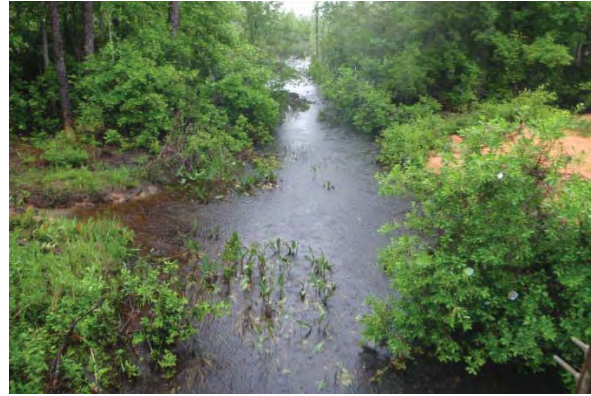
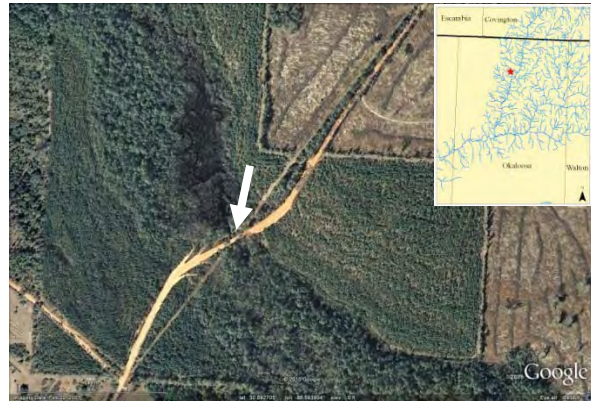
Crossing Structure: DS

Risk Factor	Ranking	Score
<i>US Channel Morph</i>	DA	3
<i>DS Channel Morph</i>	DA	3
<i>DS Bank Alteration</i>	MINOR/PARTIAL	3
<i>Upstream Skew Angle</i>	<5°	5
<i>Crossing fill condition</i>	Poor/Bare soil	1
<i>Inlet/Outlet Condition</i>	No Impairment	5
<i>Road Approach Material</i>	All Sand/Clay	3
<i>Potential Eroded Volume Mean</i>	>40 y <sup>3</sup>	1
<i>Approach Slope Mean</i>	>4%	1
<i>Soil K Factor</i>	<0.20	5
<i>Upstream Rt Outlet</i>	Vegetated	1
<i>Upstream Lt Outlet</i>	Bare soil	0
<i>Upstream Rt Ditch</i>	Bare soil	0
<i>Upstream Lt Ditch</i>	Bare soil	0
<i>Downstream Rt Outlet</i>	Vegetated	1
<i>Downstream Lt Outlet</i>	Vegetated	1
<i>Downstream Rt Ditch</i>	Bare soil	0
<i>Downstream Lt Ditch</i>	Bare soil	0
<i>Outlet Total</i>	Partially Improved Outlet System	3
<i>Ditches Total</i>	Unimproved Drainage System	1
<b>SRI Total</b>	<b>High Risk</b>	<b>34</b>

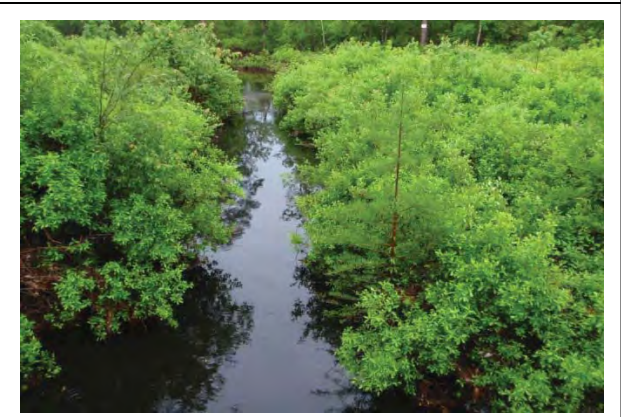
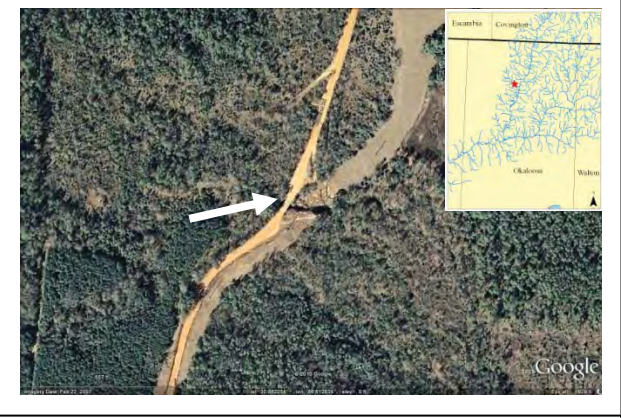
Crossing Structure: DS

Risk Factor	Ranking	Score
<i>US Channel Morph</i>	E	5
<i>DS Channel Morph</i>	E	5
<i>DS Bank Alteration</i>	NATURAL	5
<i>Upstream Skew Angle</i>	<5°	5
<i>Crossing fill condition</i>	Fair/Rip Rap	3
<i>Inlet/Outlet Condition</i>	No Impairment	5
<i>Road Approach Material</i>	All Sand/Clay	3
<i>Potential Eroded Volume Mean</i>	>40 y <sup>3</sup>	1
<i>Approach Slope Mean</i>	>4%	1
<i>Soil K Factor</i>	<0.20	5
<i>Upstream Rt Outlet</i>	Bare soil	0
<i>Upstream Lt Outlet</i>	Bare soil	0
<i>Upstream Rt Ditch</i>	Bare soil	0
<i>Upstream Lt Ditch</i>	Bare soil	0
<i>Downstream Rt Outlet</i>	Bare soil	0
<i>Downstream Lt Outlet</i>	Bare soil	0
<i>Downstream Rt Ditch</i>	Bare soil	0
<i>Downstream Lt Ditch</i>	Bare soil	0
<i>Outlet Total</i>	Unimproved Outlet System	1
<i>Ditches Total</i>	Unimproved Drainage System	1
<b>SRI Total</b>	<b>Medium Risk</b>	<b>40</b>

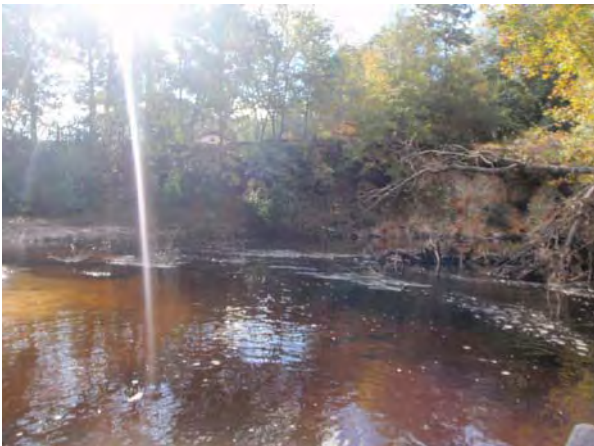
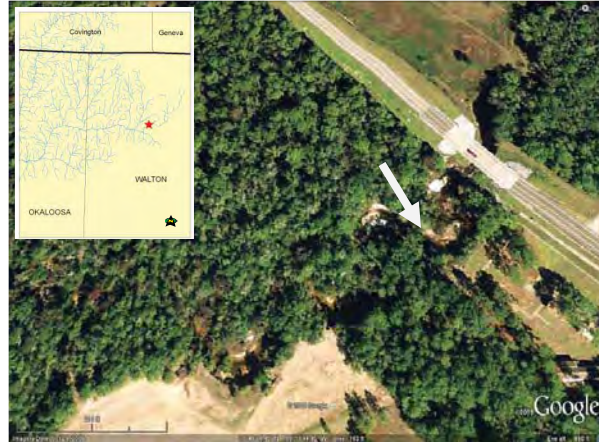
RB

Risk Factor	Ranking	Score	Feature	Within Range	Descriptive Field
<i>Channel Stability</i>	Fair	1	303(d)	No	N/A
<i>Channel Alteration</i>	In Recovery	1	Wetland Species	No	N/A
<i>Bank Erosion</i>	Active	1	Rare and Imperiled	No	N/A
<i>BEHI</i>	High	0.5	Land Use/Cover	Yes	RESIDENTIAL/ STREAMS AND WATERWAYS
<i>Local NPSP</i>	Obvious Sources	1.5	Candidate Mussels	No	N/A
<i>Shoring Structures</i>	Present	1.5	Sturgeon C.H.	No	N/A
<i>Pipe Discharge</i>	Not Present	0	<b>Additional Site Features</b>		
<i>Water Odors</i>	Not Present	0	<i>Stream Channel Woody Material:</i> Moderate		
<i>Fish Passage Barrier</i>	Present	1.5	<i>Impoundments:</i> Rip Rap		
<i>RB: Riparian Buffer</i>	0-29 ft	0.75	<i>Substrate Composition:</i> Medium Sand		
<i>LB: Riparian Buffer</i>	0-29 ft	0.75	<i>Bank Material:</i> Sand and Clay		
<i>RB: Floodplain Access</i>	None	0.75			
<i>LB: Floodplain Access</i>	None	0.25			
<b>River Threat Index:</b>		<b>10.5</b>

Notes: Rip rap has been used as a shoring structure around the bridge and large quantities have fallen in the stream channel causing a fish passage blockage during low flow stages. A house nearby is also noted as a source of NSPS.

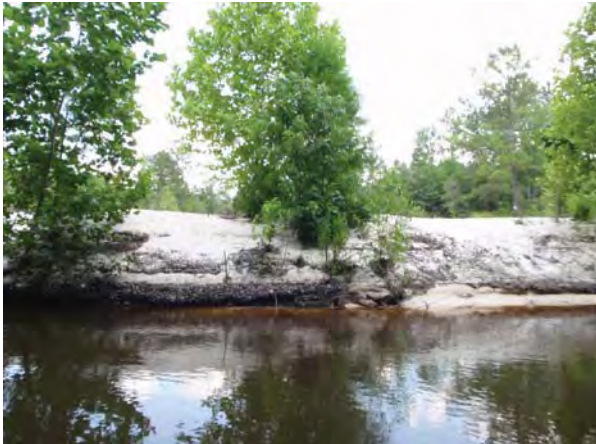
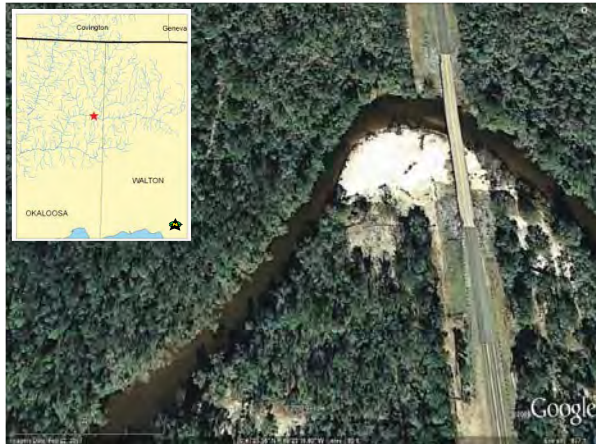
LB					
<b>Risk Factor</b>	<b>Ranking</b>	<b>Score</b>	<b>Feature</b>	<b>Within Range</b>	<b>Descriptive Field</b>
<i>Channel Stability</i>	Fair	1	303(d)	No	N/A
<i>Channel Alteration</i>	In Recovery	1	<b>Wetland Species</b>	No	N/A
<i>Bank Erosion</i>	Active	1	<b>Rare and Imperiled</b>	Yes	GOLDSTRIPE DARTER,SPECKLED CHUB,IRONCOLOR SHINER
<i>BEHI</i>	Moderate	0.5	<b>Land Use/ Cover</b>	Yes	N/A / STREAMS AND WATERWAYS
<i>Local NPSP</i>	Obvious Sources	1.5	<b>Candidate Mussels</b>	Yes	SOUTHERN SANDSHELL
<i>Shoring Structures</i>	Present	1.5	<b>Sturgeon C.H.</b>	No	N/A
<i>Pipe Discharge</i>	Not Present	0	<b>Additional Site Features</b>

<i>Water Odors</i>	Not Present	0	<i>Stream Channel Woody Material:</i> Infrequent		
<i>Fish Passage Barrier</i>	Not Present	0	<i>Impoundments:</i> None		
<i>RB: Riparian Buffer</i>	100+ ft	0	<i>Substrate Composition:</i> Clay Marl		
<i>LB: Riparian Buffer</i>	0-29 ft	0.75	<i>Bank Material:</i> Sand and Clay		
<i>RB: Floodplain Access</i>	Partial	0.25			
<i>LB: Floodplain Access</i>	Full	0			
<b>River Threat Index:</b>		<b>7.5</b>

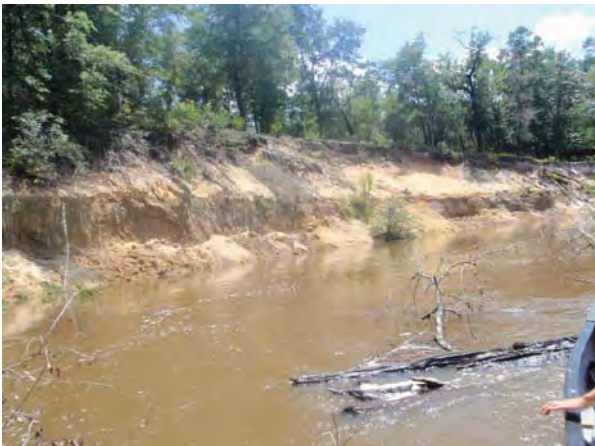
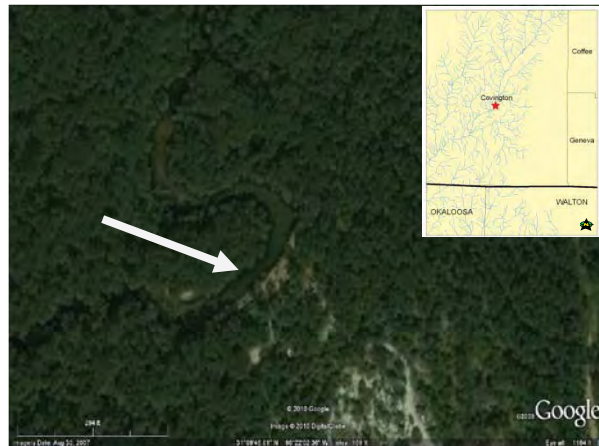
**LB**

Risk Factor	Ranking	Score	Feature	Within Range	Descriptive Field
<i>Channel Stability</i>	Poor	1.5	303(d)	No	N/A
<i>Channel Alteration</i>	None	0	Wetland Species	No	N/A
<i>Bank Erosion</i>	Mass wasting	1.5	Rare and Imperiled	No	N/A
<i>BEHI</i>	Extreme- Very High	1.5	Land Use/ Cover	Yes	N/A / EAST GULF COASTAL PLAIN SMALL STREAM AND RIVER FLOODPLAIN FOREST
<i>Local NPSP</i>	Moderate Potential	1	Candidate Mussels	No	N/A
<i>Shoring Structures</i>	Not Present	0	Sturgeon C.H.	No	N/A
<i>Pipe Discharge</i>	Not Present	0	<b>Additional Site Features</b>		
<i>Water Odors</i>	Not Present	0	<i>Stream Channel Woody Material:</i> Moderate		
<i>Fish Passage Barrier</i>	Not Present	0	<i>Impoundments:</i> None		
<i>RB: Riparian Buffer</i>	100+ ft	0	<i>Substrate Composition:</i> Medium Sand		
<i>LB: Riparian Buffer</i>	0-29 ft	0.75	<i>Bank Material:</i> Sand and Clay		
<i>RB: Floodplain Access</i>	Full	0			
<i>LB: Floodplain Access</i>	None	0.75

<b>River Threat Index:</b>		<b>7</b>

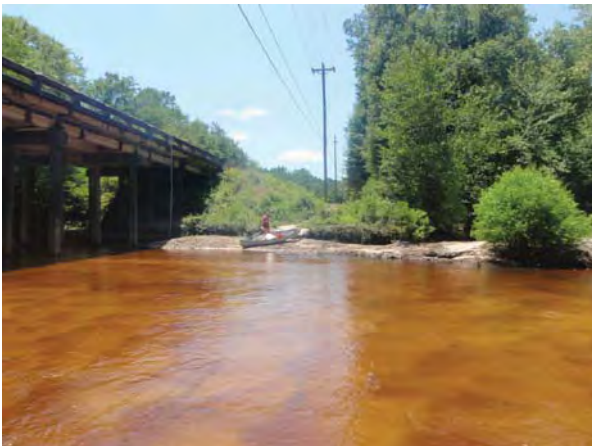
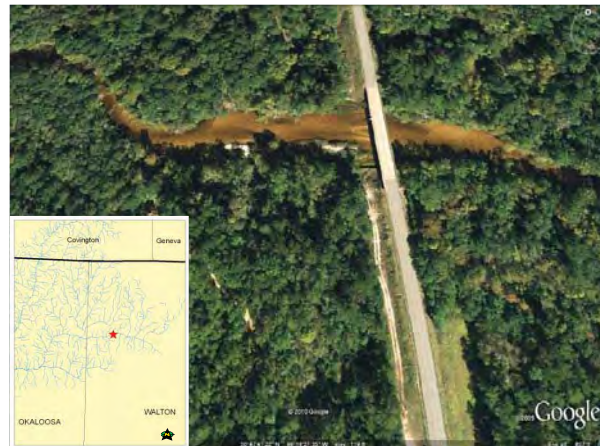
LB

Risk Factor	Ranking	Score	Feature	Within Range	Descriptive Field
<i>Channel Stability</i>	Fair	1	303(d)	No	N/A
<i>Channel Alteration</i>	Historic, Mostly Recovered	0.5	<b>Wetland Species</b>	Yes	1-3 FOCAL SPECIES IN WETLAND AREAS
<i>Bank Erosion</i>	Historic	0.5	<b>Rare and Imperiled</b>	Yes	GOLDSTRIPE DARTER, SPECKLED CHUB, IRONCOLOR SHINER
<i>BEHI</i>	High	1	<b>Land Use/ Cover</b>	Yes	PARCELS WITH NO VALUES/ STREAMS AND WATERWAYS
<i>Local NPSP</i>	Obvious Sources	1.5	<b>Candidate Mussels</b>	No	N/A
<i>Shoring Structures</i>	Present	1.5	<b>Sturgeon C.H.</b>	No	N/A
<i>Pipe Discharge</i>	Not Present	0	<b>Additional Site Features</b>		
<i>Water Odors</i>	Not Present	0	<i>Stream Channel Woody Material:</i> Infrequent		
<i>Fish Passage Barrier</i>	Not Present	0	<i>Impoundments:</i> None		
<i>RB: Riparian Buffer</i>	100+ ft	0	<i>Substrate Composition:</i> Medium Sand		
<i>LB: Riparian Buffer</i>	0-29 ft	0.75	<i>Bank Material:</i> Medium Sand

<i>RB: Floodplain Access</i>	Full	0			
<i>LB: Floodplain Access</i>	Full	0			
<b>River Threat Index:</b>		<b>6.75</b>

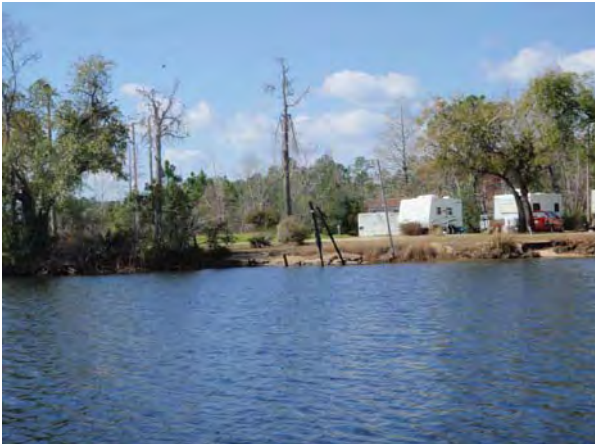
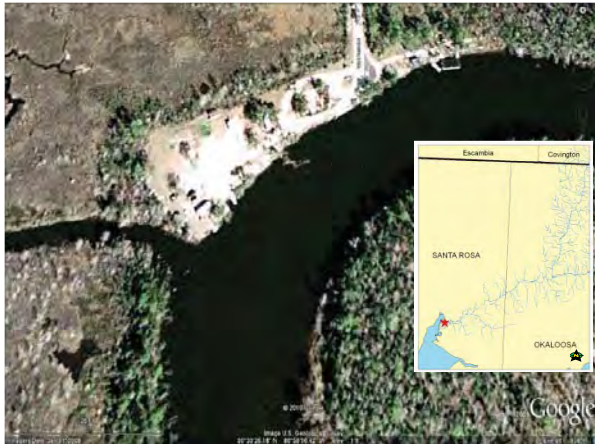
RB

Risk Factor	Ranking	Score	Feature	Within Range	Descriptive Field
<i>Channel Stability</i>	Excellent	0	303(d)	Yes	DISSOLVED OXYGEN, TURBIDITY, MERCURY
<i>Channel Alteration</i>	None	0	Wetland Species	Yes	1-3 FOCAL SPECIES IN WETLAND AREAS
<i>Bank Erosion</i>	Historic	0.5	Rare and Imperiled	Yes	GOLDSTRIPE DARTER, SPECKLED CHUB, IRONCOLOR SHINER, GULF STURGEON, ALABAMA SHAD, ALLIGATOR GAR, SPECKLED DARTER, SPOTTED BULLHEAD
<i>BEHI</i>	Moderate	0.5	Land Use/Cover	Yes	N/A/ STREAMS AND WATERWAYS
<i>Local NPSP</i>	Obvious Sources	1.5	Candidate Mussels	No	N/A
<i>Shoring Structures</i>	Present	1.5	Sturgeon C.H.	Yes	N/A
<i>Pipe Discharge</i>	Present	1.5	<b>Additional Site Features</b>		
<i>Water Odors</i>	Not Present	0	<i>Stream Channel Woody Material:</i> Infrequent		
<i>Fish Passage Barrier</i>	Not Present	0	<i>Impoundments:</i> None		
<i>RB: Riparian Buffer</i>	0-29 ft	0.75	<i>Substrate Composition:</i> Medium Sand

<i>LB: Riparian Buffer</i>	100+ ft	0	<i>Bank Material:</i> Wood, Concrete, and Sand		
<i>RB: Floodplain Access</i>	Full	0			
<i>LB: Floodplain Access</i>	Full	0			
<b>River Threat Index:</b>		<b>6.25</b>
