Appendix A. River corridor severity scores for impaired sites in the Yellow River Basin, Alabama and Florida

Appendix C. Clear Creek Watershed Focal Area. Sites with orange headings are unpaved road sites. Specific definitions and calculations described for calculating the Sediment Risk Index (SRI) are detailed in Witmer (2009).

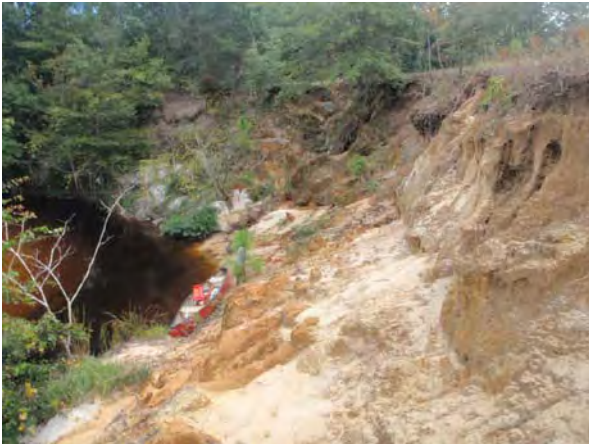
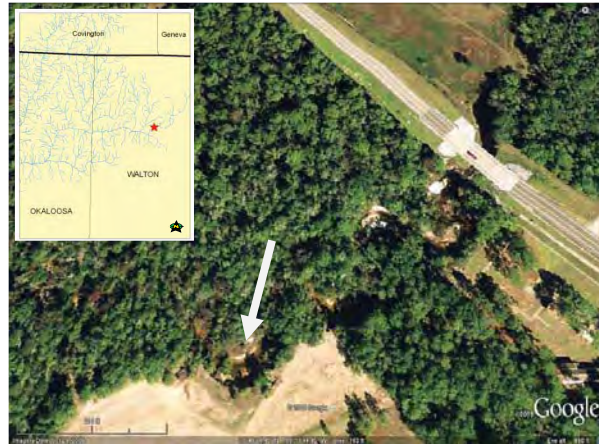
LB

Risk Factor	Ranking	Score	Feature	Within Range	Descriptive Field
<i>Channel Stability</i>	Poor	1.5	303(d)	No	N/A
<i>Channel Alteration</i>	None	0	Wetland Species	No	N/A
<i>Bank Erosion</i>	Mass Wasting	1.5	Rare and Imperiled	No	N/A
<i>BEHI</i>	Active	1	Land Use/Cover	Yes	RESIDENTIAL/ IMPROVED PASTURES
<i>Local NPSP</i>	Slight	0.5	Candidate Mussels	No	N/A
<i>Shoring Structures</i>	Not Present	0	Sturgeon C.H.	No	N/A
<i>Pipe Discharge</i>	Not Present	0	<b>Additional Site Features</b>		
<i>Water Odors</i>	Not Present	0	<i>Stream Channel Woody Material:</i> Moderate		
<i>Fish Passage Barrier</i>	Not Present	0	<i>Impoundments:</i> None		
<i>RB: Riparian Buffer</i>	100+ ft	0	<i>Substrate Composition:</i> Medium Sand		
<i>LB: Riparian Buffer</i>	0-29 ft	0.75	<i>Bank Material:</i> Sand and Clay		
<i>RB: Floodplain Access</i>	Full	0			
<i>LB: Floodplain Access</i>	None	0.75			
<b>River Threat Index:</b>		<b>6</b>

Notes: Steep bank, clear cut land above. Bank is 22ft high.

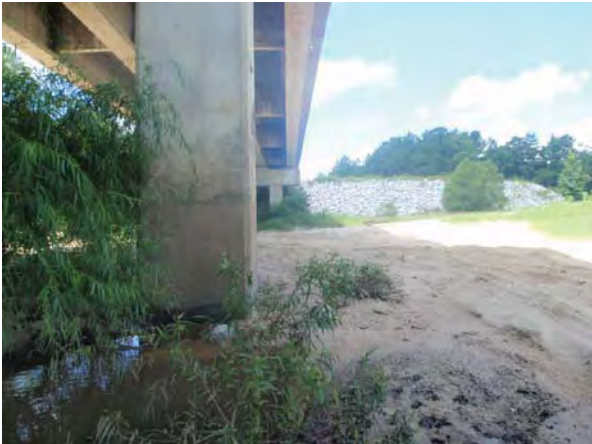
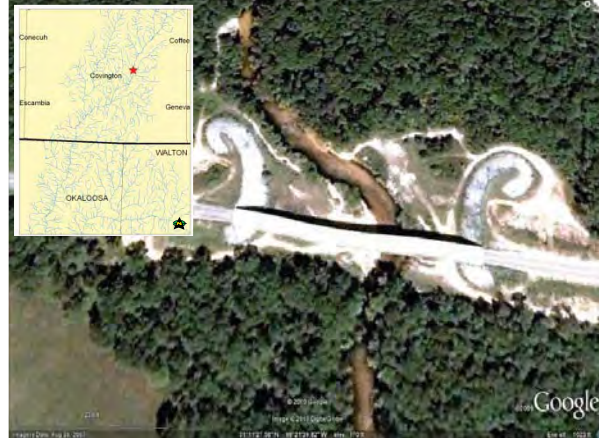
RB

Risk Factor	Ranking	Score	Feature	Within Range	Descriptive Field
<i>Channel Stability</i>	Good	0.5	303(d)	No	N/A
<i>Channel Alteration</i>	Historic, Mostly Recovered	0.5	Wetland Species	No	N/A
<i>Bank Erosion</i>	Not Eroding	0	Rare and Imperiled	No	N/A
<i>BEHI</i>	Moderate	0.5	Land Use/Cover	Yes	N/A / PASTURE/HAY
<i>Local NPSP</i>	Obvious Sources	1.5	Candidate Mussels	No	N/A
<i>Shoring Structures</i>	Present	1.5	Sturgeon C.H.	No	N/A
<i>Pipe Discharge</i>	Not Present	0	<b>Additional Site Features</b>		
<i>Water Odors</i>	Not Present	0	<i>Stream Channel Woody Material:</i> Infrequent		
<i>Fish Passage Barrier</i>	Not Present	0	<i>Impoundments:</i> None		
<i>RB: Riparian Buffer</i>	0-29 ft	0.75	<i>Substrate Composition:</i> Medium Sand		
<i>LB: Riparian Buffer</i>	0-29 ft	0.75	<i>Bank Material:</i> Sand		
<i>RB: Floodplain Access</i>	Full	0			
<i>LB: Floodplain Access</i>	Full	0			
<b>River Threat Index:</b>		<b>6</b>

Notes: Bridge crossing and campsite. Rip rap and concrete used as shoring structure.

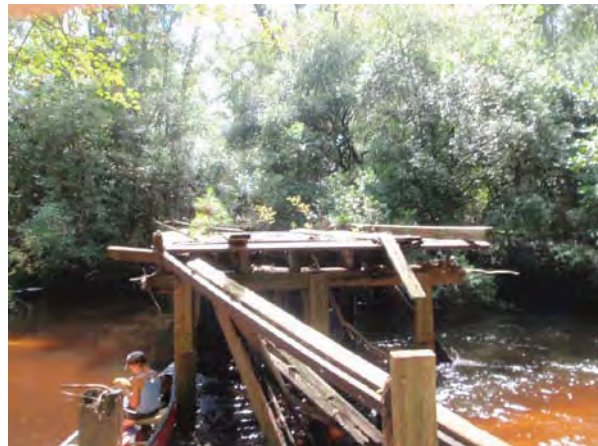
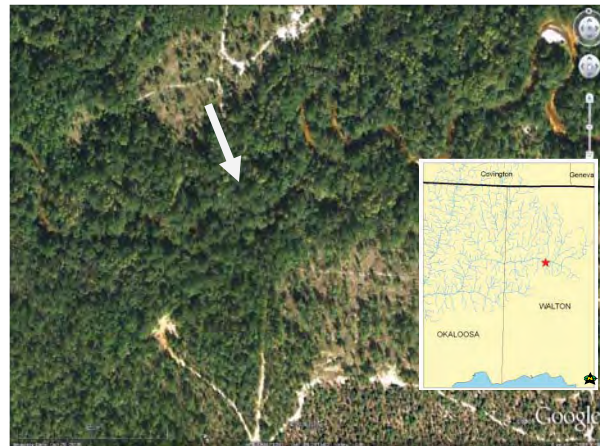
LB

Risk Factor	Ranking	Score	Feature	Within Range	Descriptive Field
<i>Channel Stability</i>	Good	0.5	303(d)	No	N/A
<i>Channel Alteration</i>	In Recovery	1	Wetland Species	Yes	1-3 FOCAL SPECIES IN WETLAND AREAS
<i>Bank Erosion</i>	Historic	0.5	Rare and Imperiled	Yes	GOLDSTRIPE DARTER, IRONCOLOR SHINER, SPECKLED CHUB
<i>BEHI</i>	Low- Very Low	0	Land Use/ Cover	Yes	RECREATION/ WETLAND FORESTED MIX
<i>Local NPSP</i>	Moderate Potential	1	Candidate Mussels	No	N/A
<i>Shoring Structures</i>	Present	1.5	Sturgeon C.H.	No	N/A
<i>Pipe Discharge</i>	Not Present	0	<b>Additional Site Features</b>		
<i>Water Odors</i>	Not Present	0	<i>Stream Channel Woody Material:</i> Moderate		
<i>Fish Passage Barrier</i>	Not Present	0	<i>Impoundments:</i> Manmade (Wooden Bridge)		
<i>RB: Riparian Buffer</i>	50-99 ft	0.25	<i>Substrate Composition:</i> Medium Sand		
<i>LB: Riparian Buffer</i>	50-99 ft	0.25	<i>Bank Material:</i> Sand

<i>RB: Floodplain Access</i>	Partial	0.25			
<i>LB: Floodplain Access</i>	Partial	0.25			
<b>River Threat Index:</b>		<b>5.5</b>

Notes: Hurricane Ivan damaged bridge structure- formerly Girl Scout Rd.

Pieces of bridge were found DS washed into trees .

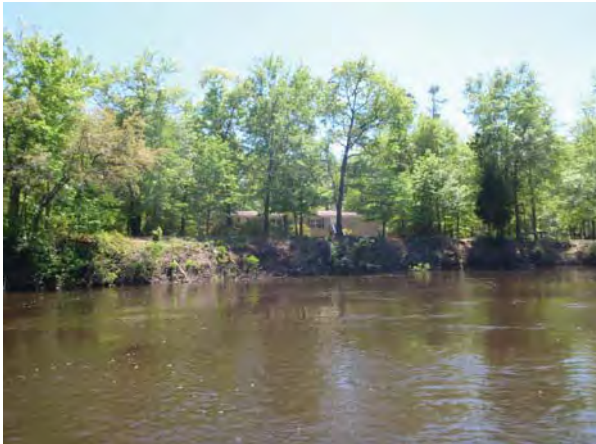
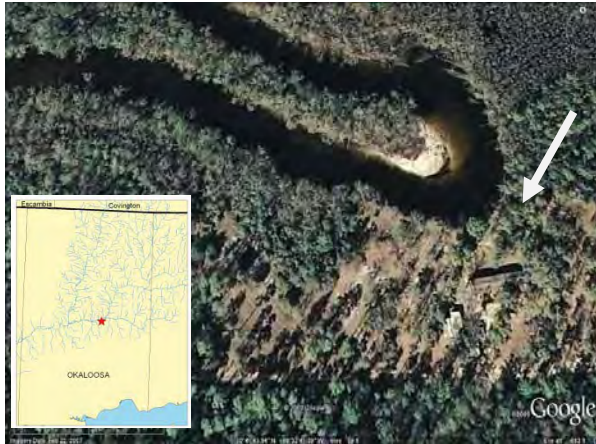
LB					
<b>Risk Factor</b>	<b>Ranking</b>	<b>Score</b>	<b>Feature</b>	<b>Within Range</b>	<b>Descriptive Field</b>
<i>Channel Stability</i>	Good	0.5	303d	No	N/A
<i>Channel Alteration</i>	None	0	Wetland Species	Yes	1-3 FOCAL SPECIES IN WETLAND AREAS
<i>Bank Erosion</i>	Historic	0.5	Rare and Imperiled	Yes	GOLDSTRIPE DARTER,SPECKLED CHUB IRONCOLOR SHINER
<i>BEHI</i>	Moderate	0.5	Land Use/ Cover	Yes	AGRICULTURAL/ STREAMS AND WATERWAYS
<i>Local NPSP</i>	Moderate Potential	1	Candidate Mussels	No	N/A
<i>Shoring Structures</i>	Not Present	0	Sturgeon C.H.	No	N/A
<i>Pipe Discharge</i>	Present	1.5	<b>Additional Site Features</b>

<i>Water Odors</i>	Not Present	0	<i>Stream Channel Woody Material:</i> Numerous		
<i>Fish Passage Barrier</i>	Not Present	0	<i>Impoundments:</i> None		
<i>RB: Riparian Buffer</i>	30-49 ft	0.5	<i>Substrate Composition:</i> Medium Sand		
<i>LB: Riparian Buffer</i>	0-29 ft	0.75	<i>Bank Material:</i> Sand and Roots		
<i>RB: Floodplain Access</i>	Full	0			
<i>LB: Floodplain Access</i>	Partial	0.25			
<b>River Threat Index:</b>		<b>5.5</b>

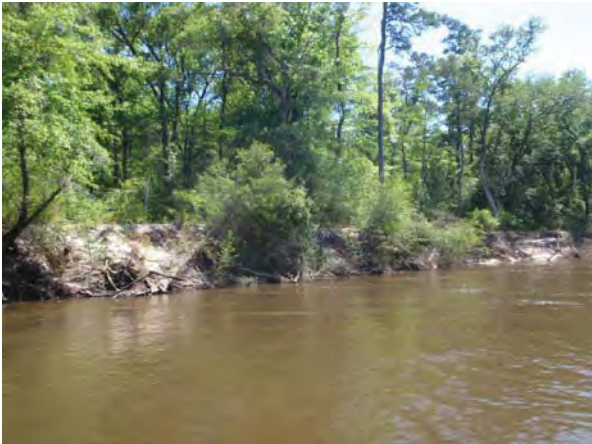
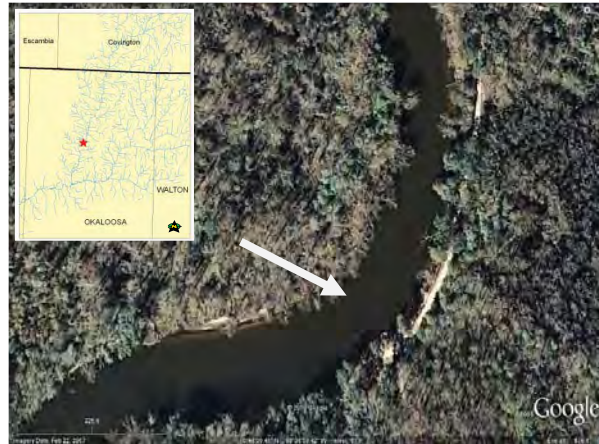
LB

Risk Factor	Ranking	Score	Feature	Within Range	Descriptive Field
<i>Channel Stability</i>	Fair	1	303(d)	Yes	COLIFORMS, TURBIDITY, MERCURY
<i>Channel Alteration</i>	None	0	Wetland Species	Yes	1-3 FOCAL SPECIES IN UPLAND AREAS
<i>Bank Erosion</i>	Active	1	Rare and Imperiled	Yes	ALABAMA SHAD, ALLIGATOR GAR, BLUENOSE SHINER, GULF STURGEON, SPECKLED CHUB, IRONCOLOR SHINER, SPOTTED BULLHEAD, SPECKLED DARTER
<i>BEHI</i>	Moderate	0.5	Land Use/ Cover	Yes	AGRICULTURAL/ STREAM AND LAKE SWAMPS (BOTTOMLAND)
<i>Local NPSP</i>	Moderate Potential	1	Candidate Mussels	No	N/A
<i>Shoring Structures</i>	Present	1.5	Sturgeon C H	Yes	N/A
<i>Pipe Discharge</i>	Not Present	0	<b>Additional Site Features</b>		
<i>Water Odors</i>	Not Present	0	<i>Stream Channel Woody Material:</i> Infrequent		
<i>Fish Passage Barrier</i>	Not Present	0	<i>Impoundments:</i> None		
<i>RB: Riparian Buffer</i>	100+ ft	0	<i>Substrate Composition:</i> Medium Sand

<i>LB: Riparian Buffer</i>	100+ ft	0	<i>Bank Material:</i> Sand		
<i>RB: Floodplain Access</i>	Full	0			
<i>LB: Floodplain Access</i>	Partial	0.25			
<b>River Threat Index:</b>		<b>5.25</b>

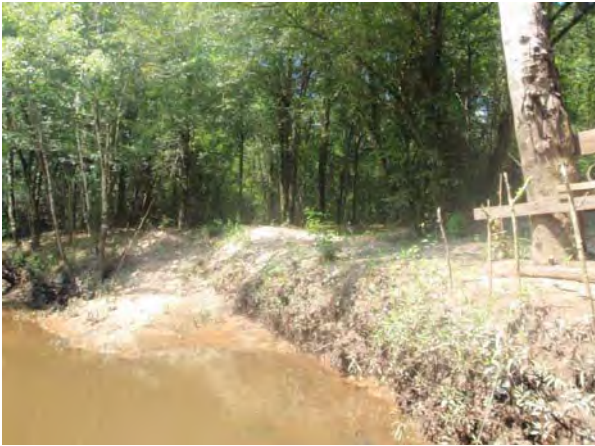
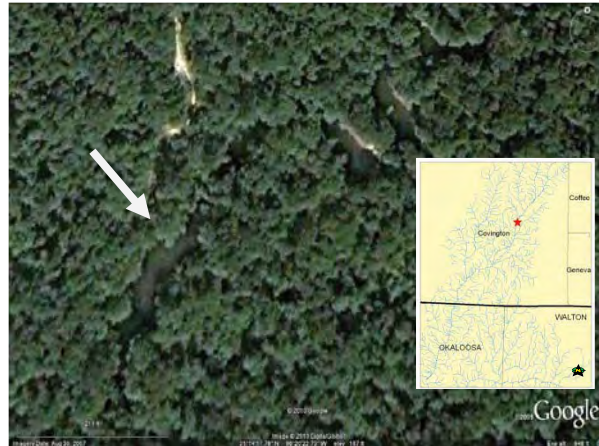
RB

Risk Factor	Ranking	Score	Feature	Within Range	Descriptive Field
<i>Channel Stability</i>	Good	0.5	303(d)	No	N/A
<i>Channel Alteration</i>	None	0	Wetland Species	No	N/A
<i>Bank Erosion</i>	Active	1	Rare and Imperiled	No	N/A
<i>BEHI</i>	Moderate	0.5	Land Use/Cover	Yes	N/A/ EAST GULF COASTAL PLAIN INTERIOR UPLAND LONGLEAF PINE WOODLAND - LOBLOLLY MODIFIER
<i>Local NPSP</i>	Moderate Potential	1	Candidate Mussels	Yes	CHOCTAW BEAN
<i>Shoring Structures</i>	Present	1.5	Sturgeon C H	No	N/A
<i>Pipe Discharge</i>	Not Present	0	<b>Additional Site Features</b>		
<i>Water Odors</i>	Not Present	0	<i>Stream Channel Woody Material:</i> None		
<i>Fish Passage Barrier</i>	Not Present	0	<i>Impoundments:</i> None		
<i>RB: Riparian Buffer</i>	0-29 ft	0.75	<i>Substrate Composition:</i> Medium Sand		
<i>LB: Riparian Buffer</i>	100+ ft	0	<i>Bank Material:</i> Silt Loam		
<i>RB: Floodplain Access</i>	Full	0			
<i>LB: Floodplain Access</i>	Full	0

<b>River Threat Index:</b>		<b>5.25</b>

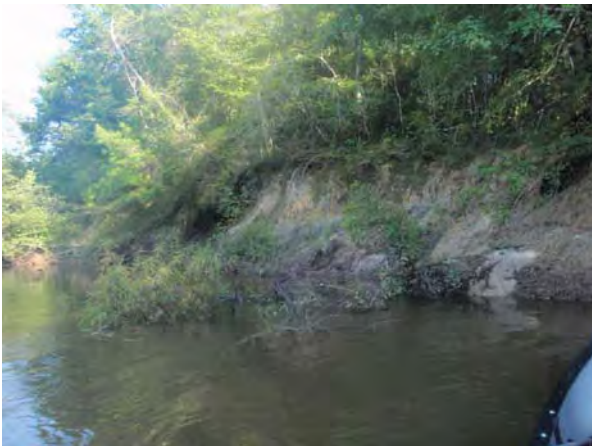
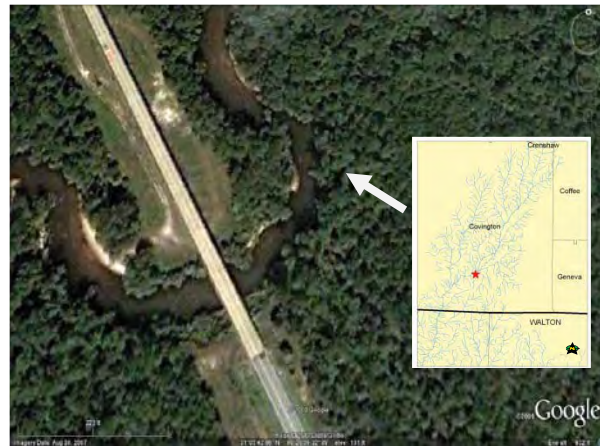
LB

Risk Factor	Ranking	Score	Feature	Within Range	Descriptive Field
<i>Channel Stability</i>	Fair	1	303(d)	Yes	METALS (MERCURY)
<i>Channel Alteration</i>	None	0	Wetland Species	No	N/A
<i>Bank Erosion</i>	Active	1	Rare and Imperiled	No	N/A
<i>BEHI</i>	Moderate	0.5	Land Use/Cover	Yes	N/A / EAST GULF COASTAL PLAIN INTERIOR UPLAND LONGLEAF PINE WOODLAND - LOBLOLLY MODIFIER
<i>Local NPSP</i>	Obvious Sources	1	Candidate Mussels	Yes	FUZZY PIGTOE, SOUTHERN SANDSHELL
<i>Shoring Structures</i>	Present	1.5	Sturgeon C.H.	No	N/A
<i>Pipe Discharge</i>	Not Present	0	<b>Additional Site Features</b>		
<i>Water Odors</i>	Not Present	0	<i>Stream Channel Woody Material:</i> Infrequent		
<i>Fish Passage Barrier</i>	Not Present	0	<i>Impoundments:</i> None		
<i>RB: Riparian Buffer</i>	100+ ft	0	<i>Substrate Composition:</i> Medium Sand		
<i>LB: Riparian Buffer</i>	100+ ft	0	<i>Bank Material:</i> Sand		
<i>RB: Floodplain Access</i>	Full	0

<i>LB: Floodplain Access</i>	Partial	0.25			
<b>River Threat Index:</b>		<b>5.25</b>

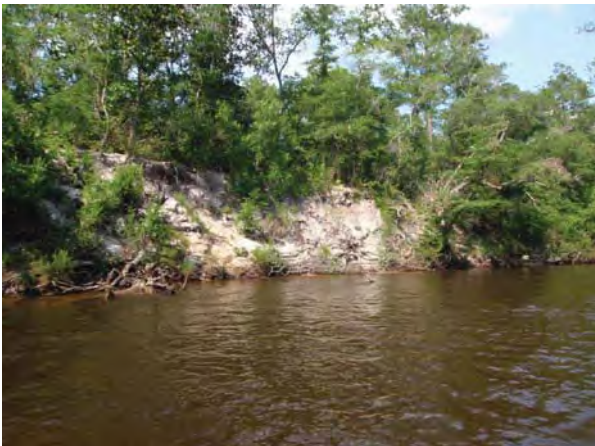
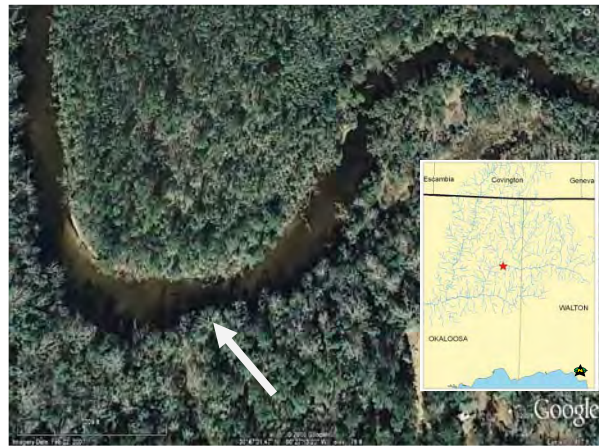
LB

Risk Factor	Ranking	Score	Feature	Within Range	Descriptive Field
<i>Channel Stability</i>	Fair	1	<b>303(d)</b>	No	N/A
<i>Channel Alteration</i>	In Recovery	0	<b>Wetland Species</b>	Yes	1-3 FOCAL SPECIES IN WETLAND AREAS
<i>Bank Erosion</i>	Historic	1	<b>Rare and Imperiled</b>	Yes	GOLDSTRIPE DARTER,SPECKLED CHUB,IRONCOLOR SHINER
<i>BEHI</i>	Extreme-Very High	1.5	<b>Land Use/Cover</b>	Yes	N/A/ STREAMS AND WATERWAYS
<i>Local NPSP</i>	No Evidence	0	<b>Candidate Mussels</b>	No	N/A
<i>Shoring Structures</i>	Not Present	0	<b>Sturgeon C.H.</b>	No	N/A
<i>Pipe Discharge</i>	Not Present	0	<b>Additional Site Features</b>		
<i>Water Odors</i>	Not Present	0	<i>Stream Channel Woody Material:</i> Moderate		
<i>Fish Passage Barrier</i>	Not Present	0	<i>Impoundments:</i> None		
<i>RB: Riparian Buffer</i>	100+ ft	0	<i>Substrate Composition:</i> Clay		
<i>LB: Riparian Buffer</i>	0-29 ft	0.75	<i>Bank Material:</i> Clay

<i>RB: Floodplain Access</i>	Full	0			
<i>LB: Floodplain Access</i>	None	0.75			
<b>River Threat Index:</b>		<b>5</b>

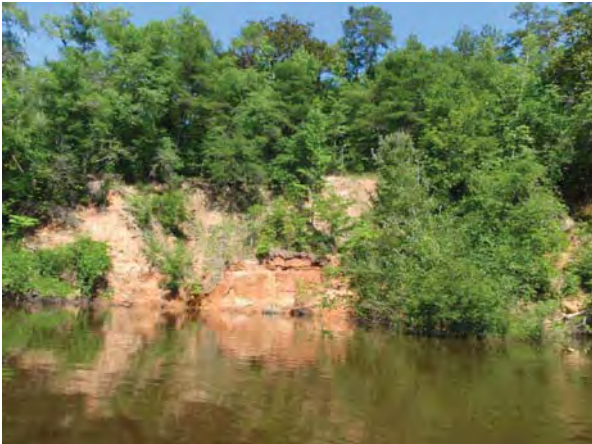
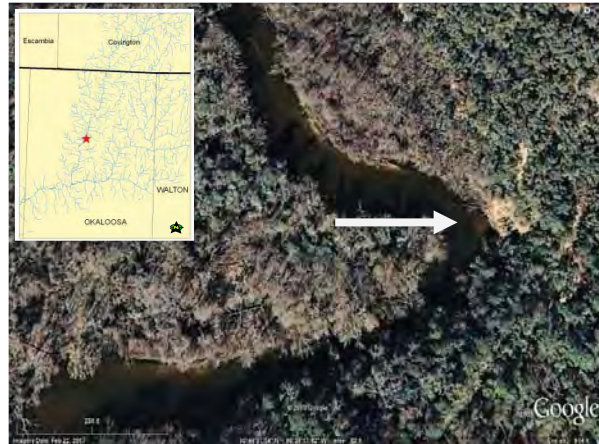
LB

Risk Factor	Ranking	Score	Feature	Within Range	Descriptive Field
<i>Channel Stability</i>	Fair	1	303(d)	Yes	COLIFORMS, TURBIDITY, MERCURY
<i>Channel Alteration</i>	None	0	Wetland Species	Yes	1-3 FOCAL SPECIES IN UPLAND AREAS
<i>Bank Erosion</i>	Recent, No Recovery	1.5	Rare and Imperiled	Yes	ALABAMA SHAD, ALLIGATOR GAR, BLUENOSE SHINER, GULF STURGEON, SPECKLED CHUB, IRONCOLOR SHINER, SPOTTED BULLHEAD, SPECKLED DARTER
<i>BEHI</i>	High	1	Land Use/Cover	Yes	N/A/ STREAMS AND WATERWAYS
<i>Local NPSP</i>	No Evidence	0	Candidate Mussels	No	N/A
<i>Shoring Structures</i>	Not Present	0	Sturgeon C.H.	Yes	N/A
<i>Pipe Discharge</i>	Not Present	0	<b>Additional Site Features</b>		
<i>Water Odors</i>	Not Present	0	<i>Stream Channel Woody Material:</i> Moderate		
<i>Fish Passage Barrier</i>	Not Present	0	<i>Impoundments:</i> None		
<i>RB: Riparian Buffer</i>	100+ ft	0	<i>Substrate Composition:</i> Clay		
<i>LB: Riparian Buffer</i>	0-29 ft	0.75	<i>Bank Material:</i> Clay

<i>RB: Floodplain Access</i>	Full	0			
<i>LB: Floodplain Access</i>	None	0.75			
<b>River Threat Index:</b>		<b>5</b>

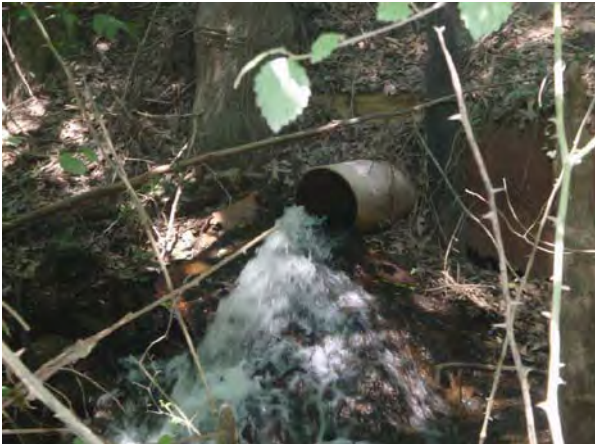
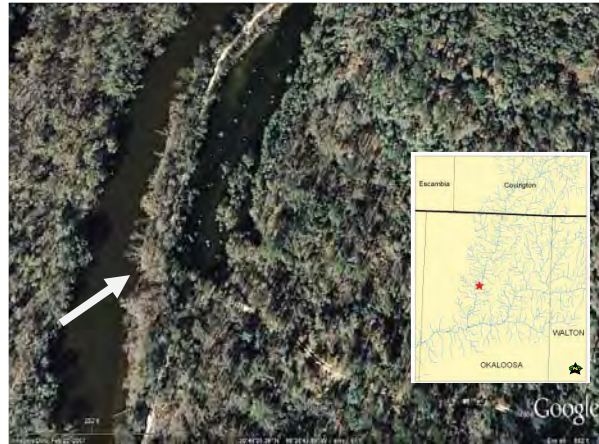
LB

Risk Factor	Ranking	Score	Feature	Within Range	Descriptive Field
<i>Channel Stability</i>	Good	0.5	303(d)	Yes	COLIFORMS, TURBIDITY, MERCURY
<i>Channel Alteration</i>	None	0	Wetland Species	Yes	1-3 FOCAL SPECIES IN UPLAND AREAS
<i>Bank Erosion</i>	Not Eroding	0	Rare and Imperiled	Yes	ALABAMA SHAD, ALLIGATOR GAR, BLUENOSE SHINER, GULF STURGEON, SPECKLED CHUB, IRONCOLOR SHINER, SPOTTED BULLHEAD, SPECKLED DARTER
<i>BEHI</i>	High	1	Land Use/Cover	Yes	AGRICULTURAL/ STREAMS AND WATERWAYS
<i>Local NPSP</i>	Moderate Potential	1	Candidate Mussels	No	N/A
<i>Shoring Structures</i>	Not Present	0	Sturgeon C.H.	Yes	N/A
<i>Pipe Discharge</i>	Present	1.5	<b>Additional Site Features</b>		
<i>Water Odors</i>	Not Present	0	<i>Stream Channel Woody Material:</i> Infrequent		
<i>Fish Passage Barrier</i>	Not Present	0	<i>Impoundments:</i> None		
<i>RB: Riparian Buffer</i>	100+ ft	0	<i>Substrate Composition:</i> Medium Sand / Silt

<i>LB: Riparian Buffer</i>	0-29 ft	0.75	<i>Bank Material:</i> Sand and Silt		
<i>RB: Floodplain Access</i>	Full	0			
<i>LB: Floodplain Access</i>	Partial	0.25			
<b>River Threat Index:</b>		<b>5</b>

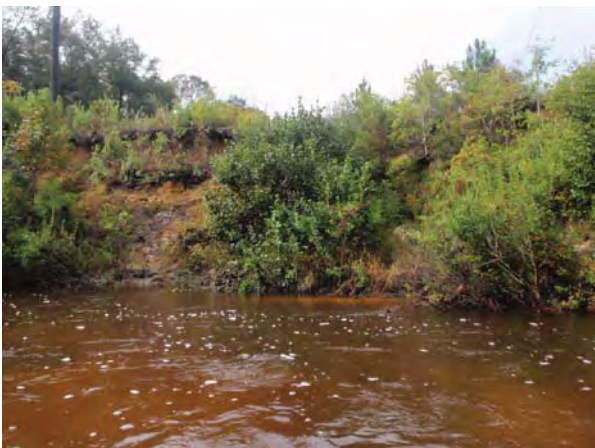
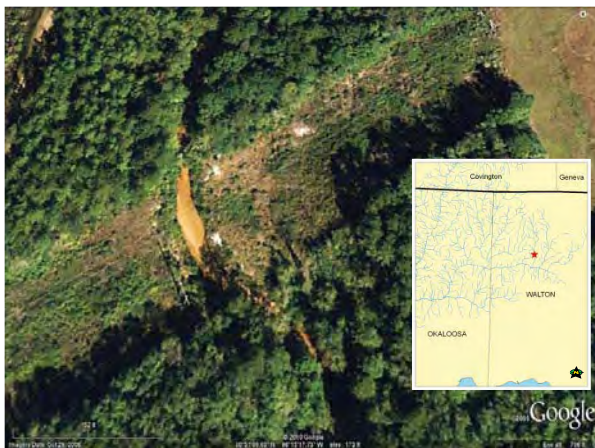
RB

Risk Factor	Ranking	Score	Feature	Within Range	Descriptive Field
<i>Channel Stability</i>	Fair	1	303(d)	Yes	COLIFORMS, TURBIDITY
<i>Channel Alteration</i>	None	0	Wetland Species	No	N/A
<i>Bank Erosion</i>	Active	1	Rare and Imperiled	No	N/A
<i>BEHI</i>	High	1	Land Use/Cover	Yes	AGRICULTURAL/ STREAMS AND WATERWAYS
<i>Local NPSP</i>	No Evidence	0	Candidate Mussels	No	N/A
<i>Shoring Structures</i>	Not Present	0	Sturgeon C.H.	No	N/A
<i>Pipe Discharge</i>	Not Present	0	<b>Additional Site Features</b>		
<i>Water Odors</i>	Not Present	0	<i>Stream Channel Woody Material:</i> Infrequent		
<i>Fish Passage Barrier</i>	Not Present	0	<i>Impoundments:</i> None		
<i>RB: Riparian Buffer</i>	0-29 ft	0.75	<i>Substrate Composition:</i> Clay Marl		
<i>LB: Riparian Buffer</i>	100 + ft	0	<i>Bank Material:</i> Clay		
<i>RB: Floodplain Access</i>	None	0.75			
<i>LB: Floodplain Access</i>	Partial	0.25			
<b>River Threat Index:</b>		<b>4.75</b>

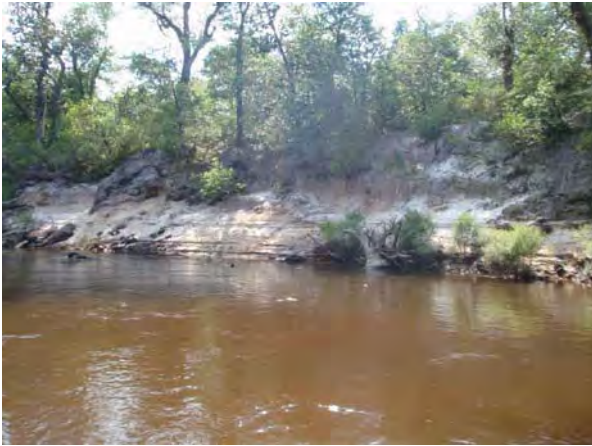
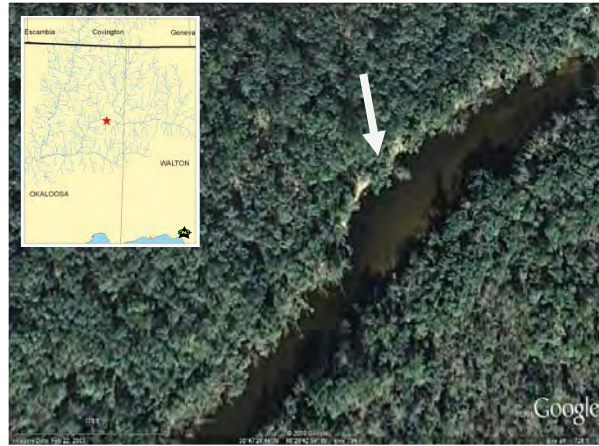
RB

Risk Factor	Ranking	Score	Feature	Within Range	Descriptive Field
<i>Channel Stability</i>	Fair	1	<b>303d</b>	No	N/A
<i>Channel Alteration</i>	None	0	<b>Wetland Species</b>	Yes	1-3 FOCAL SPECIES IN WETLAND AREAS
<i>Bank Erosion</i>	Active	1	<b>Rare and Imperiled</b>	Yes	GOLDSTRIPE DARTER, IRONCOLOR SHINER
<i>BEHI</i>	High	1	<b>Land Use/Cover</b>	Yes	N/A/ STREAMS AND WATERWAYS
<i>Local NPSP</i>	No Evidence	0	<b>Candidate Mussels</b>	No	N/A
<i>Shoring Structures</i>	Not Present	0	<b>Sturgeon C.H.</b>	No	N/A
<i>Pipe Discharge</i>	Not Present	0	<b>Additional Site Features</b>		
<i>Water Odors</i>	Not Present	0	<i>Stream Channel Woody Material:</i> Moderate		
<i>Fish Passage Barrier</i>	Not Present	0	<i>Impoundments:</i> None		
<i>RB: Riparian Buffer</i>	0-29 ft	0.75	<i>Substrate Composition:</i> Medium Sand		
<i>LB: Riparian Buffer</i>	100+ ft	0	<i>Bank Material:</i> Clay and Sand		
<i>RB: Floodplain Access</i>	None	0.75

<i>LB: Floodplain Access</i>	None	0.25			
<b>River Threat Index:</b>		<b>4.75</b>

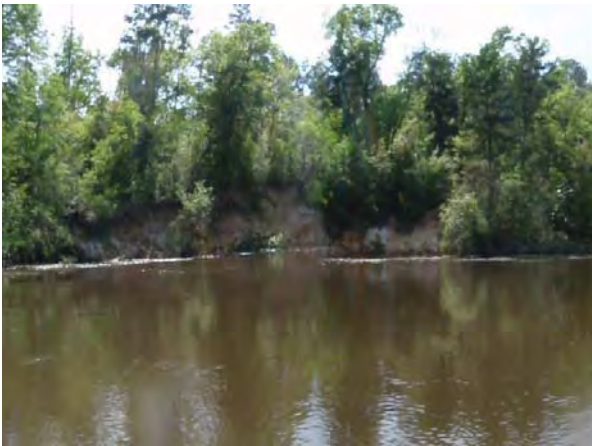
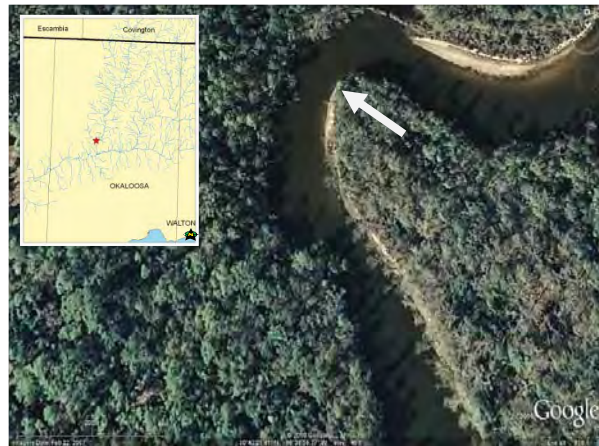
LB

Risk Factor	Ranking	Score	Feature	Within Range	Descriptive Field
Channel Stability	Poor	1.5	303(d)	Yes	COLIFORMS, TURBIDITY, MERCURY
Channel Alteration	None	0	Wetland Species	Yes	1-3 FOCAL SPECIES IN WETLAND AREAS
Bank Erosion	Mass-Wasting	1.5	Rare and Imperiled	Yes	ALABAMA SHAD, ALLIGATOR GAR, BLUENOSE SHINER, GULF STURGEON, SPECKLED CHUB, IRONCOLOR SHINER, SPOTTED BULLHEAD, SPECKLED DARTER
BEHI	High	1	Land Use/ Cover	Yes	OTHER/ STREAMS AND WATERWAYS
Local NPSP	No Evidence	0	Candidate Mussels	No	N/A
Shoring Structures	Not Present	0	Sturgeon C.H.	Yes	N/A
Pipe Discharge	Not Present	0	<b>Additional Site Features</b>		
Water Odors	Not Present	0	<u>Stream Channel Woody Material:</u> Moderate		
Fish Passage Barrier	Not Present	0	<u>Impoundments:</u> None		
RB: Riparian Buffer	100+ ft	0	<u>Substrate Composition:</u> Medium Sand		
LB: Riparian Buffer	100+ ft	0	<u>Bank Material:</u> Sand and Clay		
RB: Floodplain Access	None	0.75

LB: Floodplain Access	Full	0			
<b>River Threat Index:</b>		<b>4.75</b>

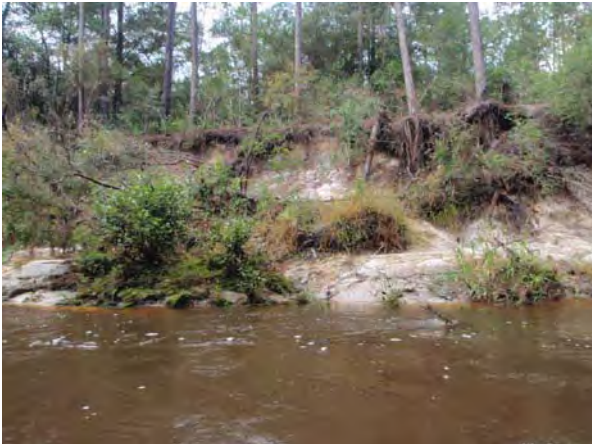
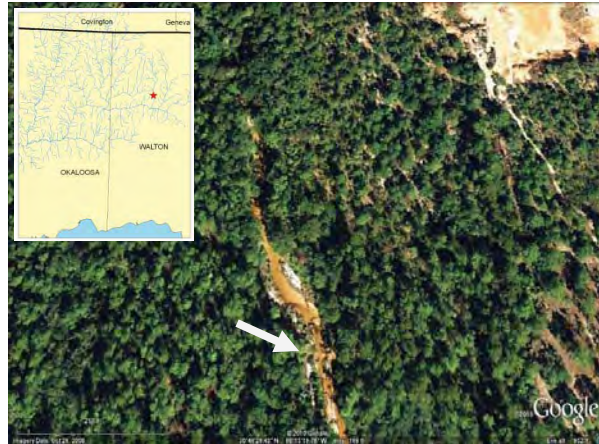
RB

Risk Factor	Ranking	Score	Feature	Within Range	Descriptive Field
<i>Channel Stability</i>	Fair	1	303(d)	Yes	COLIFORMS, TURBIDITY
<i>Channel Alteration</i>	None	0	Wetland Species	No	N/A
<i>Bank Erosion</i>	Active	1	Rare and Imperiled	No	N/A
<i>BEHI</i>	High	1	Land Use/Cover	Yes	VACANT RESIDENTIAL/ STREAMS AND WATERWAYS
<i>Local NPSP</i>	No Evidence	0	Candidate Mussels	No	N/A
<i>Shoring Structures</i>	Not Present	0	Sturgeon C.H.	No	N/A
<i>Pipe Discharge</i>	Not Present	0	<b>Additional Site Features</b>		
<i>Water Odors</i>	Not Present	0	<i>Stream Channel Woody Material:</i> Moderate		
<i>Fish Passage Barrier</i>	Not Present	0	<i>Impoundments:</i> None		
<i>RB: Riparian Buffer</i>	0-29 ft	0.75	<i>Substrate Composition:</i> Clay Marl		
<i>LB: Riparian Buffer</i>	100+ ft	0	<i>Bank Material:</i> Sand and Clay		
<i>RB: Floodplain Access</i>	None	0.75			
<i>LB: Floodplain Access</i>	Full	0			
<b>River Threat Index:</b>		<b>4.5</b>

Notes: Joyce Cordell is noted as a possible land owner. Logging road 0.3mi west of site?  
60ft site reach.

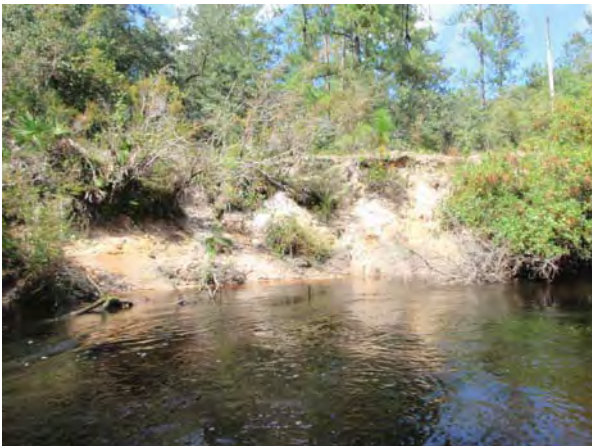
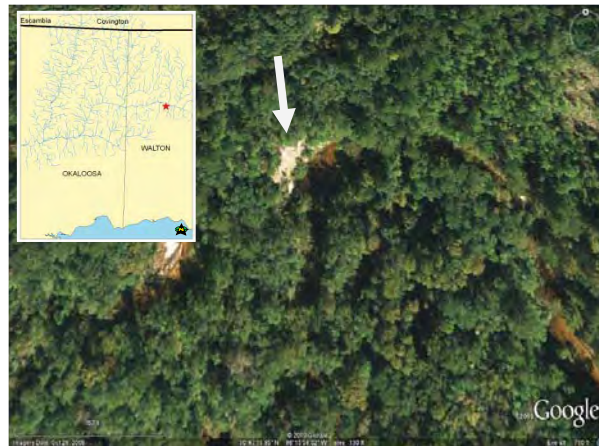
RB

Risk Factor	Ranking	Score	Feature	Within Range	Descriptive Field
<i>Channel Stability</i>	Fair	1	303(d)	No	N/A
<i>Channel Alteration</i>	None	0	<b>Wetland Species</b>	Yes	1-3 FOCAL SPECIES IN WETLAND AREAS
<i>Bank Erosion</i>	Mass Wasting	1.5	<b>Rare and Imperiled</b>	Yes	GOLDSTRIPE DARTER, IRONCOLOR SHINER, SPECKLED CHUB
<i>BEHI</i>	Historic	0.5	<b>Land Use/Cover</b>	Yes	RECREATION/WETLAND FORESTED MIX
<i>Local NPSP</i>	No Evidence	0	<b>Candidate Mussels</b>	No	N/A
<i>Shoring Structures</i>	Not Present	0	<b>Sturgeon C.H.</b>	No	N/A
<i>Pipe Discharge</i>	Not Present	0	<b>Additional Site Features</b>		
<i>Water Odors</i>	Not Present	0	<i>Stream Channel Woody Material:</i> Numerous		
<i>Fish Passage Barrier</i>	Not Present	0	<i>Impoundments:</i> None		
<i>RB: Riparian Buffer</i>	0-29 ft	0.75	<i>Substrate Composition:</i> Medium Sand		
<i>LB: Riparian Buffer</i>	100+ ft	0	<i>Bank Material:</i> Sand		
<i>RB: Floodplain Access</i>	Partial	0.75

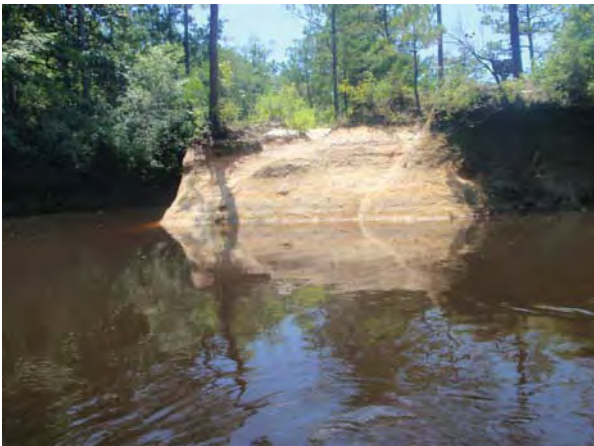
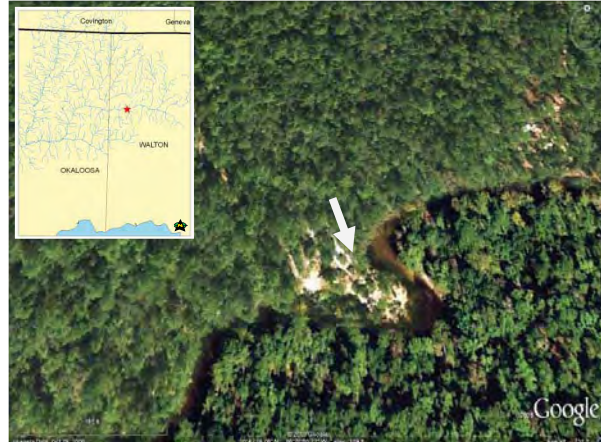
RB

Risk Factor	Ranking	Score	Feature	Within Range	Descriptive Field
<i>Channel Stability</i>	Good	0.5	303(d)	No	N/A
<i>Channel Alteration</i>	None	0	Wetland Species	Yes	1-3 FOCAL SPECIES IN WETLAND AREAS
<i>Bank Erosion</i>	Active	1	Rare and Imperiled	Yes	GOLDSTRIPE DARTER, SPECKLED CHUB, IRONCOLOR SHINER
<i>BEHI</i>	High	1	Land Use/Cover	Yes	PARCELS WITH NO VALUES/ STREAMS AND WATERWAYS
<i>Local NPSP</i>	Slight	0.5	Candidate Mussels	No	N/A
<i>Shoring Structures</i>	Not Present	0	Sturgeon C.H.	No	N/A
<i>Pipe Discharge</i>	Not Present	0	<b>Additional Site Features</b>		
<i>Water Odors</i>	Not Present	0	<i>Stream Channel Woody Material:</i> Moderate		
<i>Fish Passage Barrier</i>	Not Present	0	<i>Impoundments:</i> None		
<i>RB: Riparian Buffer</i>	0-29 ft	0.75	<i>Substrate Composition:</i> Medium Sand		
<i>LB: Riparian Buffer</i>	100+ ft	0	<i>Bank Material:</i> Sand		
<i>RB: Floodplain Access</i>	None	0.75

<i>LB: Floodplain Access</i>	Full	0			
<b>River Threat Index:</b>		<b>4.5</b>

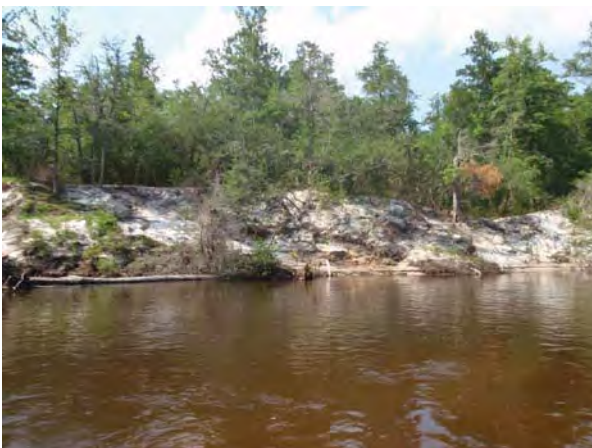
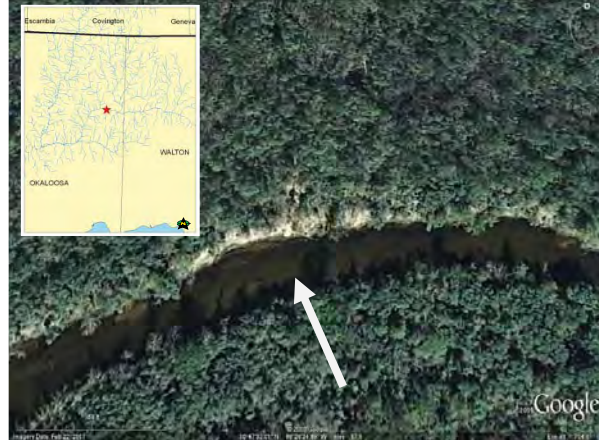
RB

Risk Factor	Ranking	Score	Feature	Within Range	Descriptive Field
<i>Channel Stability</i>	Fair	1	303(d)	No	N/A
<i>Channel Alteration</i>	None	0	Wetland Species	Yes	1-3 FOCAL SPECIES IN WETLAND AREAS
<i>Bank Erosion</i>	Active	1	Rare and Imperiled	Yes	GOLDSTRIPE DARTER, IRONCOLOR SHINER
<i>BEHI</i>	High	1	Land Use/Cover	Yes	N/A/ STREAMS AND WATERWAYS
<i>Local NPSP</i>	No Evidence	0	Candidate Mussels	No	N/A
<i>Shoring Structures</i>	Not Present	0	Sturgeon C.H.	No	N/A
<i>Pipe Discharge</i>	Not Present	0	<b>Additional Site Features</b>		
<i>Water Odors</i>	Not Present	0	<i>Stream Channel Woody Material:</i> Moderate		
<i>Fish Passage Barrier</i>	Not Present	0	<i>Impoundments:</i> None		
<i>RB: Riparian Buffer</i>	0-29 ft	0.75	<i>Substrate Composition:</i> Medium Sand		
<i>LB: Riparian Buffer</i>	100+ ft	0	<i>Bank Material:</i> Clay and Sand		
<i>RB: Floodplain Access</i>	None	0.75			
<i>LB: Floodplain Access</i>	Full	0

<b>River Threat Index:</b>		<b>4.5</b>

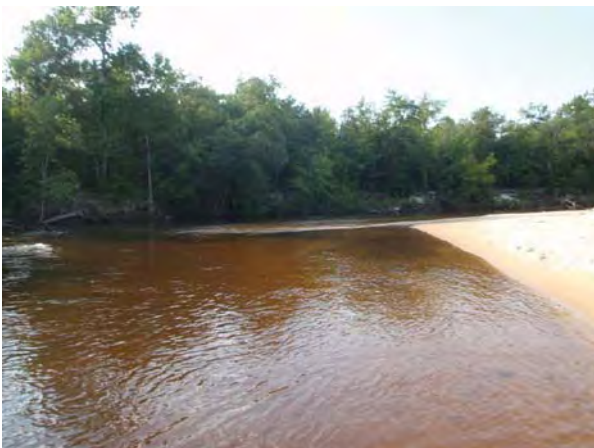
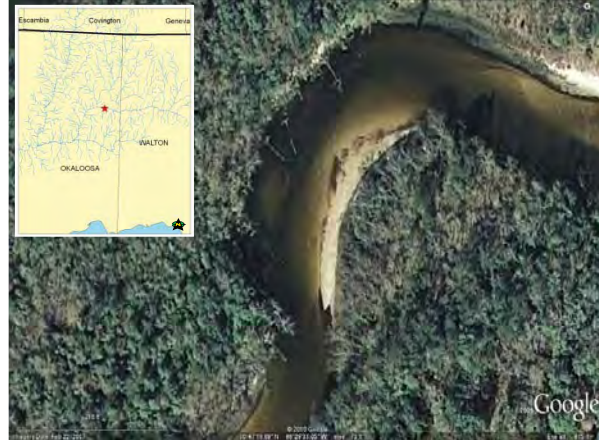
US

Risk Factor	Ranking	Score	Feature	Within Range	Descriptive Field
<i>Channel Stability</i>	Good	0.5	303d	No	N/A
<i>Channel Alteration</i>	None	0	Wetland Species	Yes	1-3 FOCAL SPECIES IN WETLAND AREAS
<i>Bank Erosion</i>	Historic	0.5	Rare and Imperiled	Yes	GOLDSTRIPE DARTER, SPECKLED CHUB, IRONCOLOR SHINER
<i>BEHI</i>	Low- Very Low	0	Land Use/ Cover	Yes	N/A/ STREAMS AND WATERWAYS
<i>Local NPSP</i>	Obvious Sources	1.5	Candidate Mussels	No	N/A
<i>Shoring Structures</i>	Not Present	0	Sturgeon C.H.	No	N/A
<i>Pipe Discharge</i>	Not Present	0	<b>Additional Site Features</b>		
<i>Water Odors</i>	Not Present	0	<i>Stream Channel Woody Material:</i> Moderate		
<i>Fish Passage Barrier</i>	Not Present	0	<i>Impoundments:</i> None		
<i>RB: Riparian Buffer</i>	0-29 ft	0.75	<i>Substrate Composition:</i> Medium Sand		
<i>LB: Riparian Buffer</i>	0-29 ft	0.75	<i>Bank Material:</i> Medium Sand		
<i>RB: Floodplain Access</i>	Partial	0.25

<i>LB: Floodplain Access</i>	Full	0			
<b>River Threat Index:</b>		<b>4.25</b>

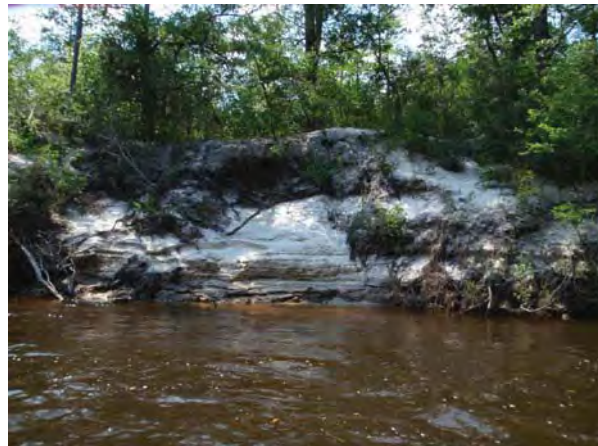
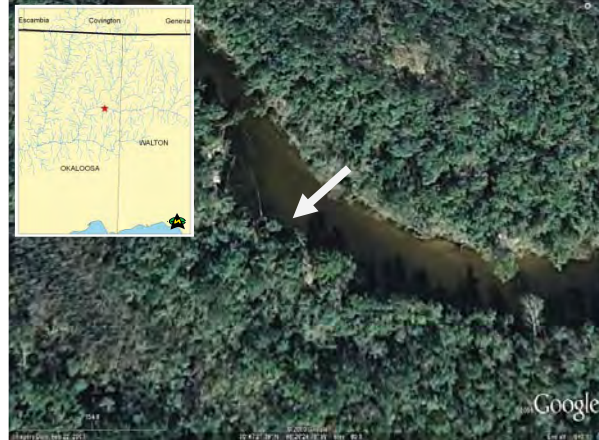
LB

Risk Factor	Ranking	Score	Feature	Within Range	Descriptive Field
<i>Channel Stability</i>	Fair	1	303(d)	No	N/A
<i>Channel Alteration</i>	None	0	Wetland Species	No	N/A
<i>Bank Erosion</i>	Active	1	Rare and Imperiled	Yes	GOLDSTRIPE DARTER,SPECKLED CHUB,IRONCOLOR SHINER
<i>BEHI</i>	High	1	Land Use/Cover	Yes	N/A/ STREAMS AND WATERWAYS
<i>Local NPSP</i>	No Evidence	0	Candidate Mussels	No	N/A
<i>Shoring Structures</i>	Not Present	0	Sturgeon C.H.	No	N/A
<i>Pipe Discharge</i>	Not Present	0	<b>Additional Site Features</b>		
<i>Water Odors</i>	Not Present	0	<i>Stream Channel Woody Material:</i> Infrequent		
<i>Fish Passage Barrier</i>	Not Present	0	<i>Impoundments:</i> None		
<i>RB: Riparian Buffer</i>	100+ ft	0	<i>Substrate Composition:</i> Medium Sand		
<i>LB: Riparian Buffer</i>	0-29 ft	0.75	<i>Bank Material:</i> Sand		
<i>RB: Floodplain Access</i>	Partial	0.25			
<i>LB: Floodplain Access</i>	Partial	0.25

<b>River Threat Index:</b>		<b>4.25</b>

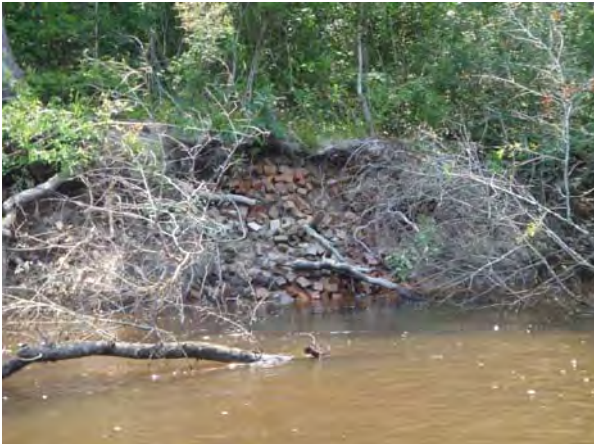
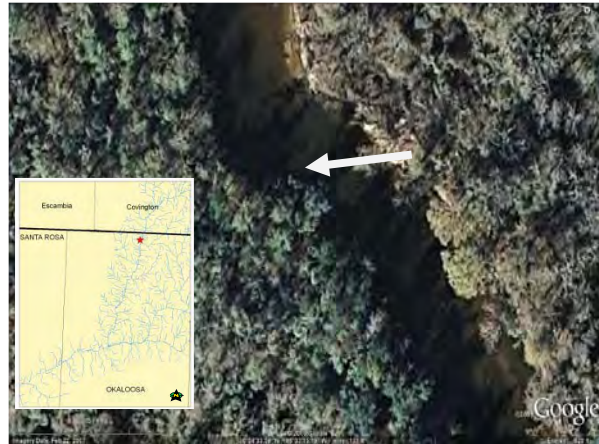
RB

Risk Factor	Ranking	Score	Feature	Within Range	Descriptive Field
<i>Channel Stability</i>	Good	0.5	<b>303d</b>	Yes	COLIFORMS, TURBIDITY, MERCURY
<i>Channel Alteration</i>	None	0	<b>Wetland Species</b>	Yes	1-3 FOCAL SPECIES IN UPLAND AREAS
<i>Bank Erosion</i>	Not eroding	0	<b>Rare and Imperiled</b>	Yes	ALABAMA SHAD, ALLIGATOR GAR, BLUENOSE SHINER, GULF STURGEON, SPECKLED CHUB, IRONCOLOR SHINER, SPOTTED BULLHEAD, SPECKLED DARTER
<i>BEHI</i>	Moderate	0.5	<b>Land Use/Cover</b>	Yes	N/A/ STREAMS AND WATERWAYS
<i>Local NPSP</i>	Moderate Potential	1	<b>Candidate Mussels</b>	No	N/A
<i>Shoring Structures</i>	Present	1.5	<b>Sturgeon C.H.</b>	Yes	N/A
<i>Pipe Discharge</i>	Not Present	0	<b>Additional Site Features</b>		
<i>Water Odors</i>	Not Present	0	<i>Stream Channel Woody Material:</i> Infrequent		
<i>Fish Passage Barrier</i>	Not Present	0	<i>Impoundments:</i> None		
<i>RB: Riparian Buffer</i>	100+ ft	0	<i>Substrate Composition:</i> Medium Sand

<i>LB: Riparian Buffer</i>	0-29 ft	0.75	<i>Bank Material:</i> Sand and Roots		
<i>RB: Floodplain Access</i>	Full	0			
<i>LB: Floodplain Access</i>	Full	0			
<b>River Threat Index:</b>		<b>4.25</b>

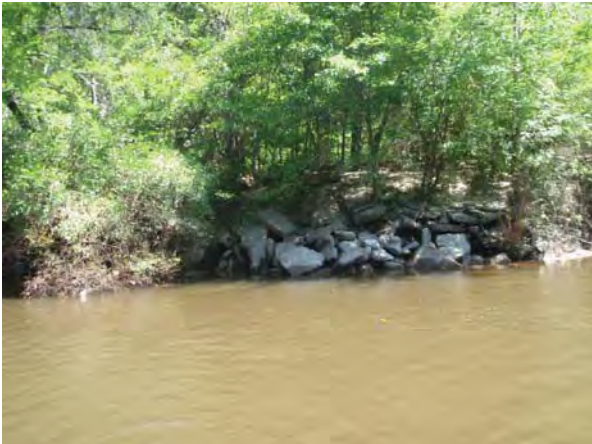
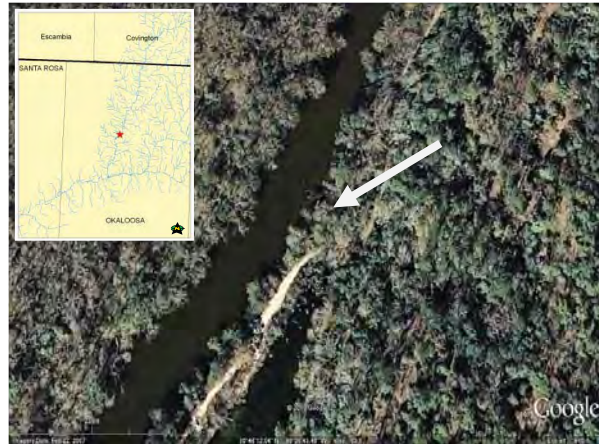
LB

Risk Factor	Ranking	Score	Feature	Within Range	Descriptive Field
<i>Channel Stability</i>	Good	0	<b>303(d)</b>	Yes	COLIFORMS, TURBIDITY, MERCURY
<i>Channel Alteration</i>	None	0	<b>Wetland Species</b>	Yes	1-3 FOCAL SPECIES IN UPLAND AREAS
<i>Bank Erosion</i>	Not Eroding	0	<b>Rare and Imperiled</b>	Yes	ALABAMA SHAD, ALLIGATOR GAR, BLUENOSE SHINER, GULF STURGEON, SPECKLED CHUB, IRONCOLOR SHINER, SPOTTED BULLHEAD, SPECKLED DARTER
<i>BEHI</i>	Moderate	0.5	<b>Land Use/Cover</b>	Yes	N/A / STREAMS AND WATERWAYS
<i>Local NPSP</i>	Moderate Potential	1	<b>Candidate Mussels</b>	No	N/A
<i>Shoring Structures</i>	Present	1.5	<b>Sturgeon C.H.</b>	Yes	N/A
<i>Pipe Discharge</i>	Not Present	0	<b>Additional Site Features</b>		
<i>Water Odors</i>	Not Present	0	<i>Stream Channel Woody Material:</i> Moderate		
<i>Fish Passage Barrier</i>	Not Present	0	<i>Impoundments:</i> None		
<i>RB: Riparian Buffer</i>	100+ ft	0	<i>Substrate Composition:</i> Medium Sand

<i>LB: Riparian Buffer</i>	0-29 ft	0.75	<i>Bank Material:</i> Concrete		
<i>RB: Floodplain Access</i>	Full	0			
<i>LB: Floodplain Access</i>	Partial	0.25			
<b>River Threat Index:</b>		<b>4</b>

Notes: Broken concrete slabs are being used as shoring structure.

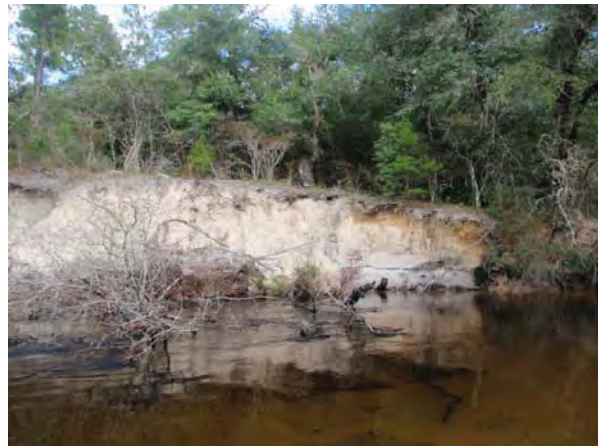
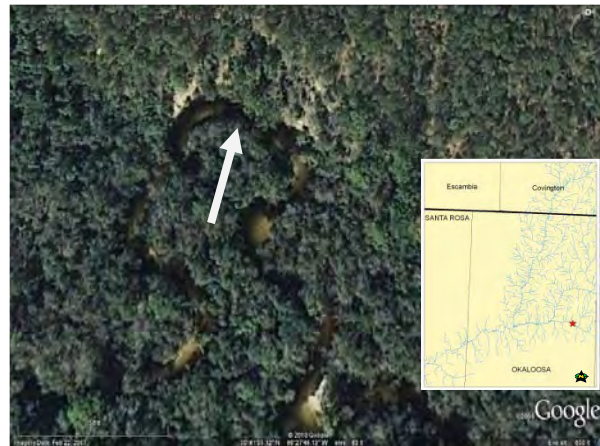
RB

Risk Factor	Ranking	Score	Feature	Within Range	Descriptive Field
<i>Channel Stability</i>	Fair	1	303(d)	No	N/A
<i>Channel Alteration</i>	None	0	Wetland Species	No	N/A
<i>Bank Erosion</i>	Active	1	Rare and Imperiled	No	N/A
<i>BEHI</i>	Moderate	0.5	Land Use/Cover	Yes	INSTITUTIONAL/ STREAMS AND WATERWAYS
<i>Local NPSP</i>	No Evidence	0	Candidate Mussels	No	N/A
<i>Shoring Structures</i>	Not Present	0	Sturgeon C.H.	No	N/A
<i>Pipe Discharge</i>	Not Present	0	<b>Additional Site Features</b>		
<i>Water Odors</i>	Not Present	0	<i>Stream Channel Woody Material:</i> Numerous		
<i>Fish Passage Barrier</i>	Not Present	0	<i>Impoundments:</i> Woody Material Jams		
<i>RB: Riparian Buffer</i>	0-29 ft	0.75	<i>Substrate Composition:</i> Coarse Sand		
<i>LB: Riparian Buffer</i>	100+ ft	0	<i>Bank Material:</i> Coarse Sand		
<i>RB: Floodplain Access</i>	None	0.75			
<i>LB: Floodplain Access</i>	Full	0			
<b>River Threat Index:</b>		<b>4</b>

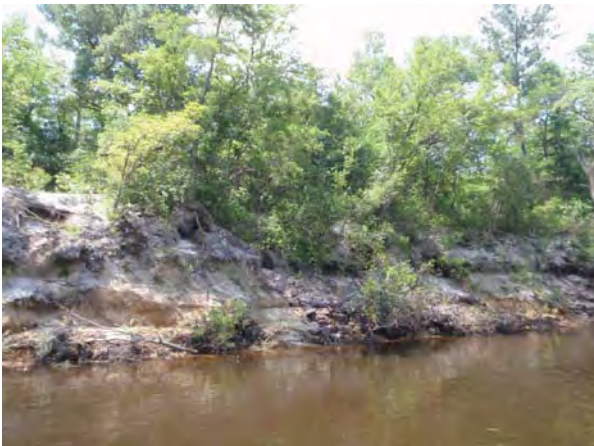
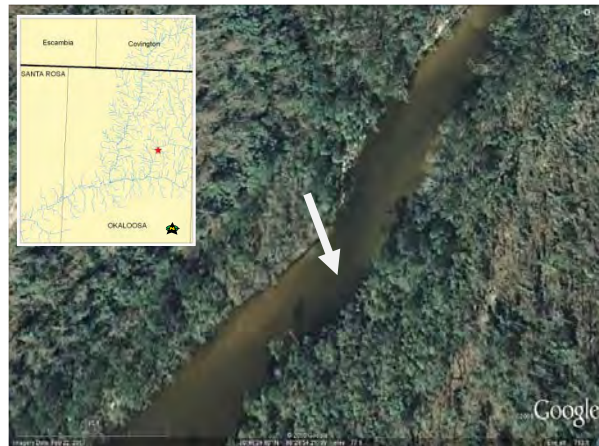
LB

Risk Factor	Ranking	Score	Feature	Within Range	Descriptive Field
<i>Channel Stability</i>	Fair	1	303(d)	No	N/A
<i>Channel Alteration</i>	None	0	Wetland Species	Yes	1-3 FOCAL SPECIES IN UPLAND AREAS
<i>Bank Erosion</i>	Historic	0.5	Rare and Imperiled	Yes	GOLDSTRIPE DARTER, IRONCOLOR SHINER, SPECKLED CHUB
<i>BEHI</i>	High	1	Land Use/Cover	Yes	N/A / STREAMS AND WATERWAYS
<i>Local NPSP</i>	No Evidence	0	Candidate Mussels	No	N/A
<i>Shoring Structures</i>	Not Present	0	Sturgeon C.H.	No	N/A
<i>Pipe Discharge</i>	Not Present	0	<b>Additional Site Features</b>		
<i>Water Odors</i>	Not Present	0	<i>Stream Channel Woody Material:</i> Moderate		
<i>Fish Passage Barrier</i>	Not Present	0	<i>Impoundments:</i> None		
<i>RB: Riparian Buffer</i>	100+ ft	0	<i>Substrate Composition:</i> Medium Sand		
<i>LB: Riparian Buffer</i>	0-29 ft	0.75	<i>Bank Material:</i> Sand		
<i>RB: Floodplain Access</i>	Full	0			
<i>LB: Floodplain Access</i>	None	0.75

Notes: New growth on eroding bank may indicate historic erosion. However bank still appears to be degrading.  
 Unpaved road on both banks. Aerials show evidence of past logging/clear cutting.

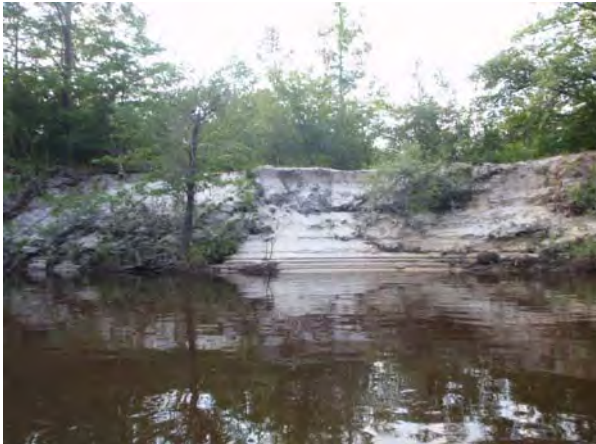
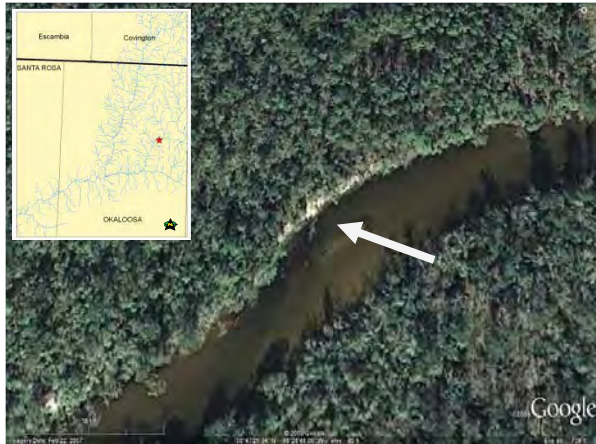
RB					
Risk Factor	Ranking	Score	Feature	Within Range	Descriptive Field
<i>Channel Stability</i>	Fair	1	303(d)	No	N/A
<i>Channel Alteration</i>	None	0	Wetland Species	No	N/A
<i>Bank Erosion</i>	Historic	0.5	Rare and Imperiled	Yes	GOLDSTRIPE DARTER, IRONCOLOR SHINER, SPECKLED CHUB
<i>BEHI</i>	High	1	Land Use/Cover	Yes	N/A / STREAMS AND WATERWAYS
<i>Local NPSP</i>	Obvious Sources	0	Candidate Mussels	No	N/A
<i>Shoring Structures</i>	Not Present	0	Sturgeon C.H.	No	N/A
<i>Pipe Discharge</i>	Not Present	0	<b>Additional Site Features</b>		
<i>Water Odors</i>	Not Present	0	<i>Stream Channel Woody Material:</i> Moderate		
<i>Fish Passage Barrier</i>	Not Present	0	<i>Impoundments:</i> None

<i>RB: Riparian Buffer</i>	0-29 ft	0.75	<i>Substrate Composition:</i> Coarse Sand		
<i>LB: Riparian Buffer</i>	100+ ft	0	<i>Bank Material:</i> Sand		
<i>RB: Floodplain Access</i>	None	0.75			
<i>LB: Floodplain Access</i>	Full	0			
<b>River Threat Index:</b>		<b>4</b>

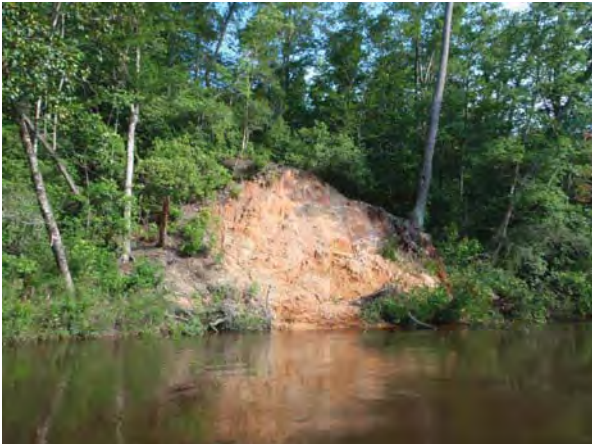
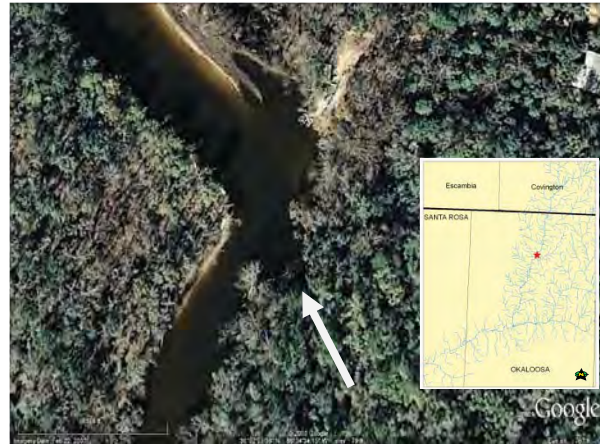
LB

Risk Factor	Ranking	Score	Feature	Within Range	Descriptive Field
<i>Channel Stability</i>	Fair	1	<b>303(d)</b>	Yes	COLIFORMS, TURBIDITY, MERCURY
<i>Channel Alteration</i>	None	0	<b>Wetland Species</b>	Yes	1-3 FOCAL SPECIES IN UPLAND AREAS
<i>Bank Erosion</i>	Historic	1	<b>Rare and Imperiled</b>	Yes	ALABAMA SHAD, ALLIGATOR GAR, BLUENOSE SHINER, GULF STURGEON, SPECKLED CHUB, IRONCOLOR SHINER, SPOTTED BULLHEAD, SPECKLED DARTER
<i>BEHI</i>	High	1	<b>Land Use/Cover</b>	Yes	VACANT RESIDENTIAL/ HARDWOOD CONIFEROUS-MIXED
<i>Local NPSP</i>	No Evidence	0	<b>Candidate Mussels</b>	No	N/A
<i>Shoring Structures</i>	Not Present	0	<b>Sturgeon C.H.</b>	Yes	N/A
<i>Pipe Discharge</i>	Not Present	0	<b>Additional Site Features</b>		
<i>Water Odors</i>	Not Present	0	<i>Stream Channel Woody Material:</i> Numerous		
<i>Fish Passage Barrier</i>	Not Present	0	<i>Impoundments:</i> None		
<i>RB: Riparian Buffer</i>	100+ ft	0	<i>Substrate Composition:</i> Medium Sand

<i>LB: Riparian Buffer</i>	0-29 ft	0.75	<i>Bank Material:</i> Clay		
<i>RB: Floodplain Access</i>	Full	0			
<i>LB: Floodplain Access</i>	Partial	0.25			
<b>River Threat Index:</b>		<b>4</b>

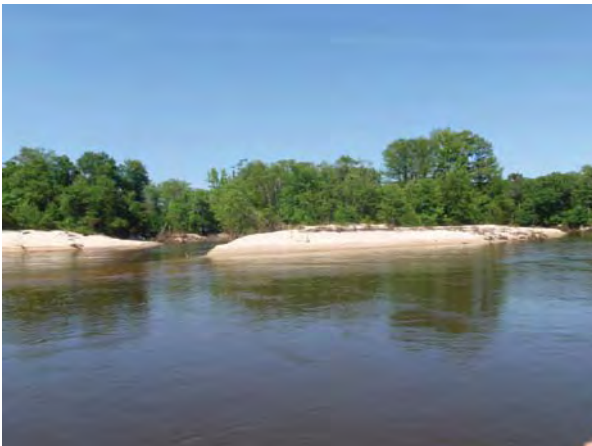
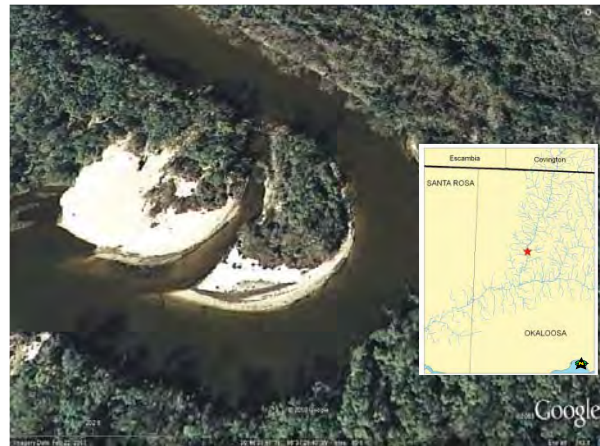
RB

Risk Factor	Ranking	Score	Feature	Within Range	Descriptive Field
<i>Channel Stability</i>	Poor	1.5	<b>303(d)</b>	Yes	COLIFORMS, TURBIDITY, MERCURY
<i>Channel Alteration</i>	None	0	<b>Wetland Species</b>	Yes	1-3 FOCAL SPECIES IN UPLAND AREAS
<i>Bank Erosion</i>	Active	1	<b>Rare and Imperiled</b>	Yes	ALABAMA SHAD, ALLIGATOR GAR, BLUENOSE SHINER, GULF STURGEON, SPECKLED CHUB, IRONCOLOR SHINER, SPOTTED BULLHEAD, SPECKLED DARTER
<i>BEHI</i>	Moderate	0.5	<b>Land Use/Cover</b>	Yes	N/A / STREAMS AND WATERWAYS
<i>Local NPSP</i>	No Evidence	0	<b>Candidate Mussels</b>	No	N/A
<i>Shoring Structures</i>	Not Present	0	<b>Sturgeon C.H.</b>	Yes	N/A
<i>Pipe Discharge</i>	Not Present	0	<b>Additional Site Features</b>		
<i>Water Odors</i>	Not Present	0	<i>Stream Channel Woody Material:</i> Moderate		
<i>Fish Passage Barrier</i>	Present	0	<i>Impoundments:</i> None		
<i>RB: Riparian Buffer</i>	0-29 ft	0.75	<i>Substrate Composition:</i> Coarse Sand

<i>LB: Riparian Buffer</i>	100+ft	0	<i>Bank Material:</i> Sand		
<i>RB: Floodplain Access</i>	Full	0			
<i>LB: Floodplain Access</i>	Partial	0.25			
<b>River Threat Index:</b>		<b>4</b>

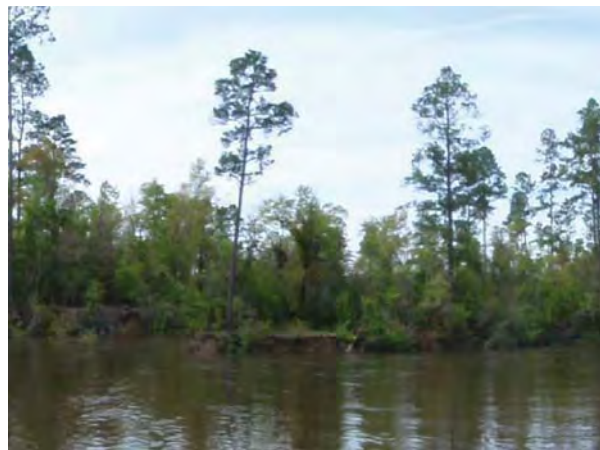
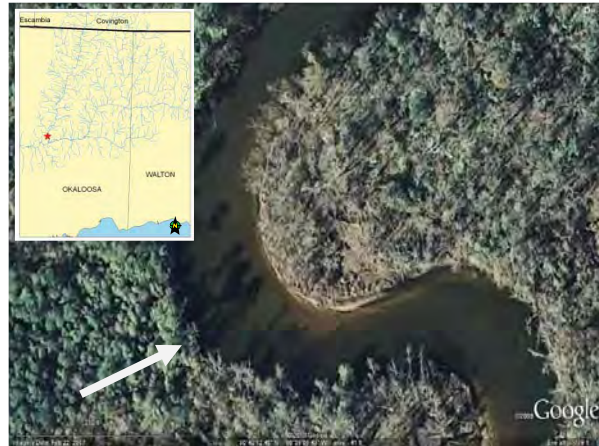
RB

Risk Factor	Ranking	Score	Feature	Within Range	Descriptive Field
<i>Channel Stability</i>	Fair	1.5	303(d)	Yes	COLIFORMS, TURBIDITY, MERCURY
<i>Channel Alteration</i>	None	0	Wetland Species	Yes	1-3 FOCAL SPECIES IN UPLAND AREAS
<i>Bank Erosion</i>	Mass Wasting	1.5	Rare and Imperiled	Yes	ALABAMA SHAD, ALLIGATOR GAR, BLUENOSE SHINER, GULF STURGEON, SPECKLED CHUB, IRONCOLOR SHINER, SPOTTED BULLHEAD, SPECKLED DARTER
<i>BEHI</i>	High	1	Land Use/Cover	Yes	N/A / STREAMS AND WATERWAYS
<i>Local NPSP</i>	No Evidence	0	Candidate Mussels	No	N/A
<i>Shoring Structures</i>	Not Present	0	Sturgeon C.H.	Yes	N/A
<i>Pipe Discharge</i>	Not Present	0	<b>Additional Site Features</b>		
<i>Water Odors</i>	Not Present	0	<i>Stream Channel Woody Material:</i> Moderate		
<i>Fish Passage Barrier</i>	Not Present	0	<i>Impoundments:</i> None		
<i>RB: Riparian Buffer</i>	100+ ft	0	<i>Substrate Composition:</i> Medium Sand		
<i>LB: Riparian Buffer</i>	100+ ft	0	<i>Bank Material:</i> Sand

<i>RB: Floodplain Access</i>	Full	0			
<i>LB: Floodplain Access</i>	Full	0			
<b>River Threat Index:</b>		<b>4</b>
