Appendix A. River corridor severity scores for impaired sites in the Yellow River Basin, Alabama and Florida

Appendix C. Clear Creek Watershed Focal Area. Sites with orange headings are unpaved road sites. Specific definitions and calculations described for calculating the Sediment Risk Index (SRI) are detailed in Witmer (2009).

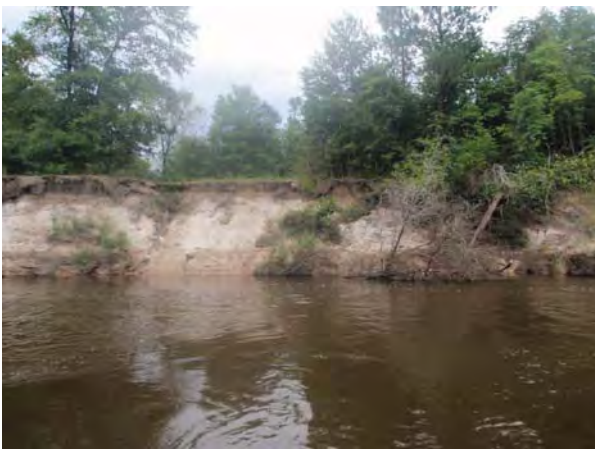
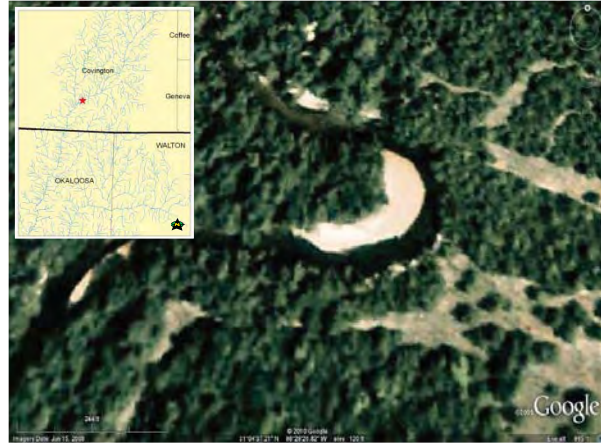
RB

Risk Factor	Ranking	Score	Feature	Within Range	Descriptive Field
<i>Channel Stability</i>	Fair	1	303(d)	Yes	METALS- MERCURY
<i>Channel Alteration</i>	None	0	Wetland Species	No	N/A
<i>Bank Erosion</i>	Active	1	Rare and Imperiled	No	N/A
<i>BEHI</i>	High	1	Land Use/ Cover	Yes	N/A / SUCCESSIONAL SHRUB/SCRUB (CLEAR CUT)
<i>Local NPSP</i>	No Evidence	0	Candidate Mussels	No	N/A
<i>Shoring Structures</i>	Not Present	0	Sturgeon C.H.	Yes	N/A
<i>Pipe Discharge</i>	Not Present	0	<b>Additional Site Features</b>		
<i>Water Odors</i>	Not Present	0	<i>Stream Channel Woody Material:</i> None		
<i>Fish Passage Barrier</i>	Not Present	0	<i>Impoundments:</i> None		
<i>RB: Riparian Buffer</i>	100+ ft	0	<i>Substrate Composition:</i> Medium Sand		
<i>LB: Riparian Buffer</i>	30-49 ft	0.5	<i>Bank Material:</i> Sand		
<i>RB: Floodplain Access</i>	Full	0			
<i>LB: Floodplain Access</i>	Partial	0.25			
<b>River Threat Index:</b>		<b>3.75</b>

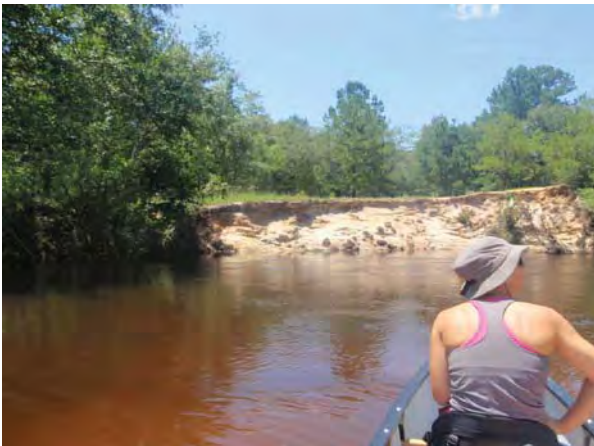
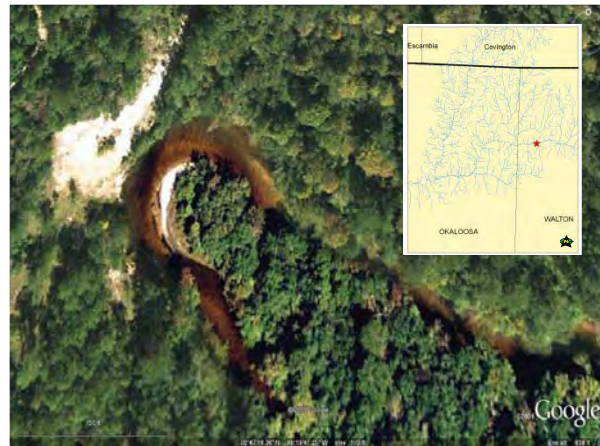
RB

Risk Factor	Ranking	Score	Feature	Within Range	Descriptive Field
<i>Channel Stability</i>	Fair	1	303(d)	No	N/A
<i>Channel Alteration</i>	None	0	Wetland Species	Yes	1-3 FOCAL SPECIES IN UPLAND AREAS
<i>Bank Erosion</i>	Historic	0.5	Rare and Imperiled	Yes	GOLDSTRIPE DARTER, IRONCOLOR SHINER, SPECKLED CHUB
<i>BEHI</i>	Moderate	0.5	Land Use/Cover	Yes	PARCELS WITH NO VALUES/ STREAMS AND WATERWAYS
<i>Local NPSP</i>	Slight	0.5	Candidate Mussels	No	N/A
<i>Shoring Structures</i>	Not Present	0	Sturgeon C.H.	No	N/A
<i>Pipe Discharge</i>	Not Present	0	<b>Additional Site Features</b>		
<i>Water Odors</i>	Not Present	0	<i>Stream Channel Woody Material:</i> Moderate		
<i>Fish Passage Barrier</i>	Not Present	0	<i>Impoundments:</i> None		
<i>RB: Riparian Buffer</i>	0-29 ft	0.75	<i>Substrate Composition:</i> Medium Sand		
<i>LB: Riparian Buffer</i>	100+ ft	0	<i>Bank Material:</i> Sand		
<i>RB: Floodplain Access</i>	Partial	0.25

<i>LB: Floodplain Access</i>	Full	0			
<b>River Threat Index:</b>		<b>3.5</b>

Notes: Power line crossing and unimproved private road coming off Plantation Ln.

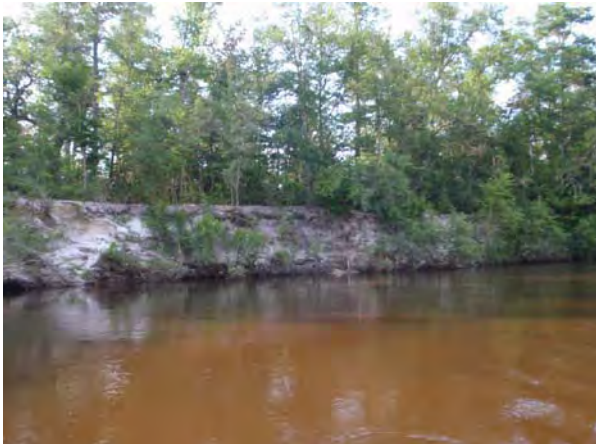
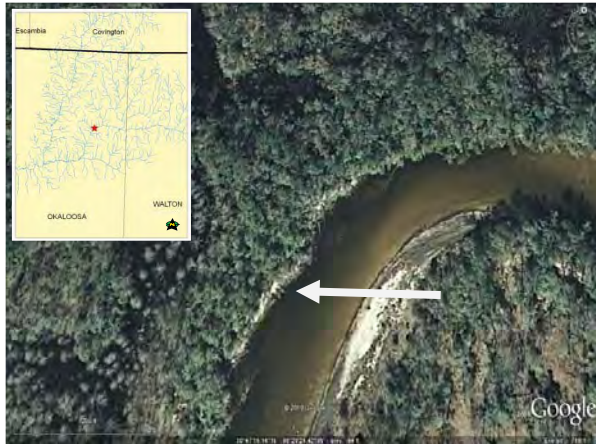
RB					
Risk Factor	Ranking	Score	Feature	Within Range	Descriptive Field
<i>Channel Stability</i>	Fair	1	303(d)	No	N/A
<i>Channel Alteration</i>	None	0	Wetland Species	Yes	1-3 FOCAL SPECIES IN UPLAND AREAS
<i>Bank Erosion</i>	Historic	0.5	Rare and Imperiled	Yes	GOLDSTRIPE DARTER, IRONCOLOR SHINER, SPECKLED CHUB
<i>BEHI</i>	Moderate	0.5	Land Use/Cover	Yes	N/A / STREAMS AND WATERWAYS
<i>Local NPSP</i>	No Evidence	0	Candidate Mussels	No	N/A
<i>Shoring Structures</i>	Not Present	0	Sturgeon C.H.	No	N/A
<i>Pipe Discharge</i>	Not Present	0	<b>Additional Site Features</b>

<i>Water Odors</i>	Not Present	0	<i>Stream Channel Woody Material:</i> Moderate		
<i>Fish Passage Barrier</i>	Not Present	0	<i>Impoundments:</i> None		
<i>RB: Riparian Buffer</i>	0-29 ft	0.75	<i>Substrate Composition:</i> Medium Sand		
<i>LB: Riparian Buffer</i>	100+ ft	0	<i>Bank Material:</i> Sand		
<i>RB: Floodplain Access</i>	None	0.75			
<i>LB: Floodplain Access</i>	Full	0			
<b>River Threat Index:</b>		<b>3.5</b>

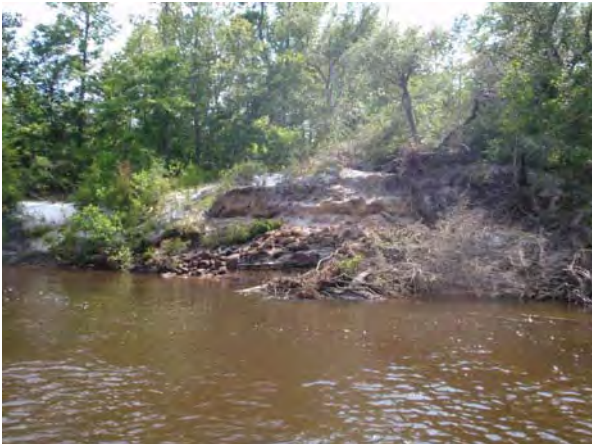
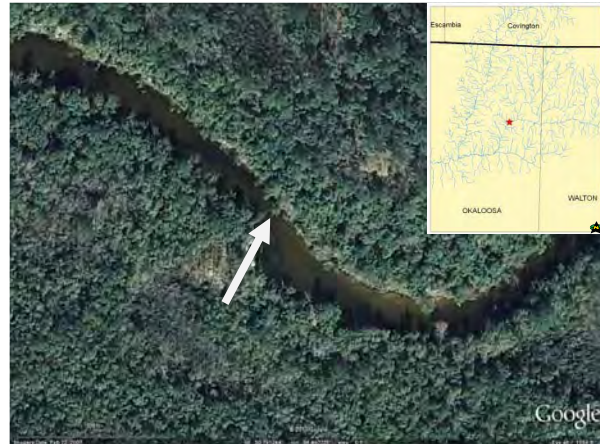
RB

Risk Factor	Ranking	Score	Feature	Within Range	Descriptive Field
<i>Channel Stability</i>	Fair	1	303(d)	No	N/A
<i>Channel Alteration</i>	None	0	Wetland Species	No	N/A
<i>Bank Erosion</i>	Active	1	Rare and Imperiled	Yes	GOLDSTRIPE DARTER, IRONCOLOR SHINER, SPECKLED CHUB
<i>BEHI</i>	High	1	Land Use/Cover	Yes	N/A / STREAMS AND WATERWAYS
<i>Local NPSP</i>	No Evidence	0	Candidate Mussels	No	N/A
<i>Shoring Structures</i>	Not Present	0	Sturgeon C.H.	No	N/A
<i>Pipe Discharge</i>	Not Present	0	<b>Additional Site Features</b>		
<i>Water Odors</i>	Not Present	0	<i>Stream Channel Woody Material:</i> Moderate		
<i>Fish Passage Barrier</i>	Not Present	0	<i>Impoundments:</i> None		
<i>RB: Riparian Buffer</i>	100+ ft	0	<i>Substrate Composition:</i> Clay		
<i>LB: Riparian Buffer</i>	100+ ft	0	<i>Bank Material:</i> Sand and Clay		
<i>RB: Floodplain Access</i>	Partial	0.25			
<i>LB: Floodplain Access</i>	Partial	0.25

<b>River Threat Index:</b>		<b>3.5</b>

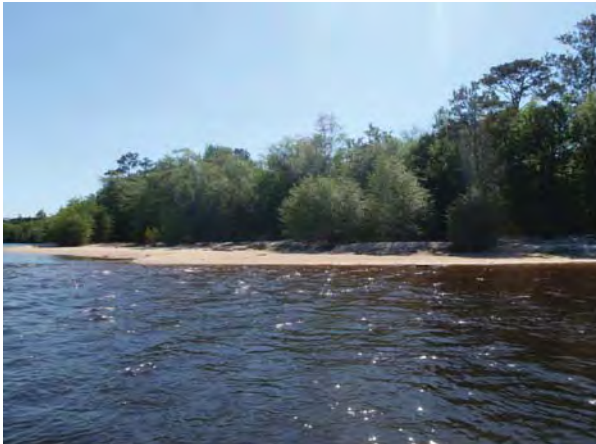
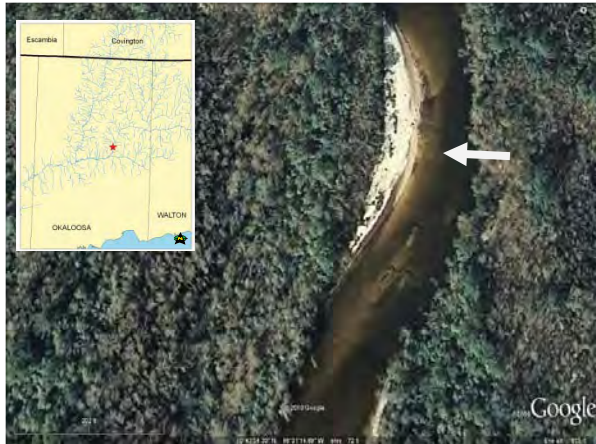
<b>RB</b>					
<b>Risk Factor</b>	<b>Ranking</b>	<b>Score</b>	<b>Feature</b>	<b>Within Range</b>	<b>Descriptive Field</b>
<i>Channel Stability</i>	Poor	1.5	303(d)	No	N/A
<i>Channel Alteration</i>	None	0	<b>Wetland Species</b>	Yes	1-3 FOCAL SPECIES IN UPLAND AREAS
<i>Bank Erosion</i>	Not eroding	0	<b>Rare and Imperiled</b>	Yes	GOLDSTRIPE DARTER, IRONCOLOR SHINER, SPECKLED CHUB
<i>BEHI</i>	High	1	<b>Land Use/Cover</b>	Yes	N/A / STREAMS AND WATERWAYS
<i>Local NPSP</i>	No Evidence	0	<b>Candidate Mussels</b>	No	N/A
<i>Shoring Structures</i>	Not Present	0	<b>Sturgeon C.H.</b>	No	N/A
<i>Pipe Discharge</i>	Not Present	0	<b>Additional Site Features</b>

<i>Water Odors</i>	Not Present	0	<i>Stream Channel Woody Material:</i> Moderate		
<i>Fish Passage Barrier</i>	Not Present	0	<i>Impoundments:</i> None		
<i>RB: Riparian Buffer</i>	0-29 ft	0.75	<i>Substrate Composition:</i> Medium Sand		
<i>LB: Riparian Buffer</i>	100+ ft	0	<i>Bank Material:</i> Sand		
<i>RB: Floodplain Access</i>	Full	0			
<i>LB: Floodplain Access</i>	Full	0			
<b>River Threat Index:</b>		<b>3.25</b>

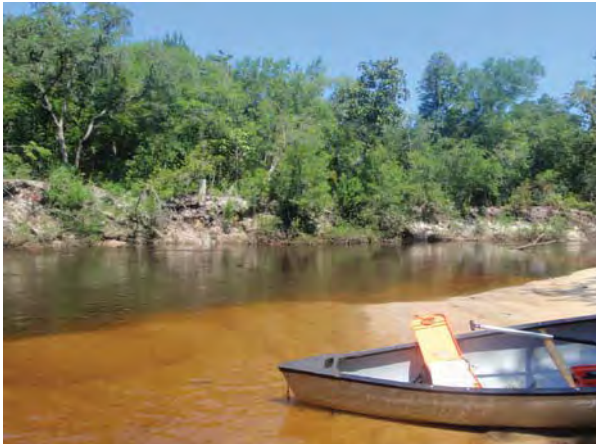
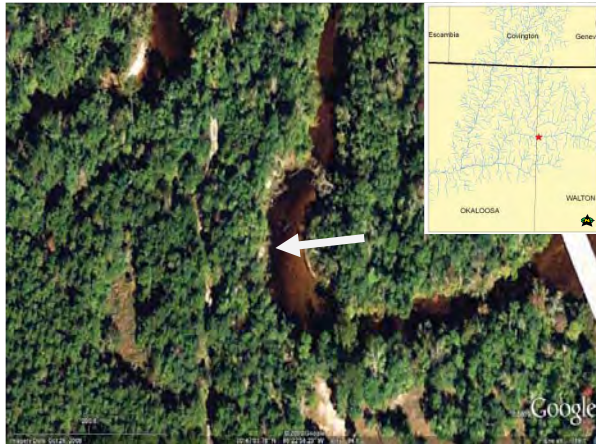
<b>LB</b>			
<b>Risk Factor</b>	<b>Ranking</b>	<b>Score</b>	<b>Feature Within Range Descriptive Field</b>
<i>Channel Stability</i>	Good	0.5	303(d) No N/A
<i>Channel Alteration</i>	None	0	Wetland Species No N/A
<i>Bank Erosion</i>	Historic	0.5	Rare and Imperiled Yes GOLDSTRIPE DARTER, IRONCOLOR SHINER, SPECKLED CHUB
<i>BEHI</i>	Moderate	0.5	Land Use/Cover Yes PARCELS WITH NO VALUES/ STREAMS AND WATERWAYS
<i>Local NPSP</i>	Moderate Potential	1	Candidate Mussels No N/A
<i>Shoring Structures</i>	Not Present	0	Sturgeon C.H. No N/A
<i>Pipe Discharge</i>	Not Present	0	
<i>Water Odors</i>	Not Present	0

<i>Fish Passage Barrier</i>	Not Present	0	
<i>RB: Riparian Buffer</i>	100+ ft	0	
<i>LB: Riparian Buffer</i>	50-99 ft	0.25	
<i>RB: Floodplain Access</i>	Full	0	
<i>LB: Floodplain Access</i>	Partial	0.25	
<b>River Threat Index:</b>		<b>3</b>	<b>Additional Site Features</b>
			<i>Stream Channel Woody Material:</i> Moderate
			<i>Impoundments:</i> None
			<i>Substrate Composition:</i> Medium Sand
			<i>Bank Material:</i> Sand

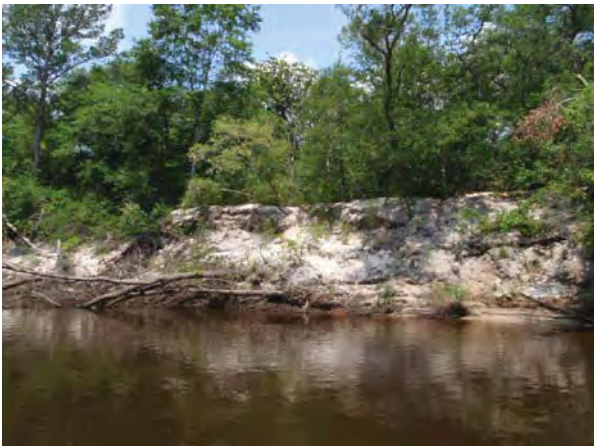
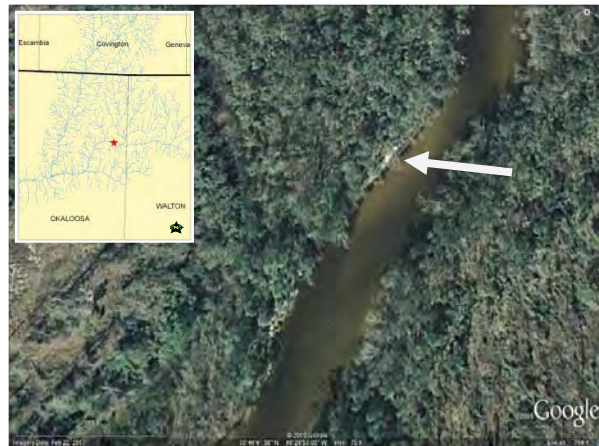
RB

Risk Factor	Ranking	Score	Feature	Within Range	Descriptive Field
<i>Channel Stability</i>	Good	0.5	303(d)	No	N/A
<i>Channel Alteration</i>	None	0	Wetland Species	Yes	1-3 FOCAL SPECIES IN UPLAND AREAS
<i>Bank Erosion</i>	Historic	0.5	Rare and Imperiled	Yes	GOLDSTRIPE DARTER, IRONCOLOR SHINER, SPECKLED CHUB
<i>BEHI</i>	High	1	Land Use/Cover	Yes	N/A / STREAMS AND WATERWAYS
<i>Local NPSP</i>	No Evidence	0	Candidate Mussels	No	N/A
<i>Shoring Structures</i>	Not Present	0	Sturgeon C.H.	No	N/A
<i>Pipe Discharge</i>	Not Present	0	<b>Additional Site Features</b>		
<i>Water Odors</i>	Not Present	0	<i>Stream Channel Woody Material:</i> Moderate		
<i>Fish Passage Barrier</i>	Not Present	0	<i>Impoundments:</i> None		
<i>RB: Riparian Buffer</i>	0-29 ft	0.75	<i>Substrate Composition:</i> Medium Sand		
<i>LB: Riparian Buffer</i>	100+ ft	0	<i>Bank Material:</i> Sand		
<i>RB: Floodplain Access</i>	Partial	0.25			
<i>LB: Floodplain Access</i>	Full	0

<b>River Threat Index:</b>		<b>3</b>

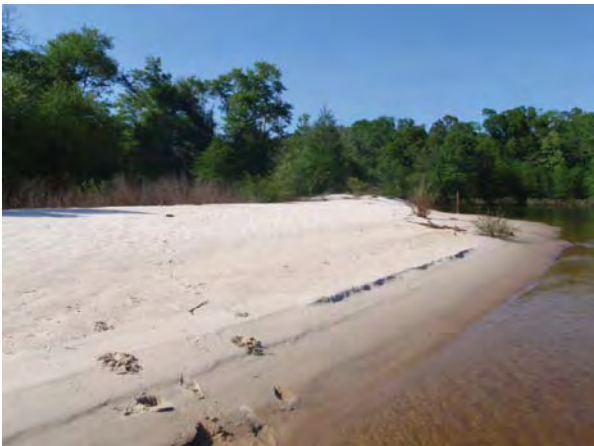
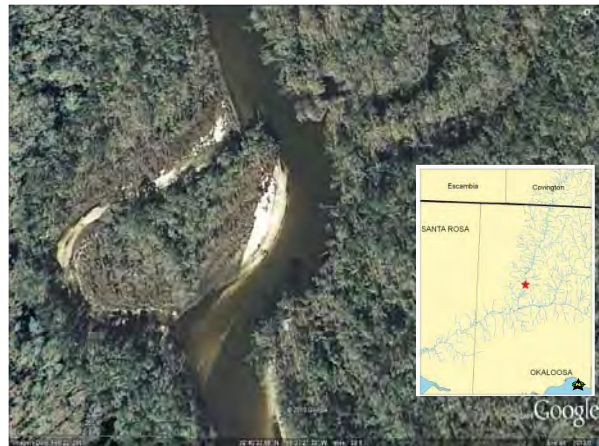
<b>Yellow River</b>	<b>ok-0424-009</b>	<i>Severity Score</i> <b>2.5</b>
---------------------	--------------------	-------------------------------------

Notes: Large aggradational site with some vegetation indicating it is not a recent deposit.

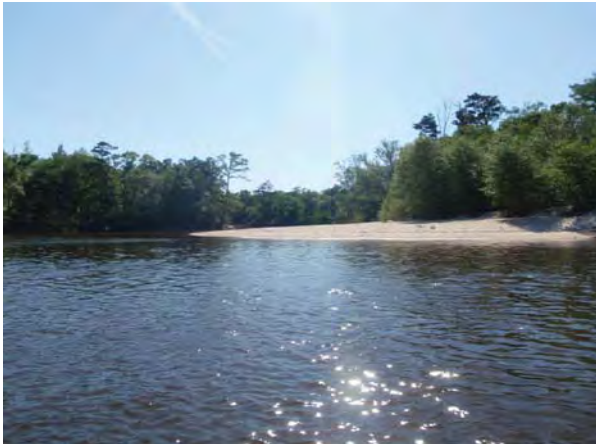
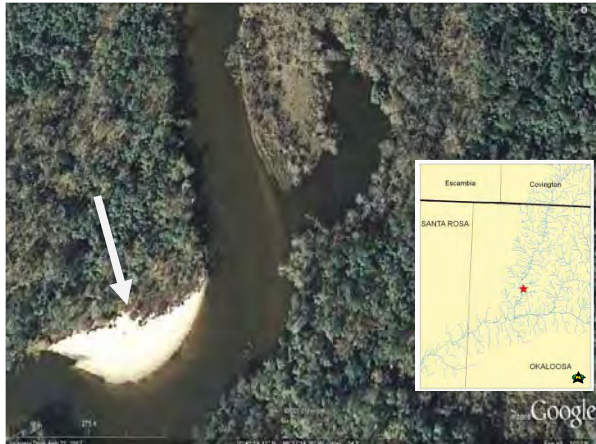
<b>RB</b>																																																																																		
<table border="1"> <thead> <tr> <th>Risk Factor</th> <th>Ranking</th> <th>Score</th> </tr> </thead> <tbody> <tr> <td><i>Channel Stability</i></td> <td>Poor</td> <td>1.5</td> </tr> <tr> <td><i>Channel Alteration</i></td> <td>None</td> <td>0</td> </tr> <tr> <td><i>Bank Erosion</i></td> <td>Historic</td> <td>0</td> </tr> <tr> <td><i>BEHI</i></td> <td>High</td> <td>1</td> </tr> <tr> <td><i>Local NPSP</i></td> <td>No Evidence</td> <td>0</td> </tr> <tr> <td><i>Shoring Structures</i></td> <td>Not Present</td> <td>0</td> </tr> <tr> <td><i>Pipe Discharge</i></td> <td>Not Present</td> <td>0</td> </tr> <tr> <td><i>Water Odors</i></td> <td>Not Present</td> <td>0</td> </tr> <tr> <td><i>Fish Passage Barrier</i></td> <td>Not Present</td> <td>0</td> </tr> <tr> <td><i>RB: Riparian Buffer</i></td> <td>100+ ft</td> <td>0</td> </tr> <tr> <td><i>LB: Riparian Buffer</i></td> <td>100+ ft</td> <td>0</td> </tr> <tr> <td><i>RB: Floodplain Access</i></td> <td>Full</td> <td>0</td> </tr> <tr> <td><i>LB: Floodplain Access</i></td> <td>Full</td> <td>0</td> </tr> <tr> <td colspan="2"><b>River Threat Index:</b></td> <td><b>2.5</b></td> </tr> </tbody> </table>	Risk Factor	Ranking	Score	<i>Channel Stability</i>	Poor	1.5	<i>Channel Alteration</i>	None	0	<i>Bank Erosion</i>	Historic	0	<i>BEHI</i>	High	1	<i>Local NPSP</i>	No Evidence	0	<i>Shoring Structures</i>	Not Present	0	<i>Pipe Discharge</i>	Not Present	0	<i>Water Odors</i>	Not Present	0	<i>Fish Passage Barrier</i>	Not Present	0	<i>RB: Riparian Buffer</i>	100+ ft	0	<i>LB: Riparian Buffer</i>	100+ ft	0	<i>RB: Floodplain Access</i>	Full	0	<i>LB: Floodplain Access</i>	Full	0	<b>River Threat Index:</b>		<b>2.5</b>	<table border="1"> <thead> <tr> <th>Feature</th> <th>Within Range</th> <th>Descriptive Field</th> </tr> </thead> <tbody> <tr> <td>303(d)</td> <td>Yes</td> <td>COLIFORMS, TURBIDITY, MERCURY</td> </tr> <tr> <td>Wetland Species</td> <td>Yes</td> <td>1-3 FOCAL SPECIES IN UPLAND AREAS</td> </tr> <tr> <td>Rare and Imperiled</td> <td>Yes</td> <td>ALABAMA SHAD, ALLIGATOR GAR, BLUENOSE SHINER, GULF STURGEON, SPECKLED CHUB, IRONCOLOR SHINER, SPOTTED BULLHEAD, SPECKLED DARTER</td> </tr> <tr> <td>Land Use/Cover</td> <td>Yes</td> <td>N/A / STREAMS AND WATERWAYS</td> </tr> <tr> <td>Candidate Mussels</td> <td>No</td> <td>N/A</td> </tr> <tr> <td>Sturgeon C.H.</td> <td>Yes</td> <td>N/A</td> </tr> <tr> <td colspan="3"><b>Additional Site Features</b></td> </tr> <tr> <td colspan="2"><i>Stream Channel Woody Material:</i></td> <td>Moderate</td> </tr> <tr> <td colspan="2"><i>Impoundments:</i></td> <td>None</td> </tr> <tr> <td colspan="2"><i>Substrate Composition:</i></td> <td>Medium Sand</td> </tr> <tr> <td colspan="2"><i>Bank Material:</i></td> <td>Sand</td> </tr> </tbody> </table>	Feature	Within Range	Descriptive Field	303(d)	Yes	COLIFORMS, TURBIDITY, MERCURY	Wetland Species	Yes	1-3 FOCAL SPECIES IN UPLAND AREAS	Rare and Imperiled	Yes	ALABAMA SHAD, ALLIGATOR GAR, BLUENOSE SHINER, GULF STURGEON, SPECKLED CHUB, IRONCOLOR SHINER, SPOTTED BULLHEAD, SPECKLED DARTER	Land Use/Cover	Yes	N/A / STREAMS AND WATERWAYS	Candidate Mussels	No	N/A	Sturgeon C.H.	Yes	N/A	<b>Additional Site Features</b>			<i>Stream Channel Woody Material:</i>		Moderate	<i>Impoundments:</i>		None	<i>Substrate Composition:</i>		Medium Sand	<i>Bank Material:</i>		Sand

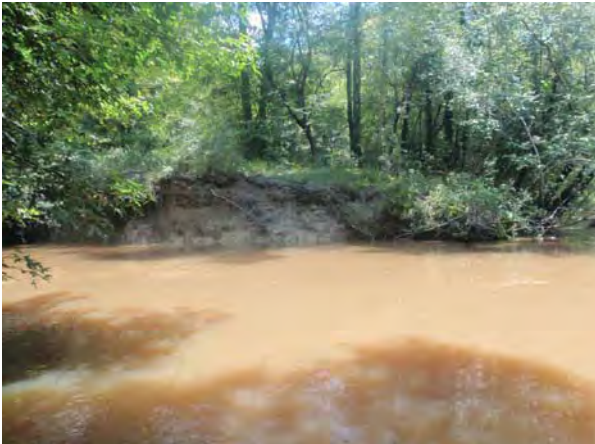
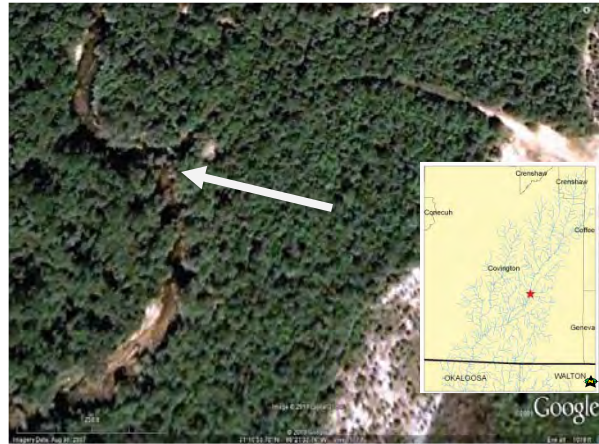
<h1>Yellow River</h1>	<h2>co-0813-001</h2>	<i>Severity Score</i> <h1>2.5</h1>
-----------------------	----------------------	---------------------------------------

Notes: Large logging operation directly west of this site with bare soil.

May be the cause of excessive turbidity and sedimentation downstream.

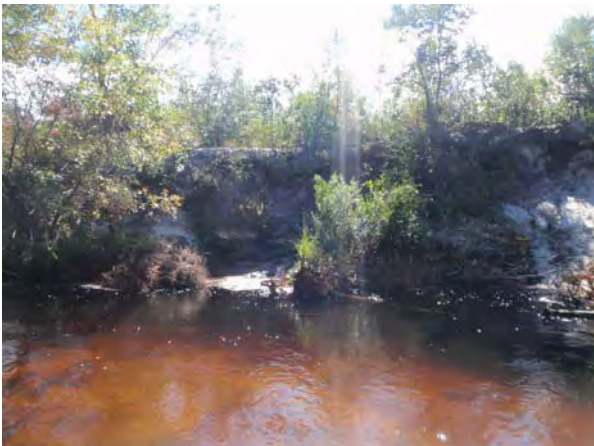
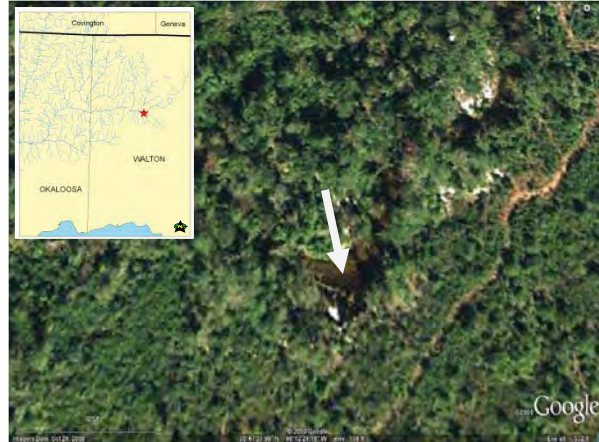
<b>Gum Creek</b>	<b>wa-1026-003</b>	<i>Severity Score</i> <b>2.25</b>
------------------	--------------------	--------------------------------------

Notes: Private road on top of left bank. Agricultural land use.

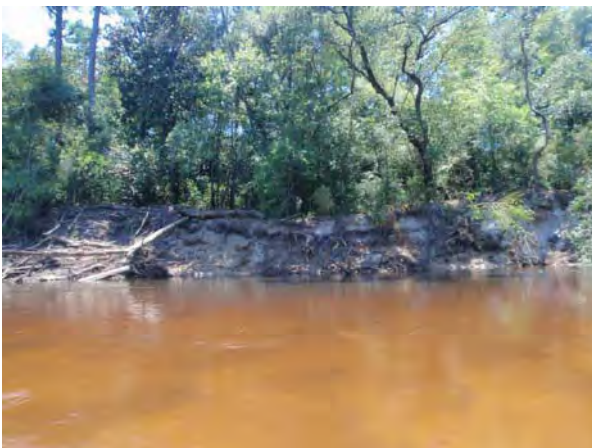
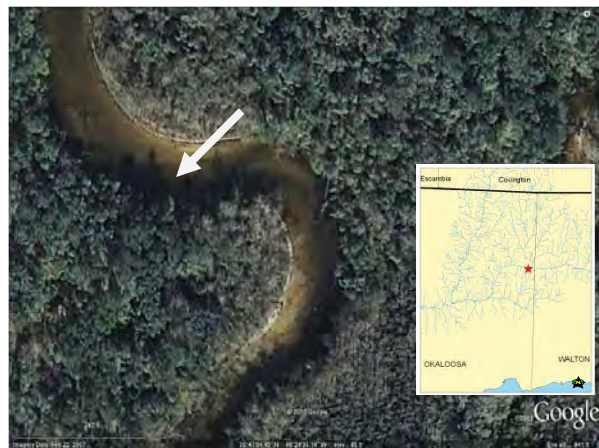
RB

Risk Factor	Ranking	Score	Feature	Within Range	Descriptive Field
<i>Channel Stability</i>	Good	0.5	303(d)	No	N/A
<i>Channel Alteration</i>	None	0	<b>Wetland Species</b>	Yes	1-3 FOCAL SPECIES IN UPLAND AREAS
<i>Bank Erosion</i>	Active	1	<b>Rare and Imperiled</b>	Yes	GOLDSTRIPE DARTER, IRONCOLOR SHINER, SPECKLED CHUB
<i>BEHI</i>	Moderate	0.5	<b>Land Use/Cover</b>	Yes	AGRICULTURAL/ STREAMS AND WATERWAYS
<i>Local NPSP</i>	No Evidence	0	<b>Candidate Mussels</b>	No	N/A
<i>Shoring Structures</i>	Not Present	0	<b>Sturgeon C.H.</b>	No	N/A
<i>Pipe Discharge</i>	Not Present	0	<b>Additional Site Features</b>		
<i>Water Odors</i>	Not Present	0	<i>Stream Channel Woody Material:</i> Moderate		
<i>Fish Passage Barrier</i>	Not Present	0	<i>Impoundments:</i> None		
<i>RB: Riparian Buffer</i>	100+ ft	0	<i>Substrate Composition:</i> Medium Sand		
<i>LB: Riparian Buffer</i>	100+ ft	0	<i>Bank Material:</i> Sand		
<i>RB: Floodplain Access</i>	Full	0

<i>LB: Floodplain Access</i>	Full	0			
<b>River Threat Index:</b>		<b>2</b>

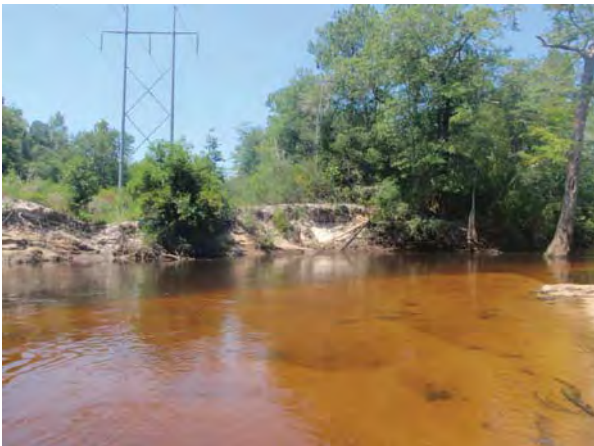
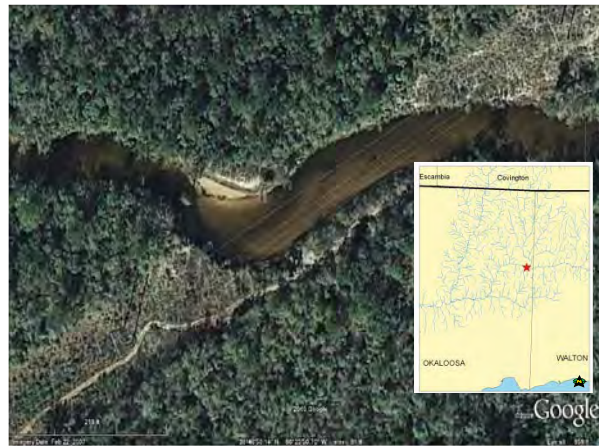
LB

Risk Factor	Ranking	Score	Feature	Within Range	Descriptive Field
<i>Channel Stability</i>	Good	0.5	303(d)	No	N/A
<i>Channel Alteration</i>	None	0	Wetland Species	Yes	1-3 FOCAL SPECIES IN UPLAND AREAS
<i>Bank Erosion</i>	Active	1	Rare and Imperiled	Yes	GOLDSTRIPE DARTER, IRONCOLOR SHINER, SPECKLED CHUB
<i>BEHI</i>	Moderate	0.5	Land Use/Cover	Yes	AGRICULTURAL/ ELECTRICAL POWER TRANSMISSION LINES
<i>Local NPSP</i>	No Evidence	0	Candidate Mussels	No	N/A
<i>Shoring Structures</i>	Not Present	0	Sturgeon C.H.	No	N/A
<i>Pipe Discharge</i>	Not Present	0	<b>Additional Site Features</b>		
<i>Water Odors</i>	Not Present	0	<i>Stream Channel Woody Material:</i> Infrequent		
<i>Fish Passage Barrier</i>	Not Present	0	<i>Impoundments:</i> None		
<i>RB: Riparian Buffer</i>	100+ ft	0	<i>Substrate Composition:</i> Medium Sand		
<i>LB: Riparian Buffer</i>	100+ ft	0	<i>Bank Material:</i> Sand		
<i>RB: Floodplain Access</i>	Full	0

<i>LB: Floodplain Access</i>	Full	0			
<b>River Threat Index:</b>		<b>2</b>

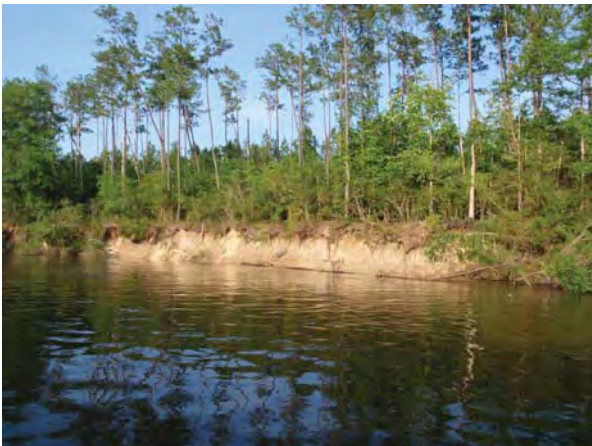
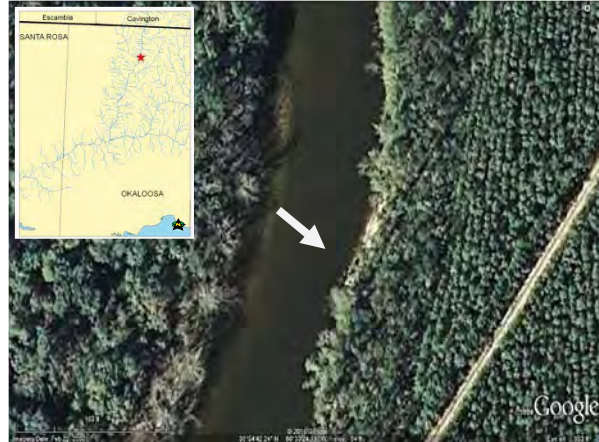
**LB**

Risk Factor	Ranking	Score	Feature	Within Range	Descriptive Field
<i>Channel Stability</i>	Good	0.5	<b>303(d)</b>	Yes	COLIFORMS, TURBIDITY, MERCURY
<i>Channel Alteration</i>	None	0	<b>Wetland Species</b>	Yes	1-3 FOCAL SPECIES IN UPLAND AREAS
<i>Bank Erosion</i>	Historic	0.5	<b>Rare and Imperiled</b>	Yes	ALABAMA SHAD, ALLIGATOR GAR, BLUENOSE SHINER, GULF STURGEON, SPECKLED CHUB, IRONCOLOR SHINER, SPOTTED BULLHEAD, SPECKLED DARTER
<i>BEHI</i>	Moderate	0.5	<b>Land Use/Cover</b>	Yes	N/A / STREAMS AND WATERWAYS
<i>Local NPSP</i>	No Evidence	0	<b>Candidate Mussels</b>	No	N/A
<i>Shoring Structures</i>	Not Present	0	<b>Sturgeon C.H.</b>	Yes	N/A
<i>Pipe Discharge</i>	Not Present	0	<b>Additional Site Features</b>		
<i>Water Odors</i>	Not Present	0	<i>Stream Channel Woody Material:</i> Infrequent		
<i>Fish Passage Barrier</i>	Not Present	0	<i>Impoundments:</i> None		
<i>RB: Riparian Buffer</i>	100+ ft	0	<i>Substrate Composition:</i> Medium Sand

<i>LB: Riparian Buffer</i>	50-99 ft	0.25	<i>Bank Material:</i> Clay		
<i>RB: Floodplain Access</i>	Full	0			
<i>LB: Floodplain Access</i>	Partial	0.25			
<b>River Threat Index:</b>		<b>2</b>

Notes: Silviculture land use. Unpaved private road on LB

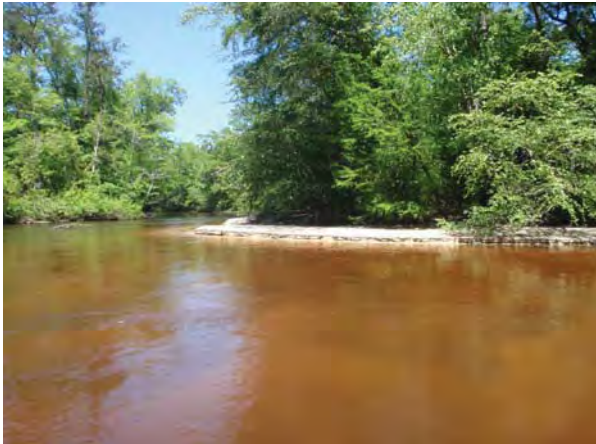
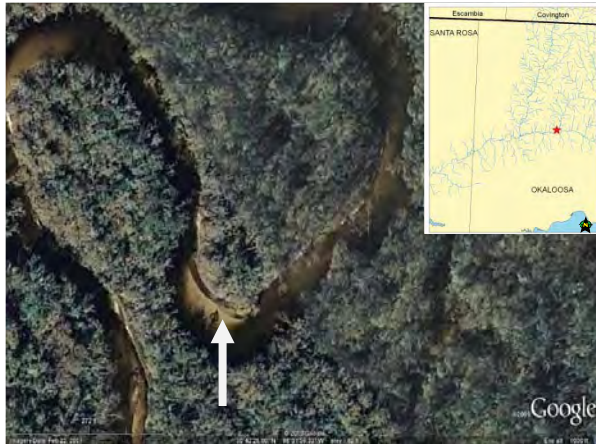
<b>RB</b>					
Risk Factor	Ranking	Score	Feature	Within Range	Descriptive Field
<i>Channel Stability</i>	Poor	1.5	303(d)	No	N/A
<i>Channel Alteration</i>	None	0	Wetland Species	Yes	1-3 FOCAL SPECIES IN UPLAND AREAS
<i>Bank Erosion</i>	Not Eroding	0	Rare and Imperiled	Yes	GOLDSTRIPE DARTER, IRONCOLOR SHINER, SPECKLED CHUB
<i>BEHI</i>	Moderate	0.5	Land Use/Cover	Yes	N/A / STREAMS AND WATERWAYS
<i>Local NPSP</i>	No Evidence	0	Candidate Mussels	No	N/A
<i>Shoring Structures</i>	Not Present	0	Sturgeon C.H.	No	N/A
<i>Pipe Discharge</i>	Not Present	0	<b>Additional Site Features</b>		
<i>Water Odors</i>	Not Present	0	<i>Stream Channel Woody Material:</i> Moderate

<i>Fish Passage Barrier</i>	Not Present	0	<i>Impoundments:</i> None		
<i>RB: Riparian Buffer</i>	100+ ft	0	<i>Substrate Composition:</i> Medium Sand		
<i>LB: Riparian Buffer</i>	100+ ft	0	<i>Bank Material:</i> Sand and Leaf Litter		
<i>RB: Floodplain Access</i>	Full	0			
<i>LB: Floodplain Access</i>	Full	0			
<b>River Threat Index:</b>		<b>2</b>

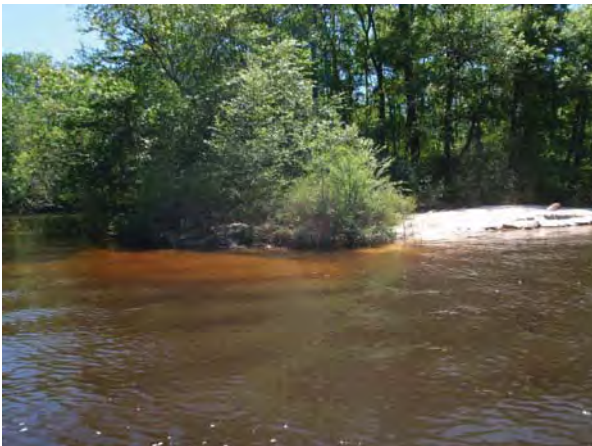
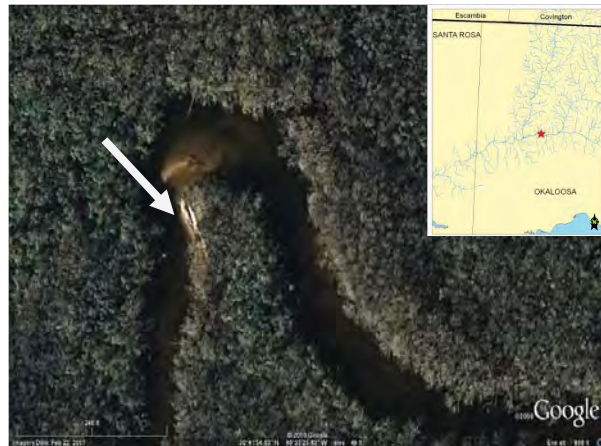
LB

Risk Factor	Ranking	Score	Feature	Within Range	Descriptive Field
<i>Channel Stability</i>	Poor	1.5	303(d)	No	N/A
<i>Channel Alteration</i>	None	0	Wetland Species	Yes	1-3 FOCAL SPECIES IN UPLAND AREAS
<i>Bank Erosion</i>	Not Eroding	0	Rare and Imperiled	Yes	GOLDSTRIPE DARTER, IRONCOLOR SHINER, SPECKLED CHUB
<i>BEHI</i>	Moderate	0.5	Land Use/Cover	Yes	N/A / STREAMS AND WATERWAYS
<i>Local NPSP</i>	No Evidence	0	Candidate Mussels	No	N/A
<i>Shoring Structures</i>	Not Present	0	Sturgeon C.H.	Yes	N/A
<i>Pipe Discharge</i>	Not Present	0	<b>Additional Site Features</b>		
<i>Water Odors</i>	Not Present	0	<i>Stream Channel Woody Material:</i> Numerous		
<i>Fish Passage Barrier</i>	Not Present	0	<i>Impoundments:</i> None		
<i>RB: Riparian Buffer</i>	100+ ft	0	<i>Substrate Composition:</i> Medium Sand and Coarse Sand		
<i>LB: Riparian Buffer</i>	100+ ft	0	<i>Bank Material:</i> Sand		
<i>RB: Floodplain Access</i>	Full	0

<i>LB: Floodplain Access</i>	Full	0			
<b>River Threat Index:</b>		<b>2</b>

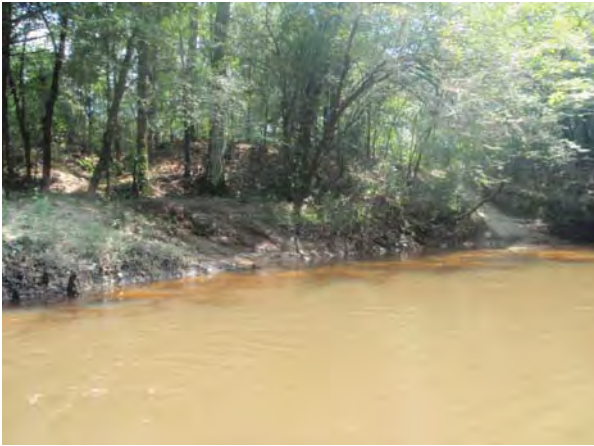
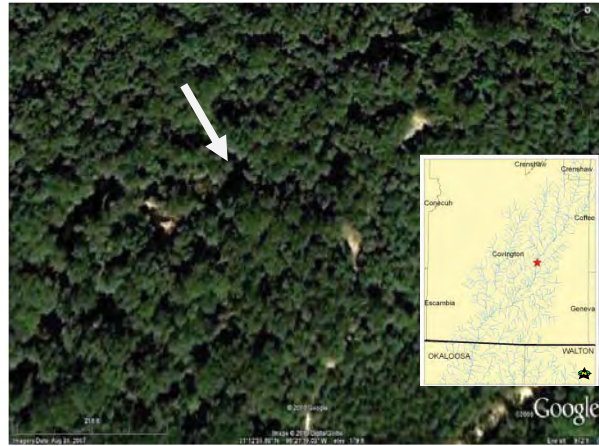
RB

Risk Factor	Ranking	Score	Feature	Within Range	Descriptive Field
<i>Channel Stability</i>	Fair	0.5	303(d)	No	N/A
<i>Channel Alteration</i>	None	0	Wetland Species	No	N/A
<i>Bank Erosion</i>	Historic	0.5	Rare and Imperiled	No	N/A
<i>BEHI</i>	High	0	Land Use/Cover	Yes	N/A / EAST GULF COASTAL PLAIN SMALL STREAM AND RIVER FLOODPLAIN FOREST
<i>Local NPSP</i>	Moderate Potential	1	Candidate Mussels	Yes	SOUTHERN SANDSHELL
<i>Shoring Structures</i>	Not Present	0	Sturgeon C.H.	No	N/A
<i>Pipe Discharge</i>	Not Present	0	<b>Additional Site Features</b>		
<i>Water Odors</i>	Not Present	0	<i>Stream Channel Woody Material:</i> Infrequent		
<i>Fish Passage Barrier</i>	Not Present	0	<i>Impoundments:</i> None		
<i>RB: Riparian Buffer</i>	100+ ft	0	<i>Substrate Composition:</i> Medium Sand		
<i>LB: Riparian Buffer</i>	100+ ft	0	<i>Bank Material:</i> Sand		
<i>RB: Floodplain Access</i>	Full	0			
<i>LB: Floodplain Access</i>	Full	0

<b>River Threat Index:</b>		<b>2</b>

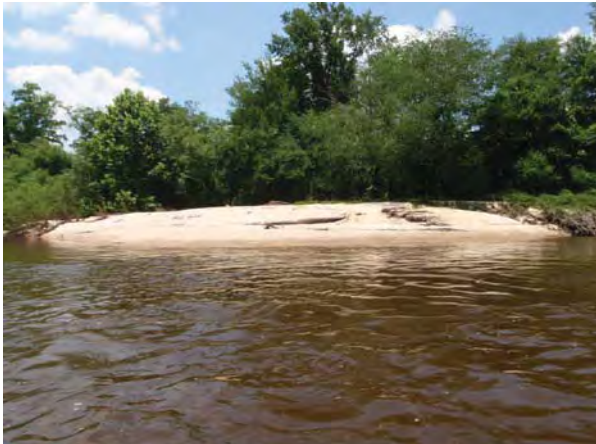
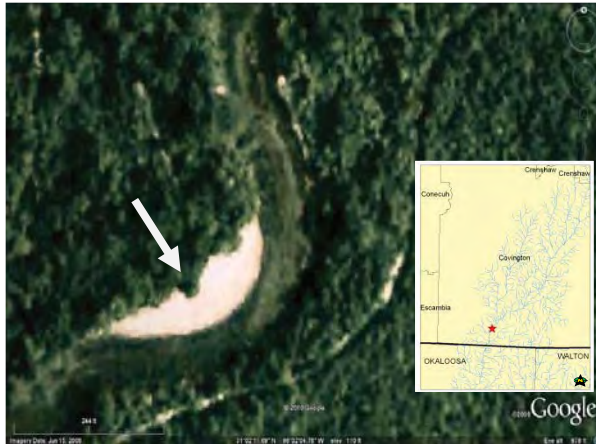
<p><b>RB</b></p>					
Risk Factor	Ranking	Score	Feature	Within Range	Descriptive Field
<i>Channel Stability</i>	Fair	1	303(d)	Yes	METALS- MERCURY
<i>Channel Alteration</i>	None	0	Wetland Species	No	N/A
<i>Bank Erosion</i>	Historic	0	Rare and Imperiled	No	N/A
<i>BEHI</i>	High	1	Land Use/Cover	No	N/A
<i>Local NPSP</i>	No Evidence	0	Candidate Mussels	No	N/A
<i>Shoring Structures</i>	Not Present	0	Sturgeon C.H.	Yes	N/A
<i>Pipe Discharge</i>	Not Present	0	<b>Additional Site Features</b>		
<i>Water Odors</i>	Not Present	0	<i>Stream Channel Woody Material:</i> Infrequent

<i>Fish Passage Barrier</i>	Not Present	0	<i>Impoundments:</i> None		
<i>RB: Riparian Buffer</i>	100+ ft	0	<i>Substrate Composition:</i> Medium Sand		
<i>LB: Riparian Buffer</i>	100+ ft	0	<i>Bank Material:</i> Sand		
<i>RB: Floodplain Access</i>	Full	0			
<i>LB: Floodplain Access</i>	Full	0			
<b>River Threat Index:</b>		<b>2</b>

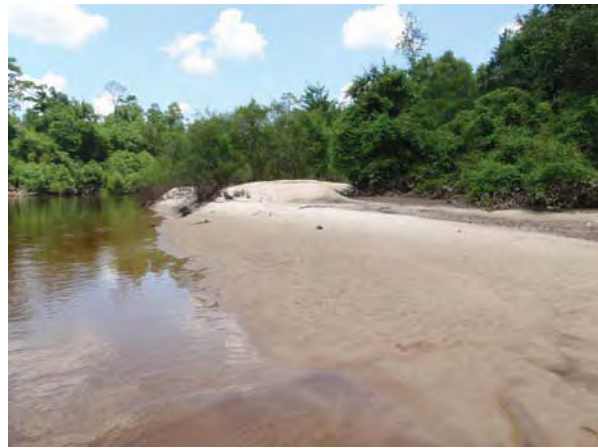
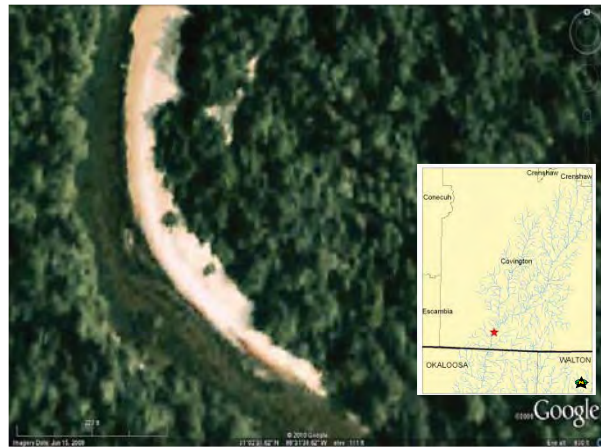
LB

Risk Factor	Ranking	Score	Feature	Within Range	Descriptive Field
<i>Channel Stability</i>	Fair	1	303(d)	Yes	METALS- MERCURY
<i>Channel Alteration</i>	None	0	Wetland Species	No	N/A
<i>Bank Erosion</i>	Not Eroding	0	Rare and Imperiled	No	N/A
<i>BEHI</i>	High	1	Land Use/ Cover	No	N/A
<i>Local NPSP</i>	No Evidence	0	Candidate Mussels	No	N/A
<i>Shoring Structures</i>	Not Present	0	Sturgeon C.H.	Yes	N/A
<i>Pipe Discharge</i>	Not Present	0	<b>Additional Site Features</b>		
<i>Water Odors</i>	Not Present	0	<i>Stream Channel Woody Material:</i> Infrequent		
<i>Fish Passage Barrier</i>	Not Present	0	<i>Impoundments:</i> None		
<i>RB: Riparian Buffer</i>	100+ ft	0	<i>Substrate Composition:</i> Clay Marl and Medium Sand		
<i>LB: Riparian Buffer</i>	100+ ft	0	<i>Bank Material:</i> Sand		
<i>RB: Floodplain Access</i>	Full	0			
<i>LB: Floodplain Access</i>	Full	0			
<b>River Threat Index:</b>		<b>2</b>

Notes: Large aggradational site.

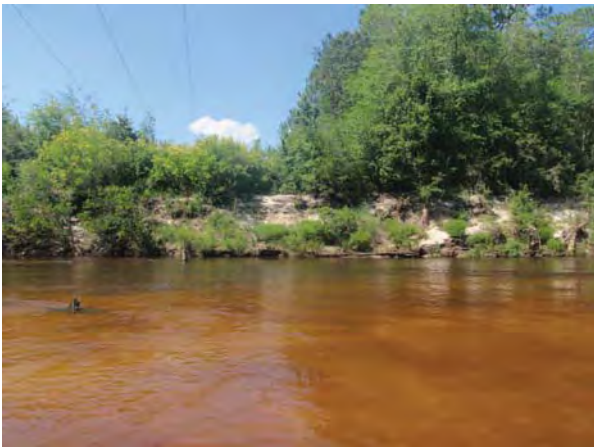
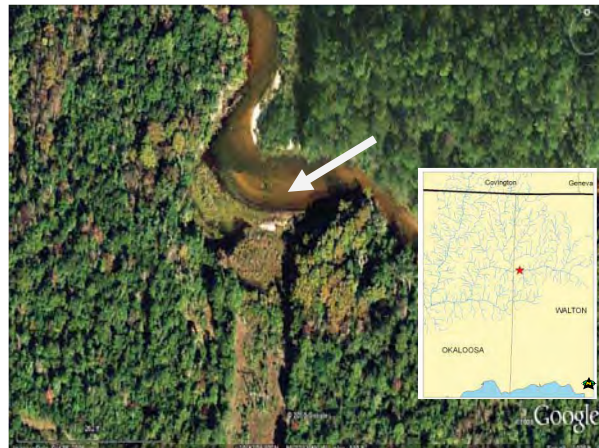
LB

Risk Factor	Ranking	Score	Feature	Within Range	Descriptive Field
<i>Channel Stability</i>	Fair	1	303(d)	No	N/A
<i>Channel Alteration</i>	None	0	<b>Wetland Species</b>	Yes	1-3 FOCAL SPECIES IN UPLAND AREAS
<i>Bank Erosion</i>	Historic	0.5	<b>Rare and Imperiled</b>	Yes	GOLDSTRIPE DARTER, IRONCOLOR SHINER, SPECKLED CHUB
<i>BEHI</i>	High	0	<b>Land Use/Cover</b>	No	N/A
<i>Local NPSP</i>	No Evidence	0	<b>Candidate Mussels</b>	No	N/A
<i>Shoring Structures</i>	Not Present	0	<b>Sturgeon C.H.</b>	No	N/A
<i>Pipe Discharge</i>	Not Present	0	<b>Additional Site Features</b>		
<i>Water Odors</i>	Not Present	0	<i>Stream Channel Woody Material:</i> Moderate		
<i>Fish Passage Barrier</i>	Not Present	0	<i>Impoundments:</i> None		
<i>RB: Riparian Buffer</i>	100+ ft	0	<i>Substrate Composition:</i> Medium Sand		
<i>LB: Riparian Buffer</i>	100+ ft	0	<i>Bank Material:</i> Sand		
<i>RB: Floodplain Access</i>	Partial	0.25			
<i>LB: Floodplain Access</i>	Full	0

<b>River Threat Index:</b>		<b>1.75</b>

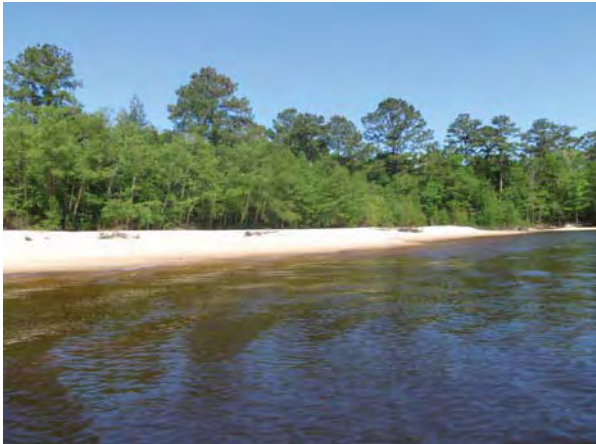
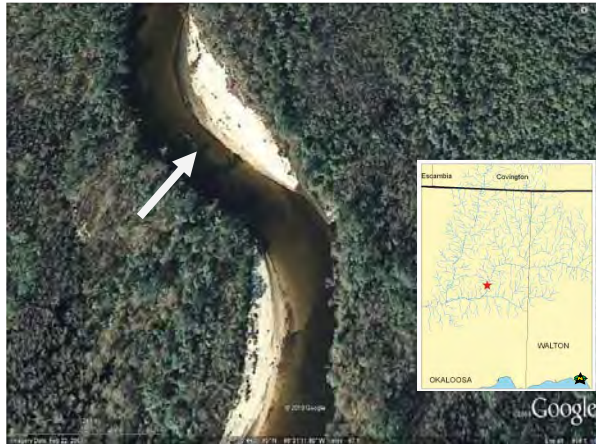
LB					
Risk Factor	Ranking	Score	Feature	Within Range	Descriptive Field
<i>Channel Stability</i>	Fair	1	303(d)	No	N/A
<i>Channel Alteration</i>	None	0	Wetland Species	Yes	1-3 FOCAL SPECIES IN UPLAND AREAS
<i>Bank Erosion</i>	Not eroding	0	Rare and Imperiled	Yes	GOLDSTRIPE DARTER, IRONCOLOR SHINER, SPECKLED CHUB
<i>BEHI</i>	Moderate	0.5	Land Use/Cover	Yes	N/A / STREAMS AND WATERWAYS
<i>Local NPSP</i>	No Evidence	0	Candidate Mussels	No	N/A
<i>Shoring Structures</i>	Not Present	0	Sturgeon C.H.	No	N/A
<i>Pipe Discharge</i>	Not Present	0	<b>Additional Site Features</b>		
<i>Water Odors</i>	Not Present	0	<i>Stream Channel Woody Material:</i> Moderate

<i>Fish Passage Barrier</i>	Not Present	0	<i>Impoundments:</i> None		
<i>RB: Riparian Buffer</i>	100+ ft	0	<i>Substrate Composition:</i> Medium and Fine Sand		
<i>LB: Riparian Buffer</i>	100+ ft	0	<i>Bank Material:</i> Sand		
<i>RB: Floodplain Access</i>	Partial	0.25			
<i>LB: Floodplain Access</i>	Full	0			
<b>River Threat Index:</b>		<b>1.75</b>

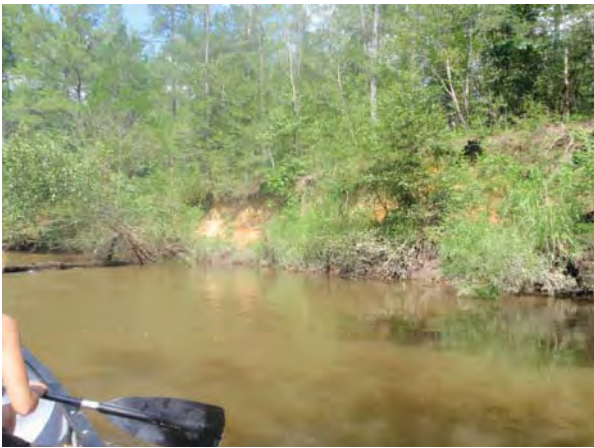
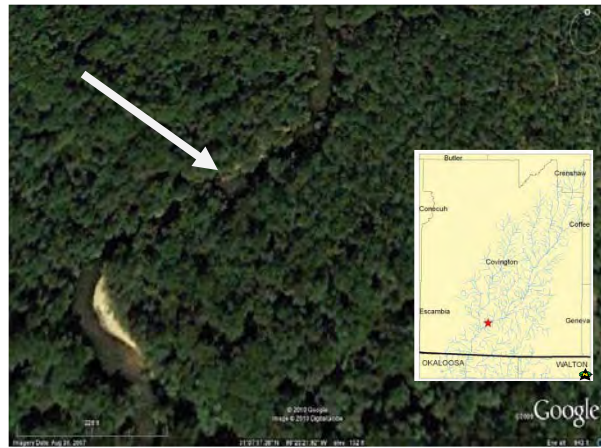
LB

Risk Factor	Ranking	Score	Feature	Within Range	Descriptive Field
<i>Channel Stability</i>	Good	0.5	303(d)	No	N/A
<i>Channel Alteration</i>	None	0	Wetland Species	No	N/A
<i>Bank Erosion</i>	Historic	0.5	Rare and Imperiled	No	N/A
<i>BEHI</i>	Moderate	0.5	Land Use/Cover	No	N/A
<i>Local NPSP</i>	No Evidence	0	Candidate Mussels	No	N/A
<i>Shoring Structures</i>	Not Present	0	Sturgeon C.H.	No	N/A
<i>Pipe Discharge</i>	Not Present	0	<b>Additional Site Features</b>		
<i>Water Odors</i>	Not Present	0	<i>Stream Channel Woody Material:</i> None		
<i>Fish Passage Barrier</i>	Not Present	0	<i>Impoundments:</i> None		
<i>RB: Riparian Buffer</i>	100+ ft	0	<i>Substrate Composition:</i> Medium Sand		
<i>LB: Riparian Buffer</i>	100+ ft	0	<i>Bank Material:</i> Sand		
<i>RB: Floodplain Access</i>	Full	0			
<i>LB: Floodplain Access</i>	Partial	0.25			
<b>River Threat Index:</b>		<b>1.75</b>

Notes: Natural meander incision. Highly vegetated bank.

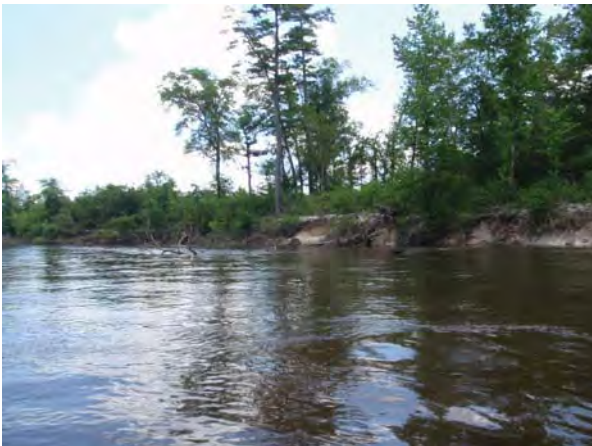
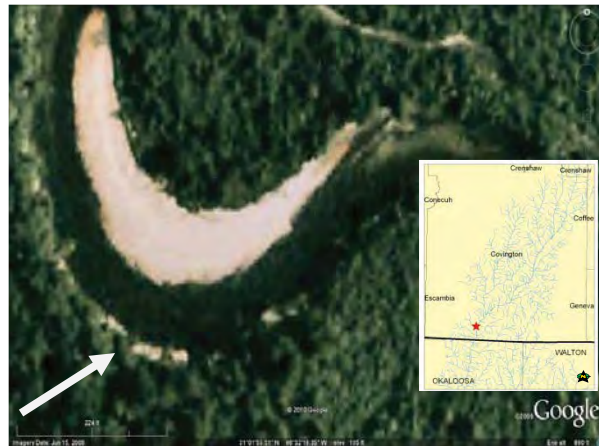
RB

Risk Factor	Ranking	Score	Feature	Within Range	Descriptive Field
<i>Channel Stability</i>	Fair	1	303(d)	Yes	METALS- MERCURY
<i>Channel Alteration</i>	None	0	Wetland Species	No	N/A
<i>Bank Erosion</i>	Historic	0.5	Rare and Imperiled	No	N/A
<i>BEHI</i>	Low- Very Low	0	Land Use/ Cover	Yes	N/A/ ROW CROP
<i>Local NPSP</i>	No Evidence	0	Candidate Mussels	No	N/A
<i>Shoring Structures</i>	Not Present	0	Sturgeon C.H.	Yes	N/A
<i>Pipe Discharge</i>	Not Present	0	<b>Additional Site Features</b>		
<i>Water Odors</i>	Not Present	0	<i>Stream Channel Woody Material:</i> Moderate		
<i>Fish Passage Barrier</i>	Not Present	0	<i>Impoundments:</i> None		
<i>RB: Riparian Buffer</i>	100+ ft	0	<i>Substrate Composition:</i> Medium Sand		
<i>LB: Riparian Buffer</i>	100+ ft	0	<i>Bank Material:</i> Sand and Roots		
<i>RB: Floodplain Access</i>	Partial	0.25			
<i>LB: Floodplain Access</i>	Full	0			
<b>River Threat Index:</b>		<b>1.75</b>

Notes: Nearby road runs parallel to river 60 feet east.

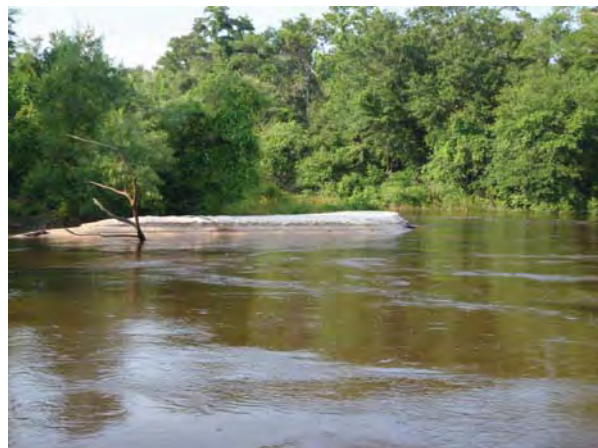
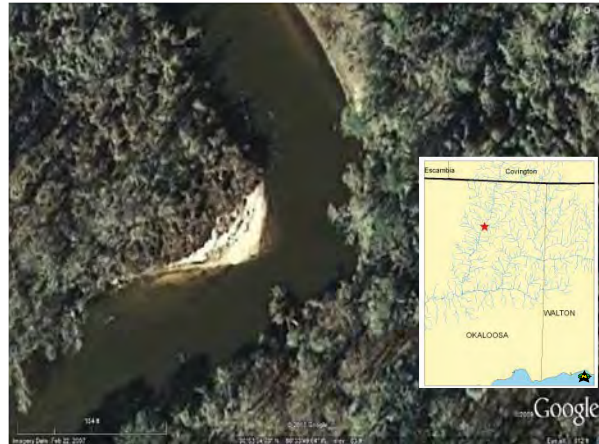
RB

Risk Factor	Ranking	Score	Feature	Within Range	Descriptive Field
<i>Channel Stability</i>	Good	0.5	303(d)	Yes	COLIFORMS, TURBIDITY, MERCURY
<i>Channel Alteration</i>	None	0	Wetland Species	No	N/A
<i>Bank Erosion</i>	Historic	0	Rare and Imperiled	Yes	ALABAMA SHAD, ALLIGATOR GAR, BLUENOSE SHINER, GULF STURGEON, SPECKLED CHUB, IRONCOLOR SHINER, SPOTTED BULLHEAD, SPECKLED DARTER
<i>BEHI</i>	High	1	Land Use/Cover	Yes	AGRICULTURAL/ STREAMS AND WATERWAYS
<i>Local NPSP</i>	No Evidence	0	Candidate Mussels	No	N/A
<i>Shoring Structures</i>	Not Present	0	Sturgeon C.H.	Yes	N/A
<i>Pipe Discharge</i>	Not Present	0	<b>Additional Site Features</b>		
<i>Water Odors</i>	Not Present	0	<i>Stream Channel Woody Material:</i> Infrequent		
<i>Fish Passage Barrier</i>	Not Present	0	<i>Impoundments:</i> None		
<i>RB: Riparian Buffer</i>	100+ ft	0	<i>Substrate Composition:</i> Medium Sand		
<i>LB: Riparian Buffer</i>	100+ ft	0	<i>Bank Material:</i> Sand

<i>RB: Floodplain Access</i>	Full	0			
<i>LB: Floodplain Access</i>	Full	0			
<b>River Threat Index:</b>		<b>1.5</b>

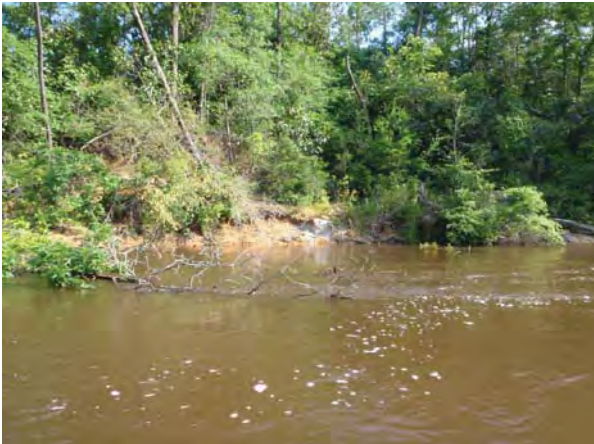
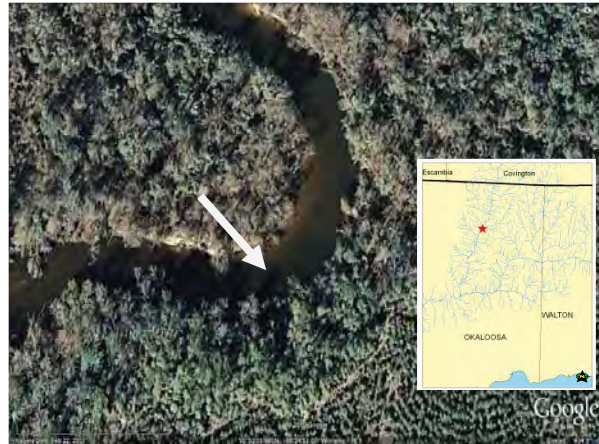
LB

Risk Factor	Ranking	Score	Feature	Within Range	Descriptive Field
<i>Channel Stability</i>	Good	0.5	<b>303(d)</b>	Yes	COLIFORMS, TURBIDITY, MERCURY
<i>Channel Alteration</i>	None	0	<b>Wetland Species</b>	No	N/A
<i>Bank Erosion</i>	Historic	0.5	<b>Rare and Imperiled</b>	Yes	ALABAMA SHAD, ALLIGATOR GAR, BLUENOSE SHINER, GULF STURGEON, SPECKLED CHUB, IRONCOLOR SHINER, SPOTTED BULLHEAD, SPECKLED DARTER
<i>Local NPSP</i>	No Evidence	0	<b>Land Use/Cover</b>	Yes	N/A / STREAMS AND WATERWAYS
<i>Shoring Structures</i>	Not Present	0	<b>Candidate Mussels</b>	No	N/A
<i>Pipe Discharge</i>	Not Present	0	<b>Sturgeon C.H.</b>	Yes	N/A
<i>Water Odors</i>	Not Present	0	<b>Additional Site Features</b>		
<i>Fish Passage Barrier</i>	Not Present	0	<i>Stream Channel Woody Material:</i> Moderate		
<i>RB: Riparian Buffer</i>	100+ ft	0	<i>Impoundments:</i> None		
<i>LB: Riparian Buffer</i>	100+ ft	0	<i>Substrate Composition:</i> Clay

<i>RB: Floodplain Access</i>	Full	0	<i>Bank Material:</i> Clay		
<i>LB: Floodplain Access</i>	Full	0			
<b>River Threat Index:</b>		<b>1.5</b>

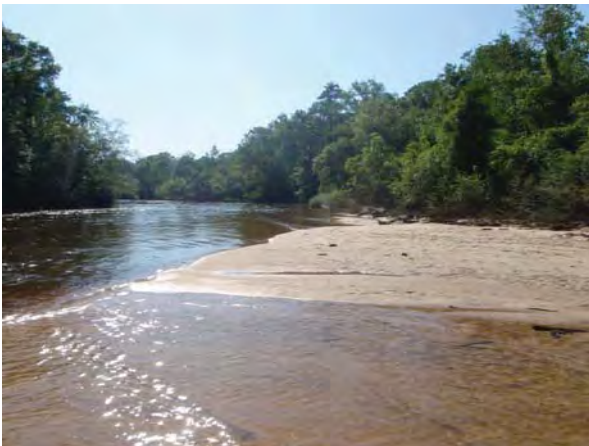
**RB**

*Common:* 3.2mi SW of Crestview      *County:* Okaloosa      *State:* Florida  
*Drainage:* Blackwater Bay      *GPS:* 30.757006293, -86.625170177      *PLSS:* 3N-24W-14  
*Land owner:* Gillis & Dixie Powell Jr.      *Parcel No.:* 1

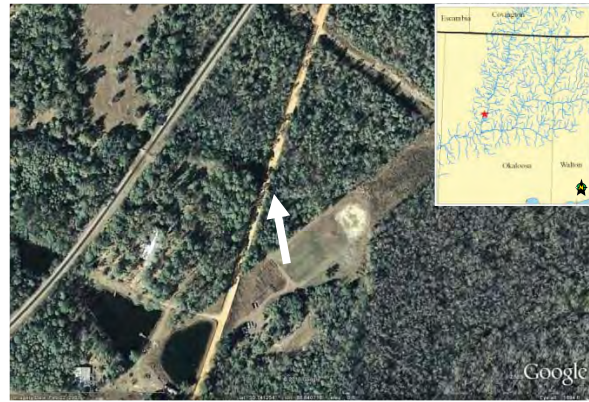
Notes: Private impounded system

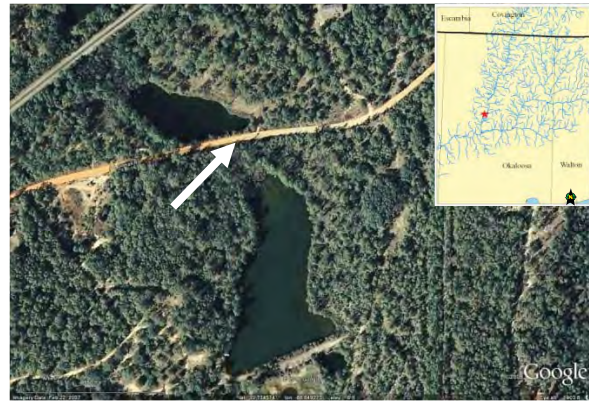
Notes: Crossing structure unknown- inaccessible due to fenced off private property.

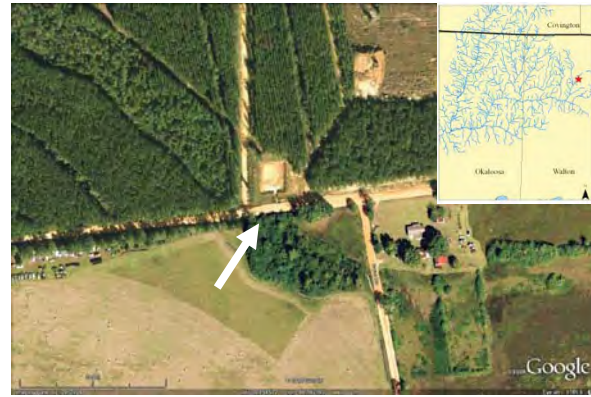
Notes: Sediment island forming in pond due to loading from culvert. Fencing across DS pond access.

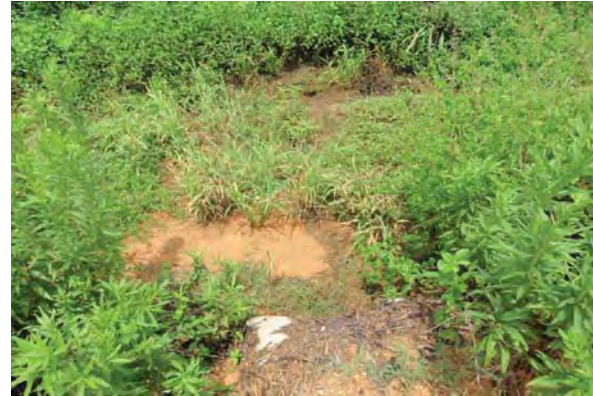
Risk Factor	Ranking	Score
<i>US Channel Morph</i>	D	1
<i>DS Channel Morph</i>	WETLAND	5
<i>DS Bank Alteration</i>	MINOR/PARTIAL	3
<i>Upstream Skew Angle</i>	>30°	1
<i>Crossing fill condition</i>	Poor/Bare soil	1
<i>Inlet/Outlet Condition</i>	No Impairment	5
<i>Road Approach Material</i>	All Sand/Clay	3
<i>Potential Eroded Volume Mean</i>	>40 y <sup>3</sup>	1
<i>Approach Slope Mean</i>	<2%	5
<i>Soil K Factor</i>	0.21-0.40	3
<i>Upstream Rt Outlet</i>	Bare soil	0
<i>Upstream Lt Outlet</i>	Bare soil	0
<i>Upstream Rt Ditch</i>	Bare soil	0
<i>Upstream Lt Ditch</i>	Bare soil	0
<i>Downstream Rt Outlet</i>	Vegetated	1
<i>Downstream Lt Outlet</i>	Vegetated	1
<i>Downstream Rt Ditch</i>	Bare soil	0
<i>Downstream Lt Ditch</i>	Bare soil	0
<i>Outlet Total</i>	Partially Improved Outlet System	3
<i>Ditches Total</i>	Unimproved Drainage System	1
<b>SRI Total</b>	<b>High Risk</b>	<b>32</b>
