Appendix A. River corridor severity scores for impaired sites in the Yellow River Basin, Alabama and Florida

Appendix C. Clear Creek Watershed Focal Area. Sites with orange headings are unpaved road sites. Specific definitions and calculations described for calculating the Sediment Risk Index (SRI) are detailed in Witmer (2009).

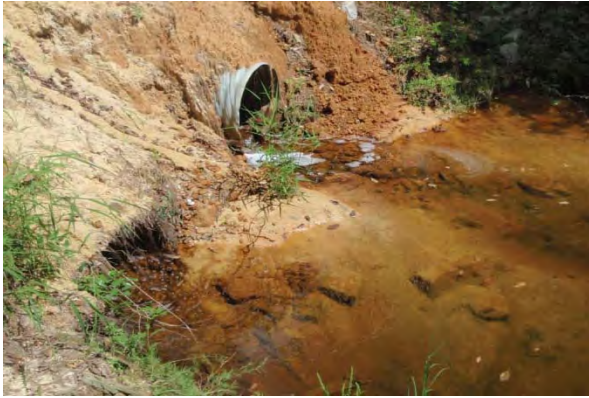
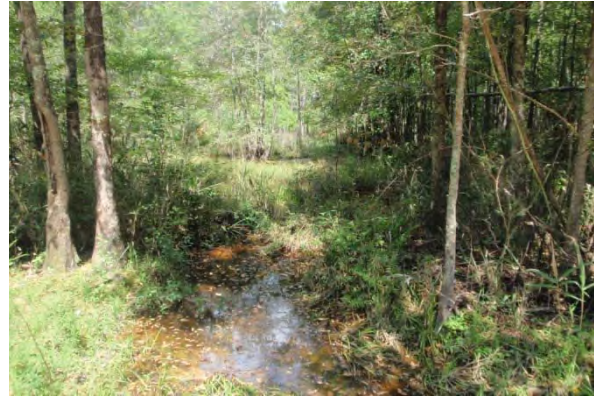
Unnamed tributary	co-0904-r-005	Sedimentation Risk Index <b>34</b>
-------------------	---------------	---------------------------------------

Risk Factor	Ranking	Score
<i>US Channel Morph</i>	WETLAND	5
<i>DS Channel Morph</i>	C	5
<i>DS Bank Alteration</i>	HIGH	1
<i>Upstream Skew Angle</i>	<5°	5
<i>Crossing fill condition</i>	Poor/Bare soil	1
<i>Inlet/Outlet Condition</i>	Sed Islands/Scouring	3
<i>Road Approach Material</i>	All Sand/Clay	3
<i>Potential Eroded Volume Mean</i>	<21 y <sup>3</sup>	5
<i>Approach Slope Mean</i>	>4%	1
<i>Soil K Factor</i>	0.21-0.40	3
<i>Upstream Rt Outlet</i>	Bare soil	0
<i>Upstream Lt Outlet</i>	Bare soil	0
<i>Upstream Rt Ditch</i>	Bare soil	0
<i>Upstream Lt Ditch</i>	Bare soil	0
<i>Downstream Rt Outlet</i>	Bare soil	0
<i>Downstream Lt Outlet</i>	Bare soil	0
<i>Downstream Rt Ditch</i>	Bare soil	0
<i>Downstream Lt Ditch</i>	Bare soil	0
<i>Outlet Total</i>	Unimproved Outlet System	1
<i>Ditches Total</i>	Unimproved Drainage System	1
<b>SRI Total</b>	<b>High Risk</b>	<b>34</b>

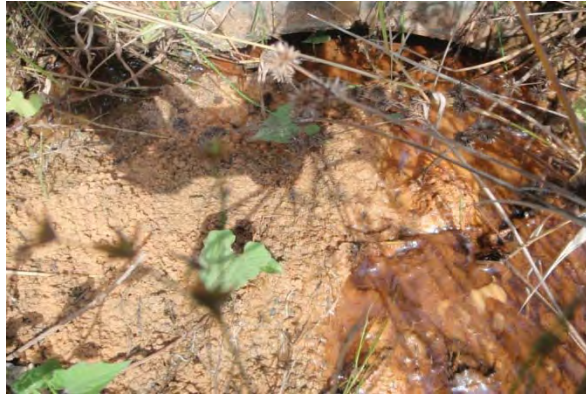
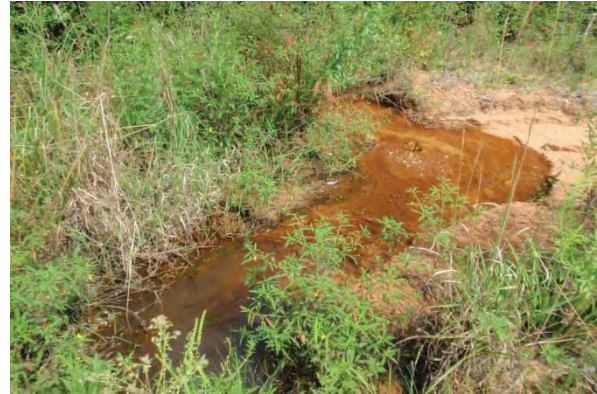
Unnamed tributary	co-0904-r-013	Sedimentation Risk Index <b>34</b>
-------------------	---------------	---------------------------------------

Risk Factor	Ranking	Score
<i>US Channel Morph</i>	DA	3
<i>DS Channel Morph</i>	E	5
<i>DS Bank Alteration</i>	HIGH	1
<i>Upstream Skew Angle</i>	>30°	1
<i>Crossing fill condition</i>	Poor/Bare soil	1
<i>Inlet/Outlet Condition</i>	Blocked	1
<i>Road Approach Material</i>	All Sand/Clay	3
<i>Potential Eroded Volume Mean</i>	<21 y <sup>3</sup>	5
<i>Approach Slope Mean</i>	2.1-4%	3
<i>Soil K Factor</i>	<0.20	5
<i>Upstream Rt Outlet</i>	Vegetated	1
<i>Upstream Lt Outlet</i>	Vegetated	1
<i>Upstream Rt Ditch</i>	Vegetated	1
<i>Upstream Lt Ditch</i>	Vegetated	1
<i>Downstream Rt Outlet</i>	Bare soil	0
<i>Downstream Lt Outlet</i>	Vegetated	1
<i>Downstream Rt Ditch</i>	Bare soil	0
<i>Downstream Lt Ditch</i>	Vegetated	1
<i>Outlet Total</i>	Partially Improved Outlet System	3
<i>Ditches Total</i>	Partially Improved Drainage System	3
<b>SRI Total</b>	<b>High Risk</b>	<b>34</b>

Notes: Culvert mostly buried. Ponded farther US.

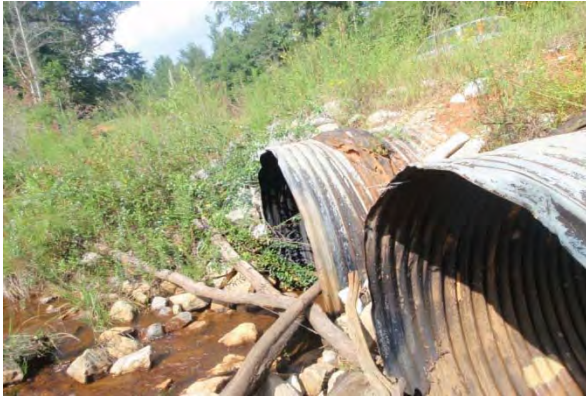
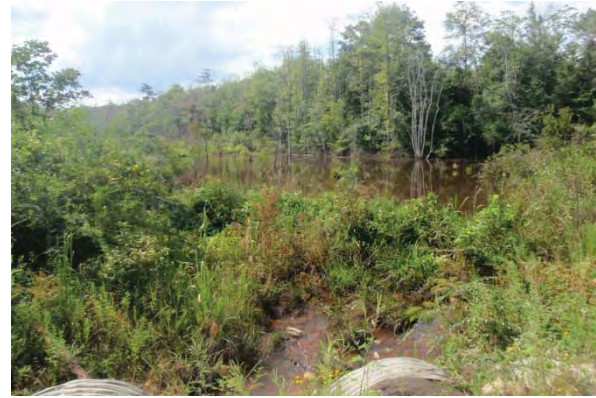
Unnamed tributary	co-0904-r-014	Sedimentation Risk Index <b>34</b>
-------------------	---------------	---------------------------------------

Risk Factor	Ranking	Score
<i>US Channel Morph</i>	PONDED	1
<i>DS Channel Morph</i>	DA	3
<i>DS Bank Alteration</i>	HIGH	1
<i>Upstream Skew Angle</i>	5-30°	3
<i>Crossing fill condition</i>	Fair/Rip Rap	3
<i>Inlet/Outlet Condition</i>	No Impairment	5
<i>Road Approach Material</i>	All Sand/Clay	3
<i>Potential Eroded Volume Mean</i>	<21 y <sup>3</sup>	5
<i>Approach Slope Mean</i>	>4%	1
<i>Soil K Factor</i>	<0.20	5
<i>Upstream Rt Outlet</i>	Vegetated	1
<i>Upstream Lt Outlet</i>	Bare soil	0
<i>Upstream Rt Ditch</i>	Bare soil	0
<i>Upstream Lt Ditch</i>	Bare soil	0
<i>Downstream Rt Outlet</i>	Bare soil	0
<i>Downstream Lt Outlet</i>	Vegetated	1
<i>Downstream Rt Ditch</i>	Bare soil	0
<i>Downstream Lt Ditch</i>	Bare soil	0
<i>Outlet Total</i>	Partially Improved Outlet System	3
<i>Ditches Total</i>	Unimproved Drainage System	1
<b>SRI Total</b>	<b>High Risk</b>	<b>34</b>

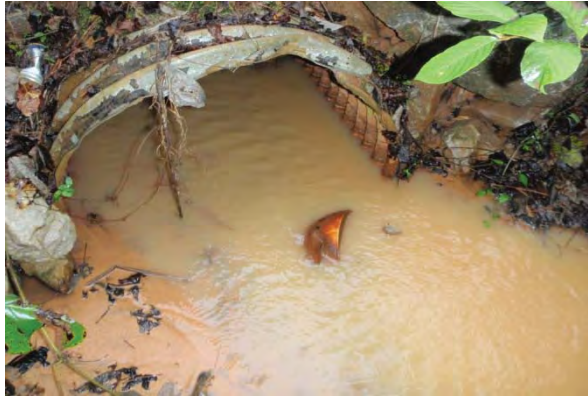
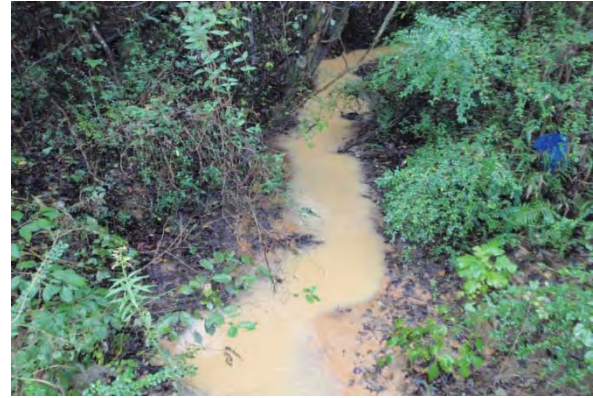
Unnamed tributary	co-1027-r-007	Sedimentation Risk Index <b>34</b>
-------------------	---------------	---------------------------------------

Risk Factor	Ranking	Score
US Channel Morph	PONDED	1
DS Channel Morph	C	5
DS Bank Alteration	HIGH	1
Upstream Skew Angle	5-30°	3
Crossing fill condition	Poor/Bare soil	1
Inlet/Outlet Condition	No Impairment	5
Road Approach Material	All Sand/Clay	3
Potential Eroded Volume Mean	21-40 y <sup>3</sup>	3
Approach Slope Mean	2.1-4%	3
Soil K Factor	<0.20	5
Upstream Rt Outlet	Bare soil	0
Upstream Lt Outlet	Bare soil	0
Upstream Rt Ditch	Bare soil	0
Upstream Lt Ditch	Bare soil	0
Downstream Rt Outlet	Vegetated	1
Downstream Lt Outlet	Bare soil	0
Downstream Rt Ditch	Bare soil	0
Downstream Lt Ditch	Bare soil	0
Outlet Total	Partially Improved Outlet System	3
Ditches Total	Unimproved Drainage System	1
<b>SRI Total</b>	<b>High Risk</b>	<b>34</b>

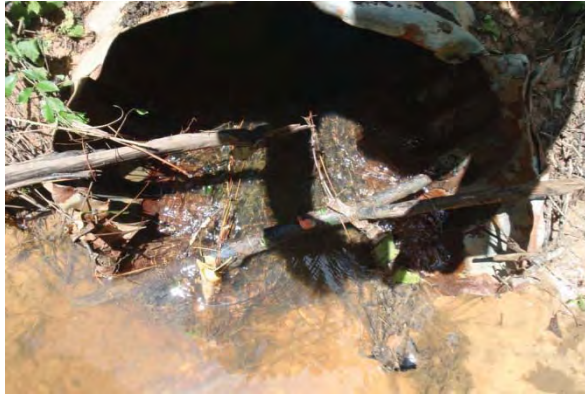
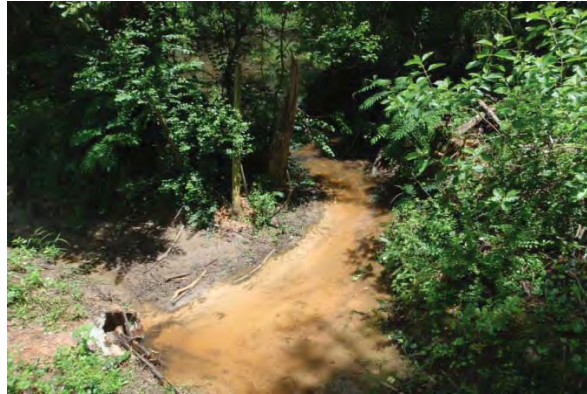
<h1>Unnamed tributary</h1>	<h2>ok-0526-r-007</h2>	<b>Sedimentation Risk Index</b> <h1>34</h1>
----------------------------	------------------------	--

Risk Factor	Ranking	Score
<i>US Channel Morph</i>	PONDED	1
<i>DS Channel Morph</i>	DA	3
<i>DS Bank Alteration</i>	HIGH	1
<i>Upstream Skew Angle</i>	5-30°	3
<i>Crossing fill condition</i>	Poor/Bare soil	1
<i>Inlet/Outlet Condition</i>	Sed Islands/Scouring	3
<i>Road Approach Material</i>	All Sand/Clay	3
<i>Potential Eroded Volume Mean</i>	21-40 y <sup>3</sup>	3
<i>Approach Slope Mean</i>	<2%	5
<i>Soil K Factor</i>	<0.20	5
<i>Upstream Rt Outlet</i>	Vegetated	1
<i>Upstream Lt Outlet</i>	Vegetated	1
<i>Upstream Rt Ditch</i>	Bare soil	0
<i>Upstream Lt Ditch</i>	Bare soil	0
<i>Downstream Rt Outlet</i>	Vegetated	1
<i>Downstream Lt Outlet</i>	Vegetated	1
<i>Downstream Rt Ditch</i>	Bare soil	0
<i>Downstream Lt Ditch</i>	Bare soil	0
<i>Outlet Total</i>	Improved Outlet System	5
<i>Ditches Total</i>	Unimproved Drainage System	1
<b>SRI Total</b>	<b>High Risk</b>	<b>34</b>

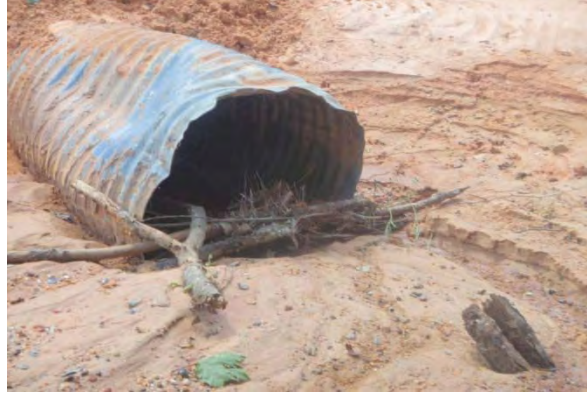
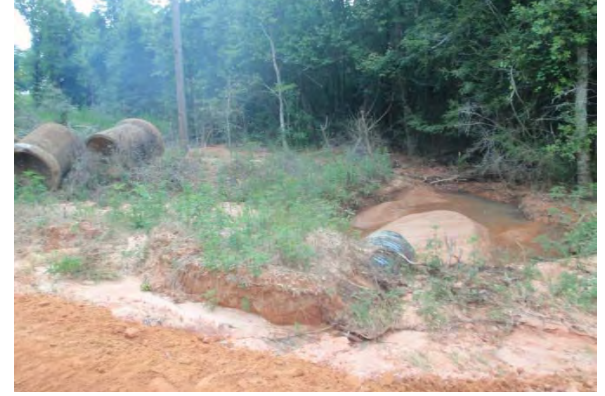
Unnamed tributary	wa-0714-r-009	Sedimentation Risk Index <b>34</b>
-------------------	---------------	---------------------------------------

Risk Factor	Ranking	Score
<i>US Channel Morph</i>	DA	3
<i>DS Channel Morph</i>	WETLAND	5
<i>DS Bank Alteration</i>	HIGH	1
<i>Upstream Skew Angle</i>	5-30°	3
<i>Crossing fill condition</i>	Poor/Bare soil	1
<i>Inlet/Outlet Condition</i>	Sed Islands/Scouring	3
<i>Road Approach Material</i>	All Sand/Clay	3
<i>Potential Eroded Volume Mean</i>	>40 y <sup>3</sup>	1
<i>Approach Slope Mean</i>	<2%	5
<i>Soil K Factor</i>	<0.20	5
<i>Upstream Rt Outlet</i>	Bare soil	0
<i>Upstream Lt Outlet</i>	Bare soil	0
<i>Upstream Rt Ditch</i>	Bare soil	0
<i>Upstream Lt Ditch</i>	Bare soil	0
<i>Downstream Rt Outlet</i>	Vegetated	1
<i>Downstream Lt Outlet</i>	Bare soil	0
<i>Downstream Rt Ditch</i>	Bare soil	0
<i>Downstream Lt Ditch</i>	Bare soil	0
<i>Outlet Total</i>	Partially Improved Outlet System	3
<i>Ditches Total</i>	Unimproved Drainage System	1
<b>SRI Total</b>	<b>High Risk</b>	<b>34</b>

Notes: Directly DS from impounded system of previous crossing.

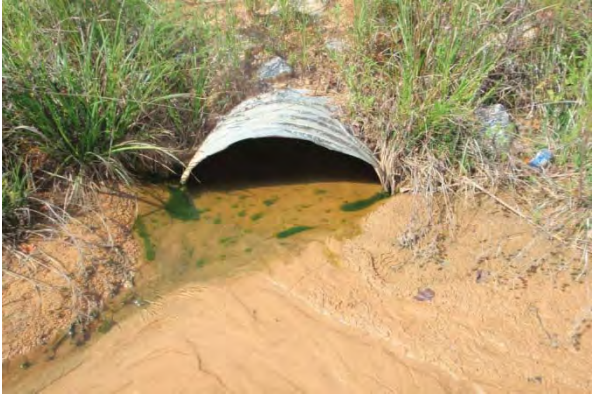
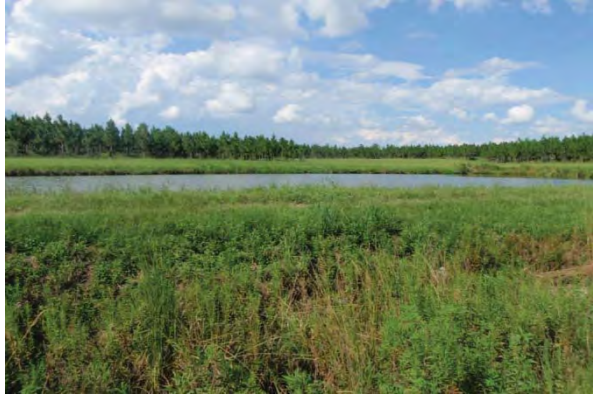
Unnamed tributary	co-0904-r-015	Sedimentation Risk Index <b>36</b>
-------------------	---------------	---------------------------------------

Risk Factor	Ranking	Score
<i>US Channel Morph</i>	PONDED	1
<i>DS Channel Morph</i>	E	5
<i>DS Bank Alteration</i>	HIGH	1
<i>Upstream Skew Angle</i>	>30°	1
<i>Crossing fill condition</i>	Fair/Rip Rap	3
<i>Inlet/Outlet Condition</i>	Sed Islands/Scouring	3
<i>Road Approach Material</i>	All Sand/Clay	3
<i>Potential Eroded Volume Mean</i>	<21 y <sup>3</sup>	5
<i>Approach Slope Mean</i>	2.1-4%	3
<i>Soil K Factor</i>	0.21-0.40	3
<i>Upstream Rt Outlet</i>	Vegetated	1
<i>Upstream Lt Outlet</i>	Vegetated	1
<i>Upstream Rt Ditch</i>	Vegetated	1
<i>Upstream Lt Ditch</i>	Vegetated	1
<i>Downstream Rt Outlet</i>	Rip Rap	1
<i>Downstream Lt Outlet</i>	Rip Rap	1
<i>Downstream Rt Ditch</i>	Bare soil	0
<i>Downstream Lt Ditch</i>	Bare soil	0
<i>Outlet Total</i>	Improved Outlet System	5
<i>Ditches Total</i>	Partially Improved Drainage System	3
<b>SRI Total</b>	<b>High Risk</b>	<b>36</b>

Notes: Fencing across DS.

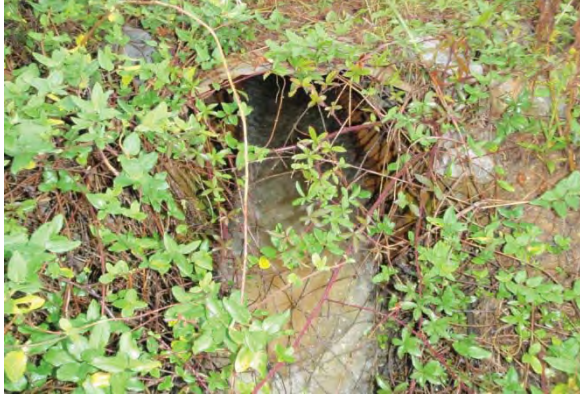
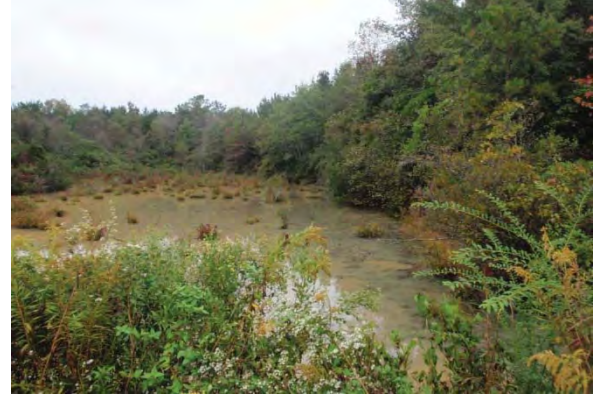
Unnamed tributary	co-1027-r-005	Sedimentation Risk Index <b>36</b>
-------------------	---------------	---------------------------------------

Risk Factor	Ranking	Score
<i>US Channel Morph</i>	WETLAND	5
<i>DS Channel Morph</i>	PONDED	1
<i>DS Bank Alteration</i>	HIGH	1
<i>Upstream Skew Angle</i>	<5°	5
<i>Crossing fill condition</i>	Fair/Rip Rap	3
<i>Inlet/Outlet Condition</i>	Sed Islands/Scouring	3
<i>Road Approach Material</i>	All Sand/Clay	3
<i>Potential Eroded Volume Mean</i>	>40 y <sup>3</sup>	1
<i>Approach Slope Mean</i>	2.1-4%	3
<i>Soil K Factor</i>	<0.20	5
<i>Upstream Rt Outlet</i>	Vegetated	1
<i>Upstream Lt Outlet</i>	Bare soil	0
<i>Upstream Rt Ditch</i>	Bare soil	0
<i>Upstream Lt Ditch</i>	Bare soil	0
<i>Downstream Rt Outlet</i>	Vegetated	1
<i>Downstream Lt Outlet</i>	Rip Rap	1
<i>Downstream Rt Ditch</i>	Vegetated	1
<i>Downstream Lt Ditch</i>	Rip Rap	1
<i>Outlet Total</i>	Partially Improved Outlet System	3
<i>Ditches Total</i>	Partially Improved Drainage System	3
<b>SRI Total</b>	<b>High Risk</b>	<b>36</b>

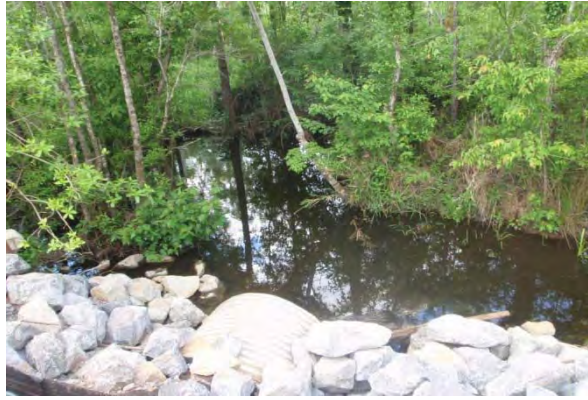
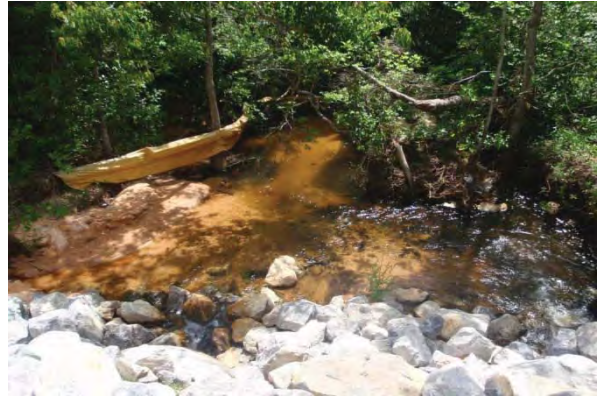
<h1 style="margin:0;">Indigo Creek</h1>	<h2 style="margin:0;">ok-0429-r-002</h2>	<i>Sedimentation Risk Index</i> <h1 style="margin:0;">36</h1>
---	--	--

Risk Factor	Ranking	Score
<i>US Channel Morph</i>	BEAVER DAM	3
<i>DS Channel Morph</i>	DA	3
<i>DS Bank Alteration</i>	HIGH	1
<i>Upstream Skew Angle</i>	5-30°	3
<i>Crossing fill condition</i>	Fair/Rip Rap	3
<i>Inlet/Outlet Condition</i>	Sed Islands/Scouring	3
<i>Road Approach Material</i>	All Sand/Clay	3
<i>Potential Eroded Volume Mean</i>	<21 y <sup>3</sup>	5
<i>Approach Slope Mean</i>	2.1-4%	3
<i>Soil K Factor</i>	0.21-0.40	3
<i>Upstream Rt Outlet</i>	Rip Rap	1
<i>Upstream Lt Outlet</i>	Rip Rap	1
<i>Upstream Rt Ditch</i>	Bare soil	0
<i>Upstream Lt Ditch</i>	Bare soil	0
<i>Downstream Rt Outlet</i>	Rip Rap	1
<i>Downstream Lt Outlet</i>	Rip Rap	1
<i>Downstream Rt Ditch</i>	Bare soil	0
<i>Downstream Lt Ditch</i>	Bare soil	0
<i>Outlet Total</i>	Improved Outlet System	5
<i>Ditches Total</i>	Unimproved Drainage System	1
<b><i>SRI Total</i></b>	<b>High Risk</b>	<b>36</b>

Notes: Turbidity curtain DS and silt fencing in place both US/DS. Failing BMPs.

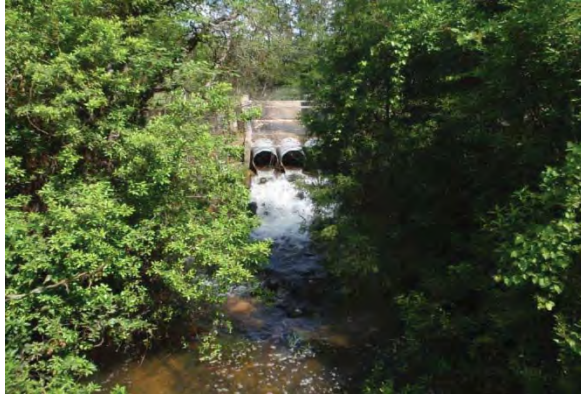
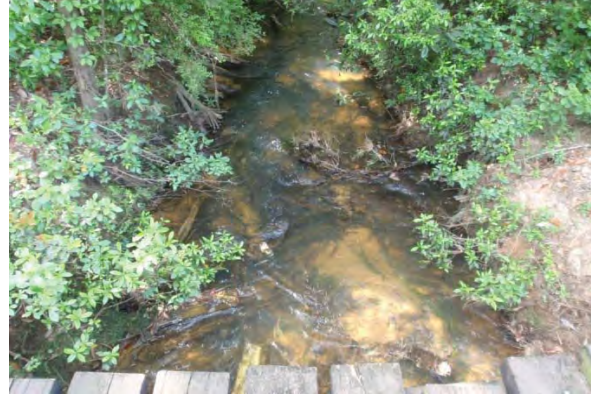
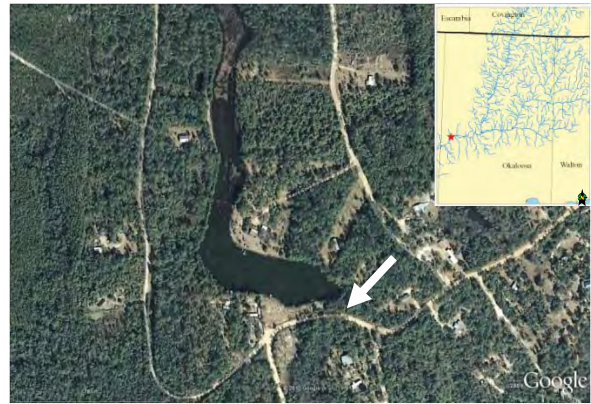
<b>Canoe Creek</b>	<b>ok-0429-r-001</b>	<i>Sedimentation Risk Index</i> <b>38</b>
--------------------	----------------------	--

Notes: Impoundment causing fish blockage. 3 culverts US 30ft from bridge.

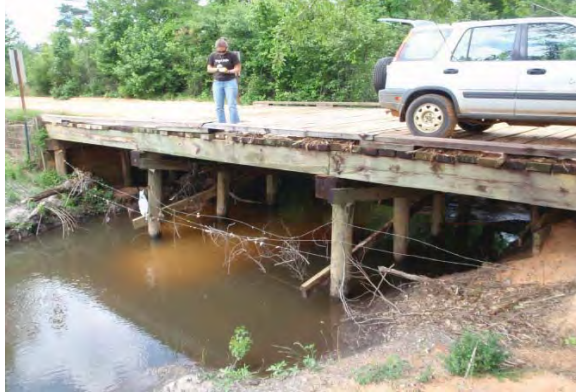
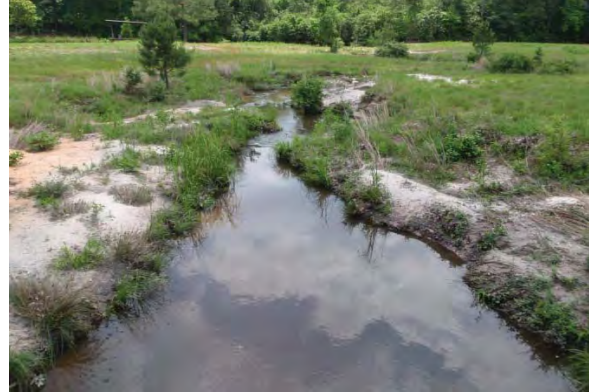
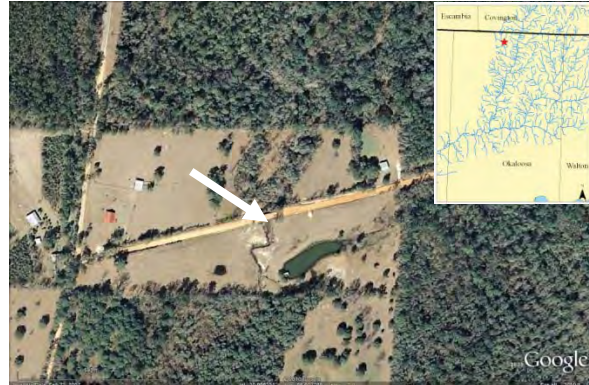
Notes: Wire spanning under bridge. DS.

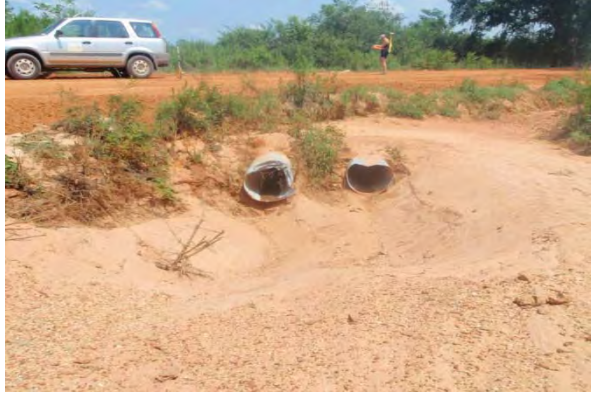
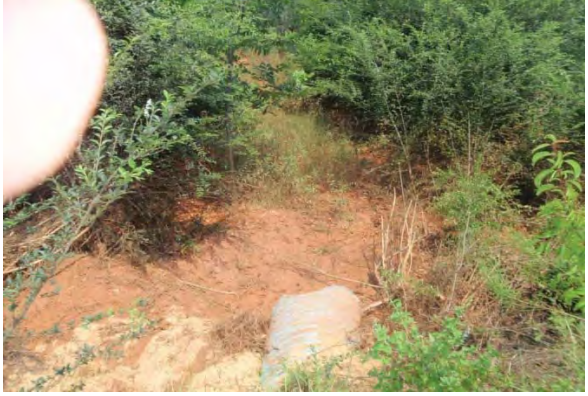
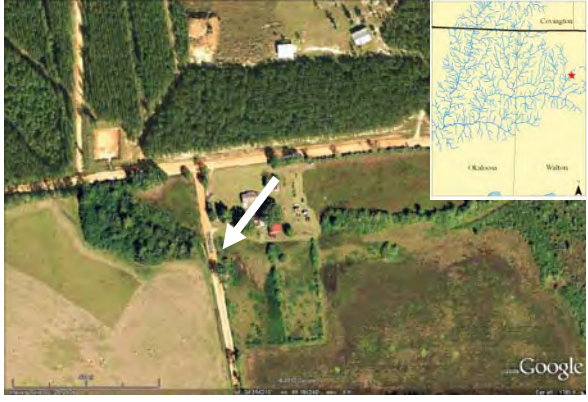
Unnamed tributary	wa-0714-r-007	Sedimentation Risk Index <b>38</b>
-------------------	---------------	---------------------------------------

Notes: Impounded system directly DS at next crossing.

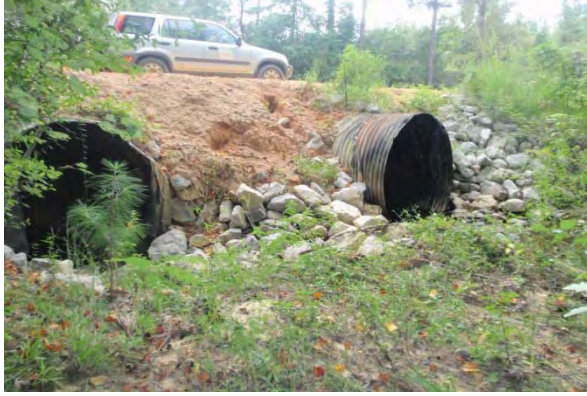
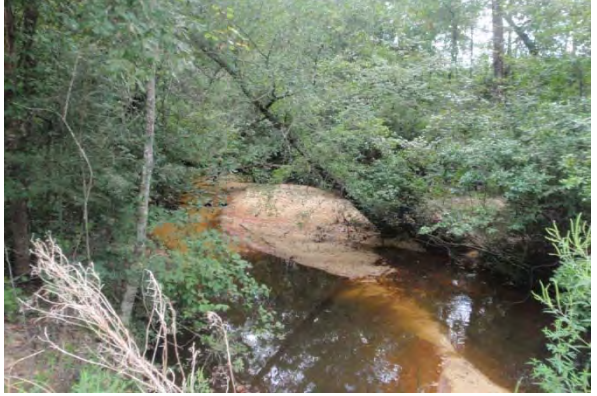
<b>Unnamed tributary</b>	<b>co-0904-r-010</b>	<i>Sedimentation Risk Index</i> <b>40</b>
--------------------------	----------------------	--

Risk Factor	Ranking	Score
<i>US Channel Morph</i>	C	5
<i>DS Channel Morph</i>	C	5
<i>DS Bank Alteration</i>	HIGH	1
<i>Upstream Skew Angle</i>	<5°	5
<i>Crossing fill condition</i>	Fair/Rip Rap	3
<i>Inlet/Outlet Condition</i>	Sed Islands/Scouring	3
<i>Road Approach Material</i>	All Sand/Clay	3
<i>Potential Eroded Volume Mean</i>	<21 y <sup>3</sup>	5
<i>Approach Slope Mean</i>	2.1-4%	3
<i>Soil K Factor</i>	<0.20	5
<i>Upstream Rt Outlet</i>	Bare soil	0
<i>Upstream Lt Outlet</i>	Bare soil	0
<i>Upstream Rt Ditch</i>	Bare soil	0
<i>Upstream Lt Ditch</i>	Bare soil	0
<i>Downstream Rt Outlet</i>	Bare soil	0
<i>Downstream Lt Outlet</i>	Bare soil	0
<i>Downstream Rt Ditch</i>	Bare soil	0
<i>Downstream Lt Ditch</i>	Bare soil	0
<i>Outlet Total</i>	Unimproved Outlet System	1
<i>Ditches Total</i>	Unimproved Drainage System	1
<b><i>SRI Total</i></b>	<b>Medium Risk</b>	<b>40</b>

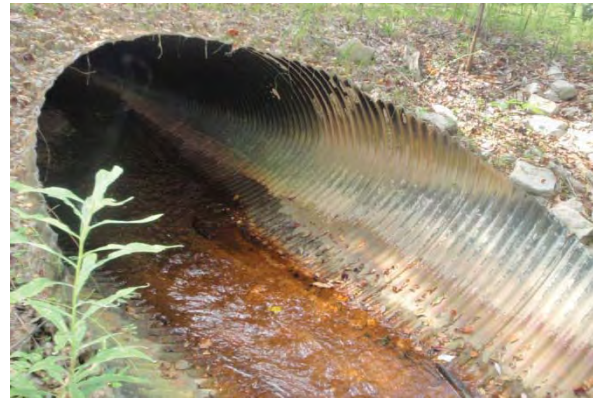
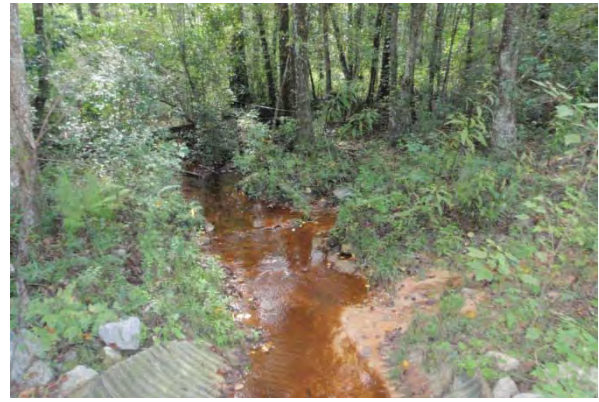
Unnamed tributary	co-0904-r-012	Sedimentation Risk Index <b>40</b>
-------------------	---------------	---------------------------------------

Risk Factor	Ranking	Score
<i>US Channel Morph</i>	WETLAND	5
<i>DS Channel Morph</i>	C	5
<i>DS Bank Alteration</i>	HIGH	1
<i>Upstream Skew Angle</i>	<5°	5
<i>Crossing fill condition</i>	Fair/Rip Rap	3
<i>Inlet/Outlet Condition</i>	Sed Islands/Scouring	3
<i>Road Approach Material</i>	All Sand/Clay	3
<i>Potential Eroded Volume Mean</i>	<21 y <sup>3</sup>	5
<i>Approach Slope Mean</i>	>4%	1
<i>Soil K Factor</i>	<0.20	5
<i>Upstream Rt Outlet</i>	Vegetated	1
<i>Upstream Lt Outlet</i>	Bare soil	0
<i>Upstream Rt Ditch</i>	Bare soil	0
<i>Upstream Lt Ditch</i>	Bare soil	0
<i>Downstream Rt Outlet</i>	Bare soil	0
<i>Downstream Lt Outlet</i>	Vegetated	1
<i>Downstream Rt Ditch</i>	Bare soil	0
<i>Downstream Lt Ditch</i>	Bare soil	0
<i>Outlet Total</i>	Partially Improved Outlet System	3
<i>Ditches Total</i>	Unimproved Drainage System	1
<b>SRI Total</b>	<b>Medium Risk</b>	<b>40</b>

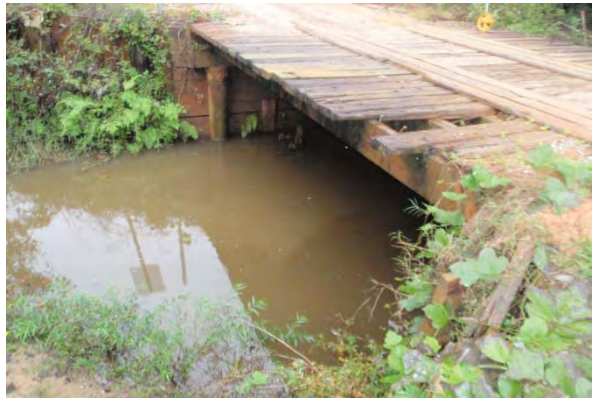
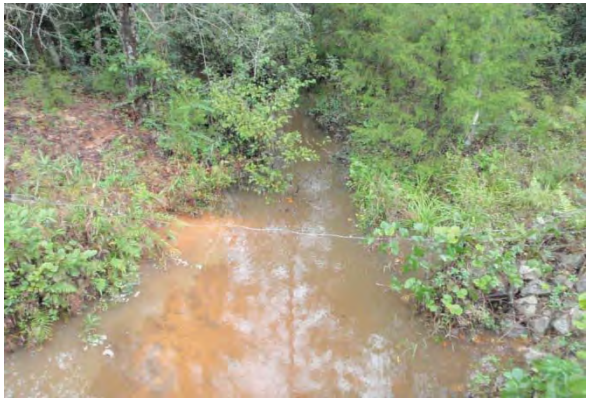
<h1>Mulberry Creek</h1>	<h2>co-1027-r-006</h2>	<b>Sedimentation Risk Index</b> <h1>40</h1>
-------------------------	------------------------	--

Risk Factor	Ranking	Score
<i>US Channel Morph</i>	C	5
<i>DS Channel Morph</i>	C	5
<i>DS Bank Alteration</i>	MINOR/PARTIAL	3
<i>Upstream Skew Angle</i>	<5°	5
<i>Crossing fill condition</i>	Fair/Rip Rap	3
<i>Inlet/Outlet Condition</i>	No Impairment	5
<i>Road Approach Material</i>	All Sand/Clay	3
<i>Potential Eroded Volume Mean</i>	>40 y <sup>3</sup>	1
<i>Approach Slope Mean</i>	>4%	1
<i>Soil K Factor</i>	<0.20	5
<i>Upstream Rt Outlet</i>	Bare soil	0
<i>Upstream Lt Outlet</i>	Vegetated	1
<i>Upstream Rt Ditch</i>	Bare soil	0
<i>Upstream Lt Ditch</i>	Bare soil	0
<i>Downstream Rt Outlet</i>	Bare soil	0
<i>Downstream Lt Outlet</i>	Vegetated	1
<i>Downstream Rt Ditch</i>	Bare soil	0
<i>Downstream Lt Ditch</i>	Bare soil	0
<b>Outlet Total</b>	Partially Improved Outlet System	3
<b>Ditches Total</b>	Unimproved Drainage System	1
<b>SRI Total</b>	<b>Medium Risk</b>	<b>40</b>

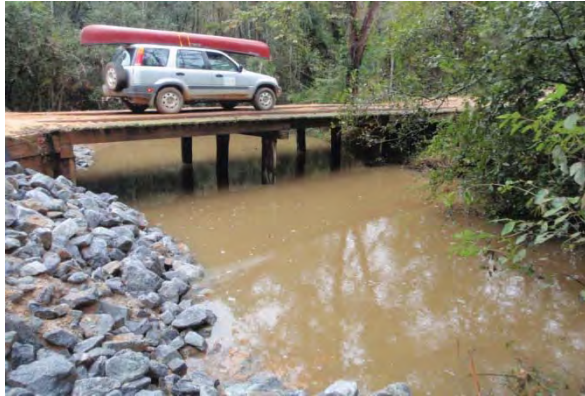
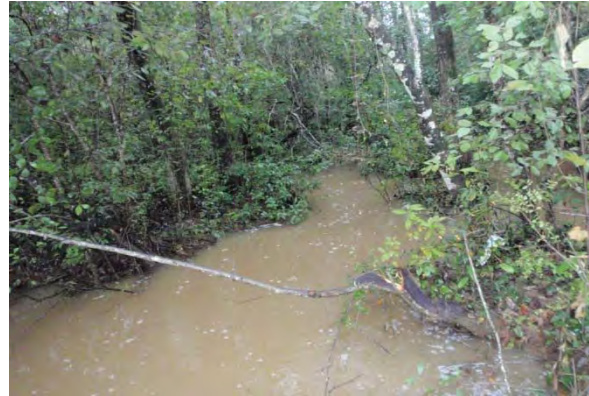
Unnamed tributary	co-1027-r-008	Sedimentation Risk Index <b>40</b>
-------------------	---------------	---------------------------------------

Risk Factor	Ranking	Score
<i>US Channel Morph</i>	DA	3
<i>DS Channel Morph</i>	E	5
<i>DS Bank Alteration</i>	HIGH	1
<i>Upstream Skew Angle</i>	<5°	5
<i>Crossing fill condition</i>	Fair/Rip Rap	3
<i>Inlet/Outlet Condition</i>	No Impairment	5
<i>Road Approach Material</i>	All Sand/Clay	3
<i>Potential Eroded Volume Mean</i>	>40 y <sup>3</sup>	1
<i>Approach Slope Mean</i>	>4%	1
<i>Soil K Factor</i>	<0.20	5
<i>Upstream Rt Outlet</i>	Vegetated	1
<i>Upstream Lt Outlet</i>	Rip Rap	1
<i>Upstream Rt Ditch</i>	Bare soil	0
<i>Upstream Lt Ditch</i>	Rip Rap	1
<i>Downstream Rt Outlet</i>	Vegetated	1
<i>Downstream Lt Outlet</i>	Rip Rap	1
<i>Downstream Rt Ditch</i>	Vegetated	1
<i>Downstream Lt Ditch</i>	Bare soil	0
<i>Outlet Total</i>	Improved Outlet System	5
<i>Ditches Total</i>	Partially Improved Drainage System	3
<b>SRI Total</b>	<b>Medium Risk</b>	<b>40</b>

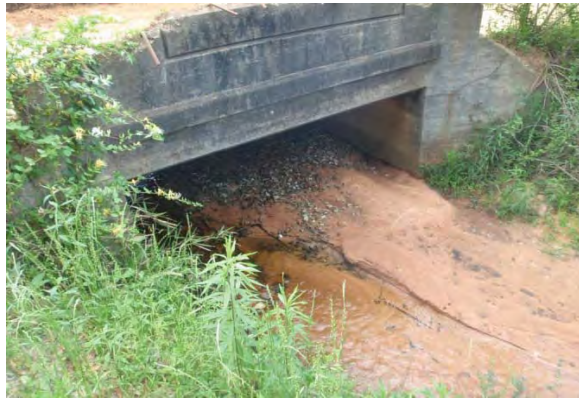
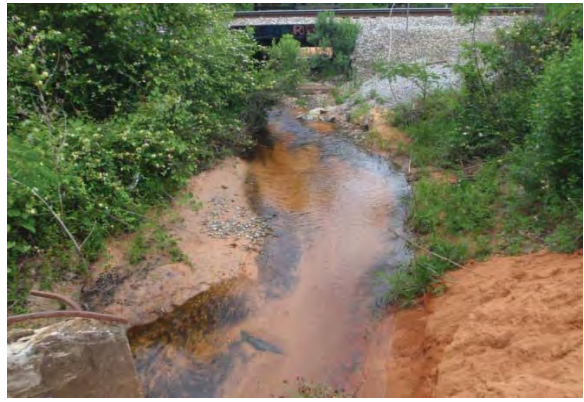
<b>Unnamed tributary</b>	<b>ok-0429-r-003</b>	<i>Sedimentation Risk Index</i> <b>40</b>
--------------------------	----------------------	--

Risk Factor	Ranking	Score
US Channel Morph	B	5
DS Channel Morph	B	5
DS Bank Alteration	MINOR/PARTIAL	3
Upstream Skew Angle	5-30°	3
Crossing fill condition	Poor/Bare soil	1
Inlet/Outlet Condition	Blocked	1
Road Approach Material	All Sand/Clay	3
Potential Eroded Volume Mean	<21 y <sup>3</sup>	5
Approach Slope Mean	<2%	5
Soil K Factor	<0.20	5
Upstream Rt Outlet	Vegetated	1
Upstream Lt Outlet	Bare soil	0
Upstream Rt Ditch	Bare soil	0
Upstream Lt Ditch	Bare soil	0
Downstream Rt Outlet	Vegetated	1
Downstream Lt Outlet	Vegetated	1
Downstream Rt Ditch	Bare soil	0
Downstream Lt Ditch	Bare soil	0
Outlet Total	Partially Improved Outlet System	3
Ditches Total	Unimproved Drainage System	1
<b>SRI Total</b>	<b>Medium Risk</b>	<b>40</b>
<b>Additional Site Features</b>		
<u>Crossing Type and Quantity:</u>	Bridge, 1	
<u>Crossing Materials:</u>	Reinforced Concrete	
<u>Soil Types:</u>	4,6,12,13,27,34,36,43,49,50,51,52	
<u>Rt Approach Prism Fill:</u>	0.2in

Notes: Railroad crossing approx 100ft US.

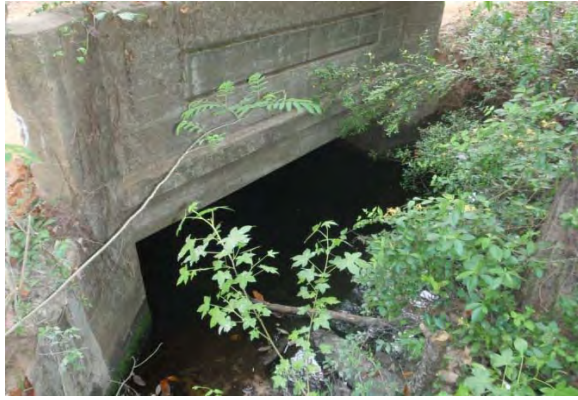
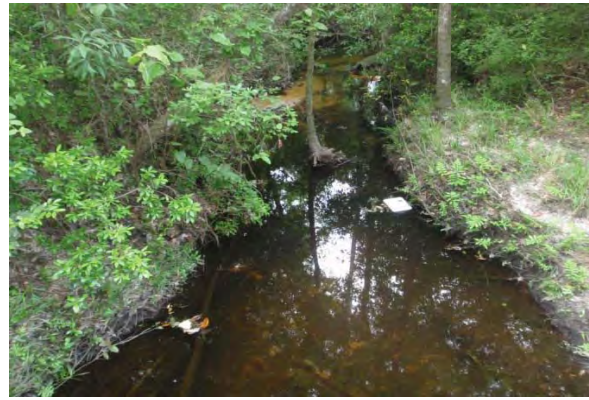
Risk Factor	Ranking	Score
<i>US Channel Morph</i>	C	5
<i>DS Channel Morph</i>	C	5
<i>DS Bank Alteration</i>	MINOR/PARTIAL	3
<i>Upstream Skew Angle</i>	>30°	1
<i>Crossing fill condition</i>	Poor/Bare soil	1
<i>Inlet/Outlet Condition</i>	No Impairment	5
<i>Road Approach Material</i>	All Sand/Clay	3
<i>Potential Eroded Volume Mean</i>	<21 y <sup>3</sup>	5
<i>Approach Slope Mean</i>	<2%	5
<i>Soil K Factor</i>	<0.20	5
<i>Upstream Rt Outlet</i>	Bare soil	0
<i>Upstream Lt Outlet</i>	Bare soil	0
<i>Upstream Rt Ditch</i>	Bare soil	0
<i>Upstream Lt Ditch</i>	Bare soil	0
<i>Downstream Rt Outlet</i>	Bare soil	0
<i>Downstream Lt Outlet</i>	Bare soil	0
<i>Downstream Rt Ditch</i>	Bare soil	0
<i>Downstream Lt Ditch</i>	Bare soil	0
<i>Outlet Total</i>	Unimproved Outlet System	1
<i>Ditches Total</i>	Unimproved Drainage System	1
<b>SRI Total</b>	<b>Medium Risk</b>	<b>40</b>

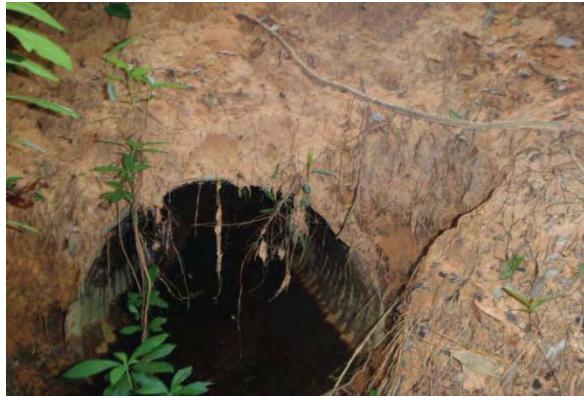
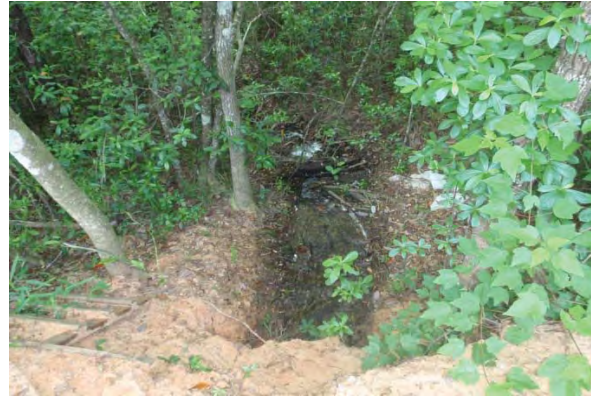
Risk Factor	Ranking	Score
<i>US Channel Morph</i>	PONDED	1
<i>DS Channel Morph</i>	C	5
<i>DS Bank Alteration</i>	HIGH	1
<i>Upstream Skew Angle</i>	5-30°	3
<i>Crossing fill condition</i>	Poor/Bare soil	1
<i>Inlet/Outlet Condition</i>	No Impairment	5
<i>Road Approach Material</i>	All Sand/Clay	3
<i>Potential Eroded Volume Mean</i>	<21 y <sup>3</sup>	5
<i>Approach Slope Mean</i>	<2%	5
<i>Soil K Factor</i>	<0.20	5
<i>Upstream Rt Outlet</i>	Vegetated	1
<i>Upstream Lt Outlet</i>	Vegetated	1
<i>Upstream Rt Ditch</i>	Bare soil	0
<i>Upstream Lt Ditch</i>	Bare soil	0
<i>Downstream Rt Outlet</i>	Vegetated	1
<i>Downstream Lt Outlet</i>	Vegetated	1
<i>Downstream Rt Ditch</i>	Bare soil	0
<i>Downstream Lt Ditch</i>	Bare soil	0
<i>Outlet Total</i>	Improved Outlet System	5
<i>Ditches Total</i>	Unimproved Drainage System	1
<b>SRI Total</b>	<b>Medium Risk</b>	<b>40</b>
<b>Additional Site Features</b>		
<i>Crossing Type and Quantity:</i>	Culvert, 1

Notes: Private impounded system US. Ladder leading DS.

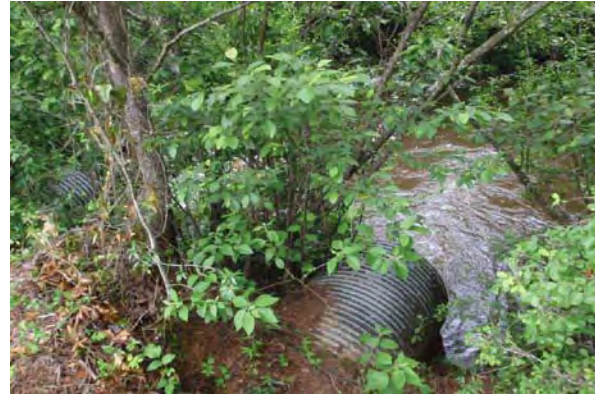
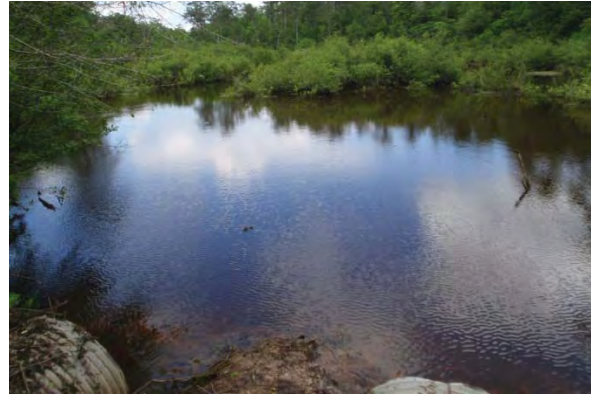
<h1 style="margin:0;">Moores Mill Creek</h1>	<h2 style="margin:0;">ok-0526-r-002</h2>	<i>Sedimentation Risk Index</i> <b style="font-size: 1.2em;">40</b>
--	--	--

Risk Factor	Ranking	Score
<i>US Channel Morph</i>	PONDED	1
<i>DS Channel Morph</i>	DA	3
<i>DS Bank Alteration</i>	HIGH	1
<i>Upstream Skew Angle</i>	5-30°	3
<i>Crossing fill condition</i>	Good/Vegetated	5
<i>Inlet/Outlet Condition</i>	Sed Islands/Scouring	3
<i>Road Approach Material</i>	All Aggregate	5
<i>Potential Eroded Volume Mean</i>	<21 y <sup>3</sup>	5
<i>Approach Slope Mean</i>	>4%	1
<i>Soil K Factor</i>	<0.20	5
<i>Upstream Rt Outlet</i>	Vegetated	1
<i>Upstream Lt Outlet</i>	Vegetated	1
<i>Upstream Rt Ditch</i>	Bare soil	0
<i>Upstream Lt Ditch</i>	Bare soil	0
<i>Downstream Rt Outlet</i>	Vegetated	1
<i>Downstream Lt Outlet</i>	Vegetated	1
<i>Downstream Rt Ditch</i>	Synthetic	1
<i>Downstream Lt Ditch</i>	Bare soil	0
<b><i>Outlet Total</i></b>	<b>Improved Outlet System</b>	<b>5</b>
<b><i>Ditches Total</i></b>	<b>Partially Improved Drainage System</b>	<b>3</b>
<b><i>SRI Total</i></b>	<b>Medium Risk</b>	<b>40</b>

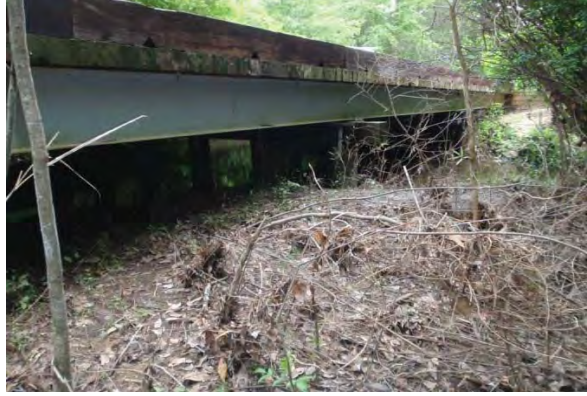
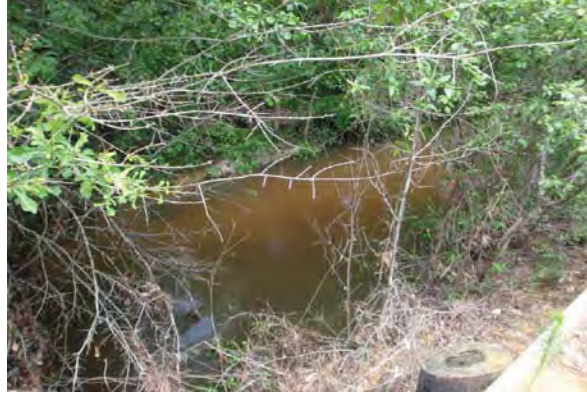
<h1>Big Horse Creek</h1>	<h2>ok-0526-r-006</h2>	<i>Sedimentation Risk Index</i> <b>40</b>
--------------------------	------------------------	--

Risk Factor	Ranking	Score
<i>US Channel Morph</i>	DA	3
<i>DS Channel Morph</i>	C	5
<i>DS Bank Alteration</i>	MINOR/PARTIAL	3
<i>Upstream Skew Angle</i>	>30°	1
<i>Crossing fill condition</i>	Poor/Bare soil	1
<i>Inlet/Outlet Condition</i>	No Impairment	5
<i>Road Approach Material</i>	All Sand/Clay	3
<i>Potential Eroded Volume Mean</i>	<21 y <sup>3</sup>	5
<i>Approach Slope Mean</i>	<2%	5
<i>Soil K Factor</i>	<0.20	5
<i>Upstream Rt Outlet</i>	Vegetated	1
<i>Upstream Lt Outlet</i>	Bare soil	0
<i>Upstream Rt Ditch</i>	Bare soil	0
<i>Upstream Lt Ditch</i>	Bare soil	0
<i>Downstream Rt Outlet</i>	Vegetated	1
<i>Downstream Lt Outlet</i>	Bare soil	0
<i>Downstream Rt Ditch</i>	Bare soil	0
<i>Downstream Lt Ditch</i>	Bare soil	0
<i>Outlet Total</i>	Partially Improved Outlet System	3
<i>Ditches Total</i>	Unimproved Drainage System	1
<b>SRI Total</b>	<b>Medium Risk</b>	<b>40</b>

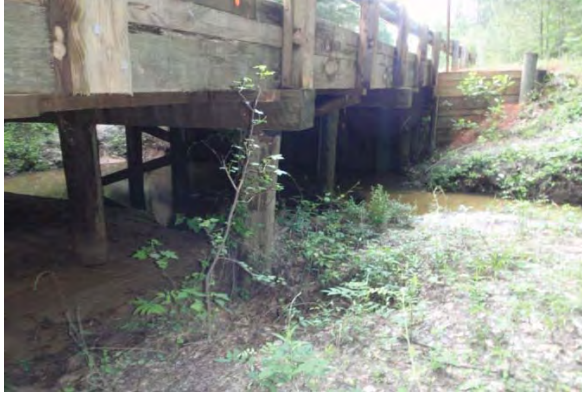
<b>Unnamed tributary</b>	<b>ok-0526-r-011</b>	<i>Sedimentation Risk Index</i> <b>40</b>
--------------------------	----------------------	--

Risk Factor	Ranking	Score
<i>US Channel Morph</i>	E	5
<i>DS Channel Morph</i>	E	5
<i>DS Bank Alteration</i>	NATURAL	5
<i>Upstream Skew Angle</i>	5-30°	3
<i>Crossing fill condition</i>	Poor/Bare soil	1
<i>Inlet/Outlet Condition</i>	No Impairment	5
<i>Road Approach Material</i>	All Sand/Clay	3
<i>Potential Eroded Volume Mean</i>	21-40 y <sup>3</sup>	3
<i>Approach Slope Mean</i>	2.1-4%	3
<i>Soil K Factor</i>	<0.20	5
<i>Upstream Rt Outlet</i>	Bare soil	0
<i>Upstream Lt Outlet</i>	Bare soil	0
<i>Upstream Rt Ditch</i>	Bare soil	0
<i>Upstream Lt Ditch</i>	Bare soil	0
<i>Downstream Rt Outlet</i>	Bare soil	0
<i>Downstream Lt Outlet</i>	Bare soil	0
<i>Downstream Rt Ditch</i>	Bare soil	0
<i>Downstream Lt Ditch</i>	Bare soil	0
<i>Outlet Total</i>	Unimproved Outlet System	1
<i>Ditches Total</i>	Unimproved Drainage System	1
<b>SRI Total</b>	<b>Medium Risk</b>	<b>40</b>

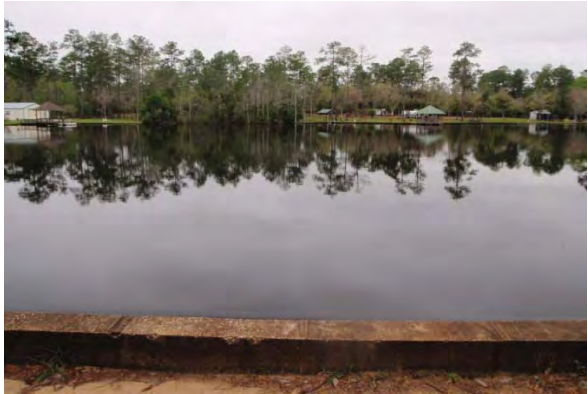
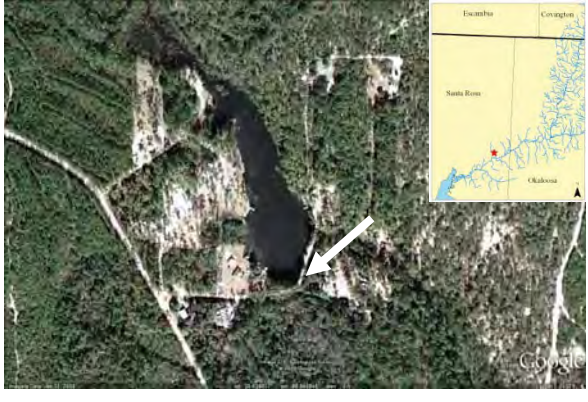
US

Notes: Drainage undersized to accommodate storm events. DS inundated.

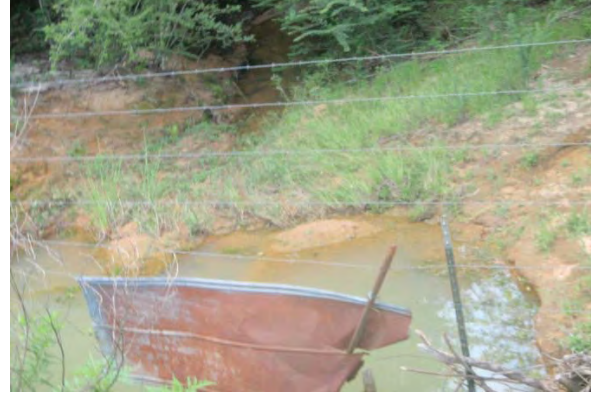
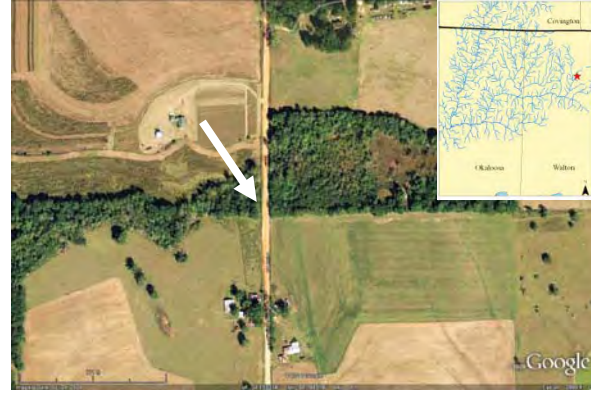
US

Notes: DS drop off creating partial fish passage barrier.

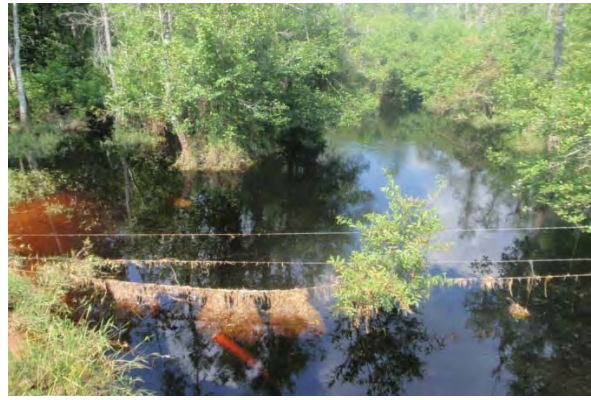
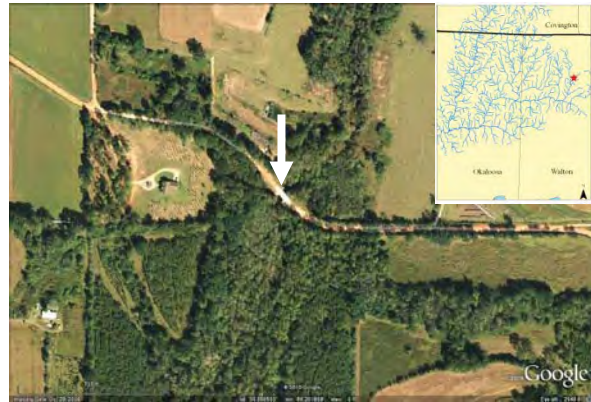
US

Notes: Road under construction at time of survey. Some erosion control attempts.

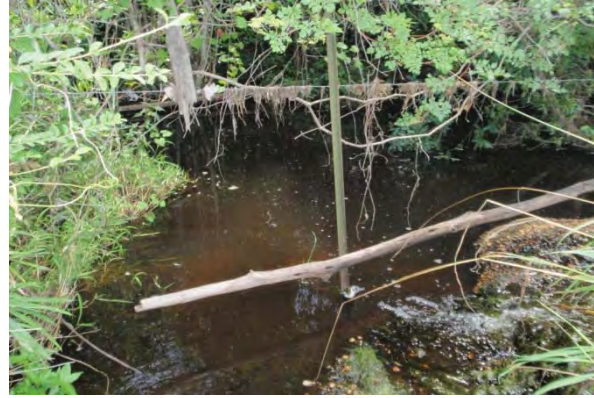
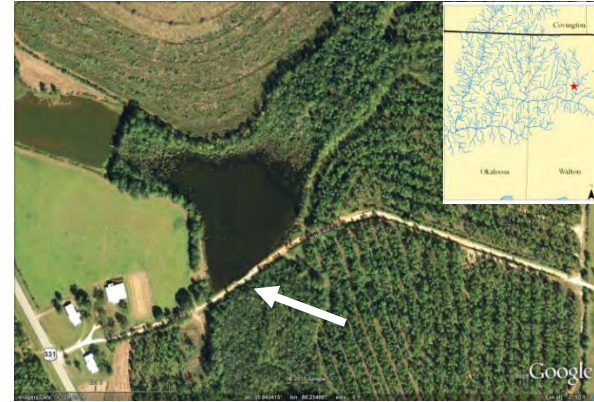
Notes: Fencing across DS

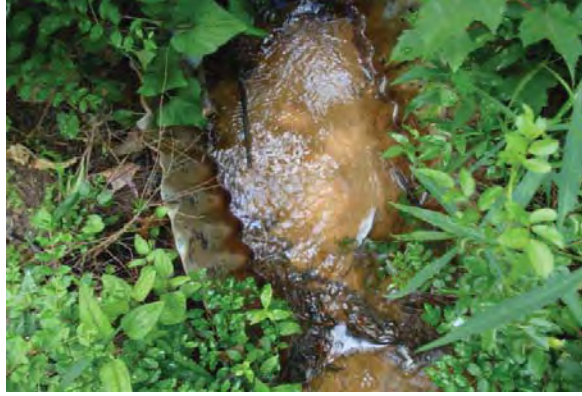
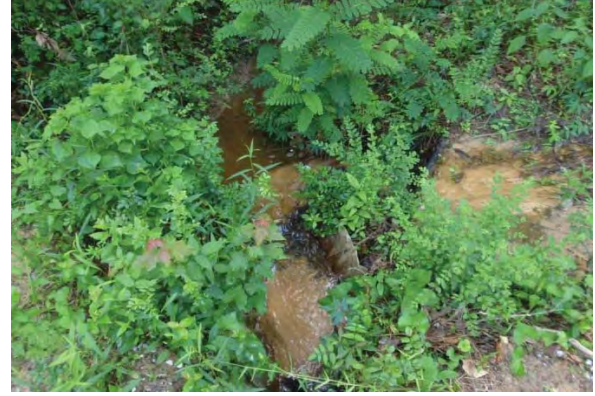
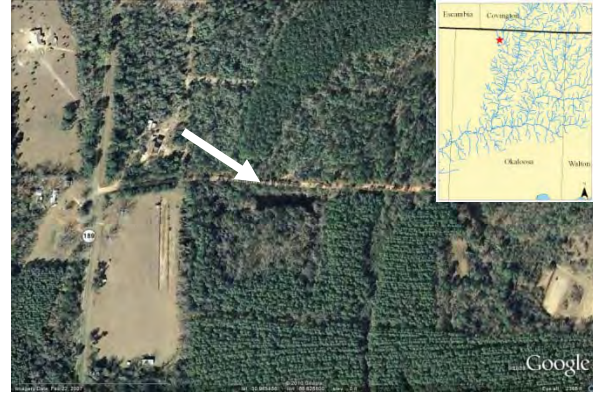
Notes: Top cut off culvert.

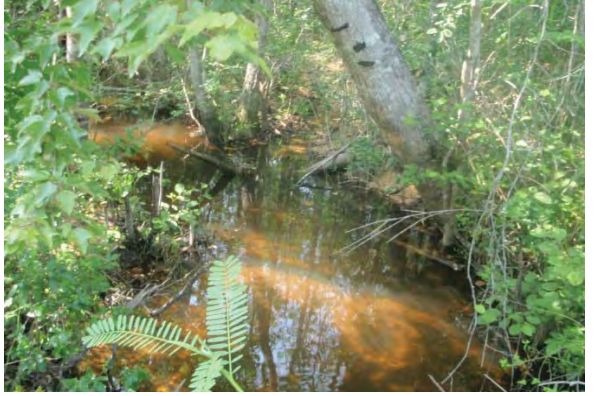
Crossing Structure: DS

Risk Factor	Ranking	Score
<i>US Channel Morph</i>	DA	3
<i>DS Channel Morph</i>	DA	3
<i>DS Bank Alteration</i>	MINOR/PARTIAL	3
<i>Upstream Skew Angle</i>	<5°	5
<i>Crossing fill condition</i>	Poor/Bare soil	1
<i>Inlet/Outlet Condition</i>	No Impairment	5
<i>Road Approach Material</i>	All Aggregate	5
<i>Potential Eroded Volume Mean</i>	<21 y <sup>3</sup>	5
<i>Approach Slope Mean</i>	>4%	1
<i>Soil K Factor</i>	<0.20	5
<i>Upstream Rt Outlet</i>	Bare soil	0
<i>Upstream Lt Outlet</i>	Bare soil	0
<i>Upstream Rt Ditch</i>	Vegetated	1
<i>Upstream Lt Ditch</i>	Bare soil	0
<i>Downstream Rt Outlet</i>	Bare soil	0
<i>Downstream Lt Outlet</i>	Vegetated	1
<i>Downstream Rt Ditch</i>	Bare soil	0
<i>Downstream Lt Ditch</i>	Bare soil	0
<i>Outlet Total</i>	Partially Improved Outlet System	3
<i>Ditches Total</i>	Partially Improved Drainage System	3
<b>SRI Total</b>	<b>Medium Risk</b>	<b>42</b>

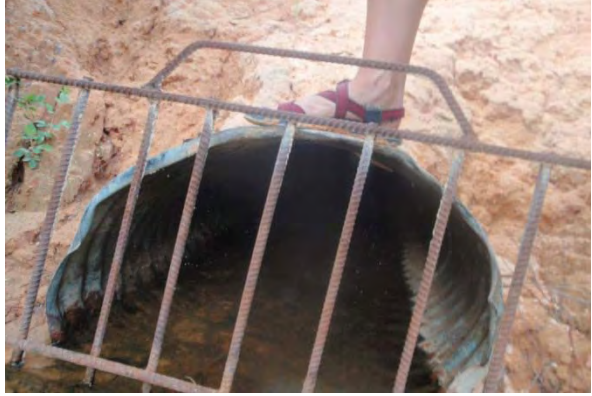
Crossing Structure: US

Risk Factor	Ranking	Score
<i>US Channel Morph</i>	WETLAND	5
<i>DS Channel Morph</i>	E	5
<i>DS Bank Alteration</i>	MINOR/PARTIAL	3
<i>Upstream Skew Angle</i>	<5°	5
<i>Crossing fill condition</i>	Poor/Bare soil	1
<i>Inlet/Outlet Condition</i>	No Impairment	5
<i>Road Approach Material</i>	All Sand/Clay	3
<i>Potential Eroded Volume Mean</i>	<21 y <sup>3</sup>	5
<i>Approach Slope Mean</i>	2.1-4%	3
<i>Soil K Factor</i>	0.21-0.40	3
<i>Upstream Rt Outlet</i>	Vegetated	1
<i>Upstream Lt Outlet</i>	Vegetated	1
<i>Upstream Rt Ditch</i>	Bare soil	0
<i>Upstream Lt Ditch</i>	Bare soil	0
<i>Downstream Rt Outlet</i>	Vegetated	1
<i>Downstream Lt Outlet</i>	Bare soil	0
<i>Downstream Rt Ditch</i>	Bare soil	0
<i>Downstream Lt Ditch</i>	Bare soil	0
<i>Outlet Total</i>	Partially Improved Outlet System	3
<i>Ditches Total</i>	Unimproved Drainage System	1
<b>SRI Total</b>	<b>Medium Risk</b>	<b>42</b>

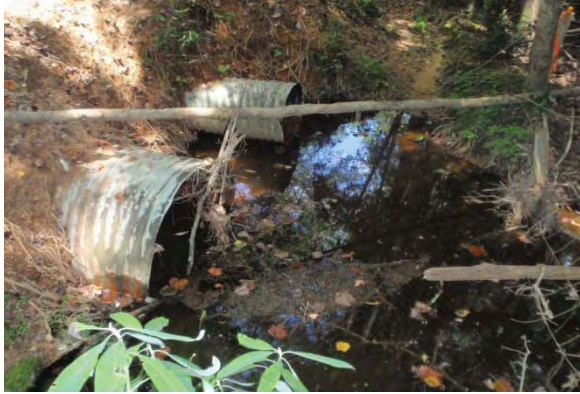
Crossing Structure: US

Risk Factor	Ranking	Score
<i>US Channel Morph</i>	DA	3
<i>DS Channel Morph</i>	C	5
<i>DS Bank Alteration</i>	MINOR/PARTIAL	3
<i>Upstream Skew Angle</i>	<5°	5
<i>Crossing fill condition</i>	Poor/Bare soil	1
<i>Inlet/Outlet Condition</i>	No Impairment	5
<i>Road Approach Material</i>	All Native Soil	1
<i>Potential Eroded Volume Mean</i>	<21 y <sup>3</sup>	5
<i>Approach Slope Mean</i>	<2%	5
<i>Soil K Factor</i>	<0.20	5
<i>Upstream Rt Outlet</i>	Bare soil	0
<i>Upstream Lt Outlet</i>	Bare soil	0
<i>Upstream Rt Ditch</i>	Bare soil	0
<i>Upstream Lt Ditch</i>	Bare soil	0
<i>Downstream Rt Outlet</i>	Vegetated	1
<i>Downstream Lt Outlet</i>	Vegetated	1
<i>Downstream Rt Ditch</i>	Bare soil	0
<i>Downstream Lt Ditch</i>	Bare soil	0
<b>Outlet Total</b>	Partially Improved Outlet System	3
<b>Ditches Total</b>	Unimproved Drainage System	1
<b>SRI Total</b>	<b>Medium Risk</b>	<b>42</b>

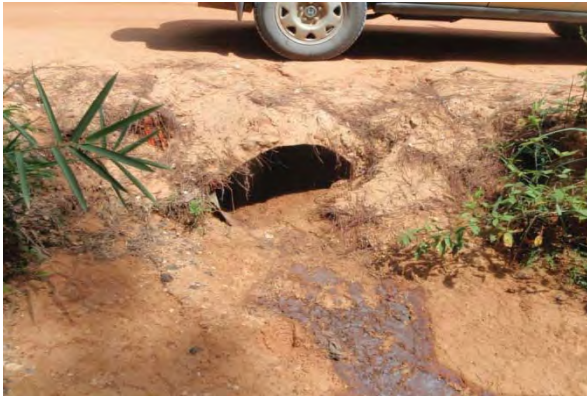
Crossing Structure: DS

Risk Factor	Ranking	Score
<i>US Channel Morph</i>	C	5
<i>DS Channel Morph</i>	C	5
<i>DS Bank Alteration</i>	MINOR/PARTIAL	3
<i>Upstream Skew Angle</i>	<5°	5
<i>Crossing fill condition</i>	Poor/Bare soil	1
<i>Inlet/Outlet Condition</i>	Sed Islands/Scouring	3
<i>Road Approach Material</i>	All Sand/Clay	3
<i>Potential Eroded Volume Mean</i>	<21 y <sup>3</sup>	5
<i>Approach Slope Mean</i>	<2%	5
<i>Soil K Factor</i>	<0.20	5
<i>Upstream Rt Outlet</i>	Bare soil	0
<i>Upstream Lt Outlet</i>	Bare soil	0
<i>Upstream Rt Ditch</i>	Bare soil	0
<i>Upstream Lt Ditch</i>	Bare soil	0
<i>Downstream Rt Outlet</i>	Bare soil	0
<i>Downstream Lt Outlet</i>	Bare soil	0
<i>Downstream Rt Ditch</i>	Bare soil	0
<i>Downstream Lt Ditch</i>	Bare soil	0
<b>Outlet Total</b>	Unimproved Outlet System	1
<b>Ditches Total</b>	Unimproved Drainage System	1
<b>SRI Total</b>	<b>Medium Risk</b>	<b>42</b>

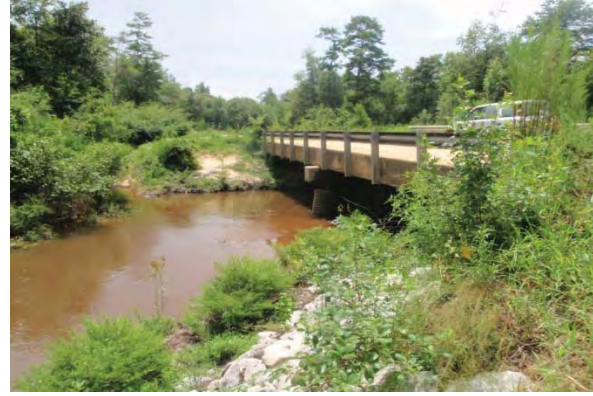
Crossing Structure: US

Risk Factor	Ranking	Score
<i>US Channel Morph</i>	DA	3
<i>DS Channel Morph</i>	C	5
<i>DS Bank Alteration</i>	MINOR/PARTIAL	3
<i>Upstream Skew Angle</i>	5-30°	3
<i>Crossing fill condition</i>	Good/Vegetated	5
<i>Inlet/Outlet Condition</i>	Sed Islands/Scouring	3
<i>Road Approach Material</i>	All Sand/Clay	3
<i>Potential Eroded Volume Mean</i>	<21 y <sup>3</sup>	5
<i>Approach Slope Mean</i>	<2%	5
<i>Soil K Factor</i>	<0.20	5
<i>Upstream Rt Outlet</i>	Rip Rap	1
<i>Upstream Lt Outlet</i>	Rip Rap	1
<i>Upstream Rt Ditch</i>	Bare soil	0
<i>Upstream Lt Ditch</i>	Bare soil	0
<i>Downstream Rt Outlet</i>	Bare soil	0
<i>Downstream Lt Outlet</i>	Bare soil	0
<i>Downstream Rt Ditch</i>	Bare soil	0
<i>Downstream Lt Ditch</i>	Bare soil	0
<i>Outlet Total</i>	Partially Improved Outlet System	3
<i>Ditches Total</i>	Unimproved Drainage System	1
<b><i>SRI Total</i></b>	<b>Medium Risk</b>	<b>44</b>

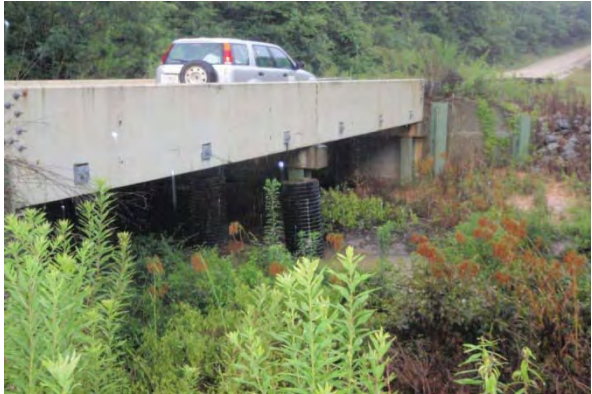
Crossing Structure: US

Risk Factor	Ranking	Score
<i>US Channel Morph</i>	C	5
<i>DS Channel Morph</i>	C	5
<i>DS Bank Alteration</i>	MINOR/PARTIAL	3
<i>Upstream Skew Angle</i>	<5°	5
<i>Crossing fill condition</i>	Good/Vegetated	5
<i>Inlet/Outlet Condition</i>	No Impairment	5
<i>Road Approach Material</i>	All Aggregate	5
<i>Potential Eroded Volume Mean</i>	>40 y <sup>3</sup>	1
<i>Approach Slope Mean</i>	>4%	1
<i>Soil K Factor</i>	<0.20	5
<i>Upstream Rt Outlet</i>	Bare soil	0
<i>Upstream Lt Outlet</i>	Rip Rap	1
<i>Upstream Rt Ditch</i>	Bare soil	0
<i>Upstream Lt Ditch</i>	Bare soil	0
<i>Downstream Rt Outlet</i>	Vegetated	1
<i>Downstream Lt Outlet</i>	Vegetated	1
<i>Downstream Rt Ditch</i>	Bare soil	0
<i>Downstream Lt Ditch</i>	Bare soil	0
<i>Outlet Total</i>	Partially Improved Outlet System	3
<i>Ditches Total</i>	Unimproved Drainage System	1
<b><i>SRI Total</i></b>	<b>Medium Risk</b>	<b>44</b>
<b>Additional Site Features</b>		
<i>Crossing Type and Quantity:</i>	Bridge, 1

Notes: US outlet sediment loading.

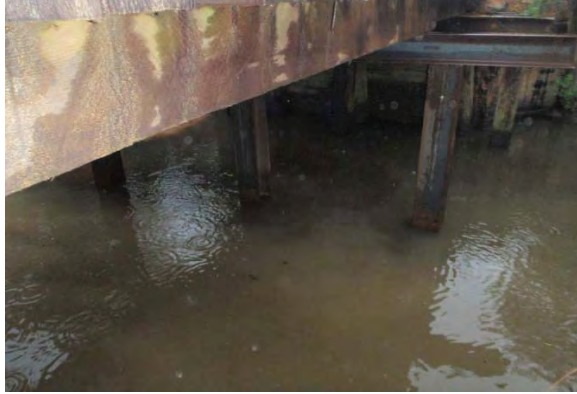
Crossing Structure: US

Risk Factor	Ranking	Score
<i>US Channel Morph</i>	C	5
<i>DS Channel Morph</i>	C	5
<i>DS Bank Alteration</i>	MINOR/PARTIAL	3
<i>Upstream Skew Angle</i>	<5°	5
<i>Crossing fill condition</i>	Good/Vegetated	5
<i>Inlet/Outlet Condition</i>	No Impairment	5
<i>Road Approach Material</i>	All Aggregate	5
<i>Potential Eroded Volume Mean</i>	>40 y <sup>3</sup>	1
<i>Approach Slope Mean</i>	>4%	1
<i>Soil K Factor</i>	<0.20	5
<i>Upstream Rt Outlet</i>	Bare soil	0
<i>Upstream Lt Outlet</i>	Bare soil	0
<i>Upstream Rt Ditch</i>	Bare soil	0
<i>Upstream Lt Ditch</i>	Bare soil	0
<i>Downstream Rt Outlet</i>	Bare soil	0
<i>Downstream Lt Outlet</i>	Vegetated	1
<i>Downstream Rt Ditch</i>	Bare soil	0
<i>Downstream Lt Ditch</i>	Bare soil	0
<i>Outlet Total</i>	Partially Improved Outlet System	3
<i>Ditches Total</i>	Unimproved Drainage System	1
<b>SRI Total</b>	<b>Medium Risk</b>	<b>44</b>
