Appendix A. River corridor severity scores for impaired sites in the Yellow River Basin, Alabama and Florida

Appendix C. Clear Creek Watershed Focal Area. Sites with orange headings are unpaved road sites. Specific definitions and calculations described for calculating the Sediment Risk Index (SRI) are detailed in Witmer (2009).

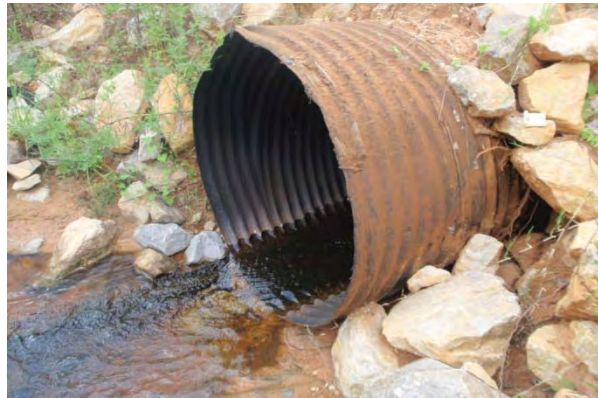
Crossing Structure: DS

Risk Factor	Ranking	Score
<i>US Channel Morph</i>	C	5
<i>DS Channel Morph</i>	C	5
<i>DS Bank Alteration</i>	MINOR/PARTIAL	3
<i>Upstream Skew Angle</i>	<5°	5
<i>Crossing fill condition</i>	Fair/Rip Rap	3
<i>Inlet/Outlet Condition</i>	Sed Islands/Scouring	3
<i>Road Approach Material</i>	All Sand/Clay	3
<i>Potential Eroded Volume Mean</i>	<21 y <sup>3</sup>	5
<i>Approach Slope Mean</i>	>4%	1
<i>Soil K Factor</i>	<0.20	5
<i>Upstream Rt Outlet</i>	Vegetated	1
<i>Upstream Lt Outlet</i>	Vegetated	1
<i>Upstream Rt Ditch</i>	Vegetated	1
<i>Upstream Lt Ditch</i>	Vegetated	1
<i>Downstream Rt Outlet</i>	Bare soil	0
<i>Downstream Lt Outlet</i>	Bare soil	0
<i>Downstream Rt Ditch</i>	Bare soil	0
<i>Downstream Lt Ditch</i>	Bare soil	0
<i>Outlet Total</i>	Partially Improved Outlet System	3
<i>Ditches Total</i>	Partially Improved Drainage System	3
<b><i>SRI Total</i></b>	<b>Medium Risk</b>	<b>44</b>
<b>Additional Site Features</b>

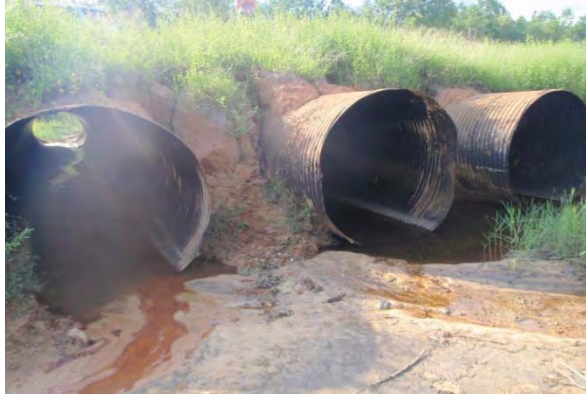
Crossing Structure: US

Risk Factor	Ranking	Score
<i>US Channel Morph</i>	C	5
<i>DS Channel Morph</i>	C	5
<i>DS Bank Alteration</i>	HIGH	1
<i>Upstream Skew Angle</i>	>30°	1
<i>Crossing fill condition</i>	Good/Vegetated	5
<i>Inlet/Outlet Condition</i>	No Impairment	5
<i>Road Approach Material</i>	All Sand/Clay	3
<i>Potential Eroded Volume Mean</i>	<21 y <sup>3</sup>	5
<i>Approach Slope Mean</i>	>4%	1
<i>Soil K Factor</i>	<0.20	5
<i>Upstream Rt Outlet</i>	Vegetated	1
<i>Upstream Lt Outlet</i>	Bare soil	0
<i>Upstream Rt Ditch</i>	Vegetated	1
<i>Upstream Lt Ditch</i>	Vegetated	1
<i>Downstream Rt Outlet</i>	Vegetated	1
<i>Downstream Lt Outlet</i>	Vegetated	1
<i>Downstream Rt Ditch</i>	Vegetated	1
<i>Downstream Lt Ditch</i>	Vegetated	1
<i>Outlet Total</i>	Partially Improved Outlet System	3
<i>Ditches Total</i>	Improved Drainage System	5
<b><i>SRI Total</i></b>	<b>Medium Risk</b>	<b>44</b>
<b>Additional Site Features</b>		
<i>Crossing Type and Quantity:</i>	Culvert, 3

Notes: Most of Rt approach paved

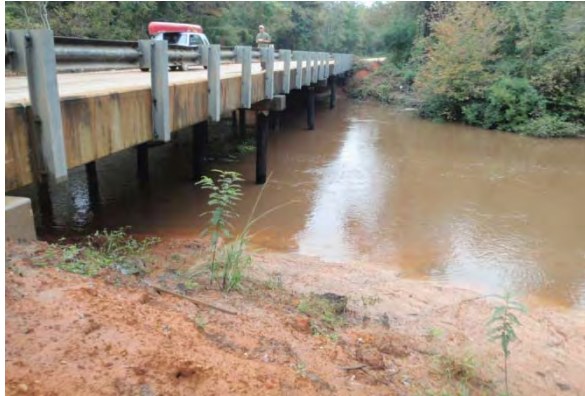
Crossing Structure: DS

Risk Factor	Ranking	Score
<i>US Channel Morph</i>	C	5
<i>DS Channel Morph</i>	C	5
<i>DS Bank Alteration</i>	MINOR/PARTIAL	3
<i>Upstream Skew Angle</i>	<5°	5
<i>Crossing fill condition</i>	Poor/Bare soil	1
<i>Inlet/Outlet Condition</i>	Sed Islands/Scouring	3
<i>Road Approach Material</i>	All Aggregate	5
<i>Potential Eroded Volume Mean</i>	21-40 y <sup>3</sup>	3
<i>Approach Slope Mean</i>	2.1-4%	3
<i>Soil K Factor</i>	<0.20	5
<i>Upstream Rt Outlet</i>	Bare soil	0
<i>Upstream Lt Outlet</i>	Vegetated	1
<i>Upstream Rt Ditch</i>	Bare soil	0
<i>Upstream Lt Ditch</i>	Bare soil	0
<i>Downstream Rt Outlet</i>	Bare soil	0
<i>Downstream Lt Outlet</i>	Bare soil	0
<i>Downstream Rt Ditch</i>	Vegetated	1
<i>Downstream Lt Ditch</i>	Vegetated	1
<i>Outlet Total</i>	Partially Improved Outlet System	3
<i>Ditches Total</i>	Partially Improved Drainage System	3
<b>SRI Total</b>	<b>Medium Risk</b>	<b>44</b>

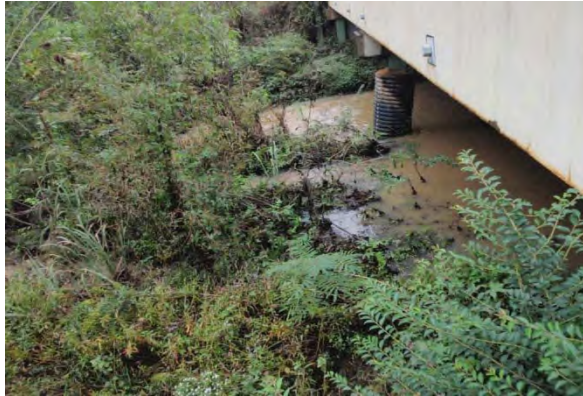
Crossing Structure: DS

Risk Factor	Ranking	Score
<i>US Channel Morph</i>	C	5
<i>DS Channel Morph</i>	C	5
<i>DS Bank Alteration</i>	MINOR/PARTIAL	3
<i>Upstream Skew Angle</i>	<5°	5
<i>Crossing fill condition</i>	Good/Vegetated	5
<i>Inlet/Outlet Condition</i>	No Impairment	5
<i>Road Approach Material</i>	All Sand/Clay	3
<i>Potential Eroded Volume Mean</i>	>40 y <sup>3</sup>	1
<i>Approach Slope Mean</i>	>4%	1
<i>Soil K Factor</i>	<0.20	5
<i>Upstream Rt Outlet</i>	Vegetated	1
<i>Upstream Lt Outlet</i>	Vegetated	1
<i>Upstream Rt Ditch</i>	Bare soil	0
<i>Upstream Lt Ditch</i>	Bare soil	0
<i>Downstream Rt Outlet</i>	Vegetated	1
<i>Downstream Lt Outlet</i>	Vegetated	1
<i>Downstream Rt Ditch</i>	Bare soil	0
<i>Downstream Lt Ditch</i>	Bare soil	0
<i>Outlet Total</i>	Improved Outlet System	5
<i>Ditches Total</i>	Unimproved Drainage System	1
<b>SRI Total</b>	<b>Medium Risk</b>	<b>44</b>

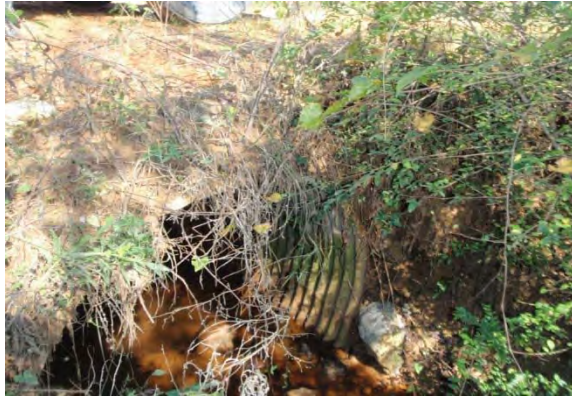
<b>Good Springs Creek</b>	<b>co-1102-r-005</b>	<i>Sedimentation Risk Index</i> <b>44</b>
---------------------------	----------------------	--

Crossing Structure: DS

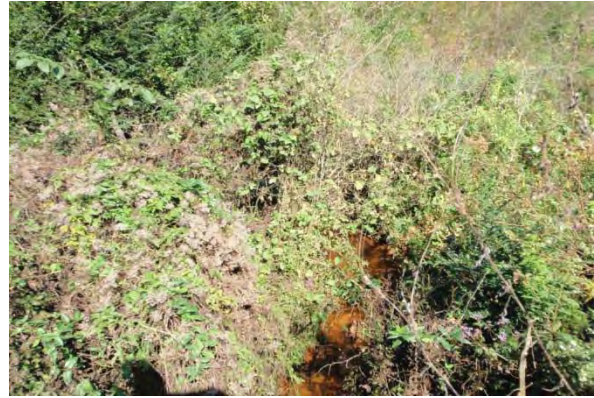
US

Risk Factor	Ranking	Score
<i>US Channel Morph</i>	C	5
<i>DS Channel Morph</i>	C	5
<i>DS Bank Alteration</i>	MINOR/PARTIAL	3
<i>Upstream Skew Angle</i>	<5°	5
<i>Crossing fill condition</i>	Good/Vegetated	5
<i>Inlet/Outlet Condition</i>	No Impairment	5
<i>Road Approach Material</i>	All Sand/Clay	3
<i>Potential Eroded Volume Mean</i>	>40 y <sup>3</sup>	1
<i>Approach Slope Mean</i>	2.1-4%	3
<i>Soil K Factor</i>	0.21-0.40	3
<i>Upstream Rt Outlet</i>	Vegetated	1
<i>Upstream Lt Outlet</i>	Vegetated	1
<i>Upstream Rt Ditch</i>	Bare soil	0
<i>Upstream Lt Ditch</i>	Bare soil	0
<i>Downstream Rt Outlet</i>	Vegetated	1
<i>Downstream Lt Outlet</i>	Vegetated	1
<i>Downstream Rt Ditch</i>	Bare soil	0
<i>Downstream Lt Ditch</i>	Bare soil	0
<i>Outlet Total</i>	Improved Outlet System	5
<i>Ditches Total</i>	Unimproved Drainage System	1
<b>SRI Total</b>	<b>Medium Risk</b>	<b>44</b>

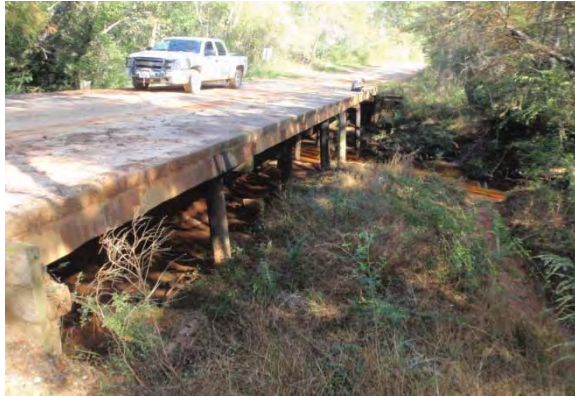
<b>Poley Creek</b>	<b>co-1102-r-009</b>	<i>Sedimentation Risk Index</i> <b>44</b>
--------------------	----------------------	--

Crossing Structure: DS

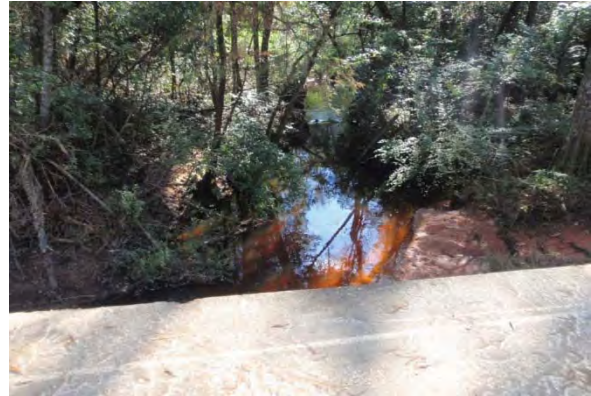
DS

Risk Factor	Ranking	Score
<i>US Channel Morph</i>	C	5
<i>DS Channel Morph</i>	C	5
<i>DS Bank Alteration</i>	MINOR/PARTIAL	3
<i>Upstream Skew Angle</i>	<5°	5
<i>Crossing fill condition</i>	Good/Vegetated	5
<i>Inlet/Outlet Condition</i>	No Impairment	5
<i>Road Approach Material</i>	All Sand/Clay	3
<i>Potential Eroded Volume Mean</i>	>40 y <sup>3</sup>	1
<i>Approach Slope Mean</i>	2.1-4%	3
<i>Soil K Factor</i>	<0.20	5
<i>Upstream Rt Outlet</i>	Vegetated	1
<i>Upstream Lt Outlet</i>	Vegetated	1
<i>Upstream Rt Ditch</i>	Bare soil	0
<i>Upstream Lt Ditch</i>	Bare soil	0
<i>Downstream Rt Outlet</i>	Bare soil	0
<i>Downstream Lt Outlet</i>	Bare soil	0
<i>Downstream Rt Ditch</i>	Bare soil	0
<i>Downstream Lt Ditch</i>	Bare soil	0
<i>Outlet Total</i>	Partially Improved Outlet System	3
<i>Ditches Total</i>	Unimproved Drainage System	1
<b>SRI Total</b>	<b>Medium Risk</b>	<b>44</b>

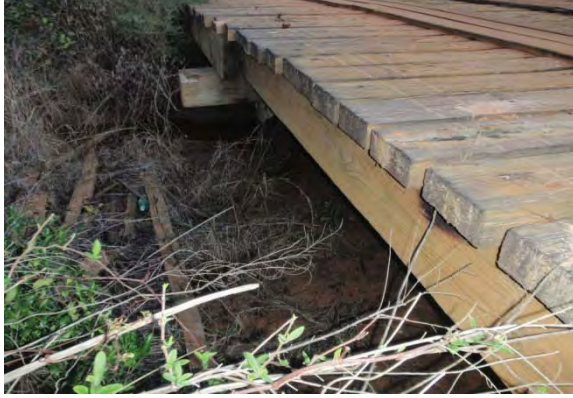
Unnamed tributary	co-1103-r-017	Sedimentation Risk Index <b>44</b>
-------------------	---------------	---------------------------------------

Crossing Structure: US

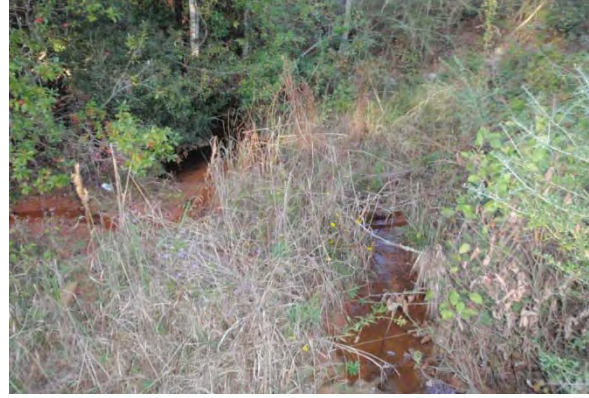
US

Risk Factor	Ranking	Score
<i>US Channel Morph</i>	DA	3
<i>DS Channel Morph</i>	E	5
<i>DS Bank Alteration</i>	NATURAL	5
<i>Upstream Skew Angle</i>	<5°	5
<i>Crossing fill condition</i>	Good/Vegetated	5
<i>Inlet/Outlet Condition</i>	No Impairment	5
<i>Road Approach Material</i>	All Sand/Clay	3
<i>Potential Eroded Volume Mean</i>	>40 y <sup>3</sup>	1
<i>Approach Slope Mean</i>	>4%	1
<i>Soil K Factor</i>	<0.20	5
<i>Upstream Rt Outlet</i>	Vegetated	1
<i>Upstream Lt Outlet</i>	Vegetated	1
<i>Upstream Rt Ditch</i>	Rip Rap	1
<i>Upstream Lt Ditch</i>	Rip Rap	1
<i>Downstream Rt Outlet</i>	Bare soil	0
<i>Downstream Lt Outlet</i>	Bare soil	0
<i>Downstream Rt Ditch</i>	Bare soil	0
<i>Downstream Lt Ditch</i>	Bare soil	0
<i>Outlet Total</i>	Partially Improved Outlet System	3
<i>Ditches Total</i>	Partially Improved Drainage System	3
<b>SRI Total</b>	<b>Medium Risk</b>	<b>44</b>

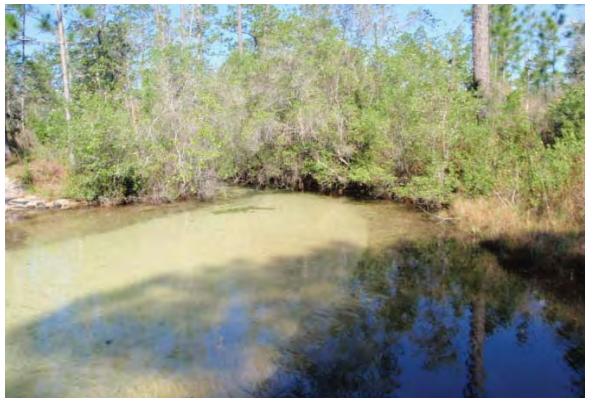
DS

Risk Factor	Ranking	Score
<i>US Channel Morph</i>	E	5
<i>DS Channel Morph</i>	C	5
<i>DS Bank Alteration</i>	NATURAL	5
<i>Upstream Skew Angle</i>	<5°	5
<i>Crossing fill condition</i>	Poor/Bare Soil	1
<i>Inlet/Outlet Condition</i>	No Impairment	5
<i>Road Approach Material</i>	All Aggregate	5
<i>Potential Eroded Volume Mean</i>	<21 y <sup>3</sup>	5
<i>Approach Slope Mean</i>	>4%	1
<i>Soil K Factor</i>	<0.20	5
<i>Upstream Rt Outlet</i>	Bare soil	0
<i>Upstream Lt Outlet</i>	Concrete	0
<i>Upstream Rt Ditch</i>	Concrete	0
<i>Upstream Lt Ditch</i>	Concrete	0
<i>Downstream Rt Outlet</i>	Concrete	0
<i>Downstream Lt Outlet</i>	Concrete	0
<i>Downstream Rt Ditch</i>	Concrete	0
<i>Downstream Lt Ditch</i>	Concrete	0
<i>Outlet Total</i>	Unimproved Outlet System	1
<i>Ditches Total</i>	Unimproved Drainage System	1
<b><i>SRI Total</i></b>	<b>Medium Risk</b>	<b>44</b>

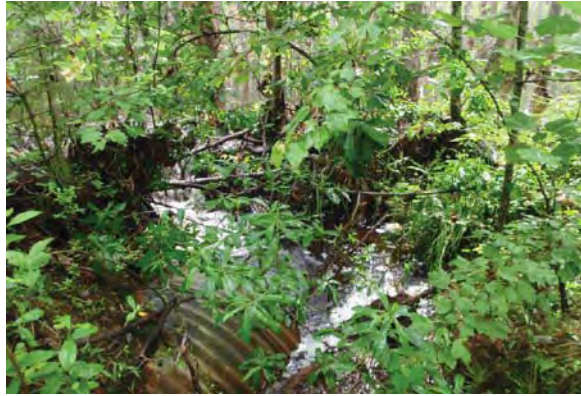
<b>Mill Branch</b>	<b>ok-0512-r-007</b>	<i>Sedimentation Risk Index</i> <b>44</b>
--------------------	----------------------	--

Crossing Structure: US

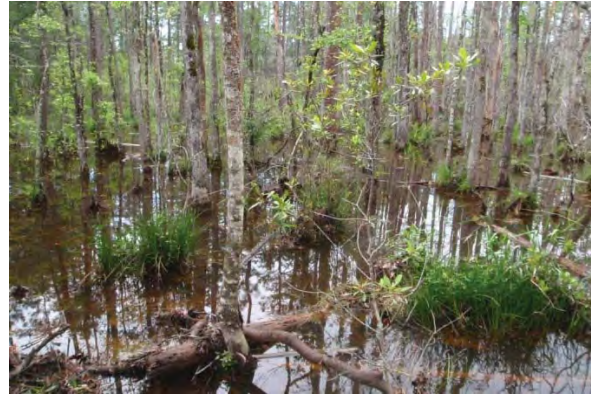
US

Risk Factor	Ranking	Score
<i>US Channel Morph</i>	WETLAND	5
<i>DS Channel Morph</i>	DA	3
<i>DS Bank Alteration</i>	MINOR/PARTIAL	3
<i>Upstream Skew Angle</i>	>30°	1
<i>Crossing fill condition</i>	Fair/Rip Rap	3
<i>Inlet/Outlet Condition</i>	No Impairment	5
<i>Road Approach Material</i>	All Aggregate	5
<i>Potential Eroded Volume Mean</i>	<21 y <sup>3</sup>	5
<i>Approach Slope Mean</i>	>4%	1
<i>Soil K Factor</i>	0.21-0.40	3
<i>Upstream Rt Outlet</i>	Vegetated	1
<i>Upstream Lt Outlet</i>	Vegetated	1
<i>Upstream Rt Ditch</i>	Vegetated	1
<i>Upstream Lt Ditch</i>	Vegetated	1
<i>Downstream Rt Outlet</i>	Vegetated	1
<i>Downstream Lt Outlet</i>	Vegetated	1
<i>Downstream Rt Ditch</i>	Vegetated	1
<i>Downstream Lt Ditch</i>	Vegetated	1
<i>Outlet Total</i>	Improved Outlet System	5
<i>Ditches Total</i>	Improved Drainage System	5
<b>SRI Total</b>	<b>Medium Risk</b>	<b>44</b>

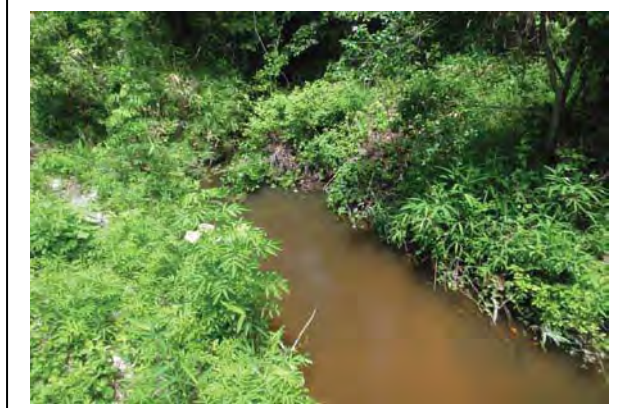
<h1>Little Horse Creek</h1>	<h2>ok-0526-r-003</h2>	<b>Sedimentation Risk Index</b> <h1>44</h1>
-----------------------------	------------------------	--

US

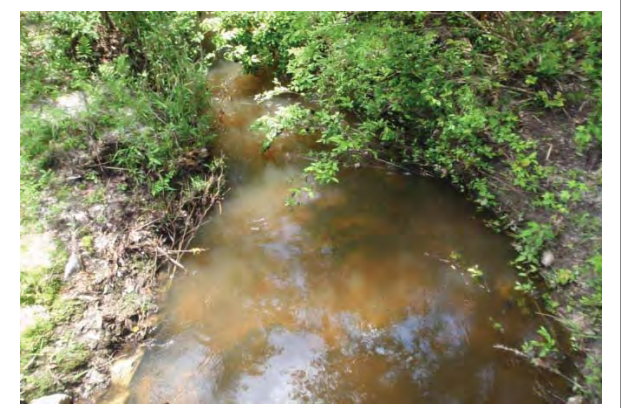
DS

Risk Factor	Ranking	Score
<i>US Channel Morph</i>	E	5
<i>DS Channel Morph</i>	E	5
<i>DS Bank Alteration</i>	NATURAL	5
<i>Upstream Skew Angle</i>	<5°	5
<i>Crossing fill condition</i>	Fair/Rip Rap	3
<i>Inlet/Outlet Condition</i>	No Impairment	5
<i>Road Approach Material</i>	All Sand/Clay	3
<i>Potential Eroded Volume Mean</i>	21-40 y <sup>3</sup>	3
<i>Approach Slope Mean</i>	>4%	1
<i>Soil K Factor</i>	0.21-0.40	3
<i>Upstream Rt Outlet</i>	Vegetated	1
<i>Upstream Lt Outlet</i>	Vegetated	1
<i>Upstream Rt Ditch</i>	Vegetated	1
<i>Upstream Lt Ditch</i>	Vegetated	1
<i>Downstream Rt Outlet</i>	Bare soil	0
<i>Downstream Lt Outlet</i>	Rip Rap	1
<i>Downstream Rt Ditch</i>	Bare soil	0
<i>Downstream Lt Ditch</i>	Bare soil	0
<i>Outlet Total</i>	Partially Improved Outlet System	3
<i>Ditches Total</i>	Partially Improved Drainage System	3
<b><i>SRI Total</i></b>	<b>Medium Risk</b>	<b>44</b>

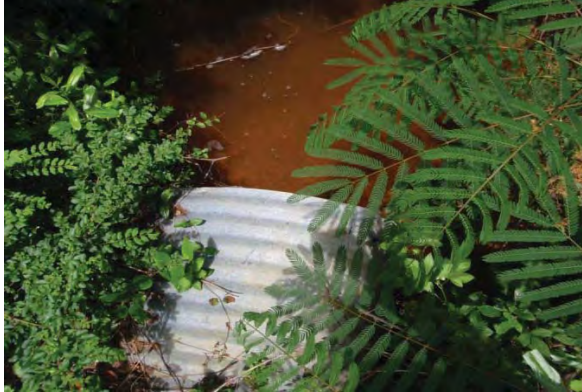
<h1>Unnamed tributary</h1>	<h2>ok-0526-r-009</h2>	<i>Sedimentation Risk Index</i> <b>44</b>
----------------------------	------------------------	--

Crossing Structure: DS

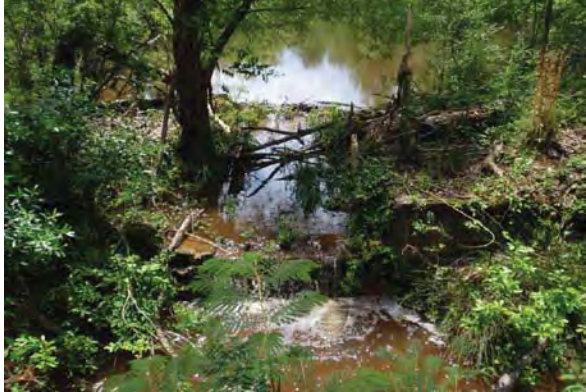
US

Risk Factor	Ranking	Score
<i>US Channel Morph</i>	PONDED	1
<i>DS Channel Morph</i>	B	5
<i>DS Bank Alteration</i>	HIGH	1
<i>Upstream Skew Angle</i>	<5°	5
<i>Crossing fill condition</i>	Good/Vegetated	5
<i>Inlet/Outlet Condition</i>	No Impairment	5
<i>Road Approach Material</i>	All Native Soil	1
<i>Potential Eroded Volume Mean</i>	<21 y <sup>3</sup>	5
<i>Approach Slope Mean</i>	2.1-4%	3
<i>Soil K Factor</i>	<0.20	5
<i>Upstream Rt Outlet</i>	Vegetated	1
<i>Upstream Lt Outlet</i>	Vegetated	1
<i>Upstream Rt Ditch</i>	Vegetated	1
<i>Upstream Lt Ditch</i>	Bare soil	0
<i>Downstream Rt Outlet</i>	Vegetated	1
<i>Downstream Lt Outlet</i>	Vegetated	1
<i>Downstream Rt Ditch</i>	Bare soil	0
<i>Downstream Lt Ditch</i>	Bare soil	0
<i>Outlet Total</i>	Improved Outlet System	5
<i>Ditches Total</i>	Partially Improved Drainage System	3
<b>SRI Total</b>	<b>Medium Risk</b>	<b>44</b>

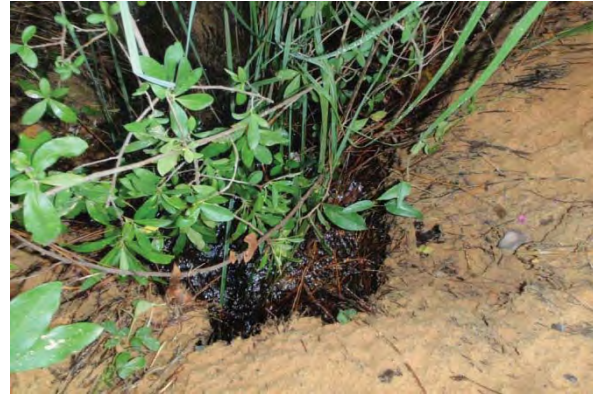
<b>Bridge Branch</b>	<b>ok-1005-r-003</b>	<i>Sedimentation Risk Index</i> <b>44</b>
----------------------	----------------------	--

Crossing Structure: US

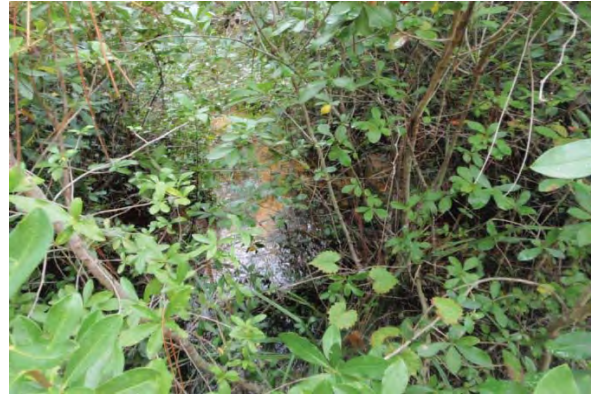
US

Risk Factor	Ranking	Score
<i>US Channel Morph</i>	B	5
<i>DS Channel Morph</i>	B	5
<i>DS Bank Alteration</i>	NATURAL	5
<i>Upstream Skew Angle</i>	<5°	5
<i>Crossing fill condition</i>	Good/Vegetated	5
<i>Inlet/Outlet Condition</i>	Sed Islands/Scouring	3
<i>Road Approach Material</i>	All Sand/Clay	3
<i>Potential Eroded Volume Mean</i>	>40 y <sup>3</sup>	1
<i>Approach Slope Mean</i>	>4%	1
<i>Soil K Factor</i>	<0.20	5
<i>Upstream Rt Outlet</i>	Vegetated	1
<i>Upstream Lt Outlet</i>	Vegetated	1
<i>Upstream Rt Ditch</i>	Bare soil	0
<i>Upstream Lt Ditch</i>	Bare soil	0
<i>Downstream Rt Outlet</i>	Vegetated	1
<i>Downstream Lt Outlet</i>	Vegetated	1
<i>Downstream Rt Ditch</i>	Bare soil	0
<i>Downstream Lt Ditch</i>	Bare soil	0
<i>Outlet Total</i>	Improved Outlet System	5
<i>Ditches Total</i>	Unimproved Drainage System	1
<b>SRI Total</b>	<b>Medium Risk</b>	<b>44</b>

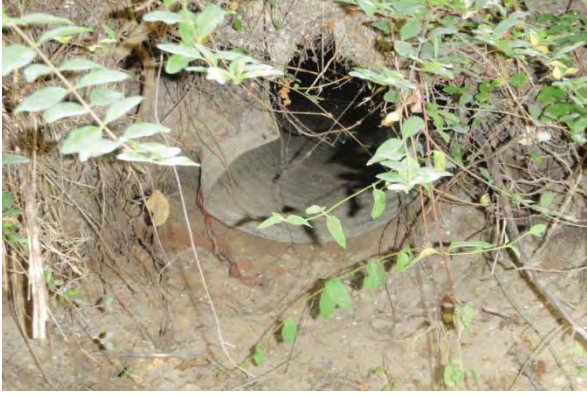
<b>Unnamed tributary</b>	<b>wa-0626-r-007</b>	<i>Sedimentation Risk Index</i> <b>44</b>
--------------------------	----------------------	--

Crossing Structure: DS

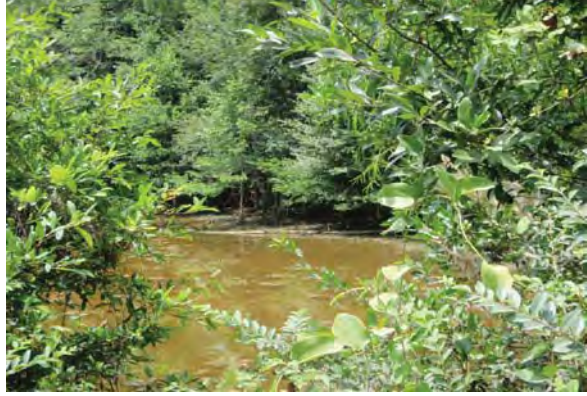
US

Risk Factor	Ranking	Score
<i>US Channel Morph</i>	PONDED	1
<i>DS Channel Morph</i>	C	5
<i>DS Bank Alteration</i>	HIGH	1
<i>Upstream Skew Angle</i>	5-30°	3
<i>Crossing fill condition</i>	Good/Vegetated	5
<i>Inlet/Outlet Condition</i>	No Impairment	5
<i>Road Approach Material</i>	All Aggregate	5
<i>Potential Eroded Volume Mean</i>	<21 y <sup>3</sup>	5
<i>Approach Slope Mean</i>	2.1-4%	3
<i>Soil K Factor</i>	0.21-0.40	3
<i>Upstream Rt Outlet</i>	Vegetated	1
<i>Upstream Lt Outlet</i>	Vegetated	1
<i>Upstream Rt Ditch</i>	Vegetated	1
<i>Upstream Lt Ditch</i>	Vegetated	1
<i>Downstream Rt Outlet</i>	Vegetated	1
<i>Downstream Lt Outlet</i>	Vegetated	1
<i>Downstream Rt Ditch</i>	Bare soil	0
<i>Downstream Lt Ditch</i>	Bare soil	0
<i>Outlet Total</i>	Improved Outlet System	5
<i>Ditches Total</i>	Partially Improved Drainage System	3
<b>SRI Total</b>	<b>Medium Risk</b>	<b>44</b>

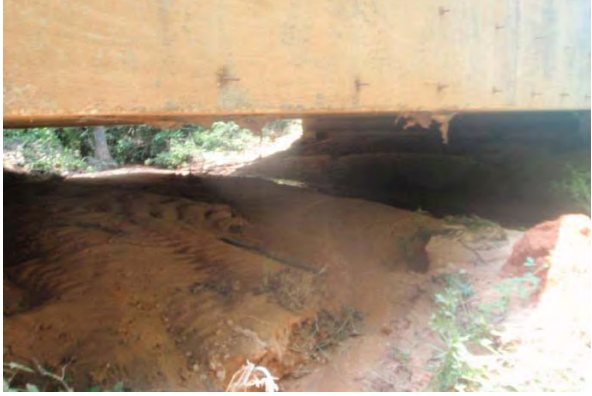
Unnamed tributary	wa-0714-r-005	Sedimentation Risk Index <b>44</b>
-------------------	---------------	---------------------------------------

Crossing Structure: DS

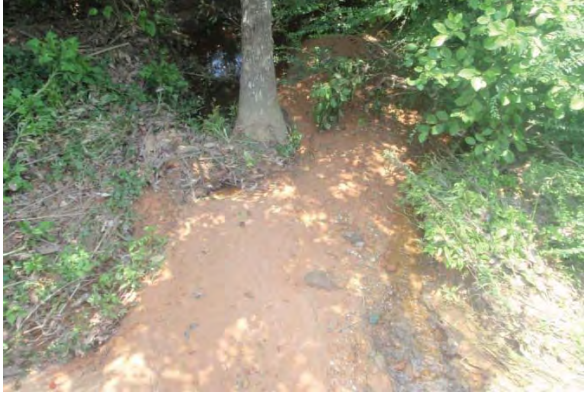
DS

Risk Factor	Ranking	Score
US Channel Morph	DA	3
DS Channel Morph	DA	3
DS Bank Alteration	MINOR/PARTIAL	3
Upstream Skew Angle	<5°	5
Crossing fill condition	Good/Vegetated	5
Inlet/Outlet Condition	Sed Islands/Scouring	3
Road Approach Material	All Aggregate	5
Potential Eroded Volume Mean	<21 y <sup>3</sup>	5
Approach Slope Mean	2.1-4%	3
Soil K Factor	<0.20	5
Upstream Rt Outlet	Vegetated	1
Upstream Lt Outlet	Vegetated	1
Upstream Rt Ditch	Bare soil	0
Upstream Lt Ditch	Bare soil	0
Downstream Rt Outlet	Bare soil	0
Downstream Lt Outlet	Vegetated	1
Downstream Rt Ditch	Bare soil	0
Downstream Lt Ditch	Bare soil	0
Outlet Total	Partially Improved Outlet System	3
Ditches Total	Unimproved Drainage System	1
<b>SRI Total</b>	<b>Medium Risk</b>	<b>44</b>
<b>Additional Site Features</b>		
<u>Crossing Type and Quantity:</u>	Bridge, 1	
<u>Crossing Materials:</u>	Reinforced Concrete	
<u>Soil Types:</u>	15,26,60	
<u>Rt Approach Prism Fill:</u>	0.1in

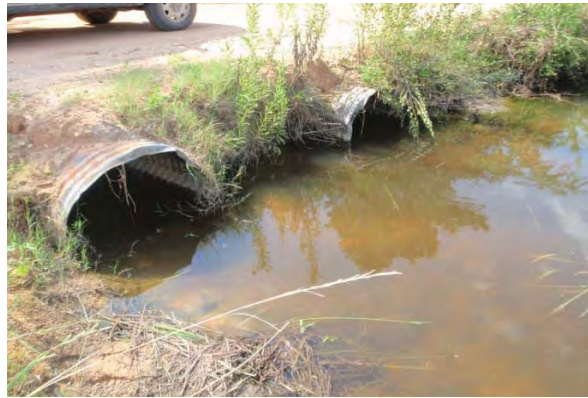
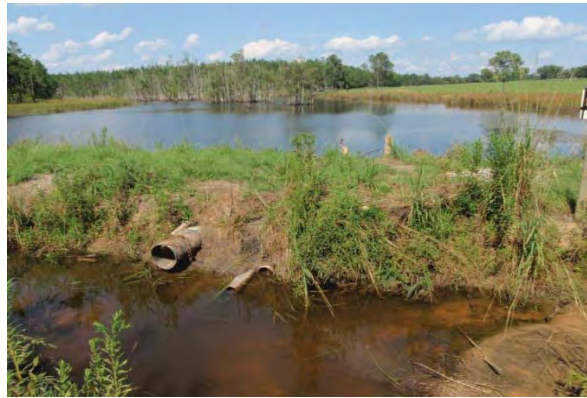
<h1>Unnamed tributary</h1>	<h2>wa-0722-r-009</h2>	<i>Sedimentation Risk Index</i> <b>44</b>
----------------------------	------------------------	--

Crossing Structure: DS

US

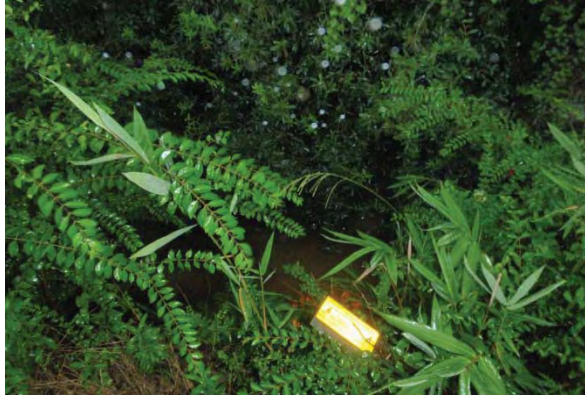
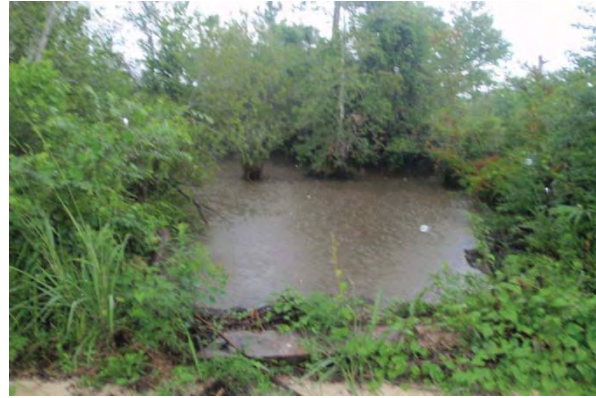
Unnamed tributary	wa-0723-r-003	Sedimentation Risk Index <b>44</b>
-------------------	---------------	---------------------------------------

DS

US

Notes: Highly vegetated DS

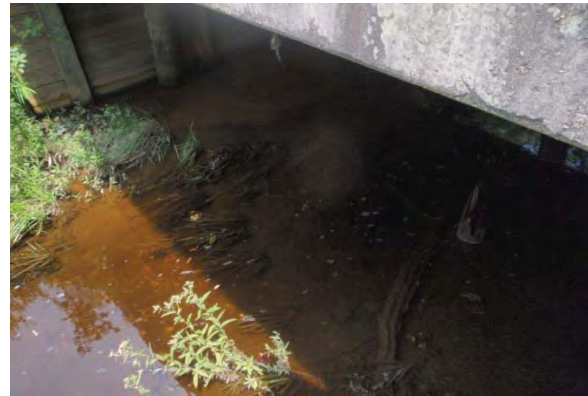
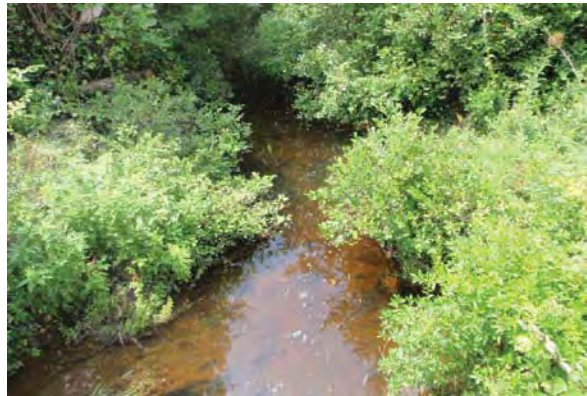
<b>Mulberry Creek</b>	<b>co-0831-r-006</b>	<i>Sedimentation Risk Index</i> <b>46</b>
-----------------------	----------------------	--

Crossing Structure: DS

DS

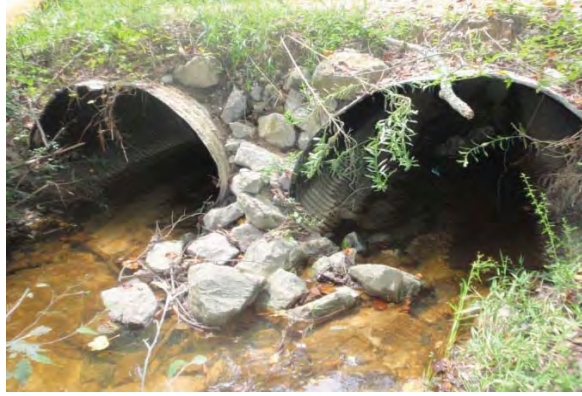
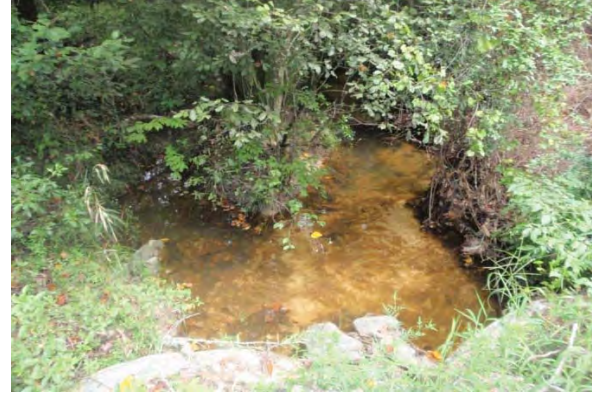
Unnamed tributary	co-0831-r-009	Sedimentation Risk Index <b>46</b>
-------------------	---------------	---------------------------------------

Crossing Structure: US

US

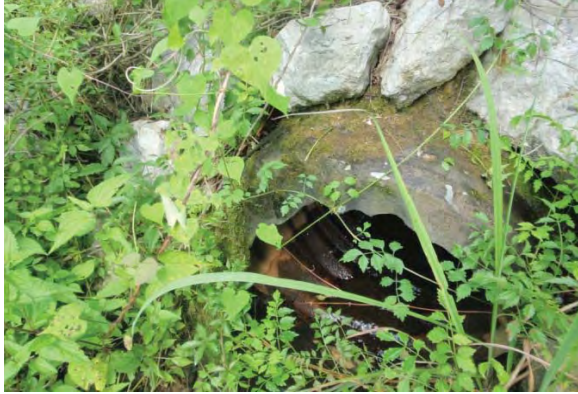
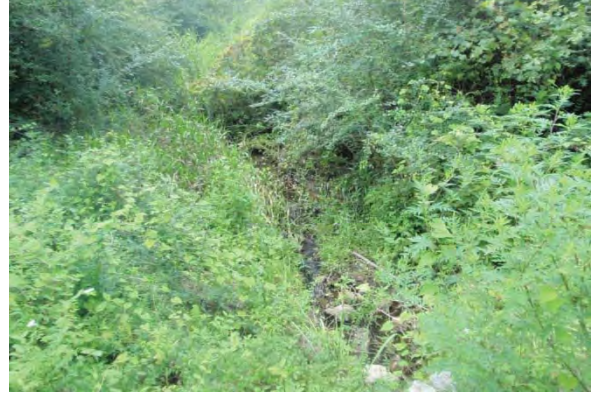
<b>Unnamed tributary</b>	<b>co-0901-r-003</b>	<i>Sedimentation Risk Index</i> <b>46</b>
--------------------------	----------------------	--

Crossing Structure: DS

DS

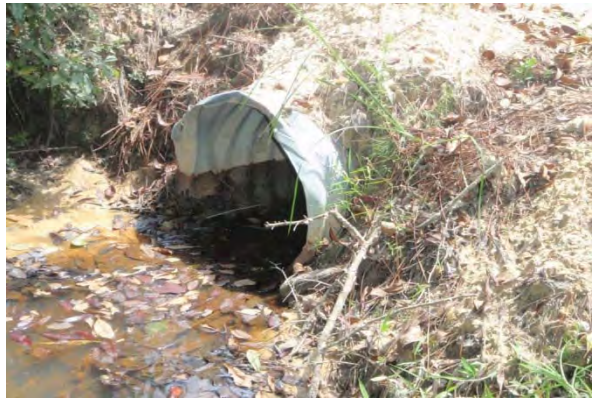
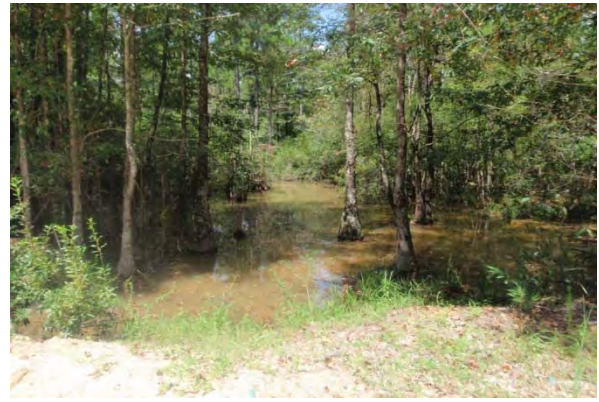
<b>Unnamed tributary</b>	<b>co-0904-r-006</b>	<i>Sedimentation Risk Index</i> <b>46</b>
--------------------------	----------------------	--

Crossing Structure: US

US

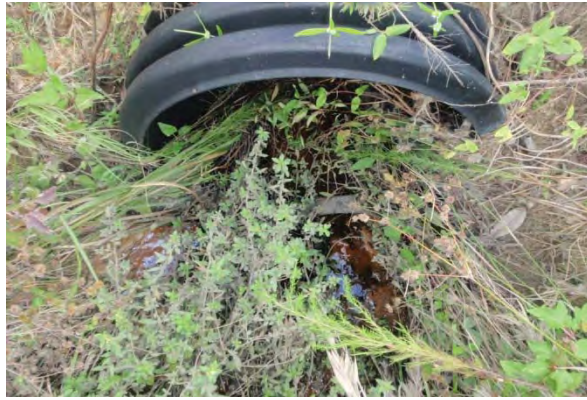
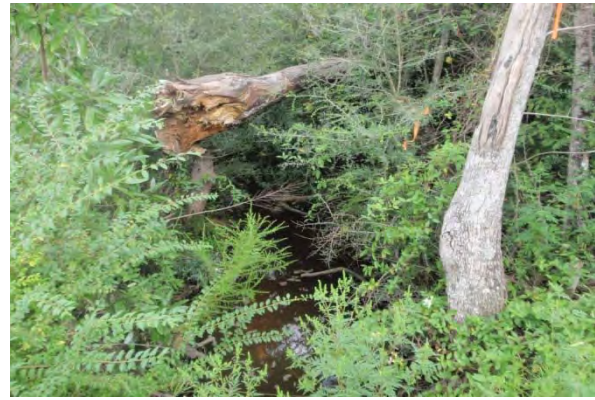
Unnamed tributary	co-0904-r-011	Sedimentation Risk Index <b>46</b>
-------------------	---------------	---------------------------------------

Crossing Structure: US

US

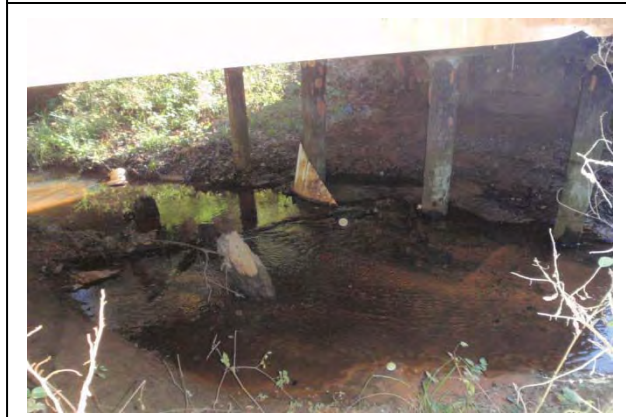
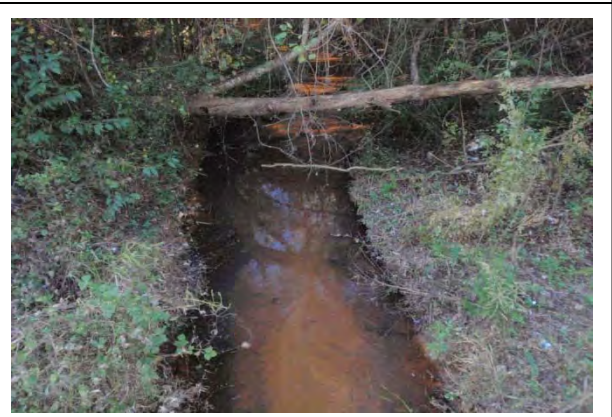
<b>Unnamed tributary</b>	<b>co-1103-r-013</b>	<i>Sedimentation Risk Index</i> <b>46</b>
--------------------------	----------------------	--

Crossing Structure: DS

DS

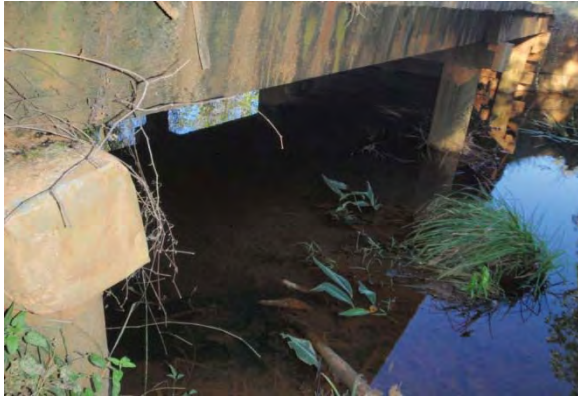
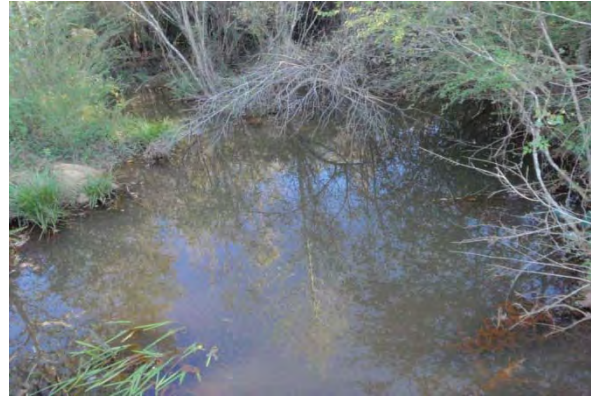
Unnamed tributary	co-1103-r-014	Sedimentation Risk Index <b>46</b>
-------------------	---------------	---------------------------------------

Crossing Structure: US

US

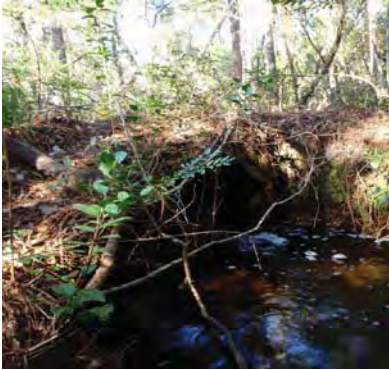
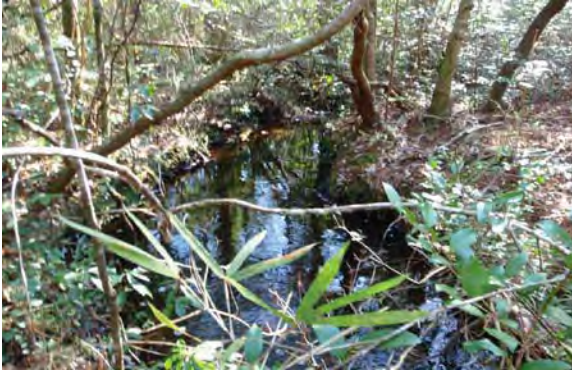
Crossing Structure- US		DS																																																																			
<table border="1"> <thead> <tr> <th>Risk Factor</th> <th>Ranking</th> <th>Score</th> </tr> </thead> <tbody> <tr><td><i>US Channel Morph</i></td><td>C</td><td>5</td></tr> <tr><td><i>DS Channel Morph</i></td><td>C</td><td>5</td></tr> <tr><td><i>DS Bank Alteration</i></td><td>MINOR/PARTIAL</td><td>3</td></tr> <tr><td><i>Upstream Skew Angle</i></td><td>&lt;5°</td><td>5</td></tr> <tr><td><i>Crossing fill condition</i></td><td>Poor/Bare Soil</td><td>1</td></tr> <tr><td><i>Inlet/Outlet Condition</i></td><td>Blocked</td><td>1</td></tr> <tr><td><i>Road Approach Material</i></td><td>All Native Soil</td><td>1</td></tr> <tr><td><i>Potential Eroded Volume Mean</i></td><td>&lt;21 y<sup>3</sup></td><td>5</td></tr> <tr><td><i>Approach Slope Mean</i></td><td>&lt;2%</td><td>5</td></tr> <tr><td><i>Soil K Factor</i></td><td>&lt;0.20</td><td>5</td></tr> <tr><td><i>Upstream Rt Outlet</i></td><td>Vegetated</td><td>1</td></tr> <tr><td><i>Upstream Lt Outlet</i></td><td>Vegetated</td><td>1</td></tr> <tr><td><i>Upstream Rt Ditch</i></td><td>Vegetated</td><td>1</td></tr> <tr><td><i>Upstream Lt Ditch</i></td><td>Vegetated</td><td>1</td></tr> <tr><td><i>Downstream Rt Outlet</i></td><td>Vegetated</td><td>1</td></tr> <tr><td><i>Downstream Lt Outlet</i></td><td>Vegetated</td><td>1</td></tr> <tr><td><i>Downstream Rt Ditch</i></td><td>Vegetated</td><td>1</td></tr> <tr><td><i>Downstream Lt Ditch</i></td><td>Vegetated</td><td>1</td></tr> <tr><td><i>Outlet Total</i></td><td>Improved Outlet System</td><td>5</td></tr> <tr><td><i>Ditches Total</i></td><td>Improved Drainage System</td><td>5</td></tr> <tr><td><b>SRI Total</b></td><td><b>Low Risk</b></td><td><b>46</b></td></tr> </tbody> </table>		Risk Factor	Ranking	Score	<i>US Channel Morph</i>	C	5	<i>DS Channel Morph</i>	C	5	<i>DS Bank Alteration</i>	MINOR/PARTIAL	3	<i>Upstream Skew Angle</i>	<5°	5	<i>Crossing fill condition</i>	Poor/Bare Soil	1	<i>Inlet/Outlet Condition</i>	Blocked	1	<i>Road Approach Material</i>	All Native Soil	1	<i>Potential Eroded Volume Mean</i>	<21 y <sup>3</sup>	5	<i>Approach Slope Mean</i>	<2%	5	<i>Soil K Factor</i>	<0.20	5	<i>Upstream Rt Outlet</i>	Vegetated	1	<i>Upstream Lt Outlet</i>	Vegetated	1	<i>Upstream Rt Ditch</i>	Vegetated	1	<i>Upstream Lt Ditch</i>	Vegetated	1	<i>Downstream Rt Outlet</i>	Vegetated	1	<i>Downstream Lt Outlet</i>	Vegetated	1	<i>Downstream Rt Ditch</i>	Vegetated	1	<i>Downstream Lt Ditch</i>	Vegetated	1	<i>Outlet Total</i>	Improved Outlet System	5	<i>Ditches Total</i>	Improved Drainage System	5	<b>SRI Total</b>	<b>Low Risk</b>	<b>46</b>

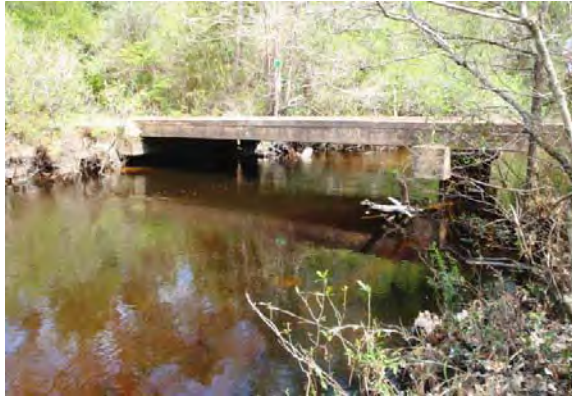
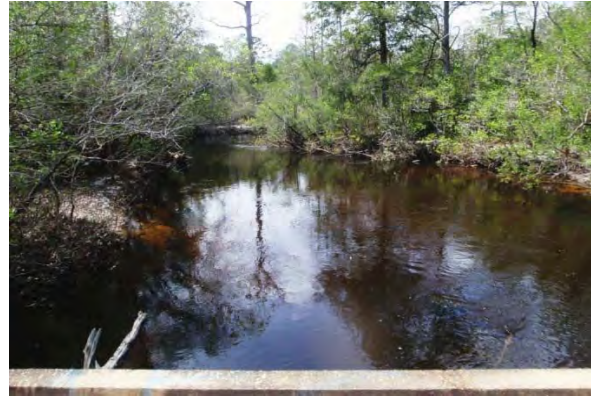
<b>Titi Creek</b>	<b>ok-0409-r-002</b>	<b>Sedimentation Risk Index</b> <b>46</b>
-------------------	----------------------	--

Crossing Structure: DS

DS

Risk Factor	Ranking	Score
<i>US Channel Morph</i>	E	5
<i>DS Channel Morph</i>	E	5
<i>DS Bank Alteration</i>	NATURAL	5
<i>Upstream Skew Angle</i>	<5°	5
<i>Crossing fill condition</i>	Fair/Riprap	3
<i>Inlet/Outlet Condition</i>	No Impairment	5
<i>Road Approach Material</i>	All Sand/Clay	3
<i>Potential Eroded Volume Mean</i>	>40 y <sup>3</sup>	1
<i>Approach Slope Mean</i>	<2%	5
<i>Soil K Factor</i>	<0.20	5
<i>Upstream Rt Outlet</i>	Vegetated	1
<i>Upstream Lt Outlet</i>	Vegetated	1
<i>Upstream Rt Ditch</i>	Bare soil	0
<i>Upstream Lt Ditch</i>	Bare soil	0
<i>Downstream Rt Outlet</i>	Vegetated	1
<i>Downstream Lt Outlet</i>	Bare soil	0
<i>Downstream Rt Ditch</i>	Bare soil	0
<i>Downstream Lt Ditch</i>	Bare soil	0
<i>Outlet Total</i>	Partially Improved Outlet System	3
<i>Ditches Total</i>	Unimproved Drainage System	1
<b>SRI Total</b>	<b>Low Risk</b>	<b>46</b>

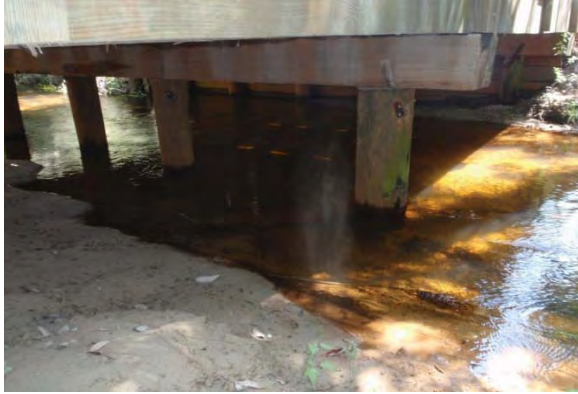
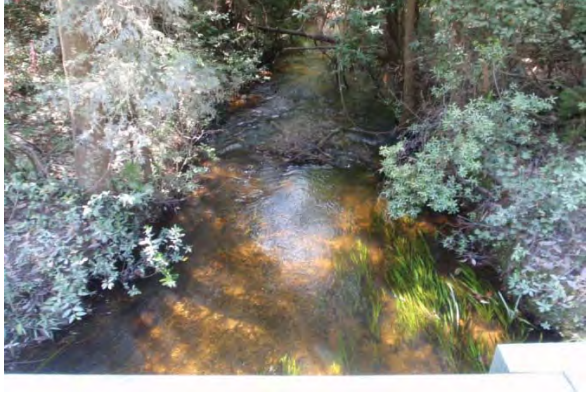
<h1>Baggett Creek</h1>	<h2>ok-0617-r-001</h2>	<b>Sedimentation Risk Index</b> <h1>46</h1>
------------------------	------------------------	--

Crossing Structure: DS

DS

Risk Factor	Ranking	Score
<i>US Channel Morph</i>	C	5
<i>DS Channel Morph</i>	C	5
<i>DS Bank Alteration</i>	MINOR/PARTIAL	3
<i>Upstream Skew Angle</i>	<5°	5
<i>Crossing fill condition</i>	Fair/Rip Rap	3
<i>Inlet/Outlet Condition</i>	No Impairment	5
<i>Road Approach Material</i>	All Aggregate	5
<i>Potential Eroded Volume Mean</i>	21-40 y <sup>3</sup>	3
<i>Approach Slope Mean</i>	>4%	1
<i>Soil K Factor</i>	<0.20	5
<i>Upstream Rt Outlet</i>	Other	0
<i>Upstream Lt Outlet</i>	Vegetated	1
<i>Upstream Rt Ditch</i>	Bare soil	0
<i>Upstream Lt Ditch</i>	Bare soil	0
<i>Downstream Rt Outlet</i>	Vegetated	1
<i>Downstream Lt Outlet</i>	Vegetated	1
<i>Downstream Rt Ditch</i>	Bare soil	0
<i>Downstream Lt Ditch</i>	Vegetated	1
<i>Outlet Total</i>	Partially Improved Outlet System	3
<i>Ditches Total</i>	Partially Improved Drainage System	3
<b>SRI Total</b>	<b>Low Risk</b>	<b>46</b>

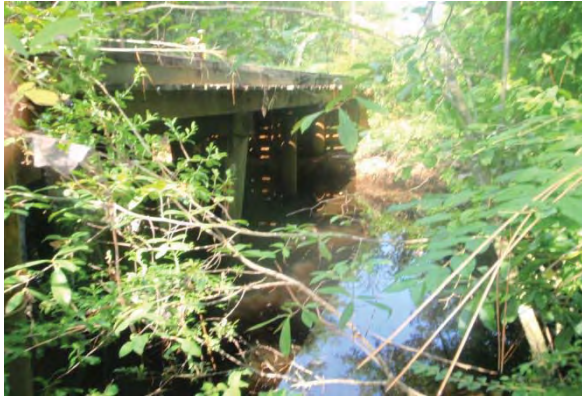
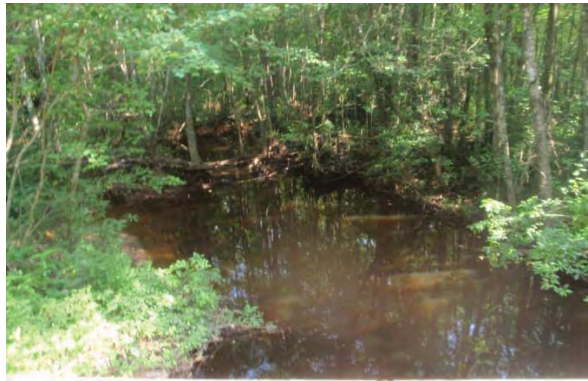
<h1>Caney Creek</h1>	<h2>wa-0714-r-011</h2>	<small>Sedimentation Risk Index</small> <h1>46</h1>
----------------------	------------------------	--

Crossing Structure: DS

DS

Risk Factor	Ranking	Score
<i>US Channel Morph</i>	E	5
<i>DS Channel Morph</i>	DA	3
<i>DS Bank Alteration</i>	MINOR/PARTIAL	3
<i>Upstream Skew Angle</i>	<5°	5
<i>Crossing fill condition</i>	Good/Vegetated	5
<i>Inlet/Outlet Condition</i>	No Impairment	5
<i>Road Approach Material</i>	All Sand/Clay	3
<i>Potential Eroded Volume Mean</i>	21-40 y <sup>3</sup>	3
<i>Approach Slope Mean</i>	2.1-4%	3
<i>Soil K Factor</i>	0.21-0.40	3
<i>Upstream Rt Outlet</i>	Vegetated	1
<i>Upstream Lt Outlet</i>	Vegetated	1
<i>Upstream Rt Ditch</i>	Vegetated	1
<i>Upstream Lt Ditch</i>	Bare soil	0
<i>Downstream Rt Outlet</i>	Vegetated	1
<i>Downstream Lt Outlet</i>	Vegetated	1
<i>Downstream Rt Ditch</i>	Bare soil	0
<i>Downstream Lt Ditch</i>	Bare soil	0
<i>Outlet Total</i>	Improved Outlet System	5
<i>Ditches Total</i>	Partially Improved Drainage System	3
<b><i>SRI Total</i></b>	<b>Low Risk</b>	<b>46</b>

Notes: Approaches in bad condition; not drivable.

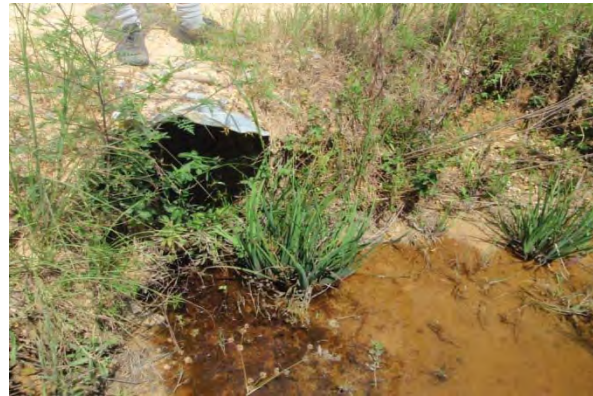
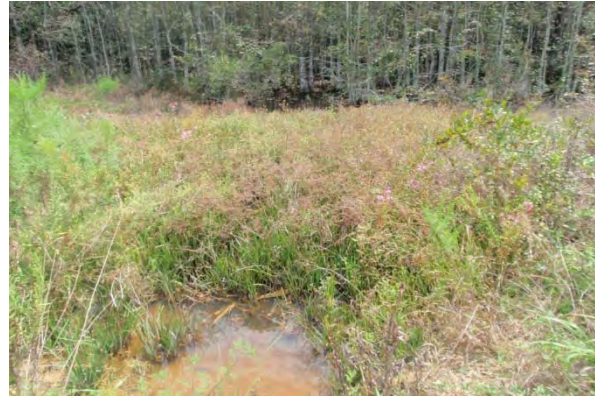
Unnamed tributary	co-0904-r-009	Sedimentation Risk Index <b>48</b>
-------------------	---------------	---------------------------------------

Crossing Structure: DS

US

Risk Factor	Ranking	Score
<i>US Channel Morph</i>	E	5
<i>DS Channel Morph</i>	WETLAND	5
<i>DS Bank Alteration</i>	HIGH	1
<i>Upstream Skew Angle</i>	<5°	5
<i>Crossing fill condition</i>	Good/Vegetated	5
<i>Inlet/Outlet Condition</i>	No Impairment	5
<i>Road Approach Material</i>	All Sand/Clay	3
<i>Potential Eroded Volume Mean</i>	<21 y <sup>3</sup>	5
<i>Approach Slope Mean</i>	2.1-4%	3
<i>Soil K Factor</i>	<0.20	5
<i>Upstream Rt Outlet</i>	Vegetated	1
<i>Upstream Lt Outlet</i>	Vegetated	1
<i>Upstream Rt Ditch</i>	Bare soil	0
<i>Upstream Lt Ditch</i>	Bare soil	0
<i>Downstream Rt Outlet</i>	Vegetated	1
<i>Downstream Lt Outlet</i>	Vegetated	1
<i>Downstream Rt Ditch</i>	Bare soil	0
<i>Downstream Lt Ditch</i>	Bare soil	0
<i>Outlet Total</i>	Improved Outlet System	5
<i>Ditches Total</i>	Unimproved Drainage System	1
<b>SRI Total</b>	<b>Low Risk</b>	<b>48</b>

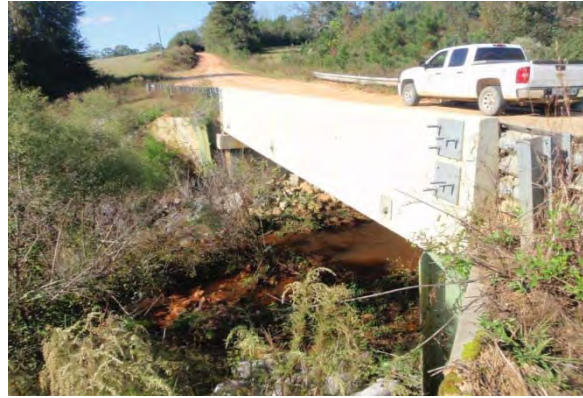
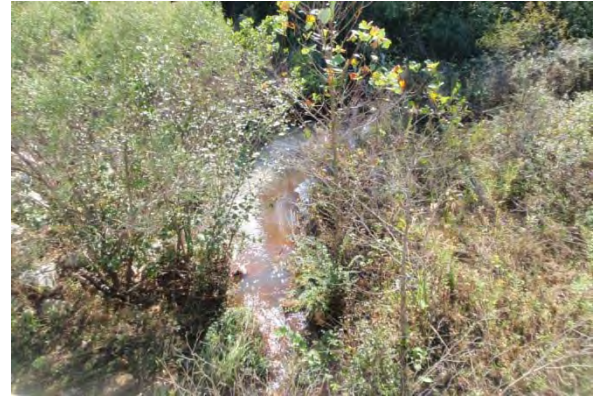
Unnamed Tributary	co-1102-r-008	Sedimentation Risk Index <b>48</b>
-------------------	---------------	---------------------------------------

Crossing Structure: DS

DS

Risk Factor	Ranking	Score
<i>US Channel Morph</i>	WETLAND	5
<i>DS Channel Morph</i>	C	5
<i>DS Bank Alteration</i>	MINOR/PARTIAL	3
<i>Upstream Skew Angle</i>	<5°	5
<i>Crossing fill condition</i>	Fair/Rip Rap	3
<i>Inlet/Outlet Condition</i>	No Impairment	5
<i>Road Approach Material</i>	All Sand/Clay	3
<i>Potential Eroded Volume Mean</i>	21-40 y <sup>3</sup>	3
<i>Approach Slope Mean</i>	2.1-4%	3
<i>Soil K Factor</i>	<0.20	5
<i>Upstream Rt Outlet</i>	Rip Rap	1
<i>Upstream Lt Outlet</i>	Vegetated	1
<i>Upstream Rt Ditch</i>	Bare soil	0
<i>Upstream Lt Ditch</i>	Vegetated	1
<i>Downstream Rt Outlet</i>	Vegetated	1
<i>Downstream Lt Outlet</i>	Vegetated	1
<i>Downstream Rt Ditch</i>	Bare soil	0
<i>Downstream Lt Ditch</i>	Vegetated	1
<i>Outlet Total</i>	Improved Outlet System	5
<i>Ditches Total</i>	Partially Improved Drainage System	3
<b>SRI Total</b>	<b>Low Risk</b>	<b>48</b>

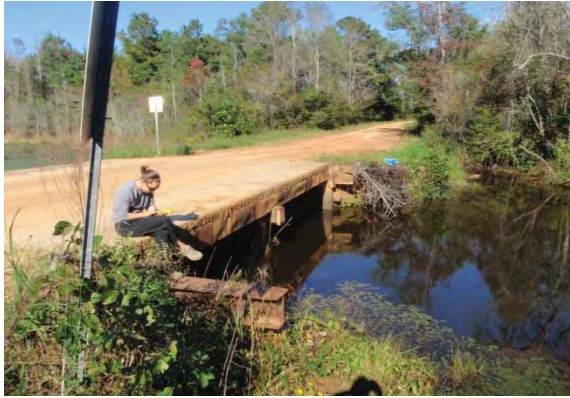
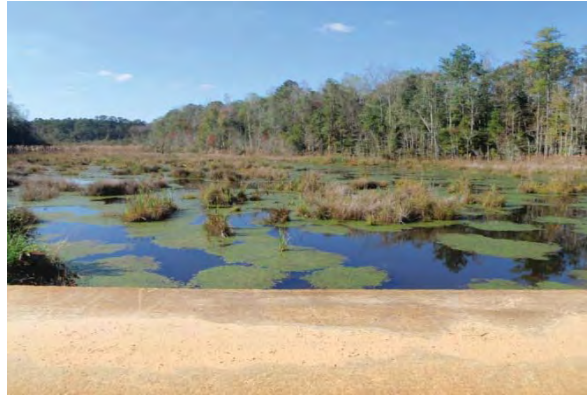
Unnamed tributary	co-1102-r-010	Sedimentation Risk Index <b>48</b>
-------------------	---------------	---------------------------------------

Crossing Structure: DS

US

Risk Factor	Ranking	Score
<i>US Channel Morph</i>	WETLAND	5
<i>DS Channel Morph</i>	WETLAND	5
<i>DS Bank Alteration</i>	MINOR/PARTIAL	3
<i>Upstream Skew Angle</i>	<5°	5
<i>Crossing fill condition</i>	Good/Vegetated	5
<i>Inlet/Outlet Condition</i>	No Impairment	5
<i>Road Approach Material</i>	All Sand/Clay	3
<i>Potential Eroded Volume Mean</i>	21-40 y <sup>3</sup>	3
<i>Approach Slope Mean</i>	<2%	5
<i>Soil K Factor</i>	<0.20	5
<i>Upstream Rt Outlet</i>	Vegetated	1
<i>Upstream Lt Outlet</i>	Vegetated	1
<i>Upstream Rt Ditch</i>	Bare soil	0
<i>Upstream Lt Ditch</i>	Bare soil	0
<i>Downstream Rt Outlet</i>	Bare soil	0
<i>Downstream Lt Outlet</i>	Bare soil	0
<i>Downstream Rt Ditch</i>	Bare soil	0
<i>Downstream Lt Ditch</i>	Bare soil	0
<i>Outlet Total</i>	Partially Improved Outlet System	3
<i>Ditches Total</i>	Unimproved Drainage System	1
<b>SRI Total</b>	<b>Low Risk</b>	<b>48</b>

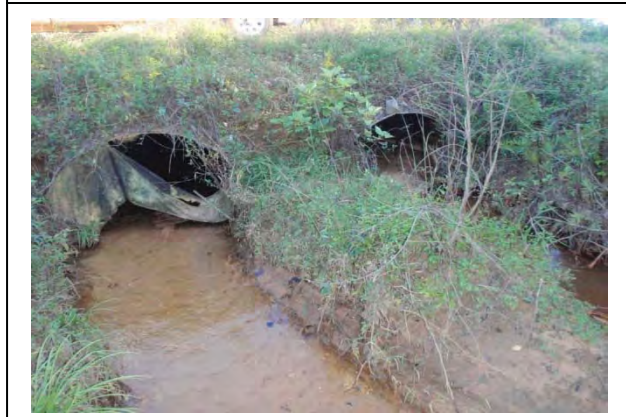
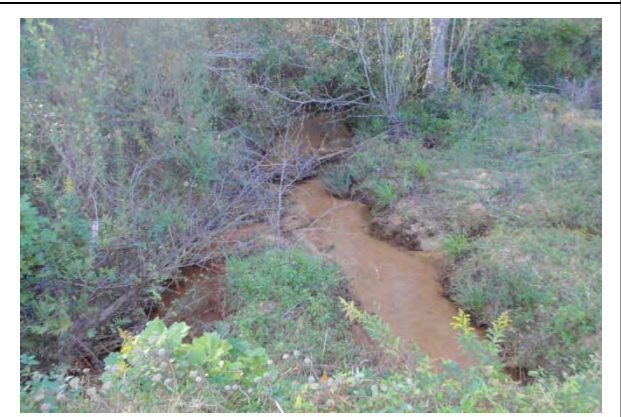
<b>Unnamed tributary</b>	<b>co-1103-r-015</b>	<b>Sedimentation Risk Index</b> <b>48</b>
--------------------------	----------------------	--

Crossing Structure: DS

DS

Risk Factor	Ranking	Score
<i>US Channel Morph</i>	E	5
<i>DS Channel Morph</i>	E	5
<i>DS Bank Alteration</i>	MINOR/PARTIAL	3
<i>Upstream Skew Angle</i>	<5°	5
<i>Crossing fill condition</i>	Good/Vegetated	5
<i>Inlet/Outlet Condition</i>	Sed Islands/Scouring	3
<i>Road Approach Material</i>	All Sand/Clay	3
<i>Potential Eroded Volume Mean</i>	<21 y <sup>3</sup>	5
<i>Approach Slope Mean</i>	2.1-4%	3
<i>Soil K Factor</i>	<0.20	5
<i>Upstream Rt Outlet</i>	Vegetated	1
<i>Upstream Lt Outlet</i>	Vegetated	1
<i>Upstream Rt Ditch</i>	Bare soil	0
<i>Upstream Lt Ditch</i>	Bare soil	0
<i>Downstream Rt Outlet</i>	Bare soil	0
<i>Downstream Lt Outlet</i>	Vegetated	1
<i>Downstream Rt Ditch</i>	Bare soil	0
<i>Downstream Lt Ditch</i>	Vegetated	1
<i>Outlet Total</i>	Partially Improved Outlet System	3
<i>Ditches Total</i>	Partially Improved Drainage System	3
<b>SRI Total</b>	<b>Low Risk</b>	<b>48</b>

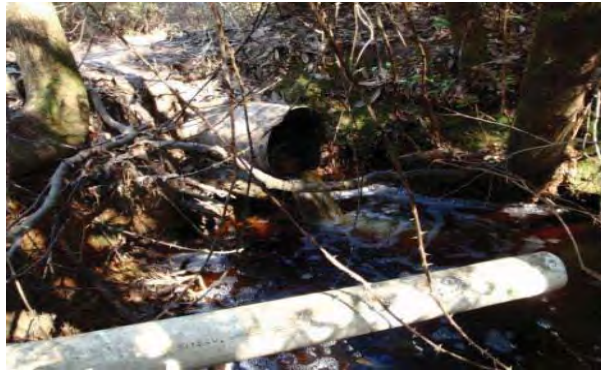
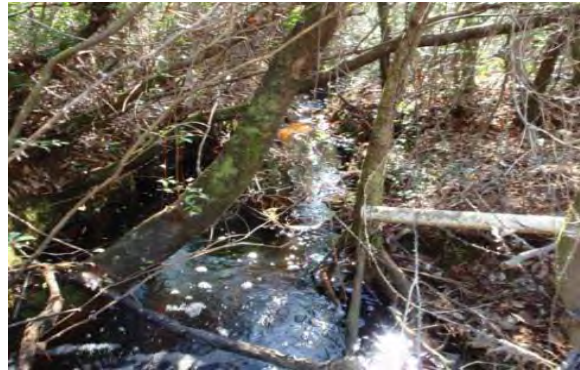
Crossing Structure- DS

DS

Risk Factor	Ranking	Score
<i>US Channel Morph</i>	B	5
<i>DS Channel Morph</i>	C	5
<i>DS Bank Alteration</i>	MINOR/PARTIAL	3
<i>Upstream Skew Angle</i>	<5°	5
<i>Crossing fill condition</i>	Poor/Bare Soil	1
<i>Inlet/Outlet Condition</i>	No Impairment	5
<i>Road Approach Material</i>	All Sand/Clay	3
<i>Potential Eroded Volume Mean</i>	<21 y <sup>3</sup>	5
<i>Approach Slope Mean</i>	<2%	5
<i>Soil K Factor</i>	<0.20	5
<i>Upstream Rt Outlet</i>	Bare Soil	0
<i>Upstream Lt Outlet</i>	Bare Soil	0
<i>Upstream Rt Ditch</i>	Vegetated	1
<i>Upstream Lt Ditch</i>	Vegetated	1
<i>Downstream Rt Outlet</i>	Bare Soil	0
<i>Downstream Lt Outlet</i>	Bare Soil	0
<i>Downstream Rt Ditch</i>	Vegetated	1
<i>Downstream Lt Ditch</i>	Vegetated	1
<i>Outlet Total</i>	Unimproved Outlet System	1
<i>Ditches Total</i>	Improved Drainage System	5
<b>SRI Total</b>	<b>Low Risk</b>	<b>48</b>

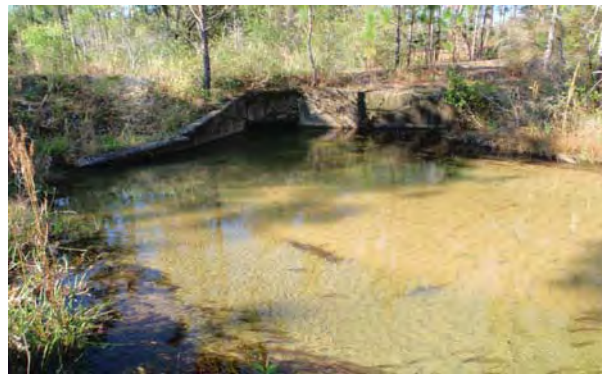
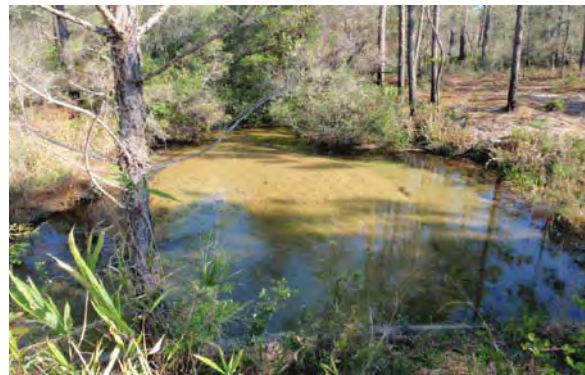
Crossing Structure- US

US

Risk Factor	Ranking	Score
<i>US Channel Morph</i>	C	5
<i>DS Channel Morph</i>	C	5
<i>DS Bank Alteration</i>	MINOR/PARTIAL	3
<i>Upstream Skew Angle</i>	<5°	5
<i>Crossing fill condition</i>	Good/Vegetated	5
<i>Inlet/Outlet Condition</i>	No Impairment	5
<i>Road Approach Material</i>	All Aggregate	5
<i>Potential Eroded Volume Mean</i>	<21 y <sup>3</sup>	5
<i>Approach Slope Mean</i>	>4%	1
<i>Soil K Factor</i>	<0.20	5
<i>Upstream Rt Outlet</i>	Concrete	0
<i>Upstream Lt Outlet</i>	Concrete	0
<i>Upstream Rt Ditch</i>	Concrete	0
<i>Upstream Lt Ditch</i>	Concrete	0
<i>Downstream Rt Outlet</i>	Vegetated	1
<i>Downstream Lt Outlet</i>	Concrete	0
<i>Downstream Rt Ditch</i>	Bare soil	0
<i>Downstream Lt Ditch</i>	Concrete	0
<i>Outlet Total</i>	Partially Improved Outlet System	3
<i>Ditches Total</i>	Unimproved Drainage System	1
<b>SRI Total</b>	<b>Low Risk</b>	<b>48</b>

Notes: Both approaches paved hilltop to hilltop

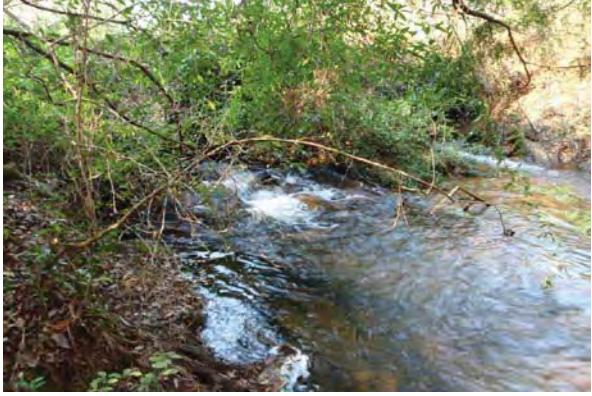
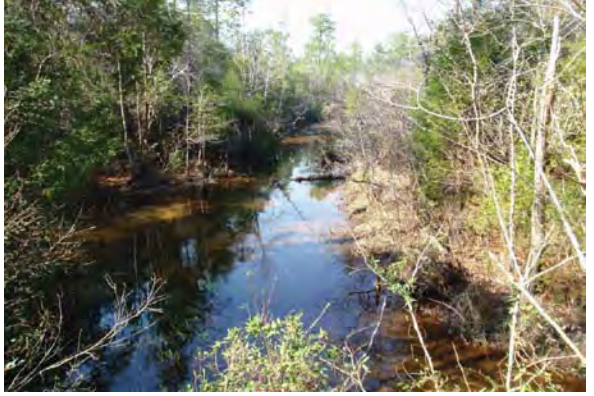
<b>Julian Mill Creek</b>	<b>sr-0223-r-002</b>	<i>Sedimentation Risk Index</i> <b>50</b>
--------------------------	----------------------	--

Notes: DS Lt Outlet vegetated, but doing little for the large amounts of sediment. DS outfall drop.
