Appendix A. River corridor severity scores for impaired sites in the Yellow River Basin, Alabama and Florida

Appendix C. Clear Creek Watershed Focal Area. Sites with orange headings are unpaved road sites. Specific definitions and calculations described for calculating the Sediment Risk Index (SRI) are detailed in Witmer (2009).

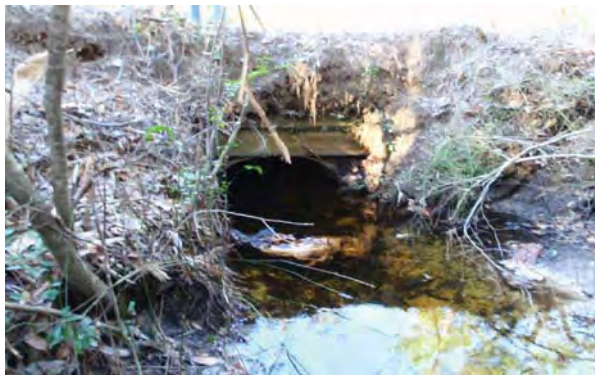
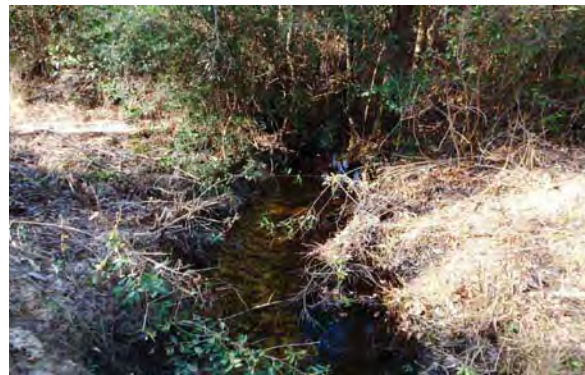
Crossing Structure- DS

Notes: Receives a lot of sediment when the road is grated. Culvert undersized.

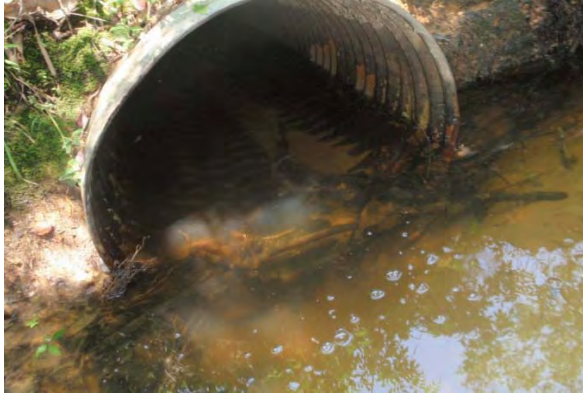
Crossing Structure: US

Risk Factor	Ranking	Score
<i>US Channel Morph</i>	C	5
<i>DS Channel Morph</i>	C	5
<i>DS Bank Alteration</i>	MINOR/PARTIAL	3
<i>Upstream Skew Angle</i>	5-30°	3
<i>Crossing fill condition</i>	Good/Vegetated	5
<i>Inlet/Outlet Condition</i>	No Impairment	5
<i>Road Approach Material</i>	All Aggregate	5
<i>Potential Eroded Volume Mean</i>	<21 y <sup>3</sup>	5
<i>Approach Slope Mean</i>	<2%	5
<i>Soil K Factor</i>	<0.20	5
<i>Upstream Rt Outlet</i>	Vegetated	1
<i>Upstream Lt Outlet</i>	Vegetated	1
<i>Upstream Rt Ditch</i>	Vegetated	1
<i>Upstream Lt Ditch</i>	Vegetated	1
<i>Downstream Rt Outlet</i>	Vegetated	1
<i>Downstream Lt Outlet</i>	Vegetated	1
<i>Downstream Rt Ditch</i>	Vegetated	1
<i>Downstream Lt Ditch</i>	Vegetated	1
<i>Outlet Total</i>	Improved Outlet System	5
<i>Ditches Total</i>	Improved Drainage System	5
<b>SRI Total</b>	<b>Low Risk</b>	<b>56</b>

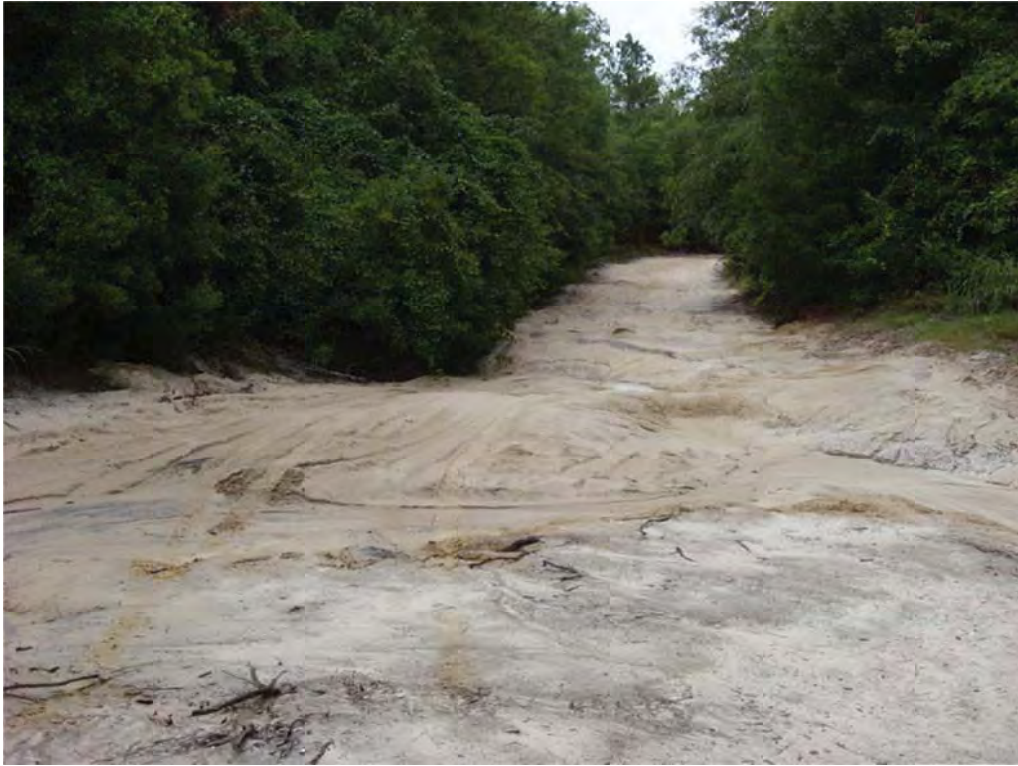
**Figure 5. Eroding unpaved road discharging into the Dripping Rock site, Yellow River.**

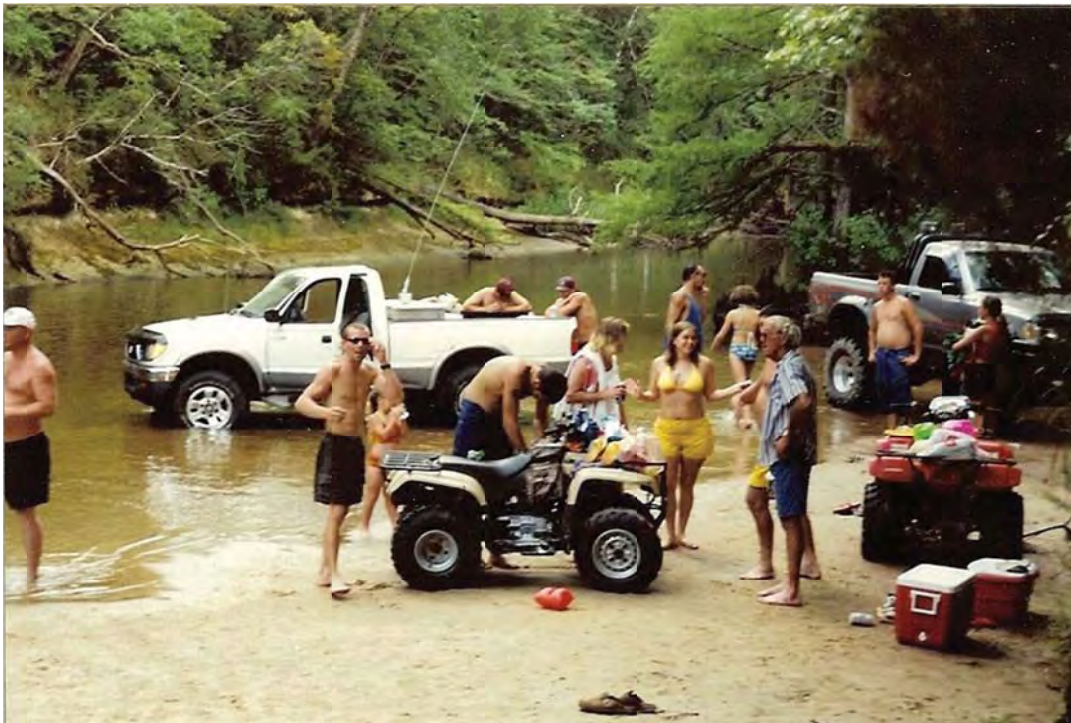
However, this location has substantial public use along its banks adjacent to this spawning area. This has resulted in denuded river banks which are known to slough substantial amounts of sediment to the Gulf sturgeon spawning area during rain events and high river flow periods. This has resulted in reduced water quality and significant bank erosion (Figure 4) at this site, and is believed to smother and otherwise degrade the natural bedrock and gravel spawning substrate needed by Gulf sturgeon for population recovery in this river. The USFWS Gulf Sturgeon Recovery/Management Plan (1995) identifies habitat degradation, including degradation and loss of spawning habitat, as a significant contributor to the decline of this species and responsible for its listing under the Endangered Species Act. The plan also recommends habitat restoration to reduce these impacts for long-term recovery of Gulf sturgeon populations in affected systems.

**Figure 6. Local impacts on Gulf sturgeon spawning habitat at the Dripping Rock site, Yellow River.**

The objectives of this project are to (1) reshape the right streambank at the Yellow River to create a stable slope and minimize sedimentation, (2) replant riparian vegetation to restore the natural floodplain ecosystem along the Yellow River, (3) isolate the reach from degradation caused by vehicles, and (4) provide stream corridor habitat necessary for long-term (+10 years) recovery of the natural riparian vegetation community of this stream system.

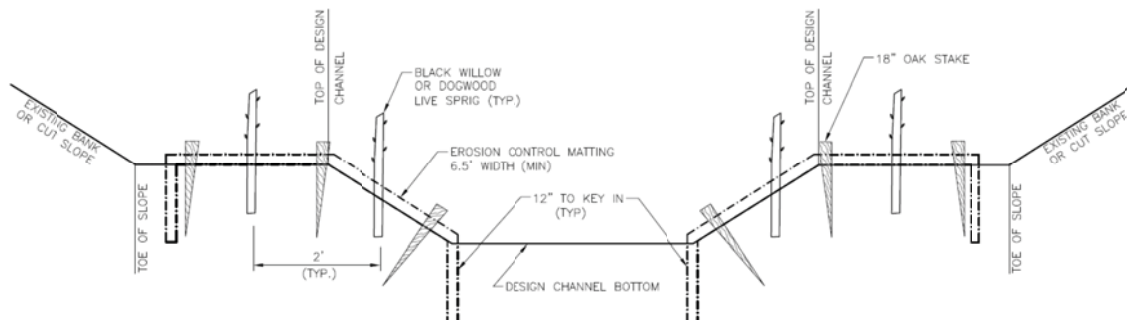
**Figure 1. Typical Erosion Control Fabric Type and Placement Along Streambank with Live Staking Placement.**

Coir fiber blankets should be placed on all exposed streambank soils and anchored with either live or wooden (minimum length 18") stakes every 4 feet (Figures 1 and 2). Blankets should be woven with a minimum weight of 700 grams/square meter. Along exposed upper slopes and floodplain areas, blown hay and wooden fiber blanket (i.e., excelsior) should be installed and securely fastened with either wooden stakes or metal staples.

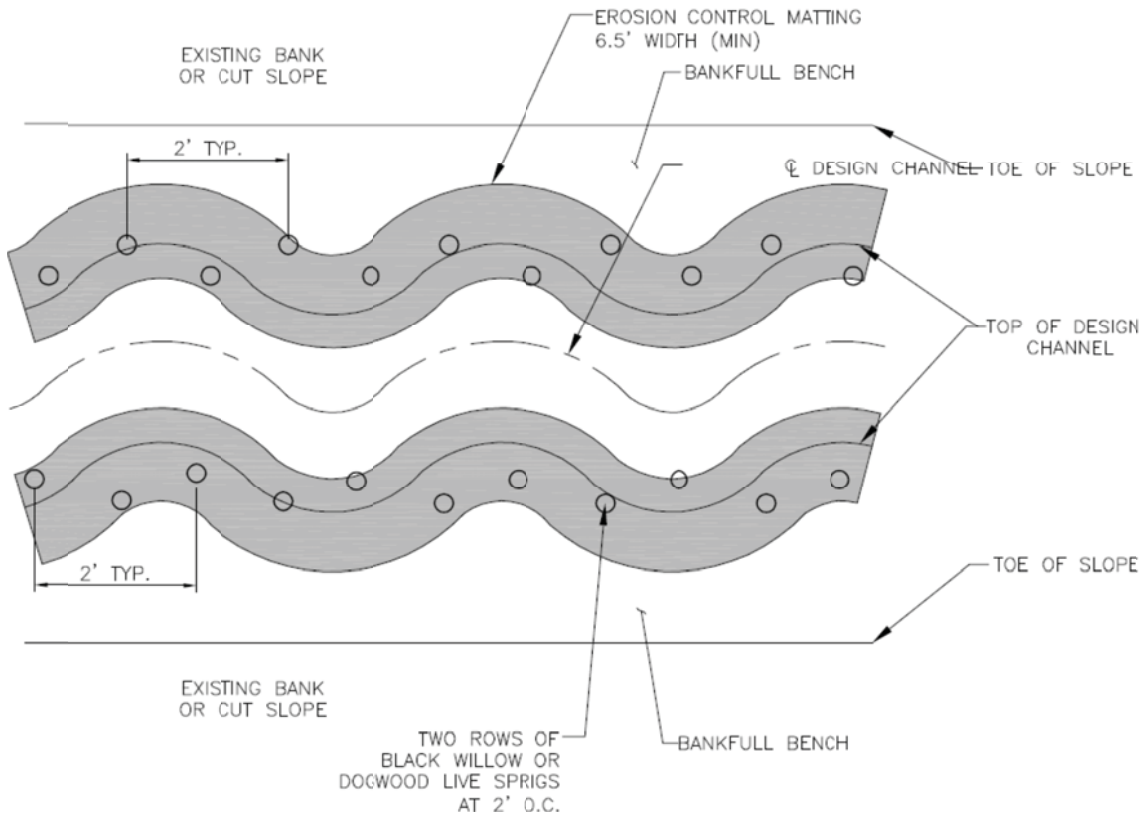
Figure 2. Typical Live Staking Placement Along Streambank.

The following plants are recommended to make live stakes. All live stakes should be harvested during the winter/dormant months and planted along the streambank where ground water will be exposed to bark. Live stakes should range between 12" to 48" long and planted at a spacing of 2 feet (Figures 1 and 2).
