UNITED STATES  
**NUCLEAR REGULATORY COMMISSION**  
REGION IV  
1600 EAST LAMAR BLVD  
ARLINGTON, TEXAS 76011-4511

**SUBJECT: SAN ONOFRE NUCLEAR GENERATING STATION – NRC AUGMENTED  
INSPECTION TEAM REPORT 05000361/2012007 and 05000362/2012007**

On March 19, 2012, an Augmented Inspection Team (AIT) was dispatched to San Onofre Nuclear Generating Station to gather facts and understand the circumstances surrounding the January 31, 2012 Unit 3 primary-to-secondary leak and failure of eight steam generator tubes to maintain structural integrity as required by plant technical specifications during testing the week of March 13, 2012. The primary-to-secondary leak was the result of a single tube in Unit 3 steam generator 3E0-88 failing to maintain structural integrity.

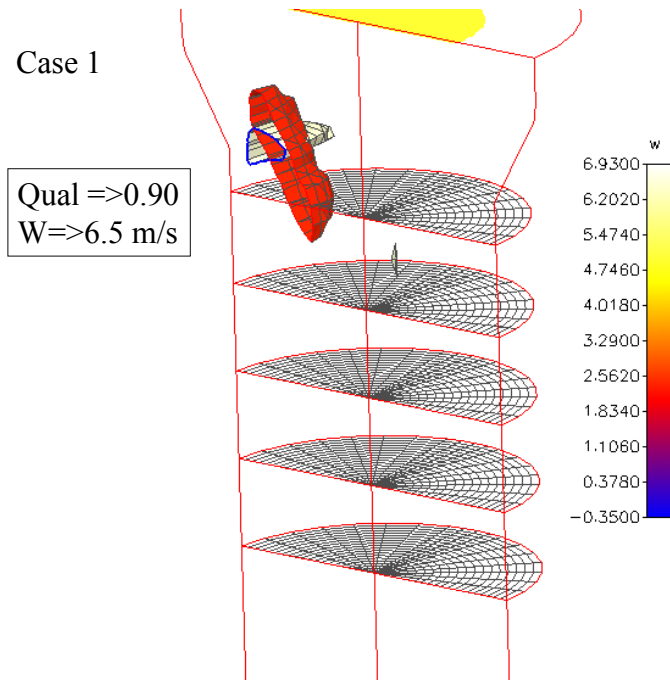
**Figure 2**

Both the NRC and Mitsubishi ATHOS results were reasonably consistent and strongly suggested that high velocities coupled with high void fraction were primary causal factors in the tube fluid-elastic instability and the excessive wear patterns observed in the Unit 3 steam generators.

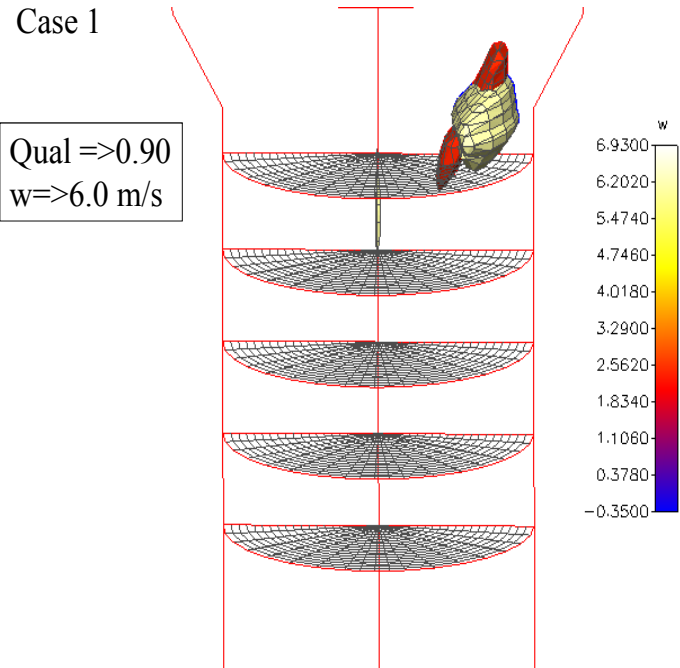
**Figure 5**

The ATHOS code predicted regions of high void fraction and high steam velocities are superimposed with tube-to-tube wear indications from Unit 3 steam generator 3E0-88

The NRC analysis indicated a correlation with the tube-to-tube wear based on a combination of high void fraction and high steam velocities. It should be noted that the traditional forcing function, fluid velocity squared times density, does not show good agreement with the tube-to-tube wear patterns. This indicated that the high quality steam fluid velocities and high void fraction may be sufficiently high to cause conditions in the generators conducive for onset of fluid-elastic instability.
