Enbridge Incorporated
Hazardous Liquid Pipeline Rupture and Release
Marshall, Michigan
July 25, 2010

NTSB/PAR-12/01
PB2012-916501
Notation 8423
Adopted July 10, 2012

Pipeline Accident Report

On Sunday, July 25, 2010, at 5:58 p.m., eastern daylight time, a segment of a 30-inch-diameter pipeline (Line 6B), owned and operated by Enbridge Incorporated (Enbridge) ruptured in a wetland in Marshall, Michigan. The rupture occurred during the last stages of a planned shutdown and was not discovered or addressed for over 17 hours. During the time lapse, Enbridge twice pumped additional oil (81 percent of the total release) into Line 6B during two startups; the total release was estimated to be 843,444 gallons of crude oil. The oil saturated the surrounding wetlands and flowed into the Talmadge Creek and the Kalamazoo River. Local residents self-evacuated from their houses, and the environment was negatively affected. Cleanup efforts continue as of the adoption date of this report, with continuing costs exceeding \$767 million. About 320 people reported symptoms consistent with crude oil exposure. No fatalities were reported.

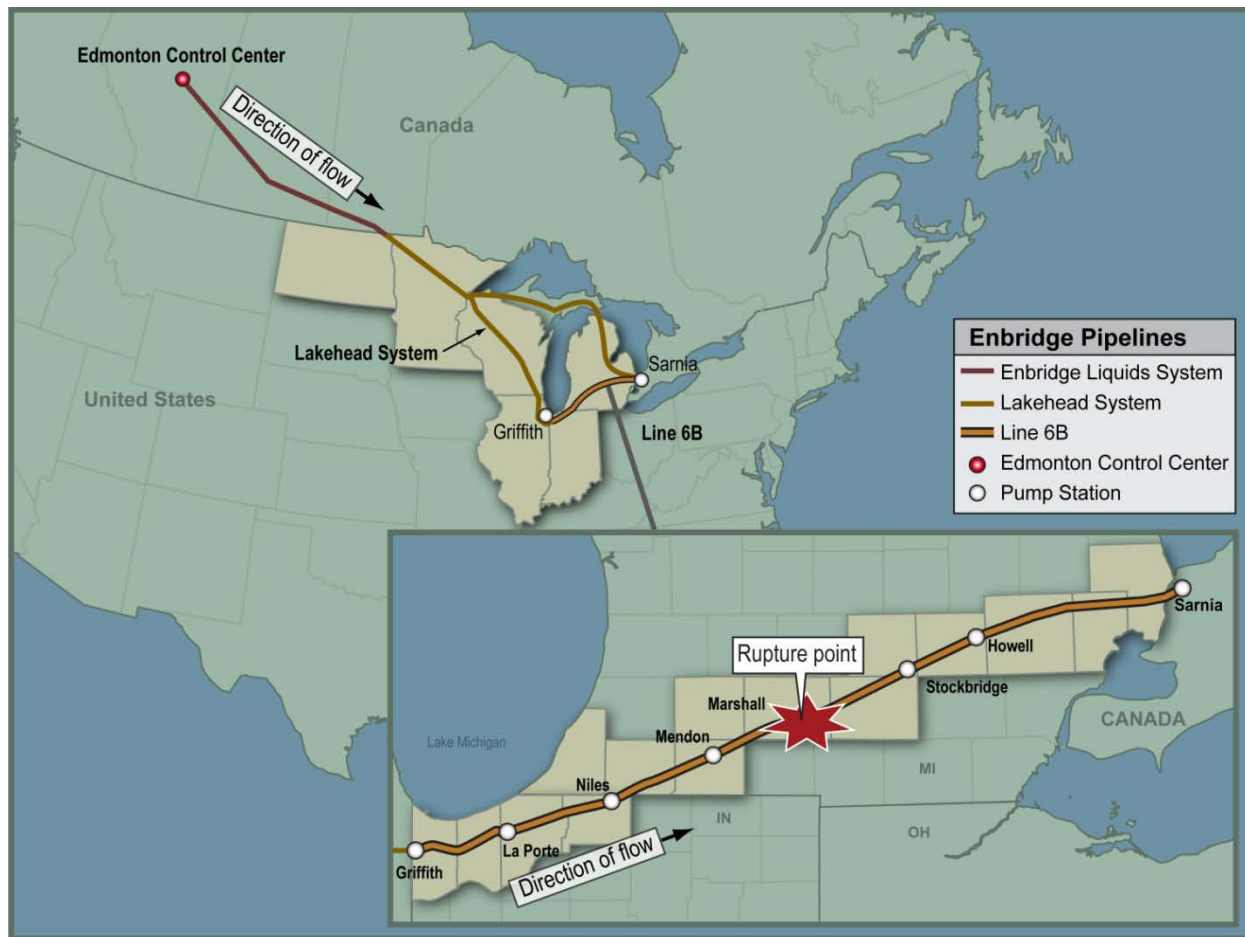
Figure 1. Enbridge’s Liquids System and the 1,900-mile Lakehead System (the U.S. portion). Inset shows Line 6B, the 293-mile extension from Griffith to Sarnia installed in 1969.

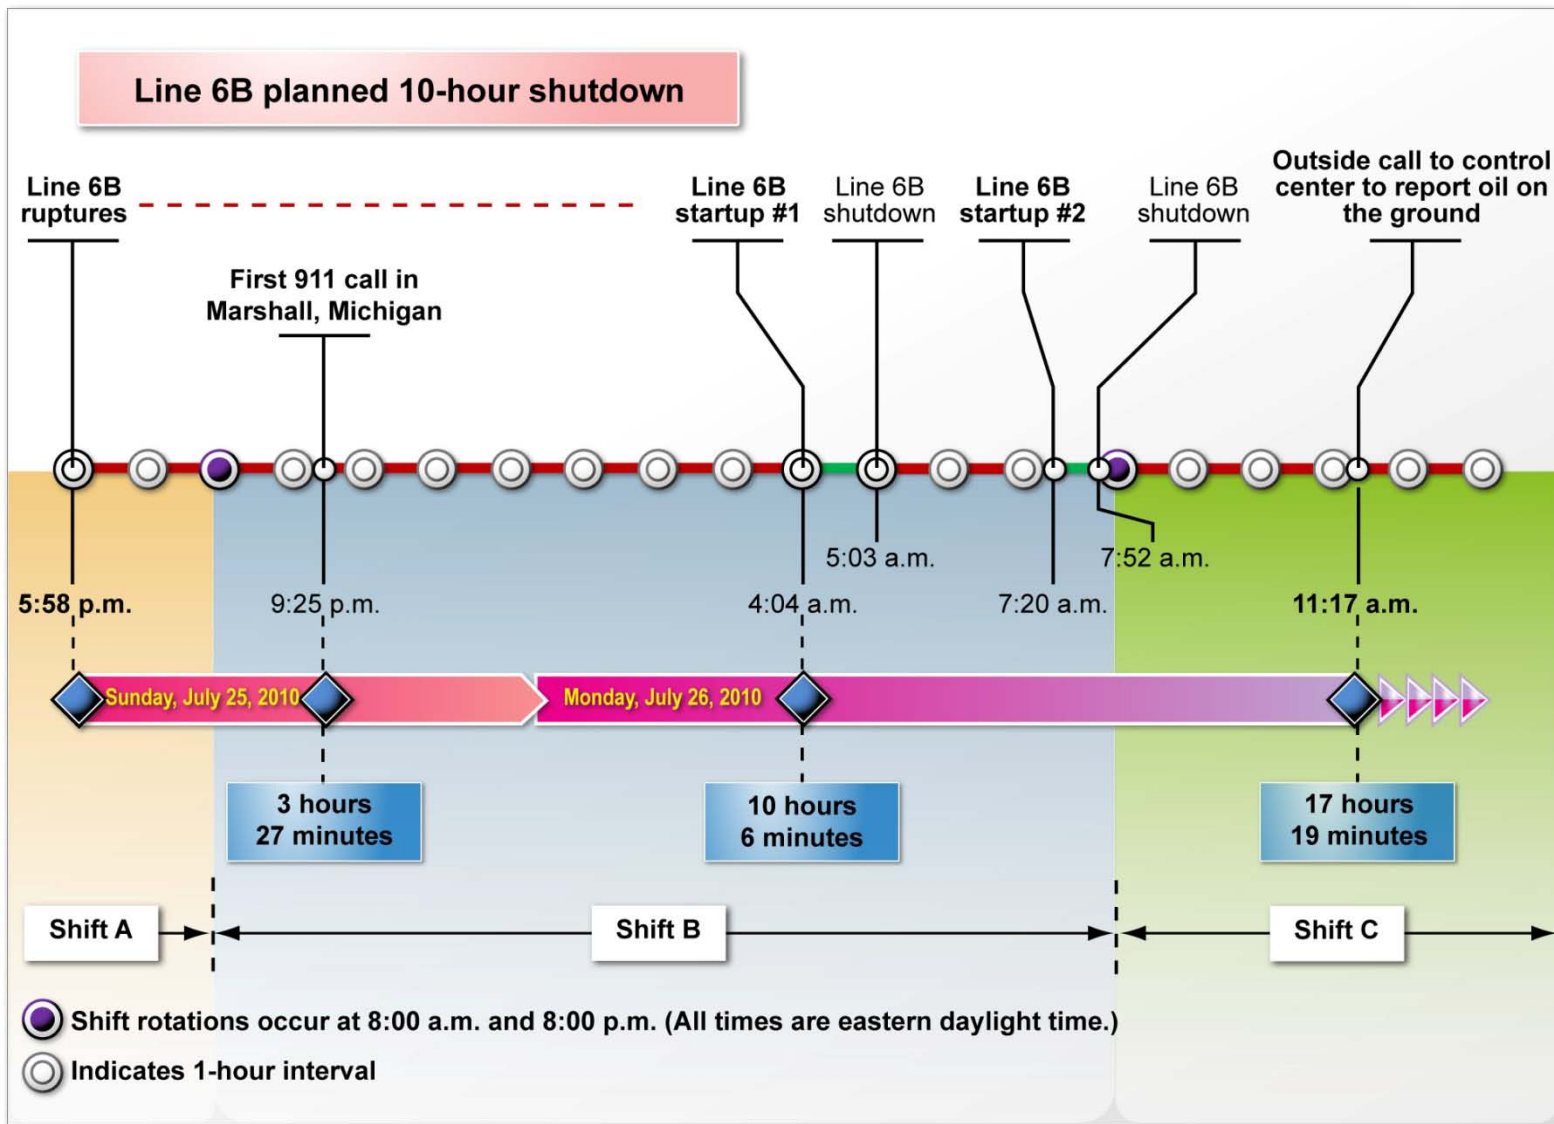
Figure 5 shows a timeline highlighting the accident events that spanned over 17 hours from the time of the rupture until the Enbridge control center was made aware of it. Figure 6 shows the key Enbridge staff involved.

Figure 5. Key events timeline of the Line 6B rupture in Marshall, Michigan, showing the events from the time of rupture on July 25, 2010, to the time of discovery on July 26, 2010.

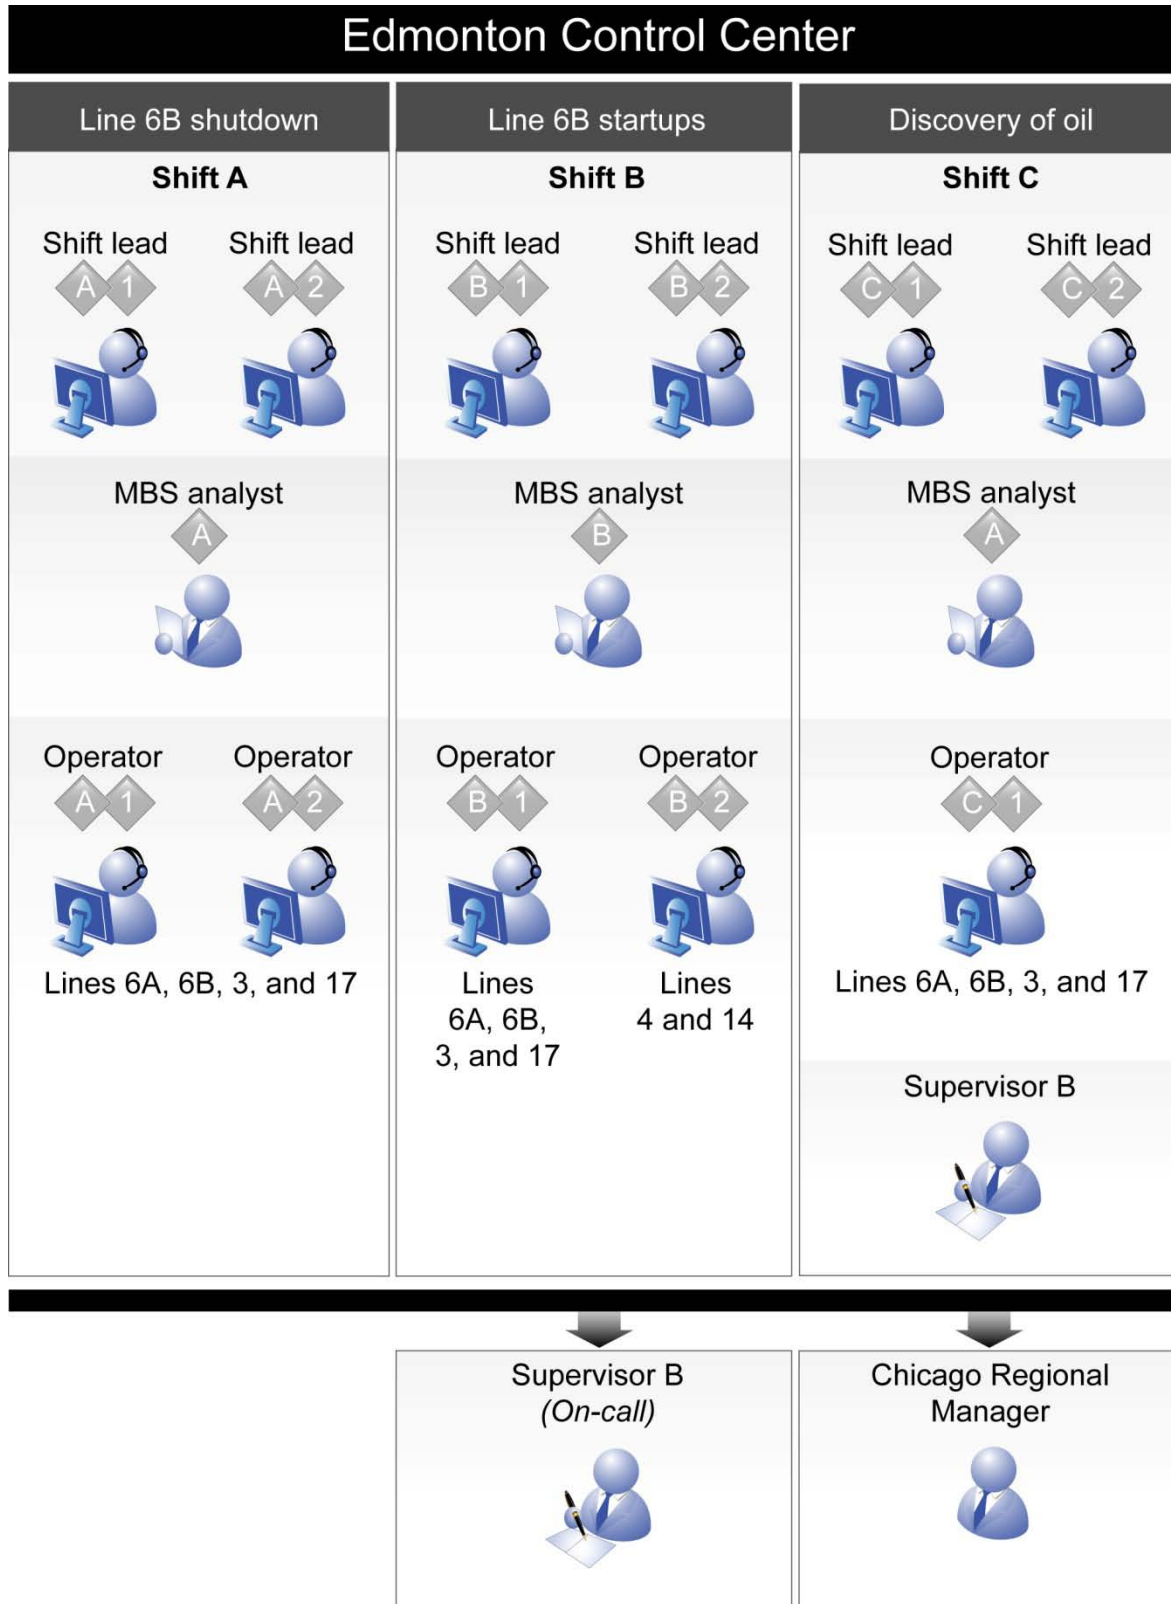
Figure 6. Key Enbridge staff involved in the 17-hour accident sequence. MBS refers to Material Balance System.

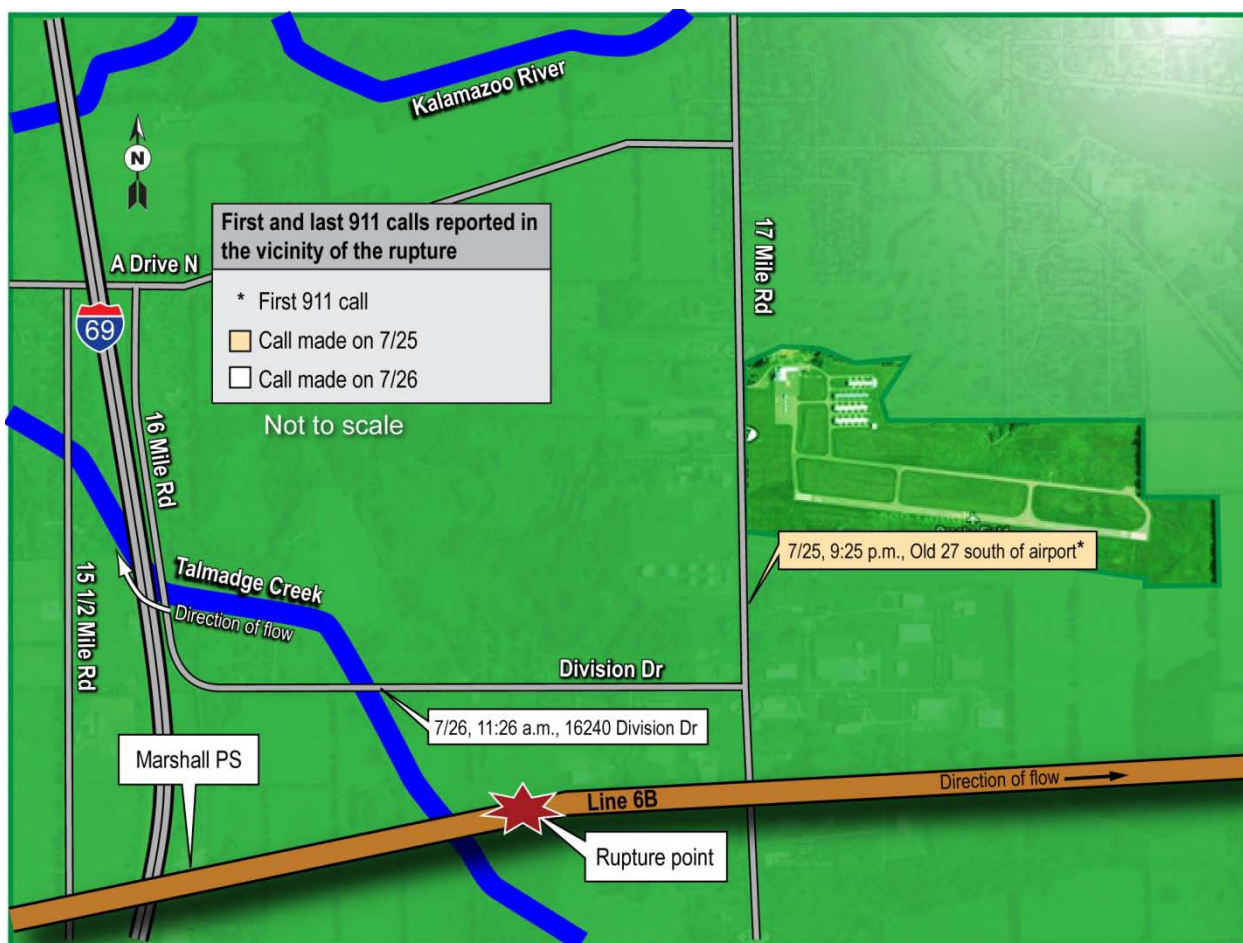
Figure 8. Emergency response and 911 calls from nearby residents. First and last calls are noted.

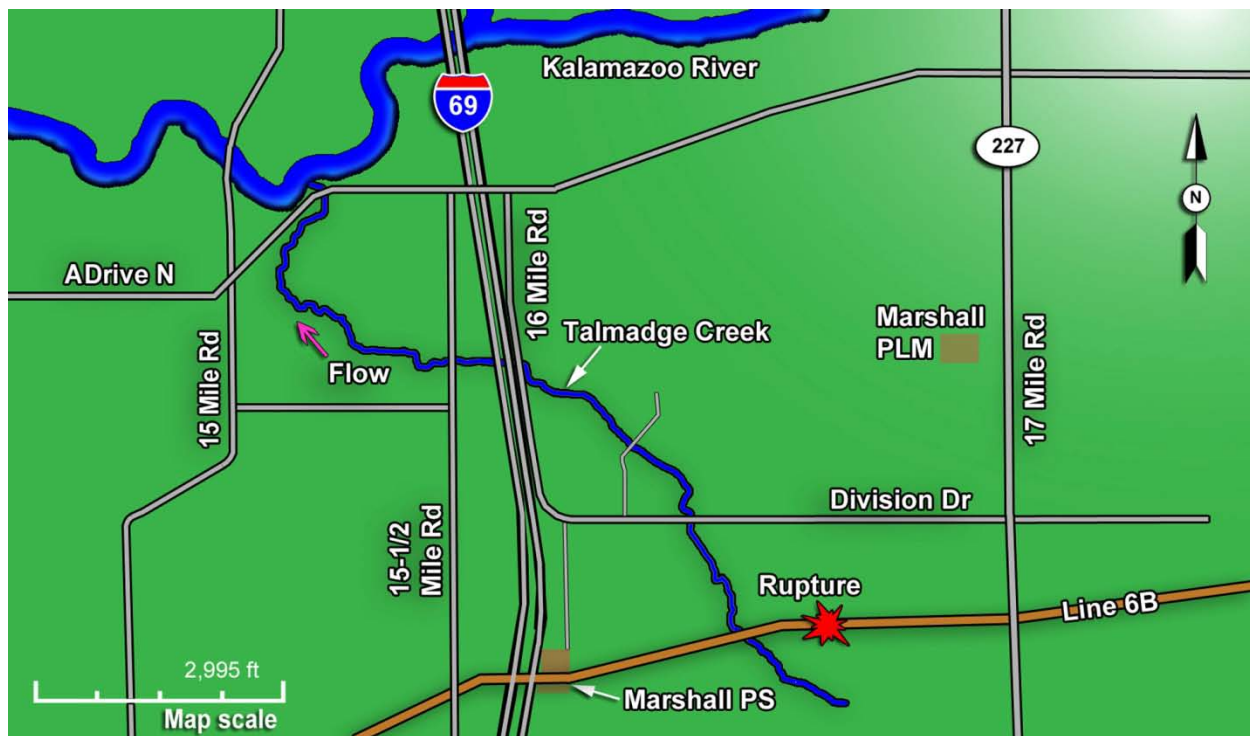
Figure 9. Area between rupture site and the Kalamazoo River where first responders concentrated efforts to contain the released oil.

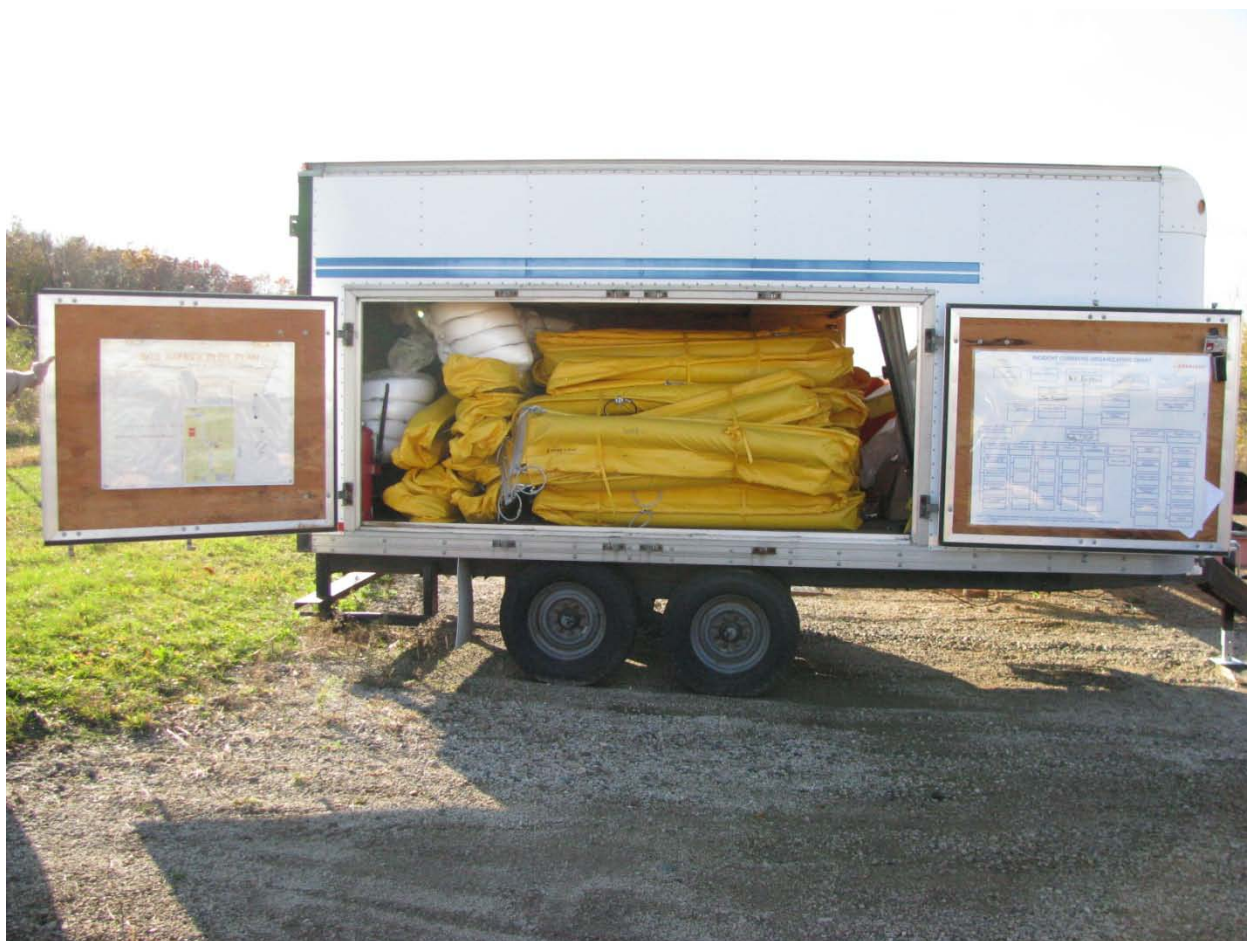
Figure 20. Enbridge PLM emergency response trailer containing the company's Tier 1 oil containment equipment, October 17, 2010.
