Collision of BNSF Coal Train With the Rear End of Standing  
BNSF Maintenance-of-Way Equipment Train  
Red Oak, Iowa  
April 17, 2011

NTSB/RAR-12/02  
PB2012-916302

## Railroad Accident Report

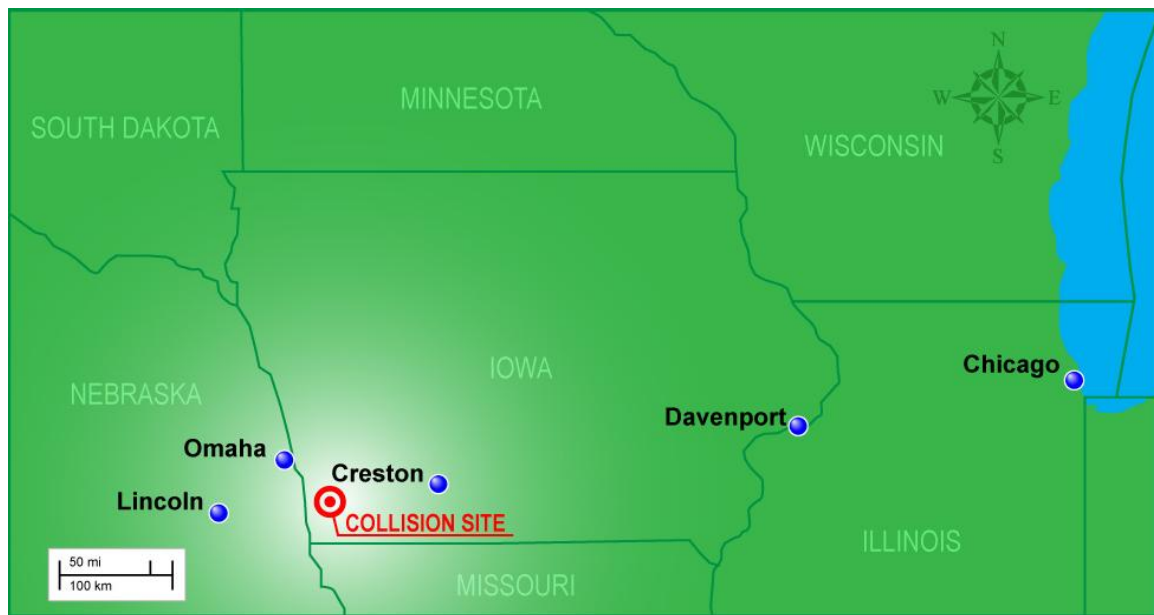
**Figure 1.** Accident location.

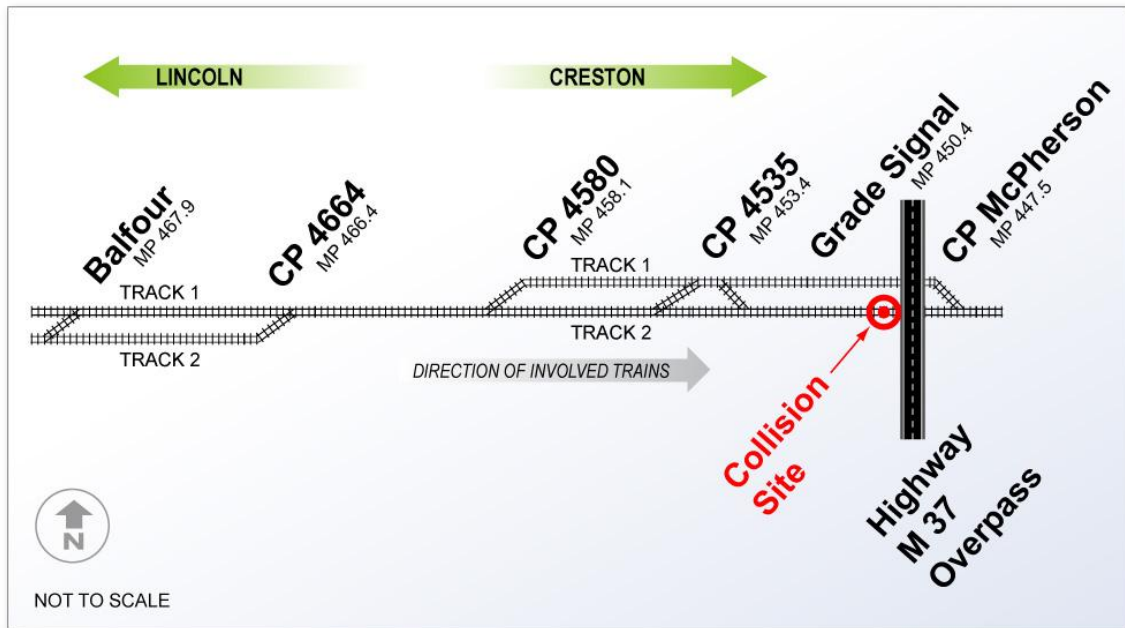
At railroad control point<sup>3</sup> (CP) 4580, the MOW equipment train entered track two behind two eastbound coal trains, neither of which was involved in this collision. The MOW equipment train stopped at a red stop signal<sup>4</sup> at CP 4535 (MP 453.5) because two coal trains were ahead on track two and the first had stopped at the end of the multiple tracks at CP McPherson (MP 447.5). (The milepost numbers were decreasing in an eastward direction). (See figure 2.)

**Figure 2.** Track map of accident area.

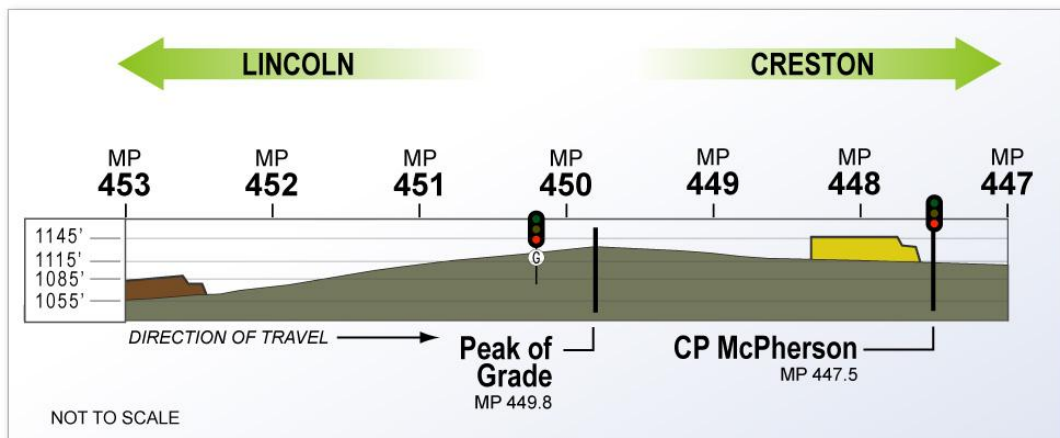
Based on event recorder data and dispatcher records, the striking coal train's trip was without incident before it reached the crest of the grade about 2 miles before the collision. Figure 3 shows 6 miles of the track profile in the area of the collision and includes the positions of the signals, the peak of the grade, and the two trains involved in this accident about 15 minutes before the collision.

**Figure 3.** Track profile between MP 453 and MP 447.

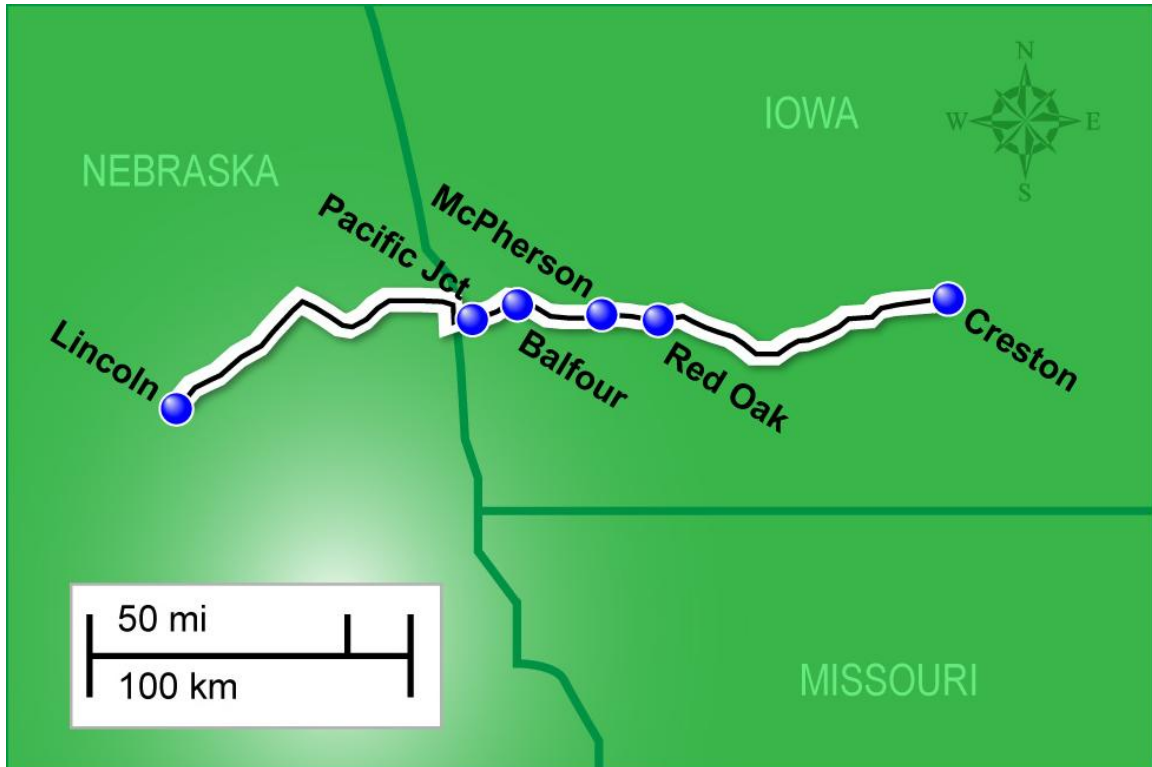
**Figure 12.** Creston subdivision of BNSF Nebraska division.

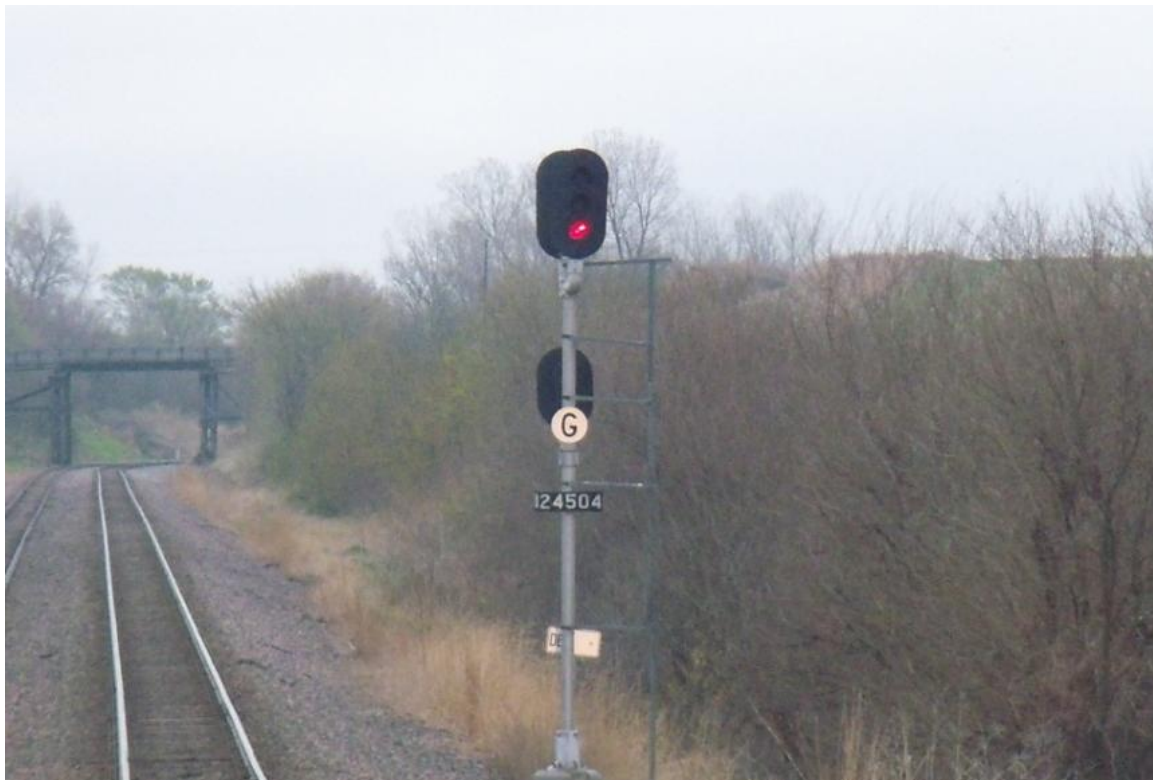
Intermediate signals are located on both main tracks at MP 450.38 about midway between the crossovers at CP 4535 (MP 453.4) and CP McPherson (MP 447.5). The last signal the striking coal train passed before the accident was intermediate signal 24504.<sup>17</sup> This consisted of a three-position color-light display with a G plate<sup>18</sup> and a number plate attached to the signal mast. (See figure 13.) Signal system data indicated that this signal was displaying a red (restricting) aspect. There were no slow orders, track bulletins, or other advisories in effect between the grade signal and the point of collision.

**Figure 13.** Eastbound intermediate grade signal 24504 with G Plate.

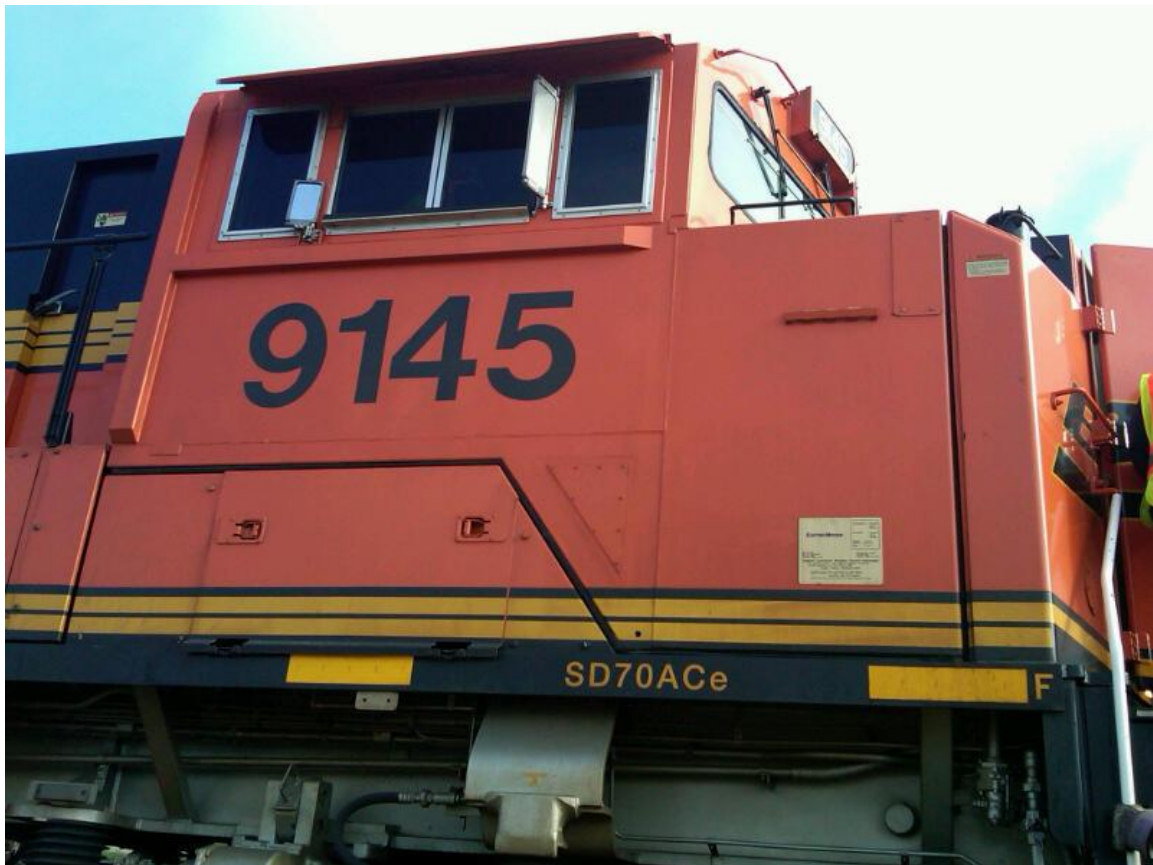
**Figure 15.** Exemplar EMD SD70ACe locomotive (same type as striking train locomotive) with modular cab.

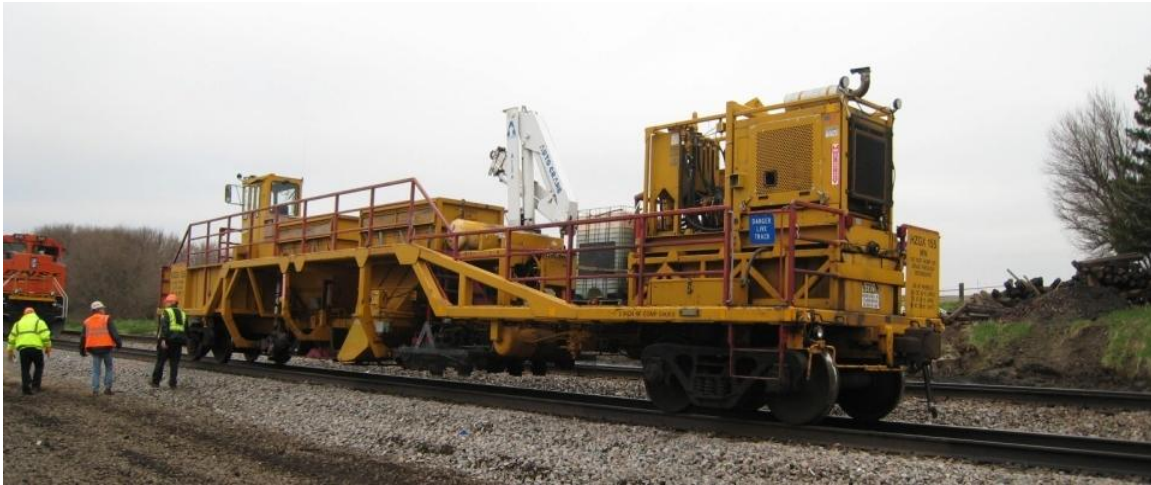
The last car of the struck train, the 34th car, was the HZGX-150, a clip car. (See figure 16.) This was the first car struck by locomotive BNSF 9159 in the collision. It is a diesel-engine-powered self-propelled unit that can be coupled into a train for transport. It has a 300-gallon fuel tank. This car was manufactured by Herzog Railroad Services, Inc.; weighed 177,000 pounds; and was 54 feet long.<sup>23</sup>

**Figure 16.** Exemplar HZGX clip car.

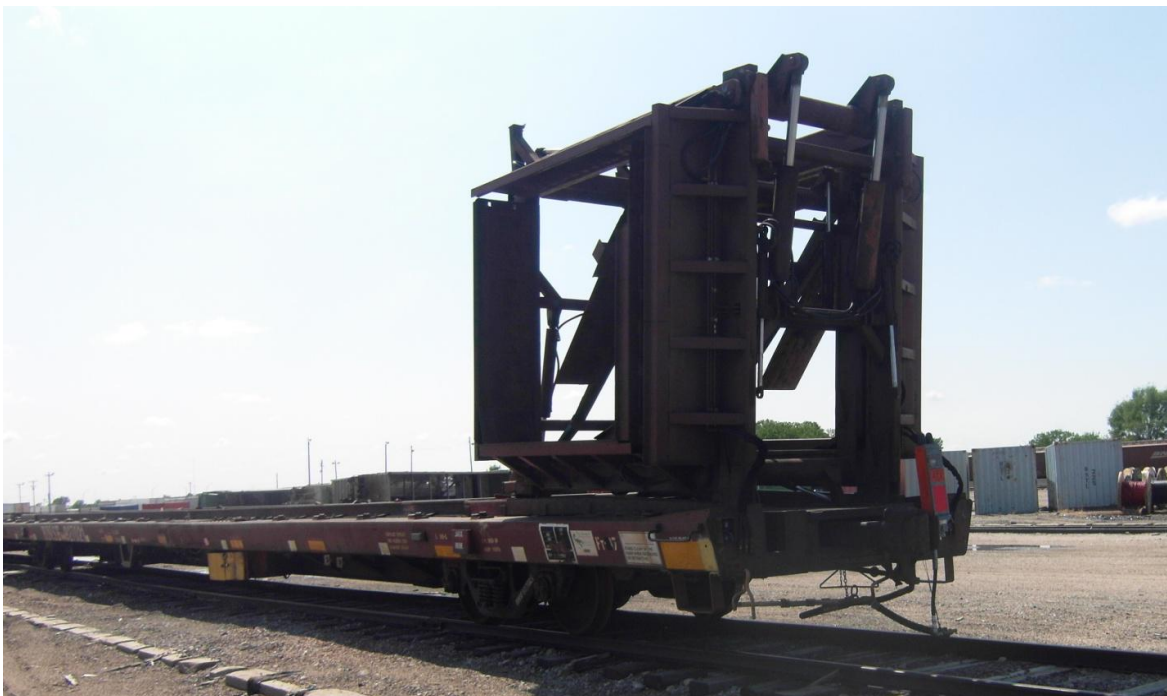
The second to the last car in the struck train was BNSF 927022. This was a scorpion car: an 89-foot flatcar with a folding loading ramp attached to the end of the car. (See figure 17.) The scorpion ramp was composed of six segments tied together with pin joints and hydraulic rams. The ramp unfolds so that MOW equipment can roll on and off the flatcar. When the ramp is fully open and extended, it is 52 feet 8 inches long. The ramp is powered by a diesel engine and has an 11.5-gallon fuel tank. The hydraulic fluid tank had a 25-gallon capacity. This car weighed 155,400 pounds.

**Figure 17.** Exemplar scorpion-equipped flatcar.

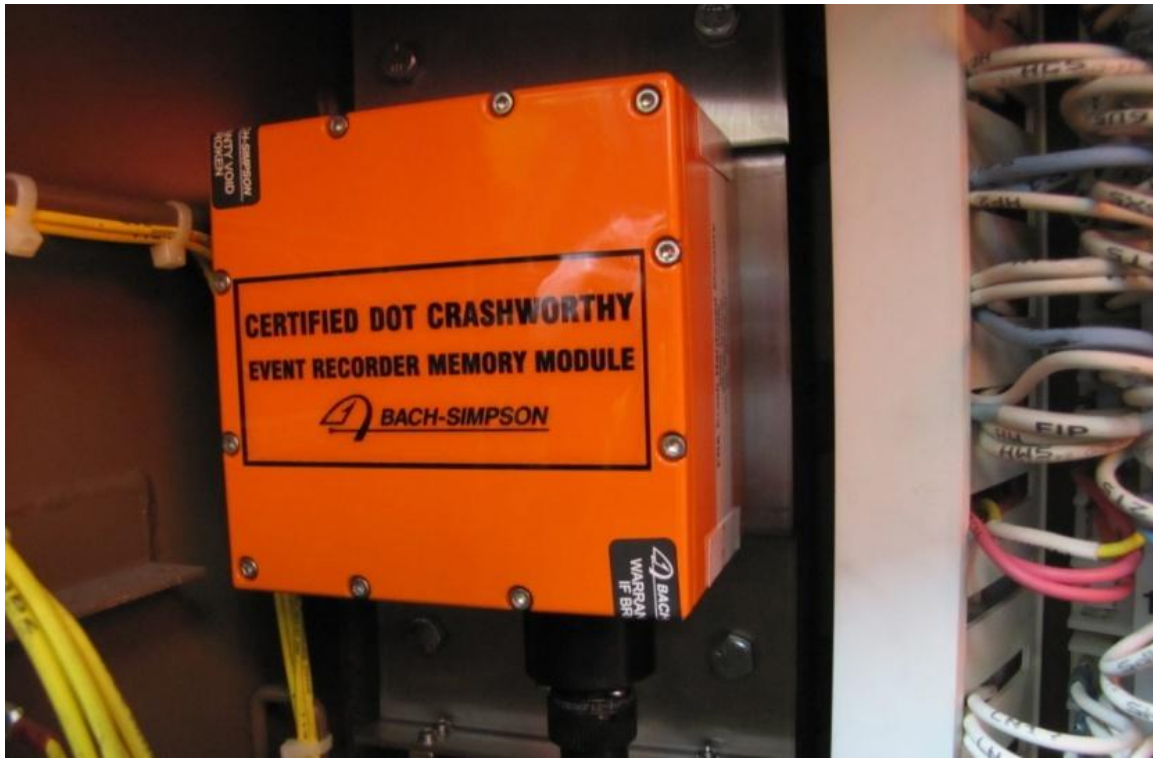
**Figure 18.** Intact exemplar crashworthy event recorder memory module.

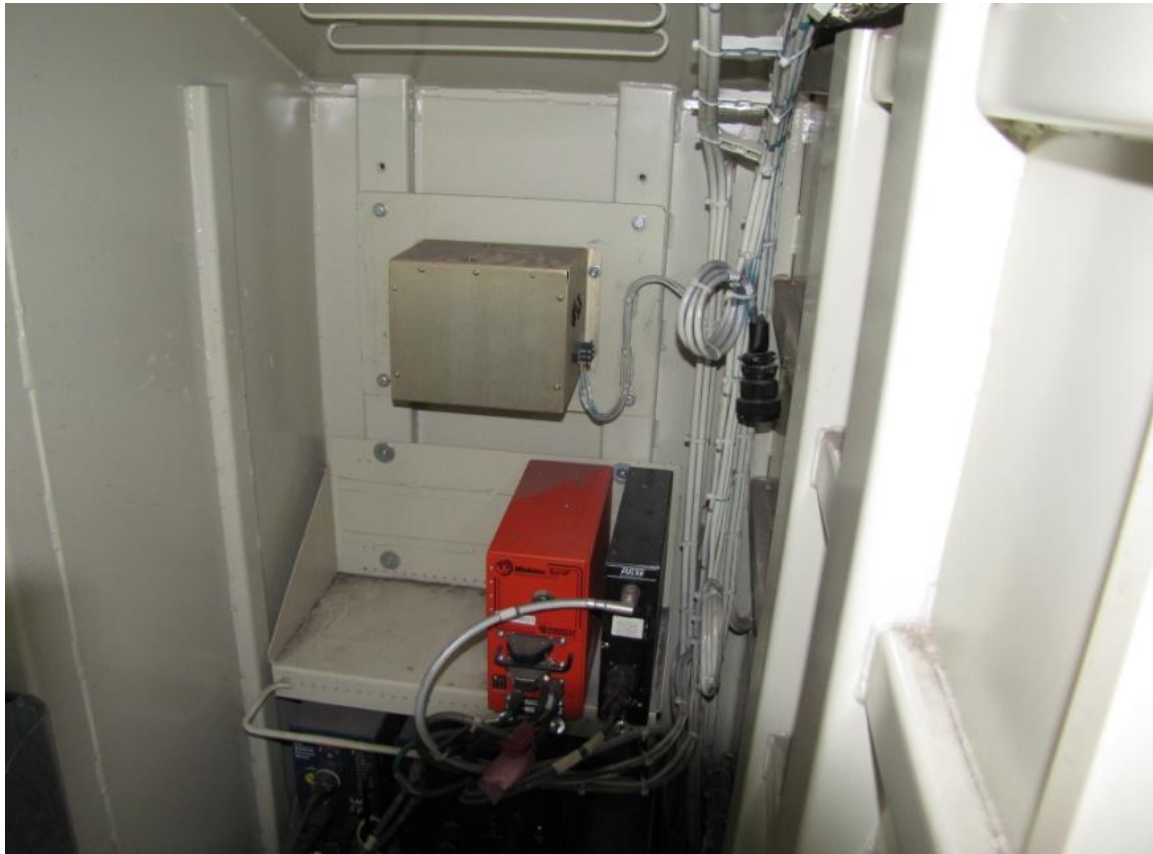
**Locomotive Cab Video Recorders.** The lead locomotive of the striking train, BNSF 9159, had a Wabtec Video Trax model forward-facing video recorder. The recorder hard drive enclosure was located in the wreckage, successfully recovered, and shipped to the NTSB laboratory in Washington, D.C. The enclosure and its contents were in poor condition because of the fire. (See figures 20 and 21.) Video data is stored on a hard drive within the enclosure. The hard drive was removed and transported to a vendor specializing in hard drive data recovery. After an examination and attempts to repair the damaged hard drive, it was determined that the hard drive was damaged beyond repair and its contents were unrecoverable. Forward-facing video recorders are not required by regulation.

**Figure 20.** Exemplar video recorder hard drive enclosure (orange case).
