Environmental Exposure Report

Depleted Uranium in the Gulf

1998190-0000-036

Last Update: July 31, 1998

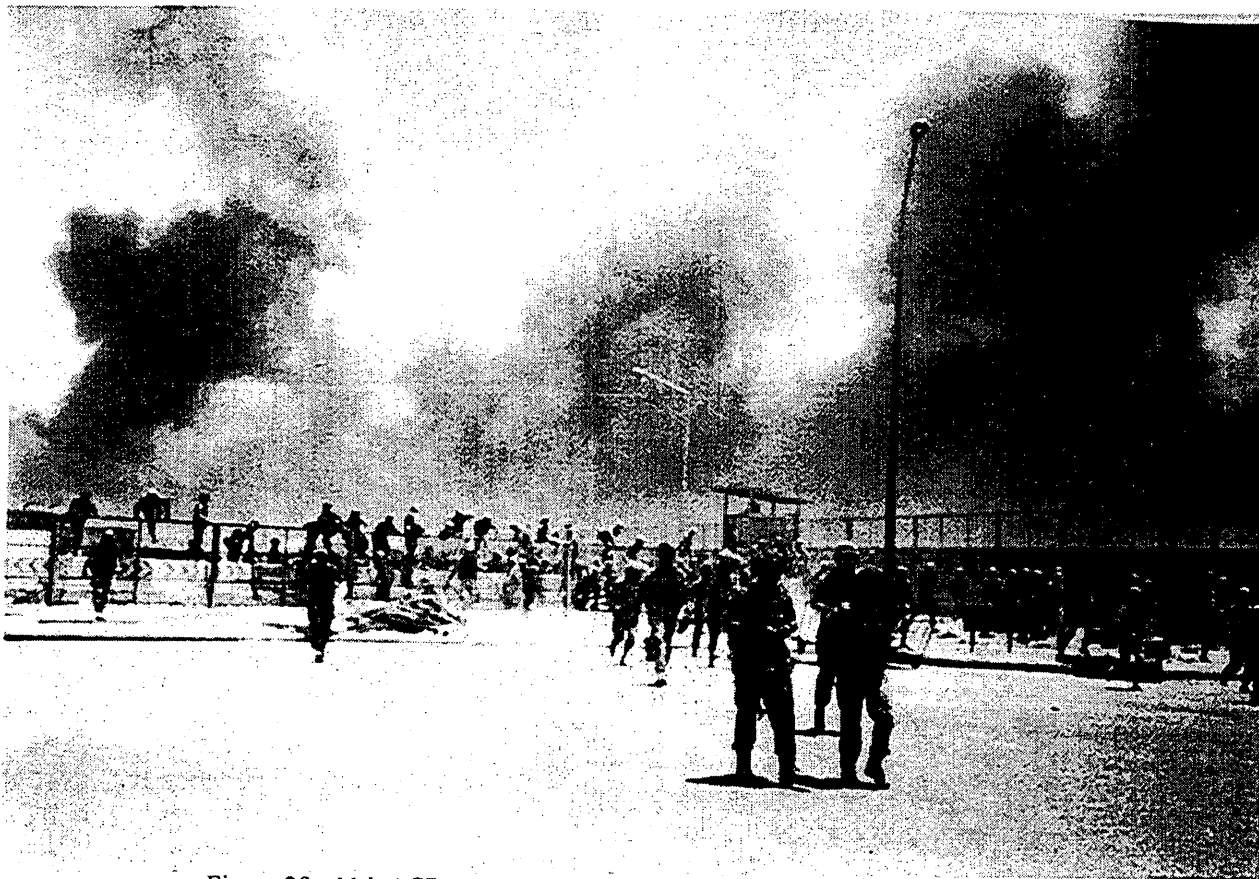
The fires had died down enough by mid-afternoon to allow a preliminary damage assessment. There were no fatalities; however, 49 US soldiers were injured, two seriously. Most of the injuries were fractures, sprains, contusions, or lacerations suffered when troops scrambled over the 15-foot high perimeter wall to escape the North Compound (Figure 28).¹⁹⁸ In addition, four British troops received minor injuries.

Figure 28 - 11th ACR troops evacuate Doha's North Compound, July 11, 1991.

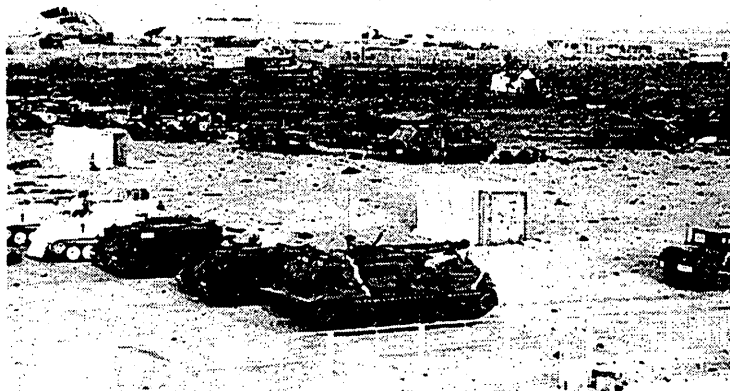
The post-blast destruction was overwhelming. One hundred and two vehicles were damaged or destroyed, including four M1A1 tanks and numerous other combat vehicles. More than two dozen buildings sustained damage as well.¹⁹⁹ Among the estimated \$14 million in munitions that had been damaged or destroyed were 660 M829 120mm DU sabot rounds.²⁰⁰

Figure 31 – Aftermath of Doha motor pool fire

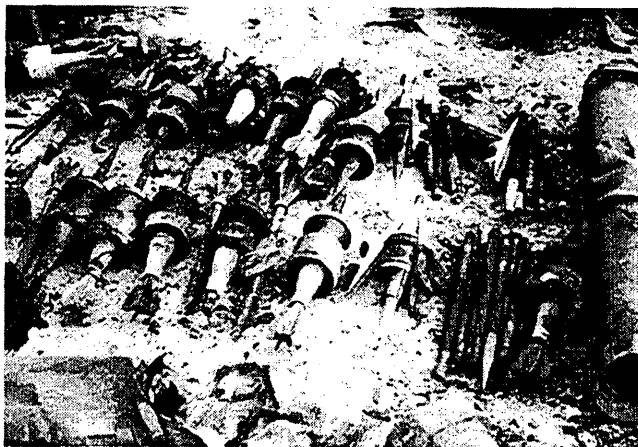
Figure 33 - DU rods collected at Doha

Most if not all of the DU penetrators recovered in the North Compound were picked up within a 120-meter radius of the three destroyed M1A1s. EOD members contacted for this report believed those rounds came from the nearby conexes, rather than the tanks, since the design of the M1A1s' blast panels did not allow most of the intact DU rounds to escape.²²⁷

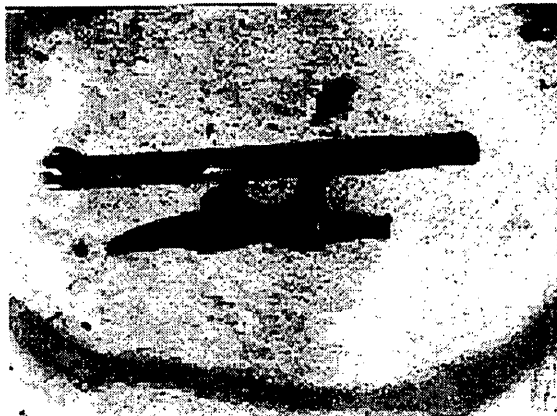
Figure 35 - Marked DU rod and sabot

The cleanup plan for the North Compound involved EOD personnel working together with the 58th Combat Engineering Company to find, mark, render safe, and remove UXOs. The former 146th Ord. Det. (EOD) Commander states that "Engineers didn't pick up any DU unless an EOD guy told them to." EOD marked the DU rounds they found with orange spray paint, painting a circle around the penetrator, and wore leather gloves to pick them up. Exposed DU penetrators were wrapped in heavy plastic and put in wooden boxes or 55-gallon drums. Later, after the AMCCOM Radiation Control team had arrived at Doha, the DU was placed inside one of the destroyed tanks for

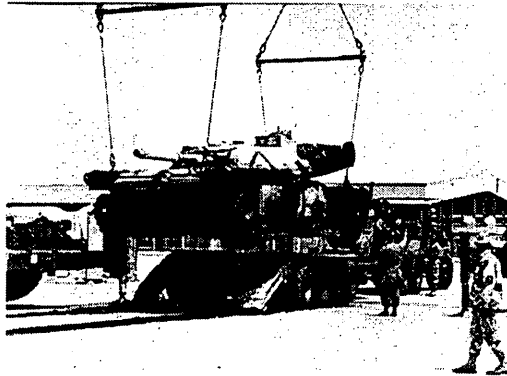
Three 55-gallon drums containing DU penetrators and a separate pile of burned penetrators were placed into the three contaminated tanks for shipment to the US. Seven M8A1 Chemical Agent Alarm Systems containing Americium-241 were also involved in the fire. One was recovered from the area cleared by EOD. The radioactive source cell was not damaged. One additional M8A1 was recovered from one of the M1A1 tanks removed from the area near the wash rack. The radioactive source cell was penetrated by a fragment from the explosion and burned in the fire. No alpha radiation

Figure 42 - Removing burned M1A1

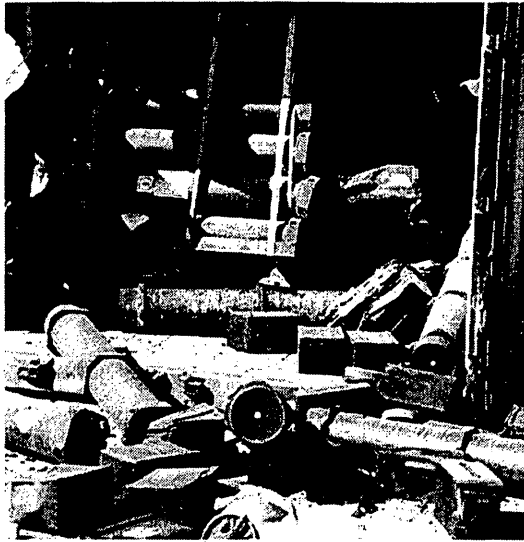
The central question remains: How much DU was actually released into the environment? A precise estimate is impossible, but some key variables have been established. The ammunition stored at Camp Doha constituted the 11th ACR's "basic load," or combat requirements. A relatively small number of DU rounds (660) were destroyed or damaged.²⁷⁵ Of these, about 111 would have been loaded in the three burned-out tanks.²⁷⁶ Many rounds included in the figure of 660 lost rounds survived the fire without exploding or burning (Figure 44) but had to be removed from the inventory since they had been in a fire.

Figure 44 - Unexploded DU rounds
