**AIRCRAFT
ACCIDENT INVESTIGATION BOARD
REPORT**

**US ARMY UH-60
BLACK HAWK HELICOPTERS
87-26000 AND 88-26060**

TECHNICAL REPORT F-15 MAINTENANCE

Aircraft Evaluated: F-15C, Tail Number 79-0025

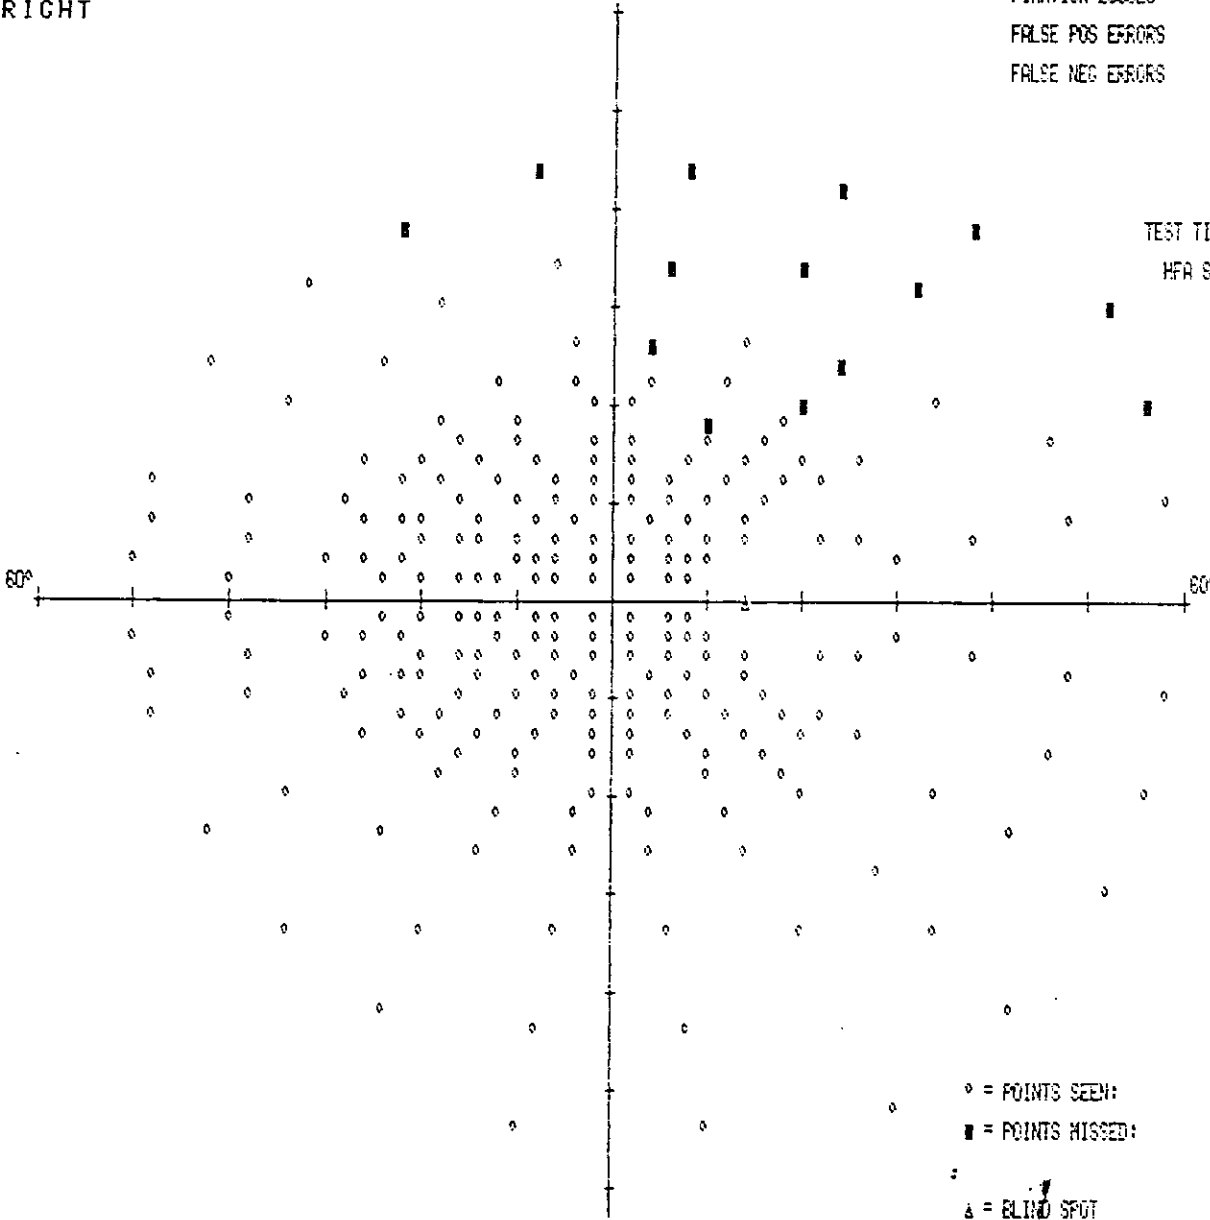
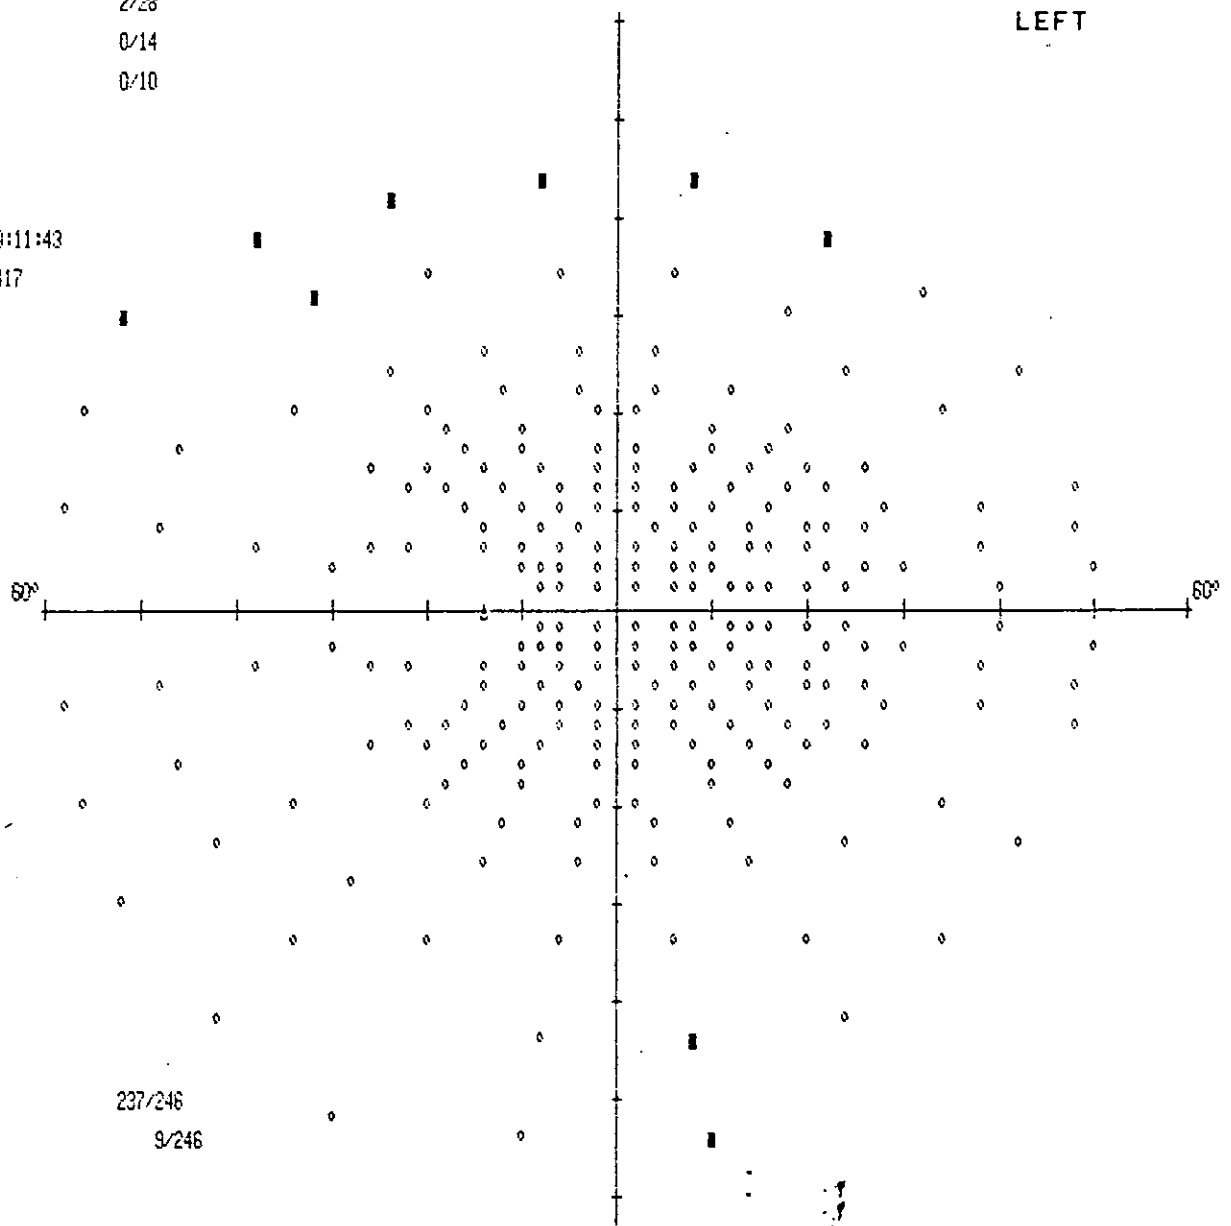
○ = POINTS SEEN: 232/246
 ■ = POINTS MISSED: 14/246
 ▲ = BLIND SPOT

° = POINTS SEEN: 237/246
 ■ = POINTS MISSED: 9/246

His exam boiled down to his prominent brow ptosis, or drooping, which caused a significant superior visual field defect when tested. His central vision in the same eye was perfectly normal (actually better), but any object (or part of an object) greater than 5 degrees above the horizontal would be occluded from view. This would only be significant if he was only using that eye, since his other eye is perfectly normal in both central vision and visual field. CR

My impression is that this condition should not adversely hamper his normal vision, as long as both eyes are being used to view an object. There may, however, be some loss of depth perception if the object is only being viewed by the normal eye; but recognition of an object should not be hampered.

Imp Vis sig. brow ptosis O.D. No other ophthalmologic abn.
Re Consider surgl repair.

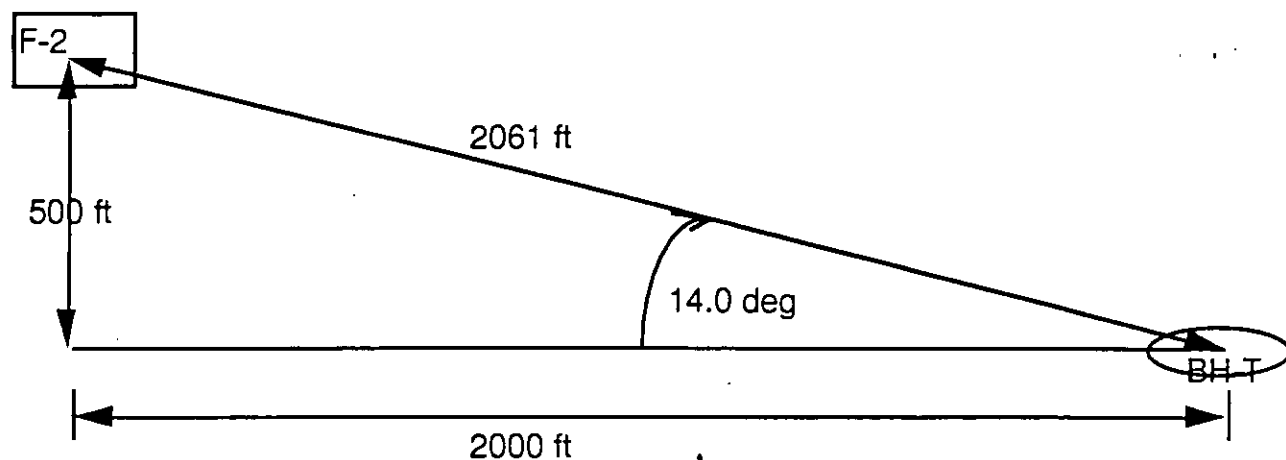
Figure 3. F-2 is at a slant range of 2061 feet from BH-T, and the look down angle is 14.0 degrees.

For a slant range of 2061.6 ft, Figure 3 shows the dimensions of the flag would be reduced by a factor of 0.54 compared to the dimensions in Figure 1. For the geometries of figures 2 and 3, with low slant angles, the BH is being viewed more from the side, and the vertical dimension of the flag is not as reduced as for a higher slant angle. For the stripes to subtend 1 arc-min, the fighter would have to view the stripes perpendicularly from a range of 501 ft. For the stars to subtend 1 arc-min, the viewing range would have to be 322 ft.

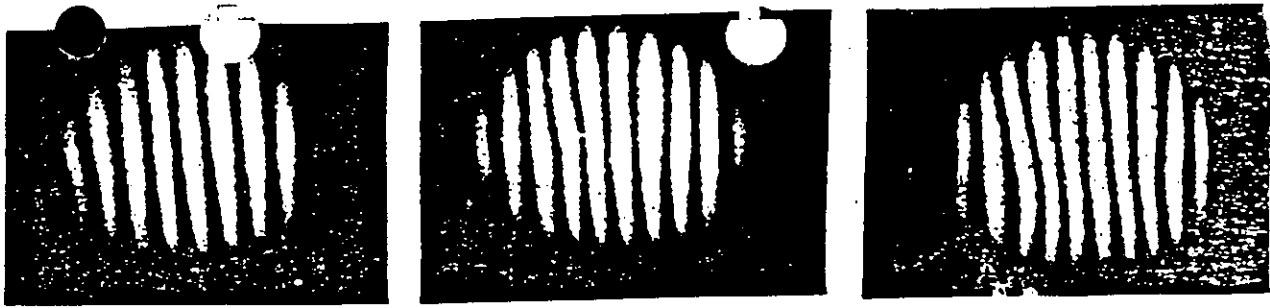
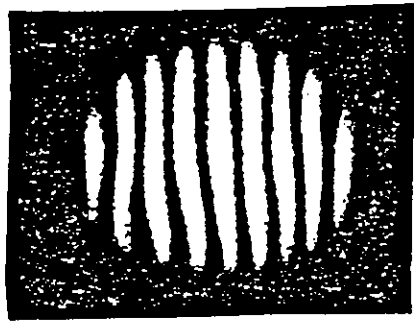
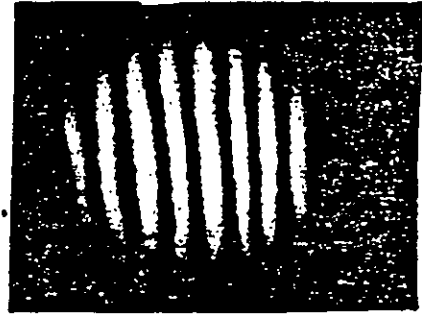
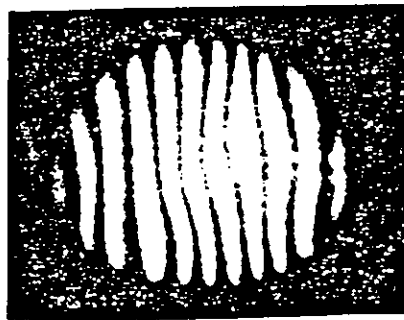
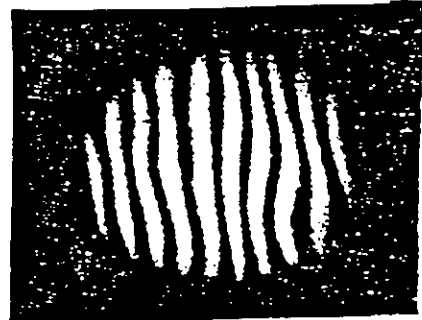
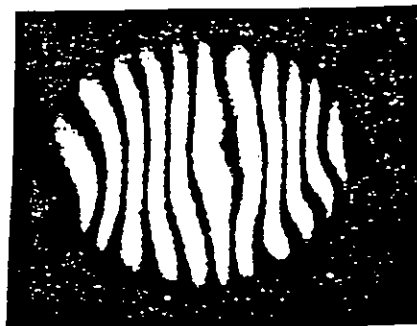
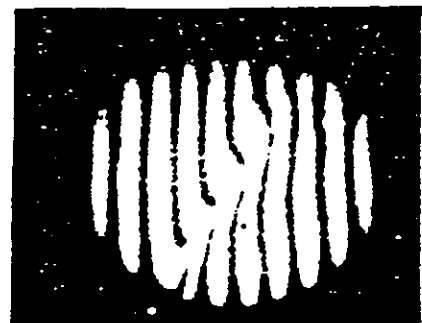
Figure 7. Examples of acceptable (1-5) and unacceptable (6-9) shearing interferometric optical distortion patterns as stated in MIL-V-43511C.

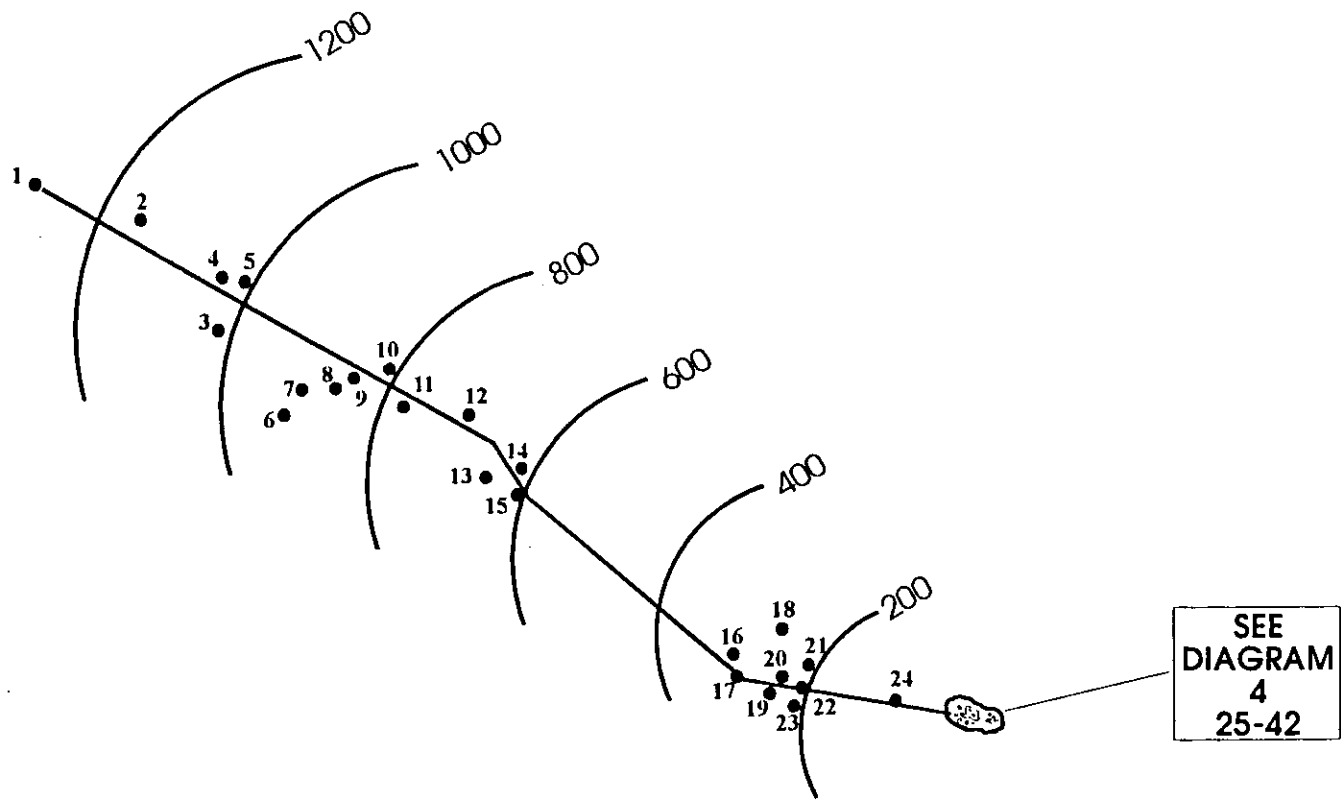
DIAGRAM 3

ITEM	DESCRIPTION	DIST (FD)	DIR (MAG)
1	CHAFF	1320	119
2	CARGO DOOR WINDOW	1200	121
3	SOUND PROOFING, PASS. CPMT	1110	116
4	TOP FUSELAGE COWLING VCTY TAIL BOOM	1095	120
5	AFT PIECE OF LEFT CARGO DOOR	1050	122
6	SLEEPING BAG	1020	113
7	VOR ANTENNA	996	116
8	PIECE OF SEAT BELT	936	117
9	SOUND PROOFING, CARGO CPMT	936	118
10	LEFT APU ACCESS DOOR (CUT)	915	121
11	RIGHT APU ACCESS DOOR	873	120
12	APU FIRE DETECT LITE	825	121
13	FUEL CAP RIGHT SIDE	762	121
14	COWLING BEHIND FIRE BOTTLES	690	116
15	SOUND PROOFING PASS. CPMT	684	115
16	APU COMPARTMENT FIREWALL	660	113
17	APX 100 ANTENNA CABLE	360	105
18	PIECE APU INTAKE HOUSING	324	096
19	PIECE APU COMBUSTION CHAMBER	300	102
20	PIECE FUSELAGE SKIN (SMALL)	294	097
21	PIECE FUSELAGE SKIN (SMALL)	258	101
22	ELECTRICAL WIRE (10' LONG)	258	100
23	APU ENGINE PART	258	094
24	TAIL BOOM SECTION, LEFT SIDE	129	100
25-42	MAIN WRECKAGE CENTER OF MASS	0	0
43	PIECE OF MISSILE	497	100

1. DISTANCES ARE IN FEET
2. DIRECTIONS ARE ESTIMATED IN DEGREES MAGNETIC
3. DISTANCES AND DIRECTIONS ARE RELATED TO CENTER OF MASS OF MAIN WRECKAGE

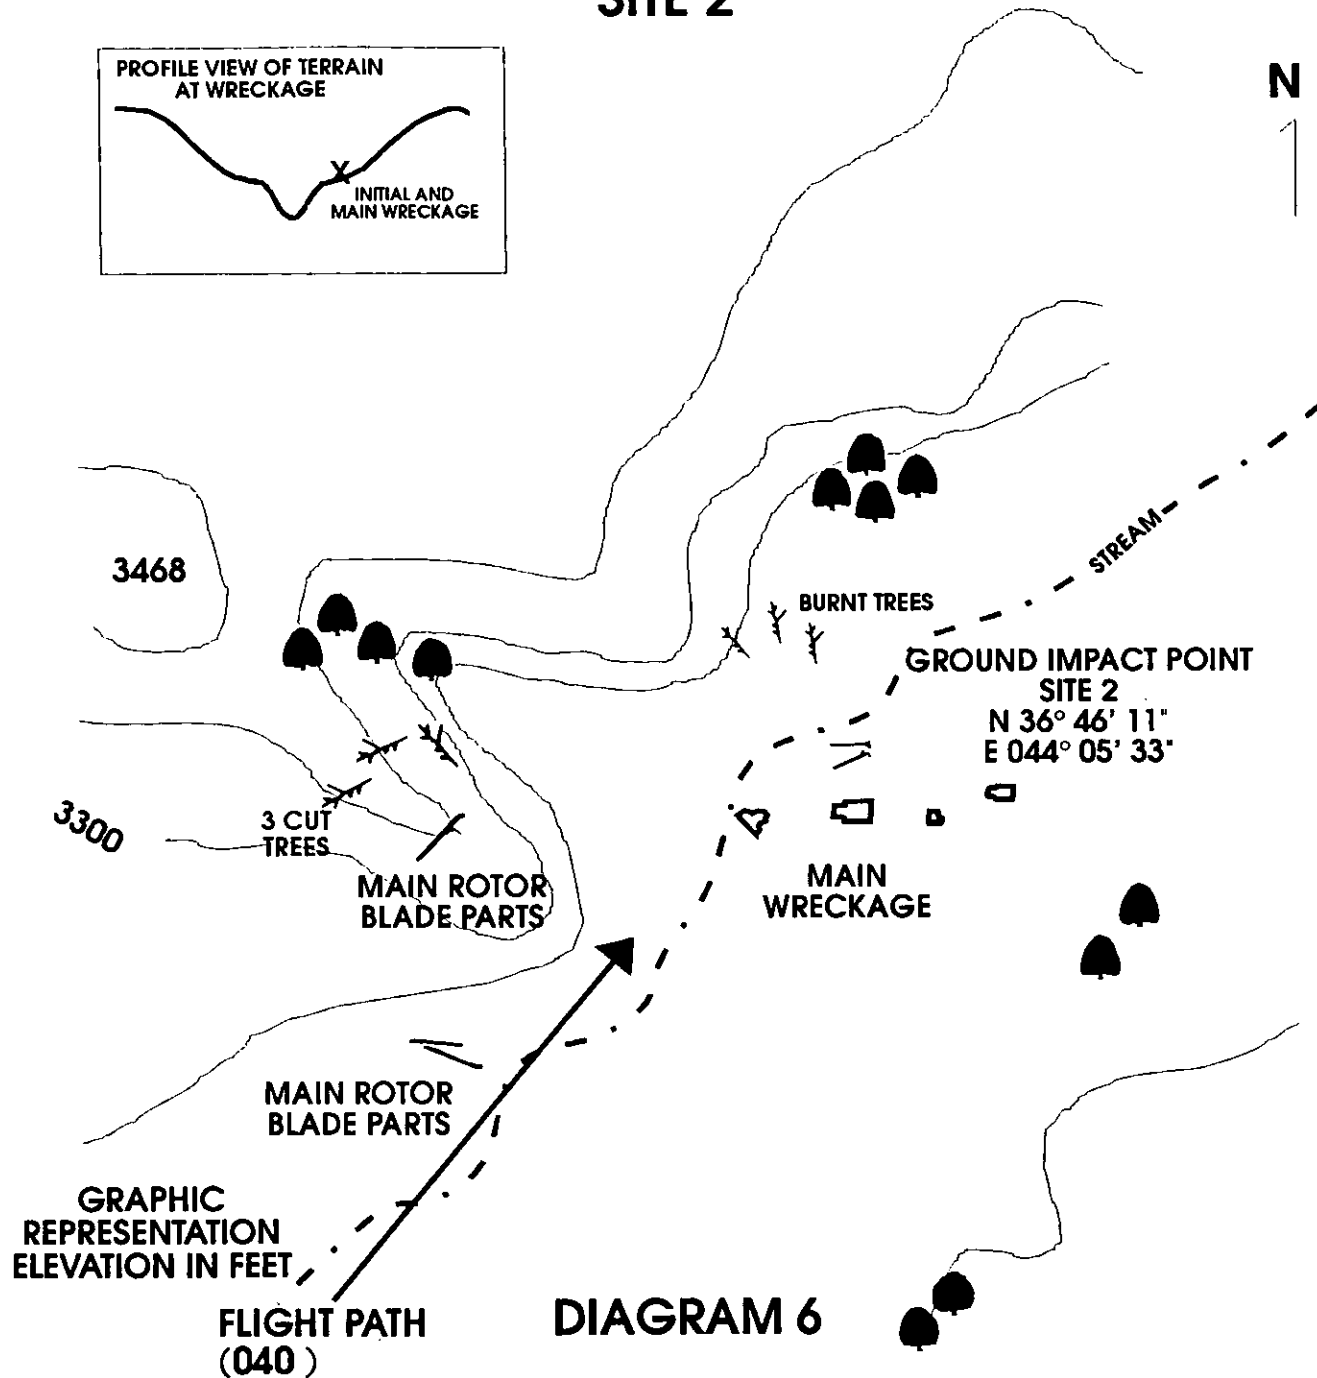
CRASH DIAGRAM SITE 2

FLIGHT PATH WRECKAGE DISTRIBUTION SITE 2 TAIL NO. 88-26060
