Kansas City, Missouri Airport Traffic Control Tower (MCI ATCT)

Post Mold Remediation Clearance Report

Report on Mold and Moisture Inspection
Kansas City International Airport
Airport Traffic Control Tower

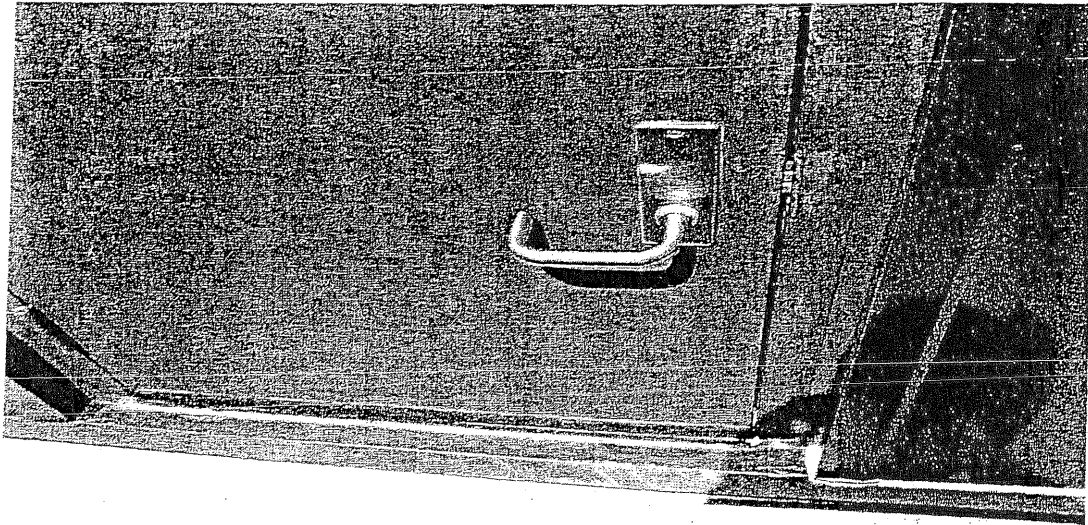
Photo 6: Cab Level, Interior of Door to Outside Walkway.

A gap in the doorframe weather-stripping and flashing that improperly slopes towards the door, have allowed water to enter the stairway near the door. The water has wicked up adjacent gypsum board causing it to deteriorate and has also resulted in mold growth behind the vinyl base.

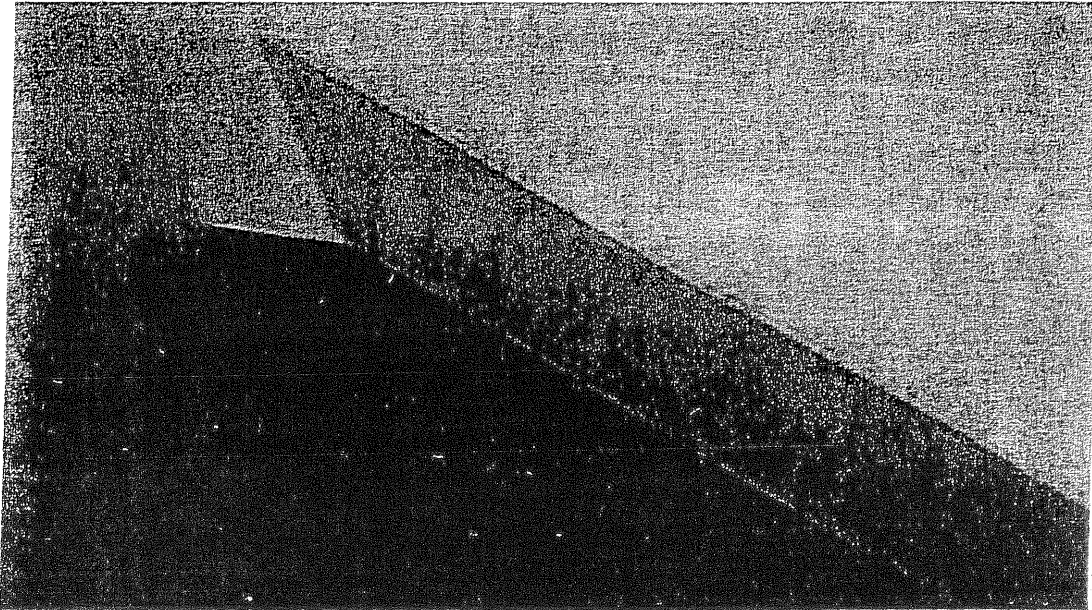
Photo 7: Cab Level, Exterior of Door by Outside Walkway.

An excessive gap is shown on the latch side of the door that allows water to enter the building. The metal flashing also has a slight slope towards the door and threshold instead of towards the exterior.

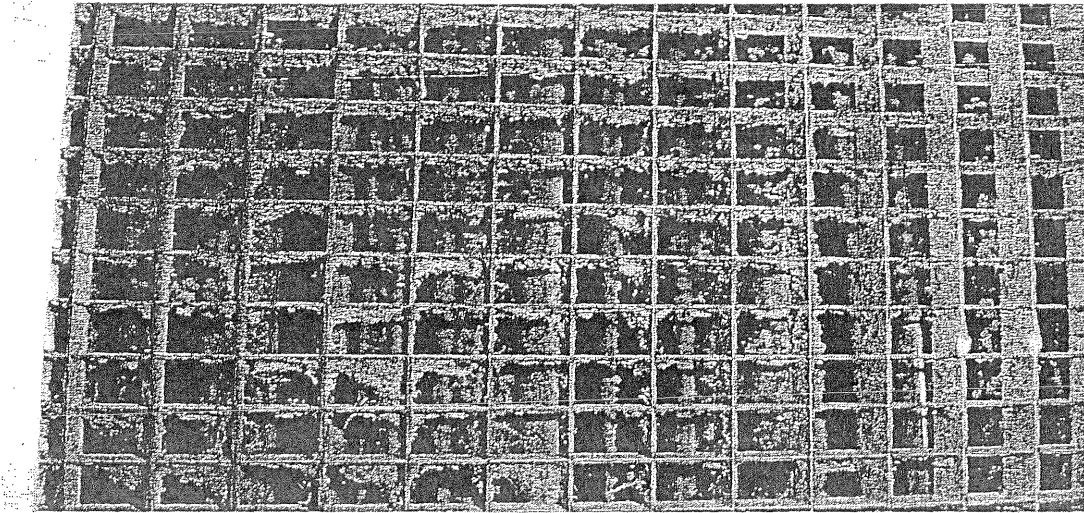
Photo 12: Below Cable Access Level, Return Air Grill.

Debris from this return air grill has contaminated adjacent walls as shown in Photo 8. Dust provides a food source, which sustains the growth of mold.

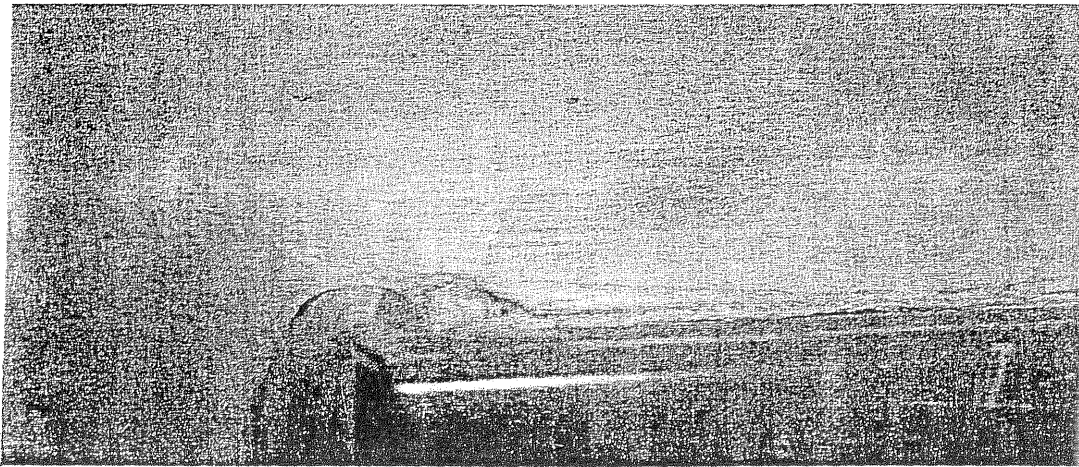
Photo 19: Junction Level, Holes in Hand Rail Post.

Each of the railing posts on the walkways has a hole in the side near the top that could allow rather small quantities of water into the tube and down into the building as shown above. The holes appear to be vent holes from when the posts were hot dip galvanized during fabrication. The holes may allow water to enter the building behind the walls of the SubJunction Level.

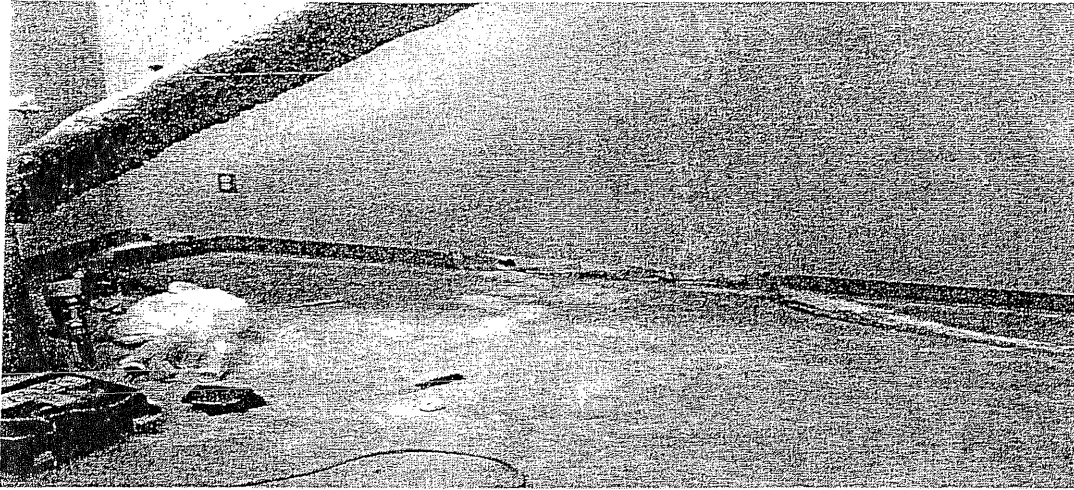
Photo 38: 11TS5, East Wall Fan Coil Unit.

Pipe insulation is shown with visible water stains in Room 11TS5. Water stained insulation should be checked regularly if in close proximity to sheetrock.

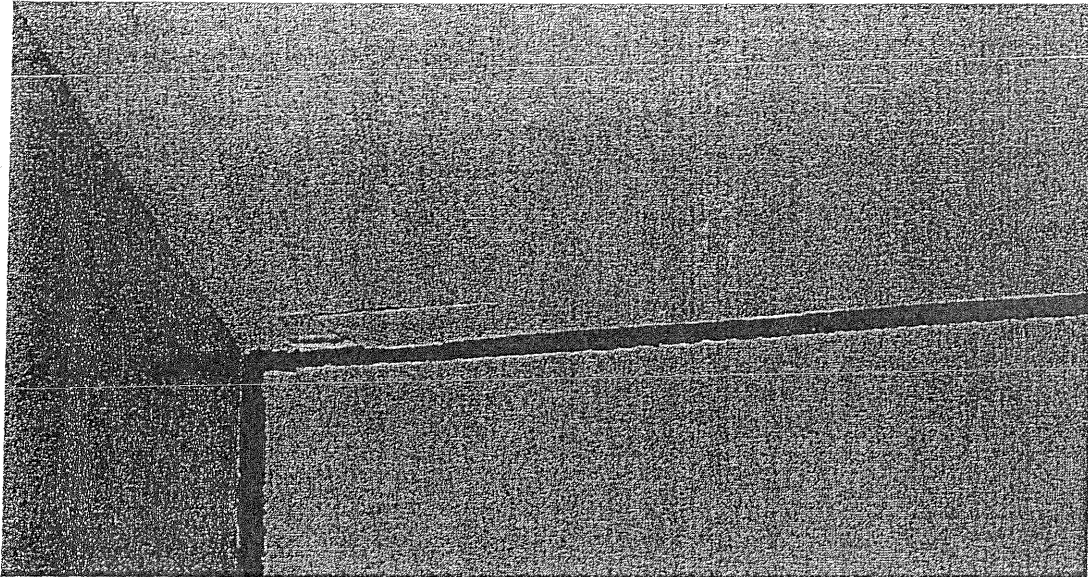
Photo 40: Yellow stained South Wall (Elevator Shaft) of 10TS5.

The yellowed areas shown on the sheetrock in Room 10TS5 often indicate the initial stage of underlying mold growth. In this case, however, the core sample obtained was negative.

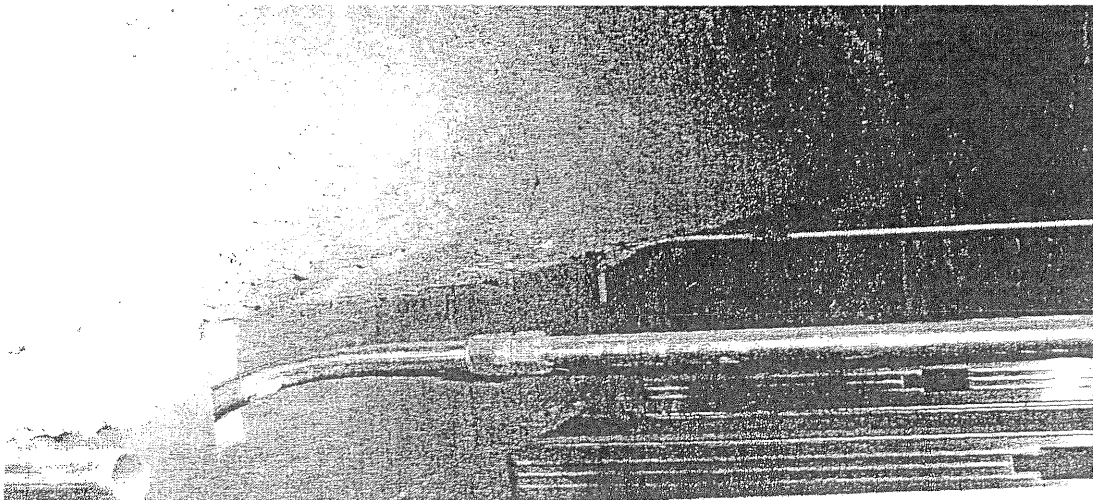
Photo 41: Water stained ceiling of 9TS1, West End.

Visible water stains, several inches wide, were found on the perimeter of the ceiling of corridor 9TS1, adjacent to the west exposed precast concrete wall and the south gypsum board wall, adjacent to the stair vestibule and stairway as shown above. The stain extends the full length of the west wall and the taped joint on the gypsum board ceiling was peeling loose. The water stain then followed along the south wall toward the east for approximately 10 feet.

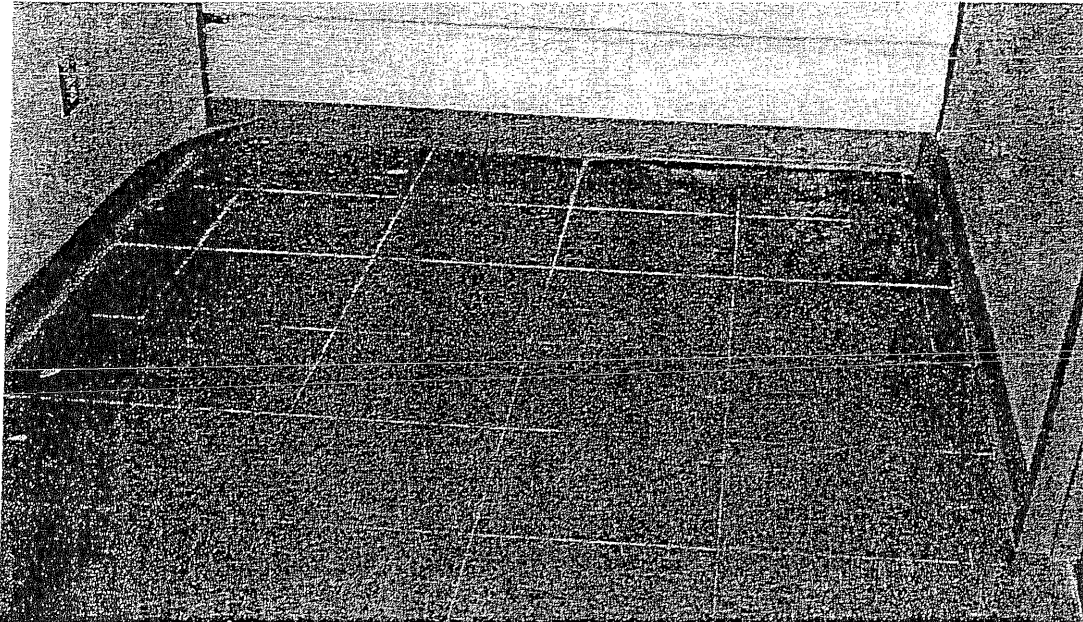
Photo 43: 9TS1, West Wall.

The floor tile at the west end of the corridor had water stains and white residue especially between the tiles as shown above. The base was pulled away for an evaluation but no mold was found. There are visible water stains on the ceiling and wall directly above this area, as shown in Photo 41.

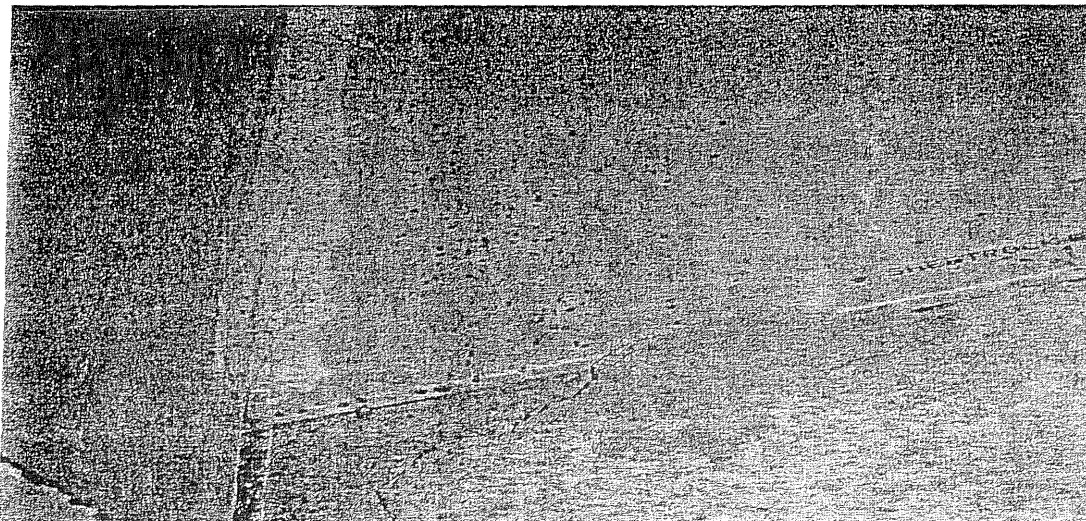
Photo 44: 9TS6, Above Ceiling, East Wall.

A visual inspection conducted by looking through the access panel in the ceiling of stair vestibule 9TS6 showed heavy water stains on the north, east, and west walls above the ceiling. The heaviest stains were near the northeast corner as shown above. No signs of mold were found.

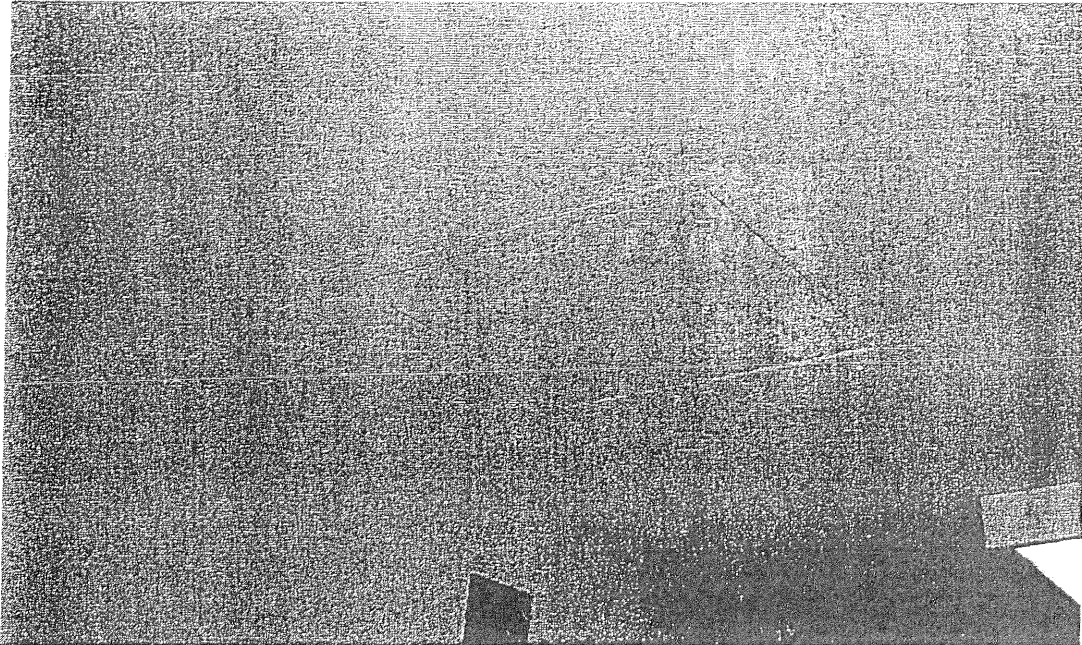
Photo 45: 9TS1, Typical Access Panel.

A typical access panel is shown in Room 9TS1. Several areas above the ceiling and other locations cannot be observed for a thorough mold and moisture evaluation. Access panels should be installed in these locations.

It is also clear that some areas within the Kansas City International Airport ATCT were not inspected during the invasive mold and moisture inspection. Photo #45 shows a typical access panel in Room 9TS1. The photograph description states, "Several areas above the ceiling and other locations cannot be observed for a thorough mold and moisture evaluation." This comments leads to the question: Why were invasive sampling techniques not used in these areas?

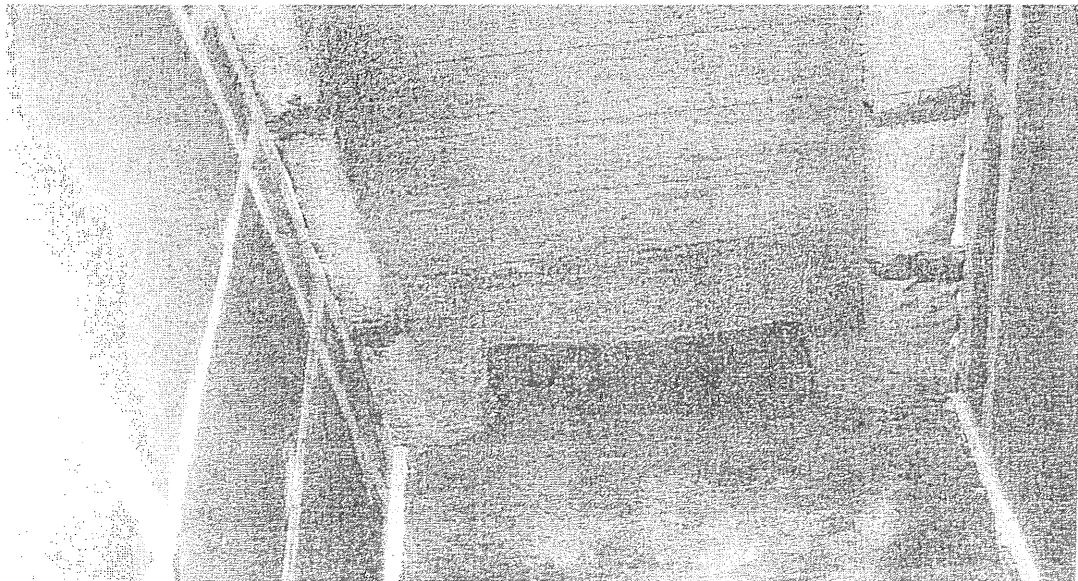
Photo 46: Underside of 9th Floor Deck, West End, Above 8TS1.

A visual inspection conducted by looking through the access panel in the ceiling of corridor 8TS1 revealed discolored and water stained fireproofing on the underside of the 9th floor metal deck as shown above.

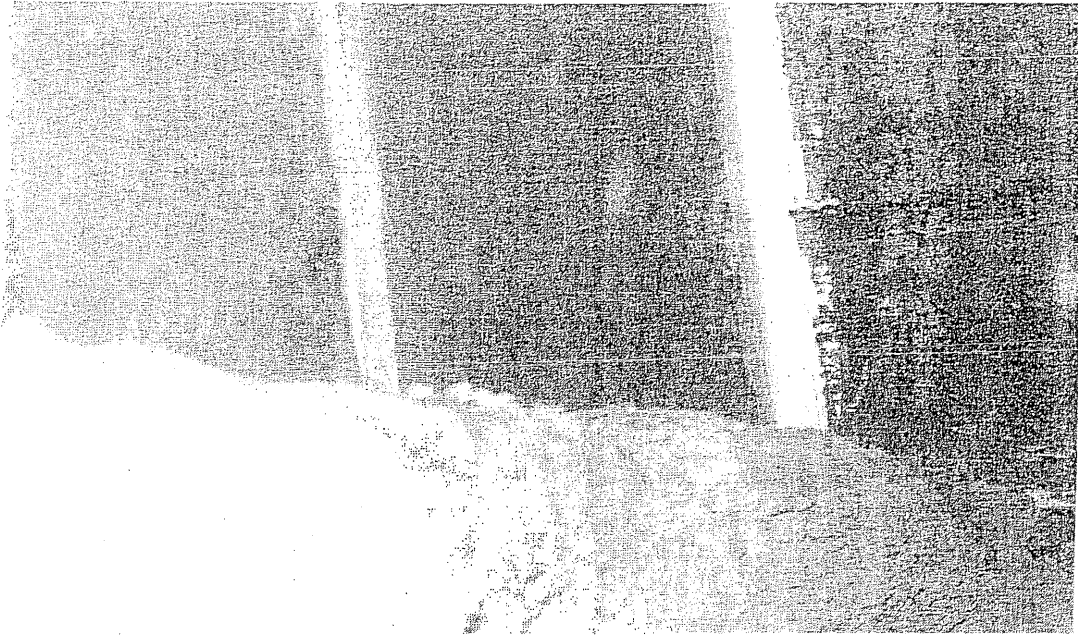
Photo 47: South Wall of 8TS1 Above Finished Ceiling.

A suspect mold area was observed on the south wall above the horizontal beam in the unfinished space above the ceiling as shown above. This spot can't be reached from the access panel.

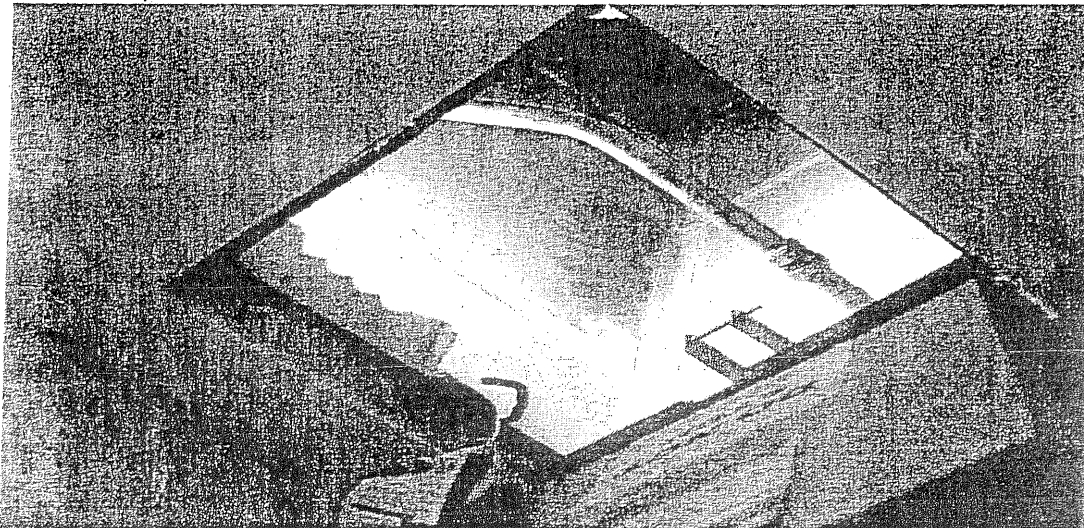
Photo 48: 8TS6 12" by 12" Access Panel Above Ceiling.

Further investigation through the access panel in the ceiling of the stair vestibule 8TS6 revealed a larger area of mold on the west wall of the fire taped gypsum board wall as shown above. This wall intersects the south wall above the corridor ceiling where the mold was found above the ceiling of 8TS1.

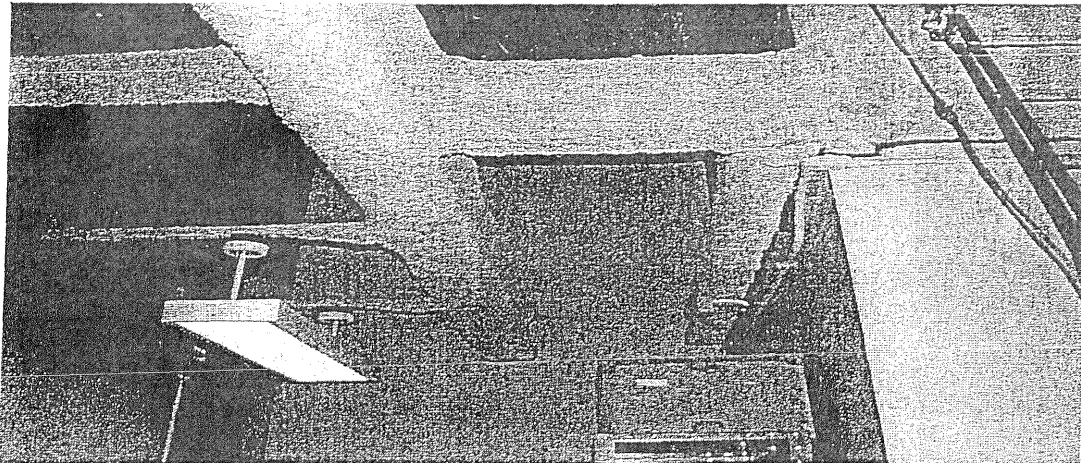
Photo 49: Yellowed Fireproofing, Intermediate Level Beam, 7TS5.

Aspergillus (3704 counts/gram) was detected in 7TS5, in a yellowed fireproofing sample. Similar yellowed fireproofing samples were collected in 7TS5 in the center of the room; in 7TS5 at the ceiling level; in 7TS5 on the metal deck; in 7TS5 on the west side of the elevator shaft; in 7TS5 on the middle of the beam on the north side of the elevator shaft; in 7TS1 above the west access panel; and in 7TS4 on the lower beam, on the west side of the elevator. All contained mold spore concentrations below the limit of detection.

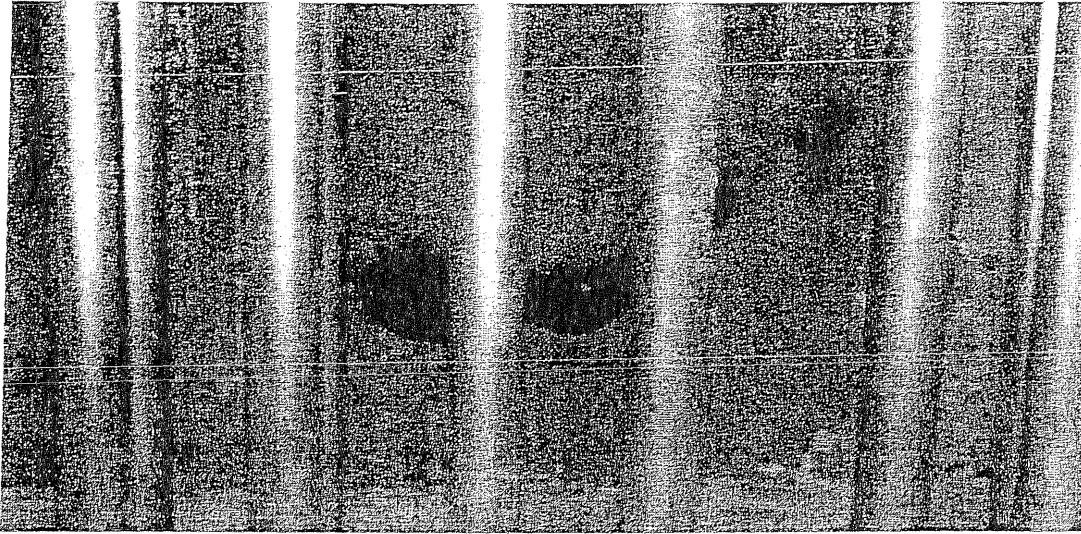
Photo 51: 3TS4, Suspect Stain on Concrete, North Wall.

A tape lift sample collected from the black material shown in Room 3TS4 did not contain mold.

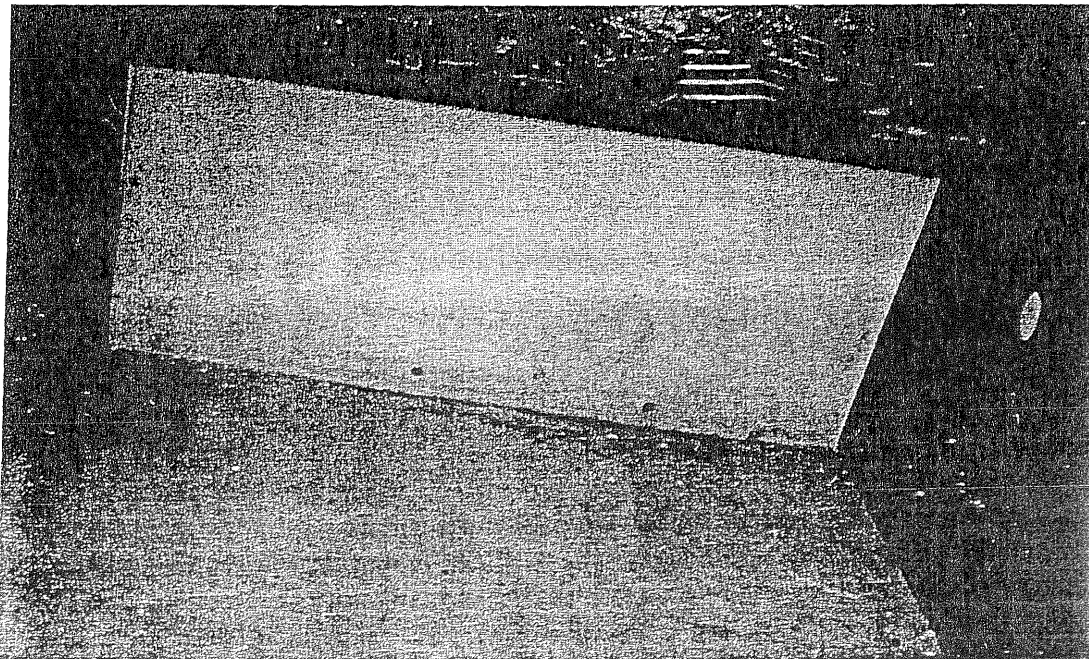
Photo 52: 3TS5, Below Fire Sprinkler Equipment, North of Elevator Shaft.

Vinyl base was pulled at multiple locations in 3TS5 where there were any signs of recurring water damage. The inspection revealed mold throughout the room. The majority of this damage has resulted over time from testing, maintenance, and repair of fire pumps and sprinkler systems.

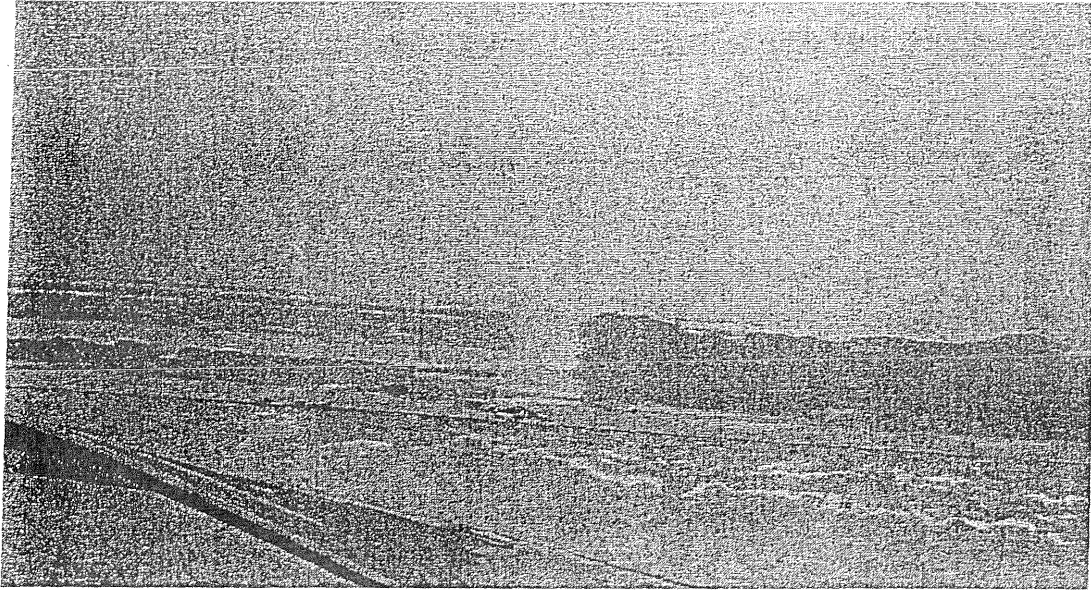
Photo 53: 3TS5, North Wall.

Mold is shown behind the base on the north wall of Room 3TS5.

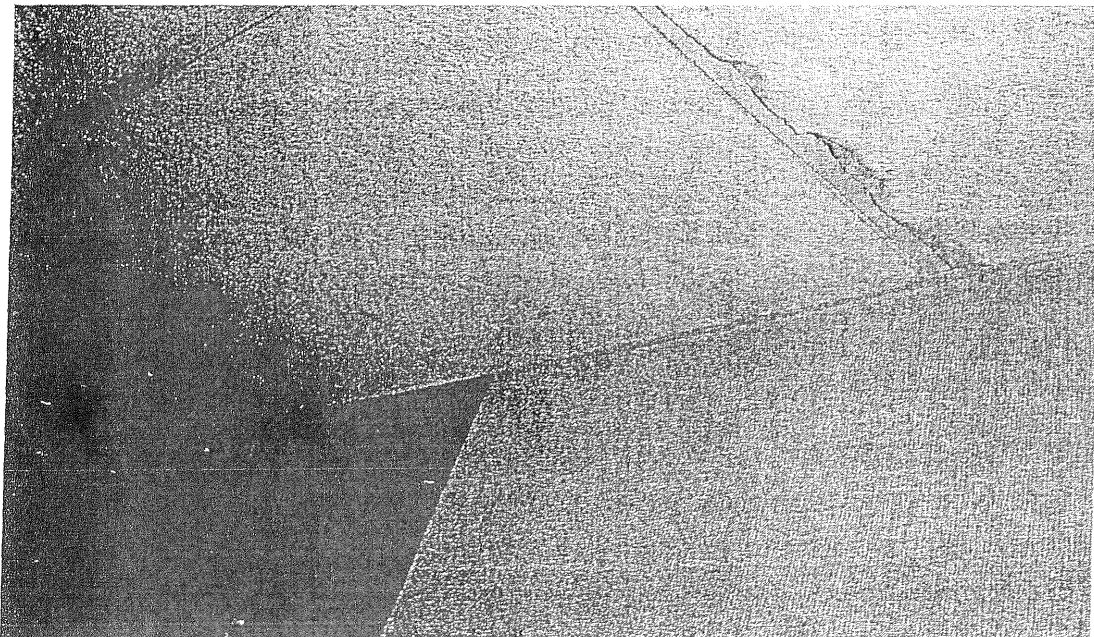
Photo 54: 2TS1, Stained Ceiling Tile.

A water stain was found on the tile adjacent to the wall outside of 2TS5 as the result of condensation from an uninsulated section of cold water return piping as shown above. The pipe is routed through the wall between two metal studs framing the door opening and there was no room to install the pipe insulation used throughout the rest of the facility.

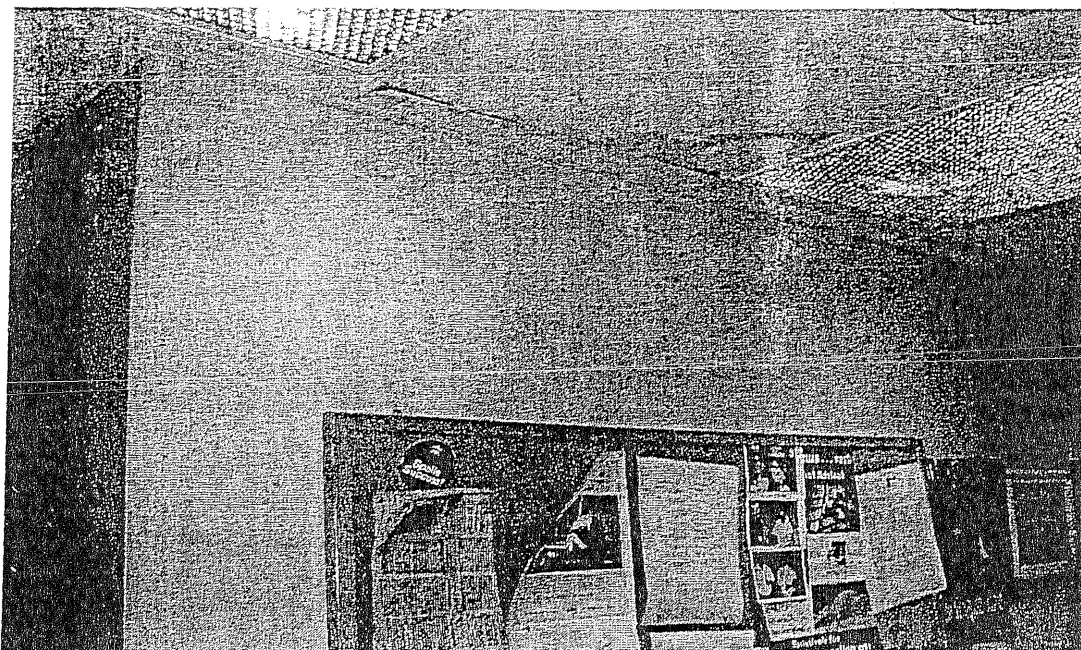
Photo 55: 2TS5, West Side of Elevator Shaft.

Several large water stains were found on the suspended acoustical ceiling in 2TS5 as shown above. Water streaks/stains were visible on the walls forming the elevator shaft and the base below was evaluated, however, no mold was found.

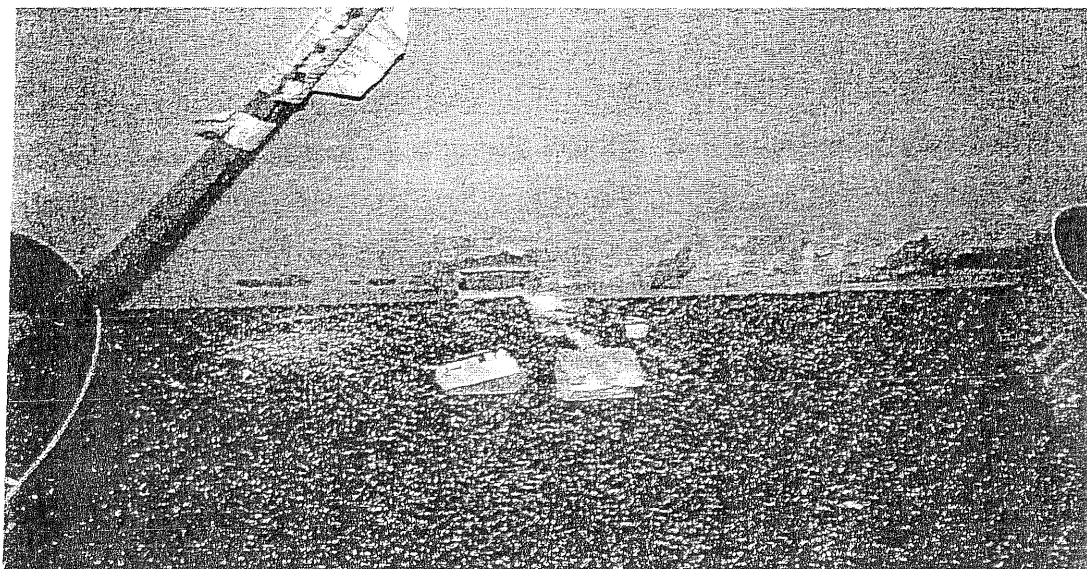
Photo 56: 2TS5, North Wall.

A small amount of mold was found behind the base on the north wall in Room 2TS5. This furred out gypsum board wall was installed adjacent to the precast concrete wall at some point after the ATCT was constructed. The source of water appears to be from old building joint leaks and water leaks from 3TS5.

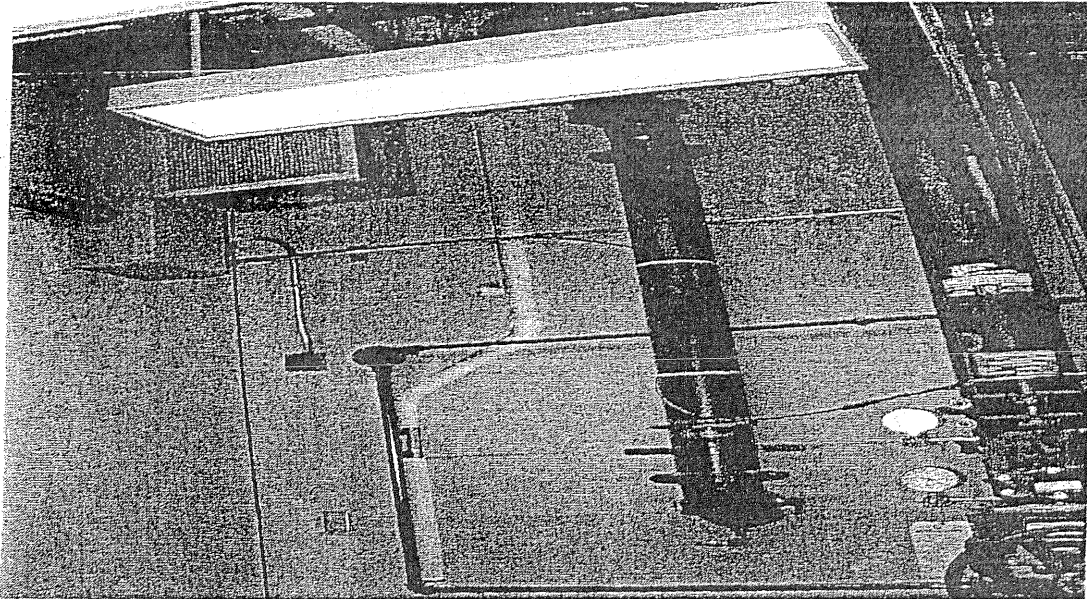
Photo 57: G4, Southwest Corner.

Water stains were visible on the unfinished gypsum board in room G4 adjacent to the outside air duct. It appears that water either leaks around or enters through the 4th floor outside air intake louver and runs down the inside, or exterior of the vertical duct run to the ground floor. This gypsum board serves as a thermal barrier over foam insulation and is not taped, finished, or painted.

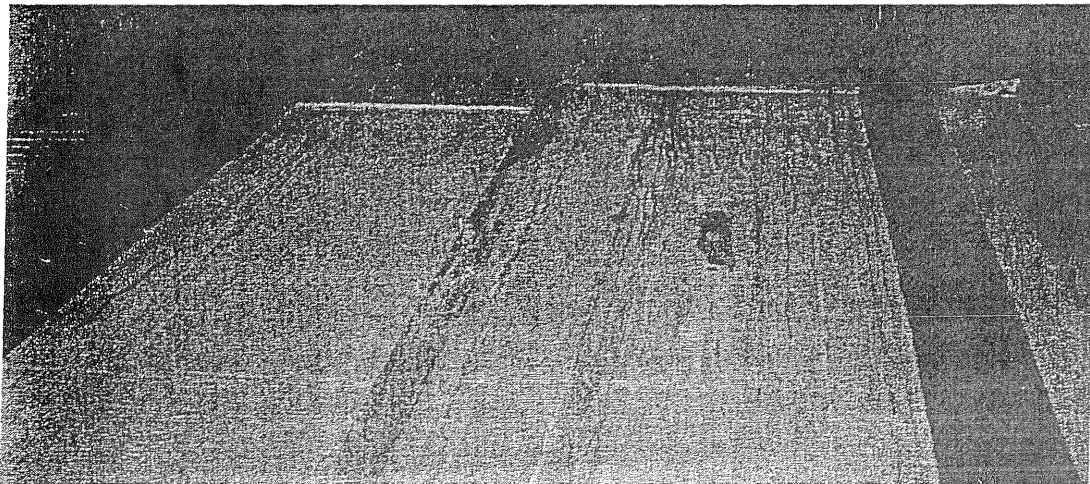
Photo 58: Elevator Shaft.

The elevator shaft was visually inspected on June 19, 2006 by personnel riding on top of the elevator car and making stops at approximately five to ten foot intervals based on conditions observed. The gypsum board shaft liner panels had water streaks or stains at many locations as shown above.

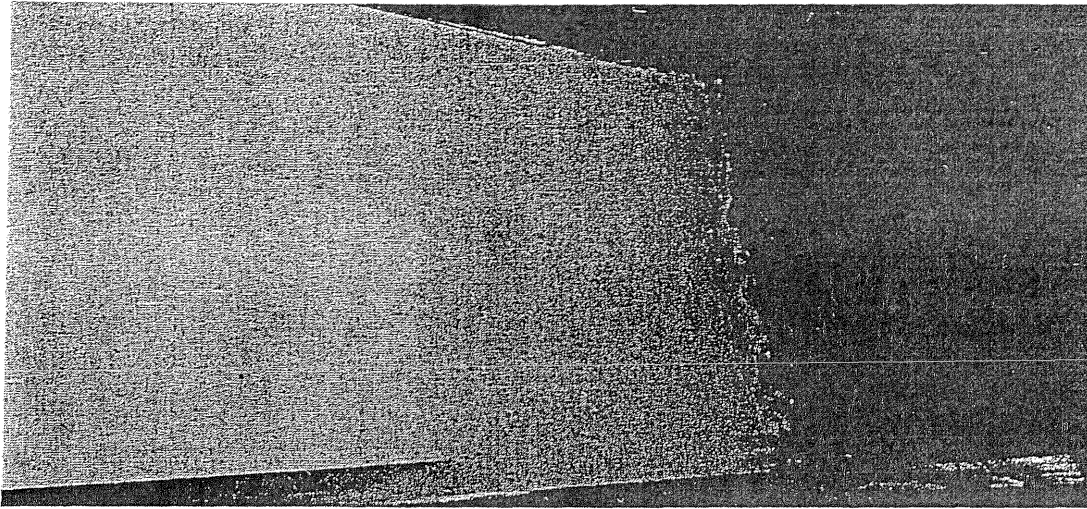
Photo 62: Stairway, Between Junction and Sub Junction Levels, Dusty Handrail.
A dusty handrail is shown above the gypsum board cover in Photo 61.

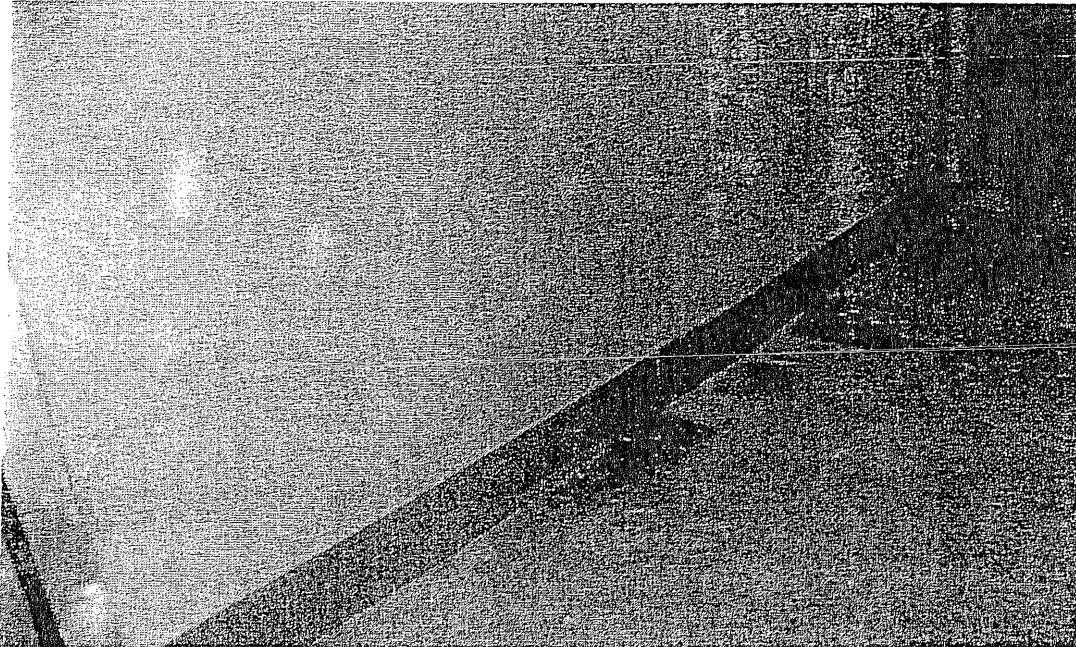
Photo 63: 8TS4, West Wall.

Condensation and frosting are shown on the west wall of Room 8TS4, on January 18, 2007.

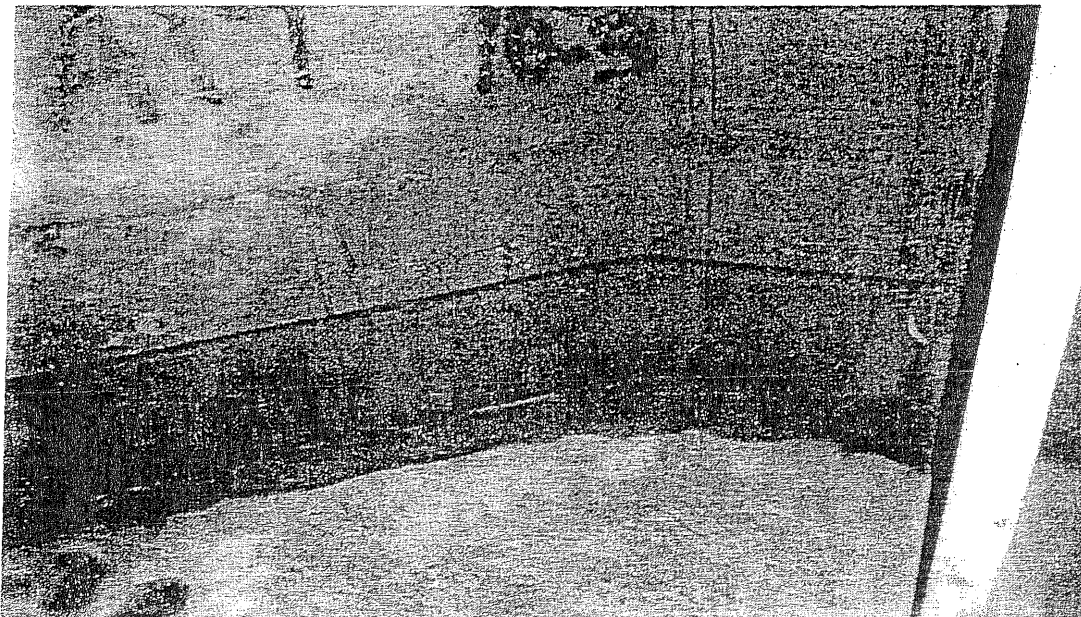
Photo 64: 8TS4, Northeast Wall.

Water and condensation is seen on the northeast wall of Room 8TS4. After a period of warmer outside temperatures, frost has melted and water is seen accumulating on the floor on January 19, 2007.

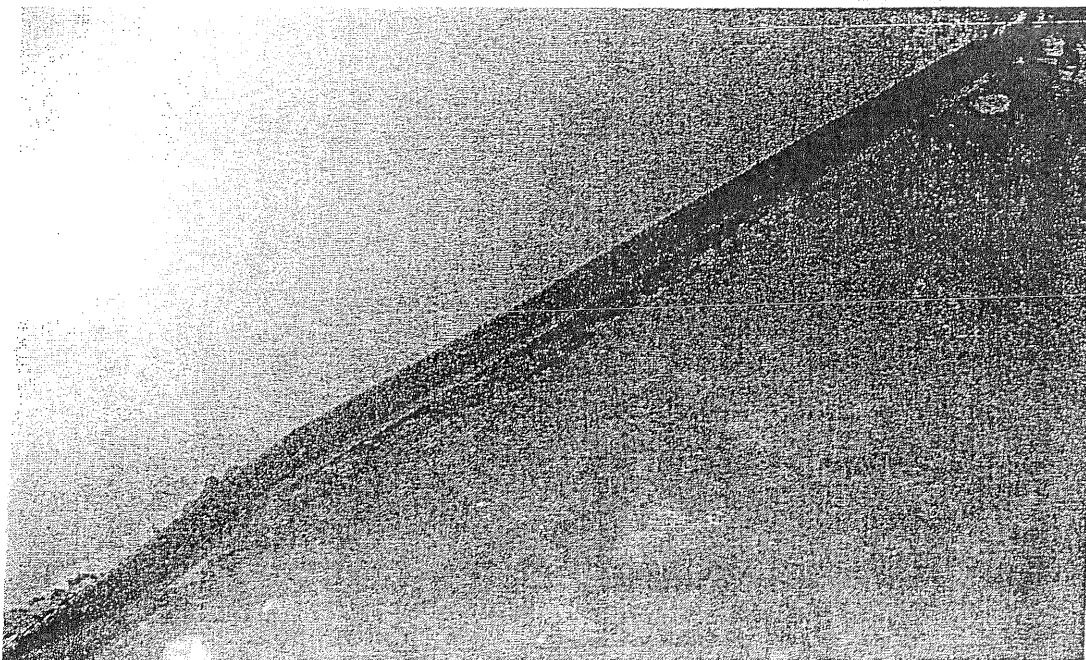
Photo 65: 10TS5, West Wall.

Standing water is seen along the base of the west wall in Room 10TS5, on January 18, 2007.

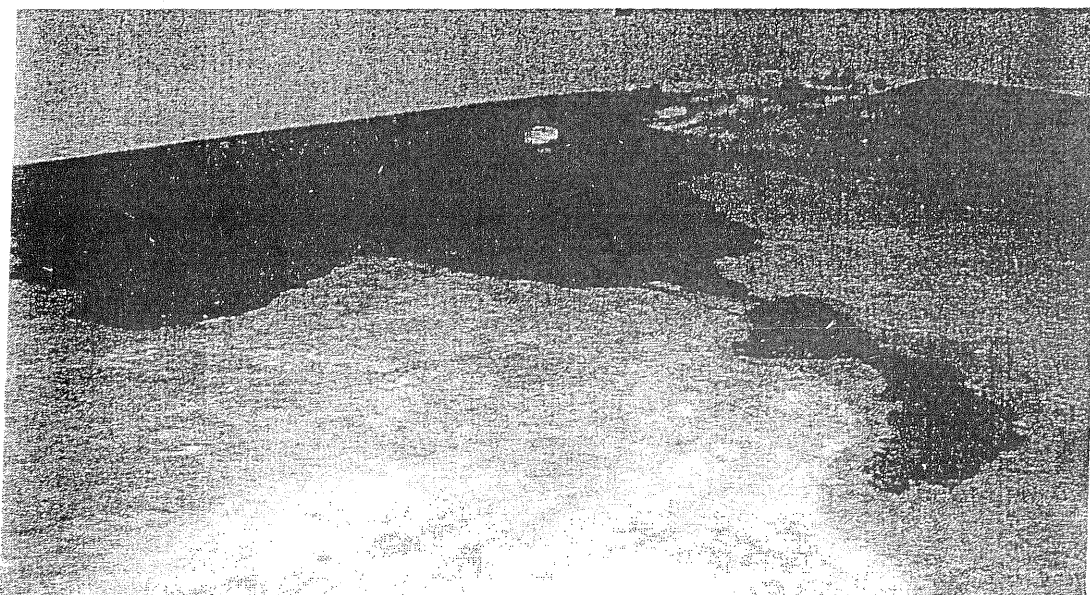
Photo 66: 10TS5, North Wall.

After warmer outside temperatures on January 19, 2007, frost on the precast panels begins to melt. Water begins to accumulate on the floor slab.

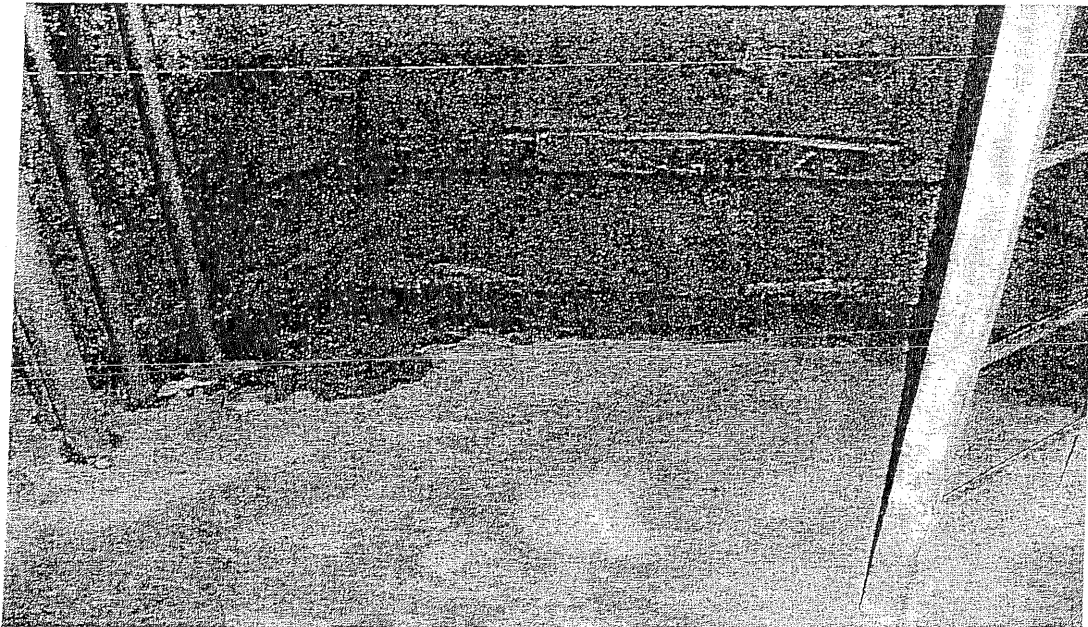
Photo 67: 9TS4, North Wall.

Melting frost and condensation are shown by the north wall of Room 9TS4, on January 18, 2007.

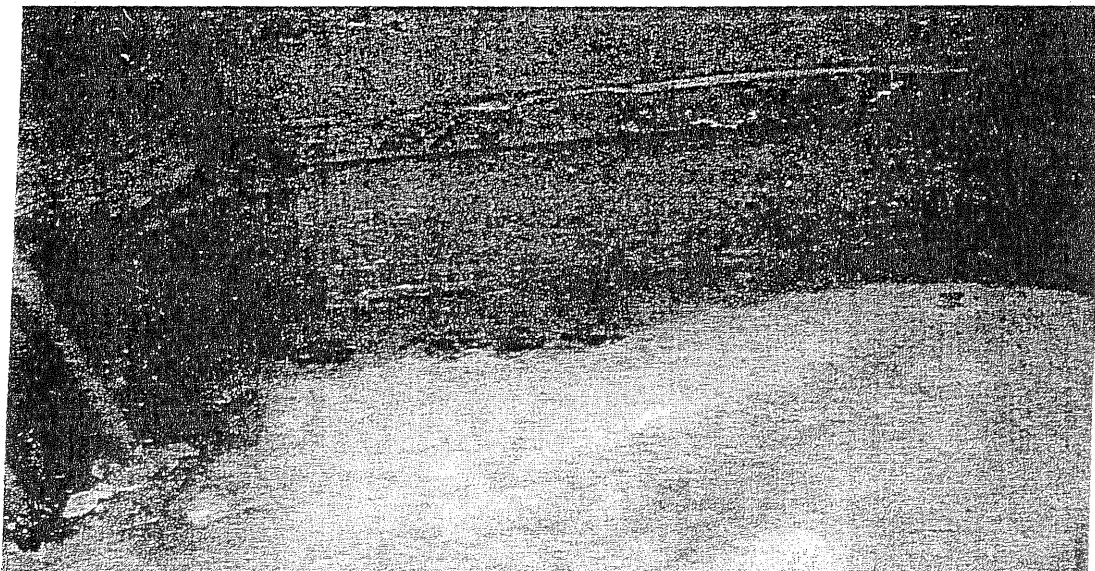
Photo 68: 9TS4, East Wall.

Melting frost and condensation are shown by the north wall of Room 9TS4, on January 19, 2007. Higher outside temperatures caused the surface temperature to rise and more water is seen accumulating on the floor.

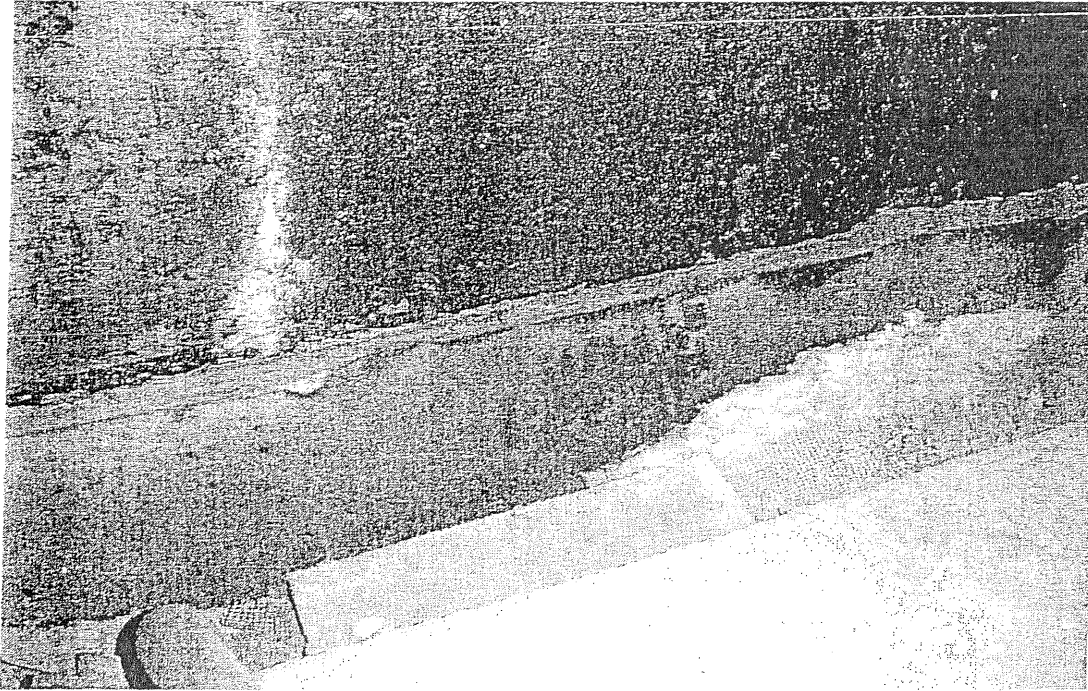
Photo 69: 11th Floor Outer Ring.

Condensation and frosting are shown on the precast walls in the 11th Floor Outer Ring, on January 18, 2007.
