Subj: (U) REPORT OF THE INVESTIGATION INTO THE FACTS AND
CIRCUMSTANCES SURROUNDING THE ACCOUNTABILITY FOR, AND
SHIPMENT OF, SENSITIVE MISSILE COMPONENTS TO TAIWAN

FINAL REPORT

INVESTIGATION INTO THE SHIPMENT OF SENSITIVE MISSILE COMPONENTS TO TAIWAN (U)

MAY 22, 2008

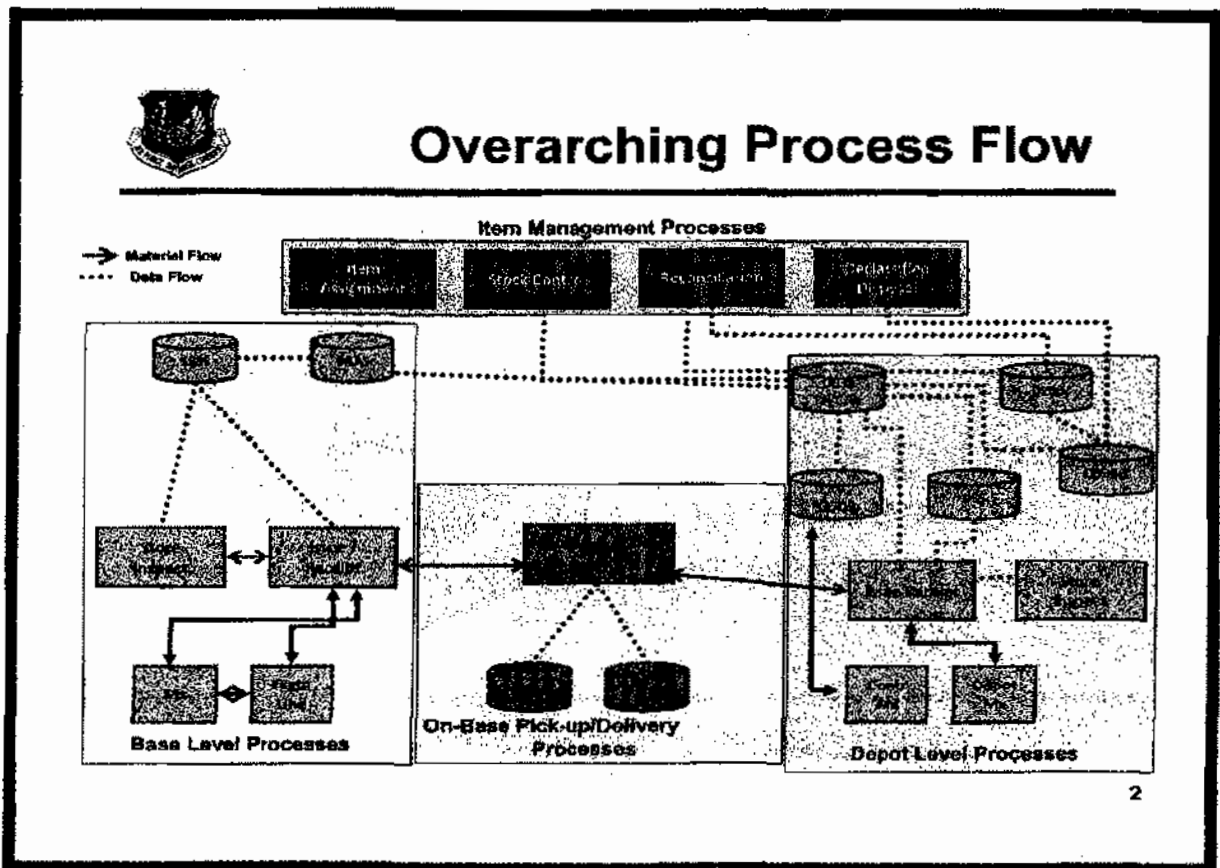
Figure 5 – Process Flow for Item Management (Source: AFMC/A4) (U)

(a) (U) While Figure 5 depicts a relatively simple process flow, according to AFMC, the Air Force supply chain management system is a loosely knitted conglomeration of applications that were independently developed over time. As a result, the interfaces between these legacy applications are complex, difficult to maintain, and require an experienced IMM to use effectively (see Figure 6 below).

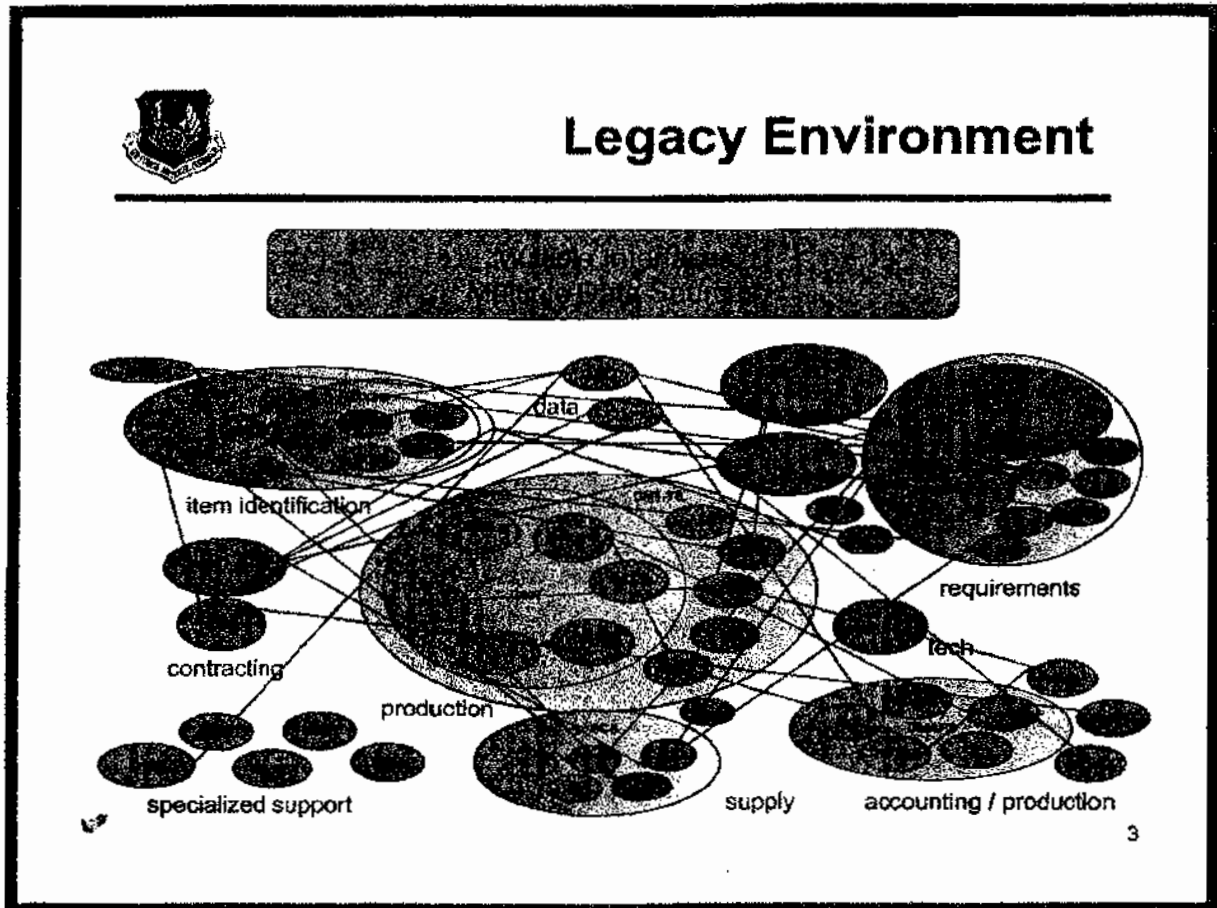
Figure 6 – Supply Chain Information Technology Systems (Source: AFMC/A4)
(U)

(b) (U) The complexity of these applications and their interfaces necessitates comprehensive IMM training to ensure effective execution of supply chain management responsibilities. Prior to the closure of Kelly AFB in 1999, the majority of these supply chain management applications were maintained by the ALC at Kelly AFB. Consequently, Kelly AFB also maintained standardized training for these applications and their interfaces.

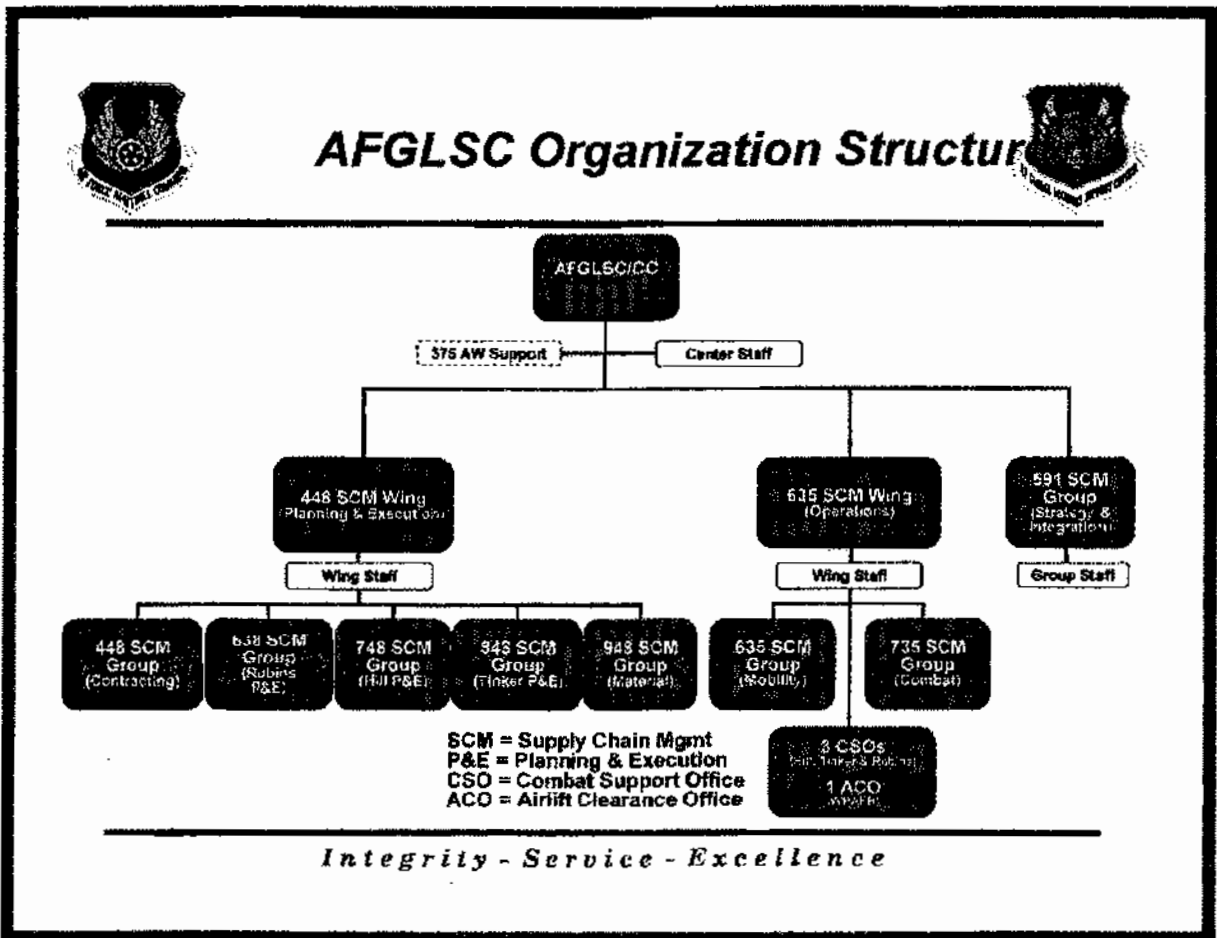
Figure 7 – Global Logistics Support Center (Source: AFMC/A4) (U)

(d) (U) Based on recent AFMC identification of the need for more standardized IMM training, AFMC is taking the initiative to standardize training under the Global Logistics Support Center (GLSC) initiative (see Figure 7 below). However, since the 526th ICBM Systems Group IMMs are not scheduled to transition to the GLSC until 2011, the 526th ICBM Systems Group and AFMC are now developing a training program for the 526th ICBM System Group IMMs that utilizes existing training plans and products from other commands. Additionally, AFMC is evaluating earlier transfer of the 526th ICBM Systems Group IMMs to the GLSC.
