Hanford BY-Farm Leak Assessments Report

Washington River Protection Solutions LLC

January 2011

Prepared for the U.S. Department of Energy
Office of River Protection

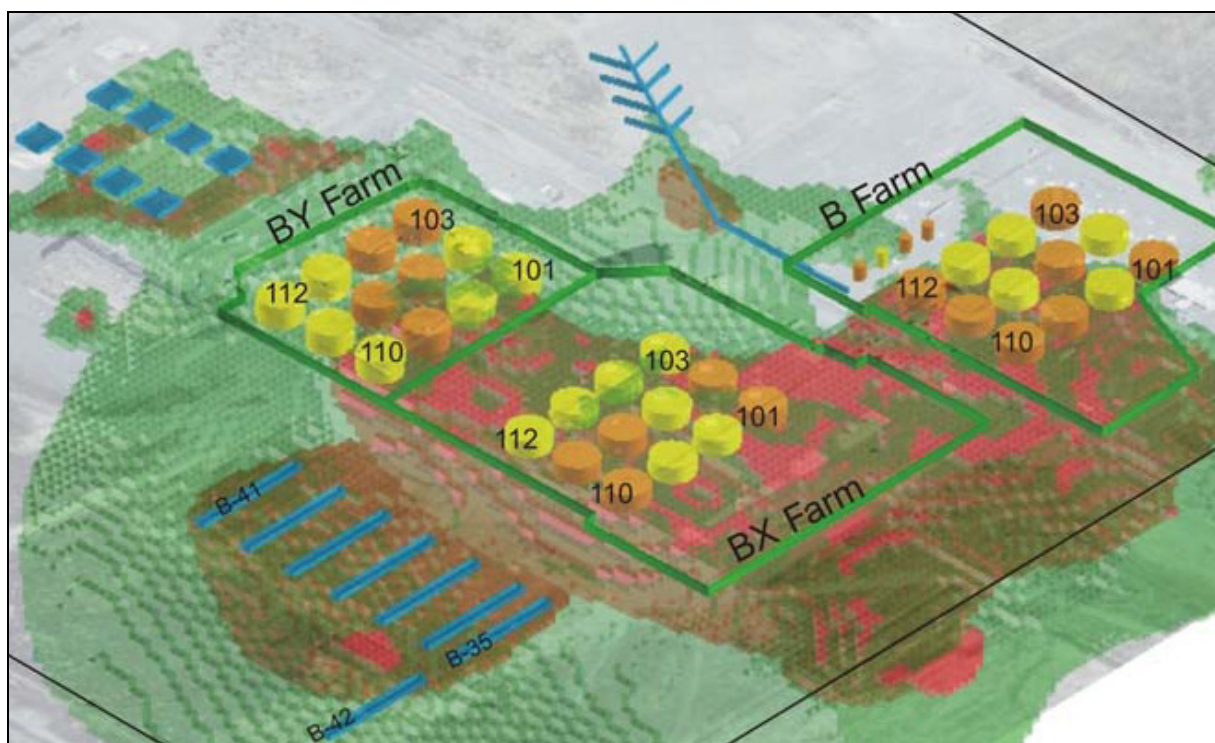
Figure 3-5. 241-BY Tank Farm Surface Geophysics Exploration Results

Figure 3-5 shows 40-50 ohm-m resistivity results for a well to well (WTW) resistivity survey with electrical connections to and between tank farm drywells and groundwater monitoring wells. It is difficult to identify a specific tank leak source within BY-Farm based on these results. Infrastructure obstructions and other physical features appear to have impacted the ability to obtain better defined images of resistivity anomalies in the soils around WMA B-BX-BY that would point to specific sources of released waste.

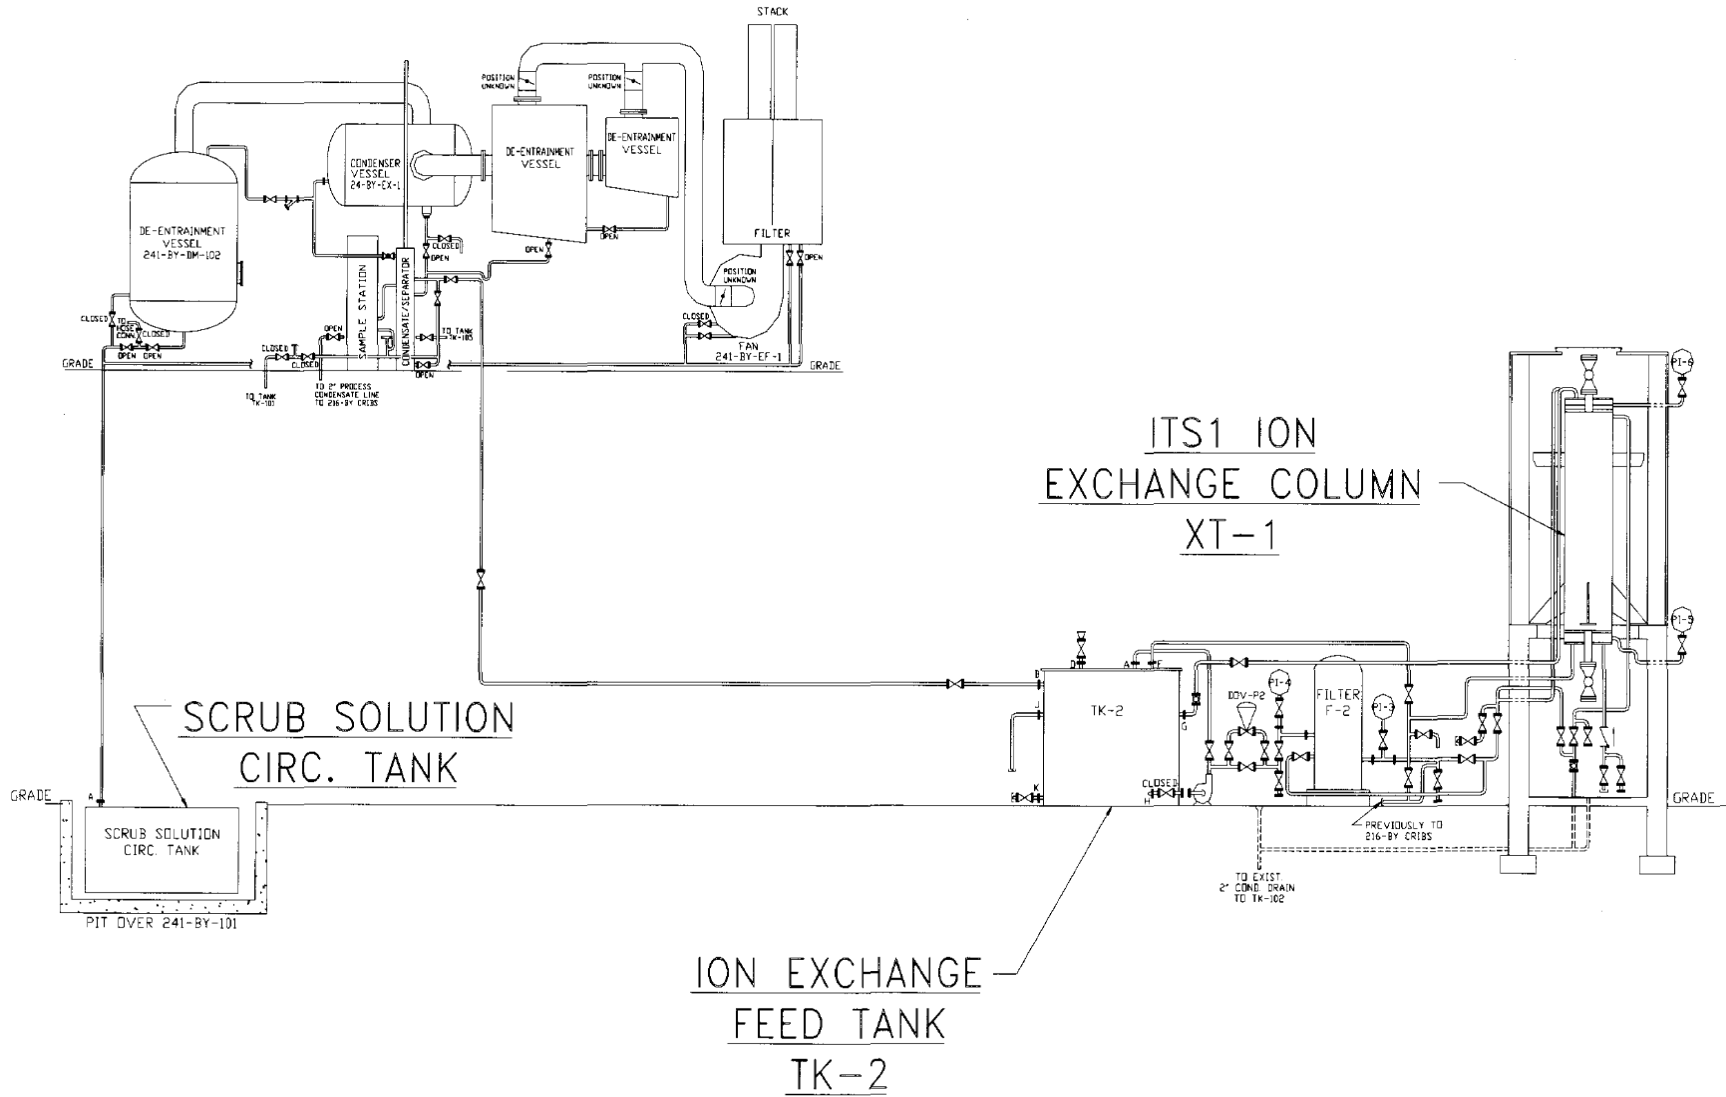
Figure 3-14. Miscellaneous Tanks in In-Tank Solidification System #1

A video inspection of Tank 2 was performed on December 4, 2006. The tank appeared structurally sound, although slight discoloration and corrosion was observed on the inside top. The tank contained a very small amount of solids located in a drift by the pump suction line (no volume reported). The tank had no liquid inside of it (RPP-RPT-32085, p. 2).

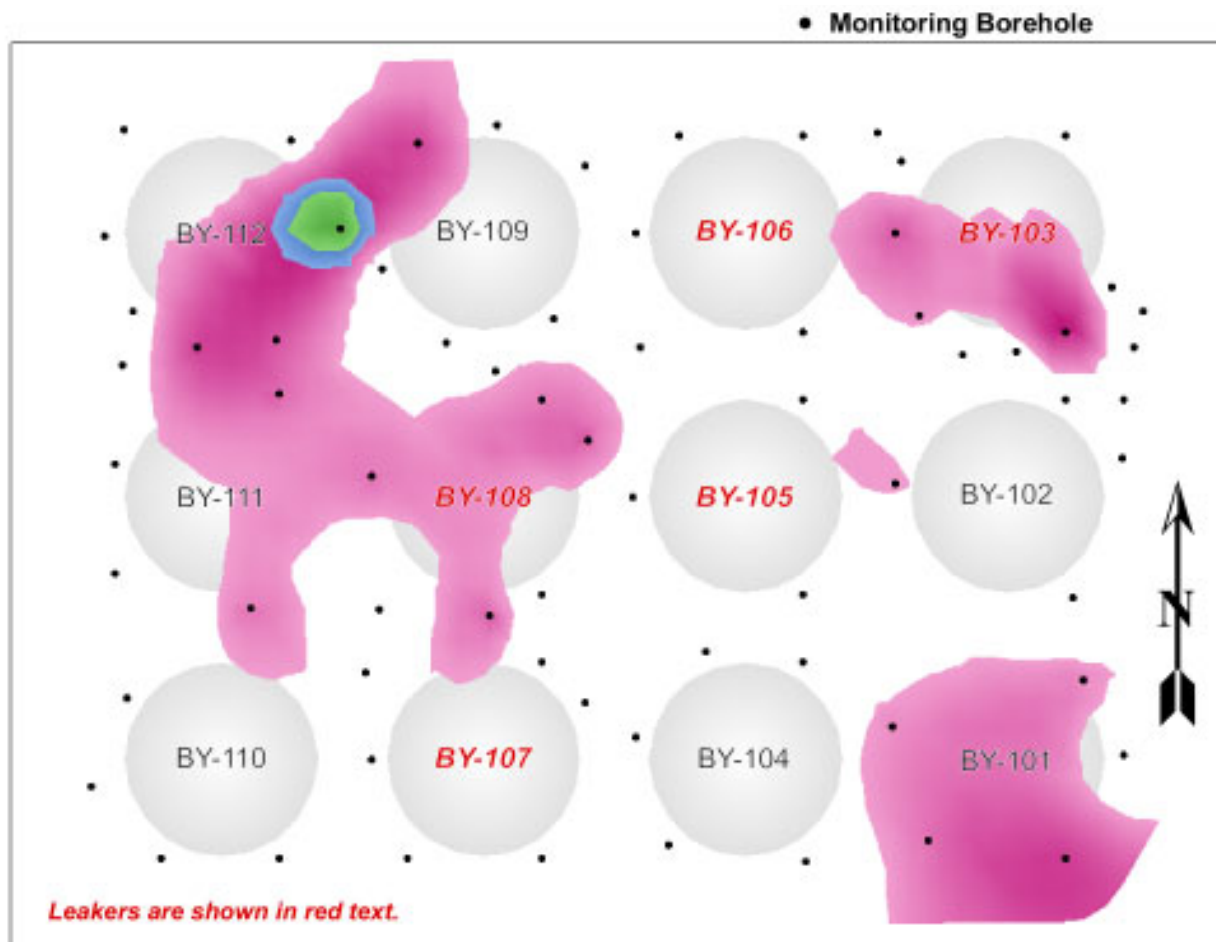
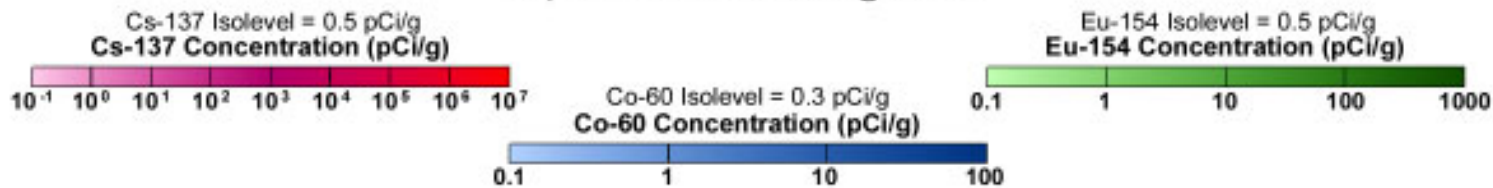
Figure 4-4. Visual Based on Drywell Logging Activity at 9 feet in 241-BY Tank Farm

Figures 4-3, 4-4 and 4-5 are cross-section visualizations based on SGLS drywell measurements. The figures illustrate the near-surface UPR at tank BY-112 and show that low levels of cesium activity are widely distributed across the farm in the top 9 ft bgs. At 35 ft, except for the UPR at tank BY-112 the highest activity for cesium is observed near tank BY-103 and cobalt plumes begin to be observed at about the same location as surface cesium activity is observed.

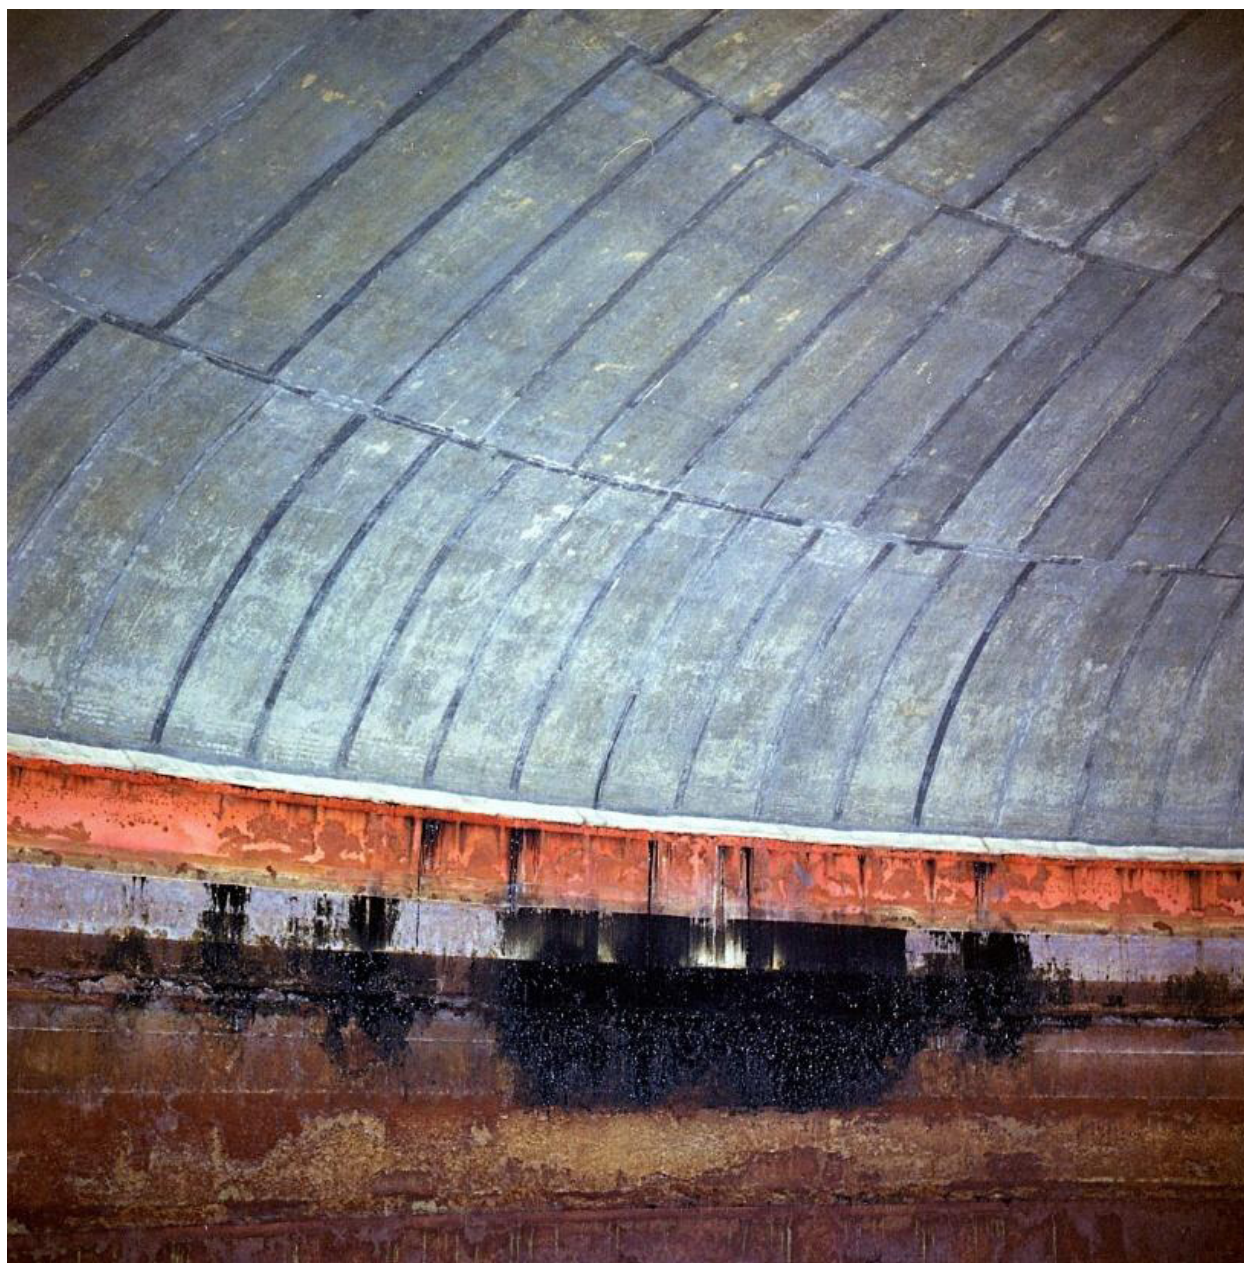
Figure 4-7. Tar Ring Photos for Tank 241-BY-110

During ITS transfers, many of the BY-Farm tanks were overfilled, as shown by process history and in-tank photos. In addition, photos show a black substance (referred to as tar rings) around the top of the steel liner in tanks BY-103, BY-106, BY-107, BY-108, BY-109, BY-110, BY-111 and BY-112 (see Figures 4-6 and 4-7). A study of tar rings in ITS tanks (ARH-1496, *Review of Storage Tank Integrity*) concluded that the tar observed on the liner was from the mastic compound (tar) placed between the steel tank liner and the concrete walls during construction. The tar rings appear to be the result of mastic compound melting and flowing from the dome of the tank and through gaps, holes, corrosion pits, and similar discontinuities at the top of the liner. ARH-1496 indicates that tar was flowing through perforations in the liner (below the top of the liner) in some locations in tank BY-110. However, this was not apparent from a review of the photos referenced.

The photos do show a black substance (tar) flowing from the top of the liners. A break in the seals between the liners may have resulted in supernate leaking between the liner and the concrete, then leaking to the soil through cracks in the concrete. However, ARH-1496 suggests that the mastic compound found between the liner and the concrete wall would tend to seal any cracks in the concrete as the tanks were heated, thus improving the containment. ARH-1496 further notes that the presence of tar rings in the tanks do not necessarily indicate that a tank has leaked. As a precaution the liquid operating level in tanks was lowered to below tar rings after they were observed.

Due to uncertainty of the liner integrity for ITS and ITS bottoms tanks, the leak assessment panel recommended that formal leak integrity assessments be conducted for all BY-Farm tanks including tanks currently classified as “sound” in HNF-EP-0182, except BY-103 (confirmed to have leaked in the past), per TFC-ENG-CHEM-D-42. The assessments are needed to support determination of technologies to retrieve waste and to determine a basis for inventory calculations from BY-Farm tanks in the future. Additional information for BY-Farm tanks currently classified as “sound” is included in Appendix C.

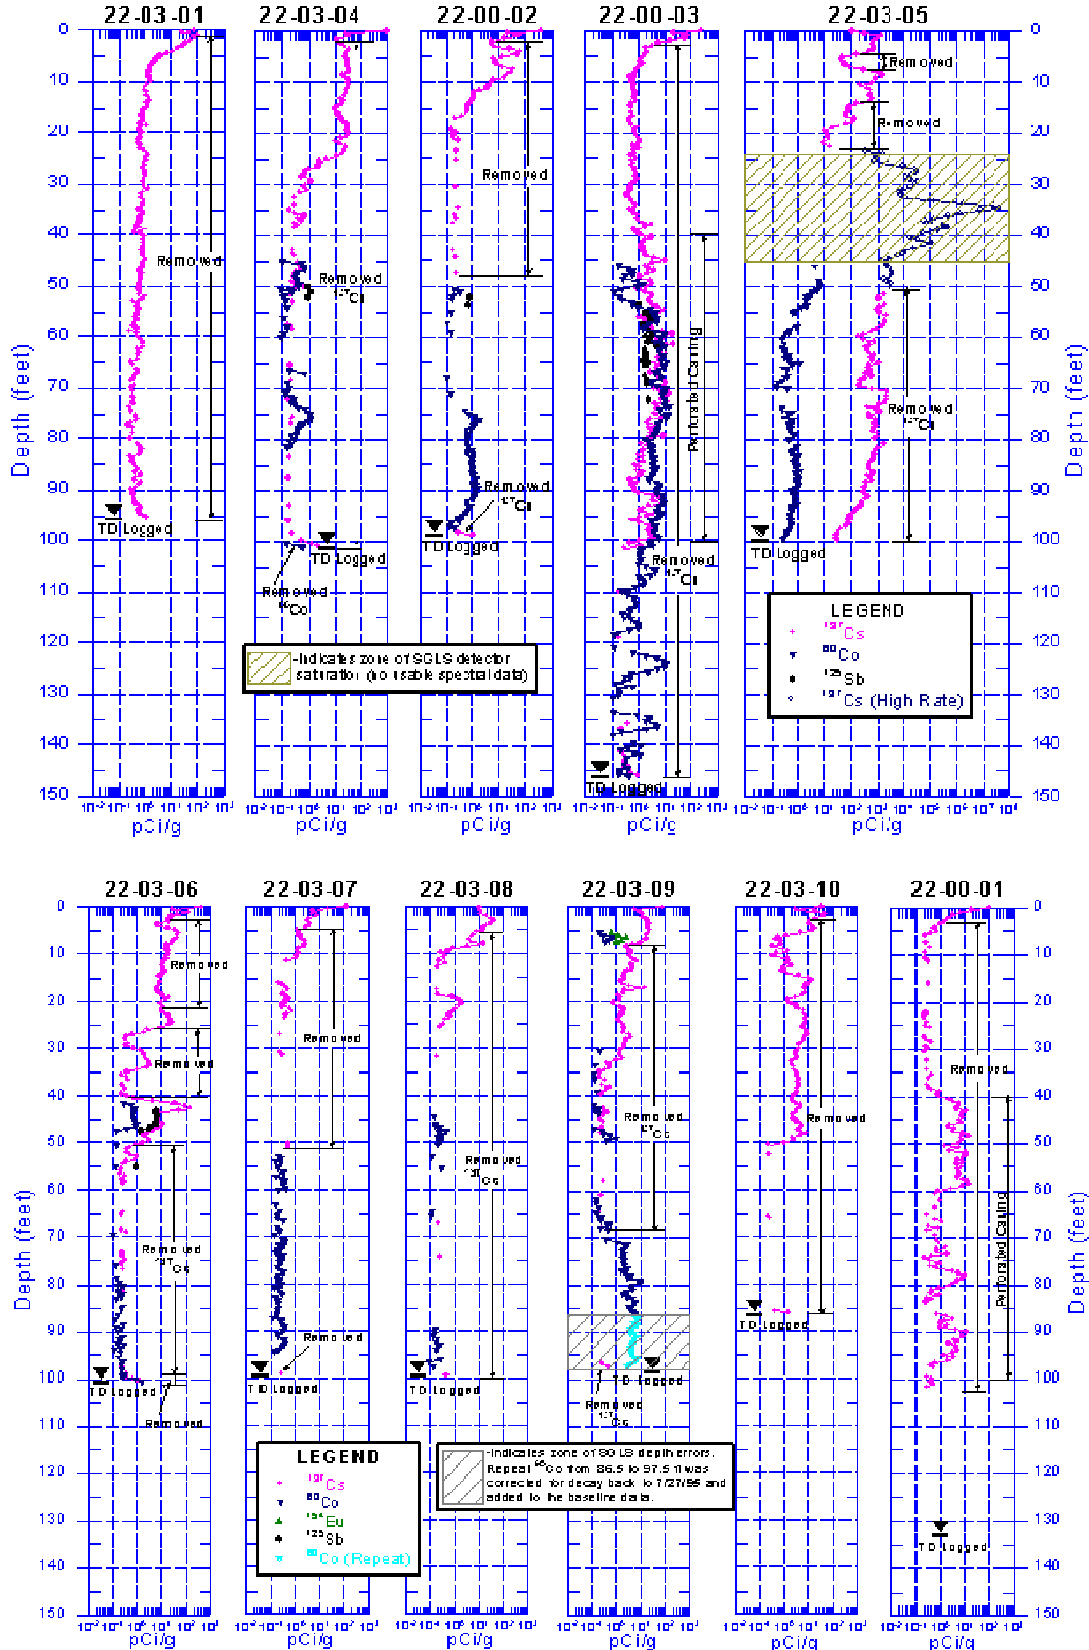
Figure B.1-6. Tank 241-BY-103 Drywell Spectral Gamma Data Collected after 1995

B.1.2.2 Drywell Logging Data. In 1969, high radiation count rates were obtained in drywell 22-00-03, which is located southeast of the tank. On the basis of continued high count rates in drywell 22-00-03, tank BY-103 was classified as a borderline leaker in 1970. In 1971, high count rates were also obtained in drywell 22-03-05, a newly drilled monitoring drywell. The liquid operating level in tank BY-103 was lowered to ~13 ft to permit continued operation of the tank as a bottoms receiver in the ITS program. In 1972 and 1973, count rates in drywell 22-03-09 spread over a widening interval from ~56 to 77 ft, although the count rates were low. Initial logging of new drywells 22-03-04 and 22-03-06 in 1973 showed enhanced count rates (Internal letter J17-30, "Integrity of Tanks 241-BY-103 and 241-TY-103"). On the basis of elevated gross gamma-ray count rates in the drywells around the tank, tank BY-103 was classified as a confirmed leaker in 1973. In 1974, a changing radiation profile and increase in radiation in drywell 22-03-09 at a depth of ~32 ft prompted an occurrence report (OR-74-106, *Increasing Radioactivity in Dry Well 22-03-09 at Tank 103-BY*) that concluded the tank may have leaked in early 1974, but that it probably no longer was leaking after the liquid level was lowered below the depth at which the radiation peak was observed (GJ-HAN-20, *Vadose Zone Characterization Project at the Hanford Tank Farms Tank Summary Data Report for Tank BY-103*).

Figure B.1-7 shows total gamma data obtained between 1975 and 1995 for drywells 22-03-04, 22-03-05, 22-03-06, 22-03-07, 22-03-08 and 22-03-09. Consistent with the spectral gamma data, drywell 22-03-05 showed the highest activity with 170,000 cps measured between 15 and 60 ft below ground surface (bgs). The activity attributed to ^{137}Cs was present in 1975 and began to stabilize and decrease following a ^{137}Cs decay trend after 1980. The next highest activity was observed in drywell 22-03-09, with 29,000 cps at 24 to 52 ft bgs attributed to ^{60}Co , ^{125}Sb and ^{106}Ru . The activity was unstable and continued to move. In 1993 the activity moved below the bottom of the drywell. On July 31, 1974 OR-74-106 noted a continued increase in activity at 34 ft bgs. A leak in the saltwell transfer line was suspected as a possible source. To investigate this possibility a test hole was augered over the tank dome and between the drywell and the center of the tank. The test hole revealed some contamination, but it could not be determined if it was from a recent event. Two possibilities for the continued increase were 1) seepage of interstitial liquid from a new leak in the tank or 2) migration of contamination from a new source (e.g., the saltwell pump transfer line [Note: the sluicing pit is near drywell 22-03-09]).

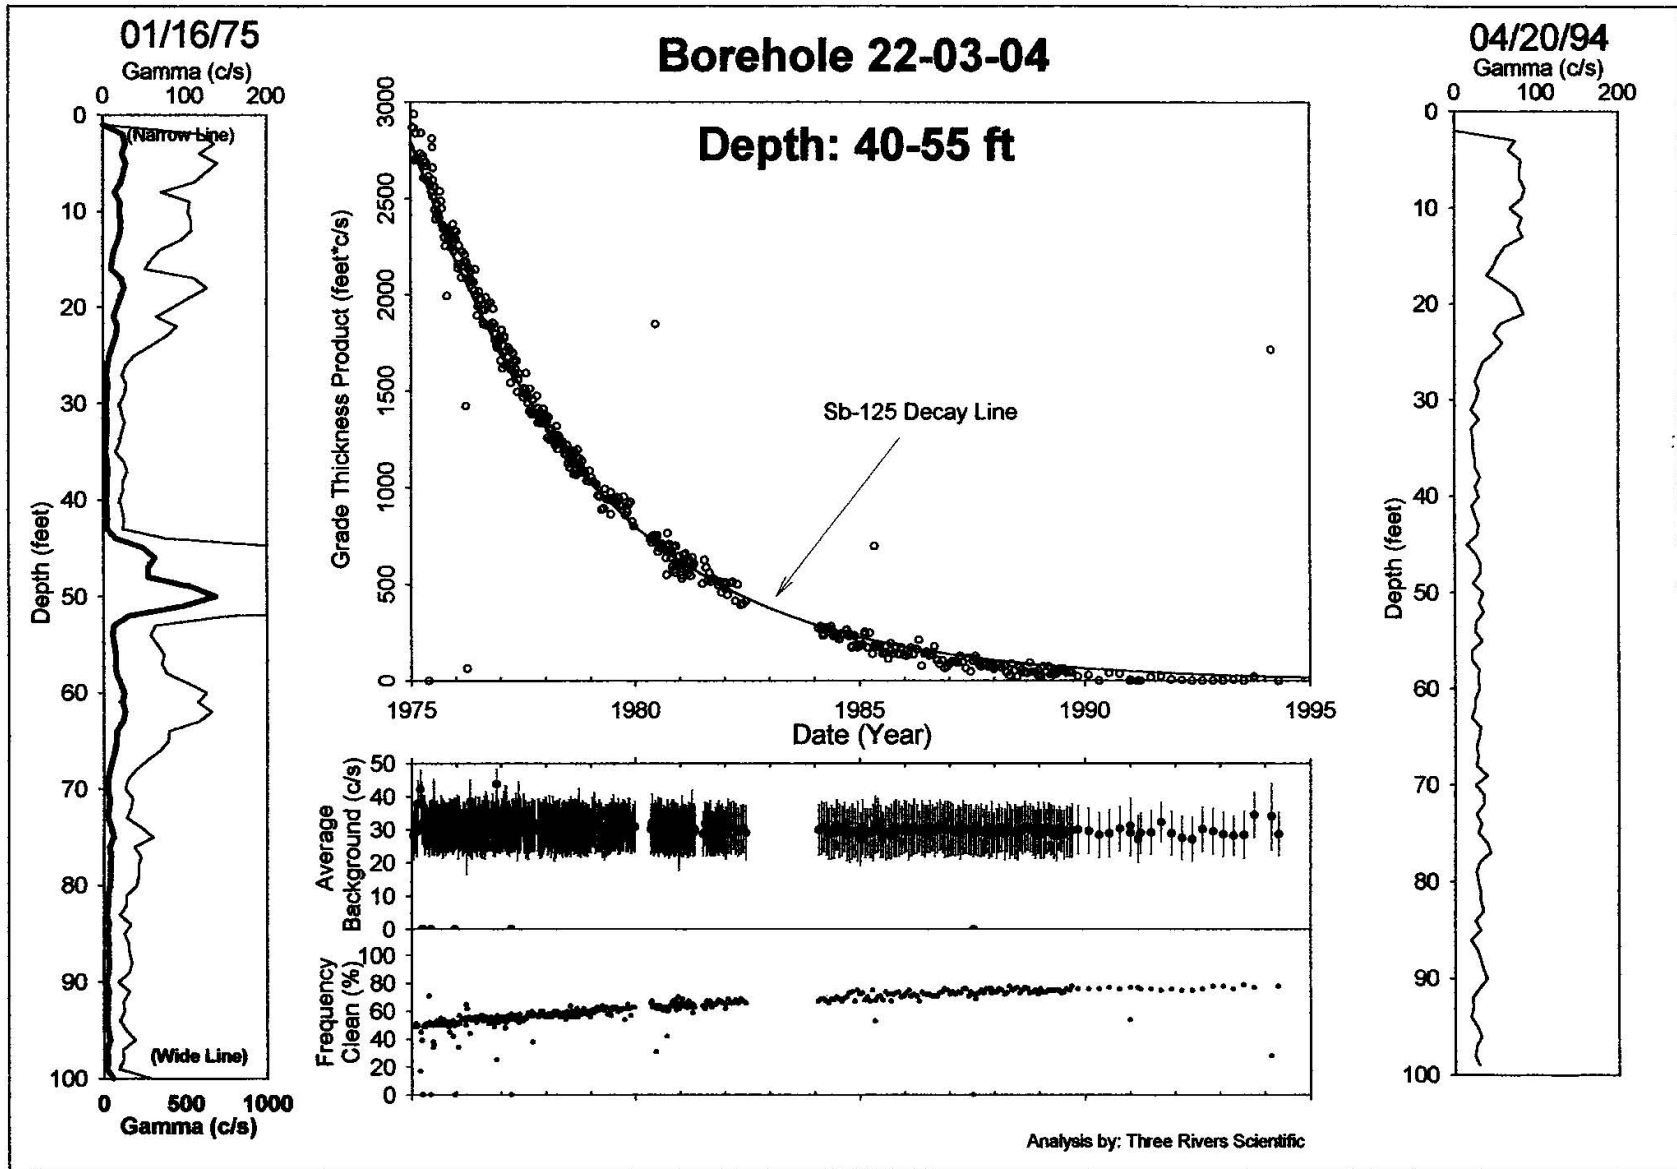
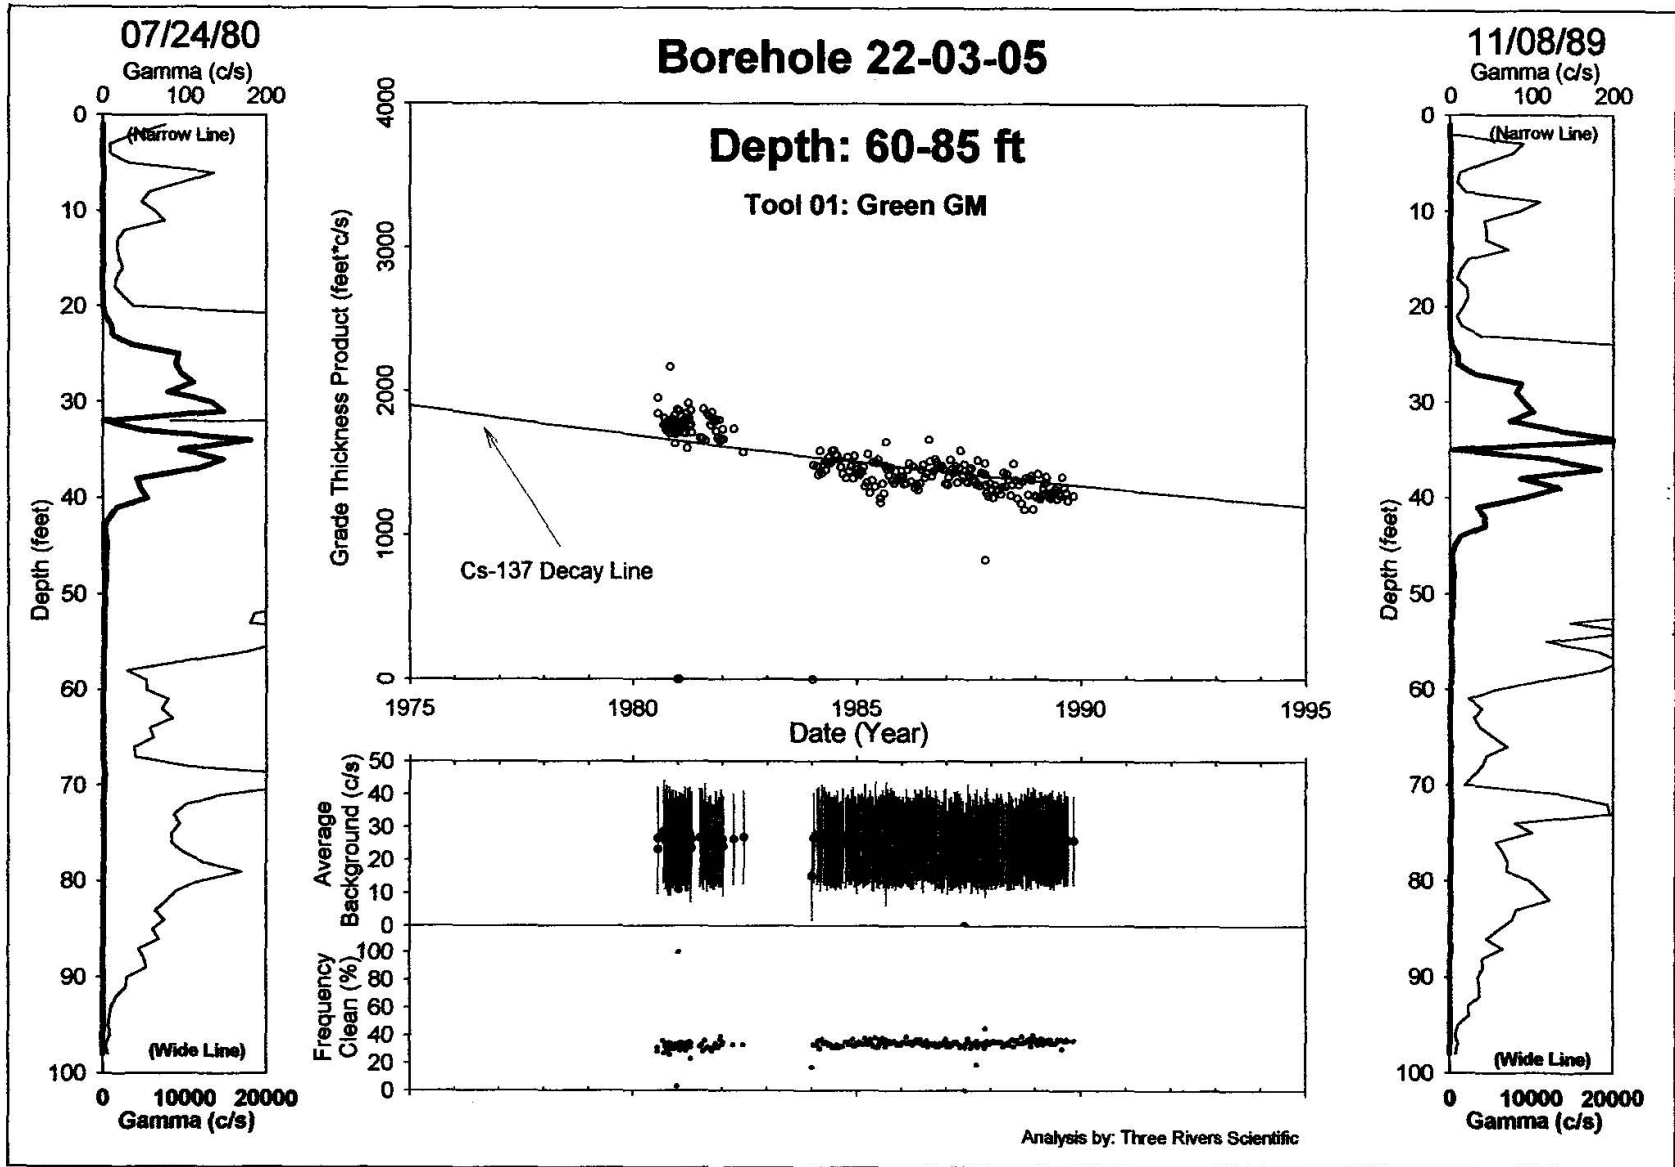
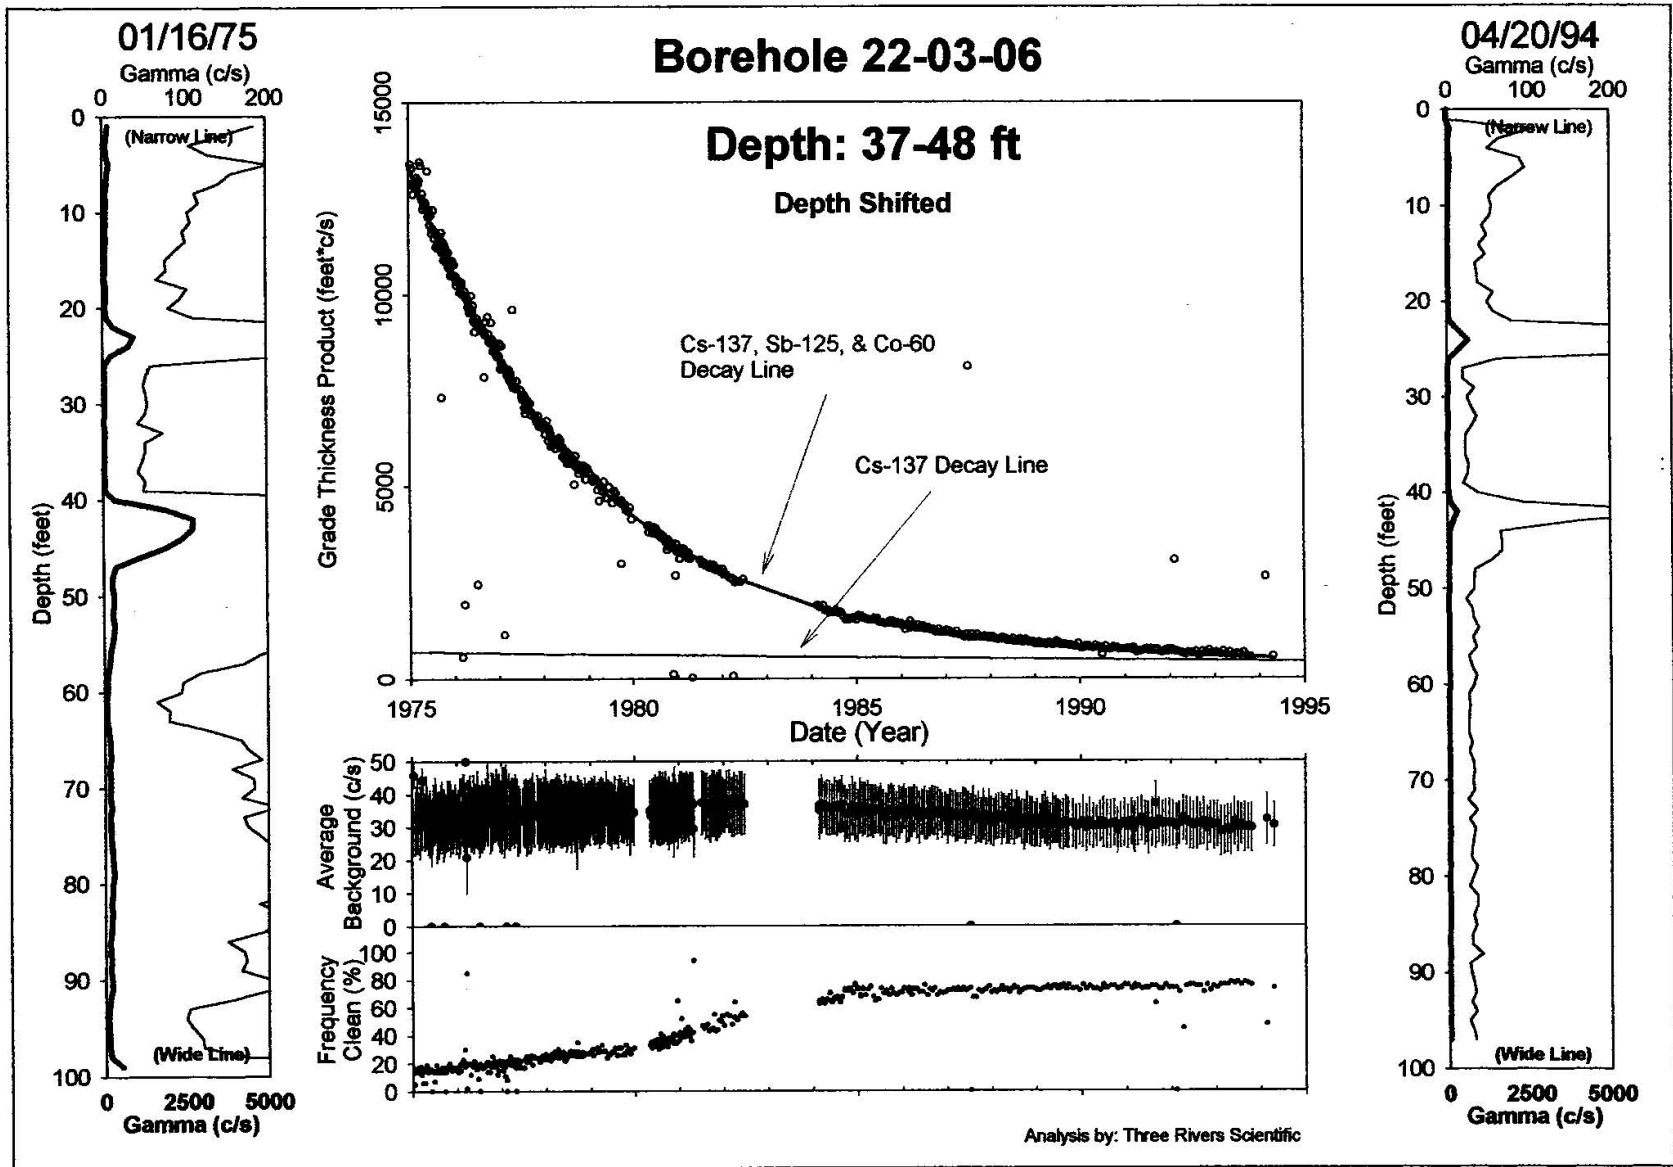
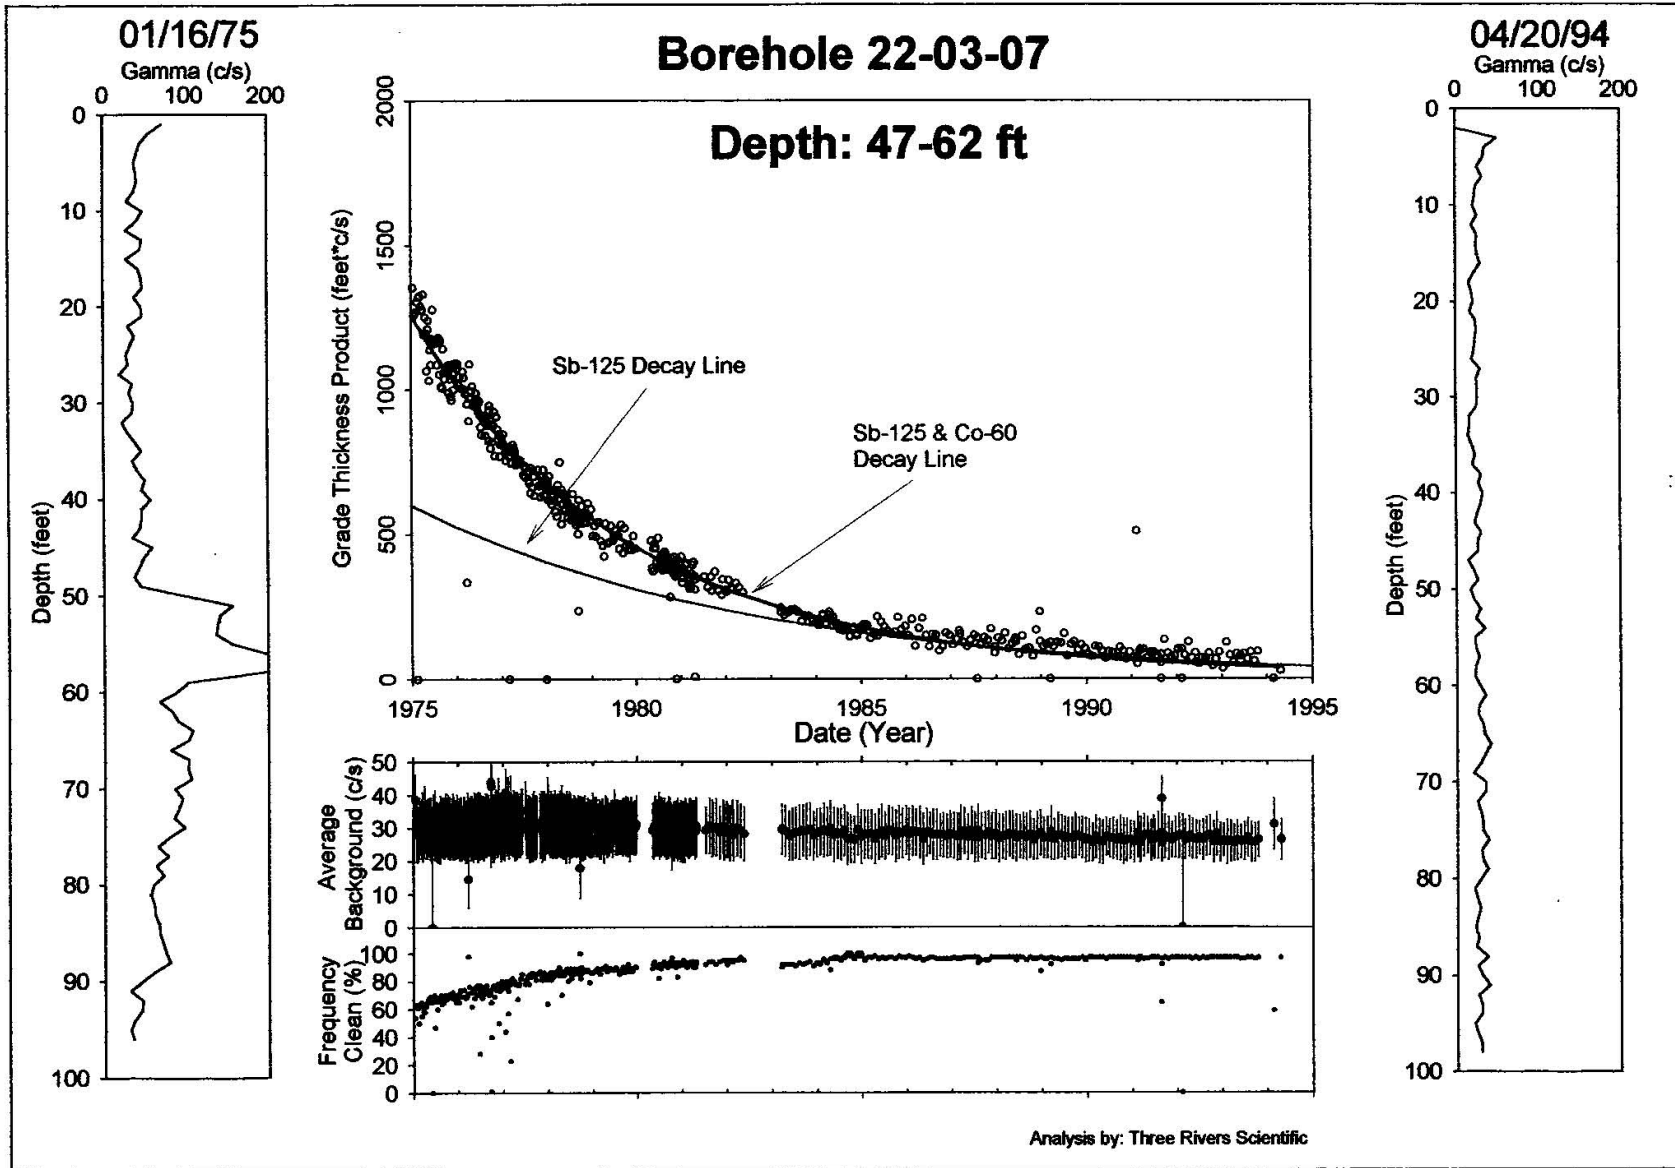
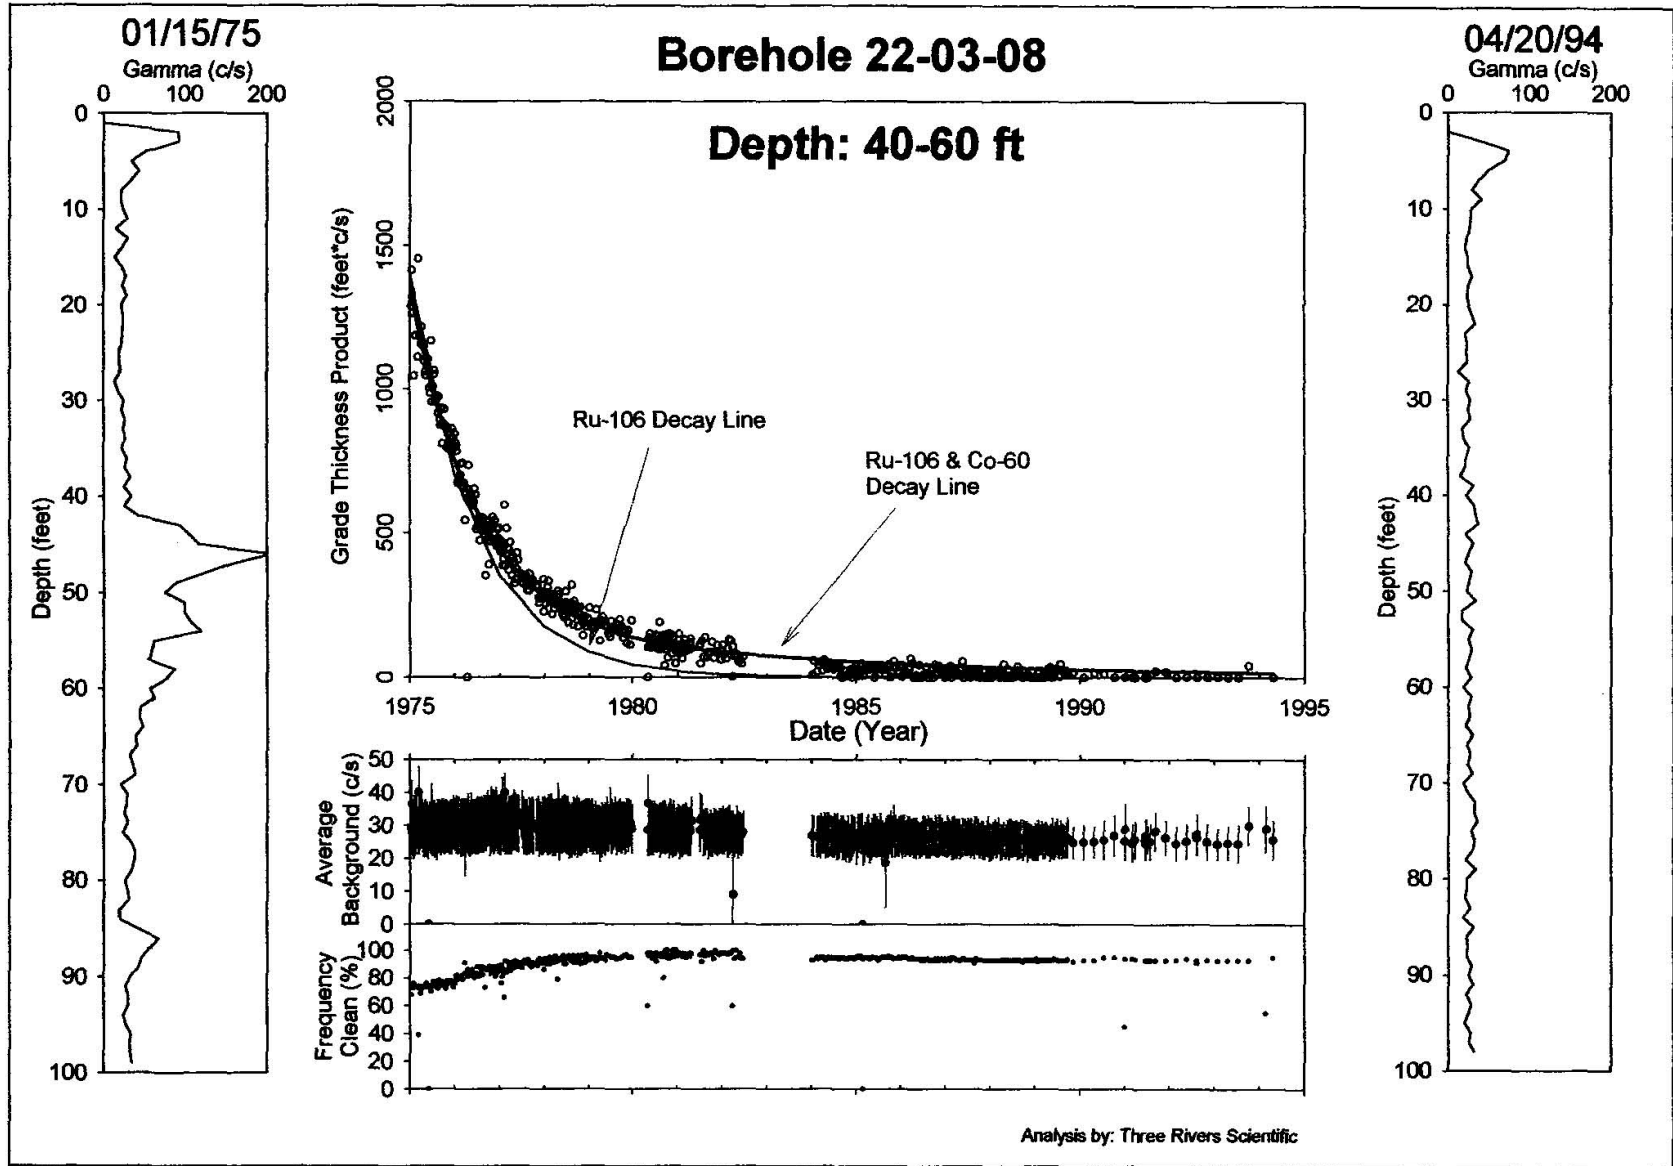
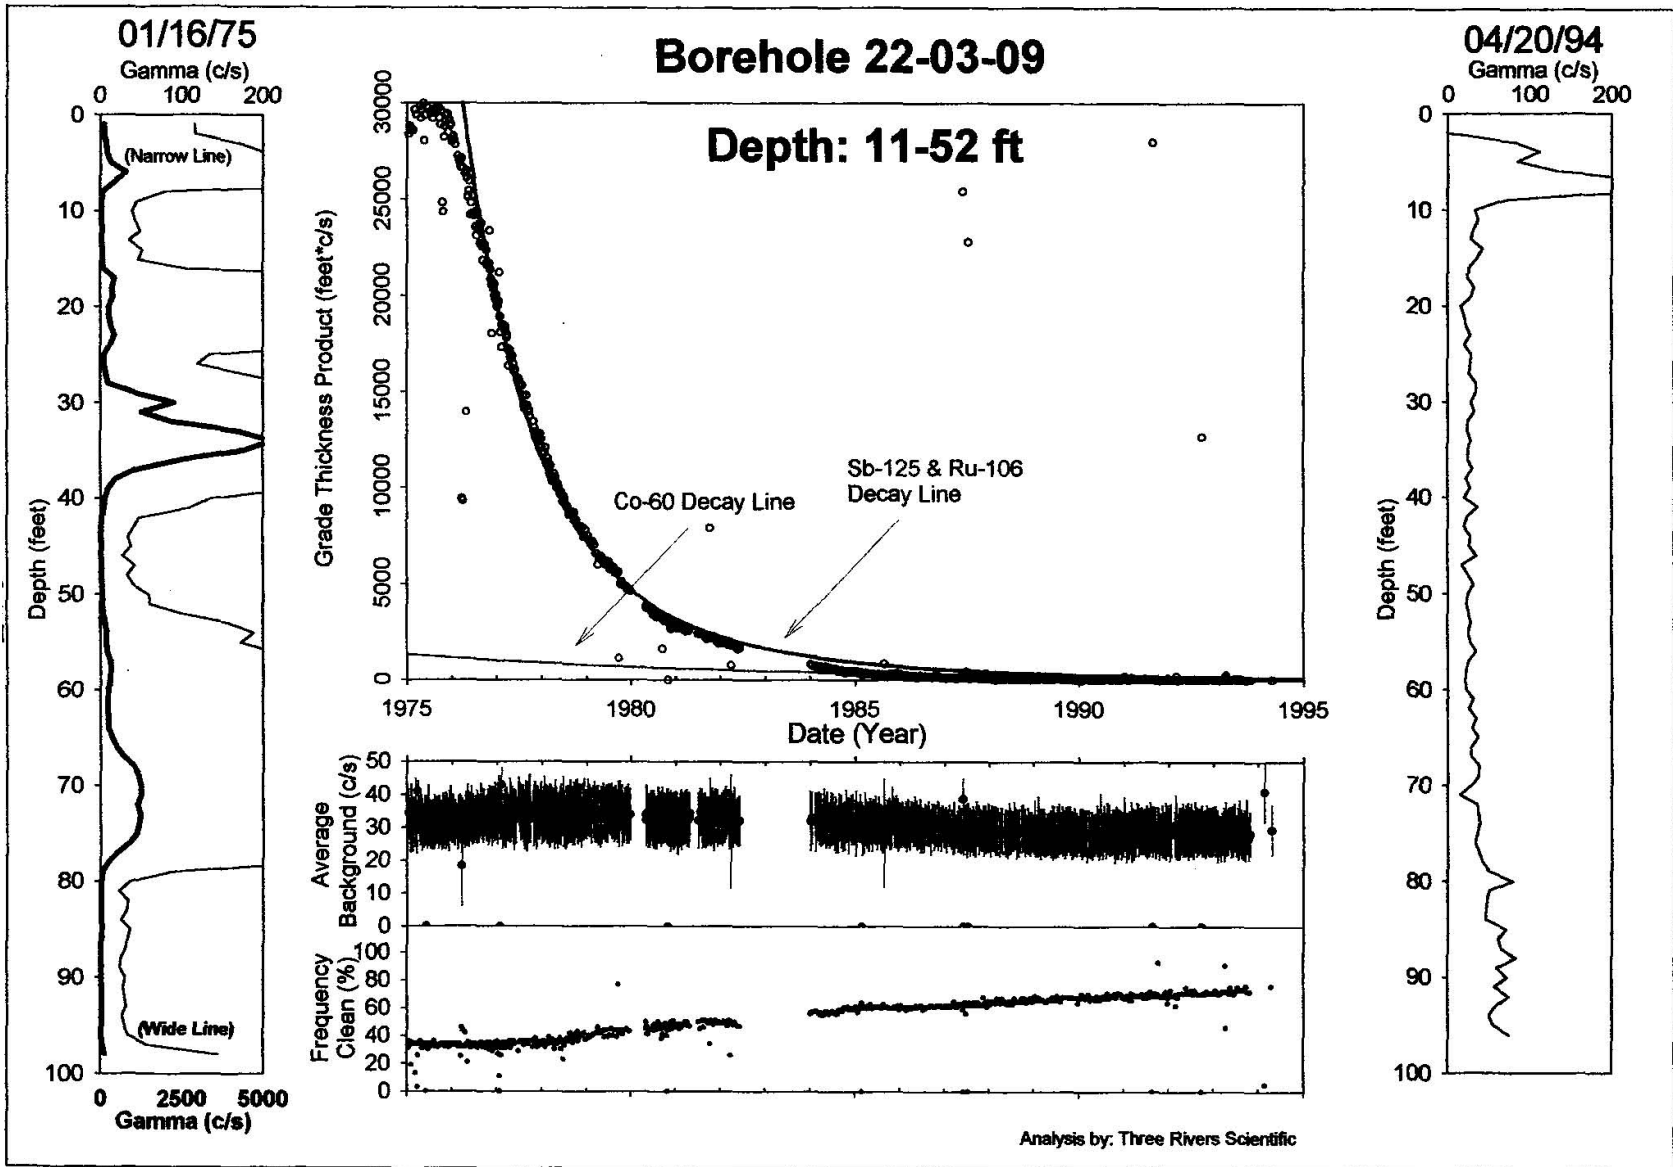
Figure B.1-7. Total Gamma Results 1975 to 1995 (sheet 1 of 6)

Drywell 22-03-06 showed a maximum of 2,300 cps from 20 to 28 ft bgs and 13,000 cps from 37 to 100 ft bgs in 1975 attributed to ^{137}Cs , ^{60}Co , ^{125}Sb and ^{106}Ru . Activity levels were stabilized and began to decrease after 1975. Drywells 22-03-04, 22-03-06, 22-03-07 and 22-03-08 all showed lower levels of activity which stabilized after 1975 following decay curves for ^{60}Co , ^{125}Sb and ^{106}Ru .

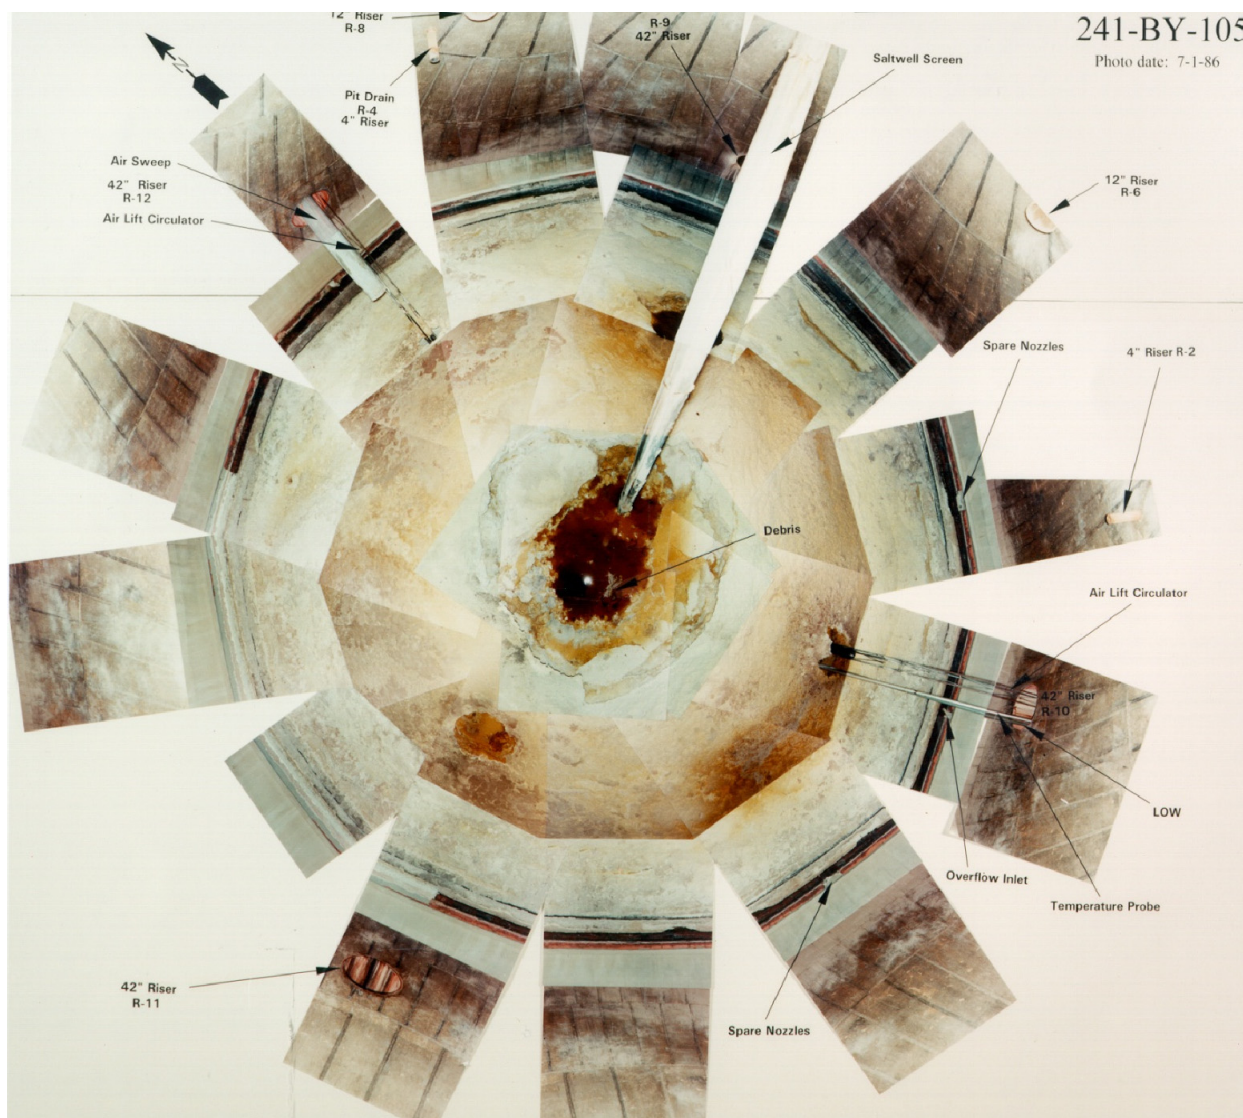
Figure B.2-4. Tank 241-BY-105 Waste Surface Photo Mosaic

The 1966 cement additions may have contributed to “erratic” surface level measurements, as well as the shelves shown in Figure B.2-6 and observed in the video taken when the tank was interim stabilized. The SACS includes the following comments regarding tank BY-105 manual tape surface level measurements:

2/29/1998 This tank had a very thin, brittle crust. The M.T. broke through the crust around January, 1994 and began reading the true liquid level. A barometric pres. correlation done & recent drops are due to height.
