Hanford BY-Farm Leak Assessments Report

Washington River Protection Solutions LLC

January 2011

Prepared for the U.S. Department of Energy
Office of River Protection

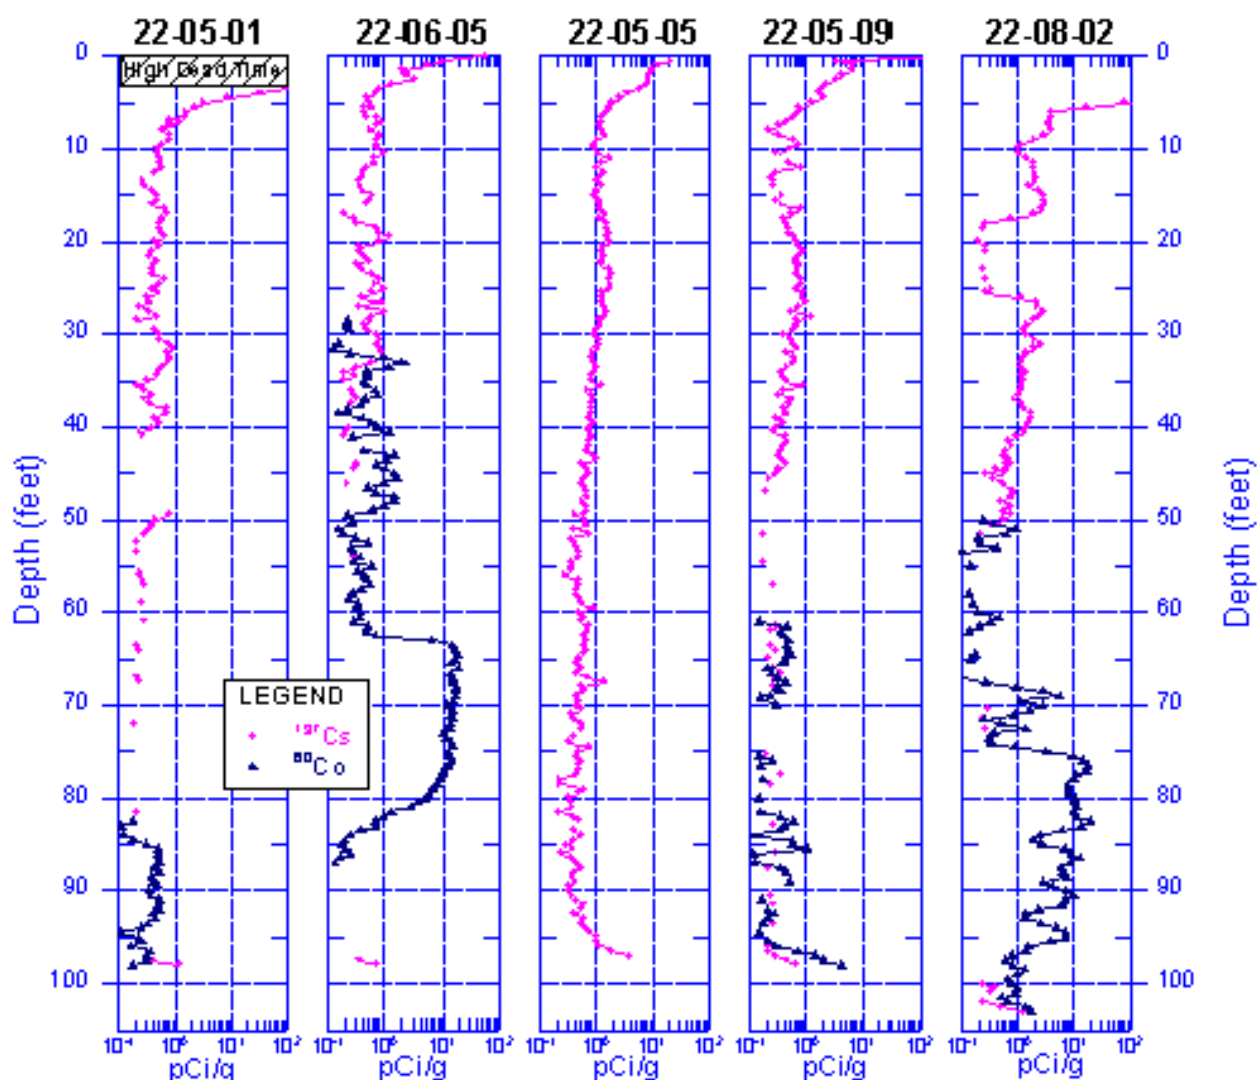
Figure B.2-7. Tank 241-BY-105 Dry Well Spectral Gamma Data Collected after 1995

B.2.2.2 Drywell Logging Data. Three drywells (22-05-01, 22-05-05 and 22-05-09) are located around tank BY-105 (see Figure 4-1 of the main text). In addition, drywells 22-06-05 and 22-08-06 are located near tank BY-105. Figure B.2-7 shows spectral gamma logging results collected after 1995 for these drywells (GJ-HAN-22, *Vadose Zone Characterization Project at the Hanford Tank Farms Tank Summary Data Report for Tank BY-105*). Figures B.2-8 and B.2-9 show total gamma results and decay curves from 1975 to 1995 (HNF-3532, *Analysis of Historical Gross Gamma Logging Data from BY Tank Farm*). It was concluded that the drywell data obtained does not indicate that tank BY-105 leaked (GJ-HAN-22).

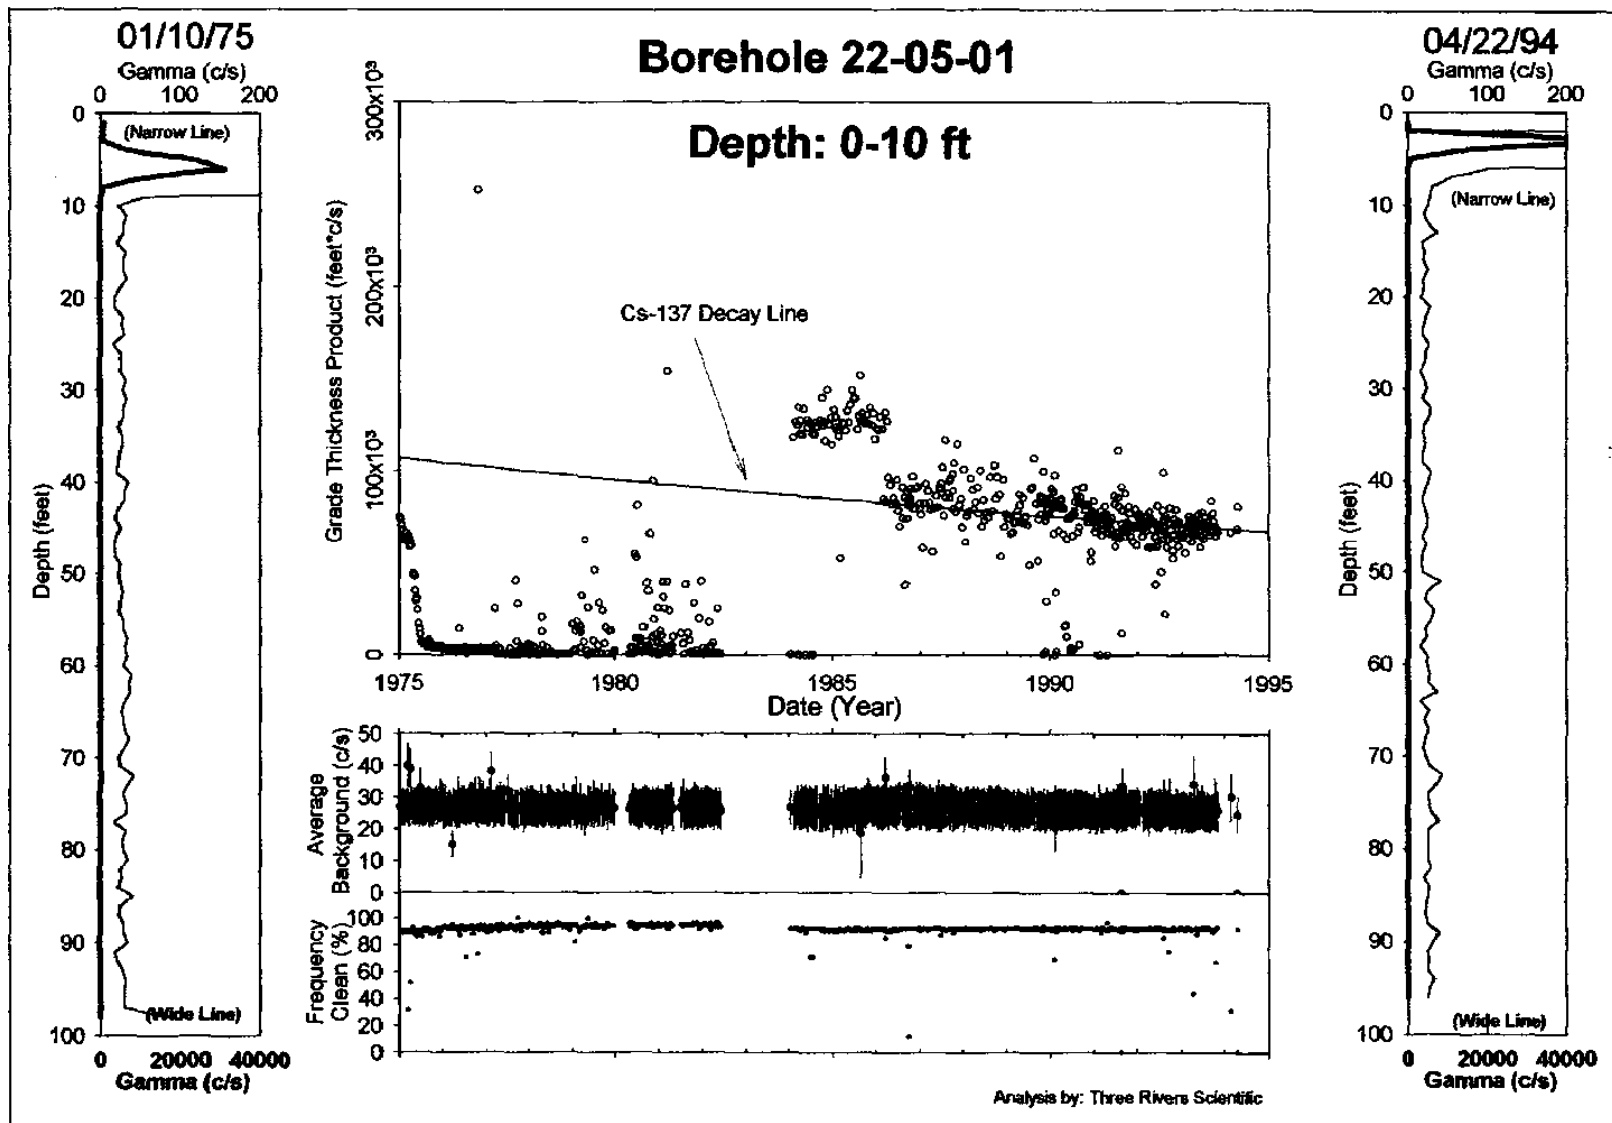
Figure B.2-8. Drywell 22-05-01 Total Gamma Results 1975 to 1995

Drywell 22-05-01 is located ~6 ft from the northeast side of tank BY-105. The TD achieved through logging operations was 98 ft. Total gamma log data collected from this drywell from 1972 to 1993 (Figure B.2-8) showed elevated gamma activity at ~200 cps between 0 and 10 ft from 1975 through 1994. Activity near the reported limit (50 cps) was also observed in 1984 at ~85 ft in depth. Between 1984 and 1987, the reported count rate remained at about the same level (50 to 55 cps). By March 1987, the count rate measured less than 50 cps and was no longer tracked (SD-WM-TI-356). Near-surface ^{137}Cs and deep ^{60}Co were identified in this drywell in spectral gamma logs collected after 1995 (Figure B.2-7). The presence of ^{137}Cs was measured almost continuously from the ground surface to ~41 ft, and intermittently below 1 pCi/g from ~49 ft to TD. The ^{137}Cs contamination measured from the surface to ~41 ft is near-surface contamination that has migrated downward. Intermittent occurrences of ^{137}Cs in the drywell below 49 ft are probably the result of contamination inside the casing or migration downward on the outside of the casing.

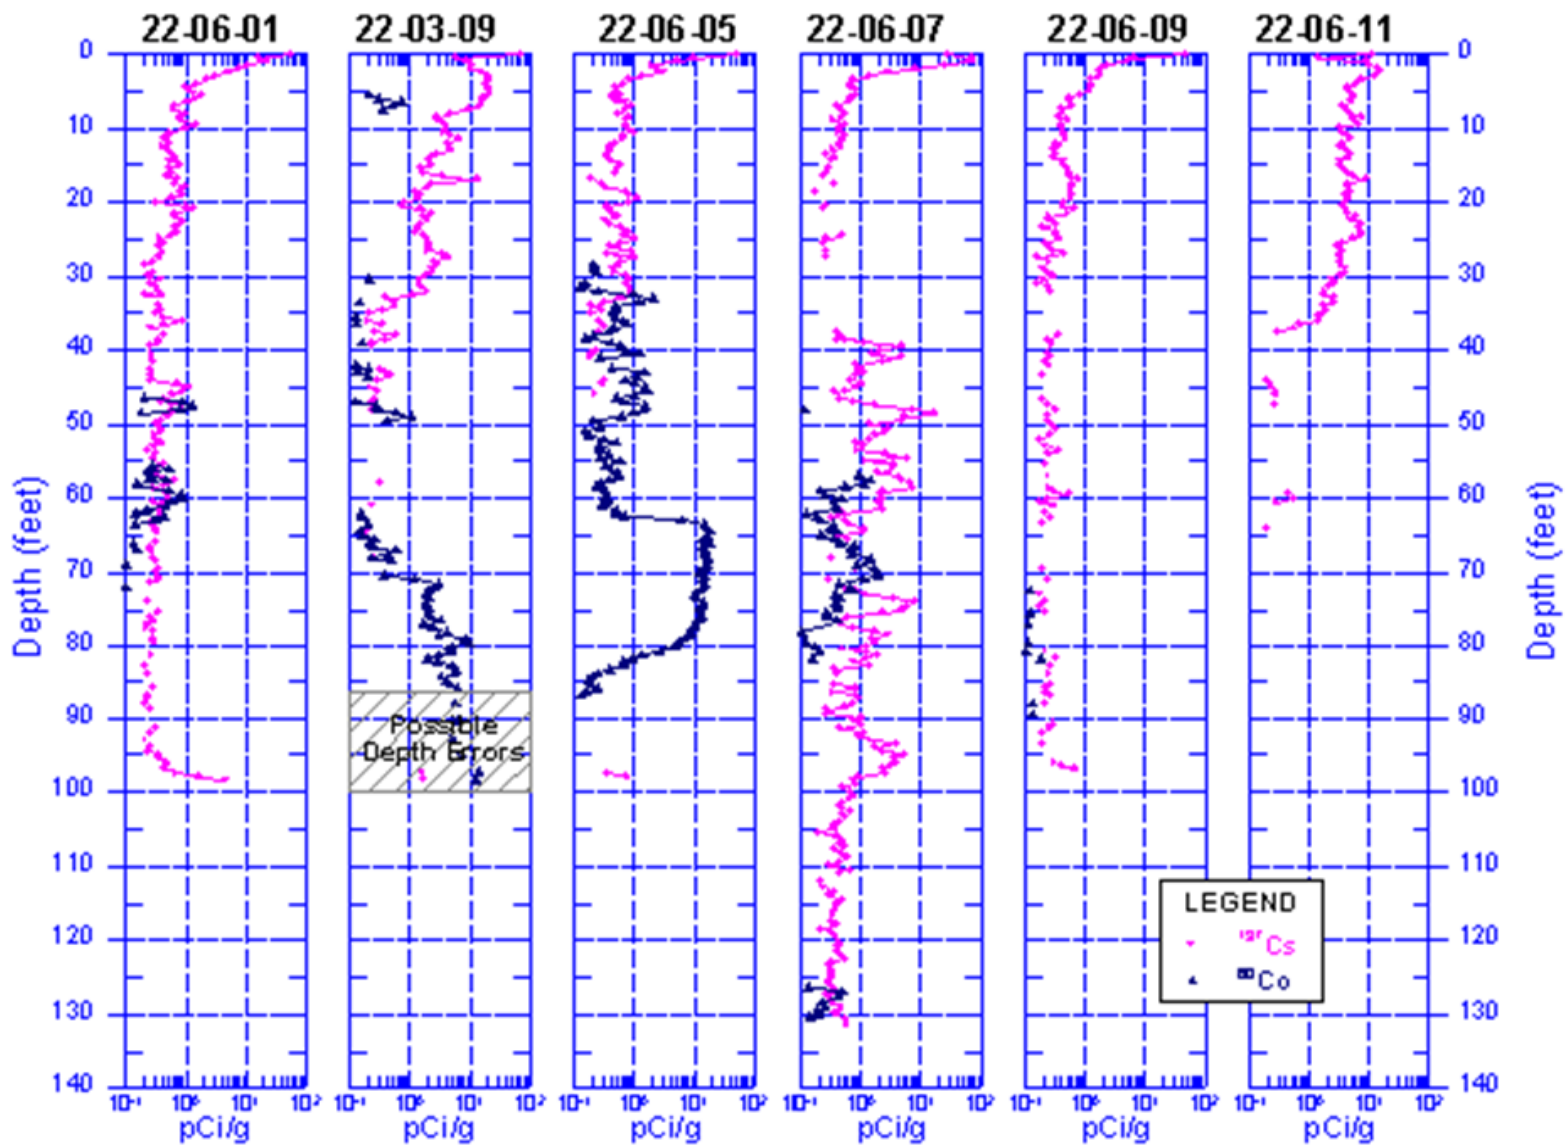
Figure B.3-6. Tank 241-BY-106 Drywell Spectral Gamma Data Collected after 1995

B.3.2.2 Drywell Logging Data. Five drywells (22-06-01, 22-06-05, 22-06-07, 22-06-09 and 22-06-11) surround tank BY-106 (see Figure 4-1 of the main text). In addition, drywell 22-03-09 is located nearby tank BY-106. Figure B.3-6 shows spectral gamma logging results collected after 1995 for these drywells (GJ-HAN-23, *Vadose Zone Characterization Project at the Hanford Tank Farms Tank Summary Data Report for Tank BY-106*).

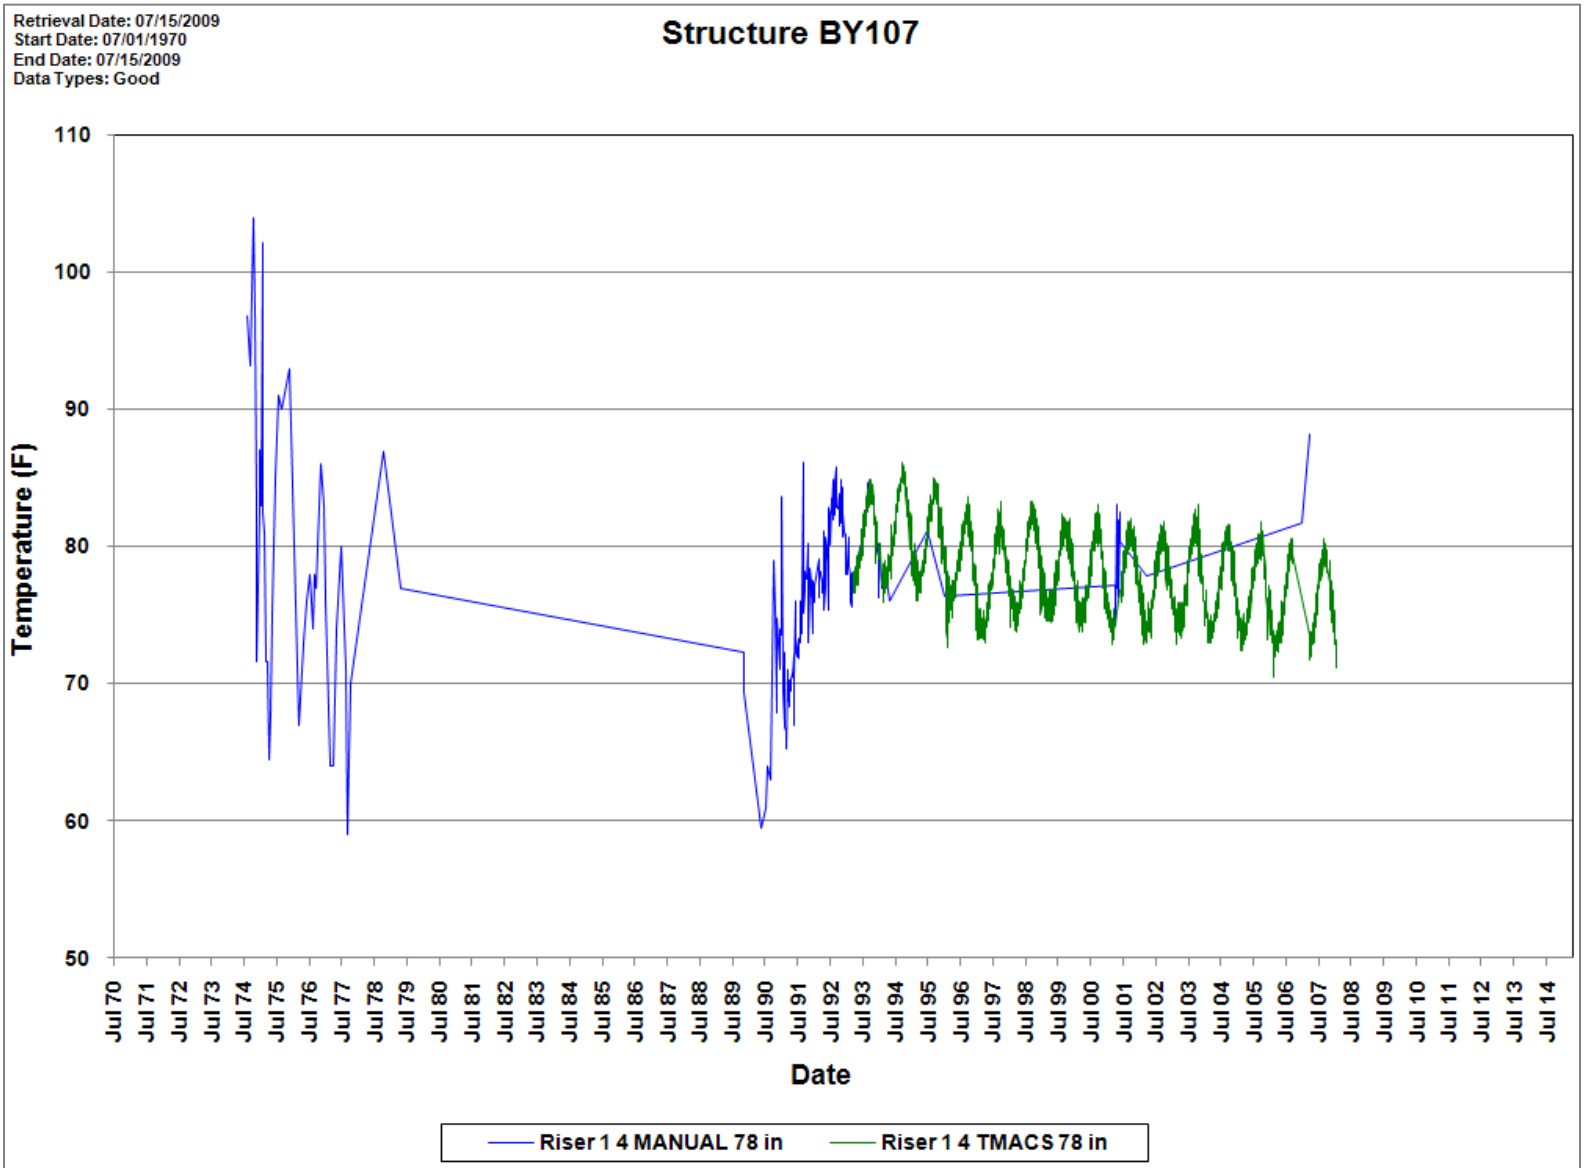
Figure B.4-5. Tank 241-BY-107 Temperature Measurements

B.4.1.3 Tank 241-BY-107 Temperature History. Figure B.4-5 shows a thermal history for thermocouple 1 in Riser 1 of tank BY-107 from July 1974 through July 2008. No temperature information was found before 1974. A maximum temperature of close to 112 °F is shown in 1974. The waste temperature gradually decreased to ~ 80 °F in 2008 due to removal of waste and decay of radionuclides. Annual waste temperature cycles shown in Figure B.4-5 are due to changing atmospheric temperatures during the year.

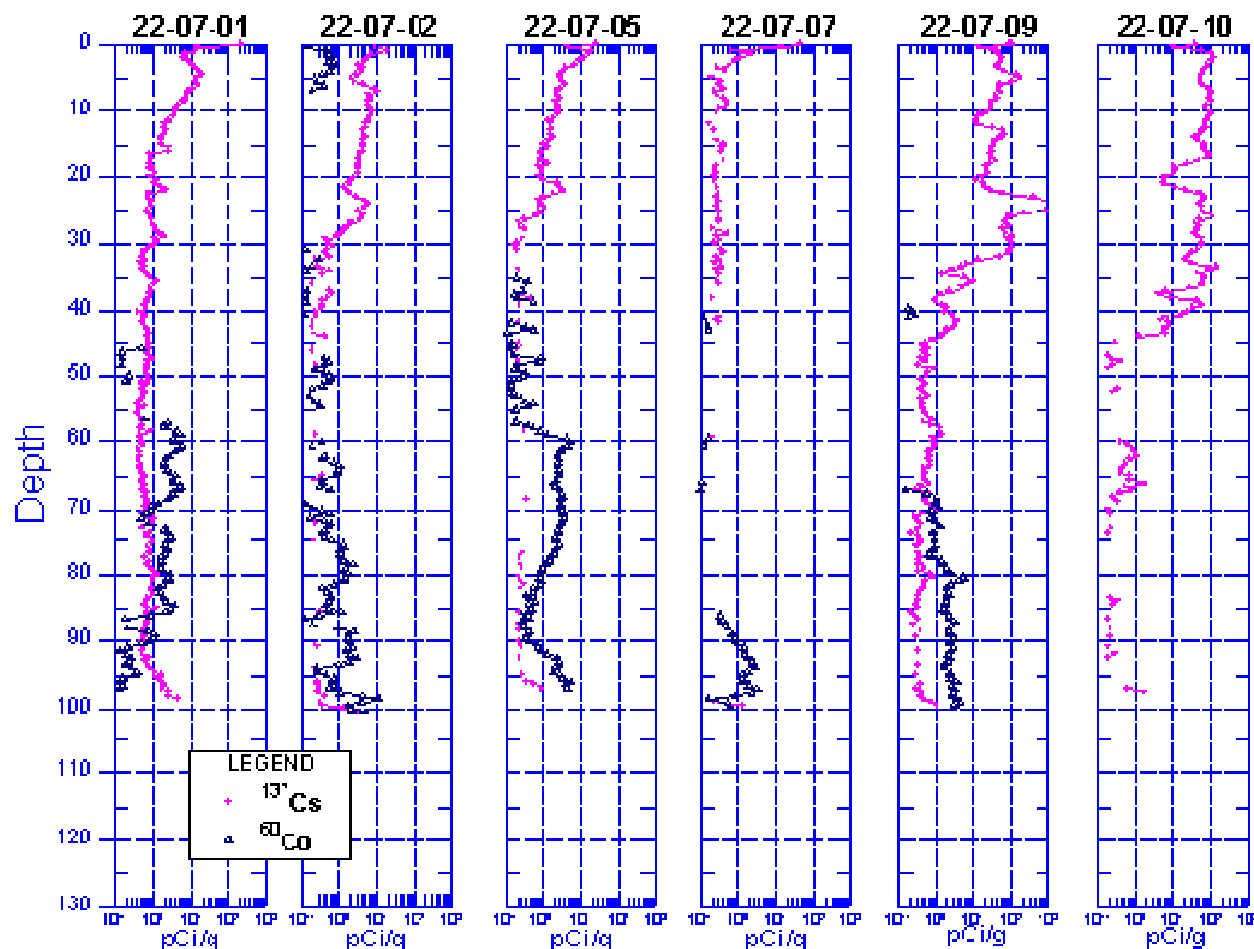
Figure B.4-6. Tank 241-BY-107 Drywell Spectral Gamma Data Collected after 1995

B.4.2.2 Drywell Logging Data. Six vadose zone monitoring drywells surround tank BY-107 (see Figure 4-1 of the main text). They were drilled in the early to mid-1970s, ~20 years after the tank went into service. The drywells are all 100 ft deep, and they are located at distances ranging from 6 to 20 ft outside the steel tank liner. Figure B.4-6 shows spectral gamma logging results collected after 1995 for these drywells (GJ-HAN-24, *Vadose Zone Characterization Project at the Hanford Tank Farms Tank Summary Data Report for Tank BY-107*). Results for 22-07-01, 22-07-02, 22-07-05 and 22-07-09 are discussed below.

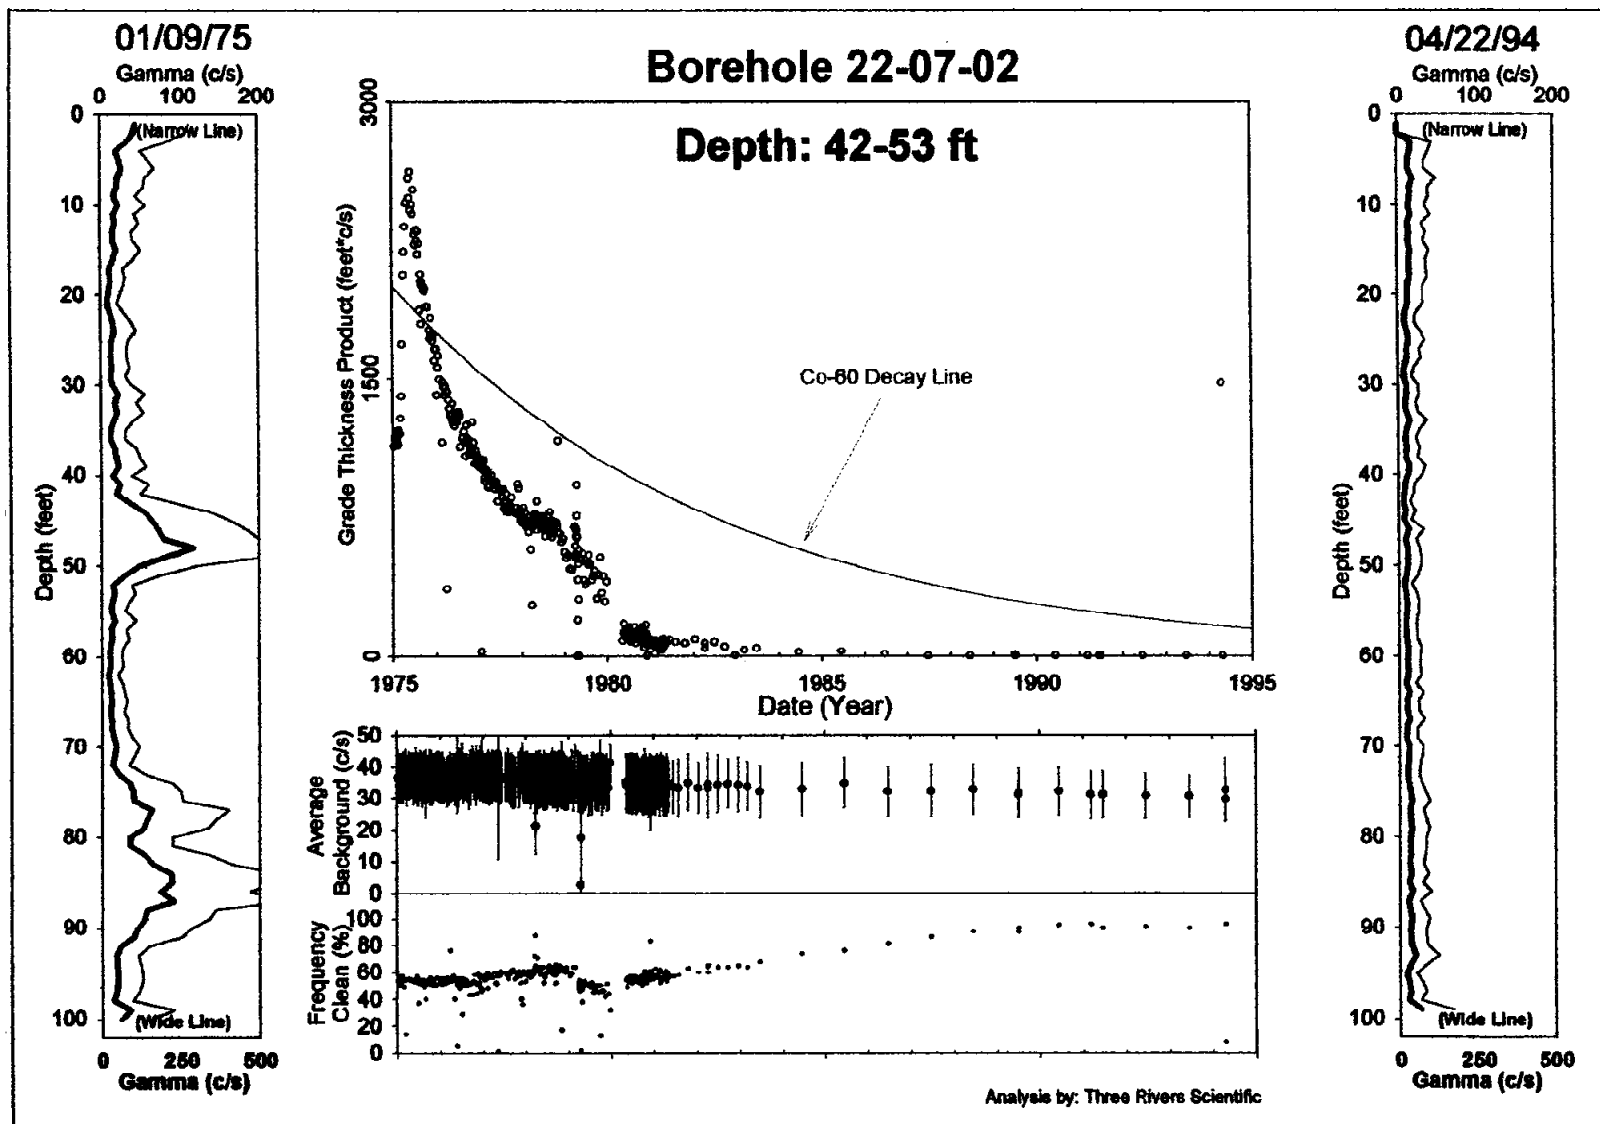
Figure B.4-8. Drywell 22-07-02 Total Gamma Results 1975 through 1995

The historical Tank Farms gross gamma-ray log data (Figure B.4-8) indicate the presence of a peak of enhanced count rate (less than 700 cps) at a depth of 83 ft in the log data acquired in 1973. In 1974 a new peak of enhanced count rate (300 cps) was detected at a depth of 48 ft. A zone of contamination was identified in 1979 that contained three peaks at depths of 48, 64, and 90 ft, respectively. The intensities of the peaks measured by the Tank Farms gross gamma-ray system ranged from 150 to 200 cps. Subsequent logging tracked a peak between 75 and 79 ft. The intensities of the gamma-ray activities appeared to diminish at a rate consistent with the half-life of ^{60}Co . Because the concentrations of the contamination detected with the SGLS are low, the most recent log data do not distinctly show any of the contamination zones.

Small drywell activity increases from <100 to 200 cps were observed in drywell 22-07-02 between January 14 and February 12, 1974 with peak reading at 29 ft below ground surface. In December 1974 OR 74-153 reported increased activity from 48 to 70 ft at 4 additional wells around the tank. OR 74-153 attributed this activity to migration of old contamination. Drywell activity observed in 1974 may also be attributed to a December 16, 1952 leak of 23,000 gal of first cycle waste from a loose flange in an overground transfer system (HW-28471, *Unconfined Underground Radioactive Waste and Contamination in the 200 Areas*, p. 5). OR 75-56 shows the location of a French drain and raw water outlet between tanks BY-107 and BY-104 believed to be the source of high moisture in the area and a contributing factor to migration of contaminants.

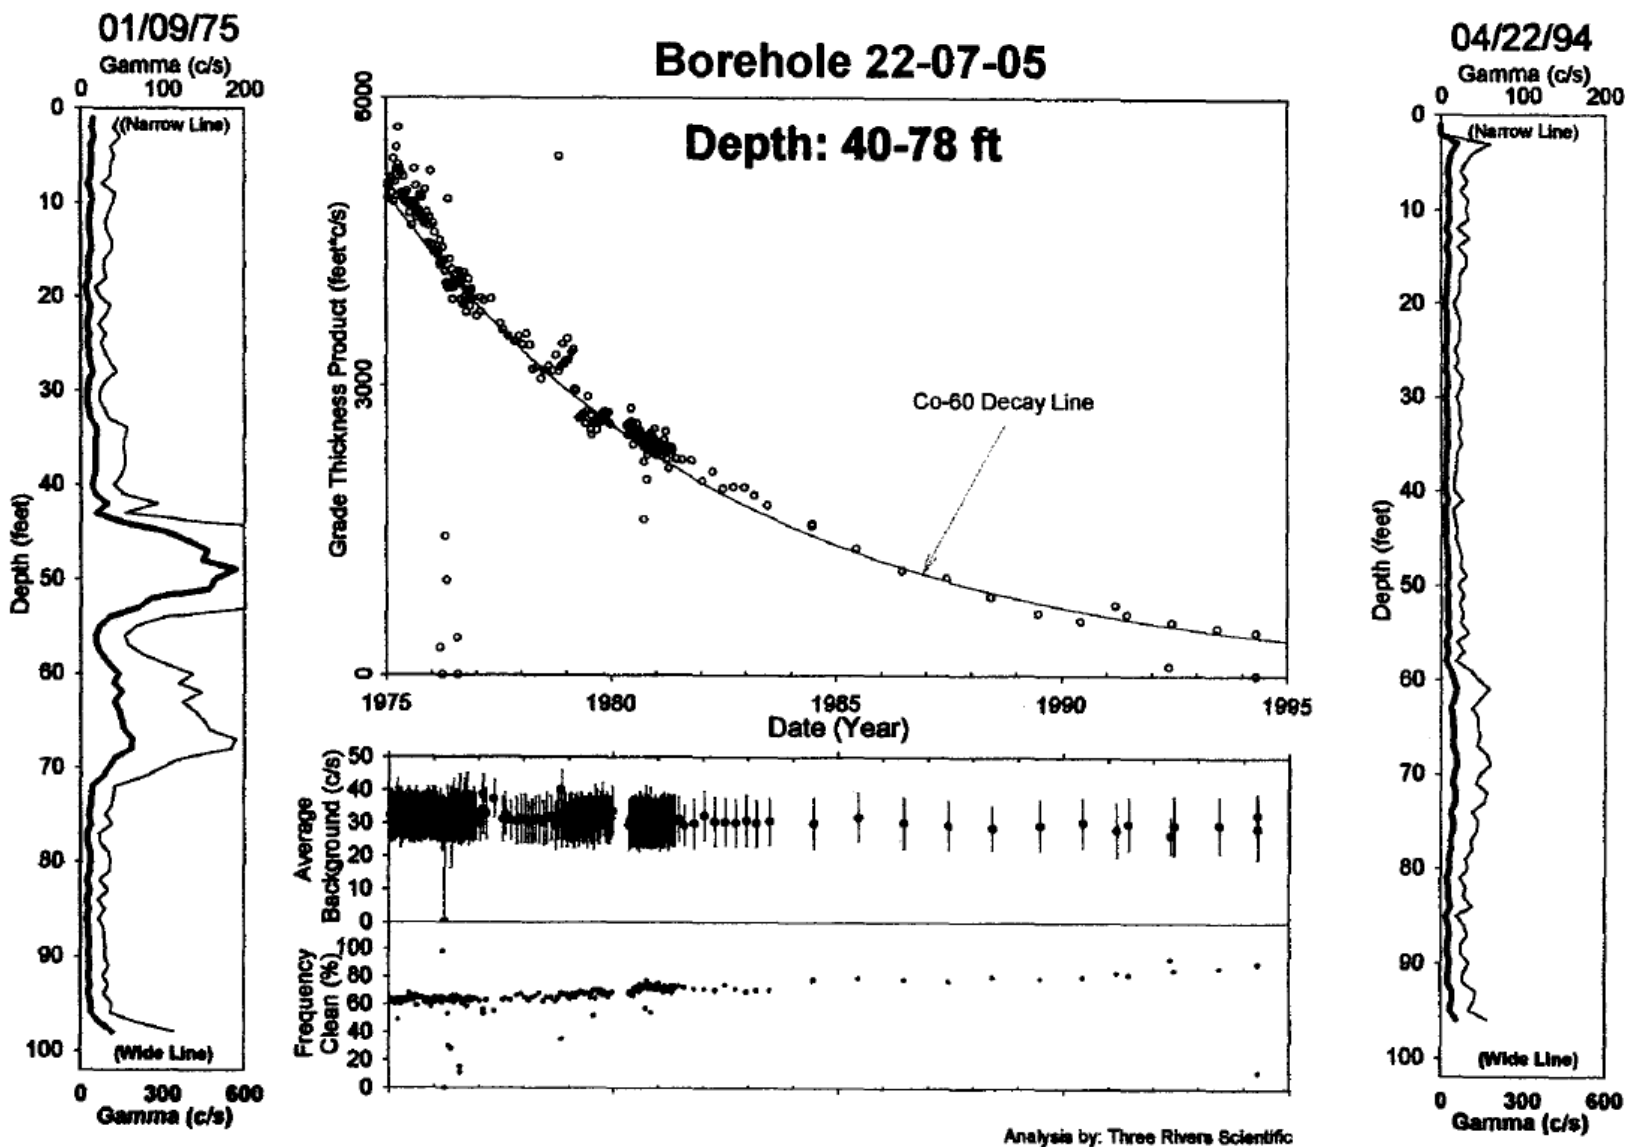
Figure B.4-9. Drywell 22-07-05 Total Gamma Results 1975 through 1994

Historical Tank Farms gross gamma-ray logging data identified two peaks of enhanced count rate: one at a depth of 25 ft and one from 68 to 70 ft. The intensity of the peak at 25 ft between 1974 and 1975 was from 22,000 to 31,000 cps. The intensity of this peak decayed gradually through 1994 following a ^{137}Cs decay curve. The peak observed at a depth of 68 to 70 ft increased in intensity from 50 cps in 1974 to 300 cps in 1975, then migrated to a depth of about 80 ft and decayed to near background levels by 1994.

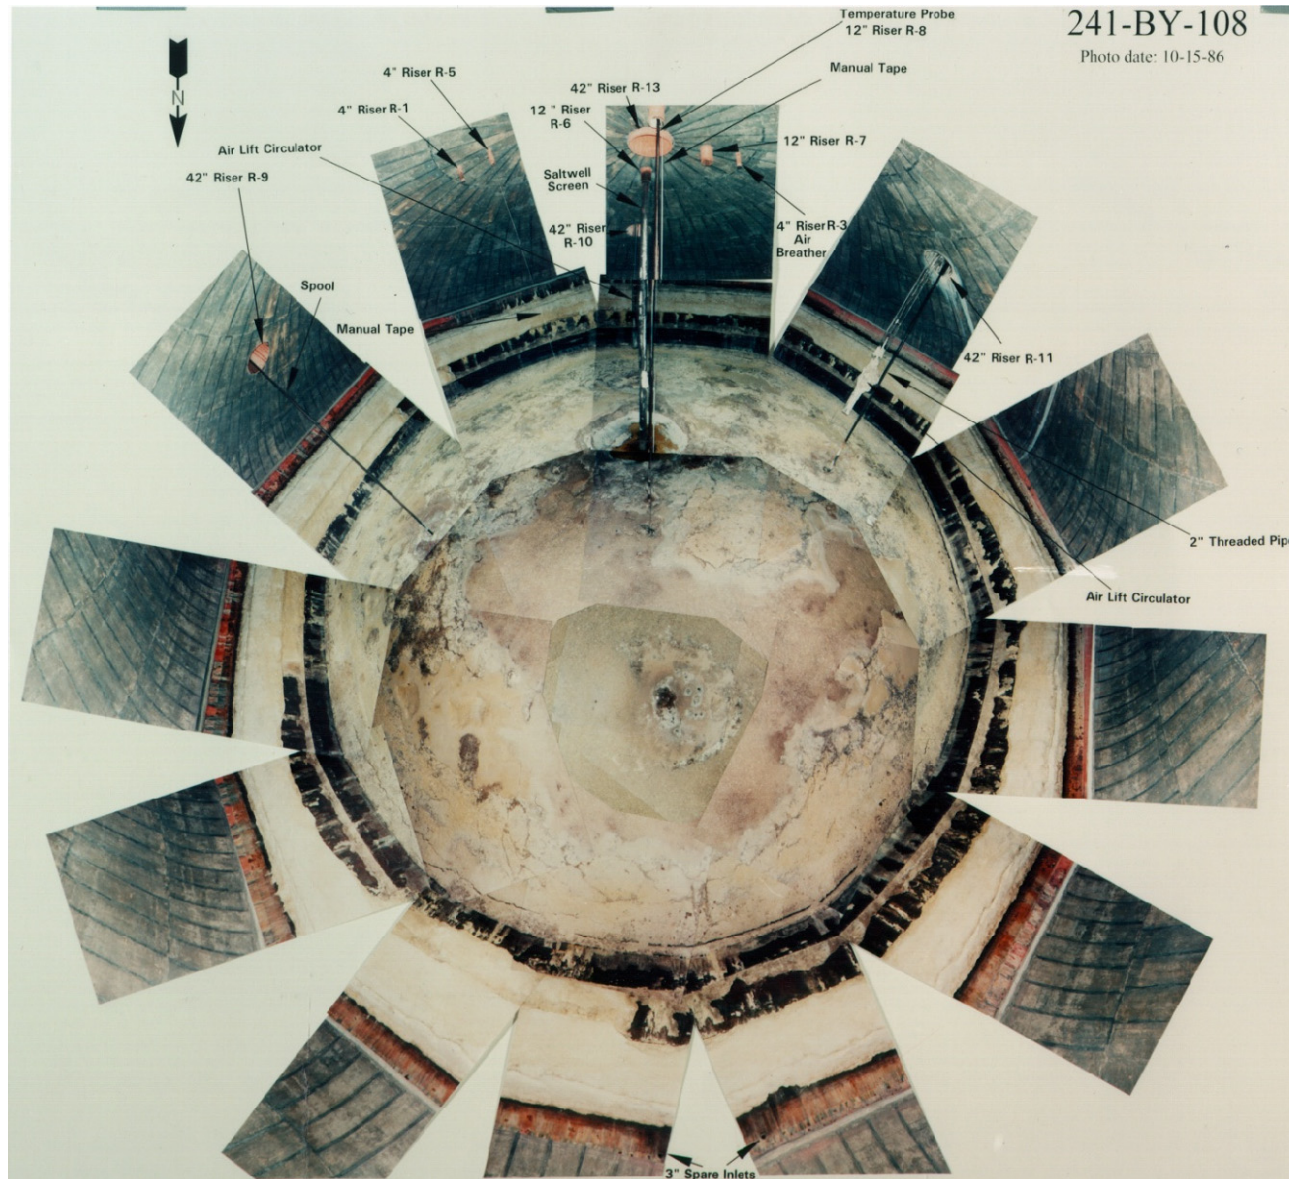
Figure B.5-4. Tank 241-BY-108 Waste Surface Photo Mosaic

B.5.1.2 Interim Stabilization. Tank BY-108 supernatant P-10 pumping was completed May 1972 (SD-WM-TI-356). Jet pumping to interim stabilize the tank began on January 9, 1984 and was halted December 9, 1984 due to failure of the jet pump (HNF-SD-RE-TI-178). 1986 photographs showed an uneven crusted surface of saltcake and a pool of liquid around the saltwell casing (Figure B.5-4).

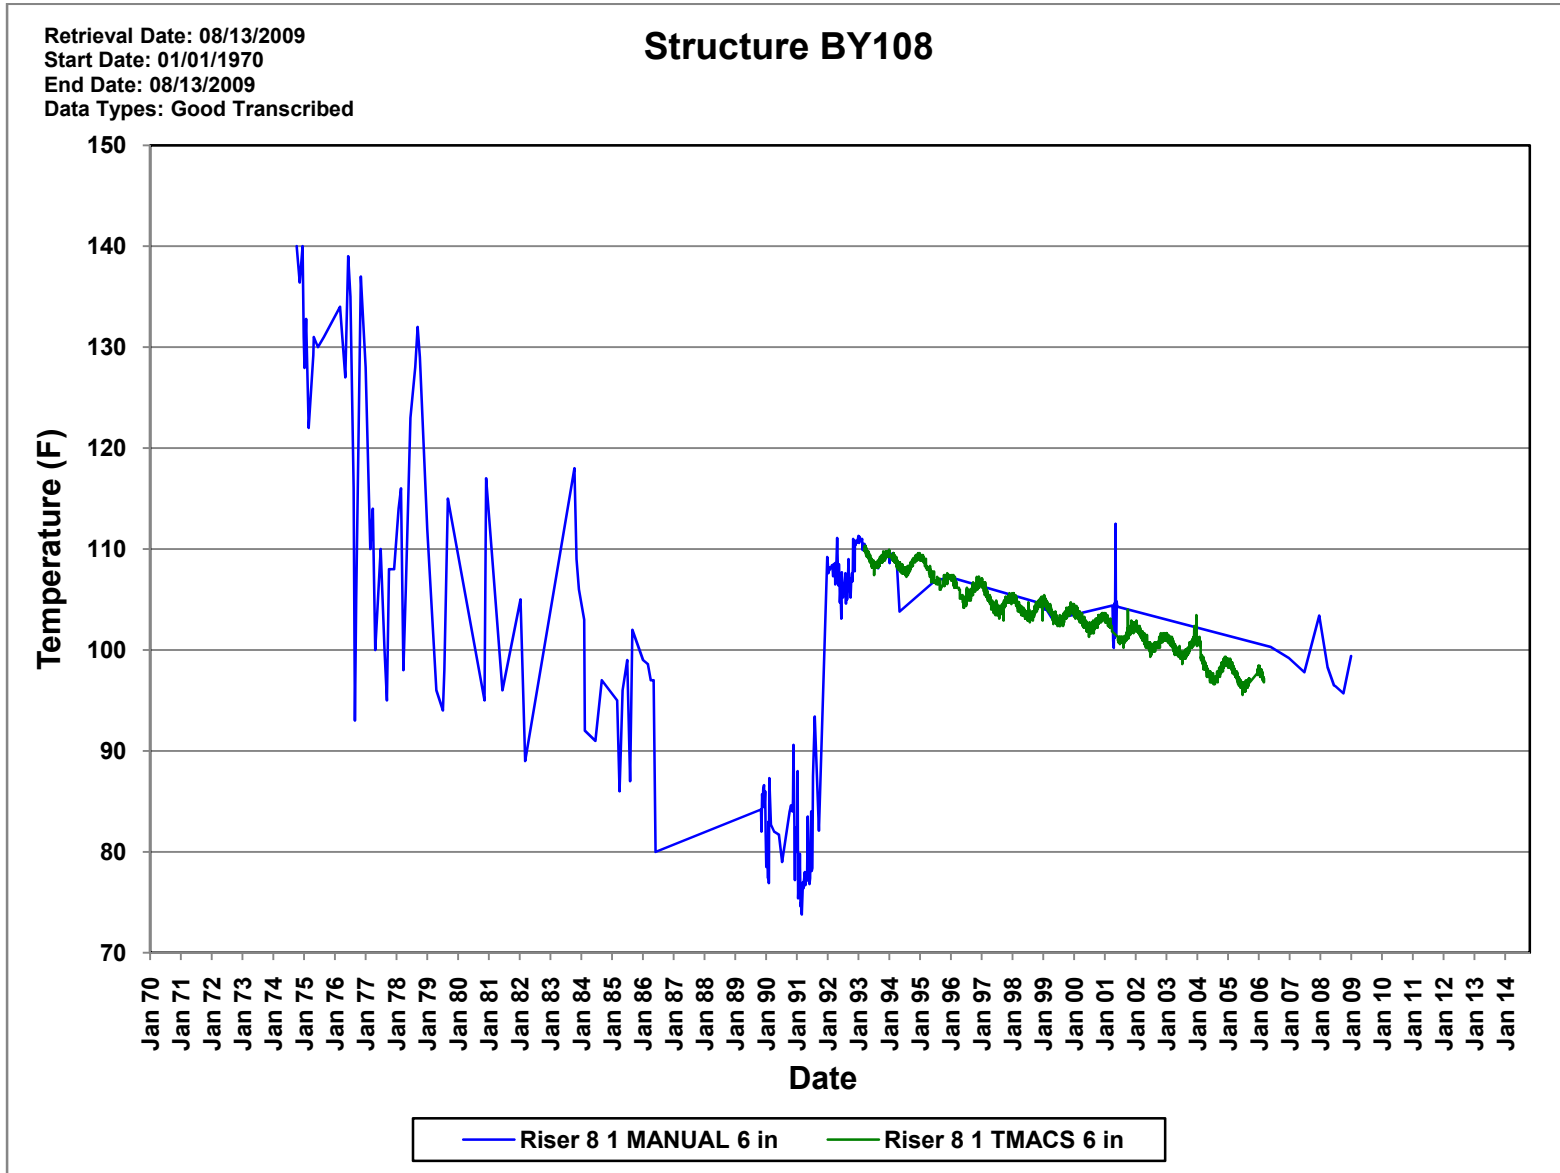
Figure B.5-5. Tank 241-BY-108 Temperature Measurements

B.5.1.3 Tank 241-BY-108 Temperature History. Figure B.5-5 shows a thermal history for thermocouple 1 in Riser 1 of tank BY-108 from 1974 through July 2008. No temperature information was found before 1974. A maximum temperature of 140 °F is shown in January 1975. The temperature decreased to ~80 °F by 1991, then increased. The temperature as of July 2009 is ~100 °F. Temperature cycling after 1993 is due to more frequent measurements and annual atmospheric temperature changes.
