Hanford BY-Farm Leak Assessments Report

Washington River Protection Solutions LLC

January 2011

Prepared for the U.S. Department of Energy
Office of River Protection

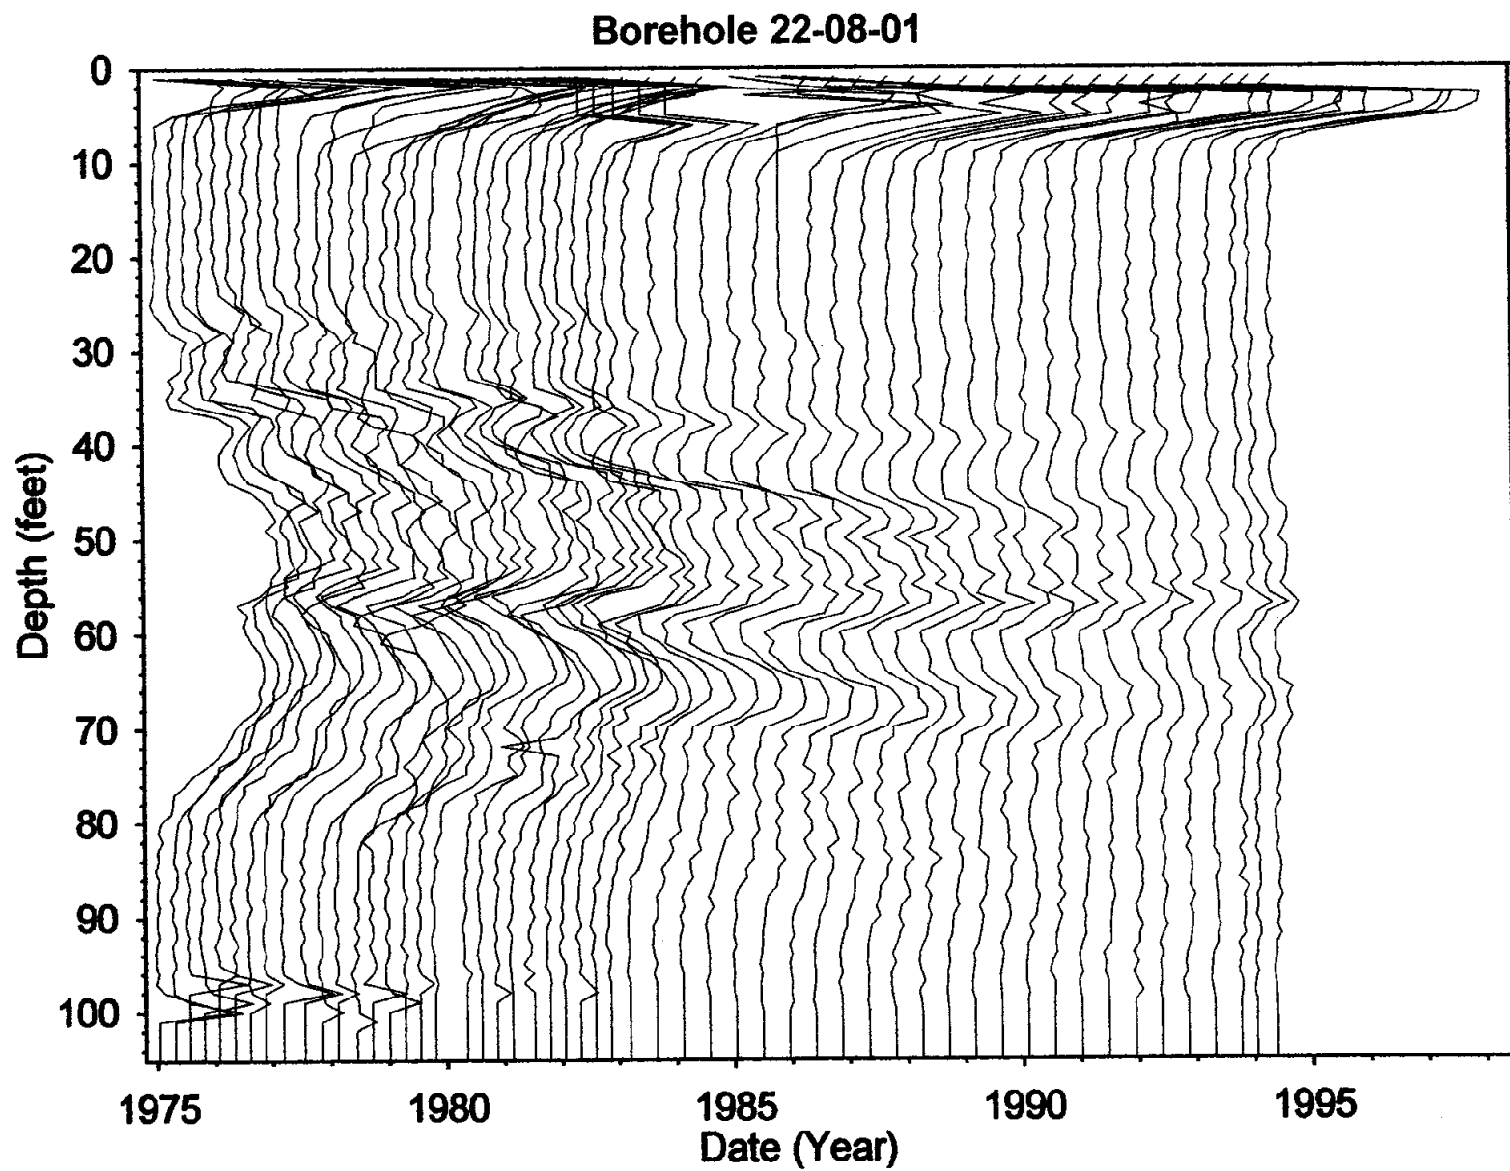
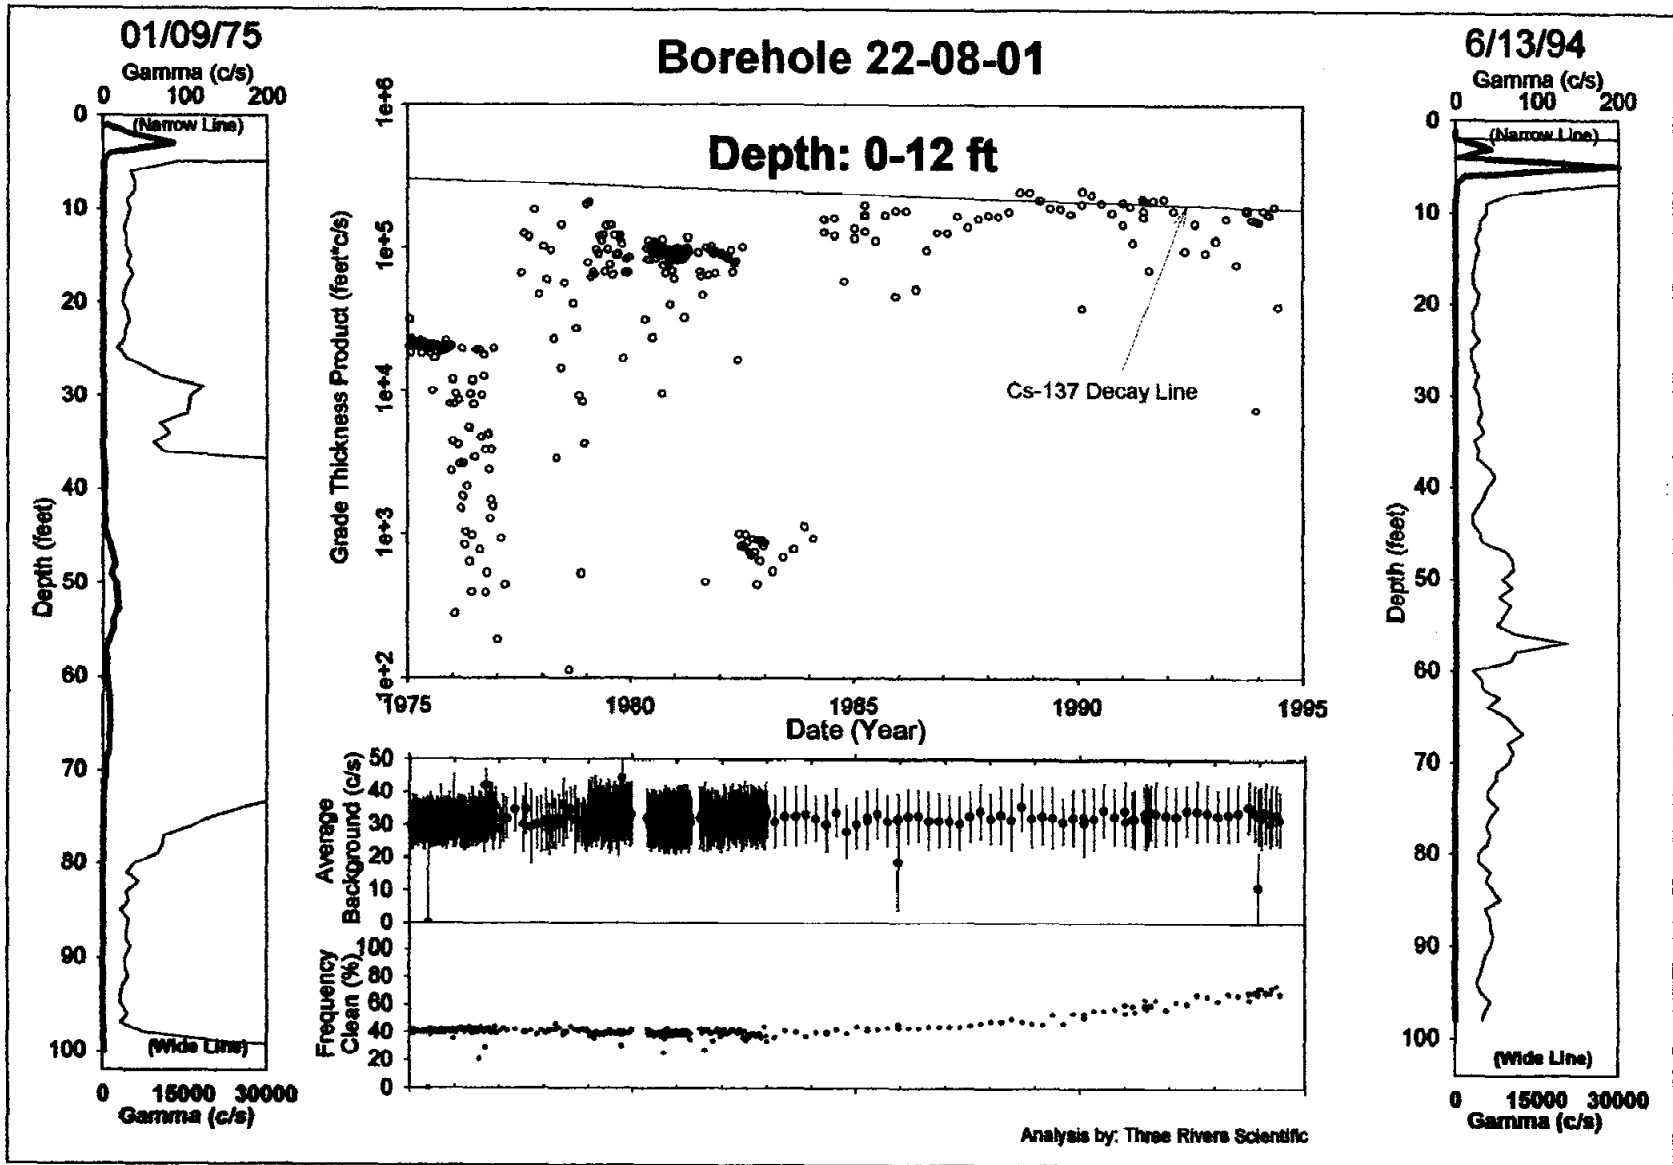
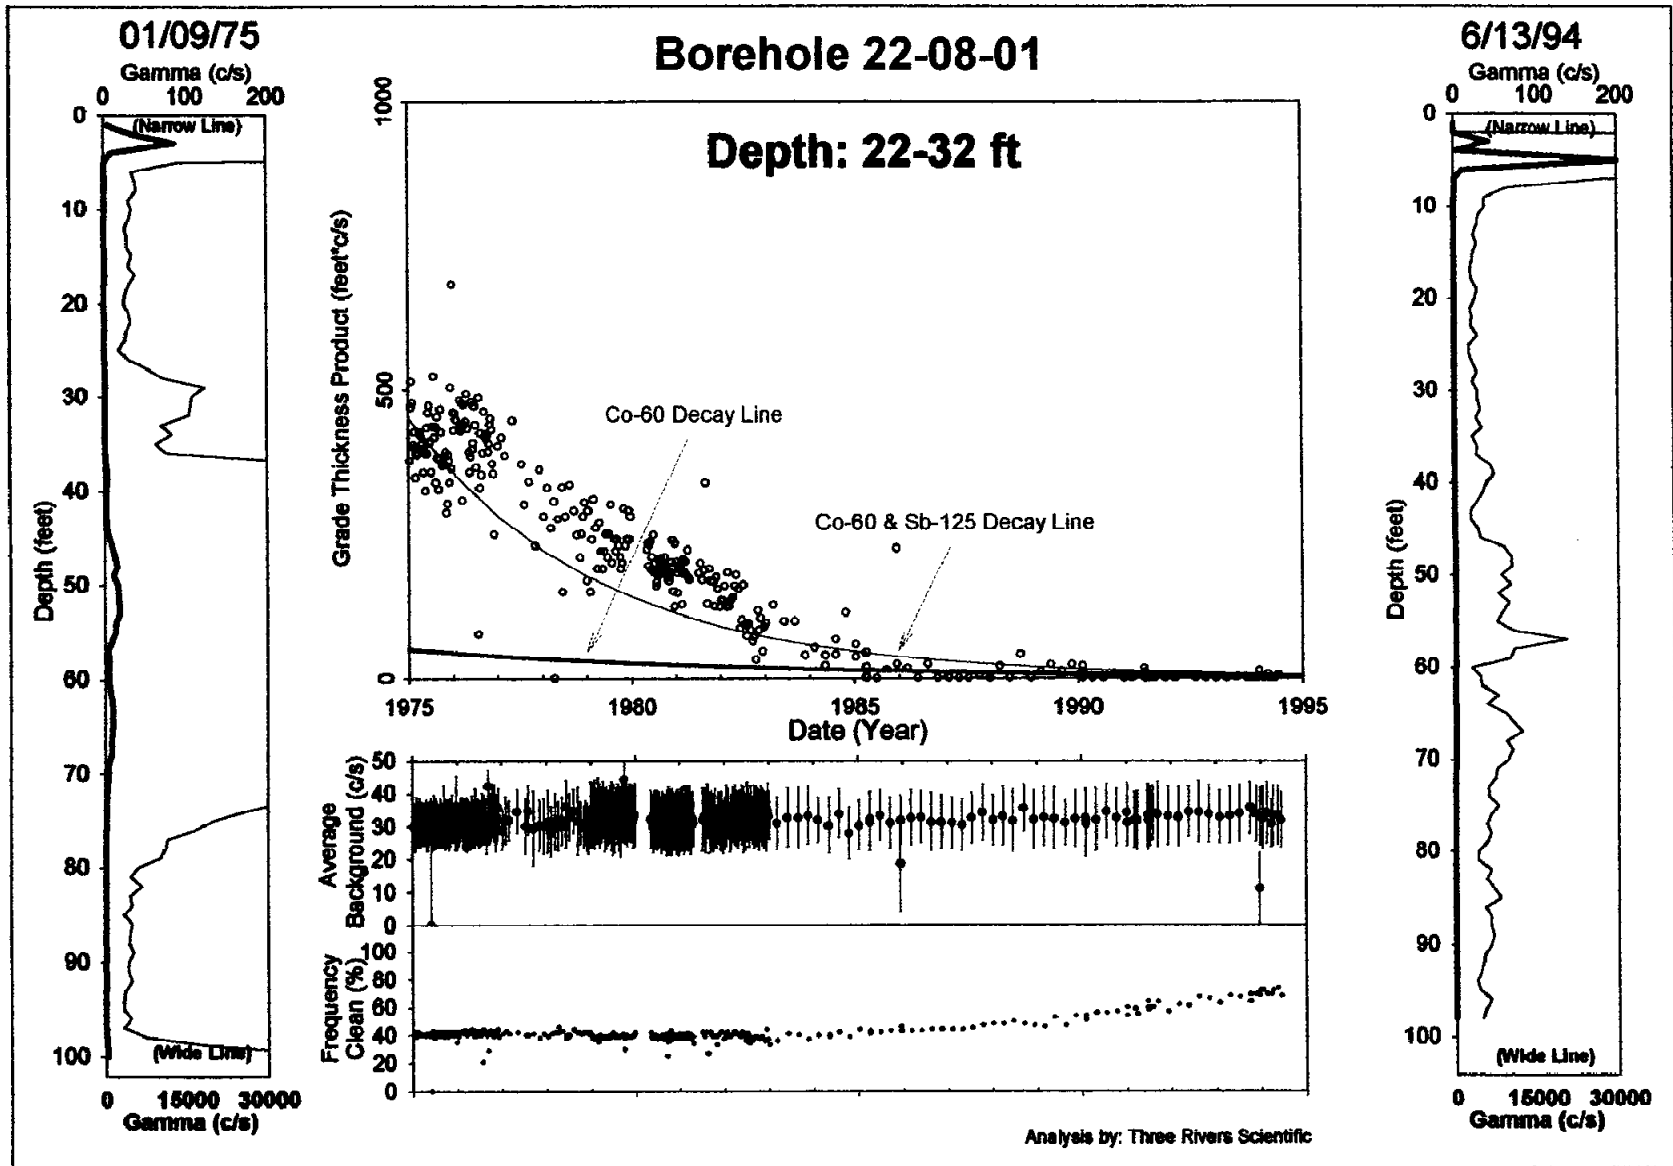
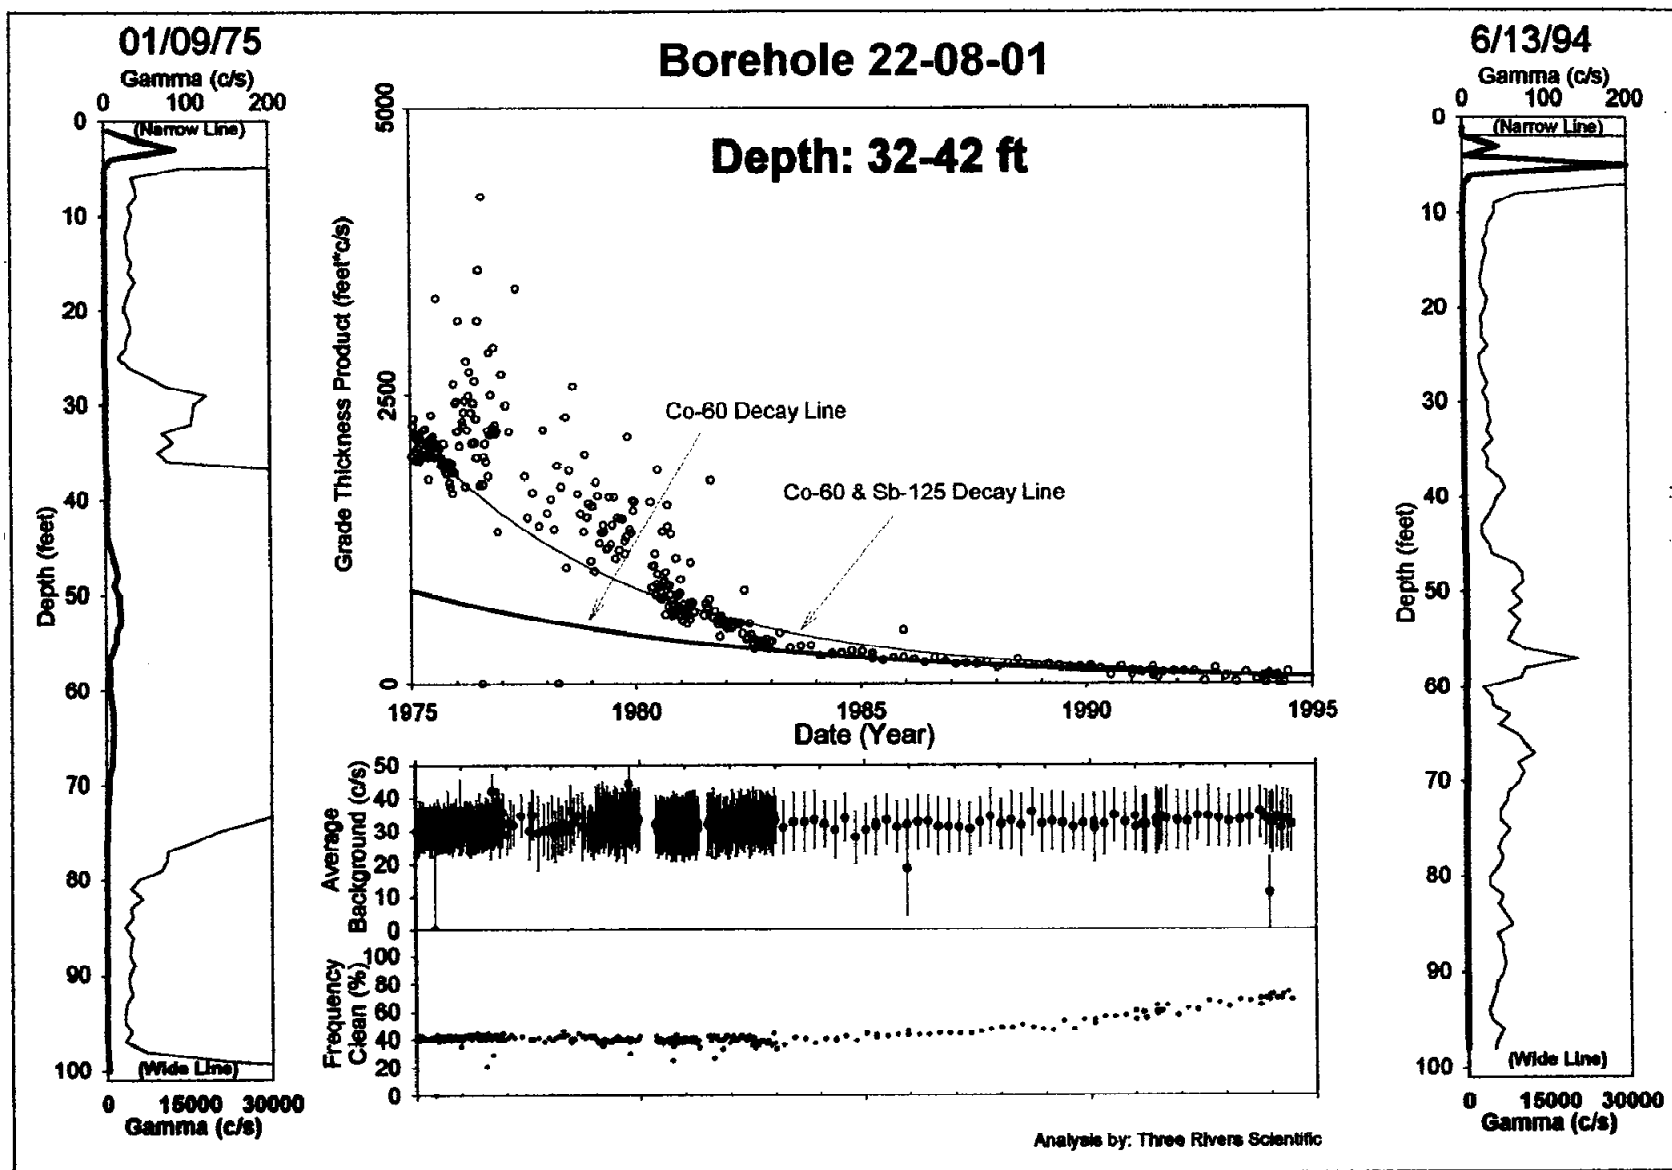
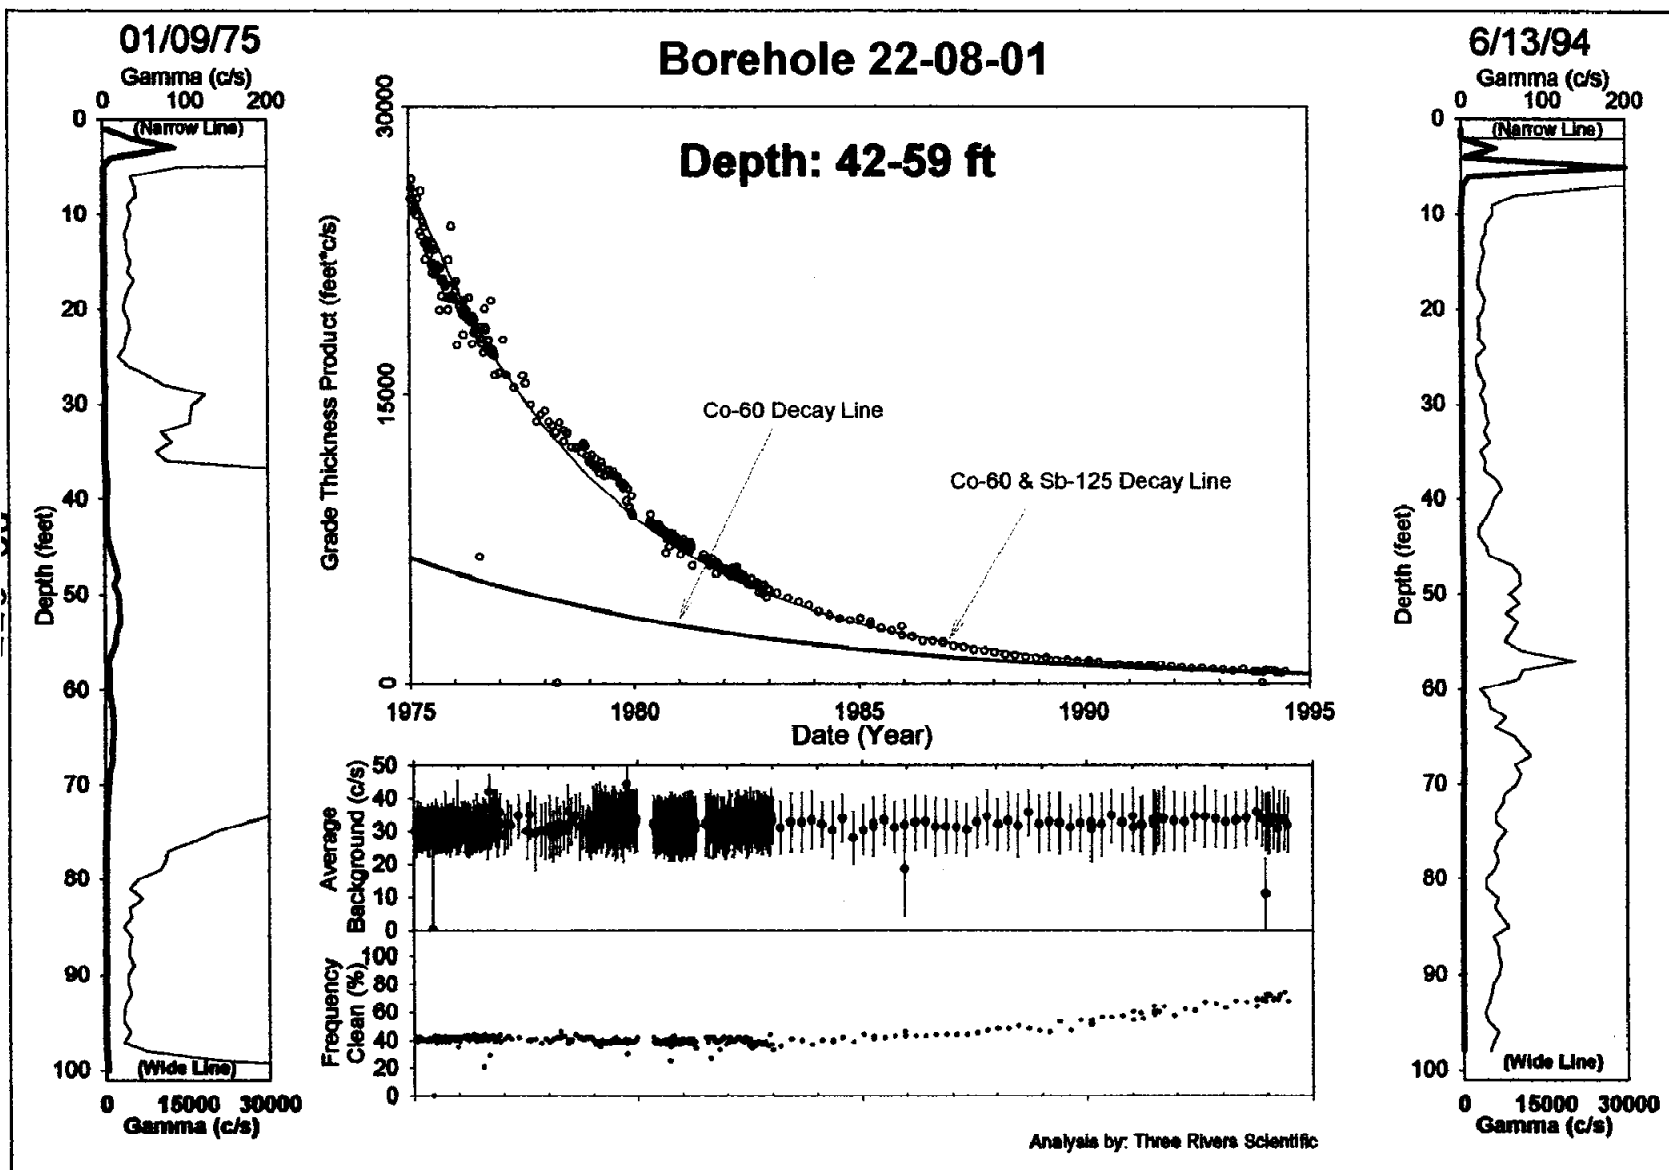
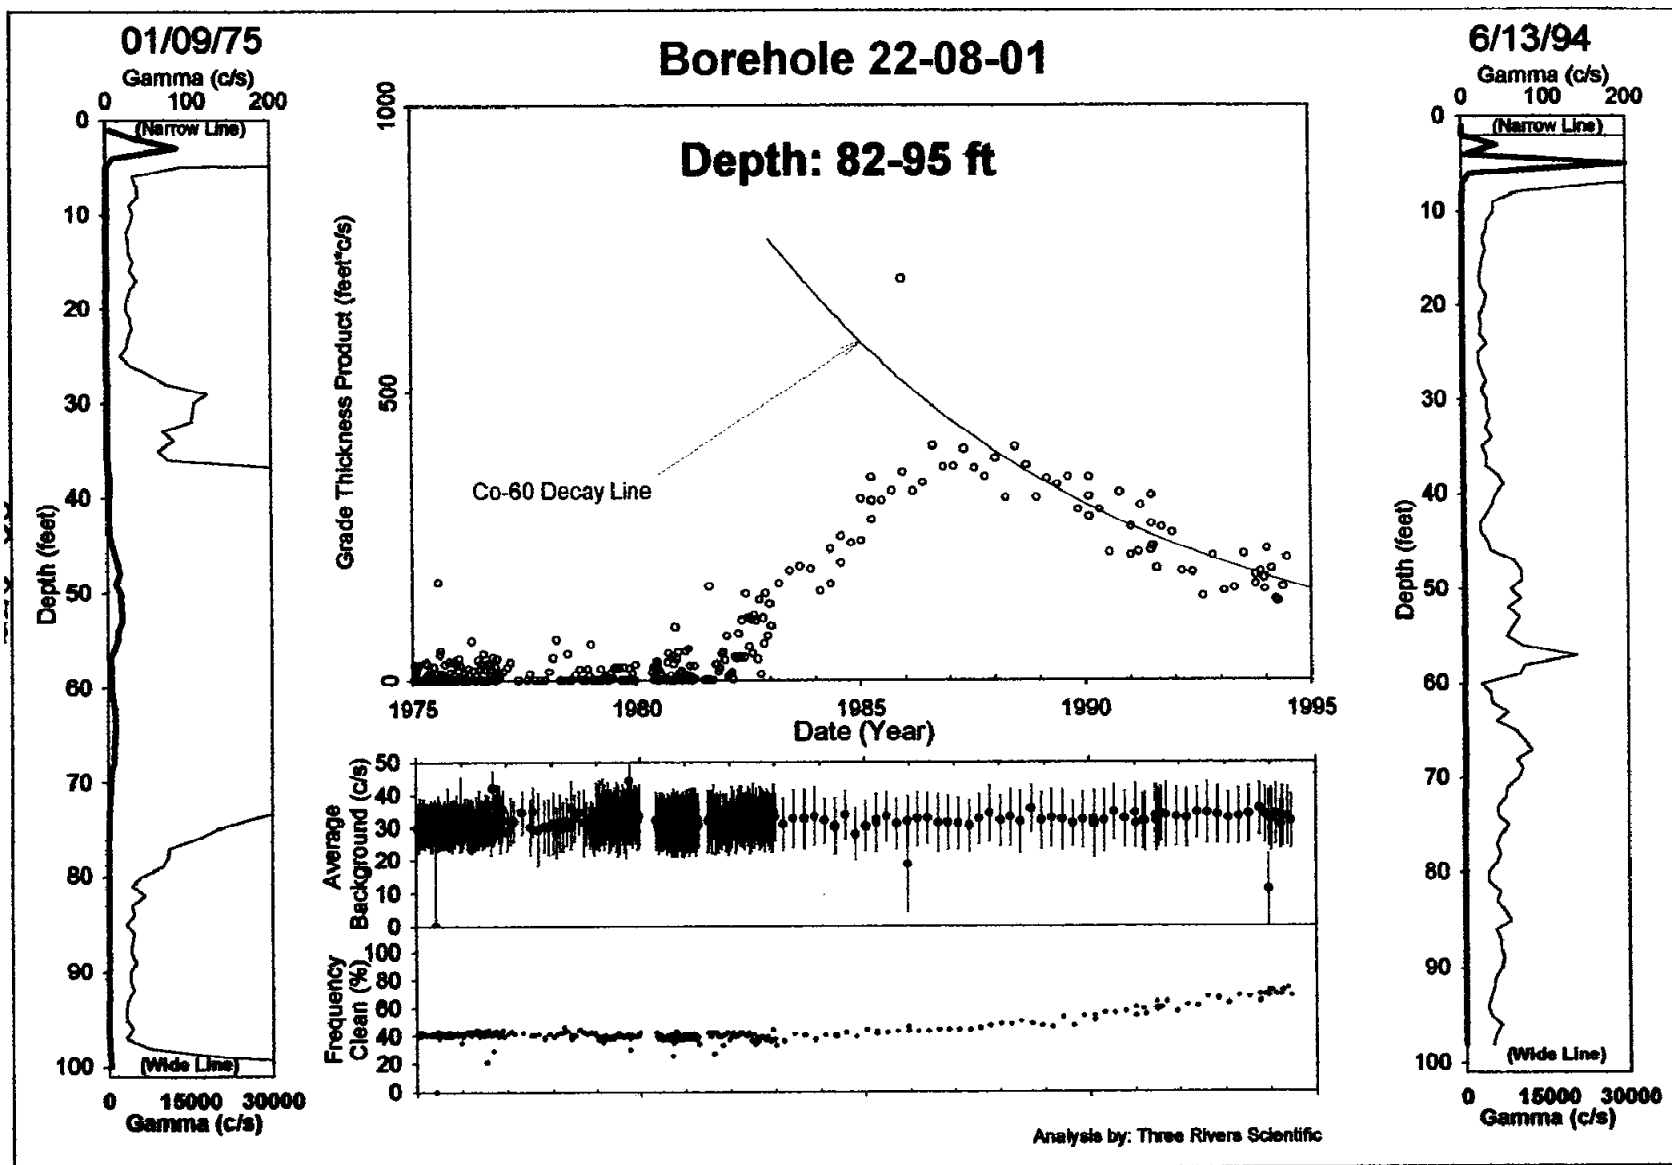
Figure B.5-7. Drywell 22-08-01 Historical Gamma Logging Plots (sheet 1 of 7)

A review of gross-gamma log data collected from this drywell from 1972 to 1994 (Figure B.5-7) shows elevated gamma activity from ~22 to 90 ft in depth. The maximum peak count rate was at 57 ft and measured 21,000 cps in 1972. The count rate steadily decreased to just more than 100 cps in 1994. The rate of decay indicates the activity is a combination of ^{60}Co and ^{125}Sb .

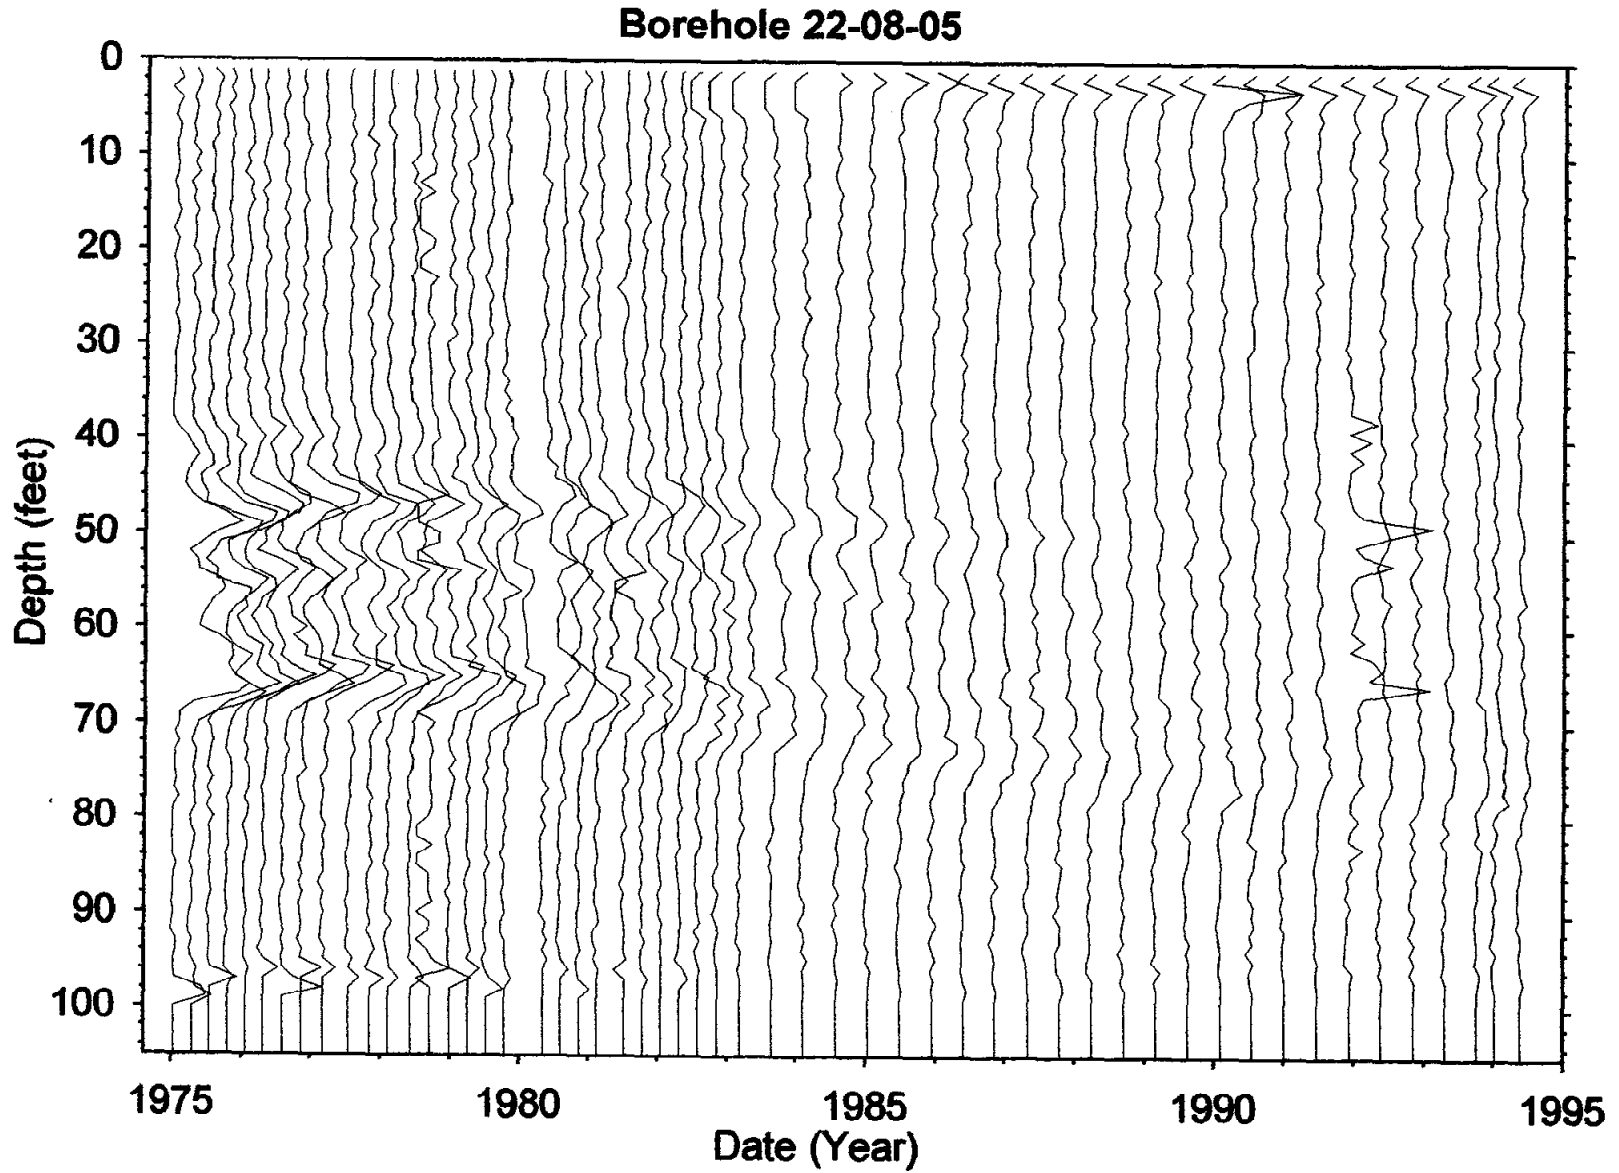
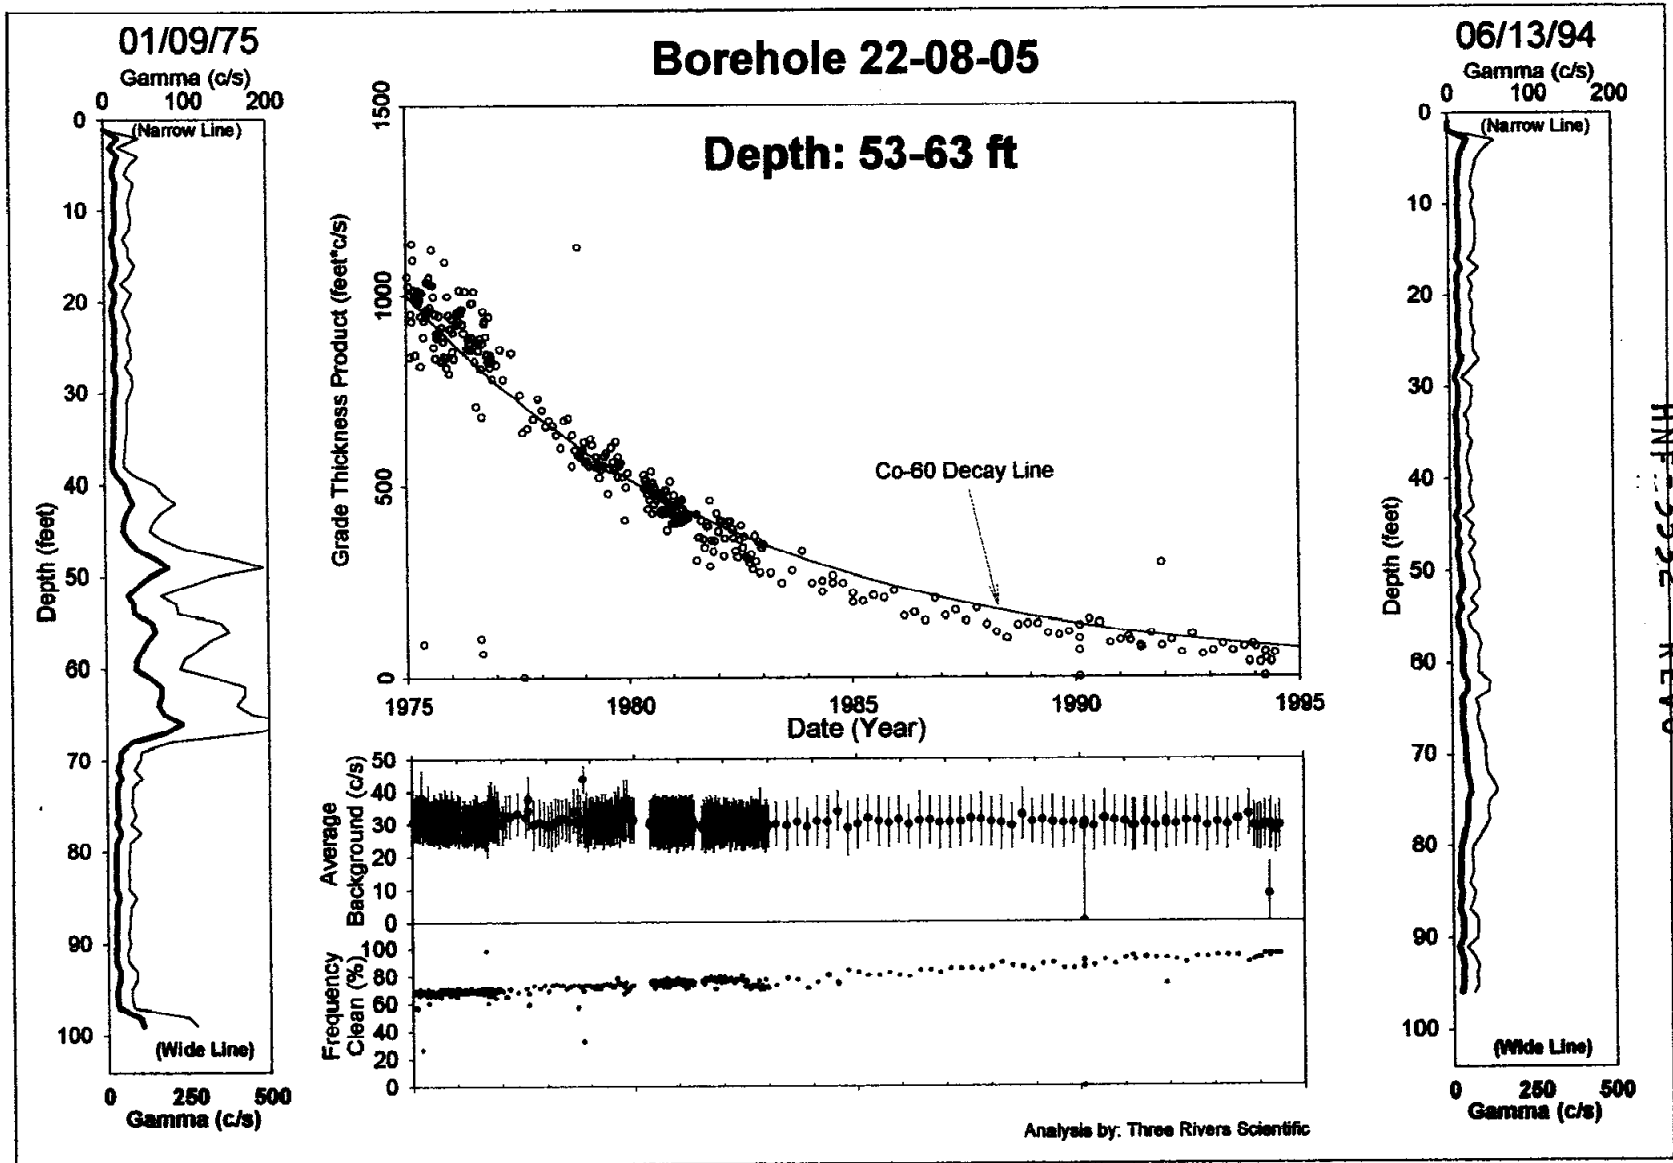
Figure B.5-9. Drywell 22-08-05 Historical Gamma Logging Plots (sheet 1 of 2)

A review of gross-gamma log data collected from this drywell from 1972 to 1994 (Figure B.5-9) shows elevated gamma activity from ~42 to 66 ft in 1972, with a count-rate peak at 50 ft. The maximum count-rate decreased and was at lower depths in successive years. This fits a ^{60}Co decay line.

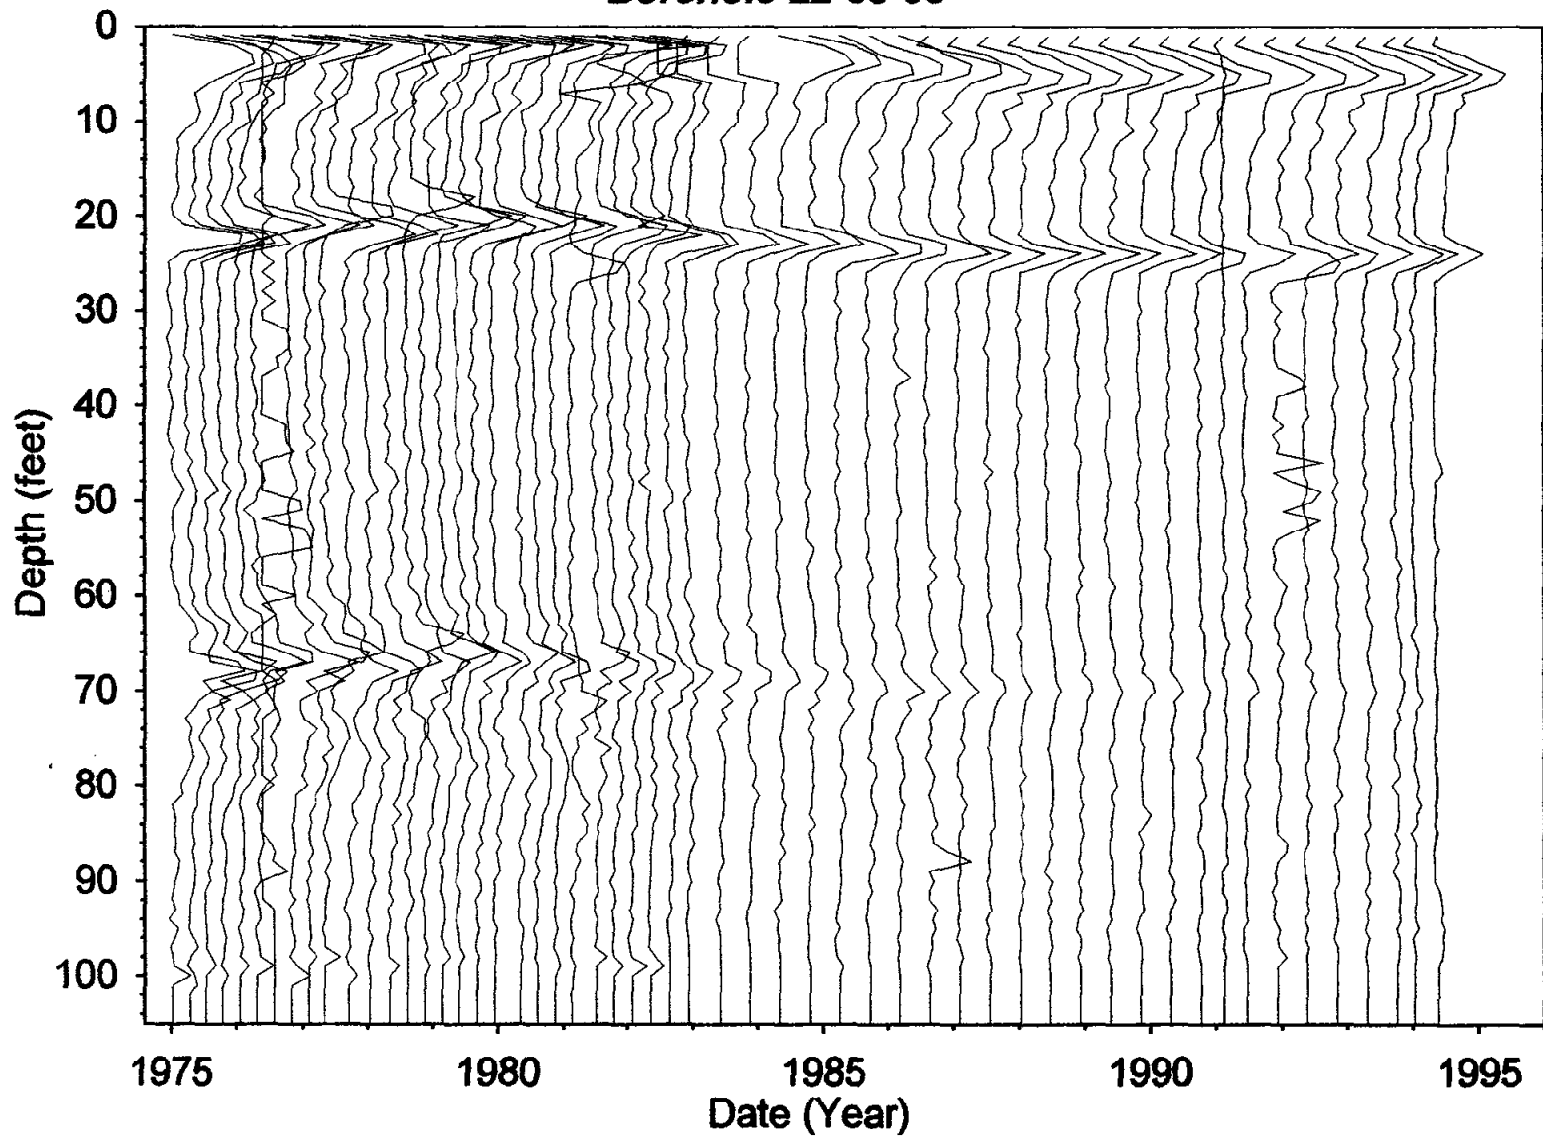
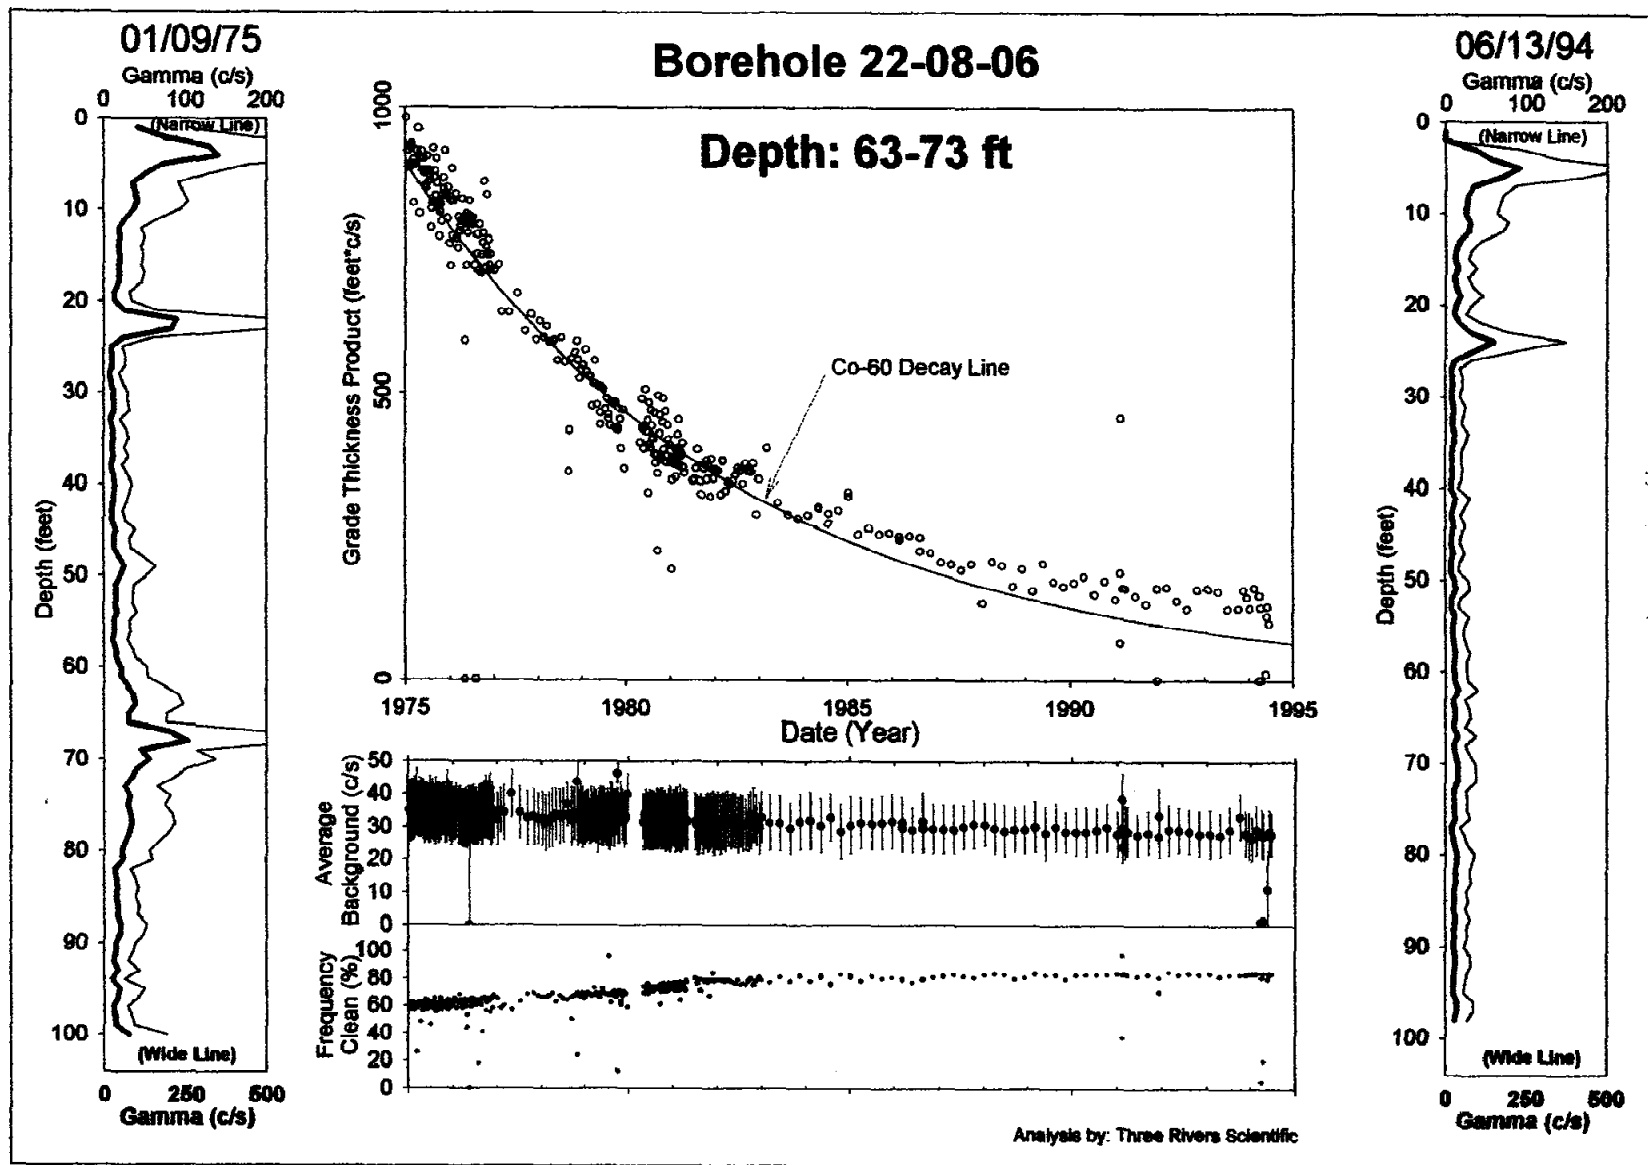
Figure B.5-10. Drywell 22-08-06 Historical Gamma Logging Plots (sheet 1 of 2)

A review of gross-gamma log data collected from this drywell from 1973 to 1994 (Figure B.5-10) shows elevated gamma activity at the surface, at 23 ft and from ~65 to 80 ft bgs. The gamma peak at 68 ft decayed following a ^{60}Co decay curve and was no longer present by 1994. The peaks at ground surface and 23 ft decayed more gradually and were still present in 1994.

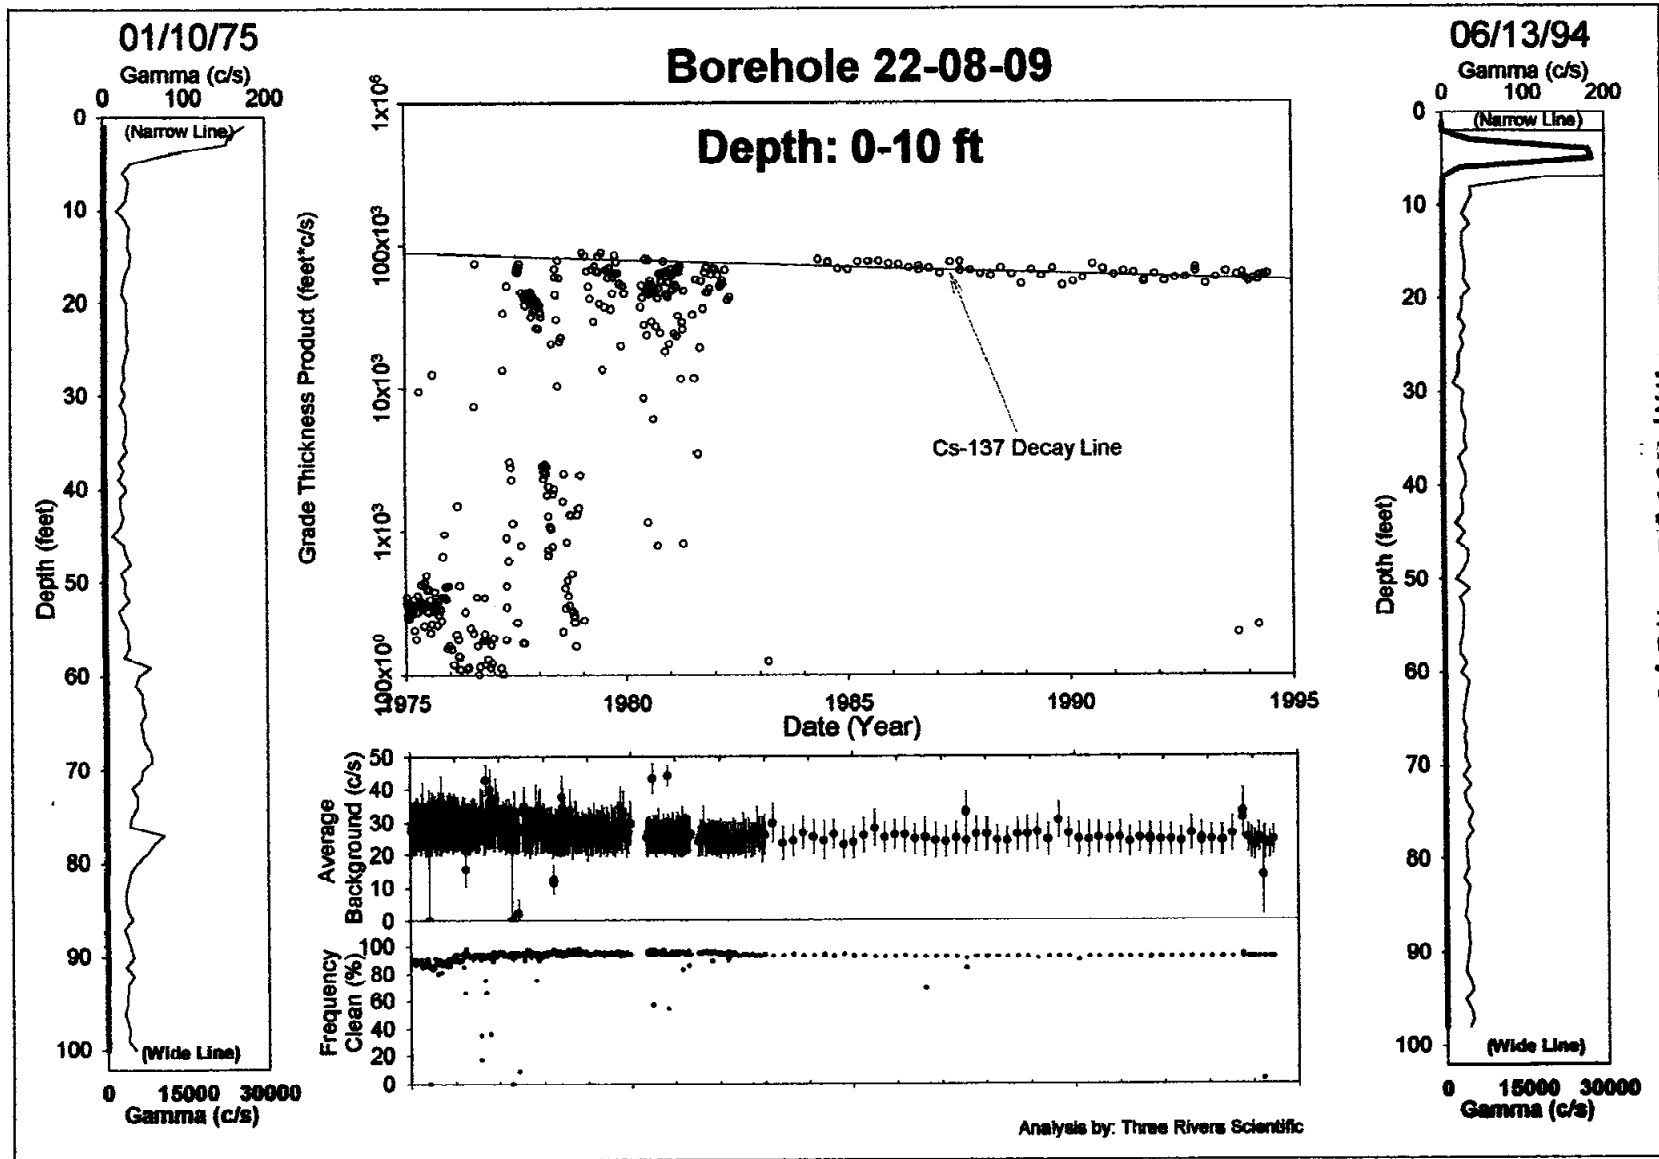
Figure B.5-12. Drywell 22-08-09 Historical Gamma Logging Plots

A review of gross-gamma log data collected from this drywell from 1975 to 1994 (Figure B.5-12) shows near surface elevated gamma activity, first noticed in 1974, increased from 75 cps in 1974 to 96 cps in 1975 and steadily decreased to 37 cps in 1981 following a ^{137}Cs decay line. Low gamma activity was also observed from 89 to 95 ft bgs.
