Hanford BY-Farm Leak Assessments Report

Washington River Protection Solutions LLC

January 2011

Prepared for the U.S. Department of Energy
Office of River Protection

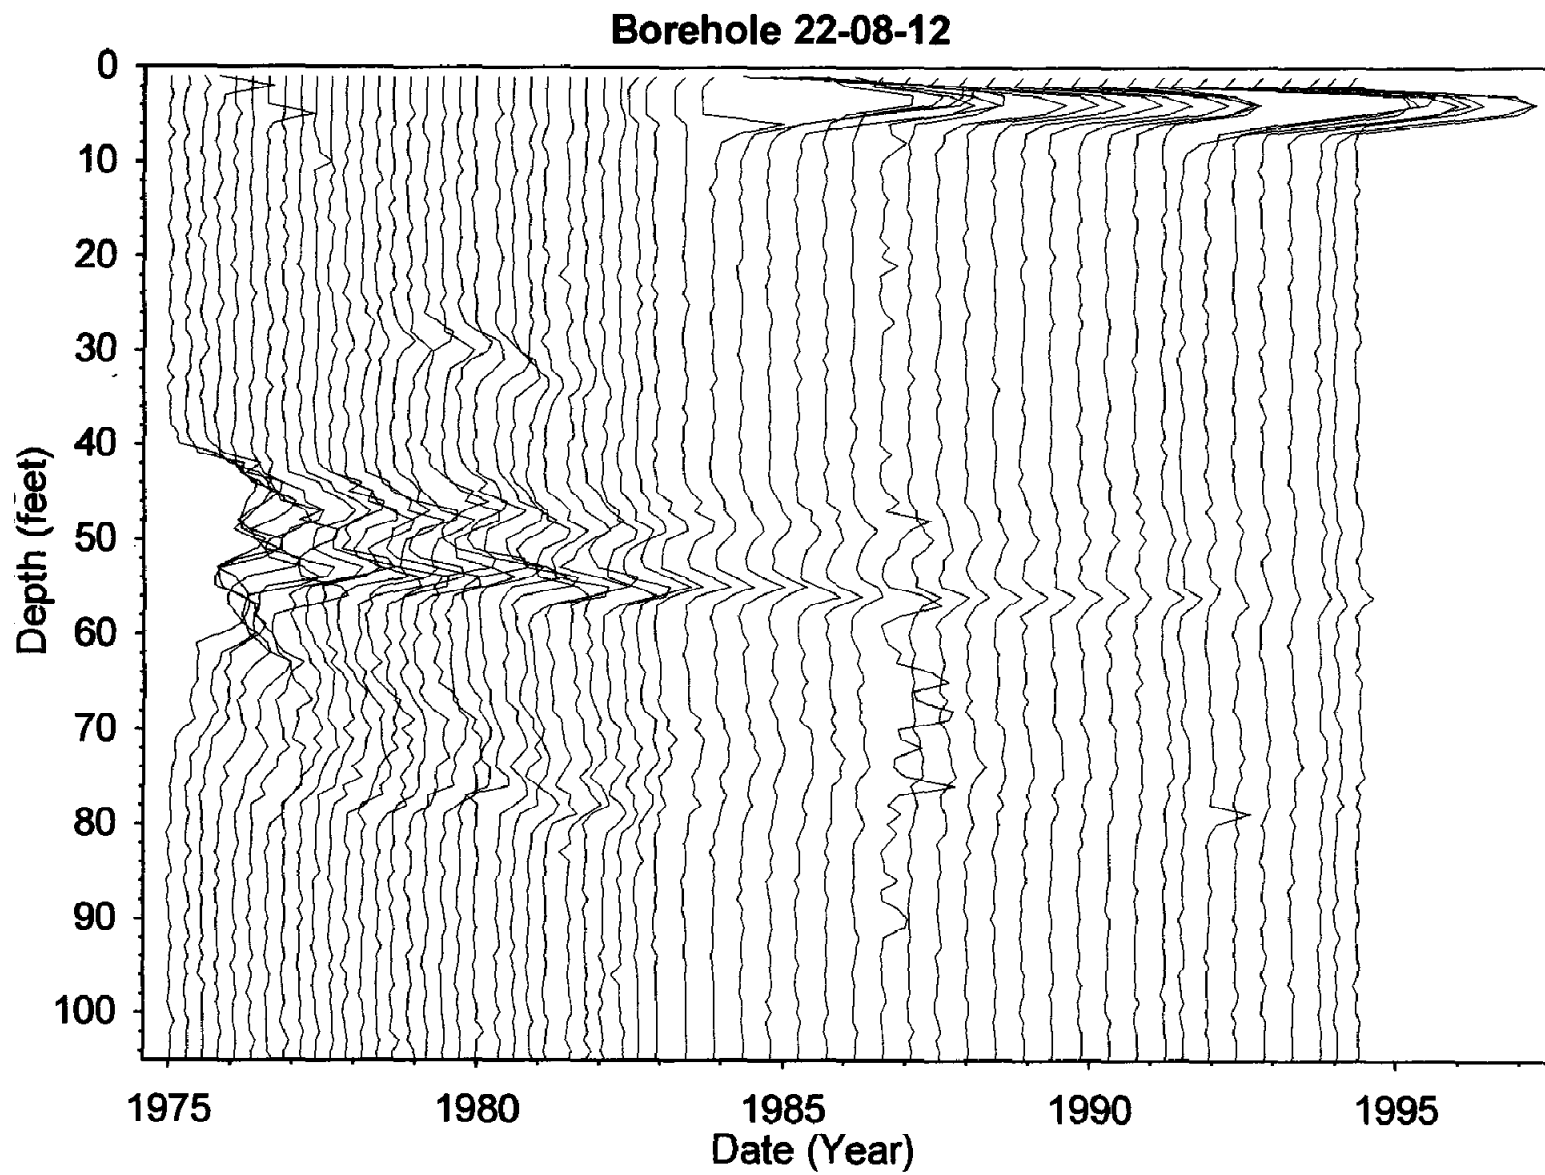
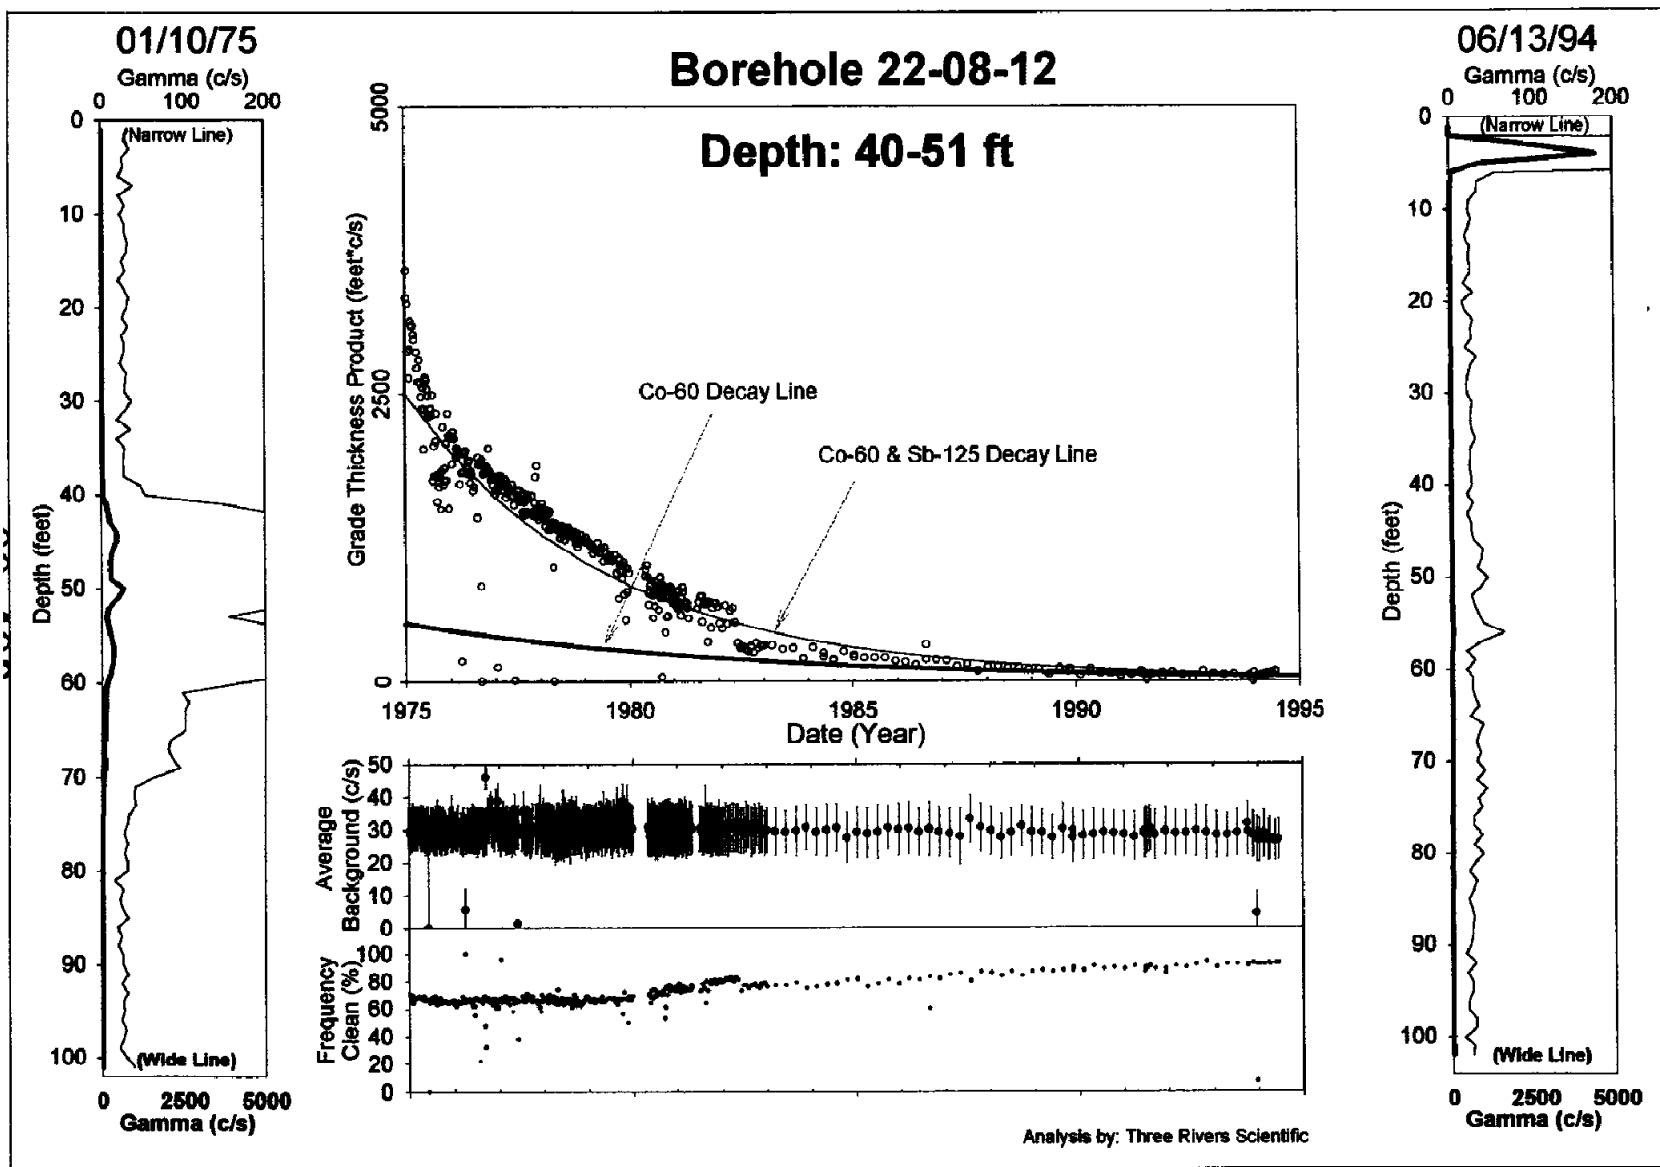
Figure B.5-13. Drywell 22-08-12 Historical Gamma Logging Plots (sheet 1 of 2)

A review of gross-gamma log data collected from this drywell from 1975 to 1994 (Figure B.5-13) indicates elevated gamma activity from 38 to 72 ft in depth. SD-WM-TI-356 shows that in 1974, a new peak was recorded at ~41 ft. The maximum count rate decreased in intensity with time following a combined ^{60}Co and ^{125}Sb decay curve and was measured at a lower depth (ranging from 41 to 55 ft) in successive years.

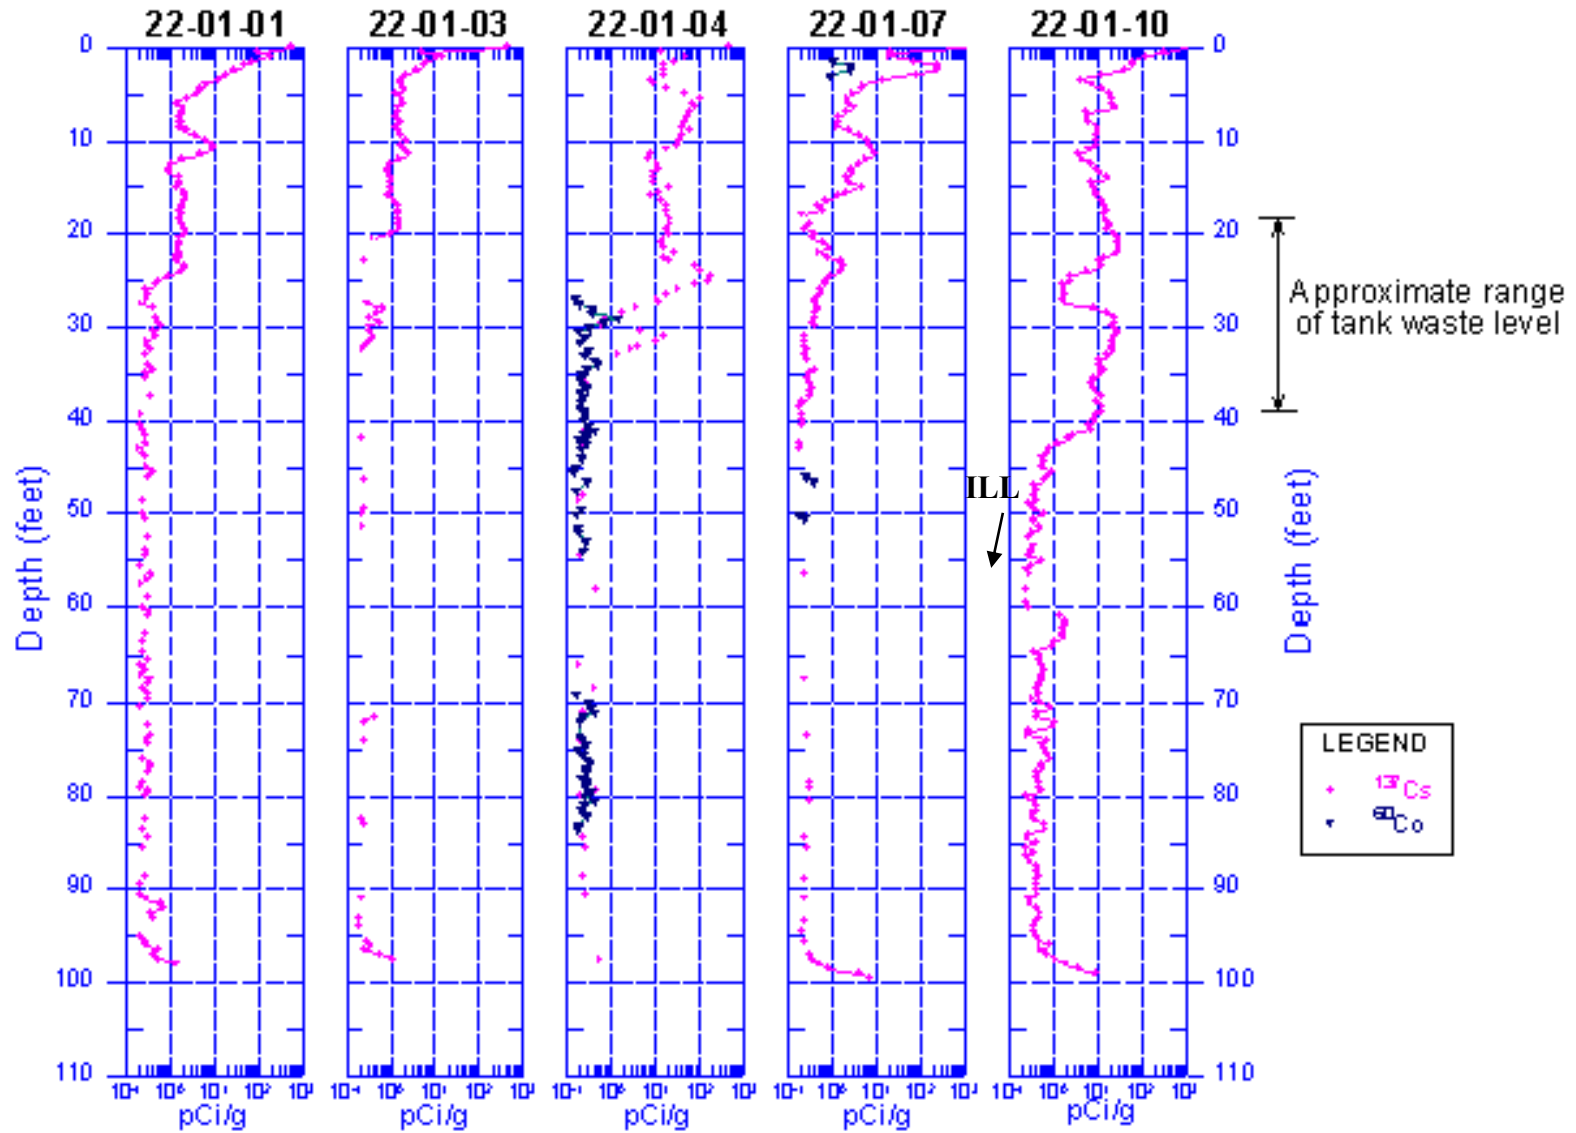
Figure C-3. Tank 241-BY-101 Drywell Spectral Gamma Data, 1995

Per SD-WM-TI-356, *Waste Storage Tank Status and Leak Detection Criteria*, it was stated that drywell readings were stable; high readings in drywell 22-01-04 are not considered to be due to tank leakage, for the depth of the contamination is above the normal operating level. GJ-HAN-18, *Vadose Zone Characterization Project at the Hanford Tank Farms Tank Summary Data Report for Tank BY-101* reports ^{137}Cs and ^{60}Co contamination at depths of 25 and 29 ft respectively in drywell 22-01-04, within range of the tank waste surface during the tank's operating period. In addition, GJ-HAN-18 notes the presence of low concentration zones of ^{137}Cs throughout various depths and at the bottom of drywells, as seen in Figure C-3.

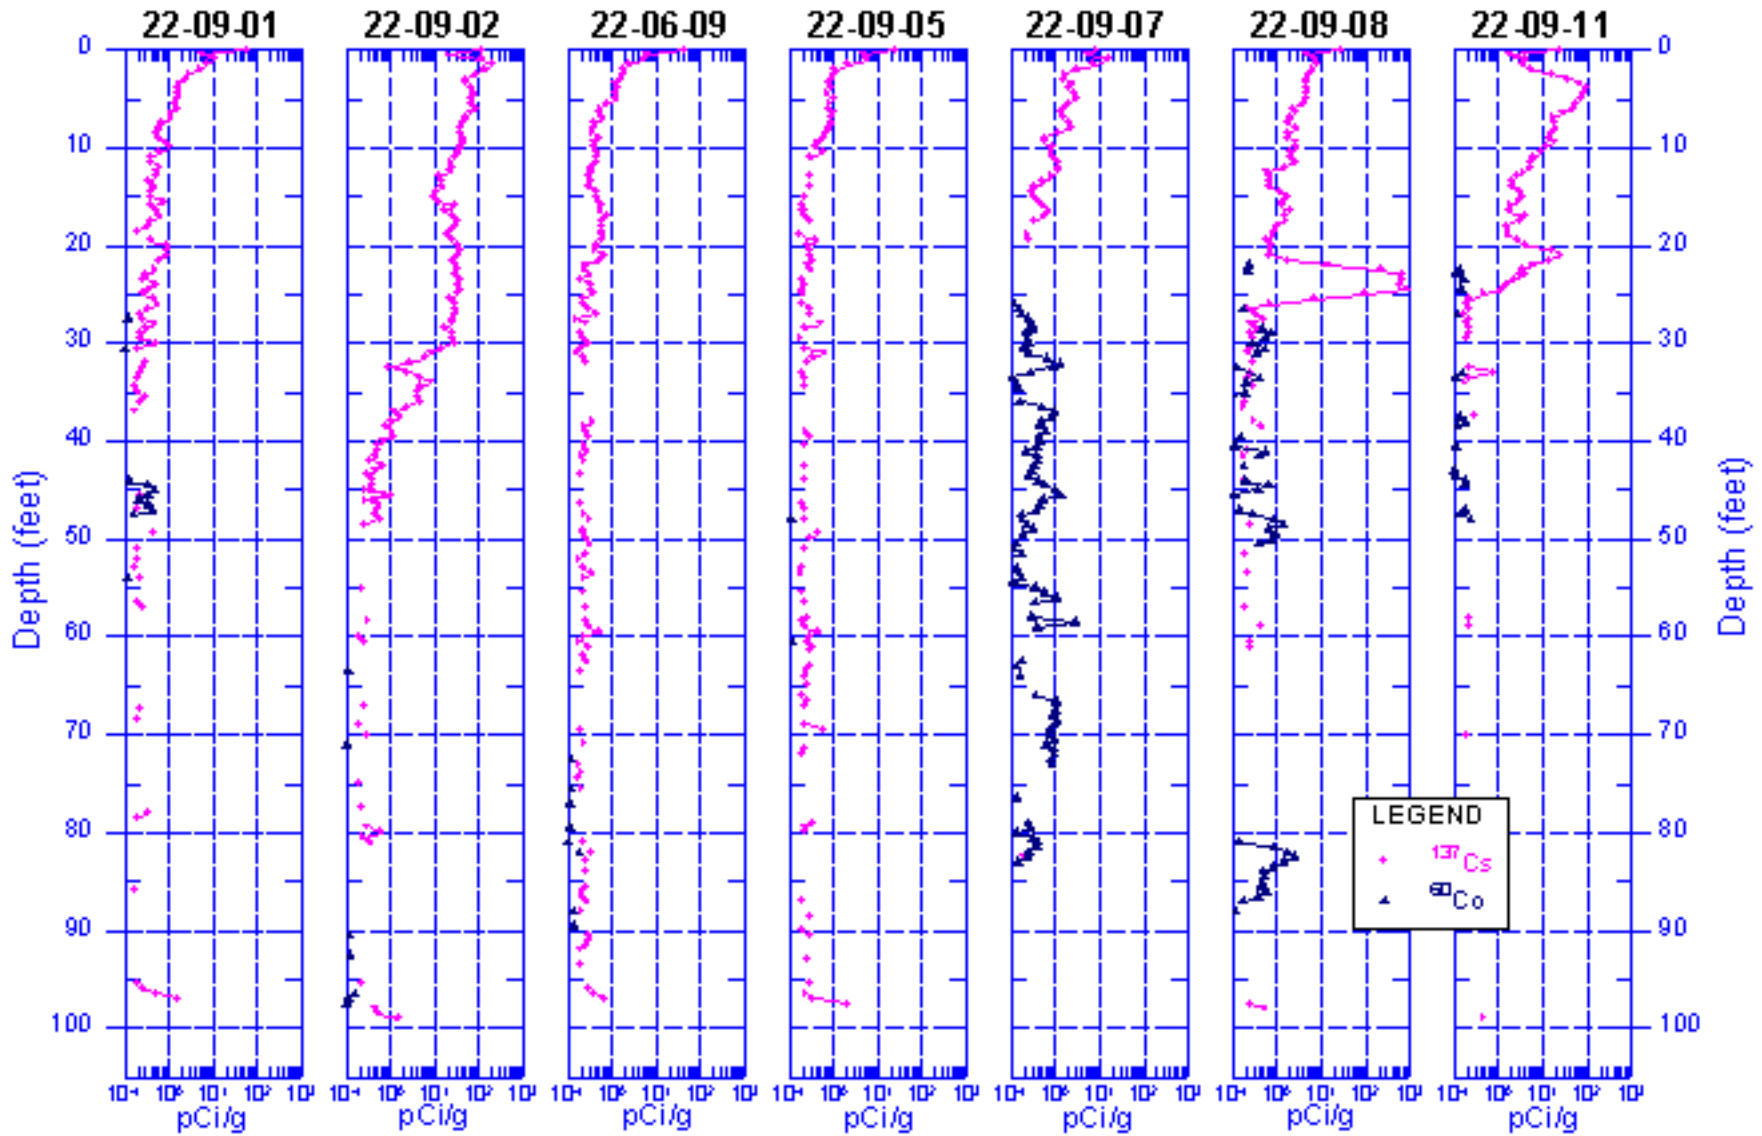
Figure C-12. Tank 241-BY-109 Drywell Spectral Gamma Data, 1995

SD-WM-TI-356 notes that tank BY-109 had a restricted use status due to tar rings above the 235 in. level (~650 kgal). Measureable contamination was detected in several drywells around the tank. GJ-HAN-26, *Vadose Zone Characterization Project at the Hanford Tank Farms Tank Summary Data Report for Tank BY-109* reports high cesium activity at 24 ft bgs in drywell 22-09-08, likely due to pipeline leaks near tank BY-109. Drywell data also indicates ⁶⁰Co present below 22 ft in drywells 22-09-07, 22-09-08, and 22-09-11 on the west side of the tank (see Figure C-12). No occurrence reports were issued for liquid level decreases.

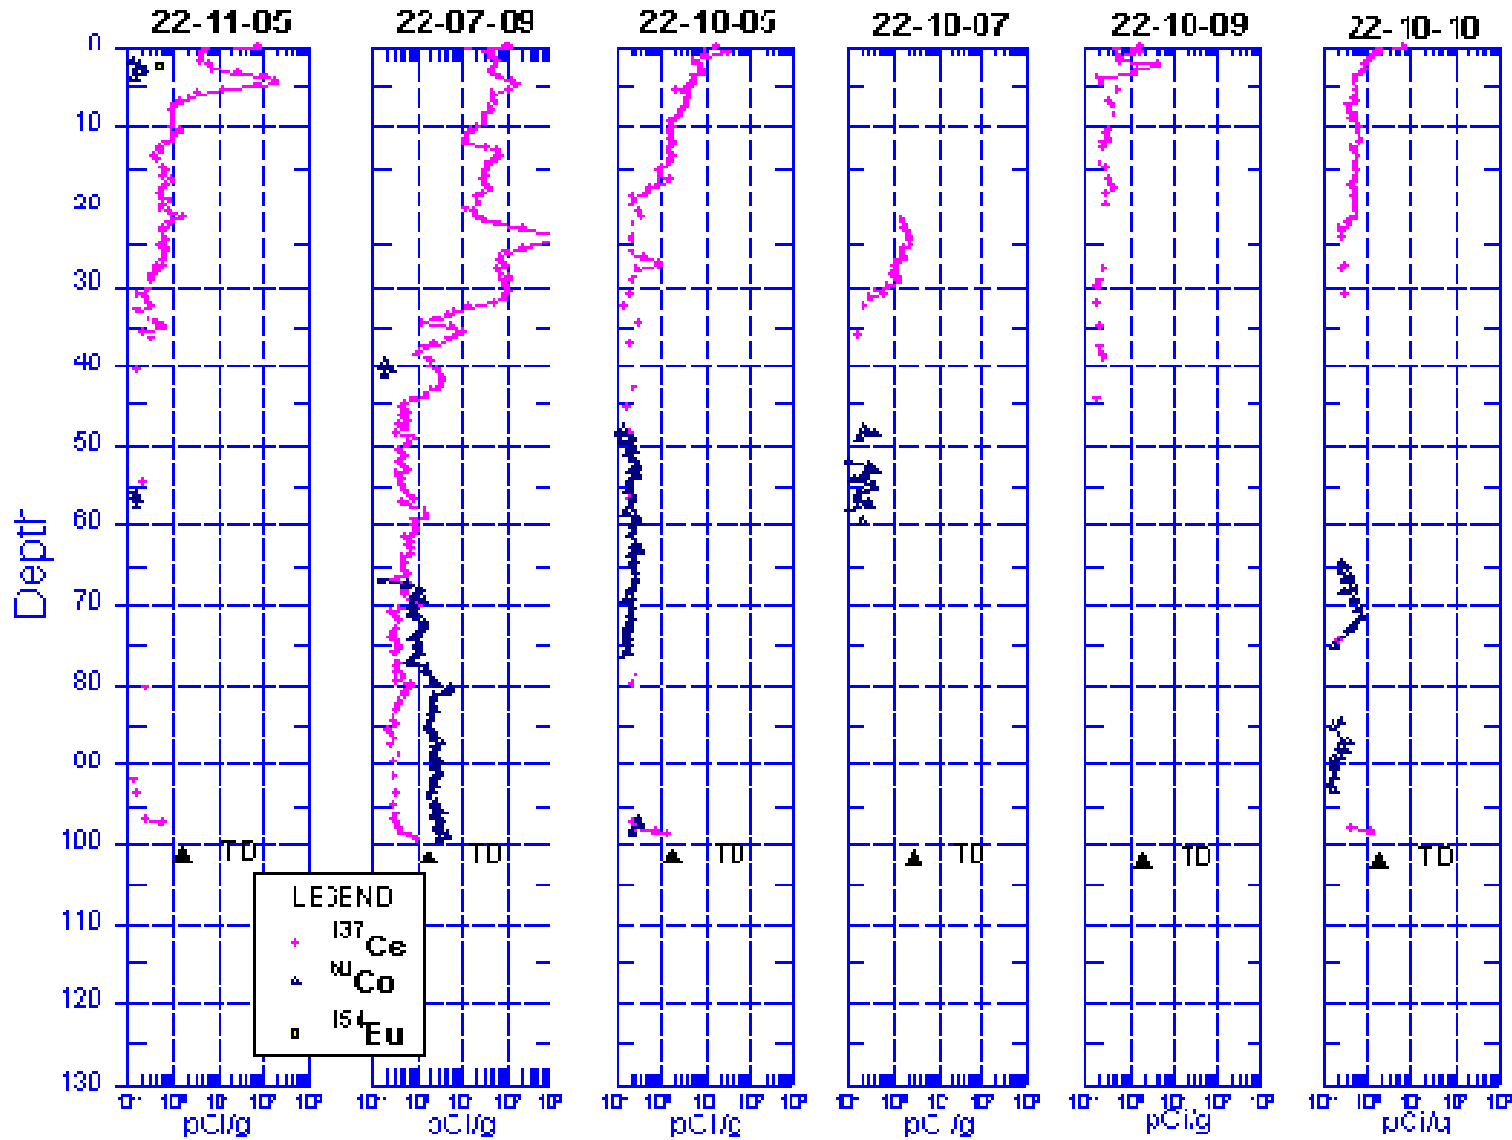
Figure C-16. Tank 241-BY-110 Drywell Spectral Gamma Data, 1995

GJ-HAN-27, *Vadose Zone Characterization Project at the Hanford Tank Farms Tank Summary Data Report for Tank BY-110* reports ^{60}Co contamination detected in drywells 22-10-05 and 22-10-07 at a depth of 48 ft, approximately 3 ft below the tank's bottom depth (Figure C-16). Other ^{60}Co zones were observed deeper in the vadose zone in drywells 22-07-09 and 22-10-10. Low levels of ^{137}Cs contamination were present in all drywells surrounding tank BY-110, while slight ^{137}Cs and ^{60}Co peaks were observed in drywell 22-07-09 at a depth of approximately 80 ft (Figure C-16).

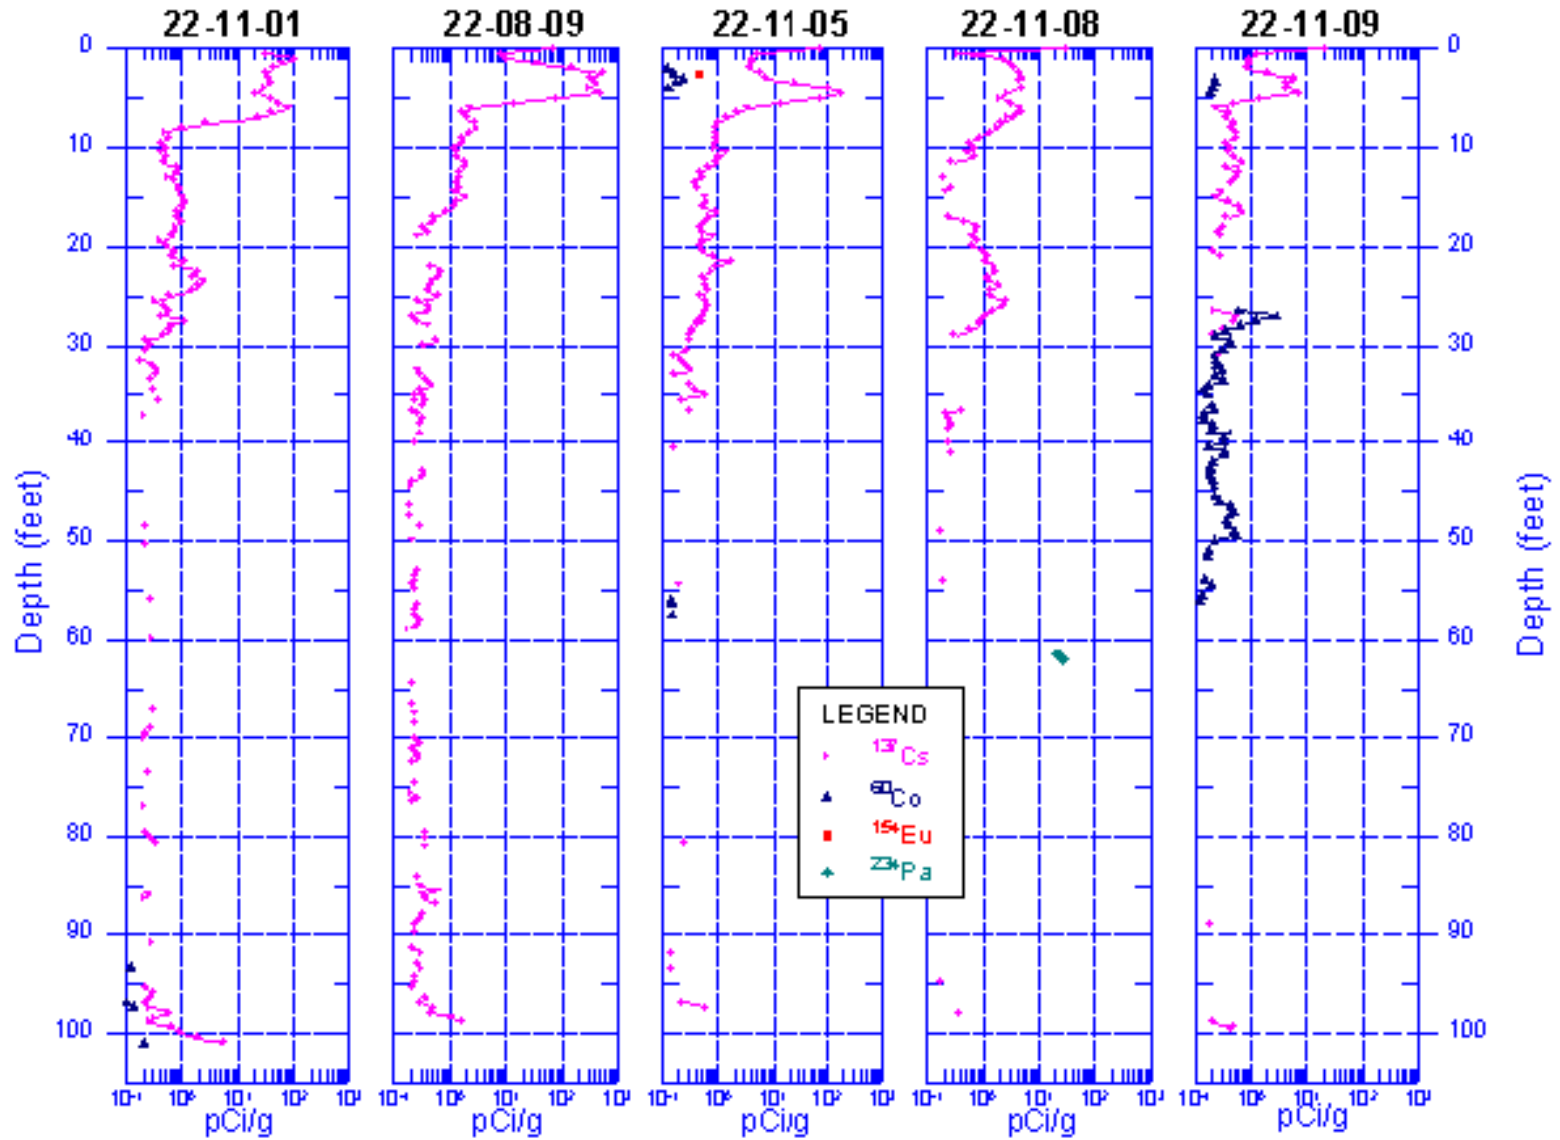
Figure C-19. Tank 241-BY-111 Drywell Spectral Gamma Data, 1995

SD-WM-TI-356 states that the waste surface inside tank BY-111 is extremely irregular, and that there were no changes in drywell activity during the review period. There were no unexplained liquid level decreases observed in BY-111, though the tank was filled to capacity in the early 1950s.

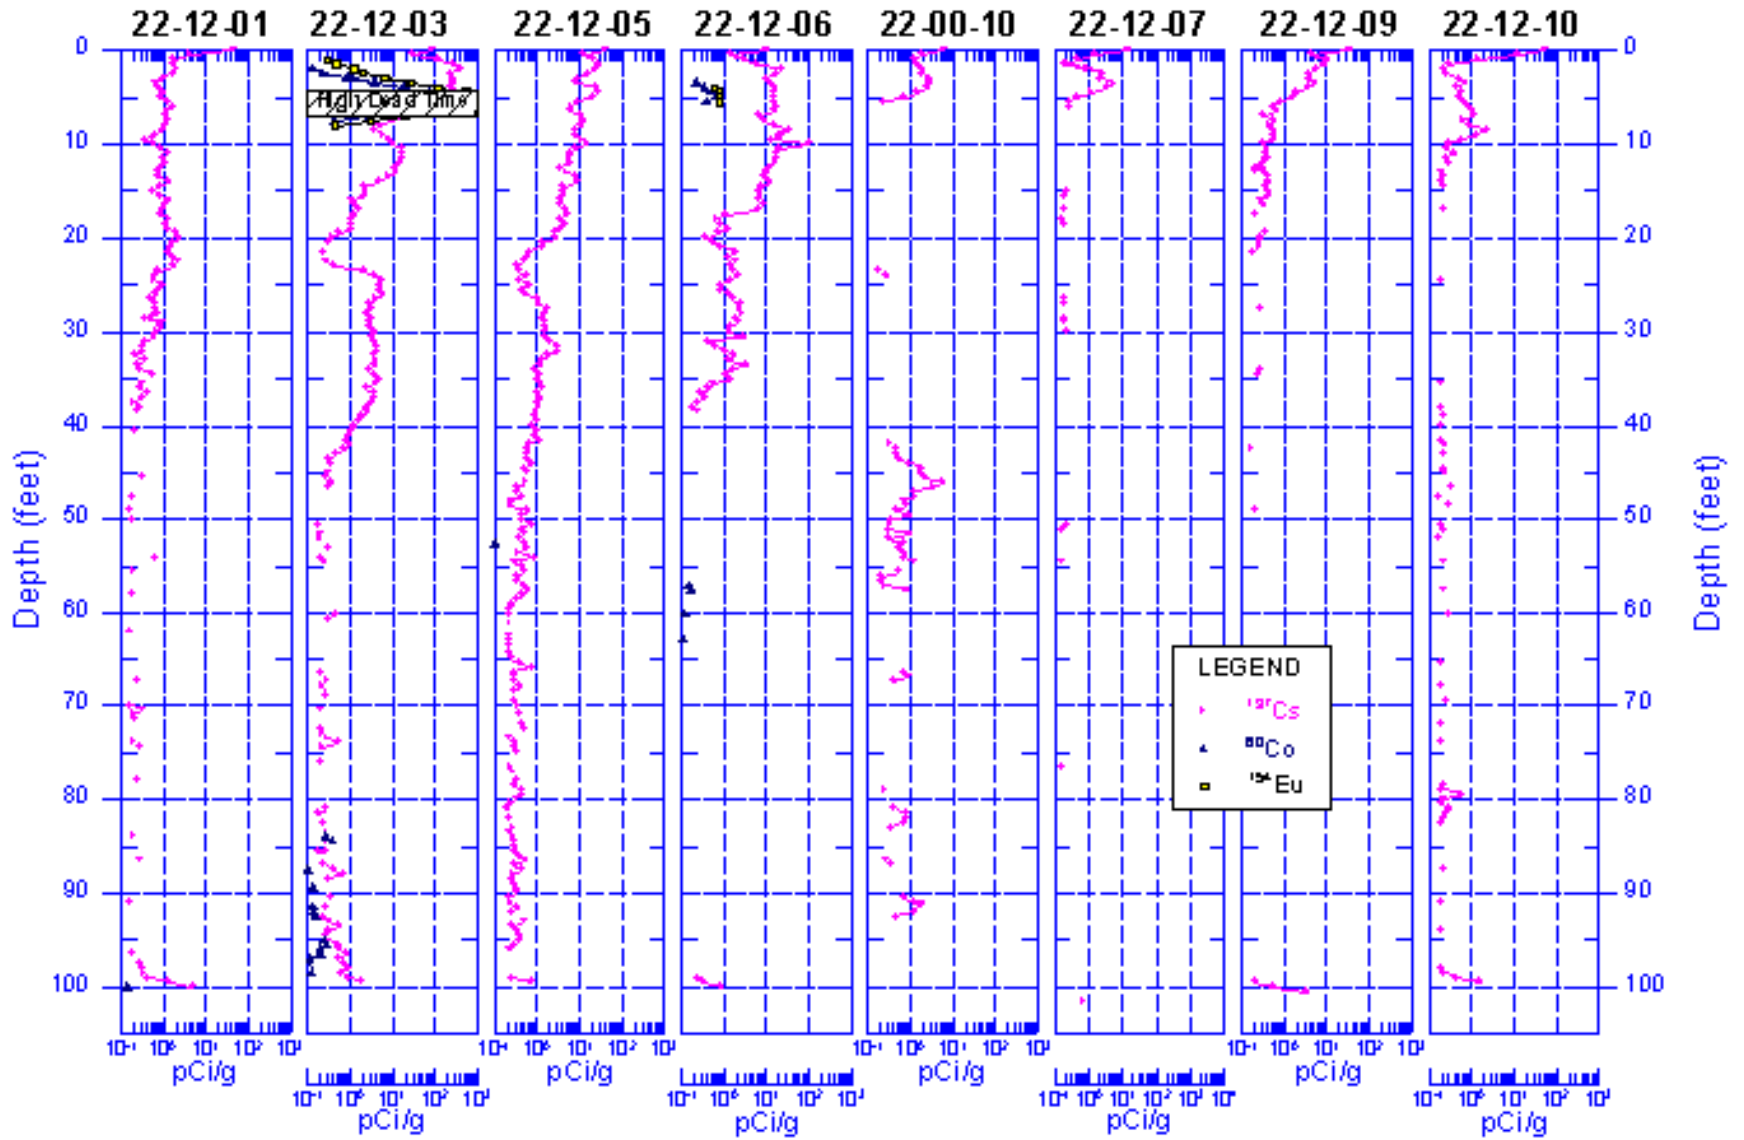
Figure C-22. Tank 241-BY-112 Drywell Spectral Gamma Data, 1995

GJ-HAN-29, *Vadose Zone Characterization Project at the Hanford Tank Farms Tank Summary Data Report for Tank BY-112* describes elevated ^{137}Cs contamination at a depth of ~24 ft in drywell 22-12-03 (Figure C-22), but attributes that activity to nearby tank BY-109 and associated piping. The report concluded that spectral gamma-ray log data show no subsurface contamination that could be associated with a possible leak from tank BY-112.
