Section 2 Project History

2.1 History of Construction of the Upper Reservoir Dam

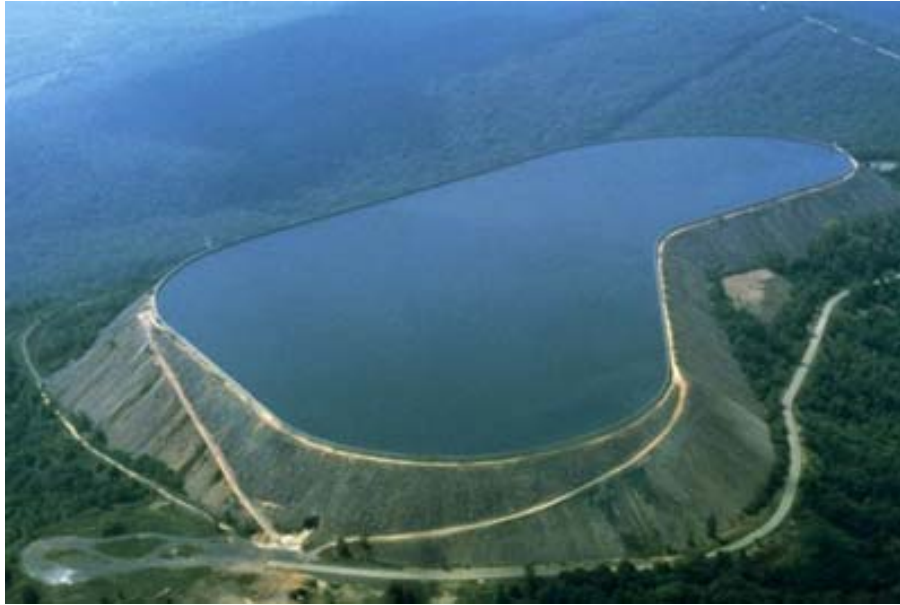
The top of Proffit Mountain was leveled and the excavated rock was used to construct the dike that forms the Upper Reservoir (Figure 2.3). The foundation area was stripped to bedrock during the dam breach. The bedrock is hard rhyolite porphyry with areas of closely spaced vertical joints (Figures 2.4 and 2.5). This rock is volcanic and formed by relatively quiet lava flows on the earth's surface. These rocks are fine grained but contain mineral crystals that formed before the rock was erupted. Even though they are 1.4+ billion years old, these rocks still exhibit flow patterns from the original lava flow.

Figure 2.3 - View of upper Reservoir.
