Dry Cask Storage Characterization Project—Phase 1: CASTOR V/21 Cask Opening and Examination

Idaho National Engineering and Environmental Laboratory

U.S. Nuclear Regulatory Commission
Office of Nuclear Regulatory Research
Washington, DC 20555-0001

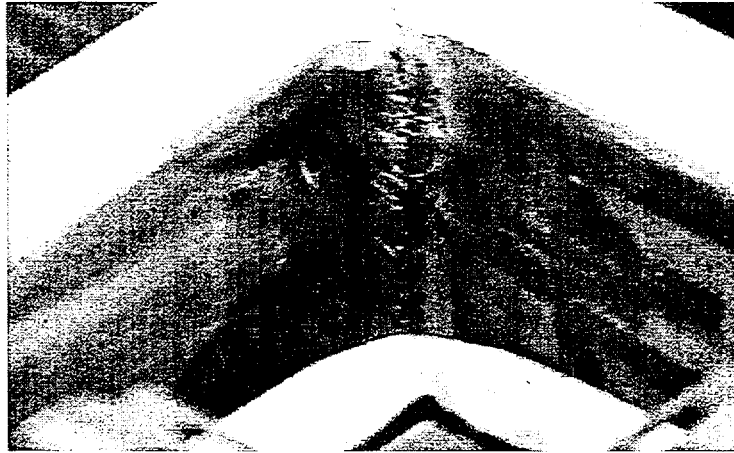
Figure 2-19. Crack in basket weld below weld crack 4 (120 degree side) identified in Figure 2-13.

The stitch welds in the triangular air channels appear to be nonstructural welds and were only intended to add additional stability for holding the fuel basket in place during 1985 fuel loading and vertical and horizontal thermal testing. The 1985 cask heat transfer performance testing (EPRI NP-4887) thermal analysis, concluded that the tightly fitted fuel basket expanded and came in contact with the basket barrel and the fuel barrel came in contact with the inner wall of the cask. The results of the thermal analysis indicated that thermal stresses in the weld joints at the eight crack locations identified in 1985 were well above yield stresses measured during tensile testing of applicable weld samples. Based on these results and speculations, it appears that all new cracks identified in 1999 occurred during the 1985 thermal testing. Further, it is concluded the cracks are not relevant to normal long-term storage and presents no adverse safety implications on the cask or components to perform their safety related function.

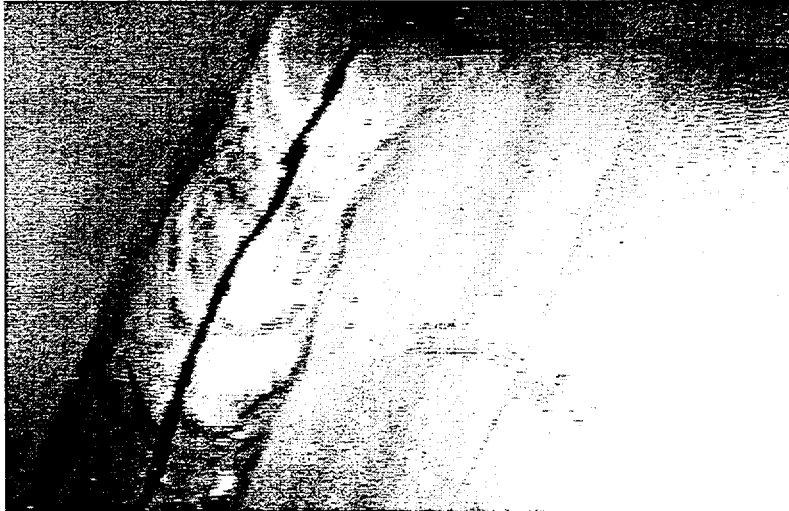
Figure B-1. Top weld crack at location 9 identified in Figure B-19.
(Triangular air channel between fuel tube A7 & B8)
