Report on Condition of Schools Under Jurisdiction of Defense Education Activity

Department of Defense Education Activity
Report to the Congressional Defense Committees
Pursuant to section 2879 of Public Law 110-181 of the
National Defense Authorization Act for Fiscal Year 2008

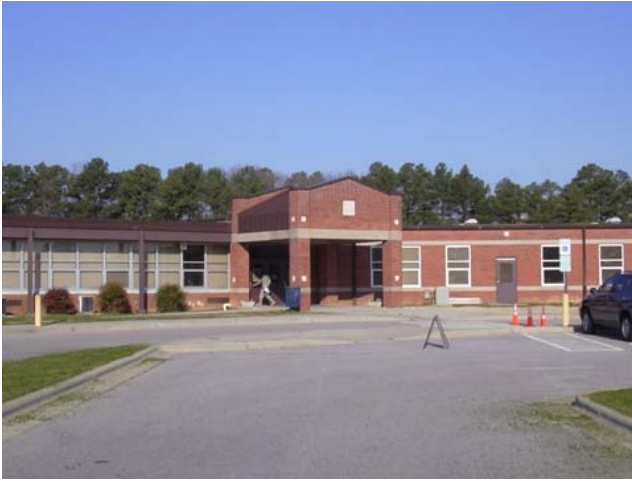
Butner Elementary School

SCHOOL SUMMARY	
Current Enrollment*	577
Maximum Capacity	642
GSF	76,750
Condition	65%
Average Q-Rating	Q-3

Heating is provided by gas-fired boilers and is distributed by a 2-pipe system to fan-coil units in most areas and to air handling units in areas such as the cafeteria. Most fan-coil units and heating piping appear to be original. Ventilation in restrooms is generally inadequate. Campus facilities have air conditioning.

DEFICIENCY SUMMARY*		
LEVEL 1 (System Renewals)		
	AMOUNT	Percent of Total
Total	\$3,958,233	54%
LEVEL 2		
CATEGORY	AMOUNT	Percent of Total
ADA	\$382,549	5.2%
AHERA	\$228,528	3.1%
Architectural	\$520,026	7.1%
Infrastructure	\$206,739	2.8%
Life-safety	\$330,027	4.5%
MEP	\$1,595,656	21.7%
Playground	\$72,103	1.0%
Security	\$74,986	1.0%
L2 TOTAL	\$3,410,613	46%
L1 & L2 TOTAL	\$ 7,368,846	100%

INVESTMENT PLAN						
SRM Project Title	FY-08	FY-09	FY-10	FY-11	FY-12	
Replace Carpet	\$249,165					
Replace Media Center Roof	\$17,000					
Replace Kitchen Hood	\$10,000					
Replace Kitchen Hood	\$75,000					
Lead paint survey		\$10,000				
Replace Media Center Roof		\$170,000				
Replace Grease Traps		\$15,000				
Refinish Stage			\$10,000			
HVAC Replacement			\$250,000			
Renovate All Restrooms				\$30,000		
HVAC Replacement						\$2,500,000
SRM Total	\$351,165	\$195,000	\$260,000	\$30,000		\$2,500,000
MILCON Project Title	FY-08	FY-09	FY-10	FY-11	FY-12	
	\$0	\$0	\$0	\$0	\$0	\$0
MILCON Total*	\$0	\$0	\$0	\$0	\$0	\$0
SRM & MILCON Total*	\$351,165	\$195,000	\$260,000	\$30,000		\$2,500,000
INVESTMENT PLAN IMPACT ON PROJECTED CONDITION						
	MILCON Impact on Condition	\$0	\$0	\$0	\$0	\$0
	Current	FY-08	FY-09	FY-10	FY-11	FY-12
% Condition**	64.7%	67%	69%	71%	71%	90%
Q-Rating	Q-3	Q-3	Q-3	Q-3	Q-3	Q-1

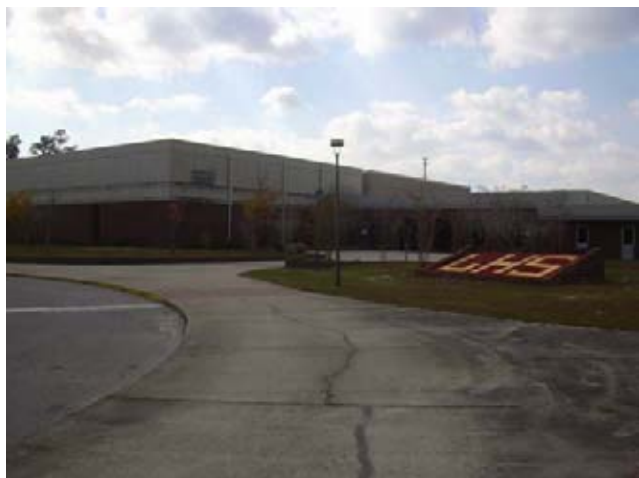
Camp Lejeune High School

SCHOOL SUMMARY	
Current Enrollment*	424
Maximum Capacity	842
GSF	123,074
Condition	72%
Average Q-Rating	Q-3

We found some signs of damage to foundations during the course of the assessment. In addition, brick veneer walls showed no indication of water penetration, or other signs of damage. Roof coverings include single-ply flexible membrane and metal panels with some minor leaks reported. Exterior doors and windows are generally weather-tight.

Heating is provided by gas-fired boilers and is distributed by a 2-pipe system to fan-coil units in most areas and to air handling units in areas such as the multi-purpose room. The heating piping appears to be original. Ventilation in restrooms is generally adequate. Campus facilities have air conditioning with dedicated air conditioning for all LAN concentrator rooms. The campus has no elevators.

DEFICIENCY SUMMARY*		
LEVEL 1 (System Renewals)		
	AMOUNT	Percent of Total
Total	\$6,514,881	75%
LEVEL 2		
CATEGORY	AMOUNT	Percent of Total
ADA	\$361,976	4.2%
AHERA	\$0	0.0%
Architectural	\$197,028	2.3%
Infrastructure	\$238,911	2.7%
Life-safety	\$77,039	0.9%
MEP	\$1,166,191	13.4%
Playground	\$0	0.0%
Security	\$156,939	1.8%
L2 TOTAL	\$2,198,085	25%
L1 & L2 TOTAL	\$ 8,712,966	100%

INVESTMENT PLAN						
SRM Project Title	FY-08	FY-09	FY-10	FY-11	FY-12	
Replace Gym Floor/Improve Gym HVAC	\$1,806,525					
Upgrade Athletic Fields for Title IX/Sewer/Concessions				\$40,000		
Upgrade Electrical Power				\$58,800		
SRM Total	\$1,806,525	\$0	\$0	\$98,800		\$0
MILCON Project Title	FY-08	FY-09	FY-10	FY-11	FY-12	
MILCON Total*	\$0	\$0	\$0	\$0		\$0
SRM & MILCON Total*	\$1,806,525	\$0	\$0	\$98,800		\$0
INVESTMENT PLAN IMPACT ON PROJECTED CONDITION						
MILCON Impact on Condition	\$0	\$0	\$0	\$0	\$0	\$0
Current	FY-08	FY-09	FY-10	FY-11	FY-12	
% Condition**	72%	79%	79%	79%	80%	80%
Q-Rating	Q-3	Q-3	Q-3	Q-3	Q-3	Q-3

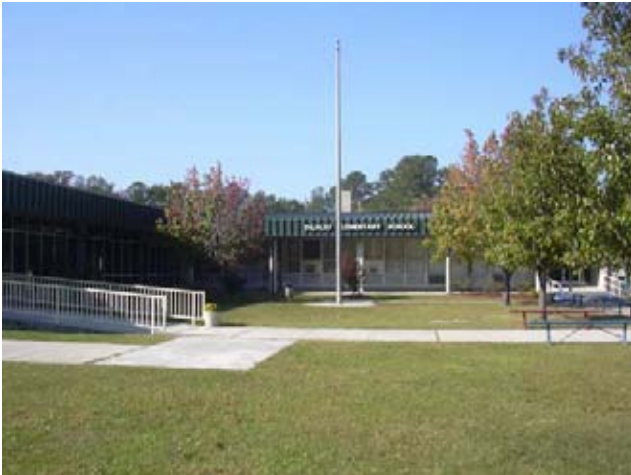
Delalio Elementary School

SCHOOL SUMMARY	
Current Enrollment*	330
Maximum Capacity	412
GSF	38,286
Condition	40%
Average Q-Rating	Q-4

We found some signs of damage to foundations during the course of the assessment. In addition, brick veneer walls showed no indication of water penetration, or other signs of damage. Roof coverings include metal panels with some minor leaks reported. Exterior doors and windows are generally weather-tight.

Heating is provided by gas-fired boilers and is distributed by a 2-pipe system to radiators in most areas and to air handling units in areas such as the multi-purpose room. The heating piping appears to be original. Ventilation in restrooms is generally adequate. Campus facilities have air conditioning but do not have dedicated air conditioning for all LAN concentrator rooms. The campus has no elevators.

DEFICIENCY SUMMARY*		
LEVEL 1 (System Renewals)		
	AMOUNT	Percent of Total
Total	\$3,417,375	64%
LEVEL 2		
CATEGORY	AMOUNT	Percent of Total
ADA	\$421,055	7.9%
AHERA	\$228,218	4.3%
Architectural	\$204,178	3.8%
Infrastructure	\$295,884	5.5%
Life-safety	\$22,822	0.4%
MEP	\$435,646	8.1%
Playground	\$277,241	5.2%
Security	\$52,886	1.0%
L2 TOTAL	\$1,937,929	36%
L1 & L2 TOTAL	\$ 5,355,304	100%

INVESTMENT PLAN						
SRM Project Title		FY-08	FY-09	FY-10	FY-11	FY-12
Upgrade Electrical Pwr		\$54,600				
Install New Tricycle Track in Pre-K Playground Area		\$55,000				
General Renovations		\$300,000				
Upgrade Playground			\$150,000			
Replace HVAC System			\$3,490,000			
Replace HVAC System			\$25,000			
Upgrade Electrical Pwr				\$385,613		
General Renovations				\$1,950,000		
	SRM Total	\$409,600	\$3,665,000	\$2,335,613	\$0	\$0
MILCON Project Title						
		FY-08	FY-09	FY-10	FY-11	FY-12
Constr New Gym and Music Room	MILCON Major	\$2,014,000				
	MILCON Total*	\$2,014,000	\$0	\$0	\$0	\$0
	SRM & MILCON Total*	\$2,423,600	\$3,665,000	\$2,335,613	\$0	\$0
INVESTMENT PLAN IMPACT ON PROJECTED CONDITION						
	MILCON Impact on Condition	\$0	\$0	\$2,014,000	\$0	\$0
	Current	FY-08	FY-09	FY-10	FY-11	FY-12
% Condition**	40.0%	46%	100%	100%	100%	100%
Q-Rating	Q-4	Q-4	Q-1	Q-1	Q-1	Q-1

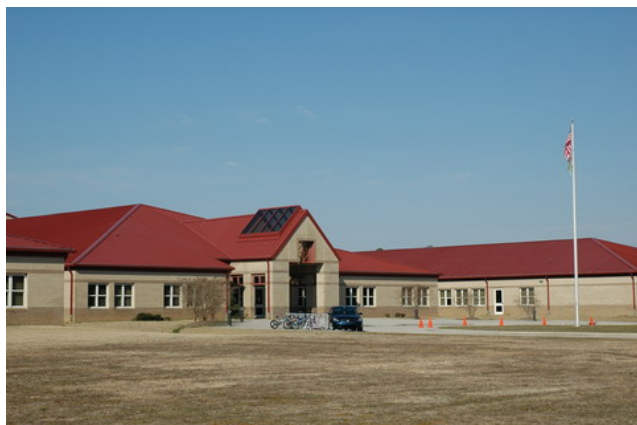
Devers Elementary School

SCHOOL SUMMARY	
Current Enrollment*	507
Maximum Capacity	717
GSF	79,767
Condition	88%
Average Q-Rating	Q-2

Brick veneer walls showed some signs of water penetration, and there was some minor damage. Roof coverings include metal panels. Exterior doors and windows are generally weather tight.

Heating is provided by gas-fired boilers and is distributed by a 2-pipe system to air handling units in most areas and to fan-coil units in areas such as the kitchen. Campus facilities have air conditioning.

DEFICIENCY SUMMARY*		
LEVEL 1 (System Renewals)		
	AMOUNT	Percent of Total
Total	\$1,697,123	59%
LEVEL 2		
CATEGORY	AMOUNT	Percent of Total
ADA	\$79,547	2.8%
AHERA	\$0	0.0%
Architectural	\$191,303	6.7%
Infrastructure	\$72,074	2.5%
Life-safety	\$169,016	5.9%
MEP	\$62,488	2.2%
Playground	\$518,378	18.0%
Security	\$86,019	3.0%
L2 TOTAL	\$1,178,825	41%
L1 & L2 TOTAL	\$ 2,875,948	100%

INVESTMENT PLAN						
SRM Project Title	FY-08	FY-09	FY-10	FY-11	FY-12	
Replace Boilers and Piping		\$290,063				
SRM Total	\$0	\$290,063	\$0	\$0	\$0	\$0
MILCON Project Title	FY-08	FY-09	FY-10	FY-11	FY-12	
MILCON Total*	\$0	\$0	\$0	\$0	\$0	\$0
SRM & MILCON Total*	\$0	\$290,063	\$0	\$0	\$0	\$0
INVESTMENT PLAN IMPACT ON PROJECTED CONDITION						
MILCON Impact on Condition	\$0	\$0	\$0	\$0	\$0	\$0
Current	FY-08	FY-09	FY-10	FY-11	FY-12	
% Condition**	87.6%	88%	90%	90%	90%	90%
Q-Rating	Q-2	Q-2	Q-2	Q-2	Q-2	Q-2

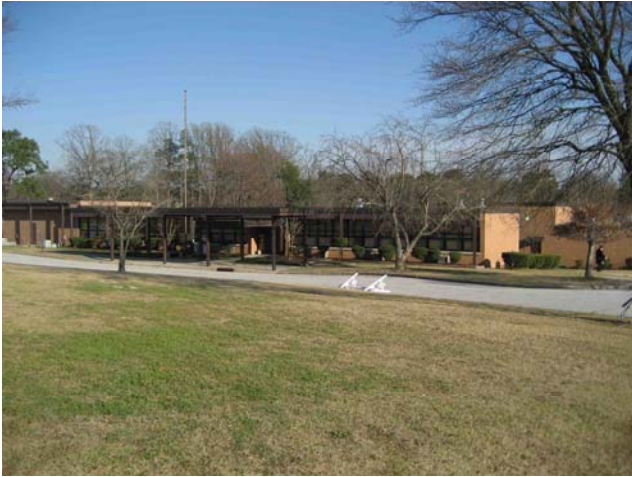
Holbrook Elementary School

SCHOOL SUMMARY	
Current Enrollment*	335
Maximum Capacity	599
GSF	61,228
Condition	56%
Average Q-Rating	Q-4

Heating is provided by gas-fired boilers and is distributed by a 2-pipe system to fan-coil units in most areas and to air handling units in areas such as the multi-purpose room. Campus facilities have air conditioning.

DEFICIENCY SUMMARY*		
LEVEL 1 (System Renewals)		
	AMOUNT	Percent of Total
Total	\$3,785,064	48%
LEVEL 2		
CATEGORY	AMOUNT	Percent of Total
ADA	\$850,651	10.7%
AHERA	\$79,628	1.0%
Architectural	\$373,000	4.7%
Infrastructure	\$222,985	2.8%
Life-safety	\$331,518	4.2%
MEP	\$1,962,071	24.7%
Playground	\$278,047	3.5%
Security	\$62,018	0.8%
L2 TOTAL	\$4,159,918	52%
L1 & L2 TOTAL	\$ 7,944,982	100%

INVESTMENT PLAN						
SRM Project Title	FY-08	FY-09	FY-10	FY-11	FY-12	
Replace Grease Traps	\$3,500					
New Kitchen Hood	\$8,000					
Asbestos Abatement and Carpet Replacement	\$25,000					
Asbestos Abatement and Carpet Replacement		\$275,000				
New Kitchen Hood		\$75,000				
New Playground		\$150,000				
Replace Grease Traps		\$0				
Replace HVAC System			\$200,000			
Replace Exterior and Interior Doors			\$20,000			
Renovate Common and Classroom Toilets				\$25,000		
Study, Design, and Replace Domestic and Waste Water Lines				\$15,000		
Study, Design, and Replace Domestic and Waste Water Lines					\$45,000	
Resurface and Expand Parking Lot					\$30,000	
Replace HVAC System					\$2,000,000	
SRM Total	\$36,500	\$500,000	\$220,000	\$40,000	\$2,075,000	
MILCON Project Title	FY-08	FY-09	FY-10	FY-11	FY-12	
	\$0	\$0	\$0	\$0	\$0	\$0
MILCON Total*	\$0	\$0	\$0	\$0	\$0	\$0
SRM & MILCON Total*	\$36,500	\$500,000	\$220,000	\$40,000	\$2,075,000
