# NATIONAL TRANSPORTATION SAFETY BOARD

## RAILROAD ACCIDENT REPORT

COLLISION OF NORTHERN INDIANA COMMUTER  
TRANSPORTATION DISTRICT TRAIN 102  
WITH A TRACTOR-TRAILER  
PORTAGE, INDIANA  
JUNE 18, 1998

NTSB/RAR-99/03  
PB99-916303  
Notation 7055B  
Adopted July 26, 1999

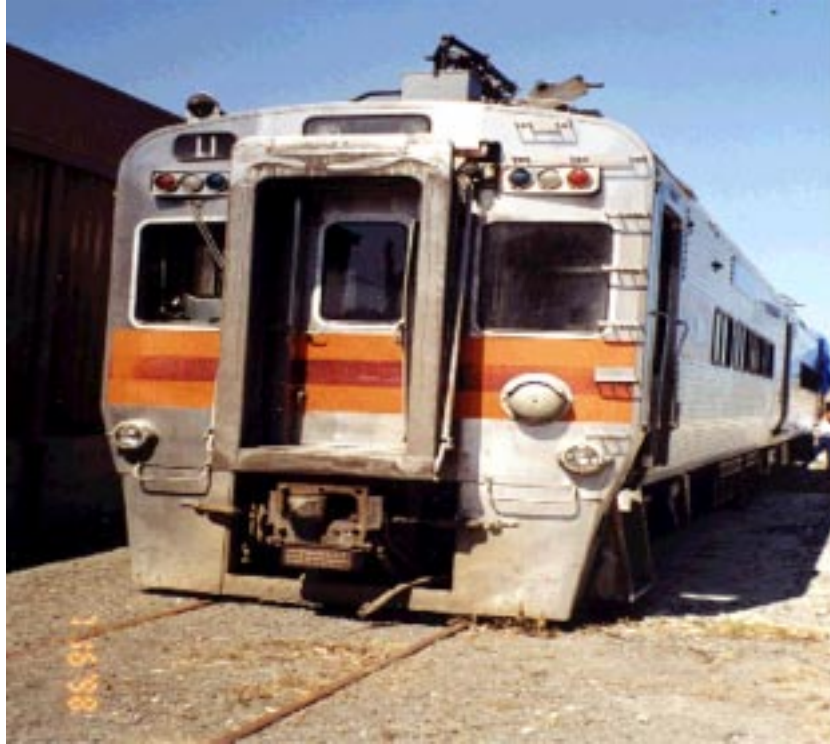
**Figure 3.** East (undamaged) end of NICTD car 11

As the collision occurred, the LCV's second semitrailer broke away from the first semitrailer and was dragged by the front of the NICTD train, while the single chain securing a steel coil to the second semitrailer broke. The released steel coil entered the lead car of the train through the front bulkhead. The coil moved through the car until it came to rest about 34 feet into the passenger compartment. (See figures 3, 4, 5, and 6.) Three fatalities and five minor injuries among the passengers resulted.

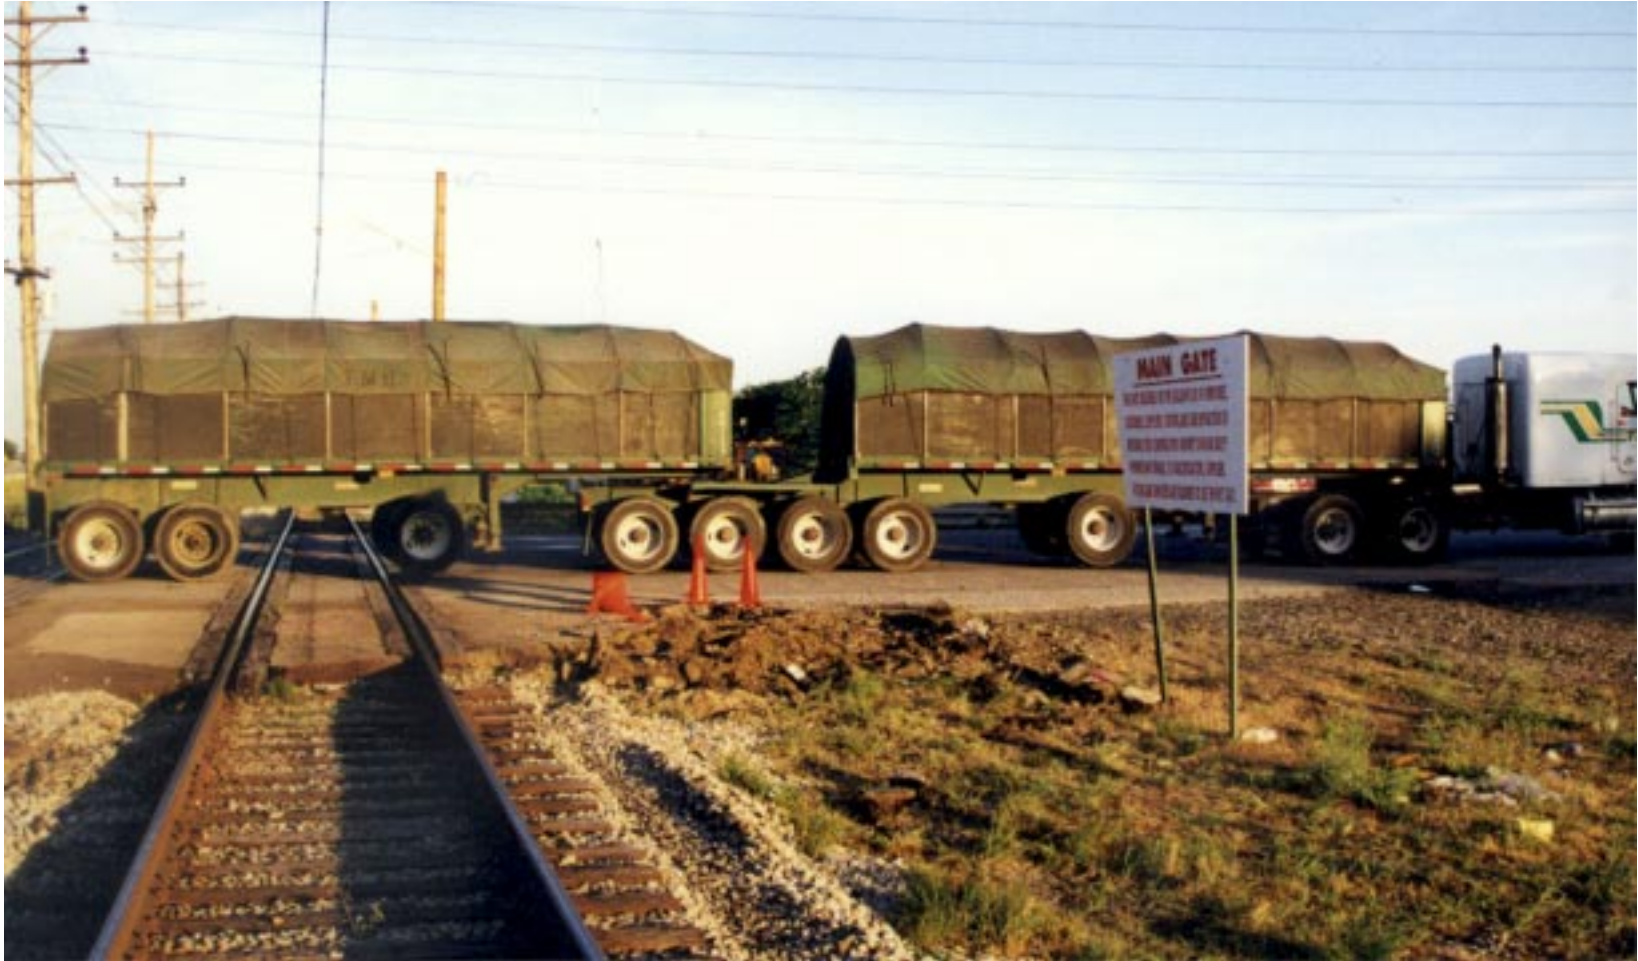
**Figure 8.** A Michigan Train at the Midwest Steel grade crossing

The LCV was a conventional truck tractor in combination with two heavy semi-trailers; such a unit is commonly referred to as a "Michigan Train."<sup>9</sup> (See figures 8 and 9 for a photo of a Michigan Train as well as a diagram of the Michigan Train involved in this accident.) The vehicle was 82 feet long, and it had a gross vehicle weight (GVW) of 153,115 pounds.<sup>10</sup>

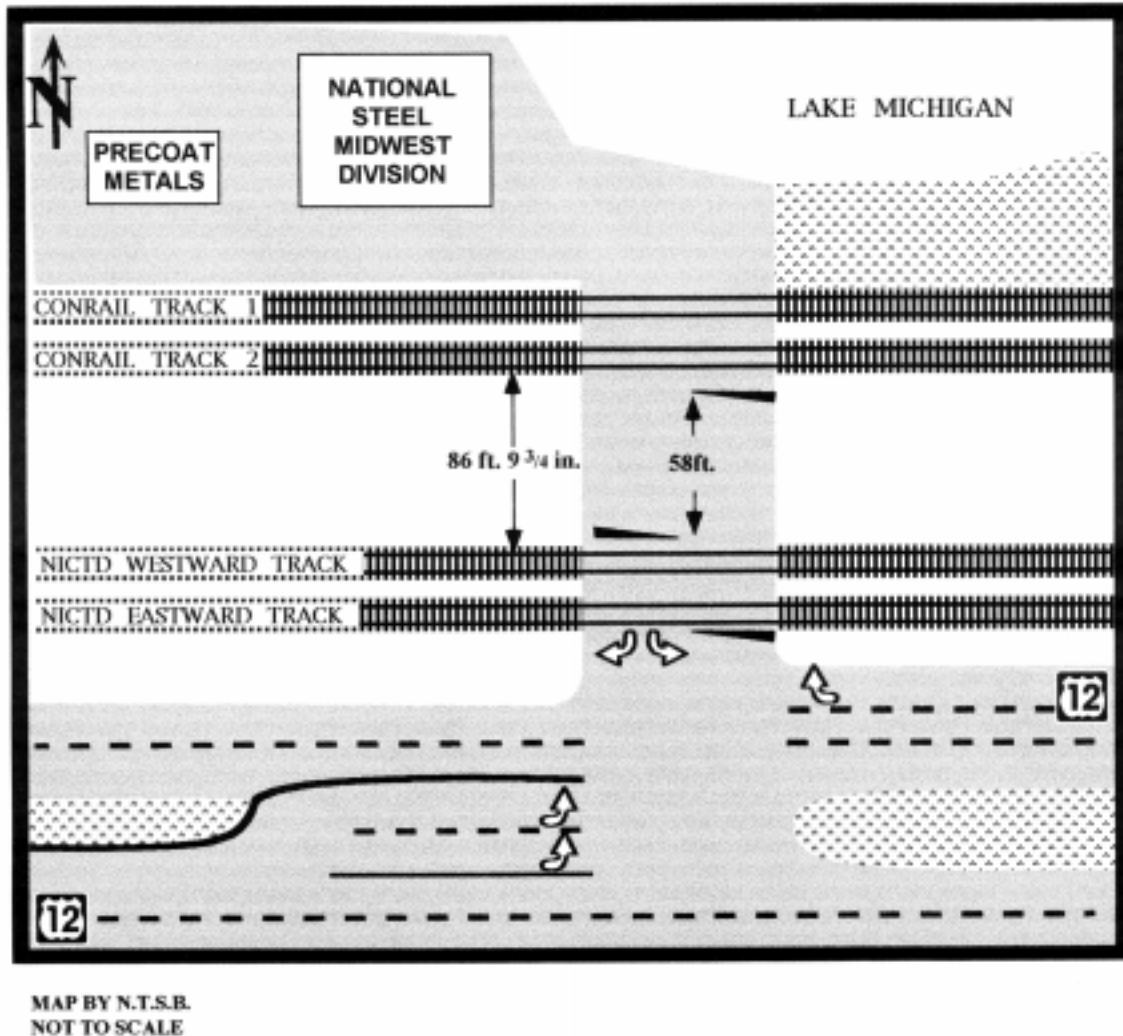
**Figure 10.** Distances at the crossing

The Conrail and NICTD sections of the crossing are separated by 86 feet and 9 3/4 inches of paved asphalt from the southernmost Conrail rail to the northernmost NICTD rail. The NICTD north gate and the Conrail south gate are 58 feet apart. (See figure 10 for representations of these distances at the crossing.)

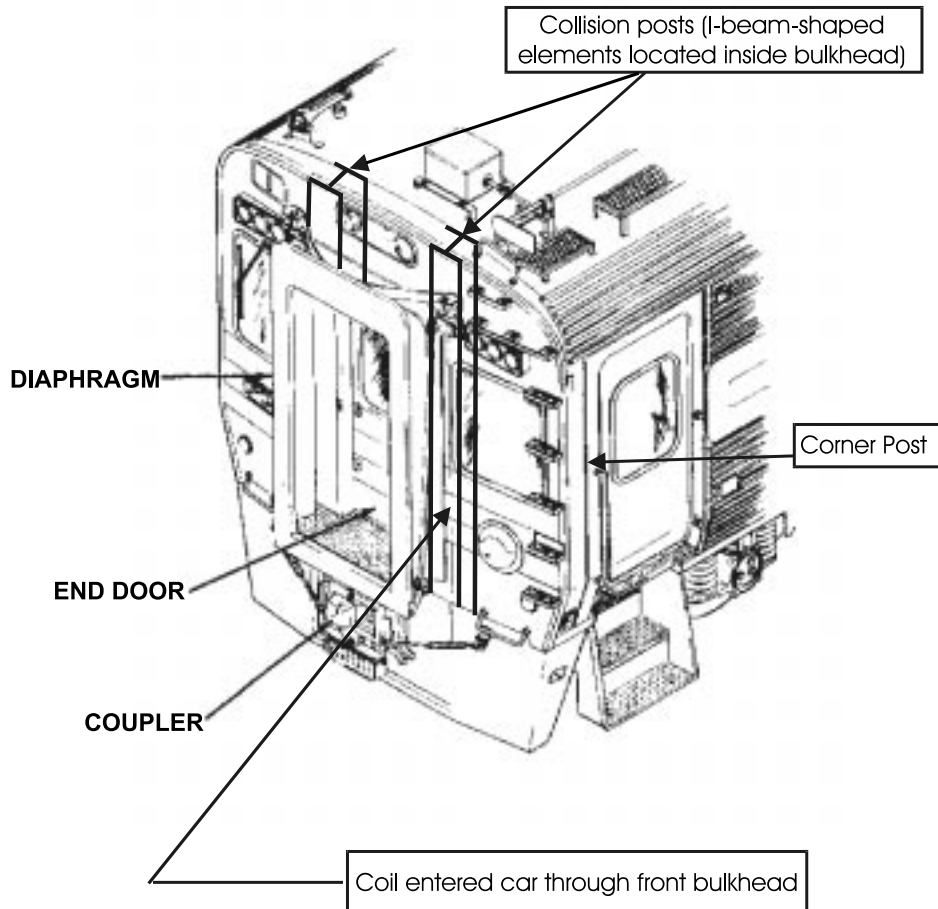
**Figure 11.** View of a typical NICTD Nippon Sharyo railcar, showing “collision post” locations within the car (Source: *NICTD Running Maintenance and Troubleshooting Manual*, September 1982 edition, as modified by the Safety Board.)

The left collision post had fractured into two pieces at a point about 39 inches above its bottom end. The connections at its upper and lower ends were not completely severed, and the top and bottom segments did not fully separate from their anchorage points. (See figure 11 for a diagram showing the collision posts within the car structure.) The front window in the operator's cab area was fractured, and several wall panels had been slightly displaced and distorted.
