PIPELINE ACCIDENT REPORT

**SAN JUAN GAS COMPANY, INC./ENRON CORP.
PROPANE GAS EXPLOSION IN SAN JUAN, PUERTO
RICO, ON NOVEMBER 21, 1996**

Abstract: About 8:30 a.m. on November 21, 1996, because of a propane gas leak, a commercial building in San Juan, Puerto Rico, exploded. Thirty-three people were killed, and at least 69 were injured.

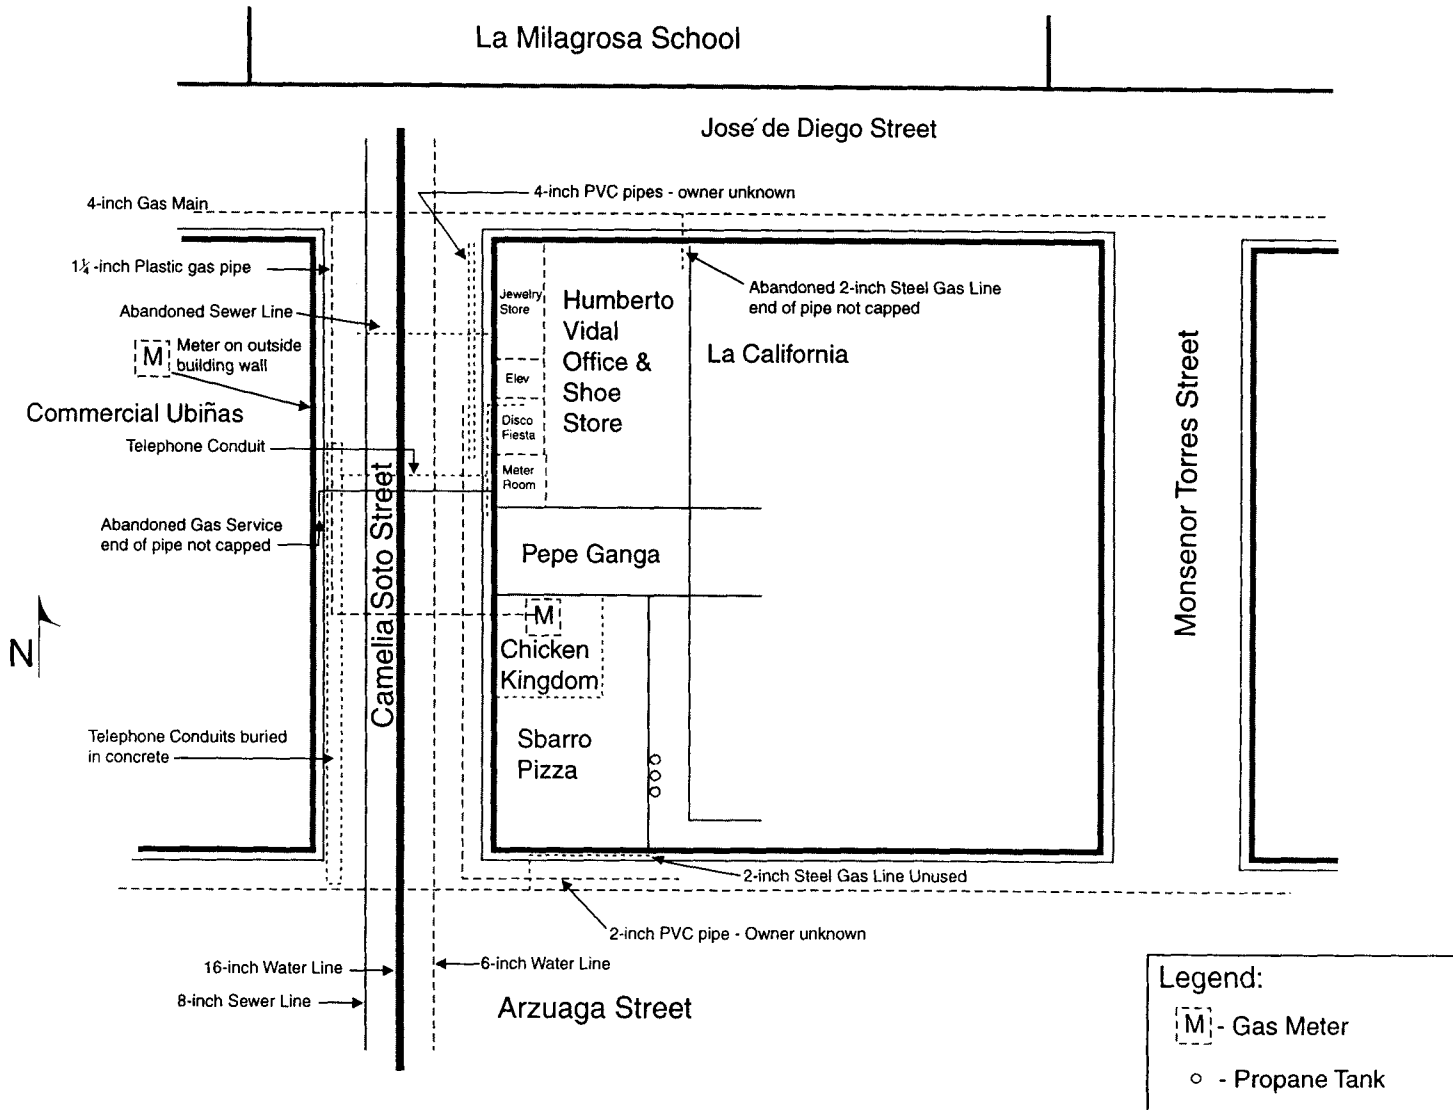
Figure 2. Sketch of Accident Area Showing Buried Conduits and Pipes.

The building was on the corner of José de Diego and Camelia Soto. (See figure 2.) The San Juan Gas Company (SJGC)¹ was the local gas pipeline distribution company. The company had a 4-inch cast-iron gas main on de Diego. A 2-inch abandoned gas line, a pressurized steel service pipe, ran from the main to the HV building, about 6 to 8 inches east of the east wall. The service pipe did not enter the building, and gas had not been used in the building for more than 10 years.
