Pedal Misapplication in Heavy Vehicles

Special Investigation Report

NTSB/SIR-09/02
PB2009-917003

NTSB/SIR-09/02
PB2009-917003
Notation 8141A
Adopted September 1, 2009

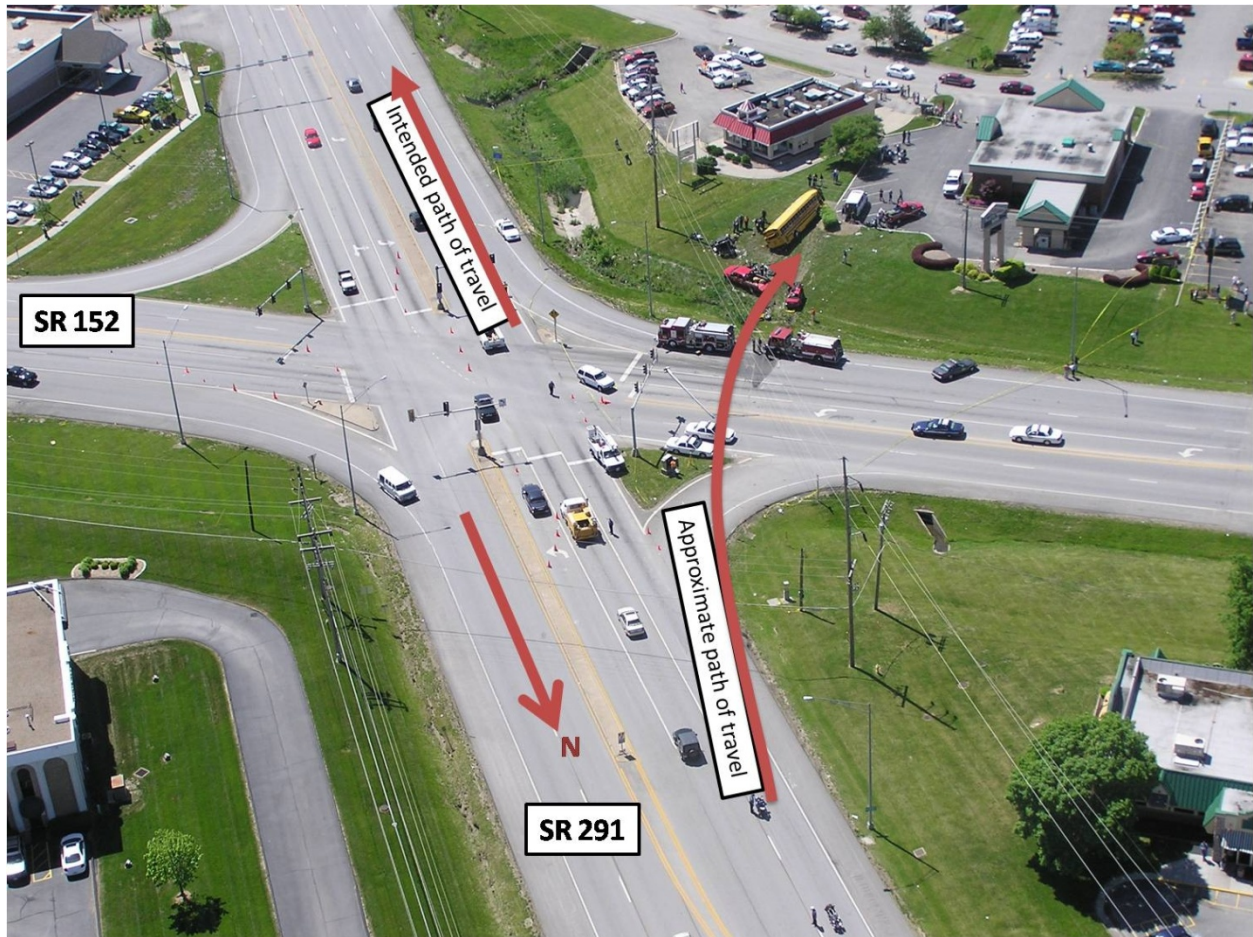
On May 9, 2005, about 8:19 a.m., a 2000 Thomas Built 84-passenger school bus, with a 45-year-old driver and 53 elementary school-aged children on board, was traveling southbound on State Route (SR) 291, approaching the intersection with SR 152, near Liberty, Missouri. (See figure 1.) The weather was clear, and the roadway was dry. The speed limit was 45 mph, dropping to 40 mph on the descending grade to the intersection. Approximately 0.5 mile prior to the intersection of SR 291 and SR 152, the bus was traveling at a global positioning system (GPS)-reported speed of 49 mph.²⁵

Figure 1. Liberty, Missouri, accident location and vehicle path. (Courtesy of Missouri State Highway Patrol)
