Truck-Tractor Semitrailer Median Crossover
Collision With 15-Passenger Van
Munfordville, Kentucky
March 26, 2010

Accident Report

NTSB/HAR-11/02
PB2011-916202

Highway Accident Report

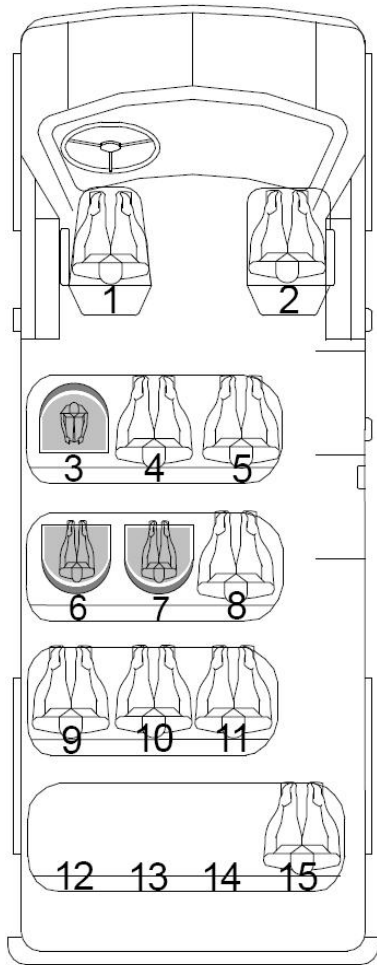
Three passengers were seated in each of rows 2, 3, and 4 of the van, and one passenger was seated in row 5. Three of the passengers were children; they were seated in child safety restraints located in the left position of row 2, and the left and center positions of row 3. One adult, a female seated in the center position of row 2, was wearing a lap belt. An inspection of the center seat lap belt revealed extensive stretching, with marks on the webbing where the latch was positioned. (See figure 6 for more information on the van occupants.)

Figure 6. 15-passenger van occupant information. (Note: Human figure images indicate occupation of a seat; shaded images indicate occupation by a child using a child restraint.)

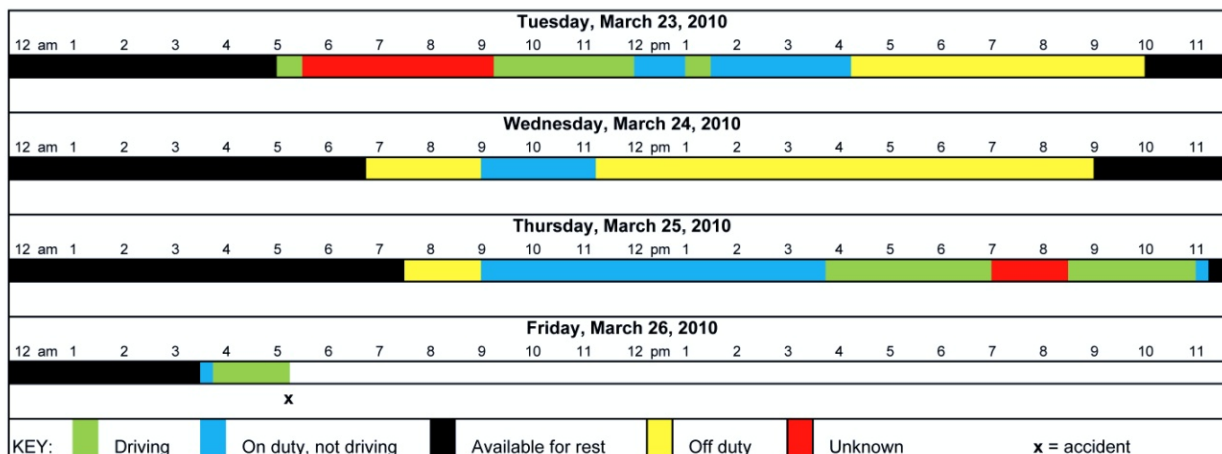
The next activity on the driver's telephone took place at 4:28 a.m. on March 26, on a cellular tower approximately 45 miles south of the overnight stop (as identified by the cellular tower that handled the text messages earlier in the night). Factoring in the drive time from the location of the 11:15 p.m. tower and the time necessary for post- and pretrip vehicle inspections, the driver had a maximum of 4 hours 15 minutes (about 11:15 p.m.–3:30 a.m.) available in which to sleep in the night before the accident.³⁵ (See figure 7 for more information on the driver's work/rest history.)

Figure 7. Truck driver's 72-hour work/rest history. [Note: Investigators were unable to confirm the driver's off-duty activity.]

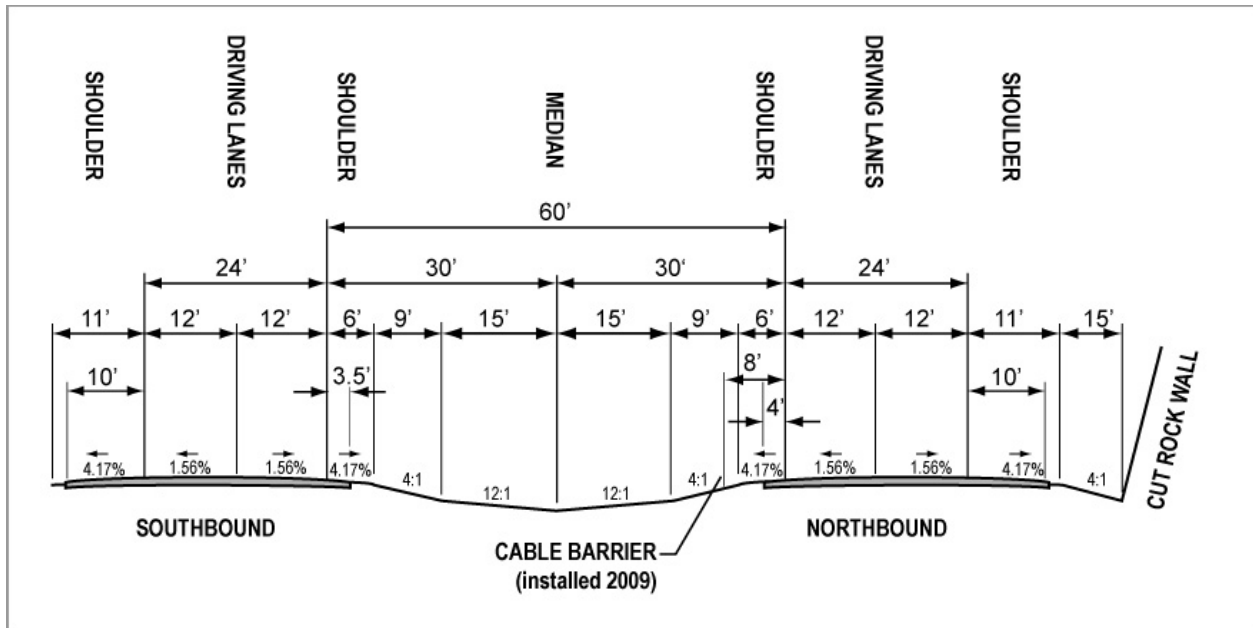
In the immediate vicinity of the accident, the interstate cuts through rock on both sides of the road. To the right of the northbound right-side lane shoulder, there is a downward-sloping drainage ditch adjacent to the cut rock wall, which is approximately 26 feet from the travel lane. Eight feet to the left of the northbound left-side lane is a longitudinal high-tension median cable barrier.⁵¹ (See figure 8.) The alignment of the southbound travel lanes is straight for approximately 700 feet approaching the accident location on a slight downhill grade. The crest of the downhill grade is 3,940 feet north of the point of the accident truck's departure from the road; for 640 feet before this point, the southbound roadway has a 2.6-percent downgrade, prior to that, the downgrade is approximately 1.9 percent.

⁵⁰ From the median center, a 15-foot width distance to either side is on a 1:12 slope, resulting in a vertical drop of 1.25 feet. The elevation then transitions to a 1:4 slope for a distance of 9 feet, resulting in a vertical drop of 2.25 feet. The elevation then transitions over a distance of 6 feet from a 4.17-percent cross slope to the level apron of the highway. This configuration yields a total vertical drop from the highway to the center of the median of approximately 4 feet.

Figure 8. Topography of the I-65 roadway and median.

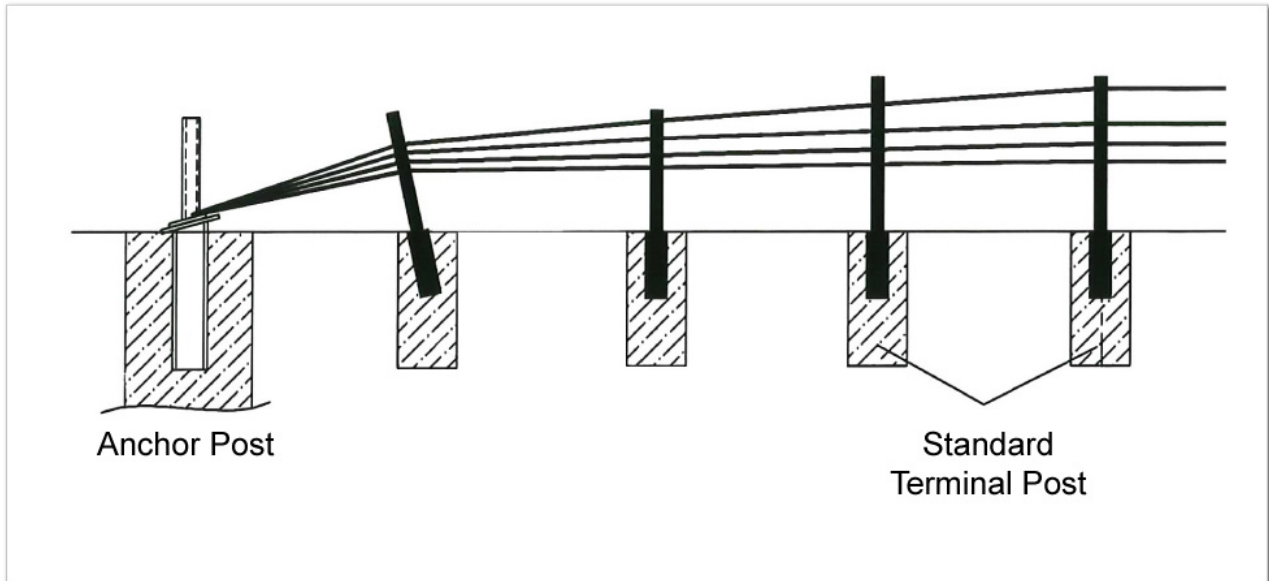
A longitudinal high-tension cable barrier system was installed 8 feet to the left of the northbound travel lanes in the median of I-65; there was no barrier system adjacent to the southbound lanes. The cross-slope break⁵⁹ began 6 feet from the roadway edge; the cable barrier was 2 feet into the 1:4 slope. The proprietary cable barrier system, from Gibraltar Cable Barrier Systems, L.P. (Gibraltar), was a four-cable design mounted on 42-inch posts spaced 10 feet apart. The posts, which had metal sleeves installed in concrete foundations,⁶⁰ were placed on alternating sides of the four high-tension cables, which were attached using cable link attachments and locking plates.⁶¹ (See figures 10 and 11 for diagrams showing the general design of the four-cable barrier system and a cross-section view of a standard post.)

Figure 10. Type of four-cable barrier system used near the accident site.

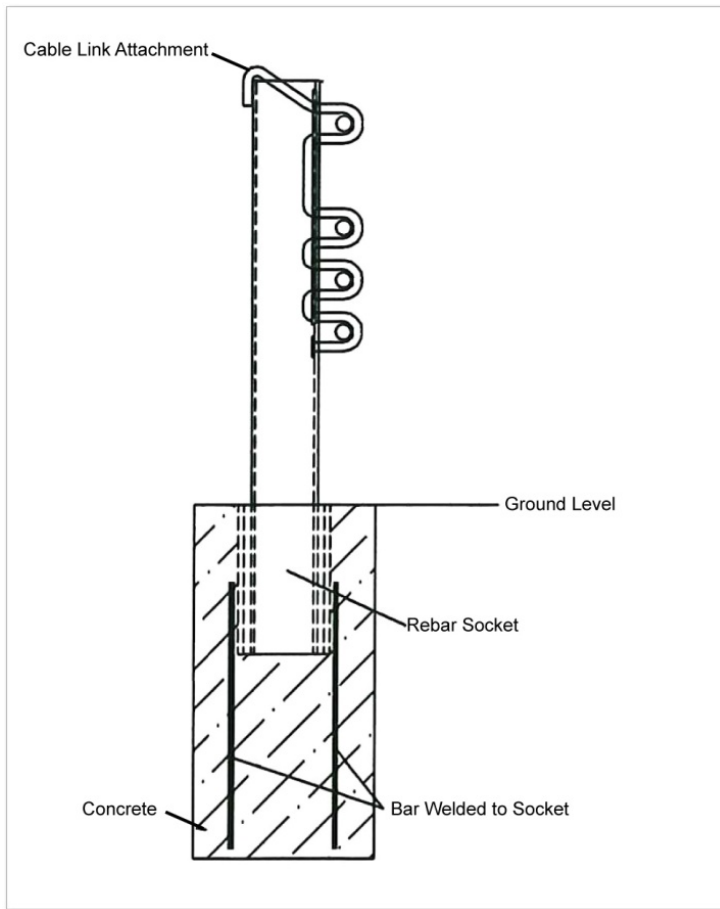
Figure 11. Cross-section of a standard post for a four-cable barrier system.

Design drawings indicated that posts placed on alternating sides of the cable were to be used in bidirectional traffic flows. If installed for traffic in one direction, the cables were to be placed on the traffic side of the posts. The I-65 installation used alternating sides of the posts, which could accommodate bidirectional traffic. Cables were mounted at heights of 20, 25, 30, and 39 inches. The cables were fastened to concrete end anchor posts approximately 1.4 miles north and 0.4 mile south of the accident site, for a total length between anchor posts of 1.8 miles (9,504 feet). The concrete end anchor posts measured 2 feet by 6 feet. The barriers had a design deflection distance of 6.8 feet during crash testing, which used 350-foot anchor spacing and 10-foot post spacing.

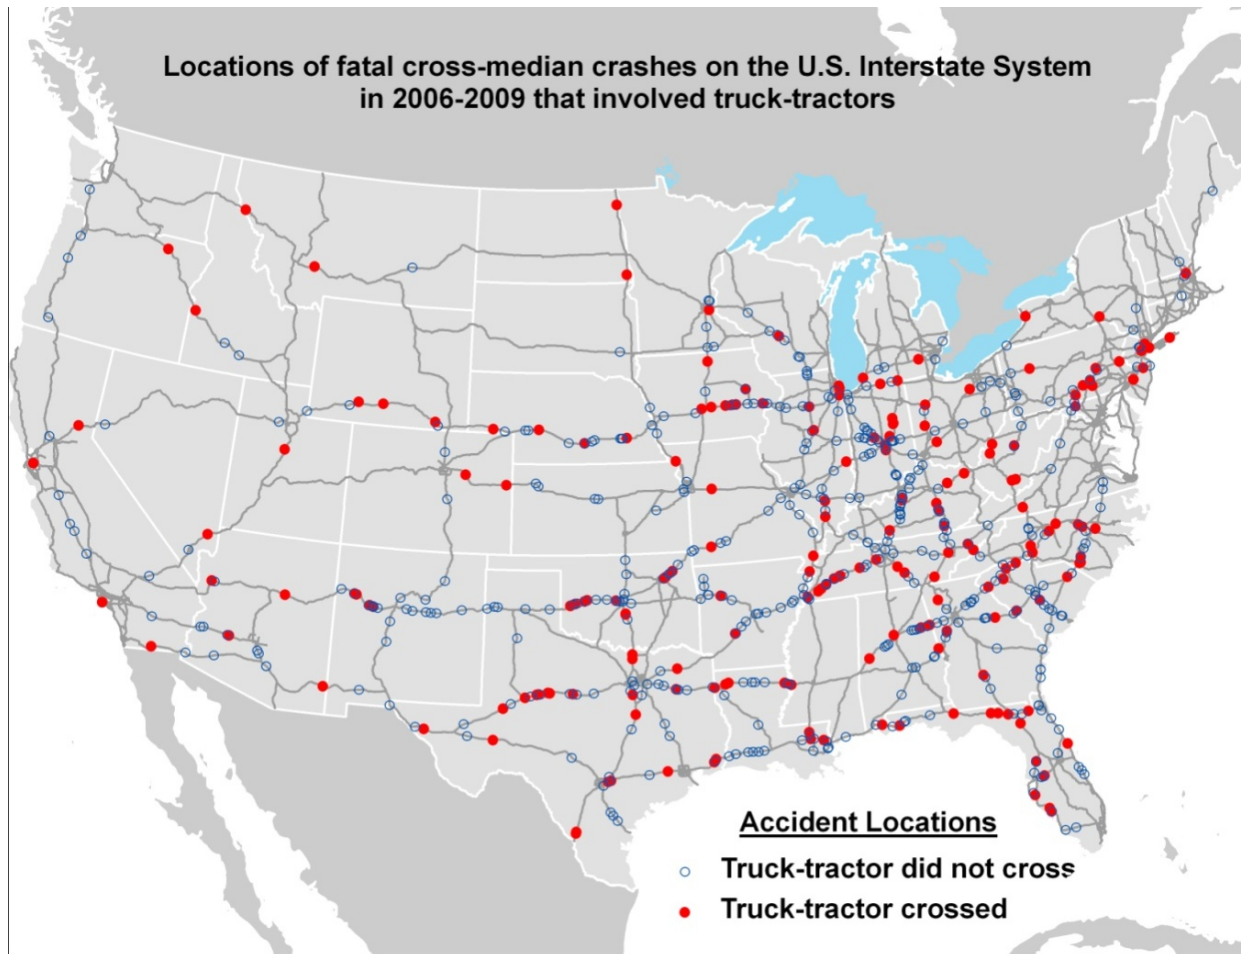
The Federal Highway Administration (FHWA) estimates that, as of 2008, about 2.2 million truck-tractor combination units were registered, and the average miles traveled per combination unit for that year were about 64,800 miles.⁶⁵ (See figure 13 for the sites of fatal cross-median truck crashes on interstates in 2006–2009. Location identification information [latitude/longitude data] is not available for 2005 accidents.)

Figure 13. Fatal cross-median truck crashes on interstates from 2006–2009.

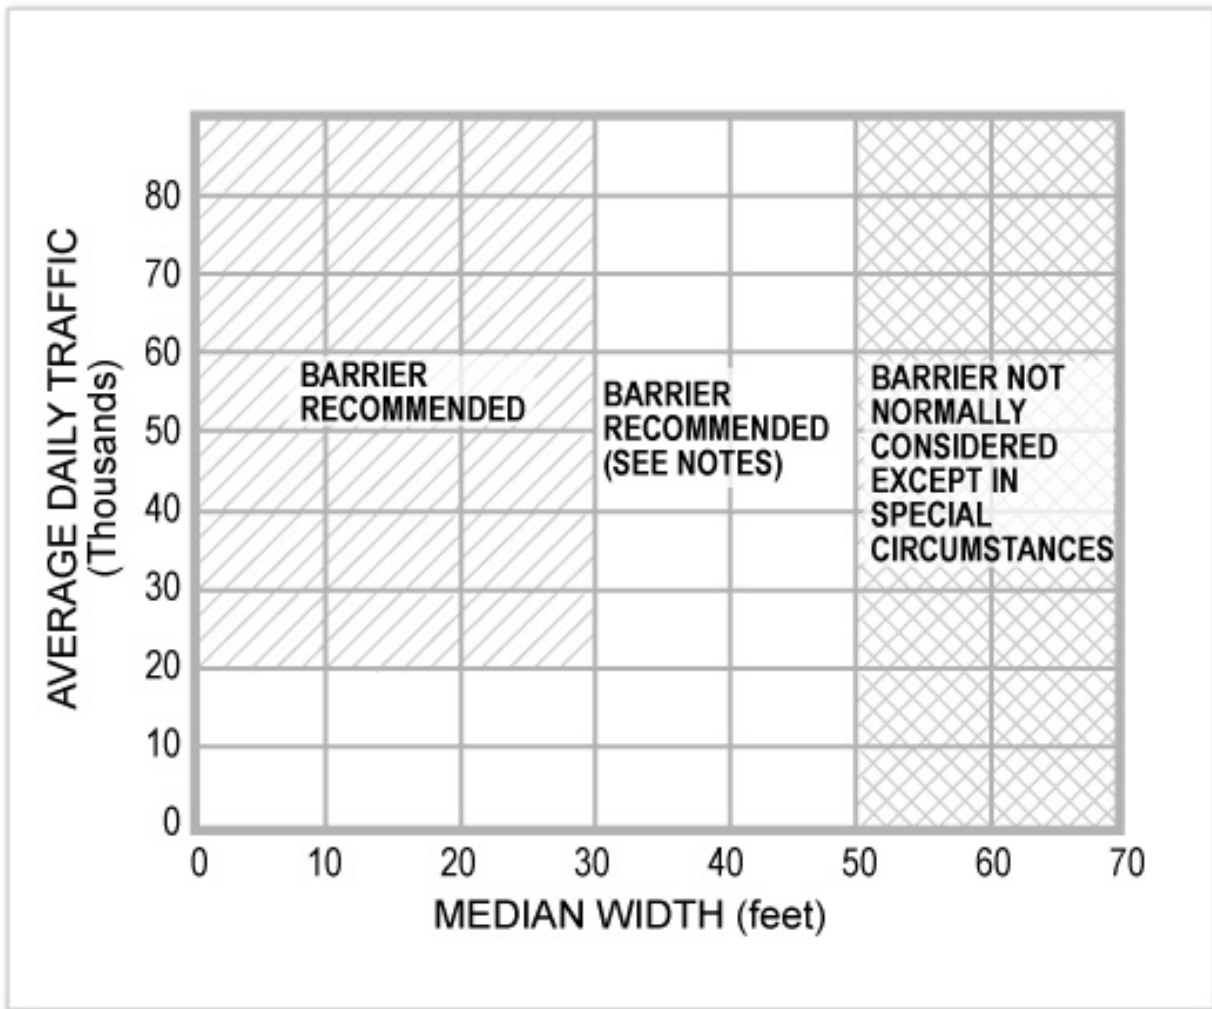
that a barrier is not cost-effective.⁷⁶ To apply this flexibility, states are encouraged to conduct a study, such as a cost/benefit analysis, for medians on their system to determine whether a barrier is appropriate in these locations. For locations with median widths greater than 50 feet, the *Roadside Design Guide* indicates that a barrier is not typically necessary except in special circumstances, such as at a location with a significant history of cross-median crashes. (See figure 14 for the guidelines from the *Roadside Design Guide* for determining when to install a median barrier.)

Figure 14. *Roadside Design Guide* guidelines for determining whether to install median barriers on high-speed, fully controlled-access roadways. Notes to the guidelines encourage states to conduct a study on whether a barrier is appropriate for locations with medians 30–50 feet wide, as well as for locations with medians less than 30 feet wide with ADT less than 20,000. (Adapted from the *Roadside Design Guide*, figure 6.1.)

¹⁶⁰ The *Roadside Design Guide* recommends installing barriers on medians with widths of 30 feet and less; for medians with widths between 30 and 50 feet, a median may be recommended, depending on the results of further study. (See figure 14 of this report for reference.)
