NTSB National Transportation Safety Board

Lessons from Icing Accidents and Incidents

Presentation of NTSB Board Member Dr. Earl Weener

Experimental Aircraft Association February 1, 2011

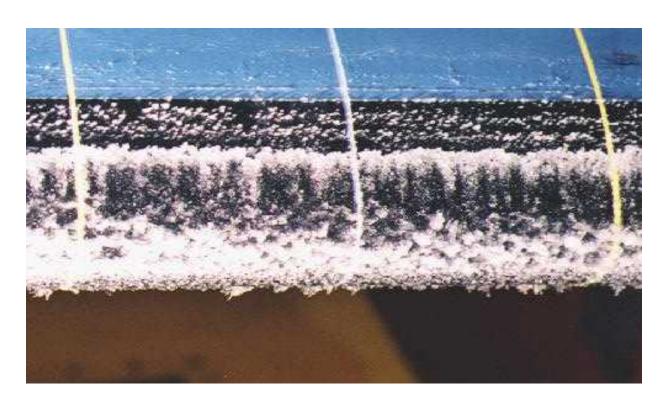
Resultant Ice Shapes

Front Edge of Wing

Rough Ice

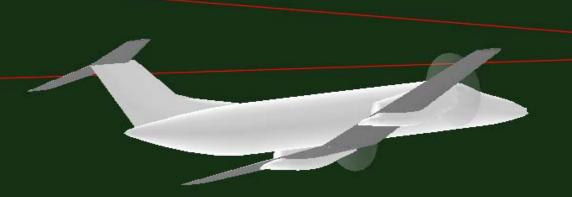
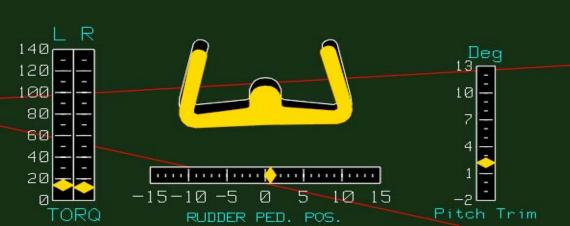
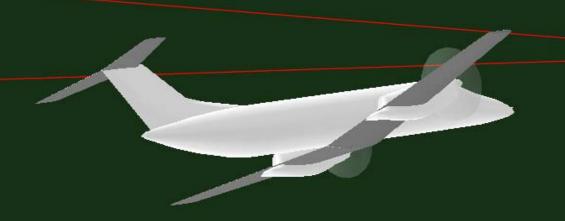
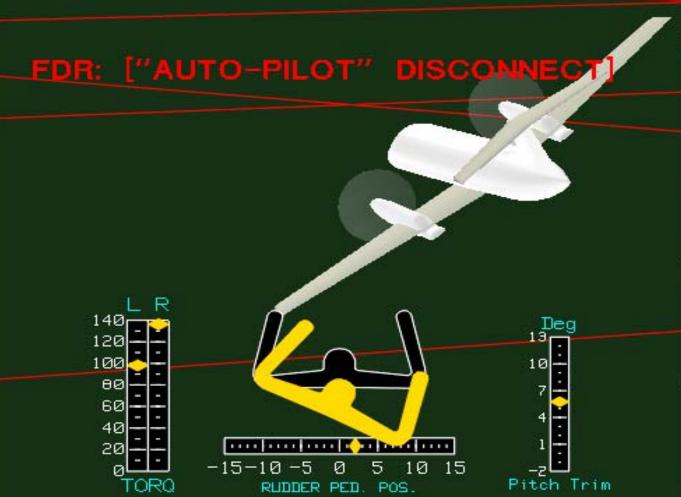
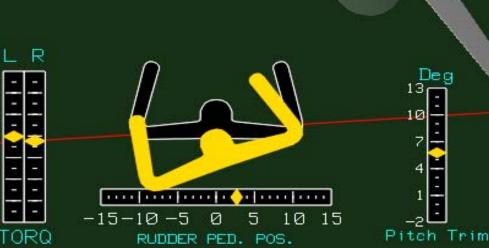
Accident Sequence – COM 3272

ENTERING THE LEFT TURN

START OF A/P WHEEL TO RIGHT 1880

AUTOPILOT DISCONNECT

2 SECONDS AFTER A/P DISCONNECT

CAM: [STICK SHAKER "ON"]
FDR: ["AUTO-PILOT" DISCONNECT]

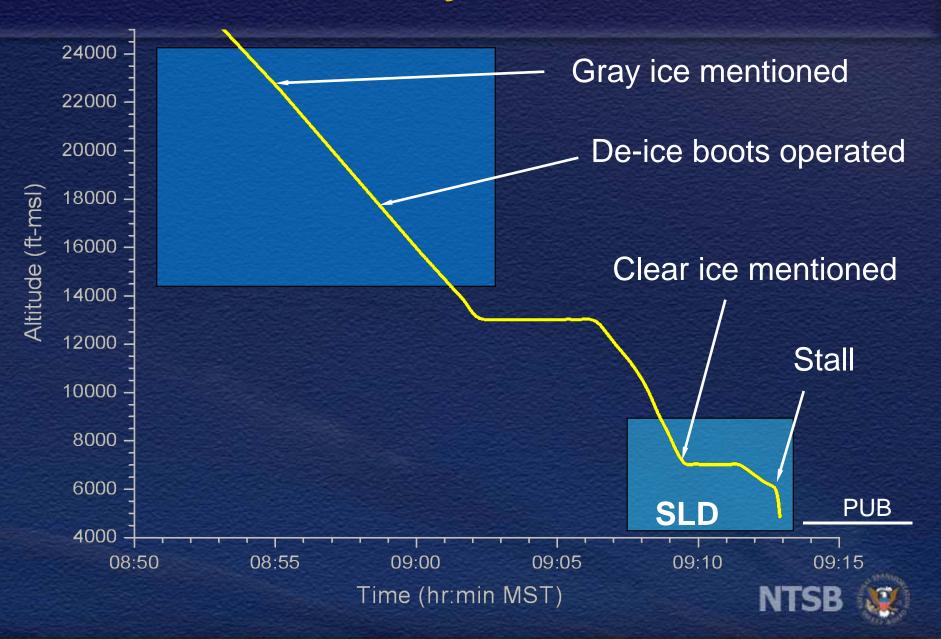
Altitude Time History – C560

- Airplane slowed below Vapproach
- De-ice boots not operated in second icing layer
- Presence of an estimated 1/6 of an inch or less of ice accreted in SLD conditions caused the airplane to stall prior to stick shaker
- Airplane entered a rapid left roll prior to stall warning
- Airplane did not recover in the 1,500 feet agl available

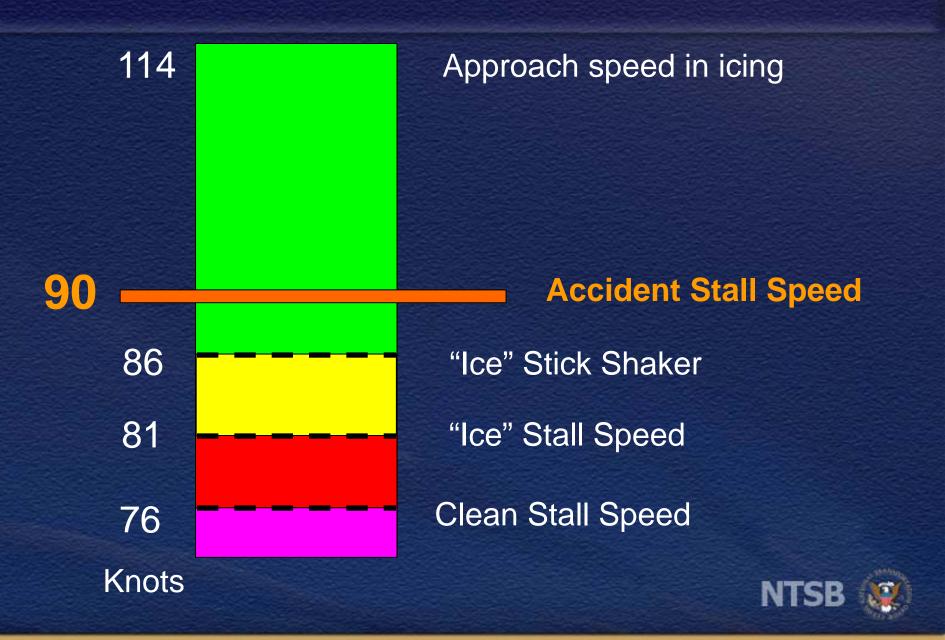
C560 Accident Airplane Relevant Speeds

"The flight crew's failure to effectively monitor and maintain airspeed and comply with procedures for deice boot activation on the approach, which caused an aerodynamic stall from which they did not recover..."

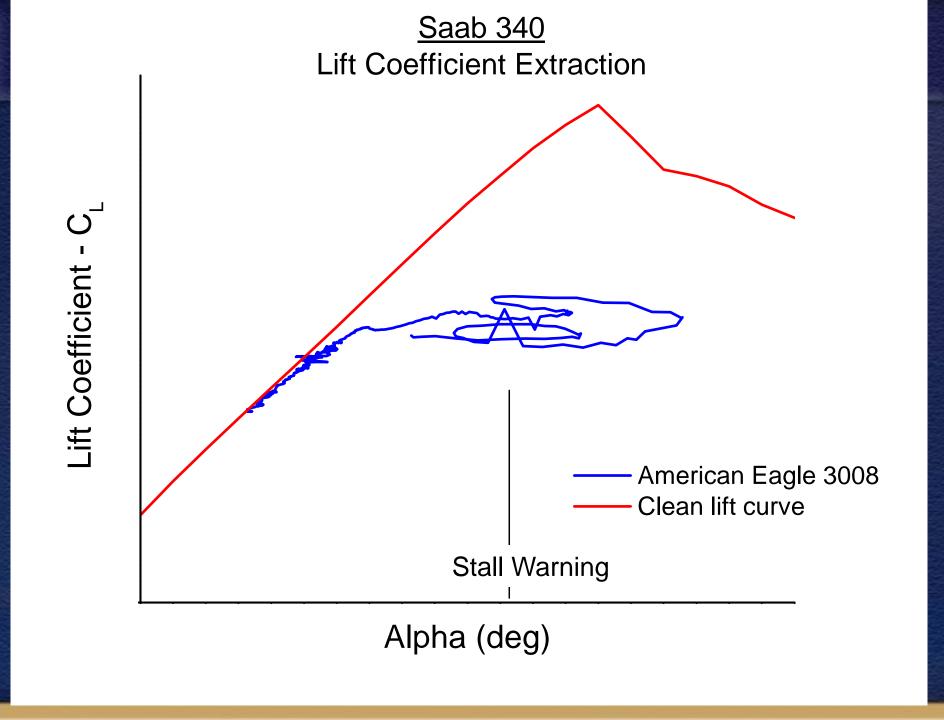
- American Eagle Saab 340B San Louis Obispo, CA - January, 2006
 - Slowed on autopilotLost 5000 feet altitude

- Nearly inverted

- Resulted in 4 recommendations
 - Minimum airspeed
 - Modify stall protection
 - Ice detection
 - Disengage autopilot in icing conditions, except in periods of high workload
- FAA working with Saab and EASA to determine response.
- FAA issued Safety Alert for Operators
