UMM QASR WATER SCHEME, IRAQ

PROJECT NUMBER SIGIR-PA-05-028

JULY 24, 2006

SUBJECT: Report on Project Assessment of the Umm Qasr Water Scheme, Iraq (Report
Number SIGIR-PA-05-028)

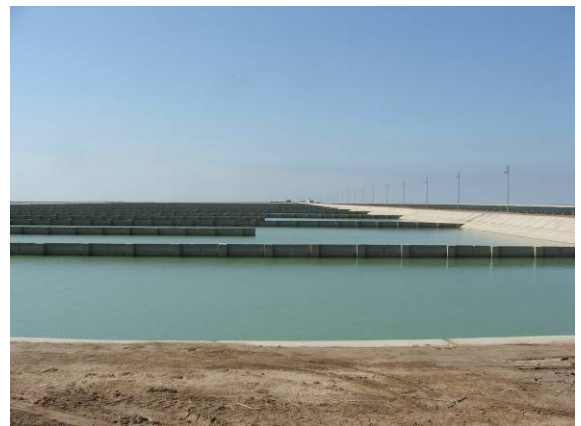
The 45 km unlined portion of the SWC we were able to visit was located between km 193 and the settling basins (km 238). Signs of past maintenance activities were observed and included dredge spoils located parallel to the canal route. Dredge spoils included a combination of soils and vegetation. Maintenance equipment, maintenance staff, or signs of recent maintenance activities were not observed at any point of the unlined section of the canal. A single set of tire prints from a heavy equipment vehicle was observed parallel to the canal. The main channel appeared free of vegetation, although vegetation was observed growing on the sides of the canal. The sluice gates which control water from the SWC to the settling basins and the settling basins themselves appeared serviceable.

Site Photo 18 shows an example of the unlined section of the SWC, Site Photo 19 shows recent tire prints from a heavy equipment vehicle, and Site Photo 20 shows dredge spoils located parallel to the canal. Site Photo 21 shows sluice gates used to control water at the entrance of the settling basin and Site Photo 22 shows the settling basin.

Site Photo 22. Settling basins
