PRIMARY HEALTH CARE CENTERS
NUMBERED KE-01, KE-02,
KE-03, KE-04, AND KE-05
KIRKUK, IRAQ

SIGIR PA-06-042
SIGIR PA-06-043
SIGIR PA-06-044
SIGIR PA-06-045
SIGIR PA-06-046

SUBJECT: Report on Project Assessments of Primary Health Care Centers Numbered
KE-01, KE-02, KE-03, KE-04, and KE-05 in Kirkuk, Iraq (Report Numbers
SIGIR-PA-06-042, PA-06-043, PA-06-044, PA-06-045, and PA-06-046)

Primary Health Care Centers Numbered KE-01, KE-02, KE-03, KE-04, and KE-05 Kirkuk, Iraq

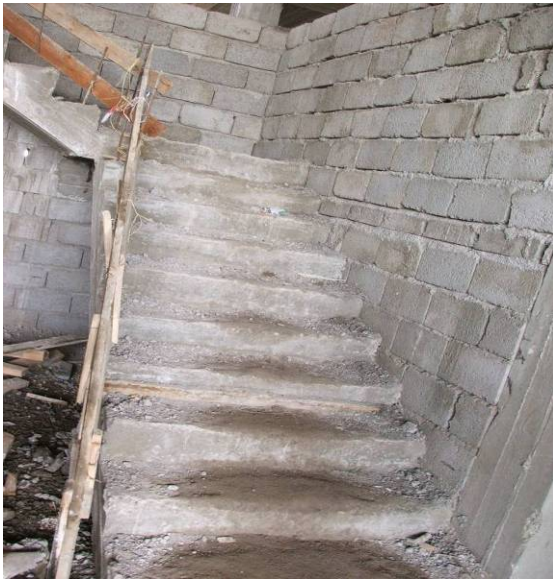
The project design required the construction of one stairwell from the interior ground floor to the first floor, consisting of “cast in-place” reinforced concrete. During our site visit, we verified that in each PHC the concrete stairwells were in-place, although the workmanship of the concrete placement was poor. We identified the following: uneven surfaces (Site Photo 7), small pieces of the stair steps were chipped (Site Photo 8), the appearance of concrete segregation on the side and underneath the stairwell (Site Photos 9 and 10, respectively). Site Photos 11 and 12 show a stairwell and the poor quality of the concrete mixture. During its construction, each PHC’s stairwell appears to have been utilized by the construction crews to move equipment from the ground floor to the first floor. While some of the damage may be attributed to construction activities, the majority of the deficiencies appeared to be due to poor concrete workmanship.

Site Photo 7. Uneven steps (PHC Hai Tis'een)

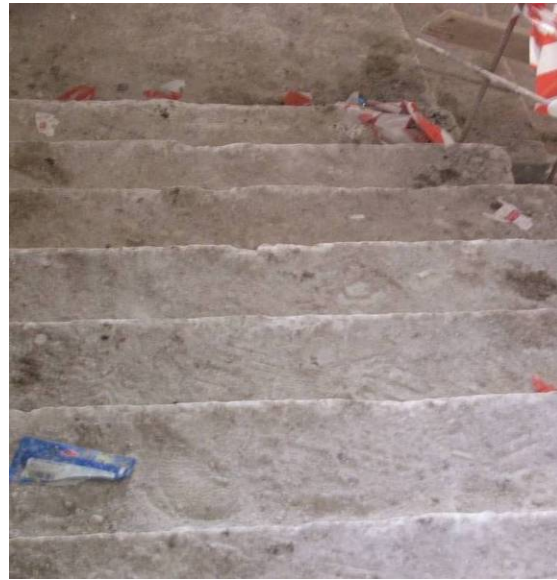
Site Photo 8. Chipped steps (PHC Hai Alhajjaj)

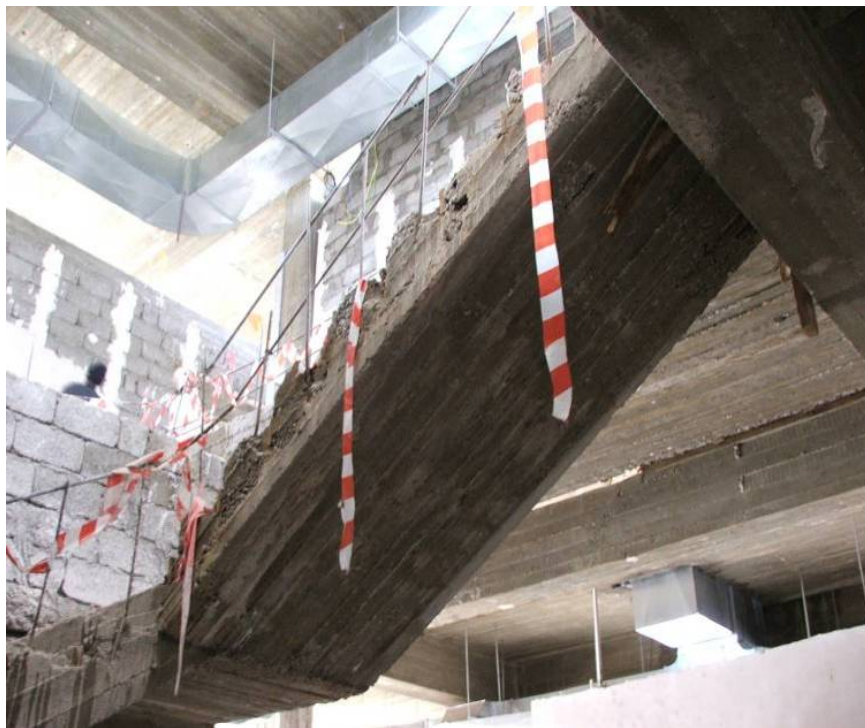
Site Photo 11. View of stairwell (PHC Hai Al Wasily)

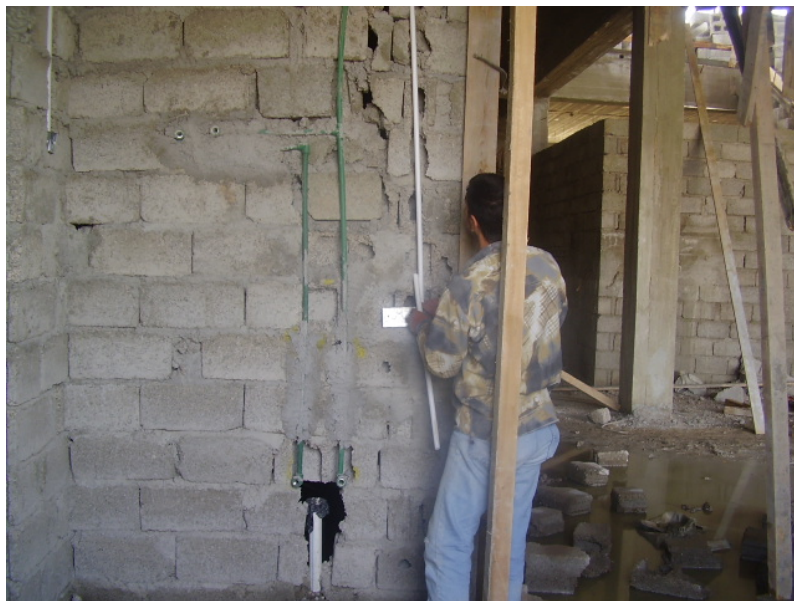
example of the 14 Feb 2006 QA report for the Hai Tis'een PHC. The USACE LN QA engineer attached a photograph (Site Photo 5 repeated below) to the daily QA report with the caption "KE-03 – installing pipe for electrical works." The daily QA report does not identify the obvious poor quality concrete workmanship, and the Gulf Region Division's project engineer did not document this issue either. There is no indication this problem was brought to the contractor's attention for corrective action.

Site Photo 5. Local National Quality Assurance Engineer photograph

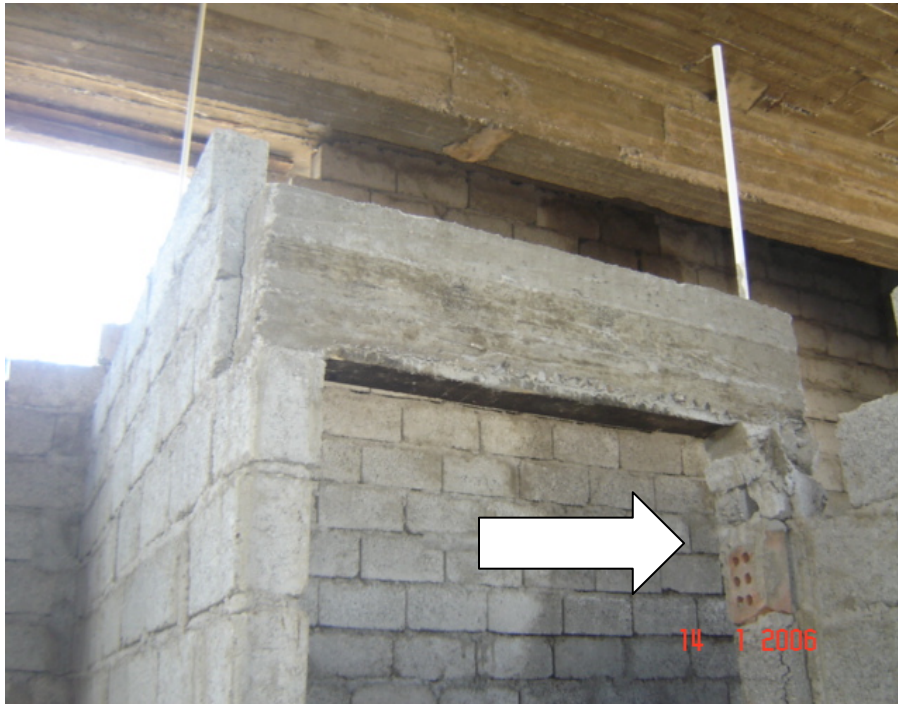
Further, the daily QA reports were not sufficiently complete and accurate. For example, the LN QA daily reports did not always document the existence of construction concerns. Specifically, one LN QA daily report included a photo of poor concrete quality beneath a lintel (Site Photo 23); however, the narrative daily report did not mention this problem nor does it mention if the LN QA engineer brought this problem to the contractor's attention. From reviewing the LN QA daily reports, we were unable to determine if the contractor corrected this problem.

Further, the Gulf Region Division's comments to our report do not address concrete work for poorly constructed load bearing lintels (Site Photos 23 and 24, repeated below). Both Site Photos, provided in the draft report, document poorly constructed lintels. While the Gulf Region Division may believe that gaps, broken blocks, and improper block placement are "acceptable" for non load-bearing walls, lintels are load bearing members used to support material over doorways and windows.

Site Photo 23. Example of a site photo included with the daily report. Taken by the USACE LN QA for PHC Shiqaq Hai Musalla (Photo courtesy of the USACE)

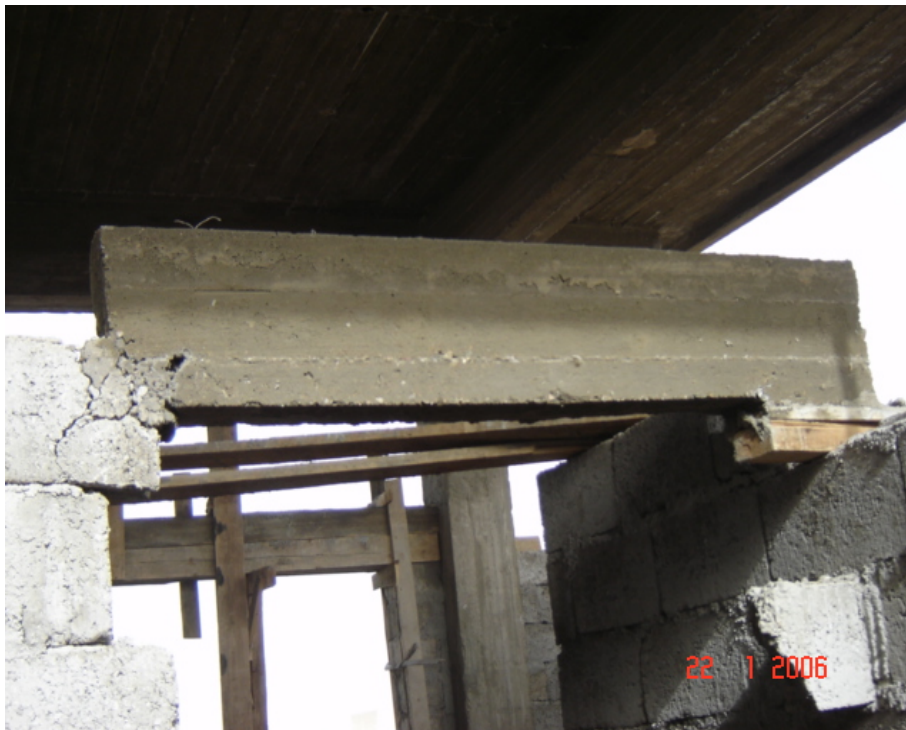
In the instances in which the LN QA engineer documented construction issues within the QA daily reports, there was no certainty that the contractor took corrective actions. For example, on 22 January 2006, the LN QA daily report and site photo documenting the poor installation of a lintel (Site Photo 24). The QA daily report, in the General Remarks section stated, “Some of the lintels have bad installation.” Yet, there is no mention in the daily report that the LN QA addressed this problem with the contractor. The contractor’s QC daily report did not identify this problem and did not mention any discussions with the LN QA regarding this issue. After reviewing the next few days QC and QA daily reports, there was no documentation that the contractor addressed and corrected this issue.

Site Photo 24. Example of a site photo included with the daily report. Taken by the USACE LN QA (Photo courtesy of the USACE)

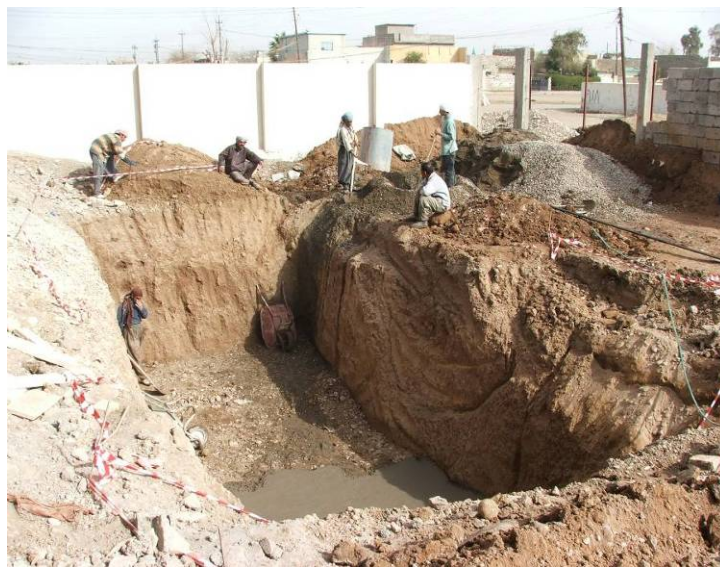
Site Photo 30. Excavated hole for septic tank

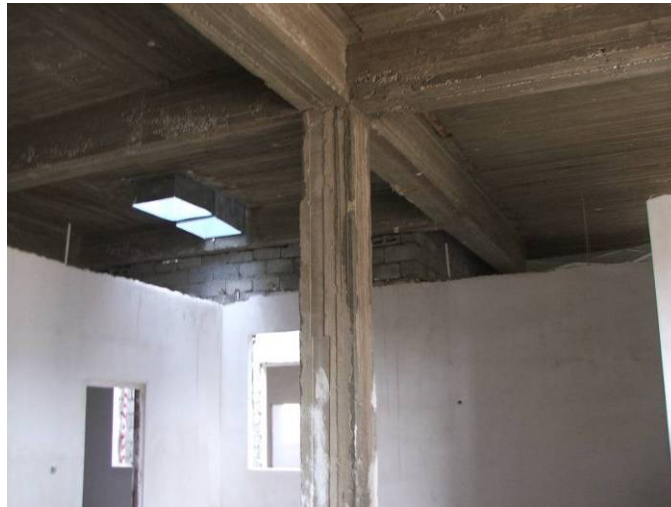
All reinforced concrete columns, slabs, and ceiling beams appeared complete and the formwork was removed (Site Photo 31). The contract and design specifications required cast in-place reinforced concrete structural beams, columns, and slabs. Due to time constraints on site, we assessed only a fraction of the structural concrete work. The ground floor columns, ground floor structural beams, ground floor ceiling slab, interior stairwell, x-ray room walls, first floor structural beams, first floor columns, and first floor ceiling slab all appeared almost complete; however, we identified quality issues. During the site assessment, we observed work in progress on the block walls and roof. The block walls appeared to be of substandard construction with quality problems. For instance, we observed block rows not level, walls with unfilled gaps between blocks, broken blocks and bricks of different sizes used in wall construction, and blocks improperly installed. Site Photo 32 shows broken blocks used in wall construction. We observed a partial application of tar on the roof; however, the placement of concrete roofing tiles had not started. Site Photo 33 shows the partial application of tar on the roof.

Site Photo 31. First floor structural column and beams

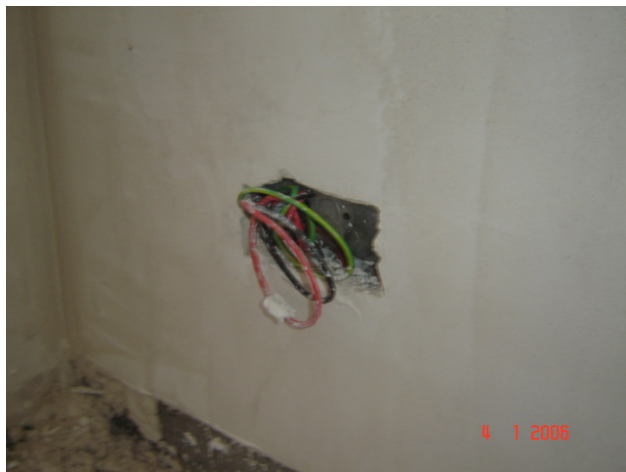
The SORS required all electrical design and construction to comply with the International Electrotechnical Commission Standards (IECS). The SORS required new energy efficient lighting, switched power outlets, and lighting switches. Electrical power and lighting requirements included interior and exterior lighting, surgical lighting, commercial grade wiring, panels, breakers, switches, outlets, junction boxes, transformers, connectors, and fixtures. Additional submittal requirements included switchgear, electric heaters, sump pumps, lightning protection, radio paging, emergency lighting, fire alarm system, central control and maintenance system, and the circuit protection. In addition, the SORS required a safe and sufficient power connection to the local grid and critical, standby, and primary power generators. At the time of the assessment, the electrical system installation was underway. We observed basic electrical preparatory work. The electrical work assessed consisted of the installation of polyvinyl chloride (PVC) conduit and plastic or metal electrical boxes attached to the surface of the block walls or recessed in a chiseled section of the wall. We observed plaster coating on some walls. We identified wiring installed inside the PVC conduit in some areas. For a picture of the basic electrical work completed, see Site Photo 34.

Site Photo 34. Electrical wiring (Photo courtesy of USACE)

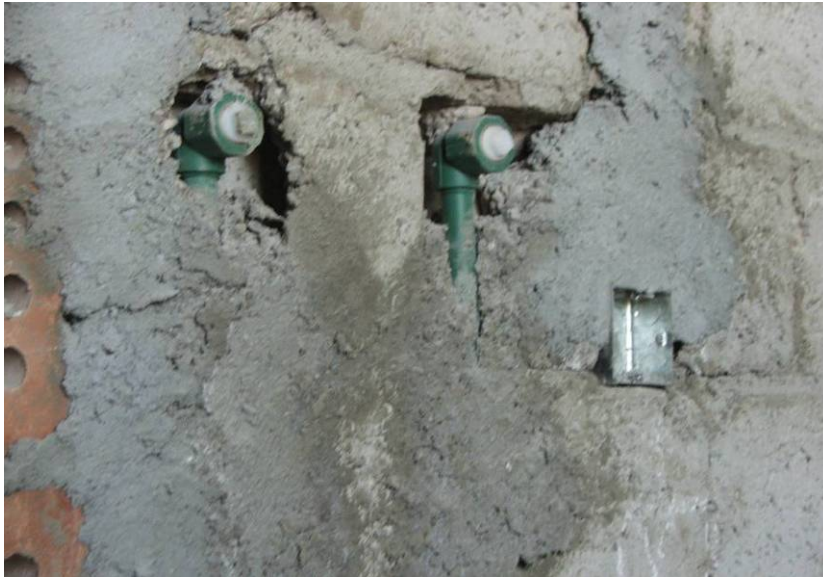
Site Photo 37. Plumbing pipes placed in block wall

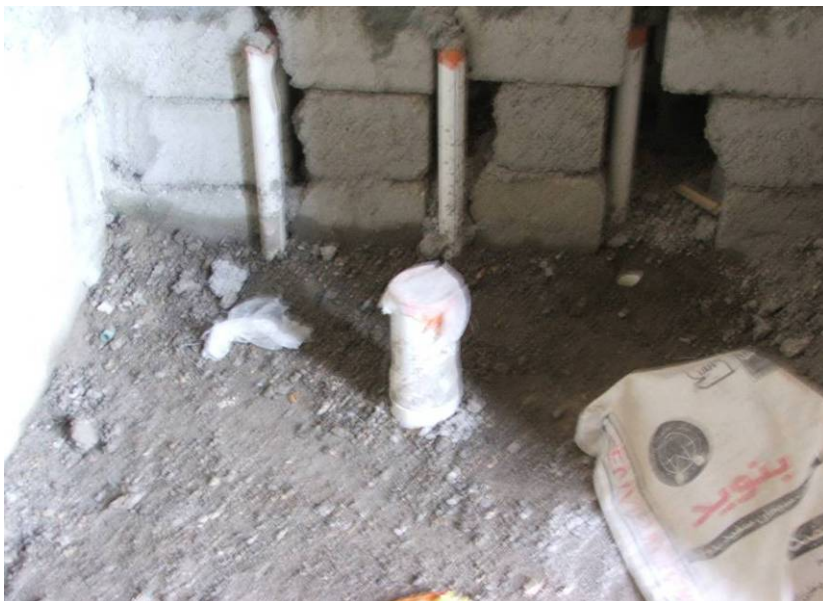
Site Photo 38. Plumbing pipes placed in concrete slab

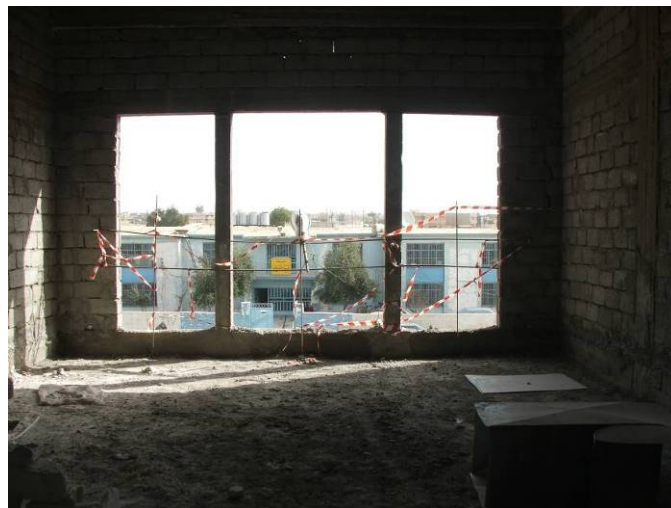
The contractor had neither completed the window frames nor installed any windows or security grilles (Site Photo 40). We did not observe any interior wall painting, the fabrication of the suspended ceiling, or tile work. We did not observe any doors, windows, or hardware on site.

Site Photo 40. Example of windows without window frames

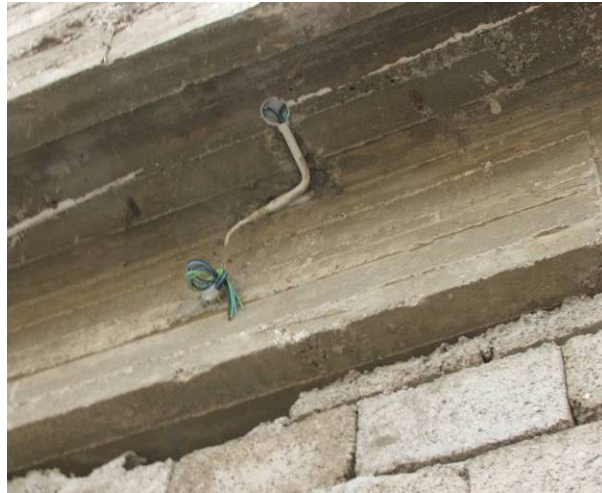
electrical preparatory work. The electrical work assessed consisted of the installation of PVC conduit and plastic or metal electrical boxes attached to the surface of the block walls or recessed into a chiseled section of the wall. We identified wiring installed inside the PVC conduit in some areas. For a picture of the basic electrical work completed, see Site Photo 44.

Site Photo 44. PVC conduit installed in structural concrete

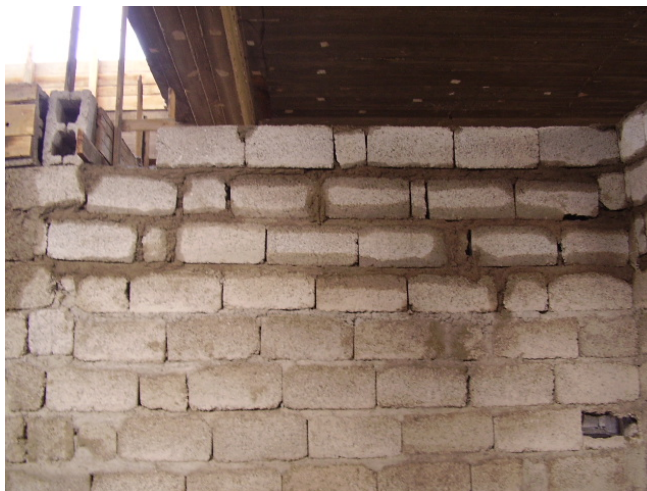
All reinforced concrete columns, slabs and ceiling beams appeared complete and most of the formwork removed. For a picture of the remaining formwork and structural beams, see Site Photos 52 and 53, respectively. The contract and design specifications required cast in-place reinforced concrete structural beams, columns, and slabs. Due to time constraints on site, we assessed only a fraction of the structural concrete work. The ground floor columns, ground floor structural beams, ground floor ceiling slab, interior stairwell, x-ray room walls, first floor structural beams, first floor columns, and first floor ceiling slab all appeared almost complete; however, we identified quality issues. During the site assessment, we observed work in progress on the block walls. The block walls appeared to be of substandard construction with quality problems. For instance, we observed block rows not level, walls with unfilled gaps between blocks, broken blocks, blocks improperly installed, and different sizes of bricks used in the wall construction. For a picture of wall construction using different sized blocks, see Site Photo 54. We did not observe roof construction underway.

**Site Photo 54. Example of different sized blocks in wall construction
(Photo courtesy of the USACE)**

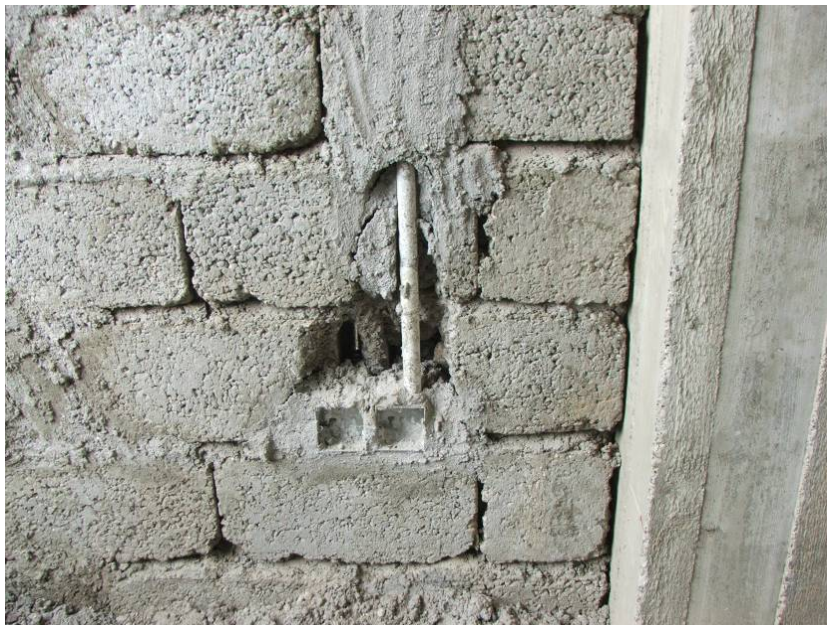
The SORS required all electrical design and construction to comply with the IECS. The SORS required new energy efficient lighting, switched power outlets and lighting switches. Electrical power and lighting requirements included interior and exterior lighting, surgical lighting, commercial grade wiring, panels, breakers, switches, outlets, junction boxes, transformers, connectors, and fixtures. Additional submittal requirements included switchgear, electric heaters, sump pumps, lightning protection, radio paging, emergency lighting, fire alarm system, central control and maintenance system, and the circuit protection. In addition, the SORS required a safe and sufficient power connection to the local grid and critical, standby and primary power generators. At the time of the assessment, the electrical system installation was underway. We observed basic electrical preparatory work. The electrical work assessed consisted of the installation of PVC conduit and plastic or metal electrical boxes attached to the surface of the block walls or recessed in a chiseled section of the wall. We observed no wiring inside the electrical boxes or PVC conduit. For a picture of the basic electrical work completed, see Site Photo 55.

Site Photo 55. PVC conduit and electrical box

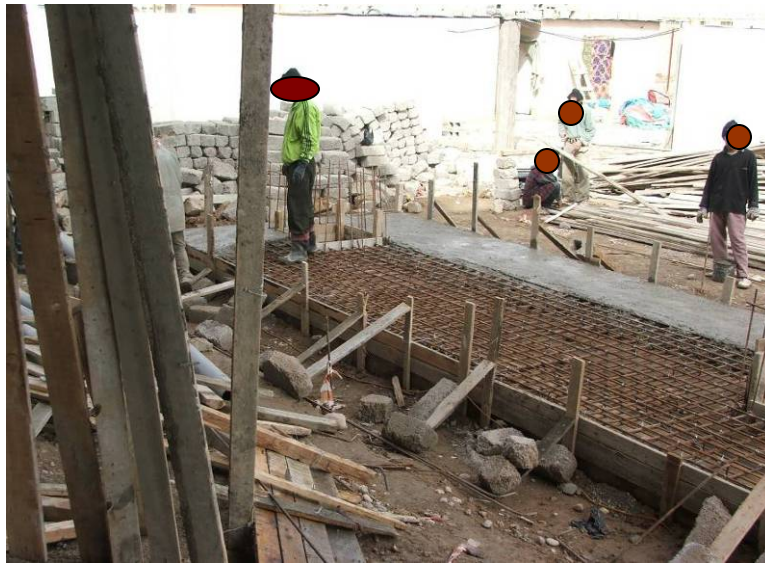
The contractor had not installed most fixtures, fittings, faucets, valves, drains and accessories; nor did the hardware or fixtures appear to be on site. The contractor had started the excavation and fabrication of the underground septic tank as indicated in the “Earthwork” section of this assessment (Site Photo 56). We witnessed construction workers mixing and pouring concrete on the ground in front of the PHC (Site Photo 57). This measuring and mixing procedure appeared to be inconsistent with the standard concrete specifications. We observed pipes placed through the concrete slabs to accommodate future drainage lines for the sinks and toilets (Site Photo 58). We did not observe water heaters and elevated water storage tanks on site.

Site Photo 56. Workers applying rebar to top of septic tank

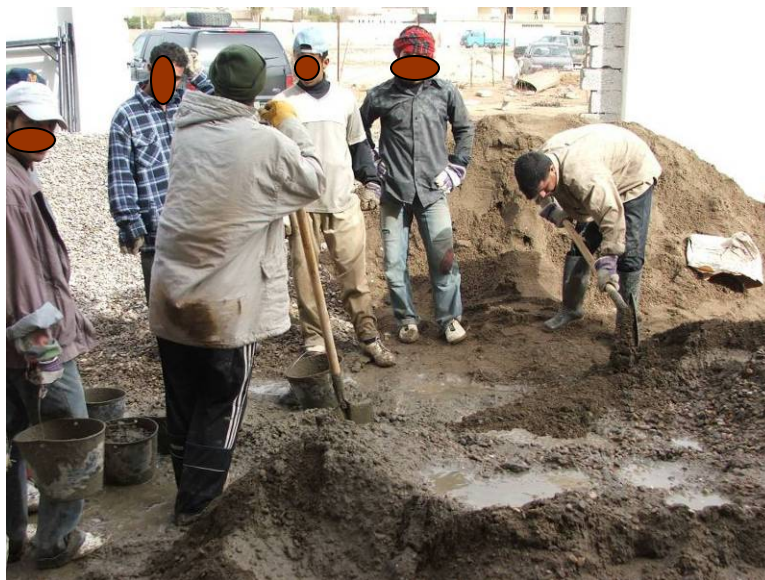
Site Photo 57. Concrete mixing

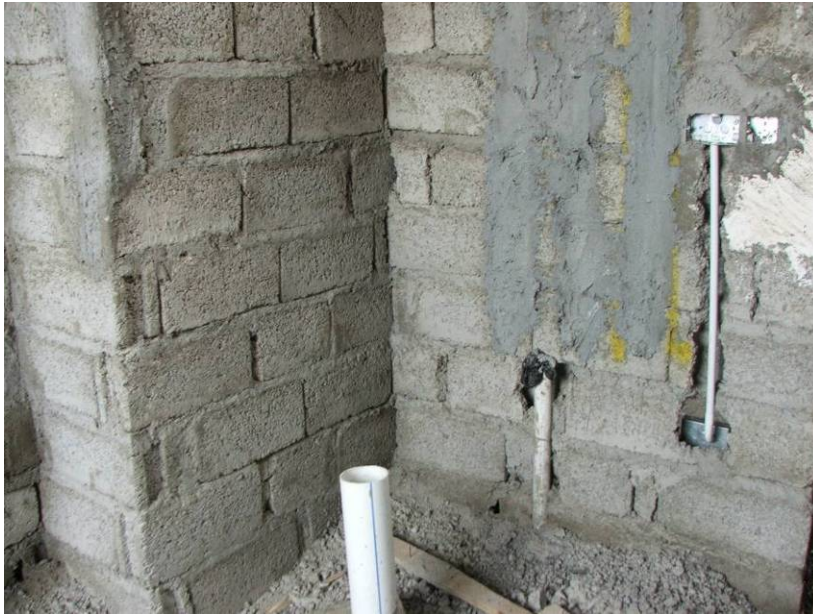
Site Photo 58. Plumbing pipes placed in concrete slab

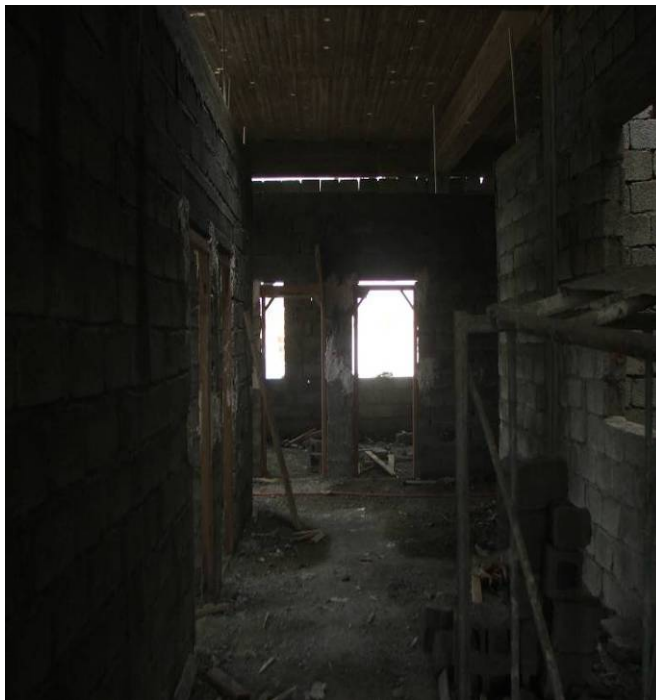
At the time of the assessment, we observed the partial installation of some wooden interior doorframes (Site Photo 59); however, we did not assess the doorframes due to time restrictions on site. We identified additional wooden doorframes on site (Site Photo 60). We did not observe any exterior doors, windows, or hardware on site.

Site Photo 59. Doorframes partially completed

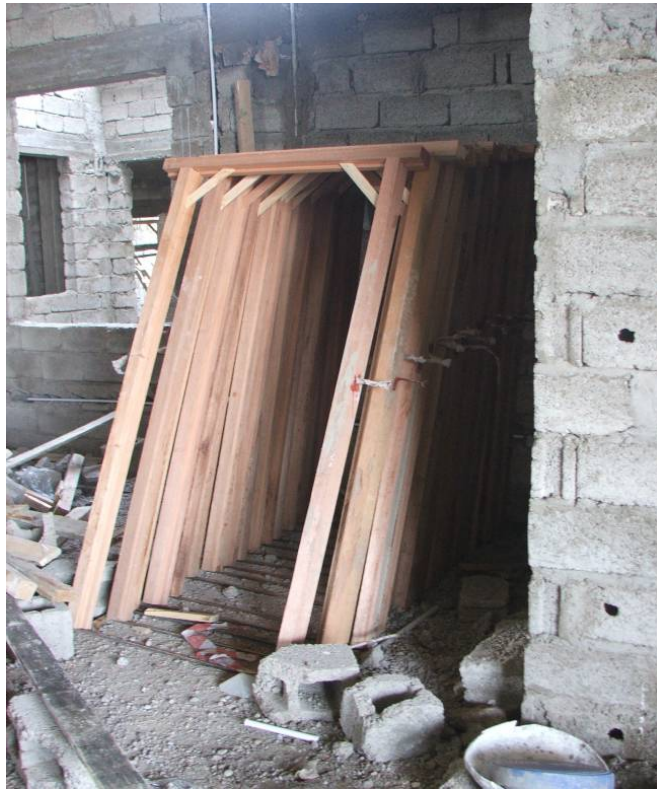
Site Photo 60. Doorframes on site but not installed

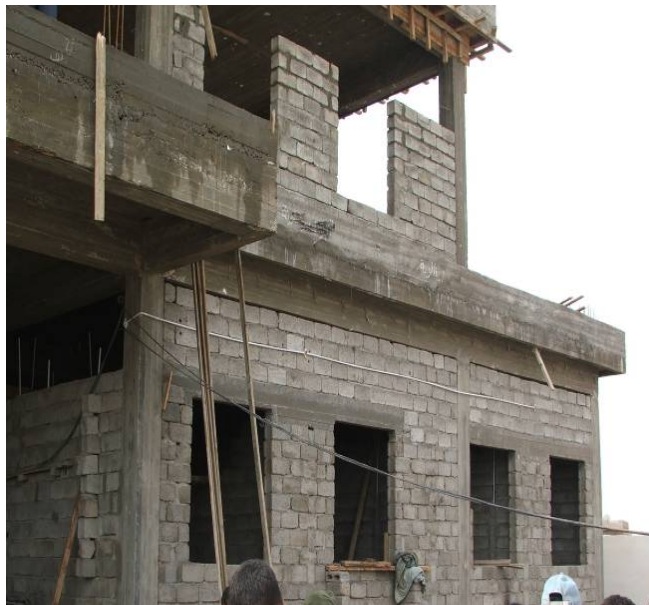
The contractor had not completed the window frames and had not installed any windows or security grilles (Site Photo 61). We did not observe the initiation of tile work, painting of the interior walls, or fabrication of the suspended ceiling. We did not observe any doors, windows, or hardware on site.

Site Photo 61. Window frames

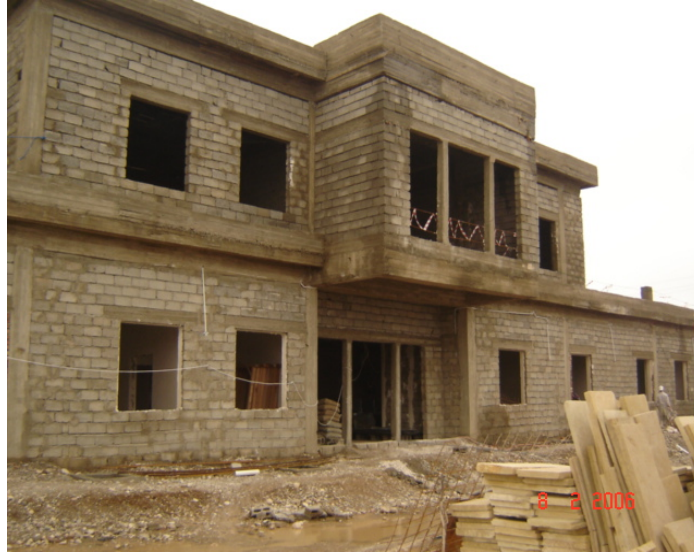
Site Photo 62. View of outside of Hai Al Wesity PHC (Photo courtesy of the USACE)

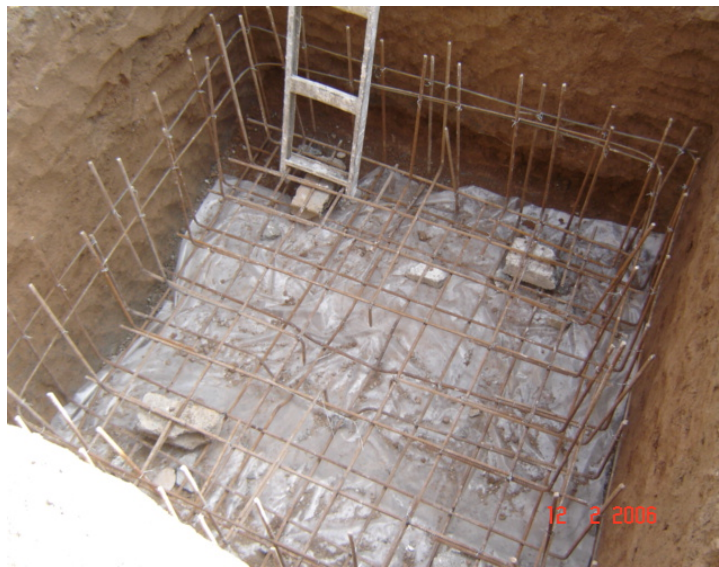
Significant work had been accomplished or was underway at the time of the assessment. The earthwork and the construction of this facility’s structural concrete elements were almost complete. The SORS required site demolition and clearance, if needed, construction of sidewalks, parking, fencing, lighting, roads, water, and sewer. Site clearing, excavation and backfilling appeared almost complete. Excavation for the septic tank was underway (Site Photo 63).

Site Photo 63. Excavated hole for septic tank (Photo courtesy of the USACE)

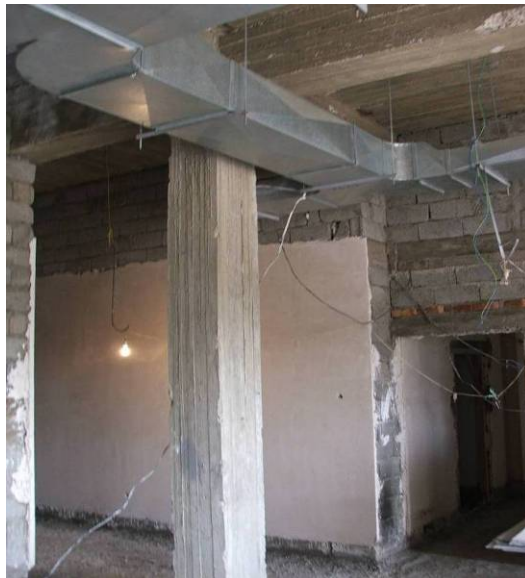
At the time of the site assessment, all reinforced concrete columns, slabs, and ceiling beams appeared complete and most of the formwork removed. For a picture of the concrete column and beams, see Site Photo 64. The contract and design specifications required cast in-place reinforced concrete structural beams, columns, and slabs. We assessed only a fraction of the structural concrete work due to time constraints on site. The ground floor columns, ground floor structural beams, ground floor ceiling slab, interior stairwell, x-ray room walls, first floor structural beams, first floor columns, and first floor ceiling slab all appeared almost complete; however, we identified quality issues. During the site assessment, we observed work in progress on the block walls. The block walls appeared to be of substandard construction with quality problems. For instance, we observed block rows not level, walls with unfilled gaps between blocks, broken blocks, blocks improperly installed, and bricks of different sizes used in the wall construction. For a picture of broken and different sized blocks used in wall construction, see Site Photo 65. The roof was in need of cleanup prior to tarring (Site Photo 66).

Site Photo 64. First floor structural column and beams

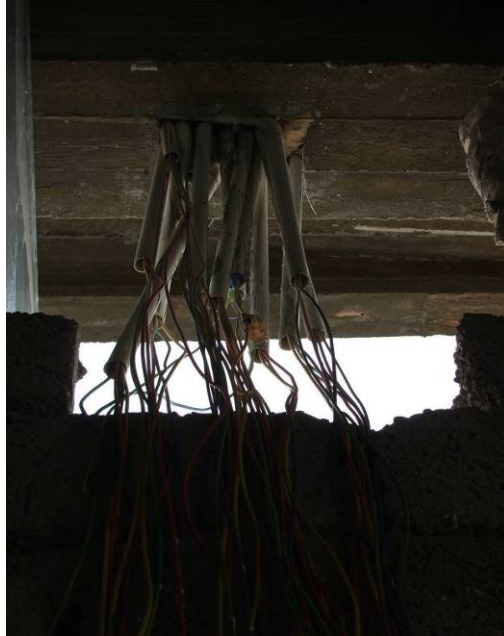
The SORS required all electrical design and construction to comply with IECS. The SORS required new energy efficient lighting, switched power outlets, and lighting switches. Electrical power and lighting requirements included interior and exterior lighting, surgical lighting, commercial grade wiring, panels, breakers, switches, outlets, junction boxes, transformers, connectors, and fixtures. Additional submittal requirements included, switchgear, electric heaters, sump pumps, lightning protection, radio paging, emergency lighting, fire alarm system, central control and maintenance system, and the circuit protection. SORS also required a safe and sufficient power connection to the local grid and critical, standby and primary power generators. At the time of the assessment, the electrical system installation was underway. We observed basic electrical preparatory work. The electrical work observed consisted of the installation of PVC conduit and plastic or metal electrical boxes attached to the surface of the block walls or recessed in a chiseled section of the wall. We observed wiring installed inside the PVC conduit in some areas (Site Photo 67) and some outlet boxes with wiring (Site Photo 68).

Site Photo 67. Electrical wire running through PVC conduit

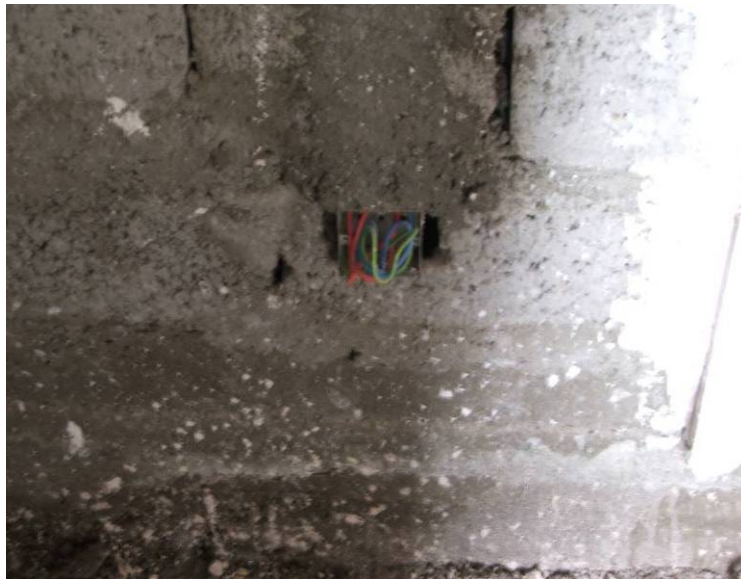
Site Photo 68. Wires within outlet box

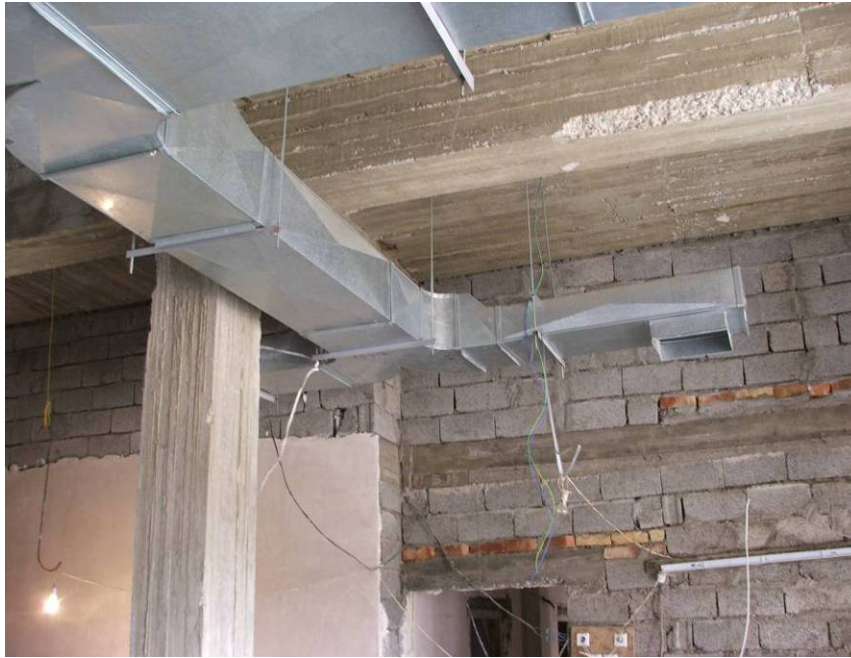
The SORS required new thermostats, heating, exhaust, ventilation and cooling systems. Work and equipment required also included condensing units, air handling units, coils, piping, ventilation and exhaust fans, grilles, registers, ductwork, hangars, insulation, and fasteners. The SORS required that all work comply with the IMC. The mechanical work was underway. The fabrication and construction of the ventilation ductwork was nearly complete and appeared to meet contract requirements (Site Photo 69). We did not observe duct fittings, grilles, registers, and diffusers on site. We did not observe either the connection of heating and cooling equipment to the ductwork or the equipment on site.

Site Photo 69. Ventilation ductwork

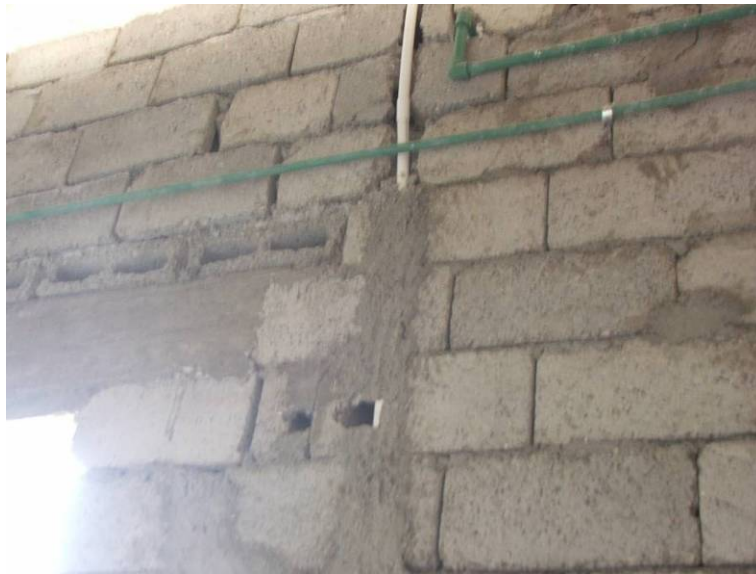
The contractor had not installed most fixtures, fittings, faucets, valves, drains and accessories; nor did the hardware or fixtures appear to be on site at the time of the assessment. The contractor had started the excavation and the fabrication of the underground septic tank as indicated in the “Earthwork” section of this assessment (Site Photo 63). We observed water pipes attached to the interior walls (Site Photo 70) and the installation of sewer piping (Site Photo 71). We observed pipes placed through the concrete slabs to accommodate future drainage lines for the sinks and toilets (Site Photo 72). We did not observe water heaters and elevated water storage tanks on site.

Site Photo 70. Plumbing lines installed across block wall

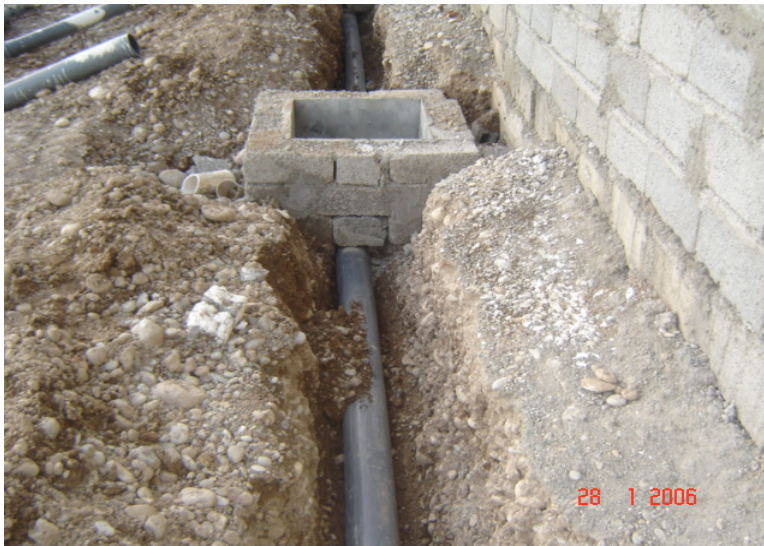
Site Photo 71. Partial installation of sewer drain (Photo courtesy of the USACE)

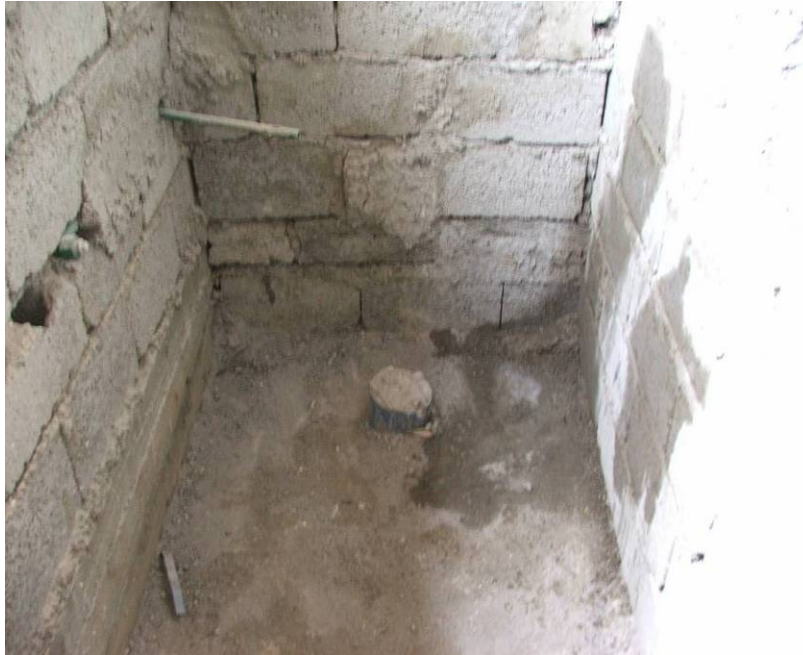
Site Photo 72. Plumbing pipes placed in concrete slab

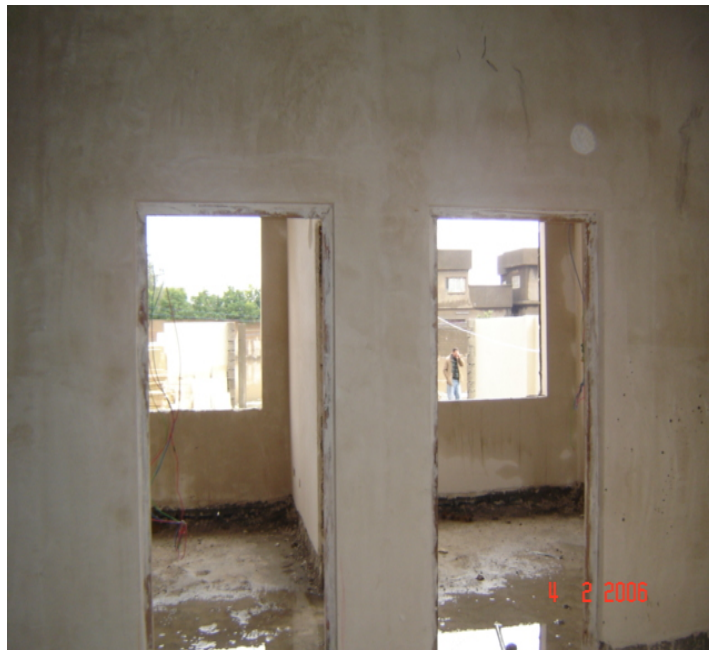
At the time of the assessment, we observed the installation of some wooden interior doorframes (Site Photo 73); however, we did not assess the doorframes due to time restrictions on site. We did not observe the installation of exterior doors nor did they appear to be on site. The contractor had not installed any windows or security grilles (Site Photo 74). Interior walls were not painted and the fabrication of the suspended ceiling had not started. We did not observe any doors, windows or hardware on site.

Site Photo 73. View of completed doorframes (Photo courtesy of the USACE)

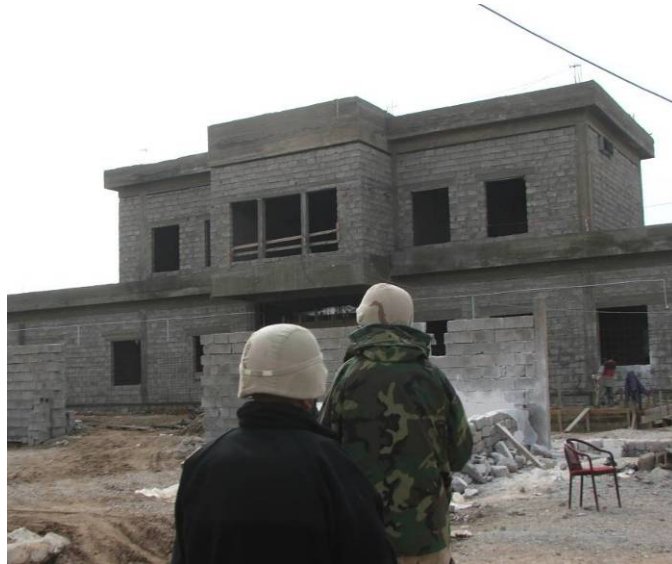
Site Photo 75. View of outside the Hai Alasra Wa Al Mafqodeen PHC

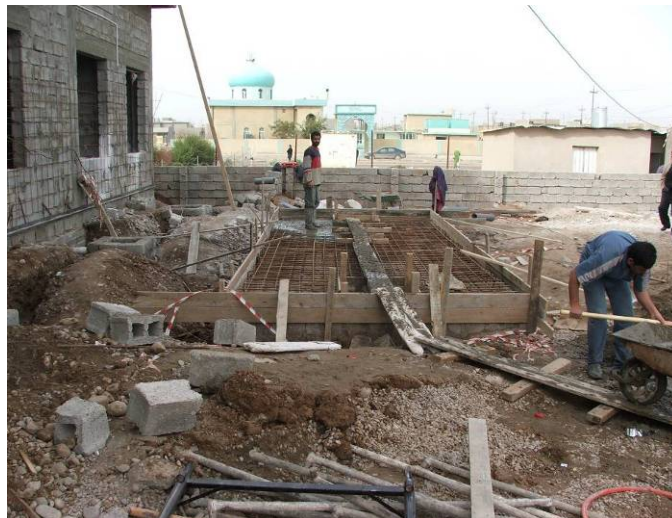
Significant work had been accomplished, or was underway, at the time of the assessment. The earthwork and the construction of this facility’s structural concrete elements were almost complete. The SORS required site demolition and clearance, if needed, and construction of sidewalks, parking, fencing, lighting, roads, water, and sewer. Site clearing, excavation and backfilling appeared almost complete. Excavation for the septic tank was underway (Site Photo 76).

Site Photo 76. Rebar and formwork for the top of the septic tank

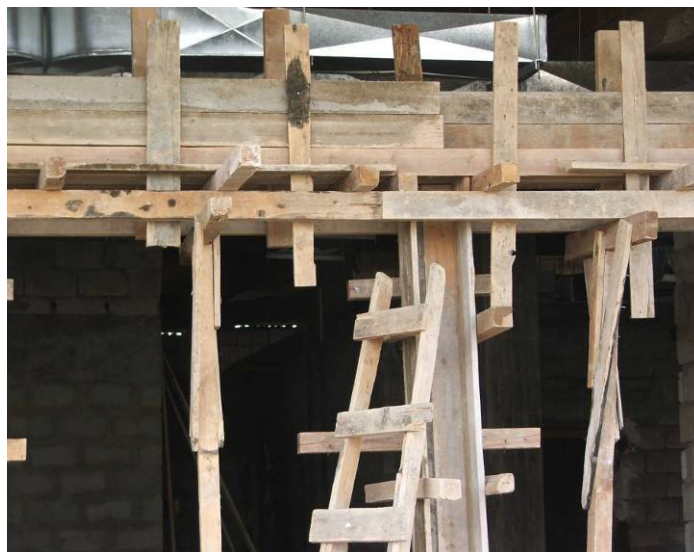
At the time of the site assessment, all reinforced concrete columns, slabs, and ceiling beams appeared complete and most of the formwork removed. For a picture of the concrete columns and remaining formwork, see Site Photos 77 and 78, respectively. The contract and design specifications required cast in-place reinforced concrete structural beams, columns, and slabs. We assessed only a fraction of the structural concrete work due to time constraints on site. The ground floor columns, ground floor structural beams, ground floor ceiling slab, interior stairwell, x-ray room walls, first floor structural beams, first floor columns, and first floor ceiling slab all appeared almost complete; however, we identified quality issues. During the site assessment, we observed work in progress on the block walls. The block walls appeared to be of substandard construction with quality problems. For instance, we observed block rows not level, walls with unfilled gaps between blocks, broken blocks, blocks improperly installed, and bricks of different sizes used in the wall construction. Site Photo 79 shows broken blocks in wall construction. We observed preparatory work in progress on the roof; however, at the time of the assessment, we did not observe roof construction activities underway (Site Photo 80).

Site Photo 78. Example of remaining formwork

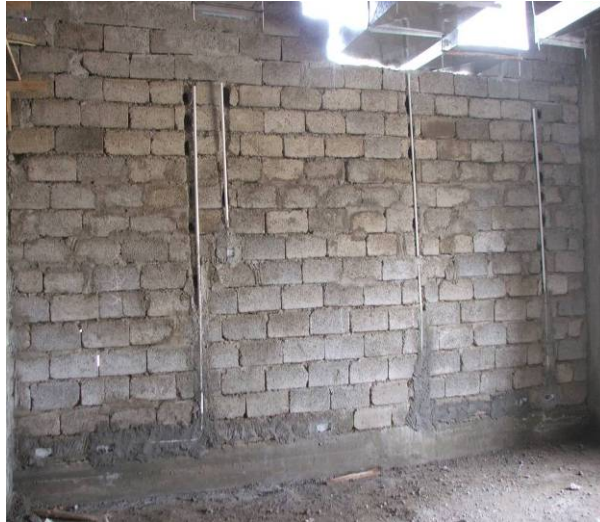
assessment, the electrical system installation was underway. We observed basic electrical preparatory work. The electrical work observed consisted of the installation of PVC conduit and plastic or metal electrical boxes attached to the surface of the block walls or recessed in a chiseled section of the wall. We did not observe wiring installed inside the PVC conduit. For a picture of the PVC conduit, see Site Photo 81.

Site Photo 81. PVC conduits attached to brick wall

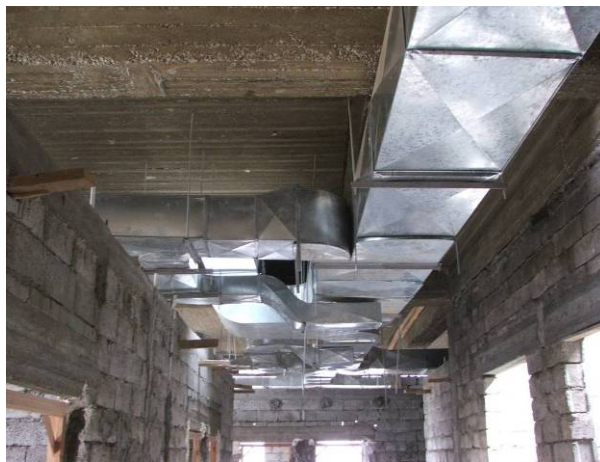
The SORS required new thermostats, heating, exhaust, ventilation and cooling systems. Work and equipment required also included condensing units, air handling units, coils, piping, ventilation and exhaust fans, grilles, registers, ductwork, hangars, insulation, and fasteners. The SORS required that all work comply with the IMC. At the time of the assessment, the mechanical work was underway. The fabrication and construction of the ventilation ductwork was nearly complete and appeared to meet the contract requirements (Site Photo 82). We did not observe duct fittings such as grilles, registers and diffusers on-site. We did not observe the connection of heating and cooling equipment to the ductwork or the equipment on site.

Site Photo 82. Completed ventilation ductwork

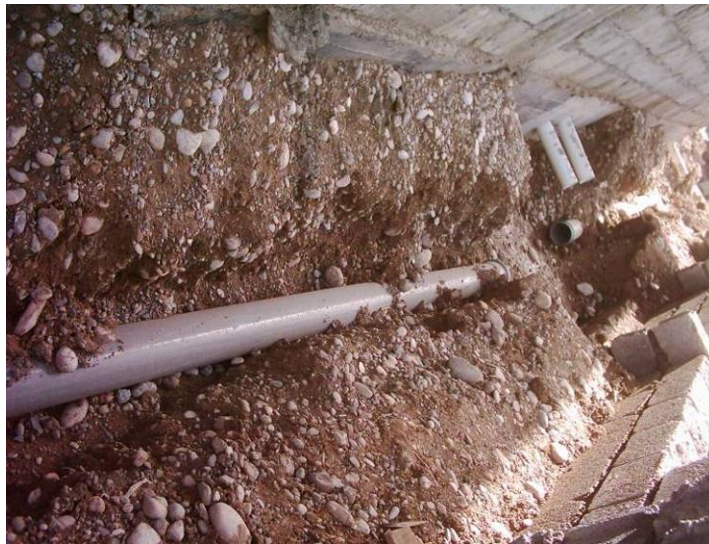
The contractor had not installed most fixtures, fittings, faucets, valves, drains and accessories; nor did the hardware or fixtures appear to be on site at the time of the assessment. The contractor had started the excavation of the underground septic tank and was fabricating the reinforced concrete top of the tank as indicated in the “Earthwork” section of this assessment (Site Photo 76). We observed pipes placed through the concrete slabs to accommodate future drainage lines and partial installation of sewer drains (Site Photo 83). We observed PVC water pipes installed and awaiting connection (Site Photo 84). We did not observe water heaters and elevated water storage tanks on site at the time of the assessment.

Site Photo 83. Partial installation of sewer drain (Photo courtesy of the USACE)

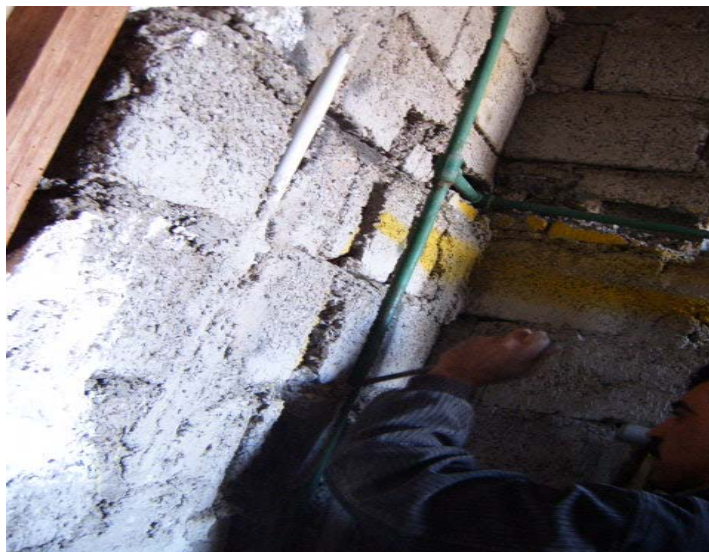
Site Photo 84. Installation of plumbing pipes into blocks

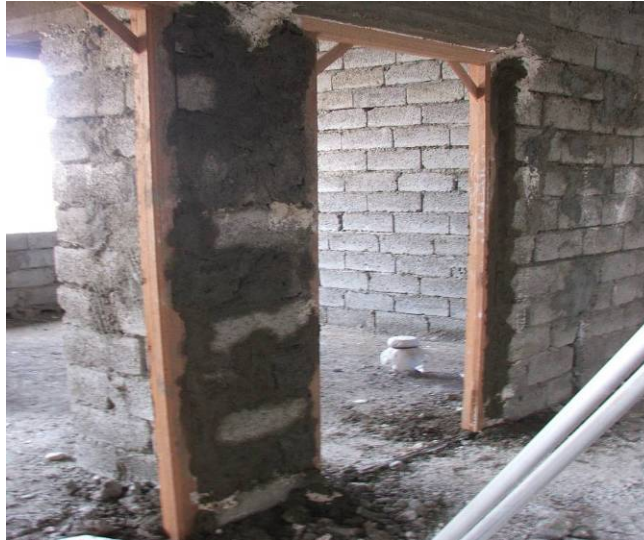
At the time of the assessment, we observed the partial installation of some wooden interior doorframes; however, due to time restrictions on site, we did not assess the doorframes. For a picture of the partially completed interior doorframes, see Site Photo 85. We did not observe the installation of exterior doors nor did they appear to be on site.

Site Photo 85. Partially installed doorframe
