SUMMARY REPORT
GROUND PROJECT SURVEYS
FOR THE QUARTER ENDED
DECEMBER 31, 2005

SIGIR PA-06-048
APRIL 13, 2006

Summary Report of Ground Project Surveys for the Quarter Ending December 31, 2005

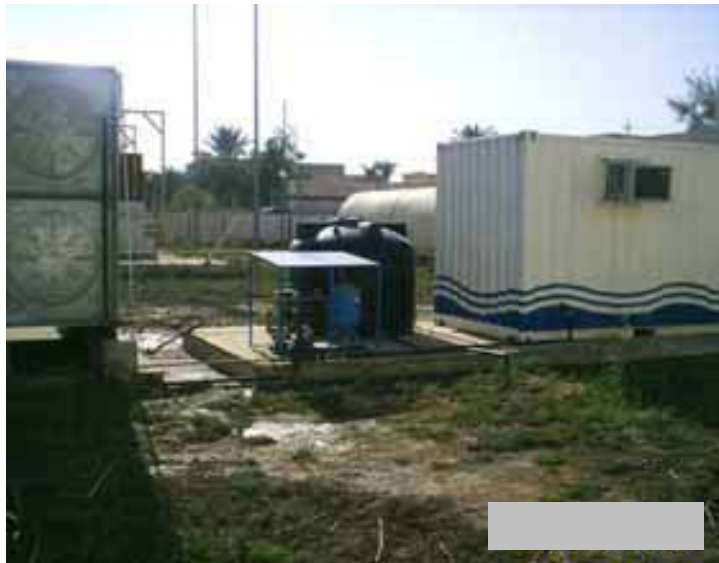
This building appeared to be an existing structure with renovations on going at the time of the site visit. A new reverse osmosis water purification unit, medical incinerator, and two generators were observed at the facility. Site Photo 19 shows the containerized reverse osmosis water purification unit with exterior pumps and water tanks. Renovation had not begun or was only partially complete on the plumbing, fixtures, electrical, and waste water systems. Observations during the site visit were:

- The interior finish is poor in some areas and there is staining on the ceiling and floors indicating water leakage either from pipes or from the roof. The floors require repair before tiling can be completed.
- New electrical boards are on site but not installed. Power cables were inappropriately passed through a window into the electrical room.

Site Photo 19: Containerized reverse osmosis unit with exterior pumps and storage tanks at Project 1270

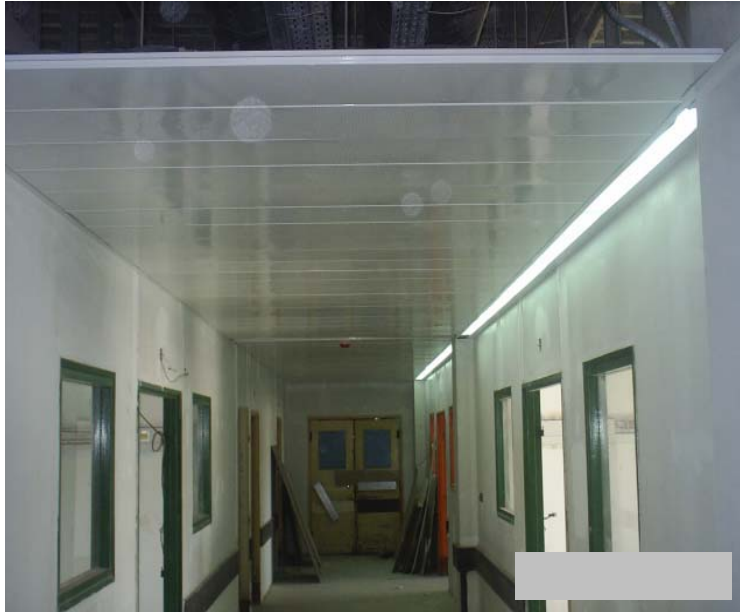
The renovation of the hospital was on going at the time of the assessment. Work included replacement of gypsum board, installation of drop ceilings, interior painting, installation of electrical wiring and circuit breaker panels, and installation of ductwork and mechanical systems. The work also included the removal and replacement of damaged floor tiles and the removal and replacement of concrete roof tiles. Overall, interior and exterior construction looks modern, and the material appeared new

throughout the facility. Site Photo 20 shows a renovated hallway. Construction of a new sewer is underway; however, there were concerns about the elevated groundwater level and the direction of drainage relative to the road.

Site Photo 20: Renovated hallway at Project 10318

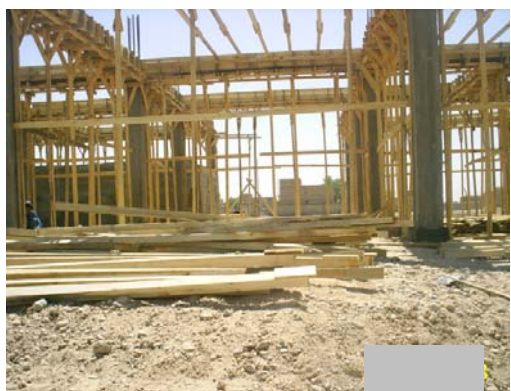
During the site visit new construction was in-progress. Concrete footers and ground level concrete reinforced columns appeared to be complete. Form work for the concrete reinforced beams were in place, although it could not be determined if the concrete beams had been poured. Concrete column surfaces appeared free of segregation. Rebar and crushed aggregate, both coarse and fine, were observed stockpiled on site. Site Photo 23 shows form work and Site Photo 24 shows aggregate stockpiled at Project 11943.

Site Photo 23: Form work at Project 11943

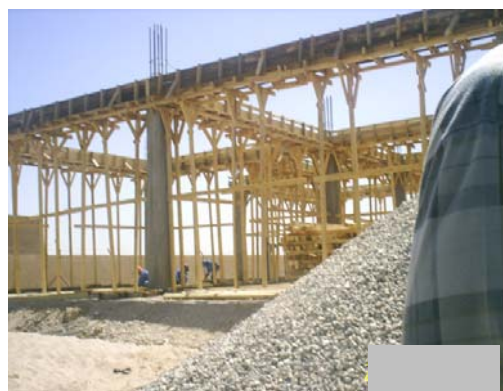
Site Photo 24: Aggregate stockpile at Project 11943

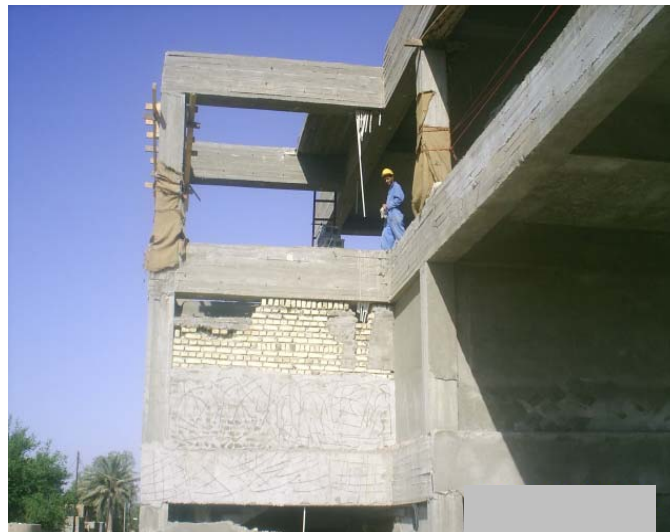
Construction of the facility was on-going at the time of the site visit. The QCQA team observed constructed structural concrete columns, beams, and elevated slabs on the ground, first, and second floor. Several columns were wrapped with burlap, presumably for curing purposes. Review of photos showed no areas of segregation, although we did not document the entire facility. Interior and exterior block walls were partially complete with external plastering in progress. Installation of window frames on the first floor rear of the building was on-going. We noted no discrepancies. Site Photo 25 shows Project 10072 under construction.

Site Photo 25: Project 10072 under construction

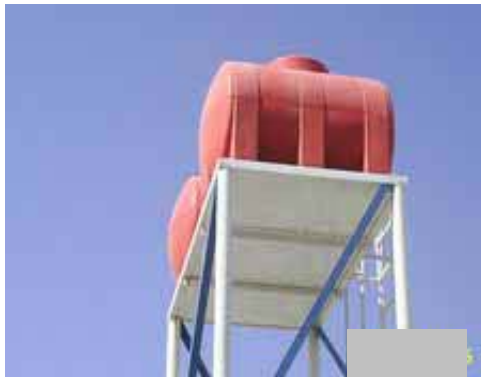
Site Photo 30: Water tanks installed on tower at Project 18243

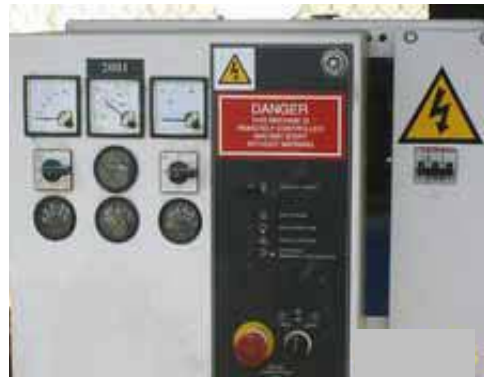
Site Photo 31: Generator electrical panel at Project 18243

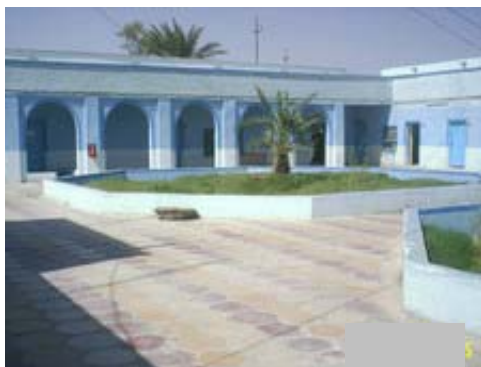
The IRMS database listed the project as 100 percent complete on 5 June 2005. The project specific Bill of Quantity was not available for review. Good quality work was apparent in the courtyard area. Site Photo 32 shows the courtyard. Deficiencies noted were:

Site Photo 32: Courtyard at Project 18248

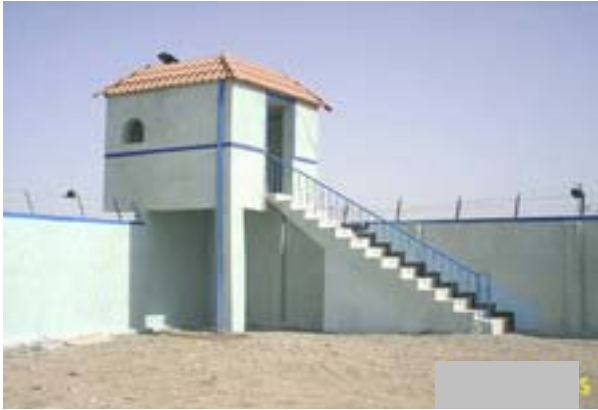
The IRMS database listed the project as 100 percent complete on 15 June 2005. A perimeter security wall with concertina wire, entrance gates, and guard towers was located on site. Site Photo 34 shows the perimeter security wall with a guard tower. The site also contained a covered 6-bay parking area and water tanks with a small installed pump. In addition, a central courtyard, constructed of a concrete pad and tiles, was located near the entrance of the main building. Deficiencies noted were:

Site Photo 34: Perimeter Security wall with concertina wire and guard post at Project 18268

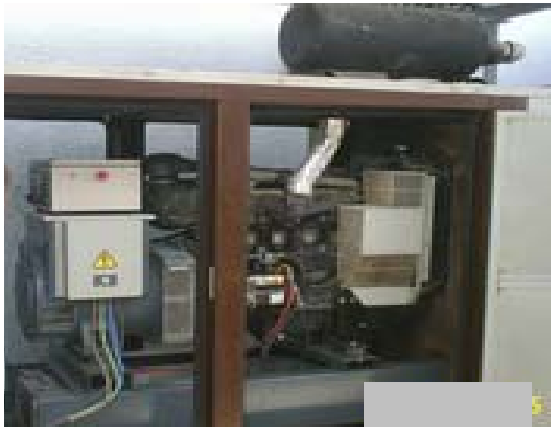
The IRMS database listed the project as 100 percent complete on 10 June 2005. The facility contained a 50 kVA generator, a covered parking area, and water tanks, which were consistent with contract requirements. Site Photo 36 shows the generator. Deficiencies noted were:

Site Photo 36: Generator at Project 18273

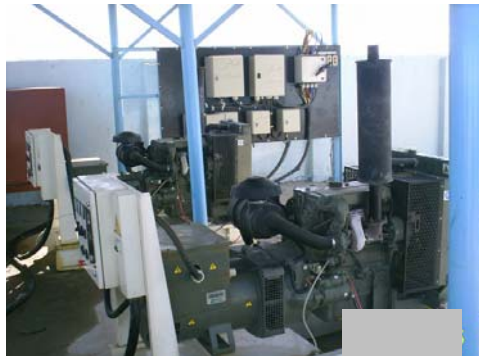
The IRMS database listed the project as 100 percent complete on 21 July 2005. The facility appeared to be new construction and consisted of a building, perimeter security wall, guard posts and checkpoint guardhouses. External security lighting was present, and two 30 kVA generators with fuel tanks were located on site. Site Photo 42 shows the two generators located on site. Deficiencies noted were:

Site Photo 42: Two 30 kVA generators at Project 19220

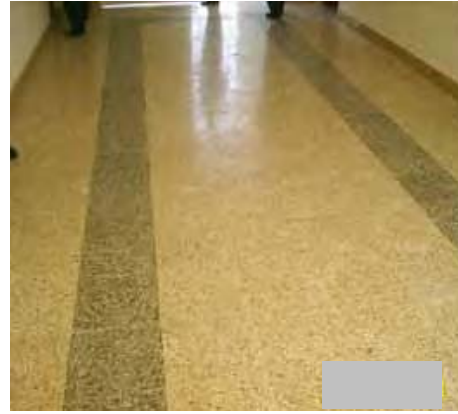
Site Photo 45: Interior tiles at Project 19221

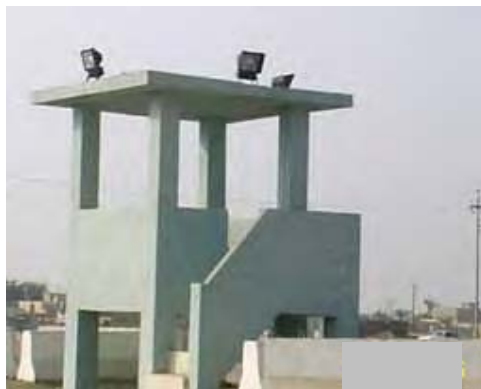
The IRMS database listed the project as 100 percent complete on 21 July 2005. Perimeter security walls with entrance gates were located on site. The main structure is located within the perimeter wall and includes corner guard towers with security lighting. Two generators were located on a concrete pad with a shed covering. Checkpoints and jersey barriers were located outside the perimeter wall and included security lighting. Site Photo 46 shows one of the checkpoints. Deficiencies noted were:

Site Photo 46: Checkpoint at Project 19222

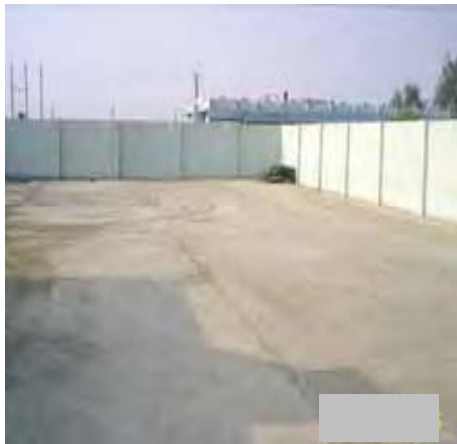
The IRMS database listed the project as 100 percent complete on 9 June 2005. A concrete slab parking area was located within the perimeter and surrounded the facility. Site Photo 48 shows the perimeter security wall and concrete pad. A generator and fuel storage tank were also located on site. Deficiencies noted were:

Site Photo 48: Perimeter security wall and concrete pad at Project 19223

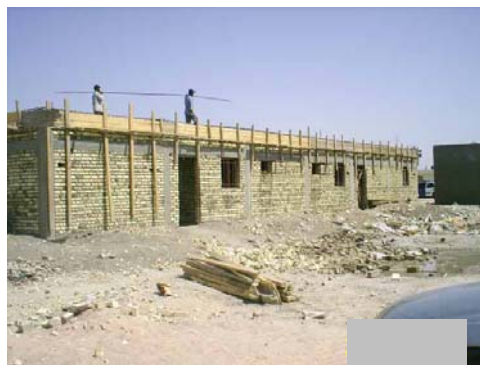
The IRMS database listed the project as 68 percent complete on 10 September 2005. New construction and renovation of buildings was in progress at the time of the site visit. Buildings were in different stages of completion from initial framing to nearly complete. The perimeter appeared complete with concertina wire, entrance gates, and guard towers. Several buildings showed installation of interior electrical components and lights, although the electrical system was not completed. We did not note any significant deficiencies. Site Photo 52 shows a building under construction and Site Photo 53 shows the perimeter security wall and guard tower at Project 20347.

Site Photo 52: Building under construction at Project 20347

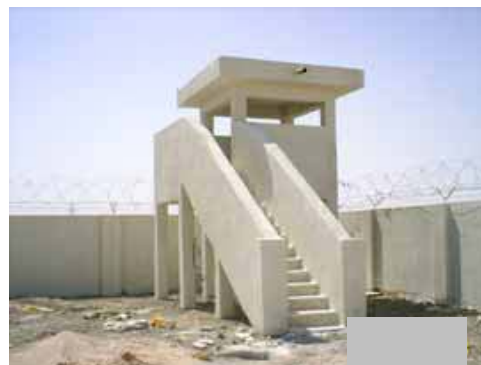
Site Photo 53: Perimeter security wall and guard tower at Project 20347

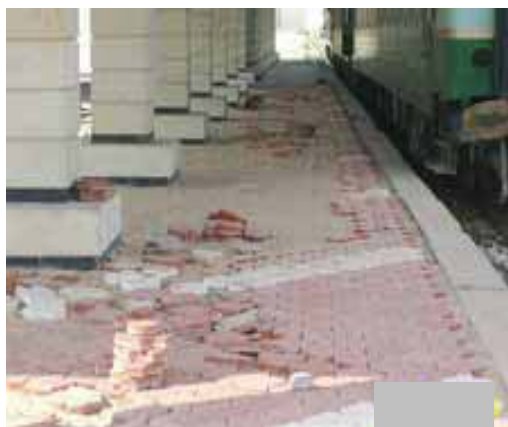
The renovation project was in-progress at the time of the survey site visit. Placement of exterior patio brick over sand base was partially complete. Site Photo 56 shows the brick installation. The survey team observed brick and cement manholes and trenches between the manholes. Site Photo 57 shows manholes under construction. Minor electrical work had also begun. Discrepancies noted were:

Site Photo 56: Installation of brickwork at Project 21251

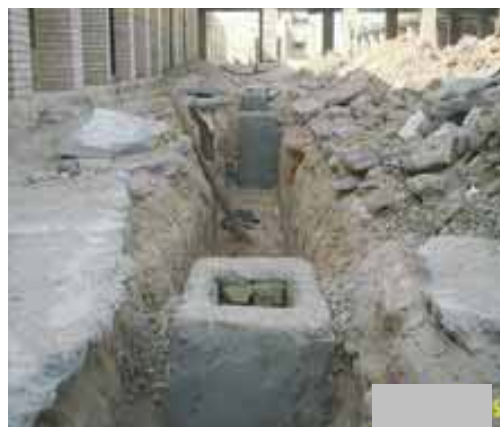
- Manholes appeared to be of poor quality.

Site Photo 57: Manholes and excavation at Project 21251
