SUMMARY REPORT
GROUND PROJECT SURVEYS
FOR THE QUARTER ENDED
MARCH 31, 2006

SIGIR PA-06-052
JULY 31, 2006

Summary Report of Ground Project Surveys for the Quarter Ending March 31, 2006

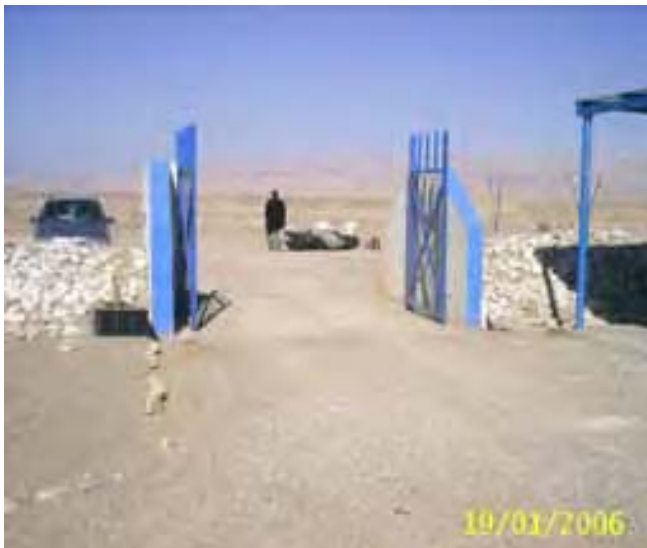
A review of the report and photos provided by the QC/QA teams determined that overall, the site associated with Task Order 0034, Project 12826, appeared to be complete and consistent with contract requirements. A perimeter berm surrounded the post and a gate was located at the entrance. Site Photo 1 shows the perimeter security berm and entrance gate. The site also contained the border post, jail facility, two electrical generators and fuel tank mounted on a concrete pad, covered parking area, and water tanks set on a concrete base. Site Photo 2 shows the exterior side of the border post.

Site Photo 1: Perimeter security berm and entrance gate (Project 12826)

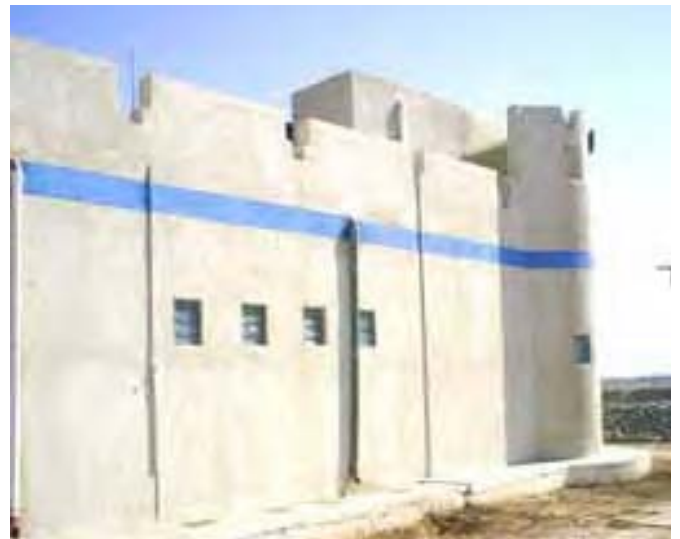
Site Photo 2: Exterior side of border post (Project 12826)

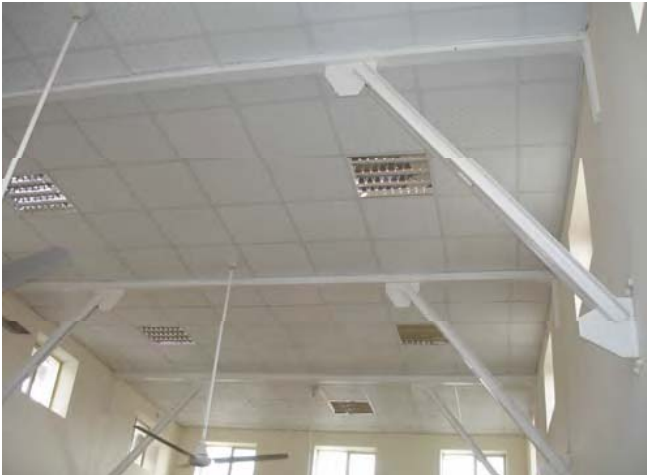
- The structural steel retrofit required due to deflection of I-beams was complete. Site Photo 5 shows the structural steel retrofit.
- Potable water was reported trucked in for use from adjacent village and users reported they are concerned about the quality and quantity of the water. No filtration or sterilization (except boiling) of the water was available.

Site Photo 5: Completed structural retrofit (Project 12807)

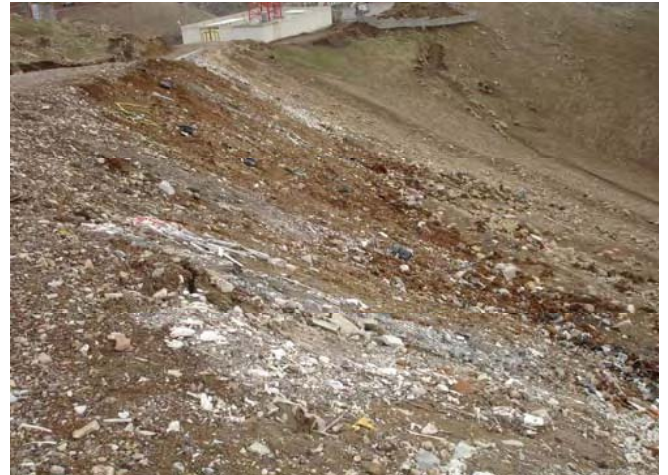
- Spot welds on the generator roofing appeared to be of poor quality.
- The facility is located approximately 20 feet up gradient from a steep slope. Retaining walls were not installed to stabilize the slope and signs of lateral movement were observed. Site Photo 6 shows the steep slope.

Site Photo 6: Down gradient slope with signs of lateral movement (Project 12807)

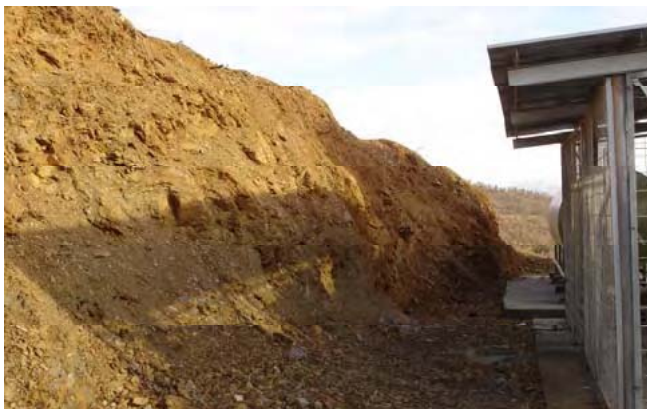
- No perimeter security fences or gates were present.
- The road to the border post was reported as difficult to access during the rainy or snowy seasons.
- The area behind the generator is a cut bank without a retaining wall. Site Photo 17 shows the cut bank behind the jail facility.
- Potable water was brought up to the border post from a nearby spring using plastic containers. No filtration or sterilization (except boiling) of the water was available.
- Spot welds on the generator roofing appeared to be of poor quality.
- Surface of exterior walls was not straight (inward curvature) and poor finishing was observed. Cracks were observed on the exterior wall below the parapets. Site Photo 18 shows the cracks in the exterior wall below the parapets.

Site Photo 17: Cut bank behind generator without retaining wall (Project 12835)

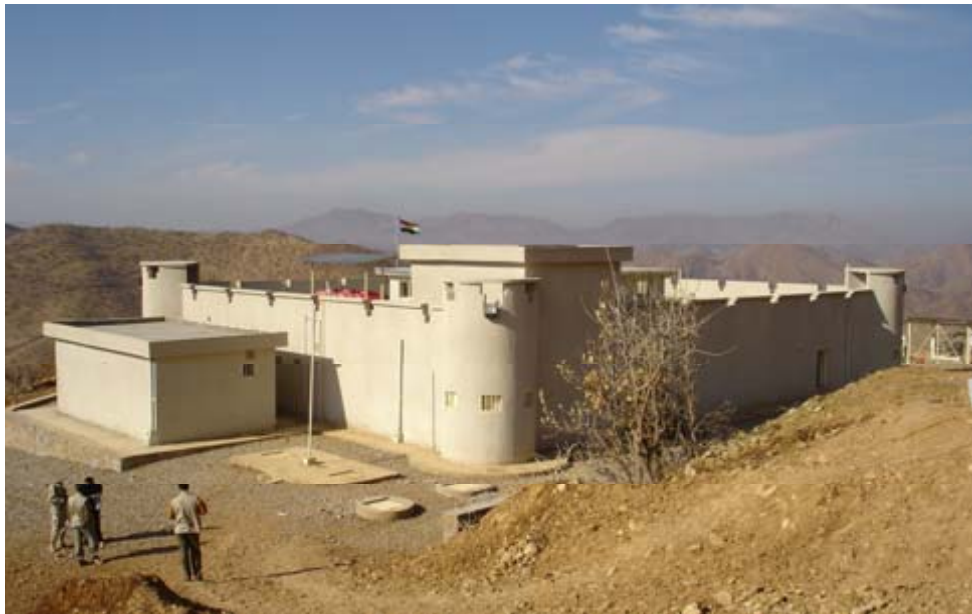
- In general, the quality of construction of this border post was noticeably better than the other border posts inspected. Exterior finishing and welding showed no discrepancies. Site Photo 19 shows the exterior view of the border post.
- No perimeter security fences or gates were present.
- The road to the border post was reported as difficult to access during the rainy or snowy seasons.
- Potable water was reported trucked in for use and users reported that they are concerned about the quality and quantity of the water. No filtration or sterilization (except boiling) of the water was available.

Site Photo 19: Exterior view of border post – Project 12836

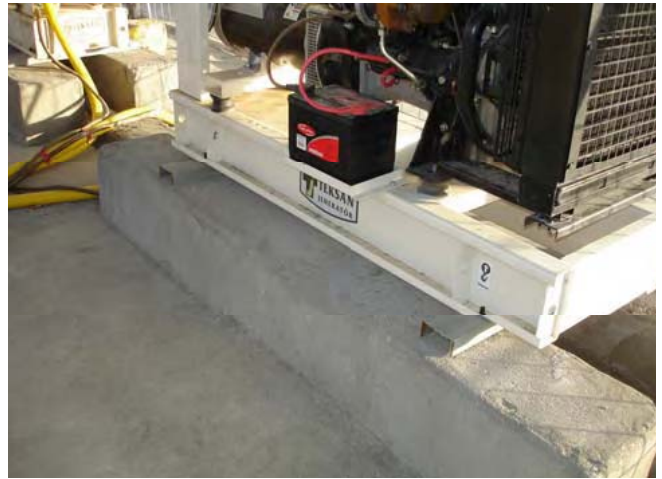
Site Photo 21: Generator on concrete base (Project 12850)

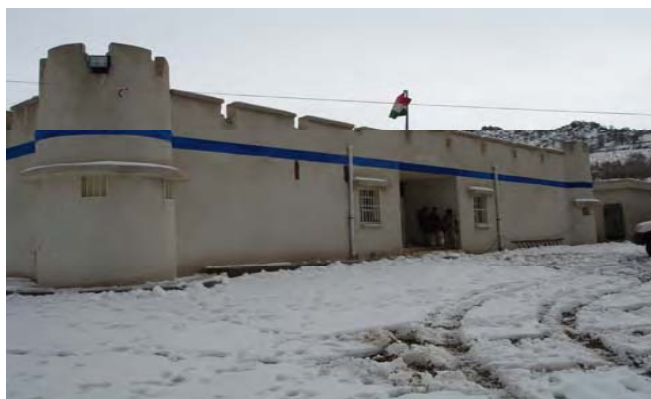
- No perimeter security fences or gates were present. Site Photo 24 shows the exterior of the border fort.
- The generator was not anchored to the concrete base.

Site Photo 24: Front exterior of border post (Project 12884)

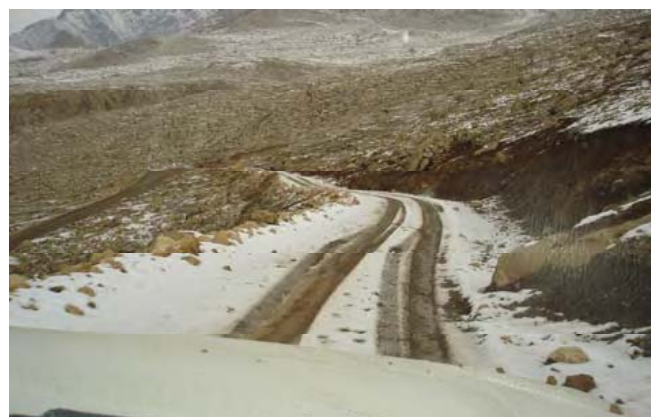
- Spot welds on the generator roofing appeared to be of poor quality.
- Structural steel retrofit required due to the deflection of I-beams was in-progress.
- The road to border post was reported as difficult to access during the rainy or snowy seasons. Site Photo 25 shows the access road.
- Potable water was reported trucked in for use and users reported that they are concerned about the quality and quantity of the water. No filtration or sterilization (except boiling) of the water was available.

Site Photo 25: Access road (Project 12884)

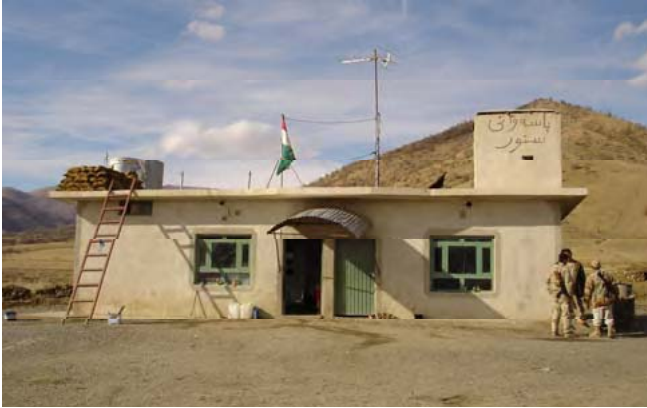
- Site Photo 30 shows an exterior view of the front of the border post.
- Electricity is supplied by a 12 KVA generator.
- The water well was reported to have dried up, and a small creek, with “dirt and worms” was the only current source of water.
- Road access to the site was reported to be difficult.
- The septic tank was reported almost full, with no plans for cleaning.
- The interior ceiling showed signs of water damage and ceiling plaster was deteriorating (Site Photo 31).
- The facility lacked security fences.
- The facility showed a lack of any recent maintenance or remodeling.

Site Photo 30: Front exterior of border post (Project 20571)

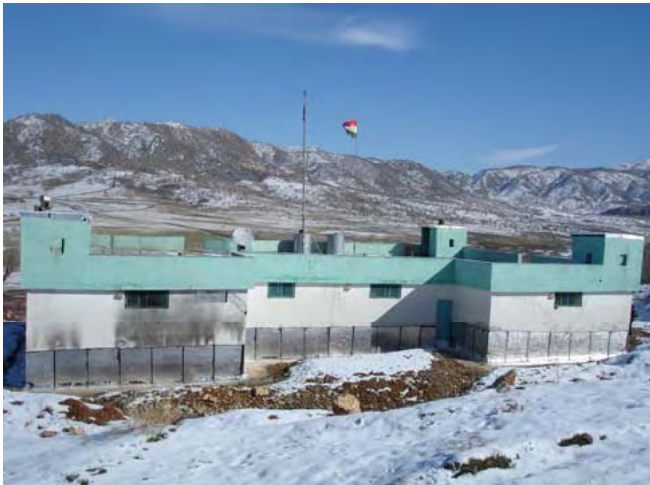
- Site Photo 34 shows the exterior to the border post.

Site Photo 34: Exterior view of border post (Project 20573)

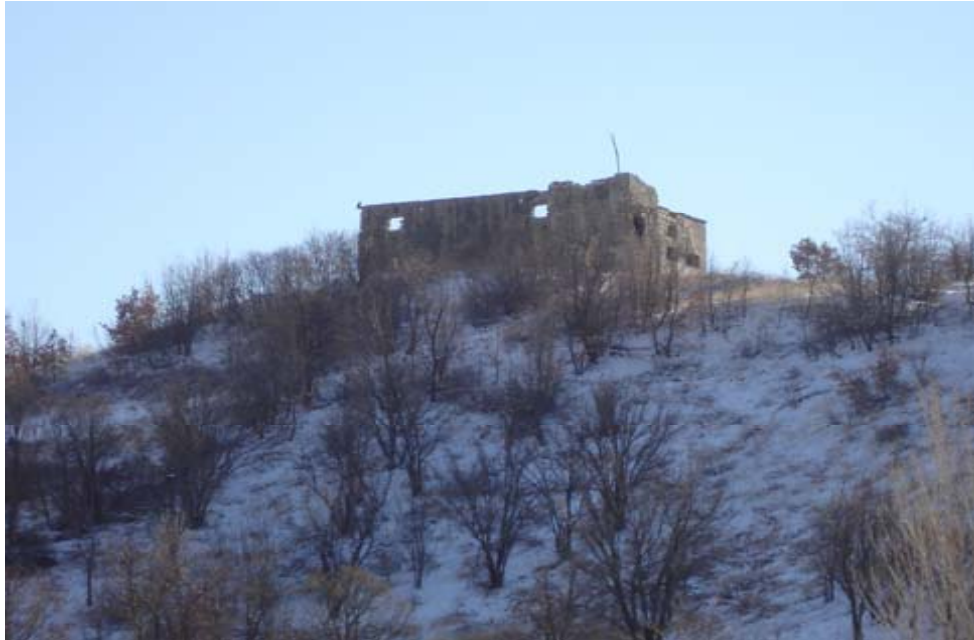
- The border post was reported to be surrounded by a mine field and access was deemed too dangerous to approach. Site Photo 36 shows the exterior of the border post. It could not be determined if renovation of the facility was completed or to what quality the renovation was accomplished.

Site Photo 36: Exterior view of border post - Project 20574

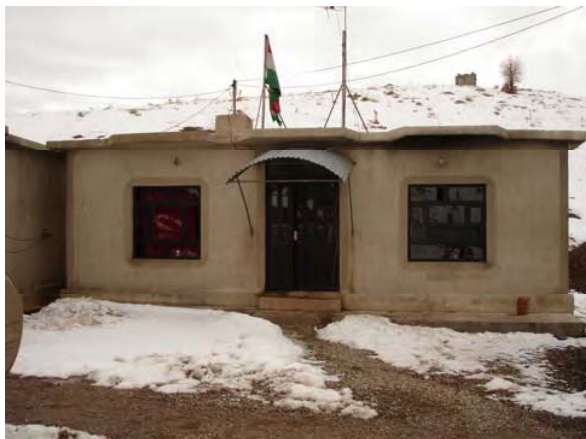
- Site Photo 39 shows the exterior front of the border post.
- Electricity is supplied by a 12 KVA generator. The generator was reportedly broken and was not on site. The border post did not have electricity at the time of the visit.

Site Photo 39: Exterior front of border post

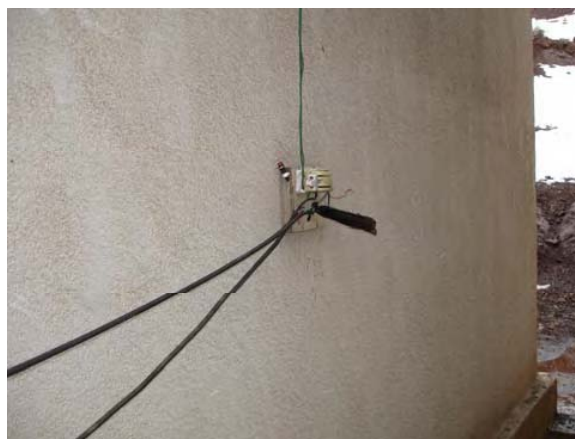
- The electrical system had exposed wires. Site Photo 40 shows an example of exterior wiring.
- The ceilings showed staining, an indication of roof leaks.

Site Photo 40: Exterior electrical wiring

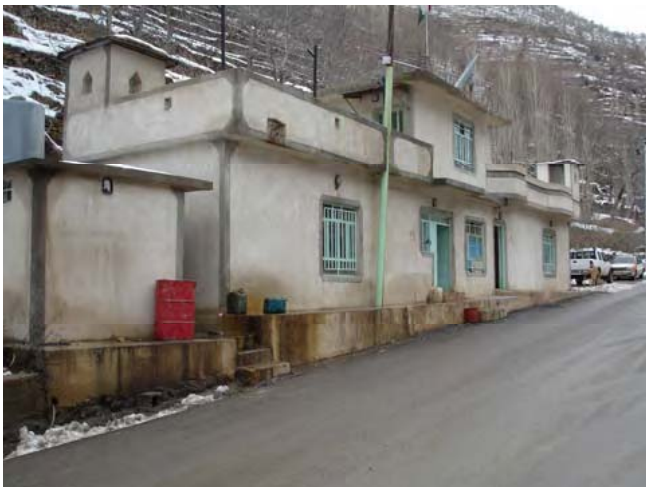
- Site Photo 41 shows the exterior of the border post.
- A 12 KVA generator was on-site, although reportedly broken. Electricity was obtained from a village generator located nearby.
- Source of water is a water spring close to the site. The spring is uncovered and water is transferred to the site through plastic water pipes. No filtration or sterilization existed and the water quantity was not enough for the requirements of the border post.
- Numerous cracks were observed in the exterior walls.
- The electrical system had exposed wires and uncovered panels. Site Photo 42 shows an example of the electrical wiring.
- Security fences were not present.

Site Photo 41: Exterior front of border post (Project 20577)

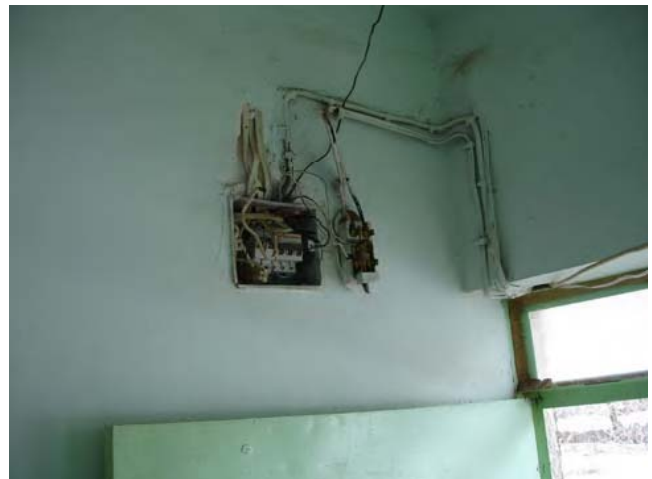
Site Photo 42: Interior electrical panel (Project 20577)

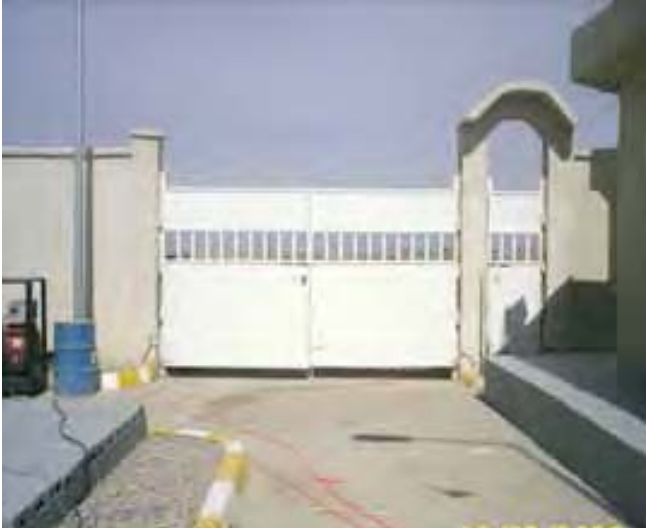
- The site visit verified new construction of the main building, sidewalks, perimeter security and guardhouse, entrance gate, and the generator shed. Site Photo 43 shows the front entrance gate.
- Two exterior located transformers (assumed 33 kilovolt (kV) / 11 kV) were observed mounted on concrete pads. A firewall was located between the transformers. Site Photo 44 shows the main transformers.
- Switchgears (assumed incoming and outgoing) were observed inside the main building. Site Photo 45 shows the switchgears.
- Thirteen split air conditioning condensing units were mounted on the roof of the main building. Site Photo 46 shows the roof mounted air conditioning condensing units.
- Exterior light poles were located throughout the facility.
- No discrepancies were reported at this location.

Site Photo 43: Front entrance gate (Project 1861)

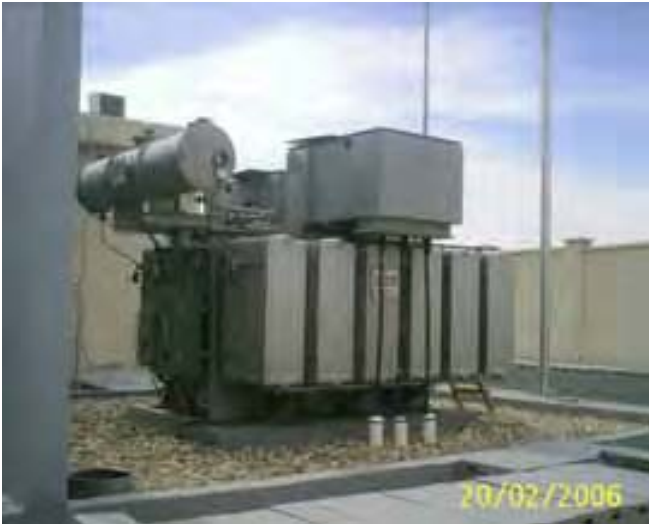
Site Photo 44: Transformer (Project 1861)

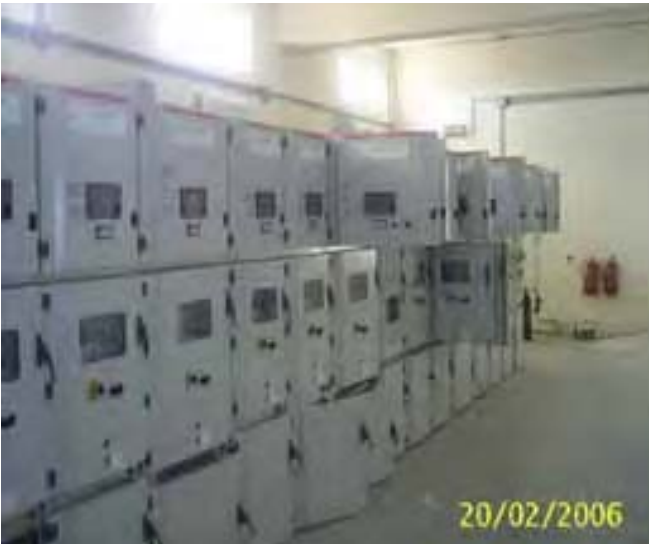
Site Photo 45: Switchgears (Project 1861)

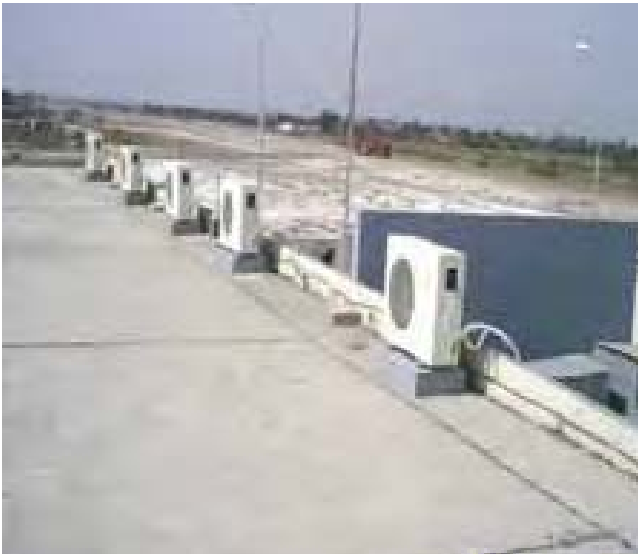
Site Photo 46: Roof mounted AC Units (Project 1861)

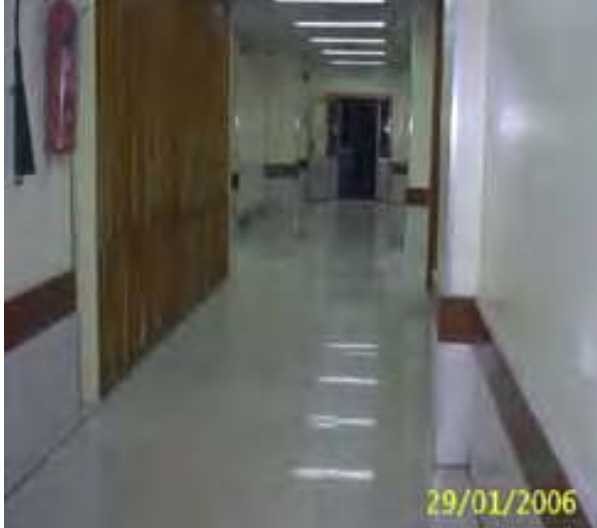
- No significant discrepancies were noted during the visit. Site Photo 47 shows an area of tile replacement, Site Photo 48 shows replaced ceiling tiles, Site Photo 49 shows renovated counter tops, and Site Photo 50 shows new electrical lighting.

Site Photo 47: Renovated hallway floor tiles (Project 10309)

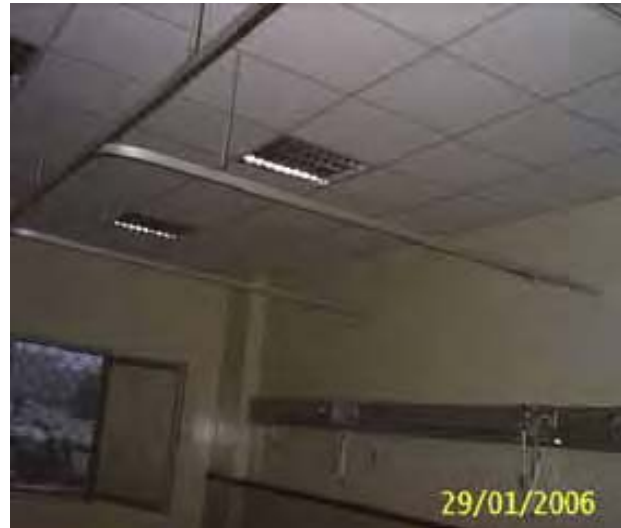
Site Photo 48: Suspended ceiling (Project 10309)

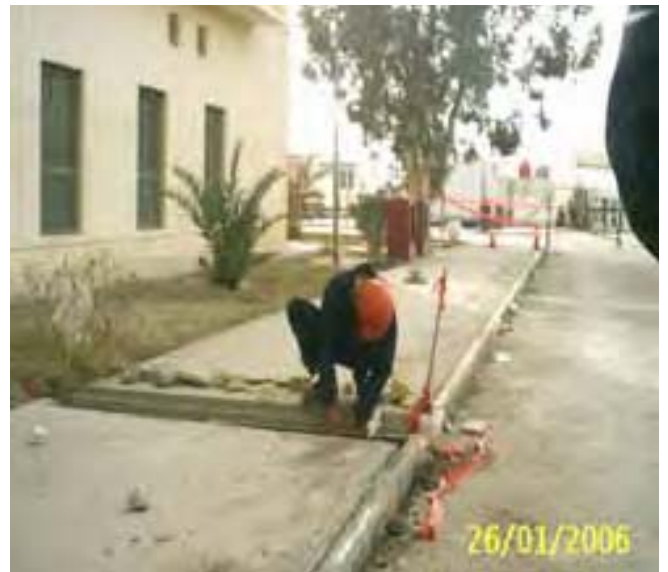
- The quality of this project was reported better than the previous contractor’s work.
- No significant discrepancies were noted. Site Photo 54 shows renovated hallway lighting repairs and Site Photo 55 shows repair of the sidewalks at the time of the site visit.

Site Photo 55: Sidewalk repairs (Project 19873)

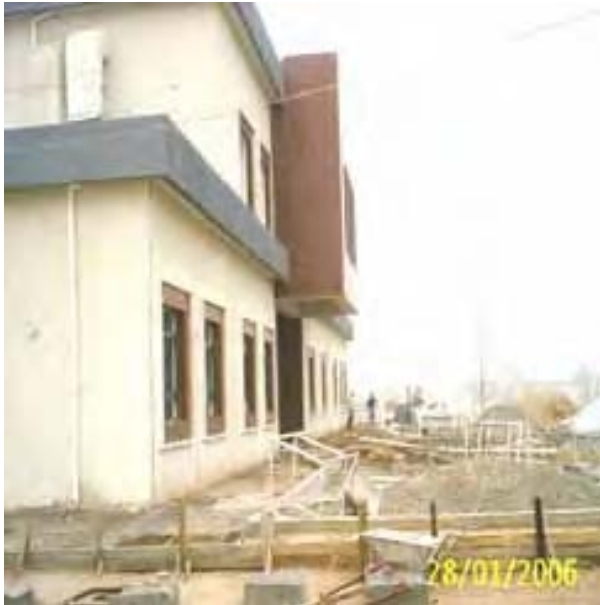
New construction was in progress at the time of the site visit and 87 construction workers were reported on site. The building was constructed with the majority of the windows, electrical, heating and air conditioning units, and septic systems in place. Remaining work included mostly finishing including completing the electrical, installation of doors and windows, installation of walkways, and painting. No significant discrepancies were noted during the site visit. Site Photo 56 shows the front exterior of the clinic and Site Photo 57 shows electrical control panels. Site Photo 58 and 59 show interior finishing underway.

Site Photo 56: Exterior of Clinic (Project 11913)

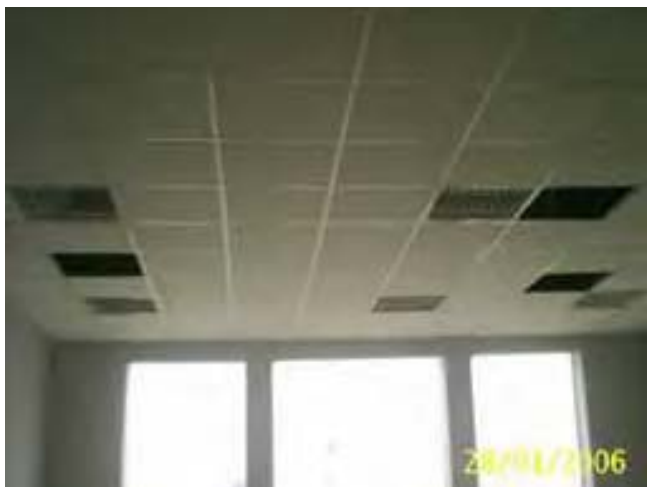
Site Photo 58: Suspended ceilings (Project 11913)

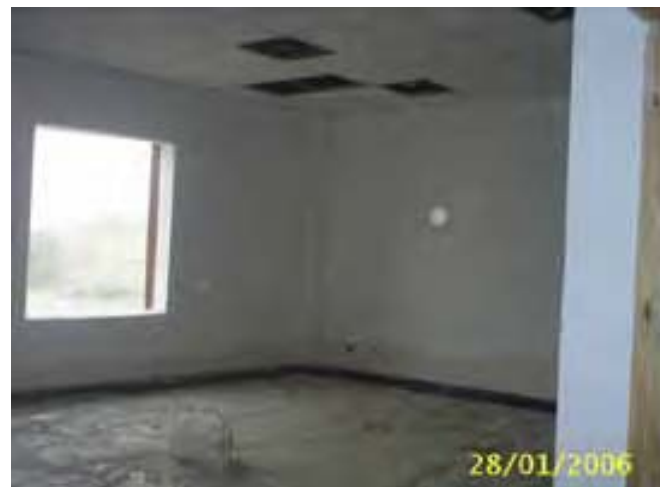
Site Photo 59: Interior room (Project 11913)

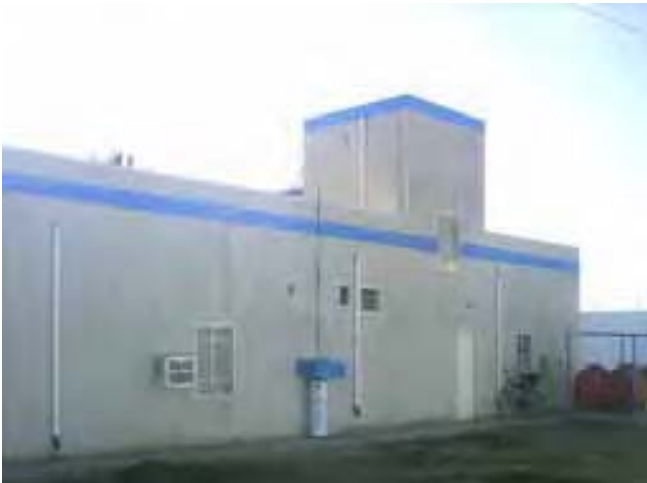
The IRMS database listed the project as 100 percent complete on 30 August - 2005. The project was new construction and included perimeter security walls, entrance gates, guard towers, and a nine-room building. Site Photo 62 shows the exterior of the building. A generator and covered parking area were also located within the perimeter walls. A crack was observed in the perimeter wall, although no other discrepancies were noted. Site Photo 63 shows the crack in the exterior perimeter wall.

Site Photo 62: Exterior of Police Station building (Project 19111)

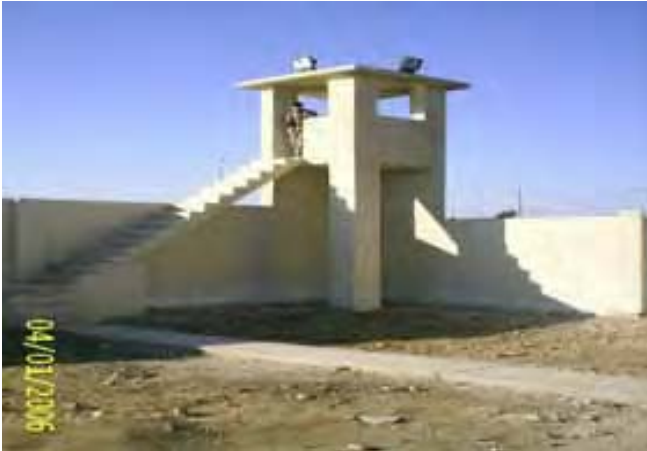
The IRMS database listed the project as 100 percent complete on 2 April 2005. The project included construction of perimeter security walls and corner guard posts, entrance gates, sidewalks, security lighting, and a parking area. Site Photo 70 shows one of the corner guard posts and Site Photo 71 shows a concrete sidewalk. In addition, the contract required renovation of the electrical and pumping systems, roof and ceilings, windows, doors and walls. Construction activities were complete at the time of the visit. Noted discrepancies included rough surfaces and cracks in the concrete parking area and

Site Photo 70: Corner guard post and perimeter walls (Project 19179)

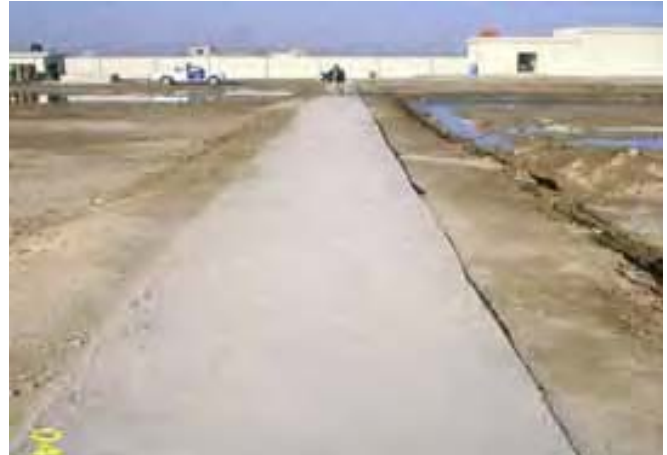
Site Photo 71: Concrete sidewalk (Project 19179)

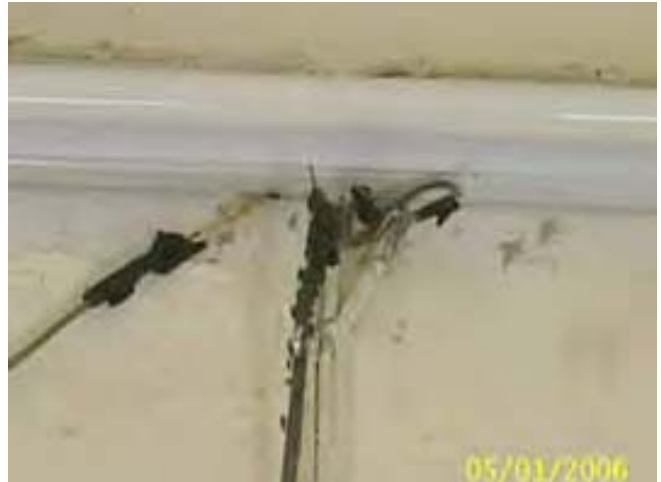
- Electrical systems had exposed wiring, broken fixtures, improper connections, and missing electrical covers throughout the entire police station. Site Photos 74 and 75 show examples of the electrical system deficiencies.

Site Photo 75: Interior electrical light with exposed wiring (Project 19181)

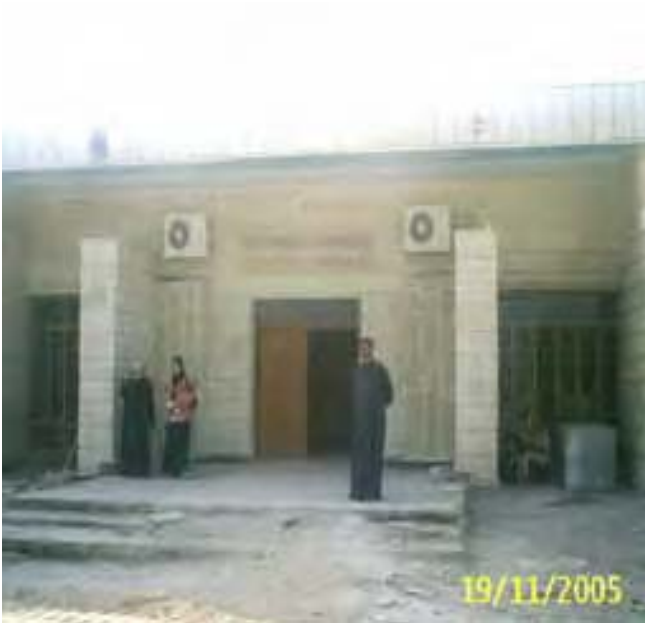
The renovation project was not complete at the time of the survey site visit and work was stopped by the contractor, although the reason was not noted. The Railway Station Manager stated the only defects were the delay and stopping of the work. Additionally, he said the Scope of Work should be increased to include new generators, sunshades, new water tanks, service roads, fencing, outdoors lights and seats for waiting passengers. No discrepancies were noted. Site Photo 84 shows the front entrance of the train station and Site Photo 85 shows the renovated hallway to include suspended ceiling and electrical lighting.

Site Photo 84: Front entrance of train station (Project 21263)

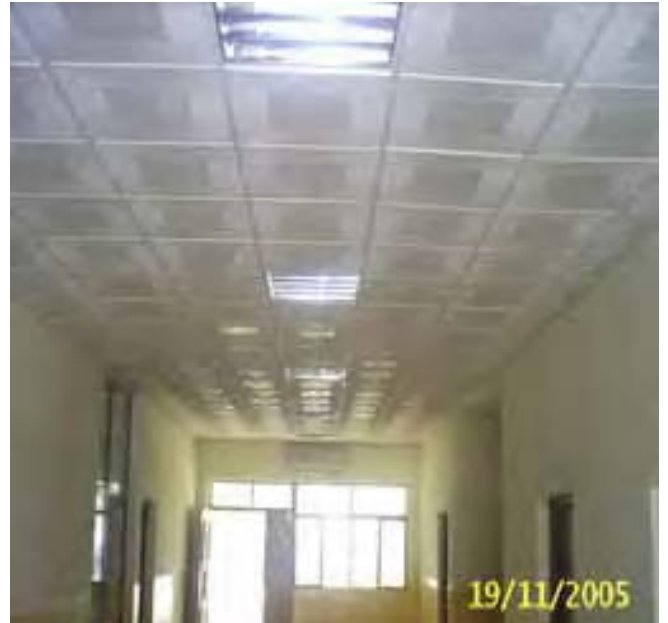
Site Photo 85: Interior hallway (Project 21263)
