BAGHDAD AL KARKH
COURTHOUSE
BAGHDAD, IRAQ

SIGIR-PA-06-058
OCTOBER 10, 2006

SUBJECT: Report on Project Assessment of the New Al Karkh Courthouse,
Baghdad, Iraq (Report Number SIGIR-PA-06-058)

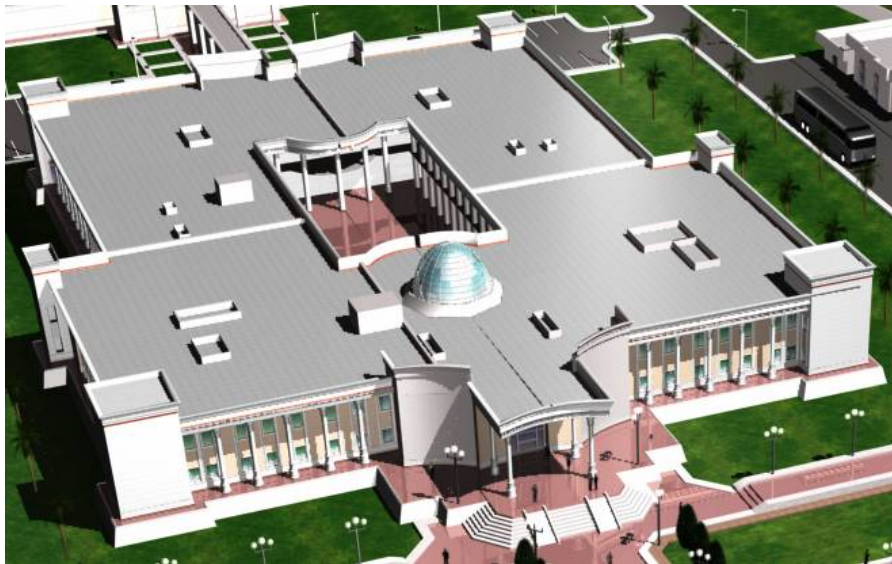
Figure 1. Artist rendering of the Al Karkh Courthouse (Photo provided by USACE)

The courthouse building was designed as a two-story, reinforced concrete and brick structure, supported by a 40 cm thick reinforced concrete “raft” foundation¹ constructed over 50 cm of compacted sub-base material. The first floor slab and the roof slab are designed as cast in place reinforced concrete floors, 20 cm thick. Most of the structure is comprised of load bearing clay brick walls. In addition to the raft foundation, the roof and ground floor slabs, and load bearing walls, the other structural components included exterior reinforced concrete columns (30 cm in diameter) along each face of the building and along the perimeter of the courtyard. The portico roof as depicted in Figure 1 is also supported by circular (30 cm in diameter) reinforced concrete columns.
