# BAGHDAD MUNICIPAL SOLID WASTE LANDFILL

SIGIR PA-06-067 OCTOBER 19, 2006

SUBJECT: Report on Project Assessment of the Baghdad Municipal Solid Waste Landfill, Baghdad, Iraq (Report Number SIGIR-PA-06-067)

# Baghdad Municipal Solid Waste Landfill Synopsis

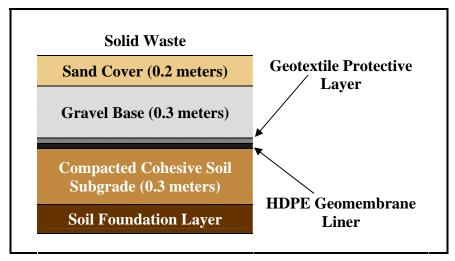
Aerial Image 1. Baghdad Landfill imagery comparison 14MAR05 and 19FEB06.

The liner system cross section is diagrammed in Figure 2. It consists of a 1.5 millimeter (mm) thick HDPE geomembrane underlain by a 0.3 m thick layer of compacted select fill or native material that serves as the soil liner. The compacted soil liner is designed to have a low hydraulic conductivity so very little leachate could actually permeate the layer. A protective geotextile fabric layer covers the liner and serves as a cushion between the liner and the drainage layers. The overlying drainage layers include granular material consisting of a 0.3 m gravel base, topped with a sand layer, 0.2 m in thickness. As the trash, rubbish, and other solid waste material are deposited, the liner system in place will prevent chemicals from the decaying solid waste from "leaching" into the underlying soil and groundwater. Further, because of the sloped construction of the landfill floor, the liner will channel any leachate to the collection system piping.

The drainage layer as shown in Figure 2 consists of 0.2 m of sand over 0.3 m of gravel that is supported by a compacted 0.3 m cohesive soil subgrade. The geomembrane liner and the geotextile cover lie between the subgrade layer and the gravel. The drainage layer was in place on the majority (approximately 75%) of the 9.7 hectare MSW landfill cell. We could not verify thicknesses of the sand layer and gravel layer, but the surface of the sand layer appeared to be graded and finished in accordance with the design. Site Photo 4 provides an example of an area where the drainage layer in the landfill is complete. The foliage in the picture occurred in the preceding seven months after construction ended in November 2005.

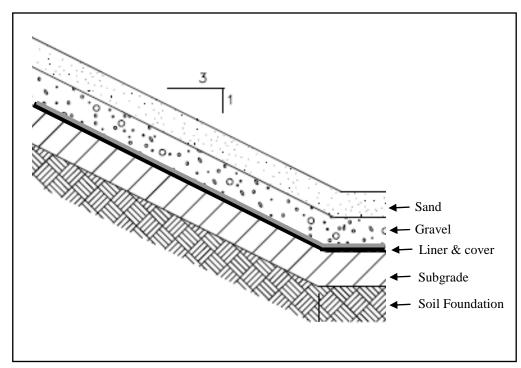
Figure 3. Cross section of the berm slope

The perimeter berm around the MSW landfill consists of an embankment of various heights constructed with a horizontal to vertical slope of 3 to 1. The design required the berm slope cross section to be the same as the landfill floor. Figure 3 illustrates the cross sectional requirements for the berm slope. The required thicknesses for the subgrade and gravel layers are 0.3 m, and 0.2 m for the sand layer.

We observed the berm in place along the perimeter of the MSW landfill. The design required the liner system to extend up the 3 horizontal to 1 vertical side slope of the berm and terminate in an anchor trench along the top of the perimeter berm. In the unfinished areas of the landfill, the liner along the inside of the berm, as shown in Site Photo 6, will require remedial work to ensure it is placed and anchored properly.

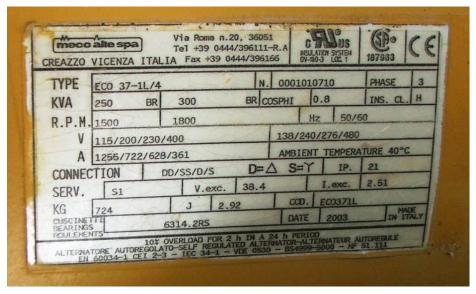
Site Photo 12. Generator factory plate

The generator on site is shown in Site Photo 11. The factory plate attached to the generator shows an Italian made "Mecc Alte Spa ECO 37-1L/4250 KVA" generator. However, the generator skid indicates an "AKSA" model generator. AKSA generators are manufactured in Turkey. Further, the factory plate (Site Photo 12) has yellow paint on its surface indicating the generator was painted after the factory plate was attached.

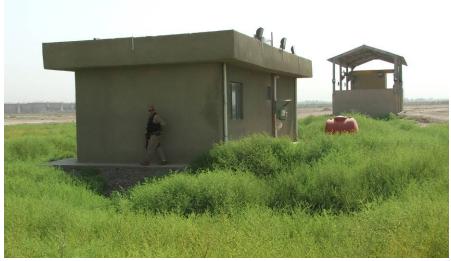
The design for the administration building showed a one story, 12 m by 5 m building. We inspected the exterior of the building and verified the building generally met the standards of the design. However, we noted some cracking in the perimeter sidewalk. Additionally, the partially covered water heater, shown in Site Photo 15, had started to rust. We also noted the building was surrounded on all sides by thick vegetation (Site Photo 16) that had grown since November 2005. The vegetation will require removal prior to the landfill becoming operational.

Site Photo 16. Administration building (truck maintenance building to the right)

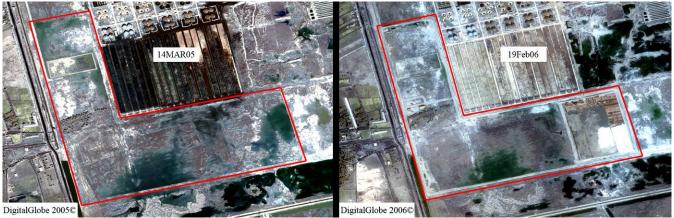
A comparison of two images taken on 14Mar05 and 19Feb06 shows construction progress of the Baghdad Landfill, outlined in red on Aerial Image 1. On imagery dated 14Mar05 the only noticeable construction is the ground preparation of the Construction Debris Landfill (Figure 1, pg. 5) portion of the Baghdad Landfill. Imagery dated 19Feb06 shows what appears to be a nearly completed landfill. Structures visible as of 19Feb06 consist of the Administration, Vehicle Maintenance, and Guardhouse buildings.
