WASTE WATER TREATMENT PLANT  
AL KASIK MILITARY TRAINING BASE  
AL KASIK, IRAQ

**SIGIR PA-06-074**  
**JANUARY 29, 2007**

SUBJECT: Report on Waste Water Treatment Plant, Al Kasik Military Training Base, Al Kasik, Iraq (Report Number SIGIR PA-06-074)

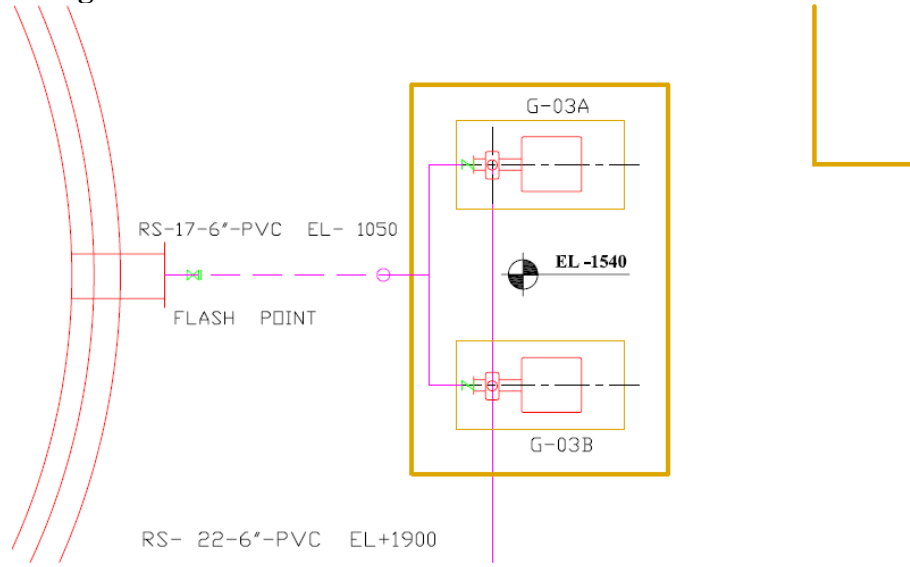
**Diagram 3. Pump Station G-03 from contractor's piping plan drawing.**

The G-03 pump station located beside the D-07 tank consisted of a below grade reinforced concrete pad with foundation walls. Placing the pumps below grade improved the efficiency of the pumps located on pads identified as G-03A and G-03B in Diagram 3. In addition, the diagram shows the relative location of the pump station in relation to the edge of the D-7 tank. In comparison to many of the concrete structures observed throughout the WWTP, the G-03 pump station was not a large structure. It measured approximately, 4.4 m (14.5 ft) by 2.7 m (9 ft) by 1.7 m (5.6 ft) deep. During the site visit, the assessment team observed significant fractures in the concrete structure along the base, walls, and corners of the G-03 pump station. A series of photos (Site Photos 11-18) illustrate what the assessment team observed while on site. Site Photos 11-16 were taken from inside the pump station while Site Photos 17 and 18 were taken from the outside.

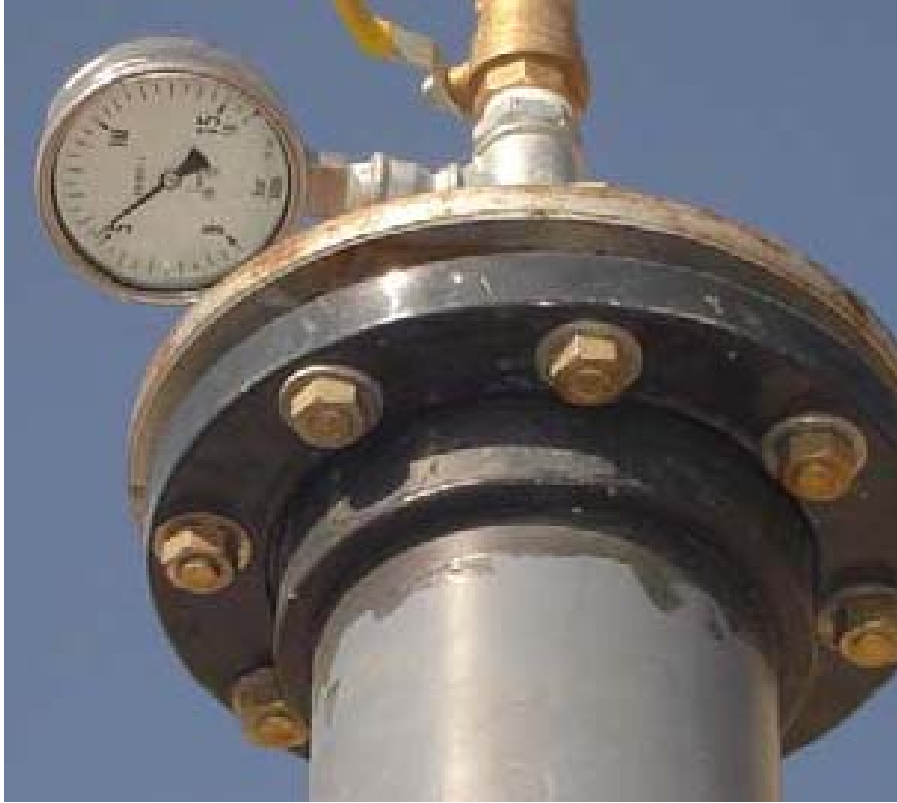
**QA Photo 1. Pressure testing a pipeline (from QA Report 4 Oct 2005).**

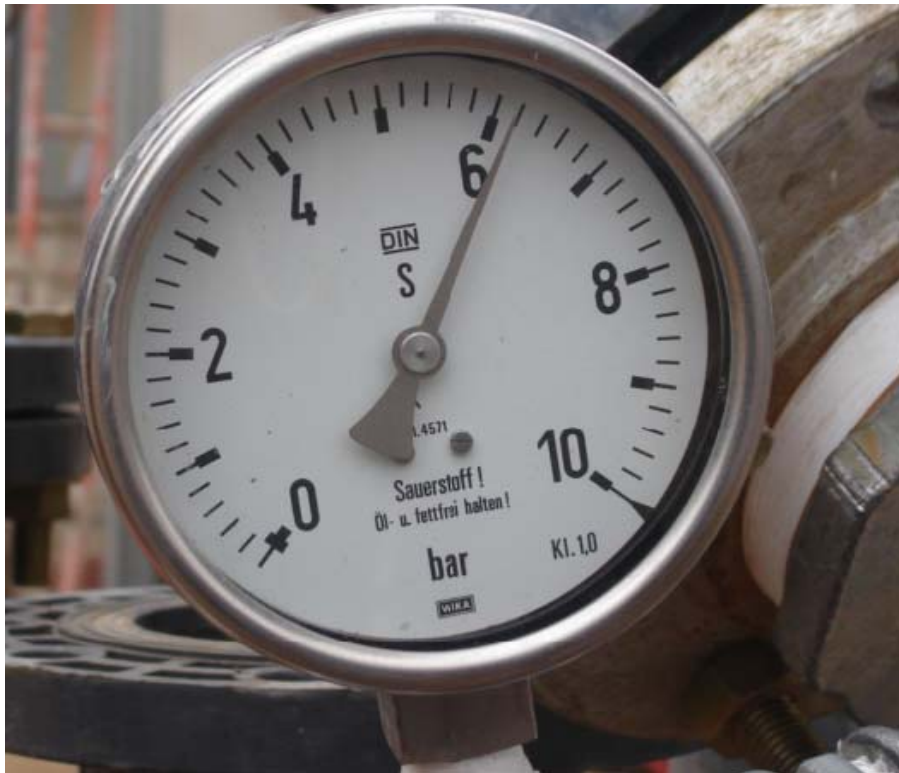
**QA Photo 2. Hydro-testing a pipe line between tanks (from QA Report 23 Dec 2005).**

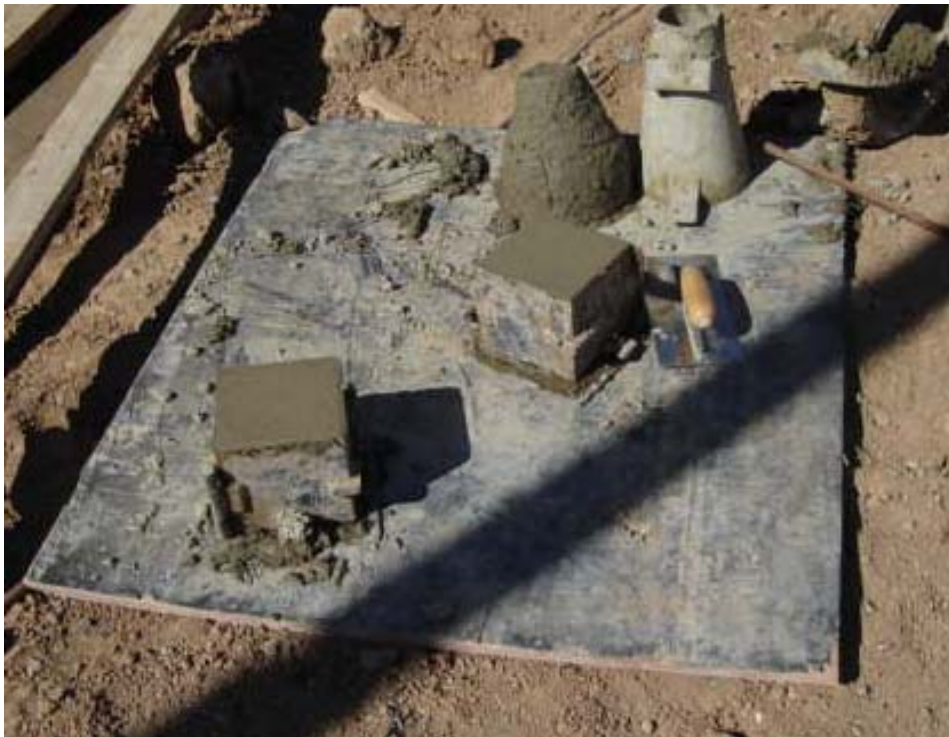
**QA Photo 4. Slump test and 2 cube samples taken for laboratory concrete strength testing (from QA report 26 Oct 2005).**

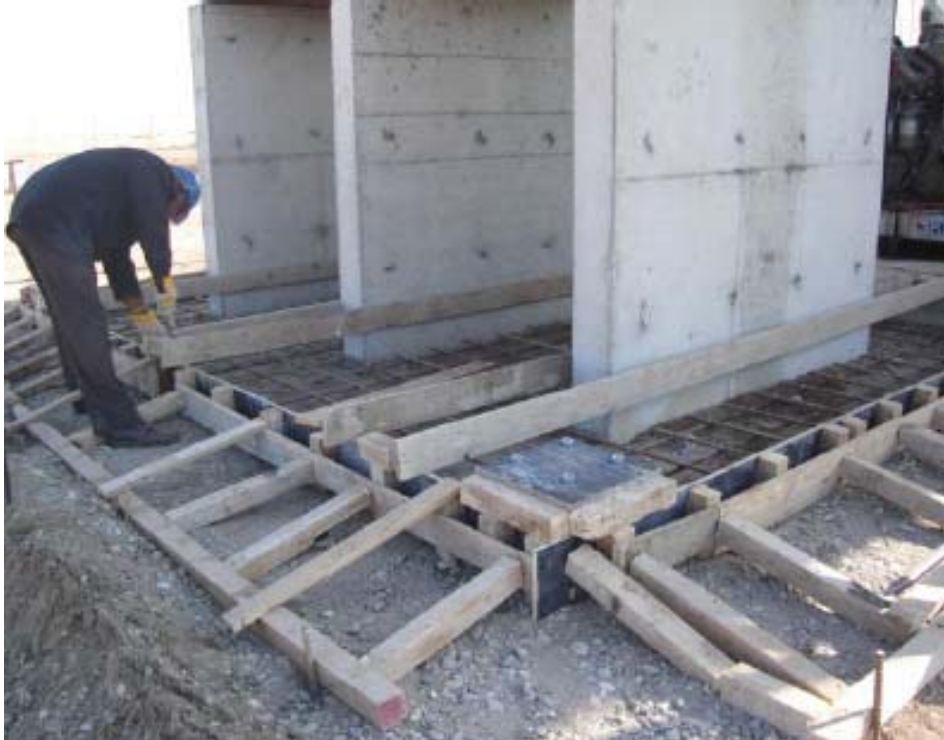
**QA Photo 5. Flatwork form with clear / sufficiently sized lumber and proper brace placement (from QA Report 14 Dec 2005).**

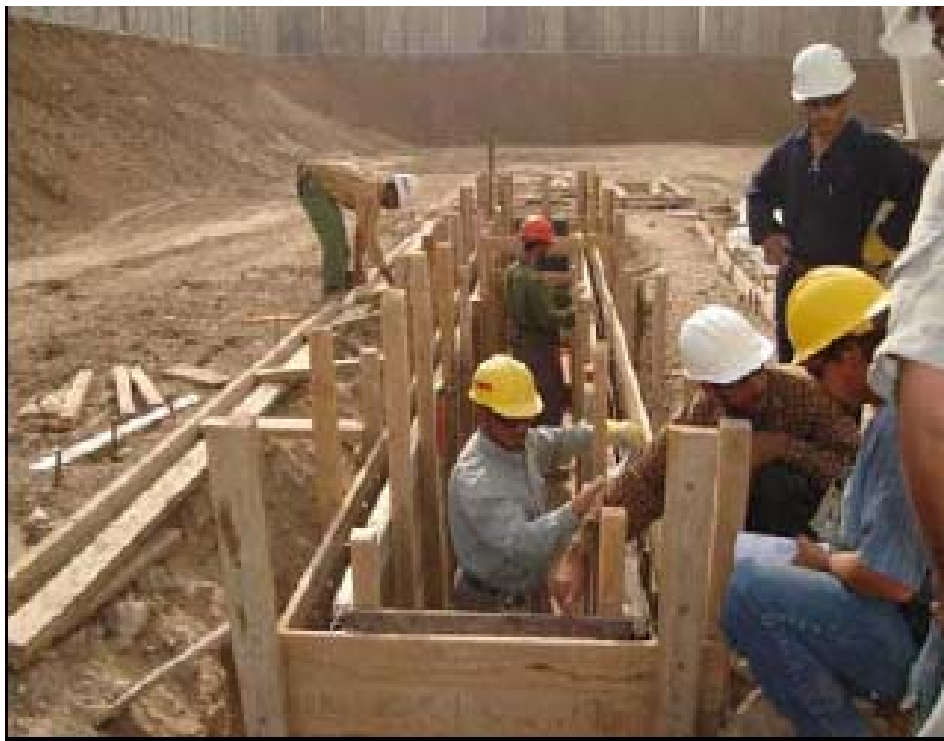
**QA Photo 6. Good form techniques were used to build a sub-grade foundation with supervisors on site (from QA Report 11 Oct 2005).**

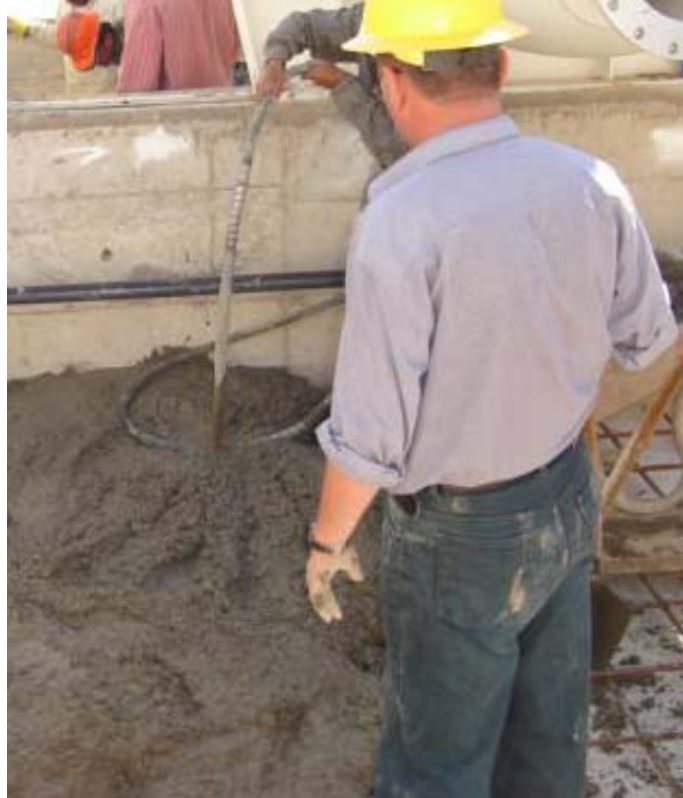
**QA Photo 7. Supervisor watched worker consolidate concrete with a hand held mechanical vibrator<sup>4</sup> (from QA Report 26 Oct 2005).**

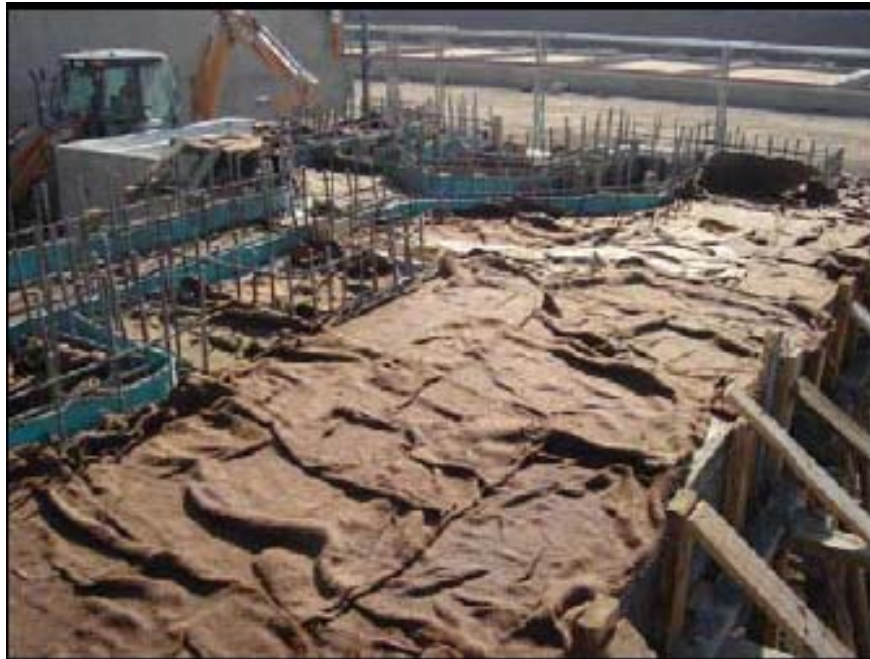
**QA Photo 8. Concrete covered with burlap to prevent too rapid drying and decreased strength (from QA Report 3 Oct 2005).**

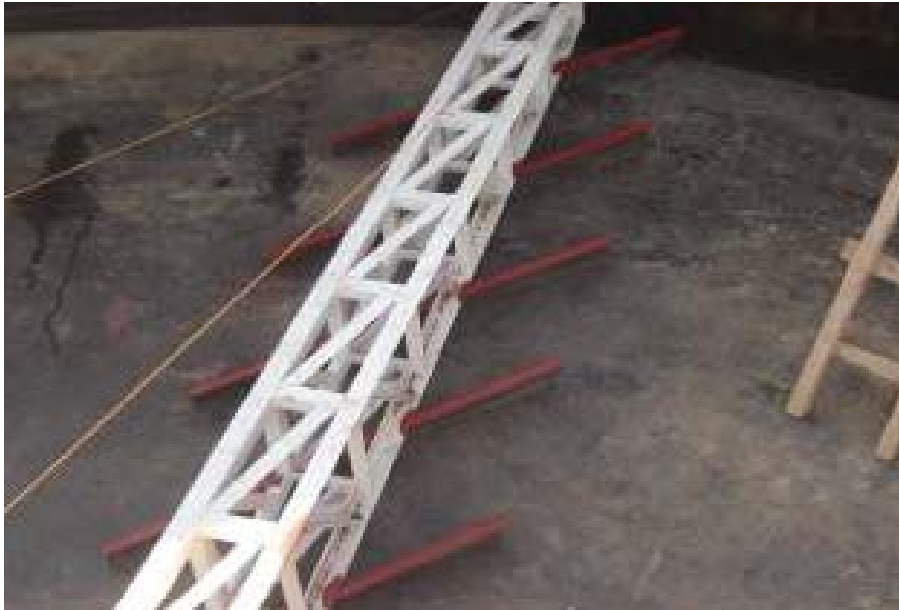
arm failure on 19 March 2006 was in part or completely caused by the Iraqi WWTP operators. In an e-mail response to our inquiry, the contractor wrote that the sweep arm would have failed *“if the tank was not drained prior to restart.”* Conversely, the AFCEE/COR wrote: *“It is believed that the Iraqi Army put the plant into operation after the turnover, but before adequate flow of liquids was available, thus causing the damage to the sweep arm.”* Based on the differences between the two explanations, what actually led to the failure could not be determined. However, it is likely that the Iraqi WWTP operators were not sufficiently trained in large part because of the reduced testing period and the contractor’s quick departure on 18 February 2006.

**QA Photo 9. Empty clarifier tank (QA Photo 9 from QA Report dated 31 Jan 2006)**

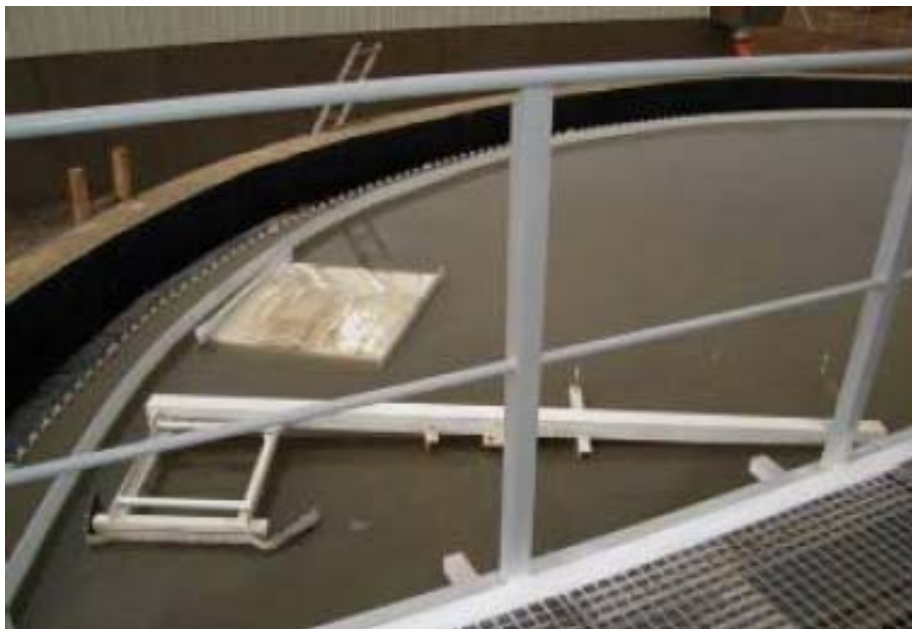
**QA Photo 10. Full clarifier tank (from QA Report dated 5 Feb 2006)**
