**BAGHDAD POLICE COLLEGE  
BAGHDAD, IRAQ**

**SIGIR PA-06-078.2**

**SIGIR PA-06-079.2**

SUBJECT: Report on Project Assessments of Reconstruction Work Performed Under Task Orders 06 and 29 at the Baghdad Police College, Baghdad, Iraq (Report Numbers SIGIR PA-06-078.2 and PA-06-079.2)

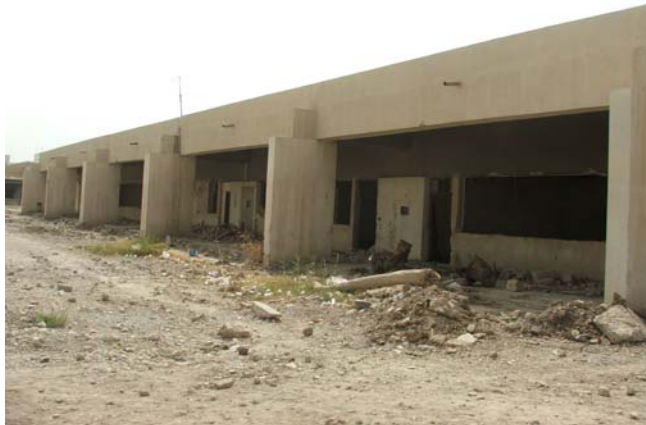
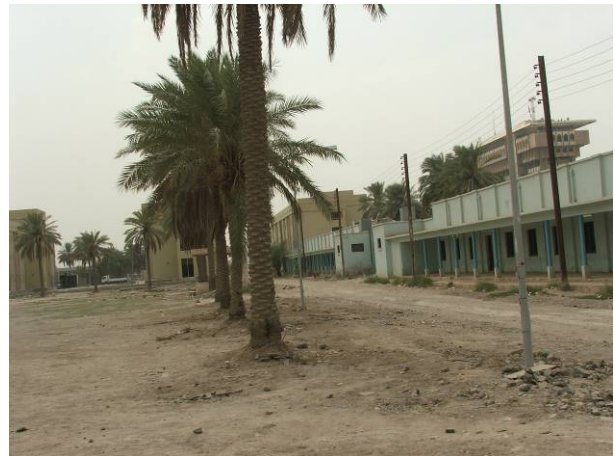
The description of the facility (pre-construction) was based on information obtained from the contract, the U.S. Army Corps of Engineers (USACE) project file, and BPC personnel. The project site is located at the existing Baghdad Police College campus, in Baghdad, Iraq. The surrounding area consists of residential homes and government buildings, such as the Ministries of Interior and Oil. The BPC previously was a three-year officer training facility. However, with an emphasis of providing a large number of cadets through Basic Police Training, this facility was determined to be insufficient. The existing facility consisted of a number of buildings, constructed approximately between 1935 to 1944. The existing buildings were in various stages of decay (Site Photos 1 and 2).

**Site Photos 1 and 2. Existing buildings at the Baghdad Police College**

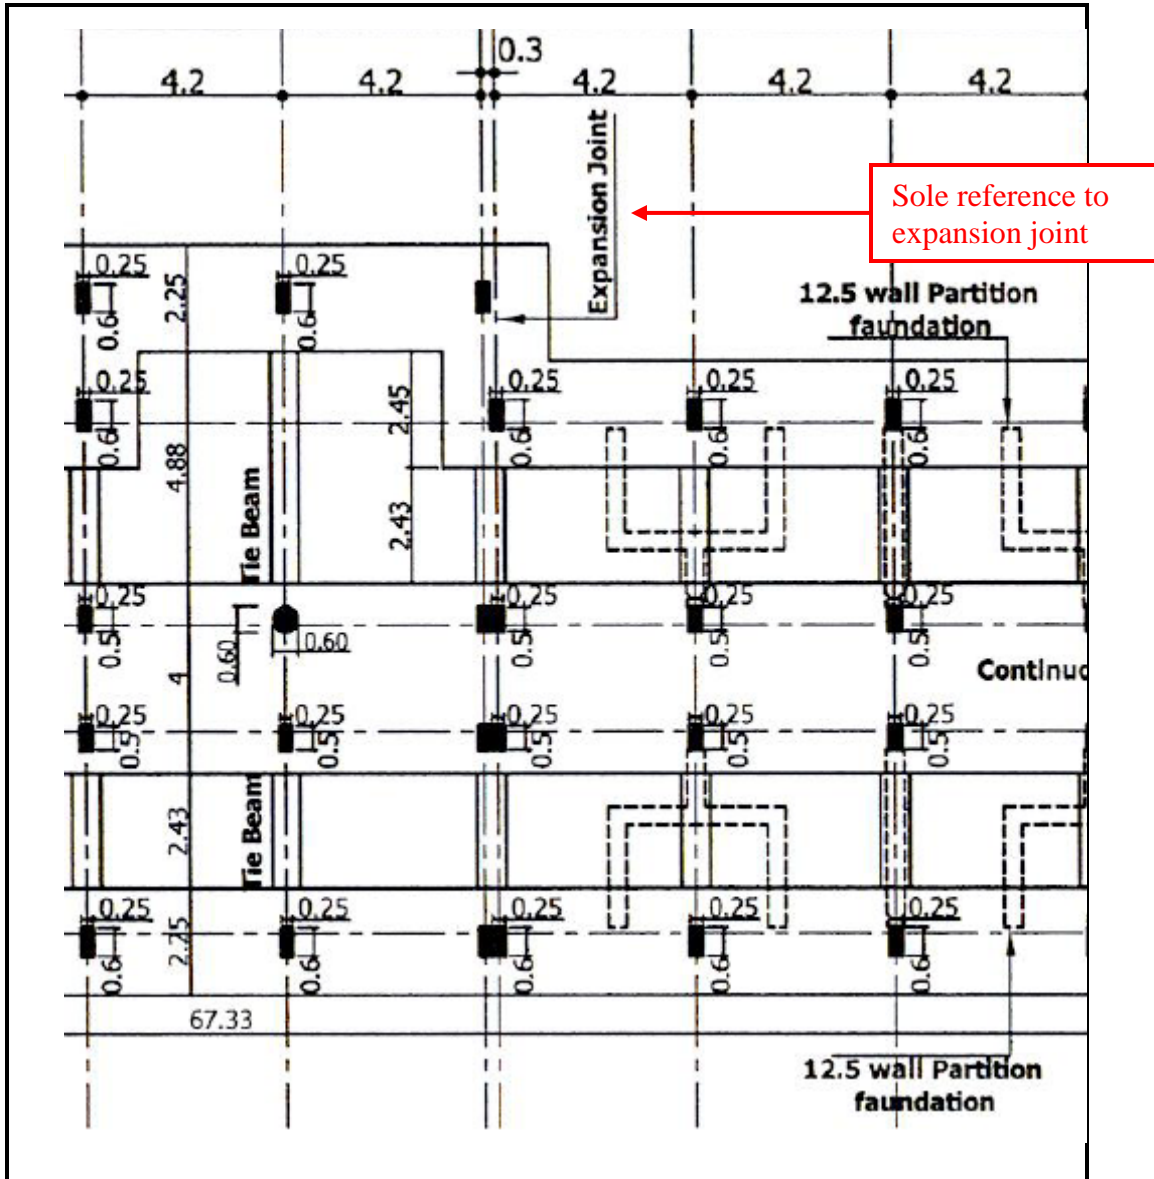
The 60% design drawings for the instructors' barracks did not include any specific details for the use and installation of expansion joints; instead there are only vague references to the expansion joints in the design drawings (Figure 3). The government engineer's design reviews did not identify the obvious absence of this item on the design drawings and subsequently did not require the contractor to resubmit the drawings with exact expansion joint details. Specific expansion joint details are critical, since properly designed and correctly installed joint systems are capable of protecting buildings and structures from damage caused by thermal expansion and contraction as well as anticipated foundation movements.

Figure 3. Contractor's 60% design drawings with vague reference to expansion joint

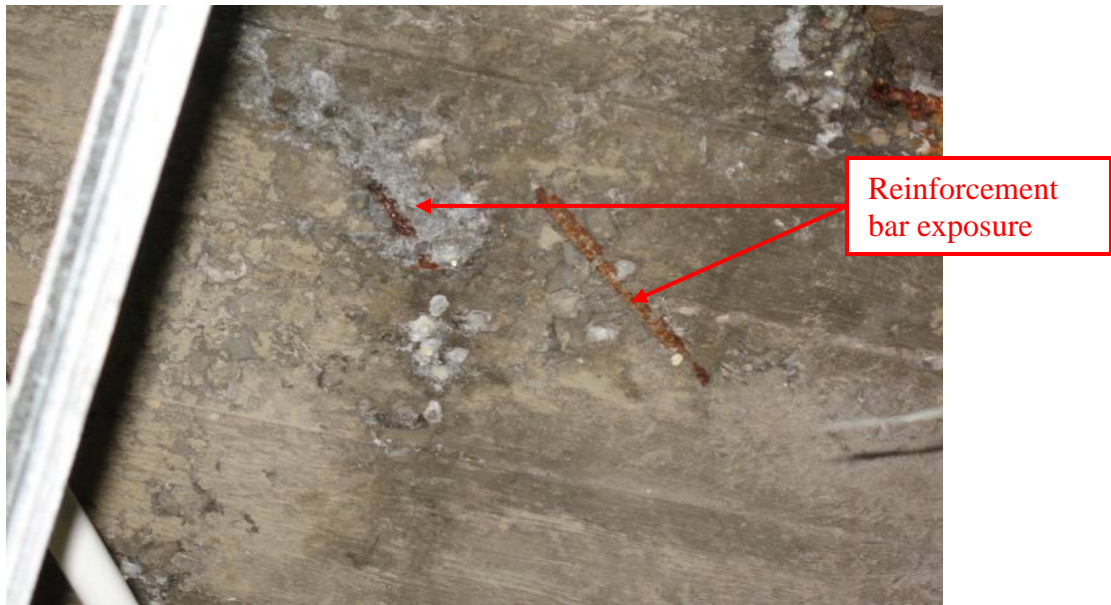
Site Photo 4 provides an example of another plumbing installation problem - improper sealing; while Site Photos 5, 6, and 7 provide examples of concrete segregation and honeycombing, and reinforcement bar exposure. In addition, the contractor did not comply with IPC code Sections 707 and 708, which specifically prohibits the use of cement or concrete joints and required the use of cleanouts for soil pipe lines greater than 45 degrees, respectively.

Reinforcement bar exposure

**Site Photo 5. Reinforcement bar exposure in cadet barracks**

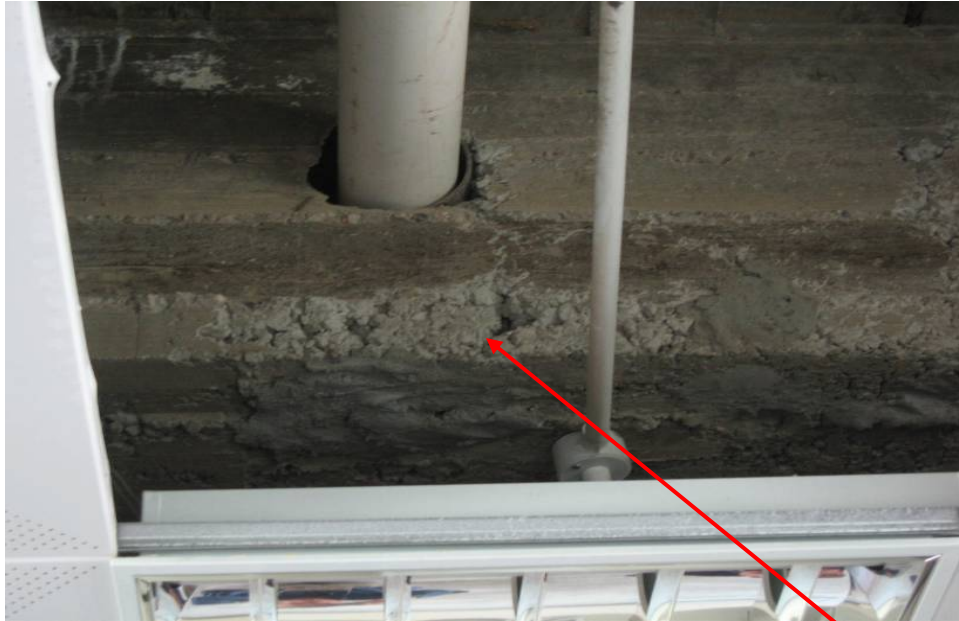
**Site Photo 6. Concrete segregation and honeycombing in cadet barracks**

Honeycombing and segregation

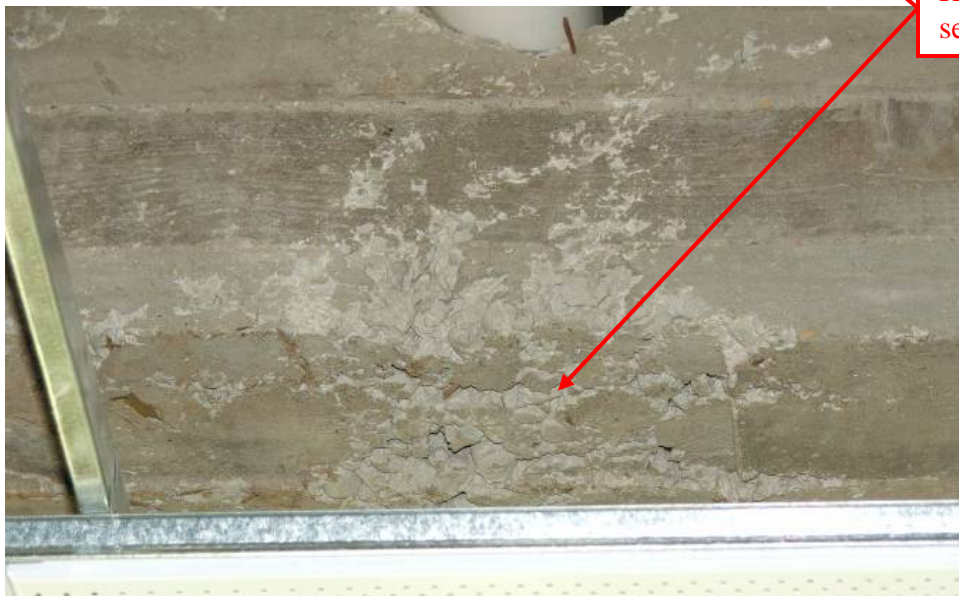
**Site Photo 7. Concrete segregation and honeycombing**

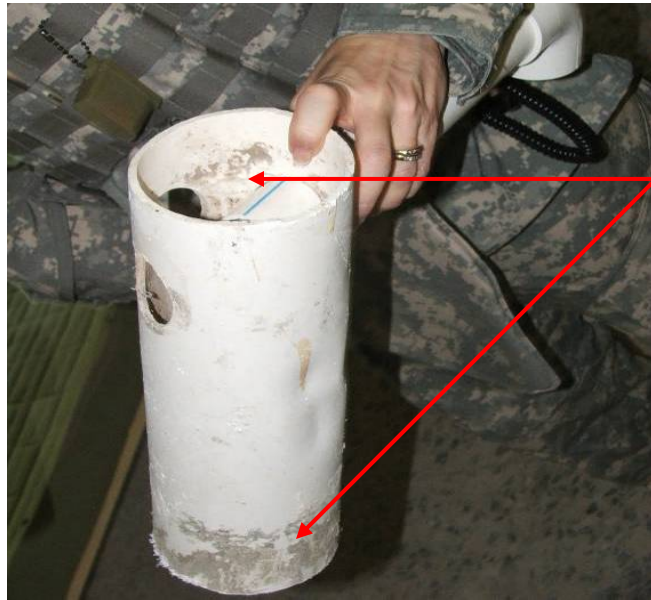
According to the USACE Gulf Region Division (GRD) and BPC representatives, the common practice of local subcontractors is to cement joints in the bathroom areas (Site Photos 8 and 9); however, this practice is strictly prohibited by the IPC. In an earlier section of this report, we mentioned the lack of the required number of cleanouts in the design drawings. Site Photo 10 shows no cleanouts for several traps and 90 degree turns. Not only is a cleanout required by the IPC, without it solid waste will collect and ultimately clog the pipe.

Evidence of failed cemented joints

Site Photo 8. Piece of original plumbing pipe removed from cadet barracks

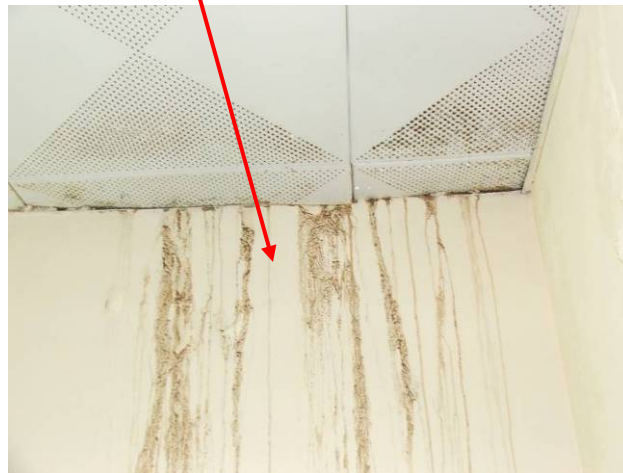
the ground floor (Site Photo 12). A third floor plumbing fixture was leaking and apparently was not correctly installed and sealed to the wall, which consequently allowed water to flow down to the ground floor.

Site Photo 12. Water damage on ground floor from leak on 2<sup>nd</sup> floor

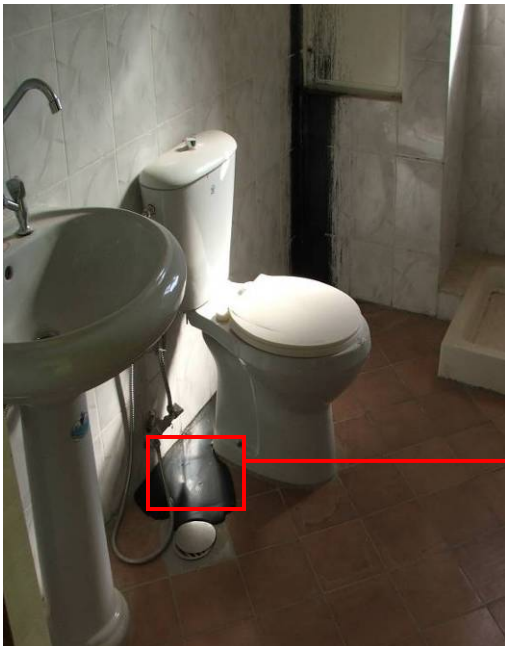
In the instructors' barracks we identified a poorly installed main water line connection, tar damage in the bathrooms, which leaked from the roof down to the ground floor, and a poorly installed electrical outlet (Site Photos 13-16). The main water line connection is peculiar since multiple sized pipes are used. Specifically, there is a reduction from the 4" main pipe to a 2" pipe and then expanding to a 4" pipe.

Site Photo 14. Tar leaking from roof to ground bathroom.

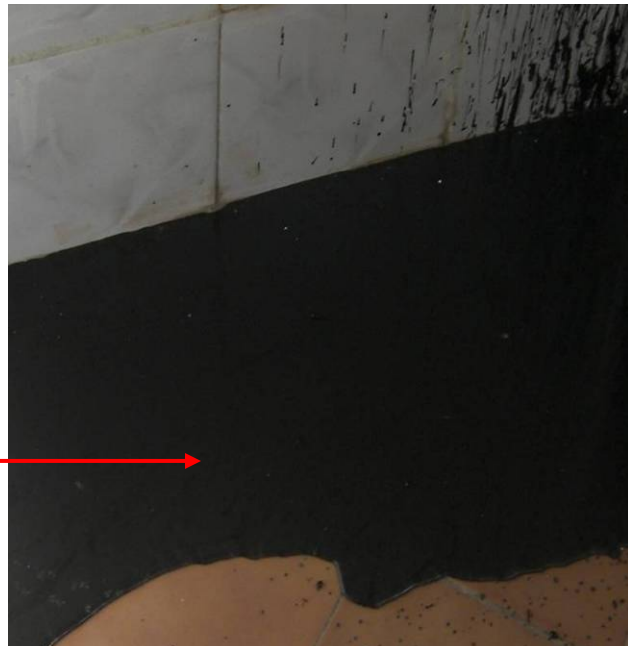
Site Photo 15. Close-up view of tar damage

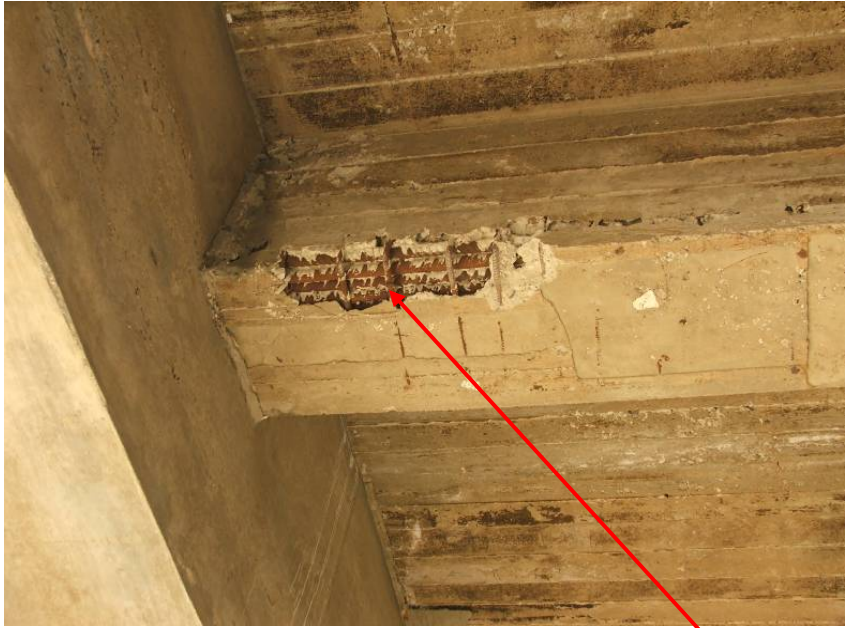
- Areas of severe reinforcement bar exposure on the surface of the load-bearing reinforced concrete ceiling beams (Site Photos 21-23)
- Areas of severe concrete segregation and honeycombing (Site Photos 24-26)
- Poor quality brick workmanship (Site Photo 27)

**Site Photo 22. Reinforcement bar exposure**

Areas of severe reinforcement bar exposure

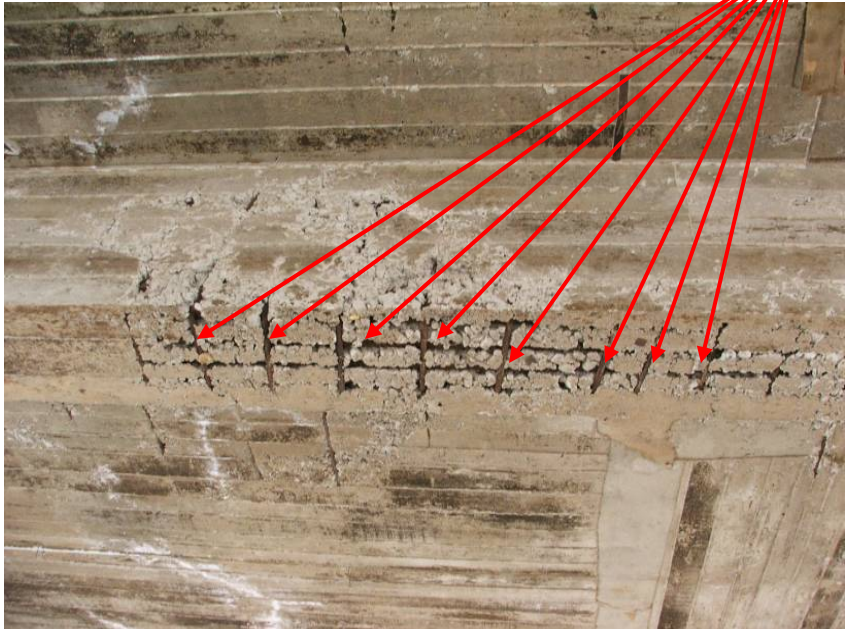
**Site Photo 23. Example of reinforcement bar exposure**

Areas of honeycombing, voids, and segregation

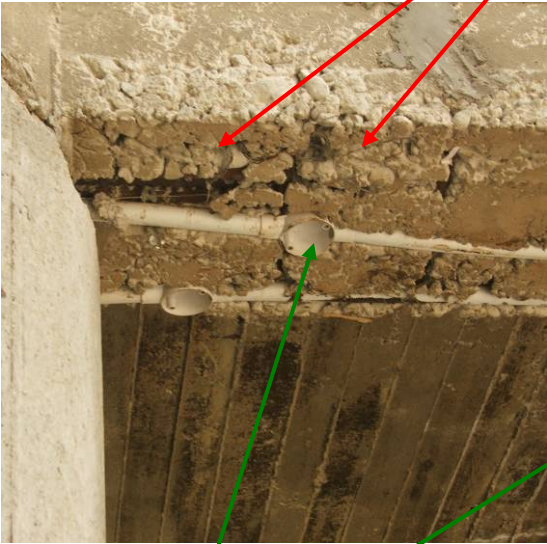
Site Photo 24. Concrete segregation and electrical conduit exposure

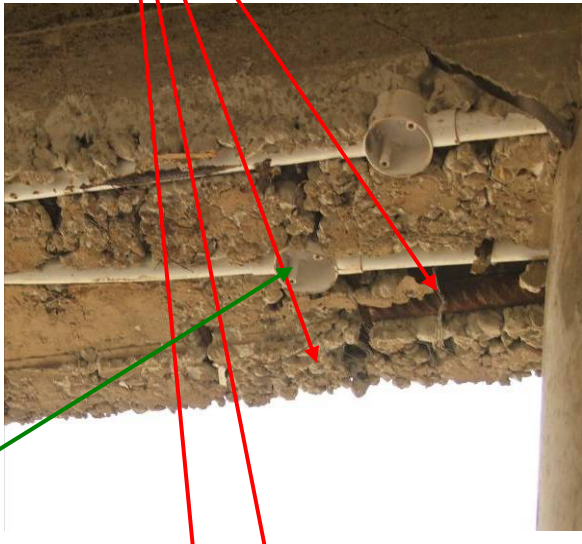
Site Photo 25. Concrete segregation and electrical conduit exposure

Electrical conduit exposure due to incorrect placement

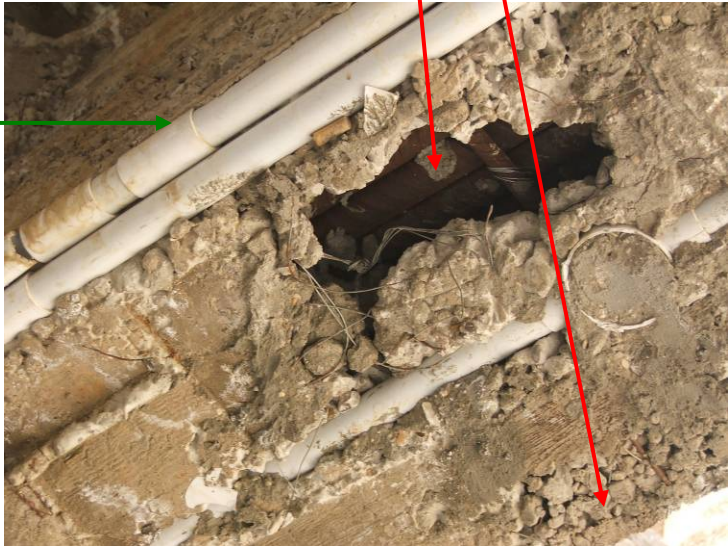
Site Photo 26. Concrete voids and electrical conduit exposure

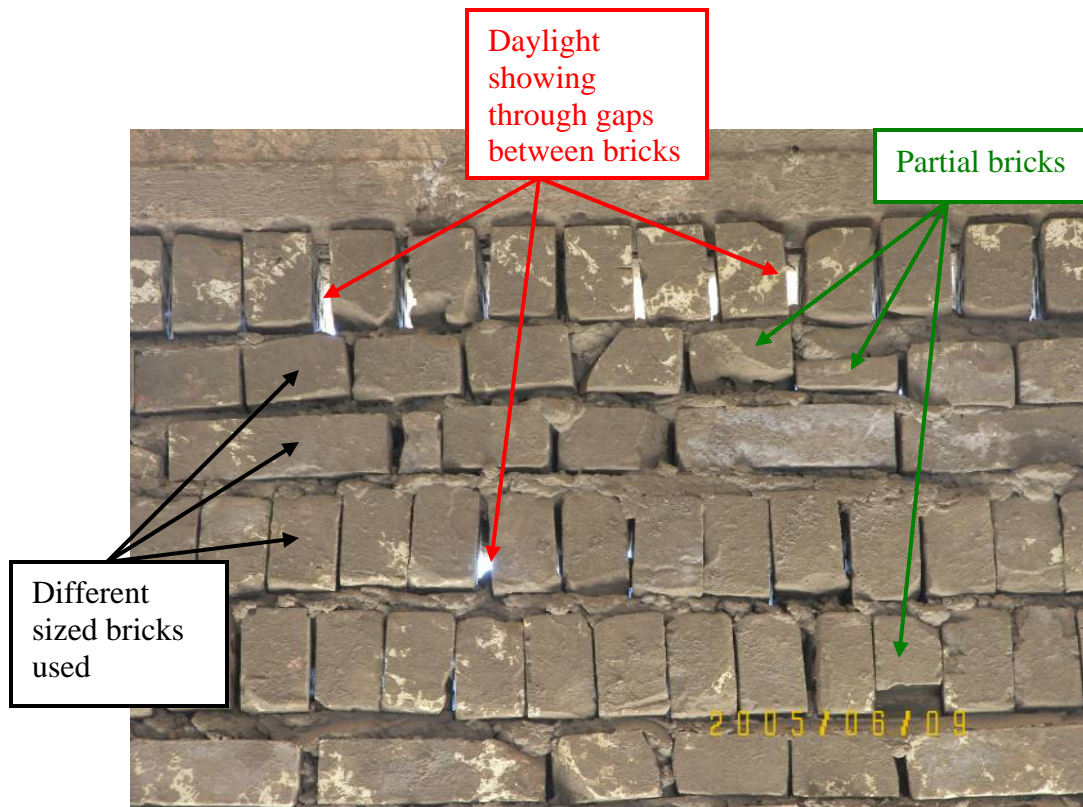
Site Photo 27. Poor brick work – not level, gaps between bricks, different sized bricks, and partial pieces of brick used in the central laundry facility

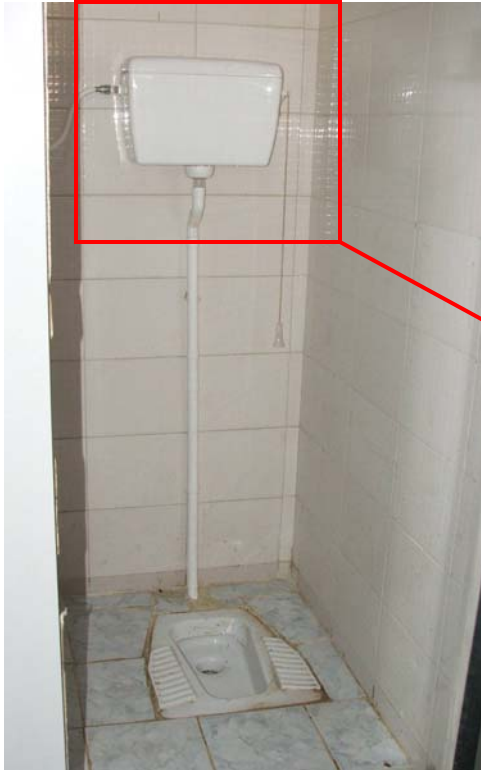
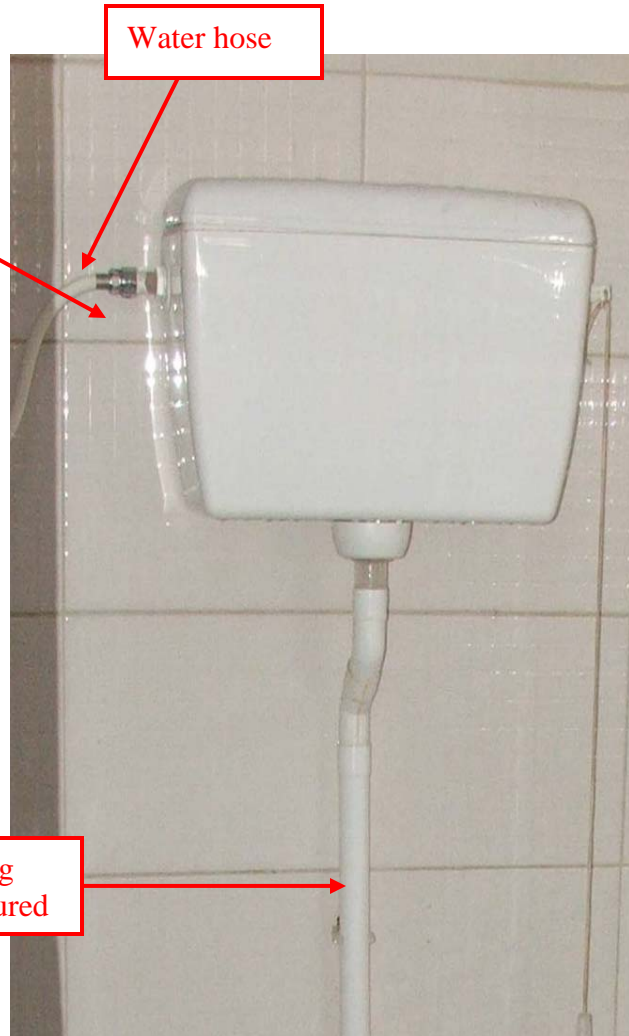
The plumbing fixtures used in the cadet and instructors' barracks bathrooms appeared to be low quality fixtures (shower heads, water supply lines, faucets, drain covers, etc) installed in the showers, wash stations (sinks), urinals, and water closets. Site Photos 28 and 29 show the type of plumbing materials used in the water closets, which included flexible water hoses, plastic supply tanks, and thin wall plastic tubing supplying water from the tank to the toilet. Site Photos 30, 31, and 32 show the shower fixtures, including the shower head, the thin metallic tubing used to supply water to the shower head, and the single clamp used to secure the water pipe to the wall. Over time, the clamp will dislodge from the wall and the shower water pipe will hang unsupported.

Site Photo 28. Water closet in cadet barracks

Site Photo 29. Enlarged view of Site Photo 28

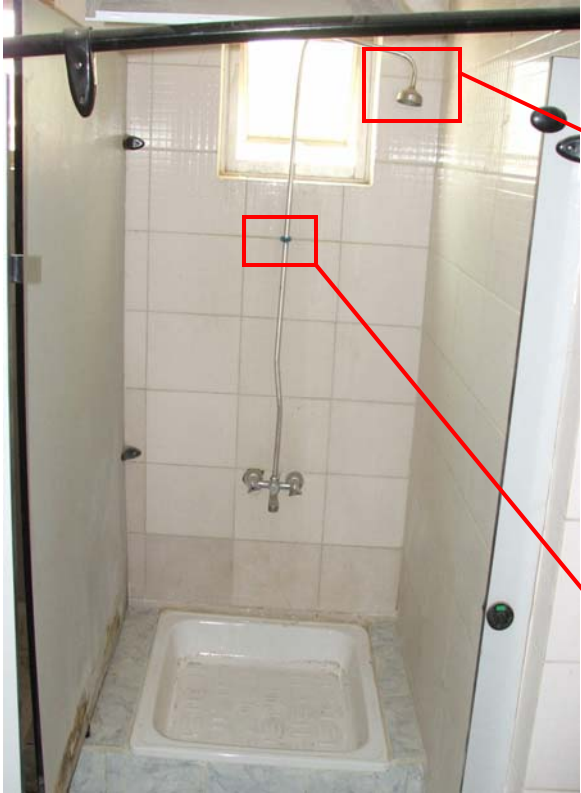
**Site Photo 30. Shower fixture in cadet barracks**

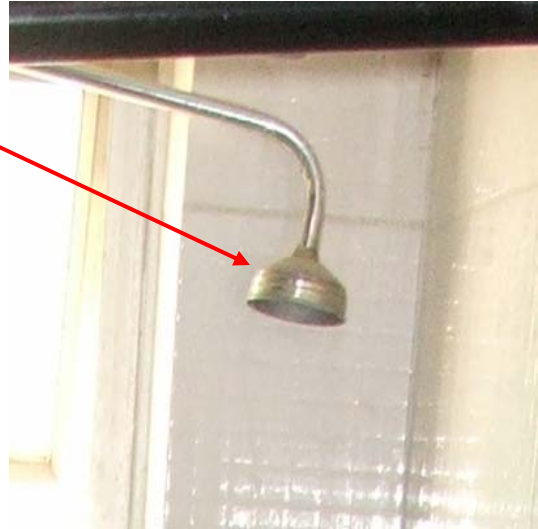
**Site Photo 31. Close-up view of shower head**

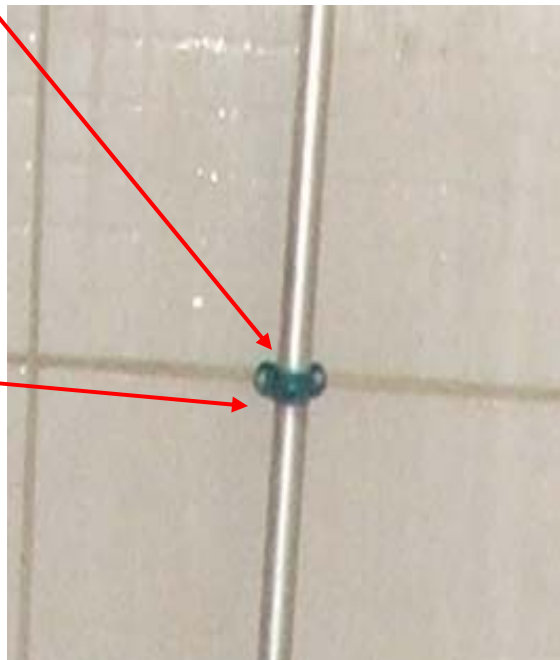
**Site Photo 32. Close-up view of clamp**

Two screws of the clamp holding the shower pipe are driven into cement mortar joint between the tiles will not provide needed strength to keep the pipe in place

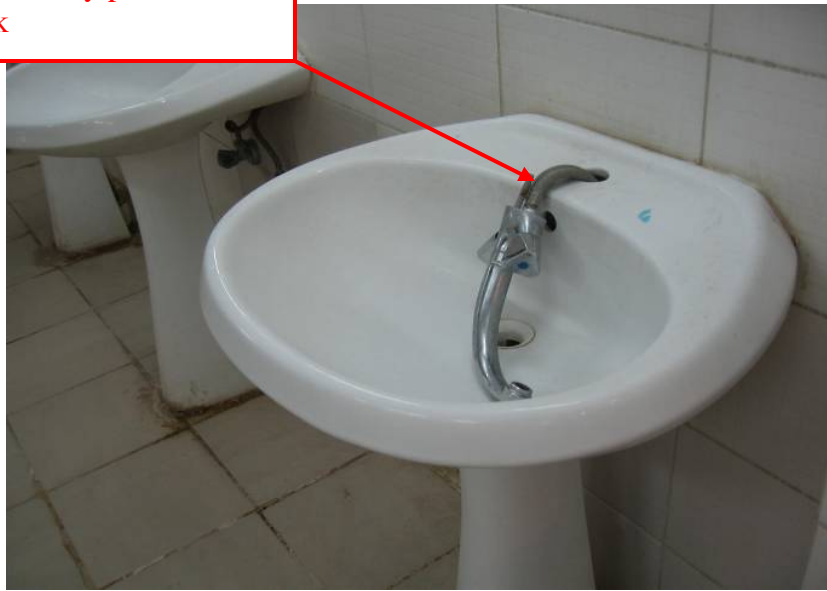
During our site visits to the BPC, we witnessed the problems associated with the use of the low quality parts. For instance, the clamps holding the shower water pipe to the wall were dislodged; the thin metallic tubing was bent; multiple sink faucets were pulled from the sink and were leaking (Site Photos 33 and 34); and shower faucets were leaking (Site Photo 35).

Low quality plumbing fixture – easily pulled from the sink

**Site Photo 33. Bathroom sink in cadet barracks**

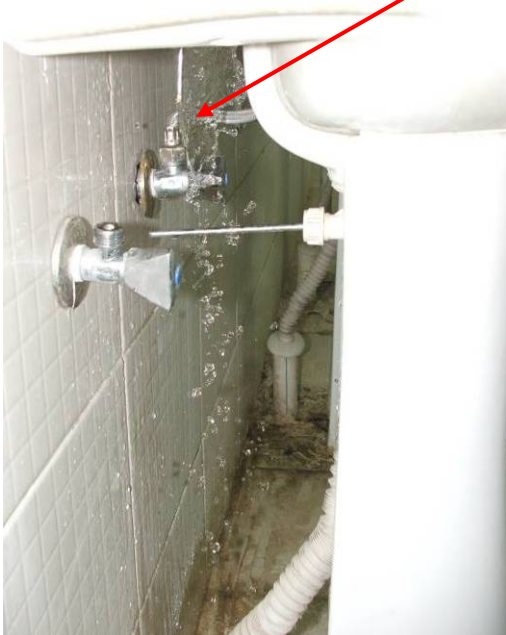
Low quality plumbing fixtures – failed to stop water flow

**Site Photo 34. Water leak**

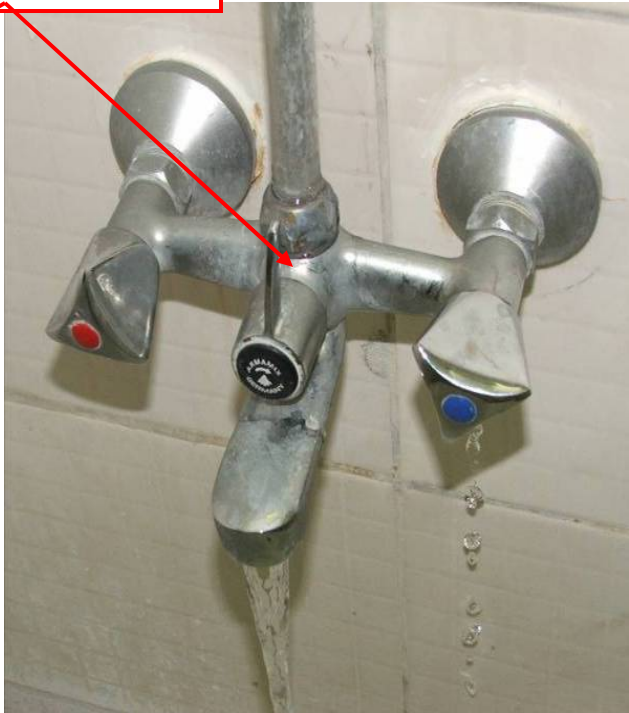
**Site Photo 35. Leaking shower faucet in cadet barracks**

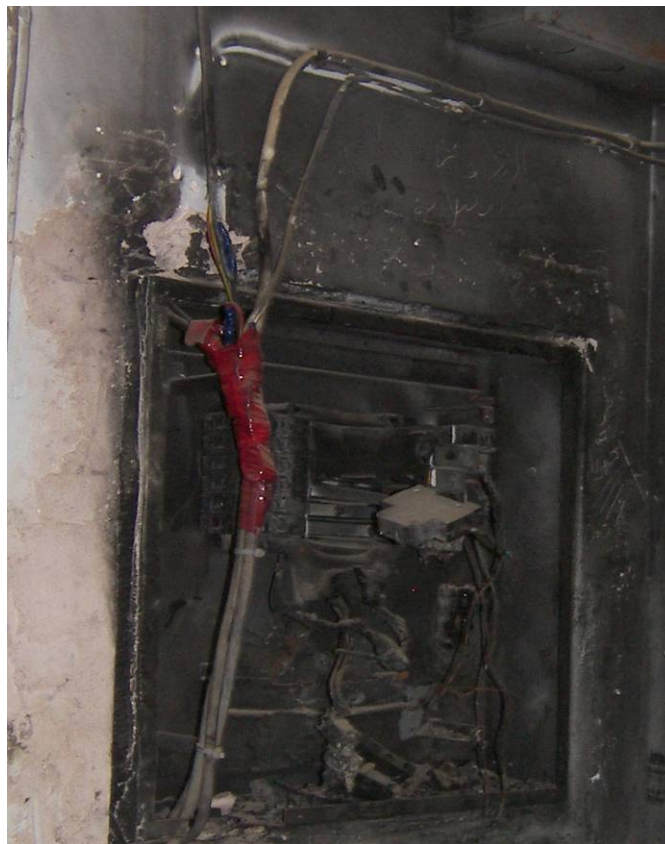
For the dog kennel, GRD and Parsons representatives signed the Beneficial Occupancy form on 7 June 2006, with no punch list items noted. GRD records indicated Parsons completed “Emergency Work” for the facility. We identified the work completed by Parsons, which consisted of re-wiring the electrical panel (Site Photo 36). By signing this form, the GRD and Parsons asserted that this electrical work was in accordance with specifications and in compliance with IEC codes.

**Site Photo 36. Electrical panel for the dog kennel**

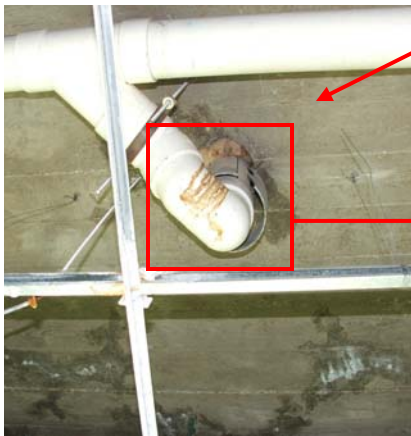
During our initial site visit, we identified either the same pipe (or one constructed in a similar manner), which confirmed the contractor did not take any corrective action to the NCR (Site Photos 39 and 40). The inability to act upon the NCRs resulted in the significant plumbing issues associated with the cadet barracks buildings. The poor soil pipe sealing work allowed waste water and solids to drain outside rather than inside the pipe, resulting in waste water leakage (Site Photos 41 and 42), which was a contributing factor to the significant water damage we witnessed on the ground floor.

Site Photo 39. Plumbing installation in cadet barracks in August 2006

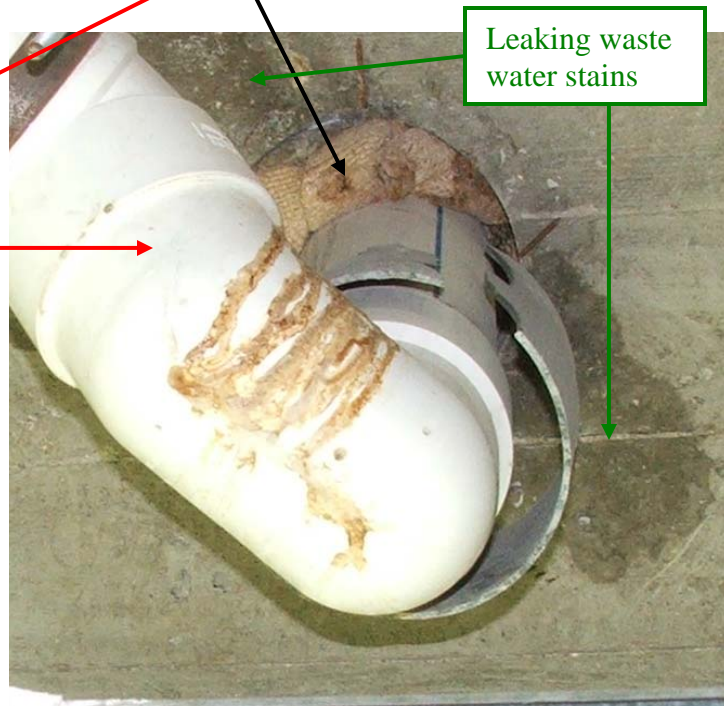
Leaking waste water stains

Site Photo 40. Enlarged view of Site Photo 39

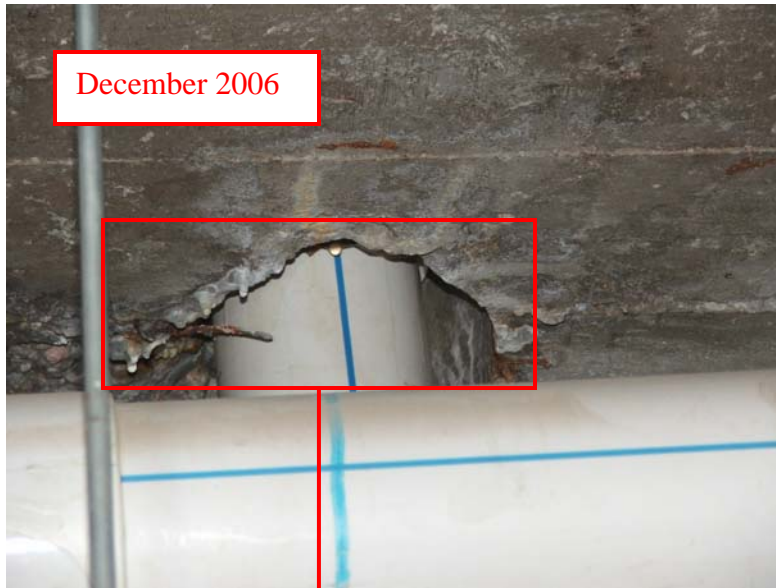
**Site Photo 41. Water leaking from poorly installed drain in cadet barracks**

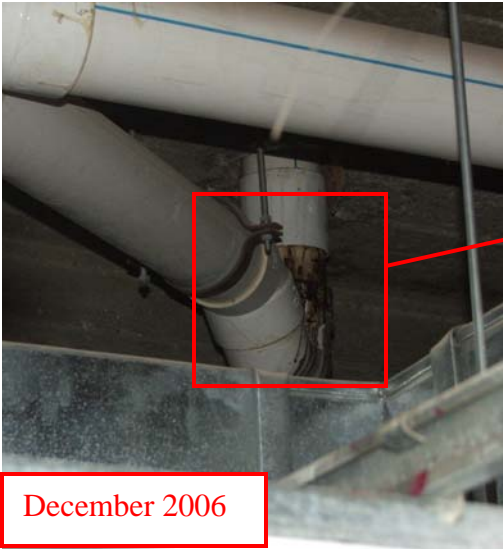
December 2006

The final cause of the waste water leakage throughout the cadet barracks appears to be inadequate sealing of pipes, which resulted in waste water flowing outside of the pipes (Site Photos 43 and 44). The pipe sealing should have been caught by the contractor’s QCR or project engineer during installation and also through testing. The absence of proactive responses by the contractor allowed the plumbing issues to go unresolved. As a result, the cadet barracks’ bathrooms had to be torn up and redone; the Iraqi police cadets were subjected to waste water raining down upon them; and BPC did not have full use of the cadet barracks.

Site Photo 43. Leaking waste water from poorly sealed pipes

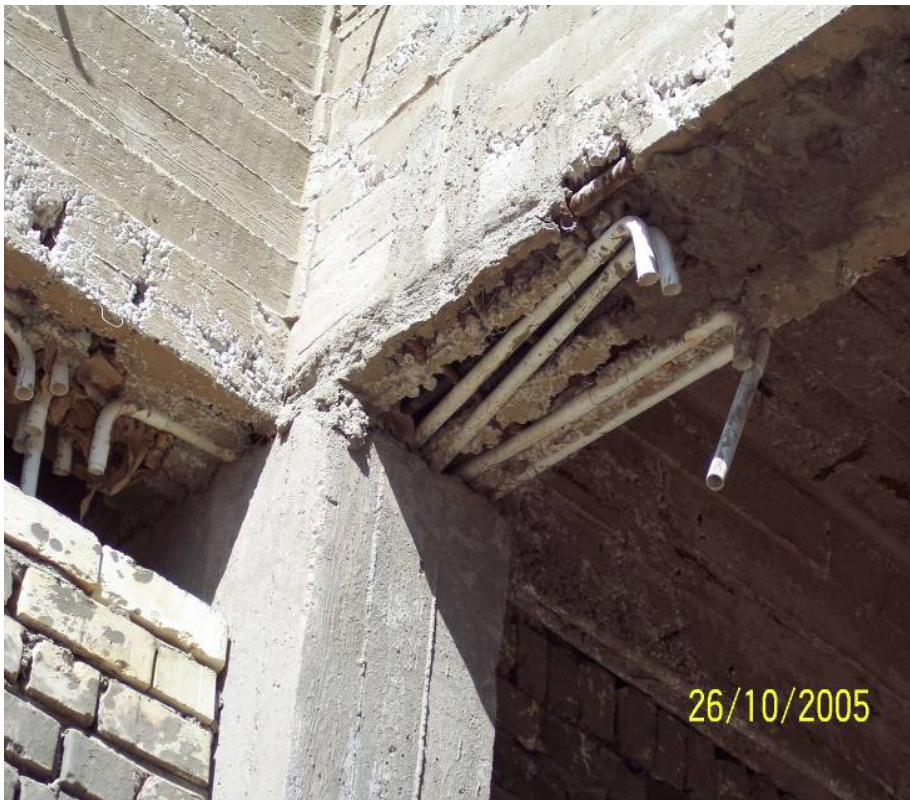
**Site Photo 47. Electrical conduit exposure (Photo courtesy of the USACE)**

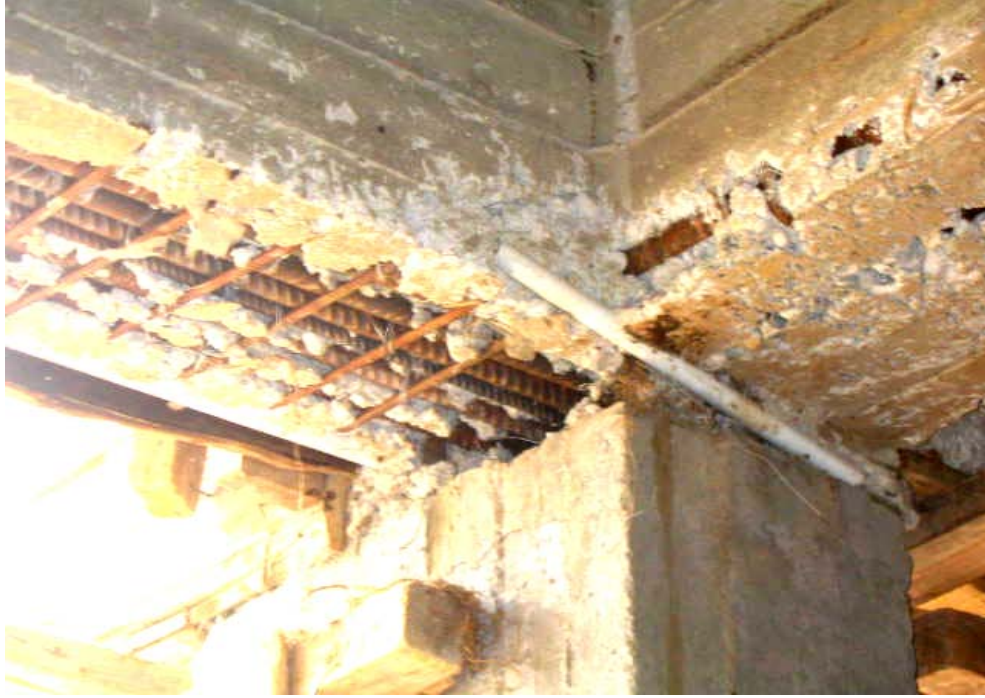
**Site Photo 50. Concrete segregation, reinforcement bar and electrical conduit exposure (Photo courtesy of the USACE)**

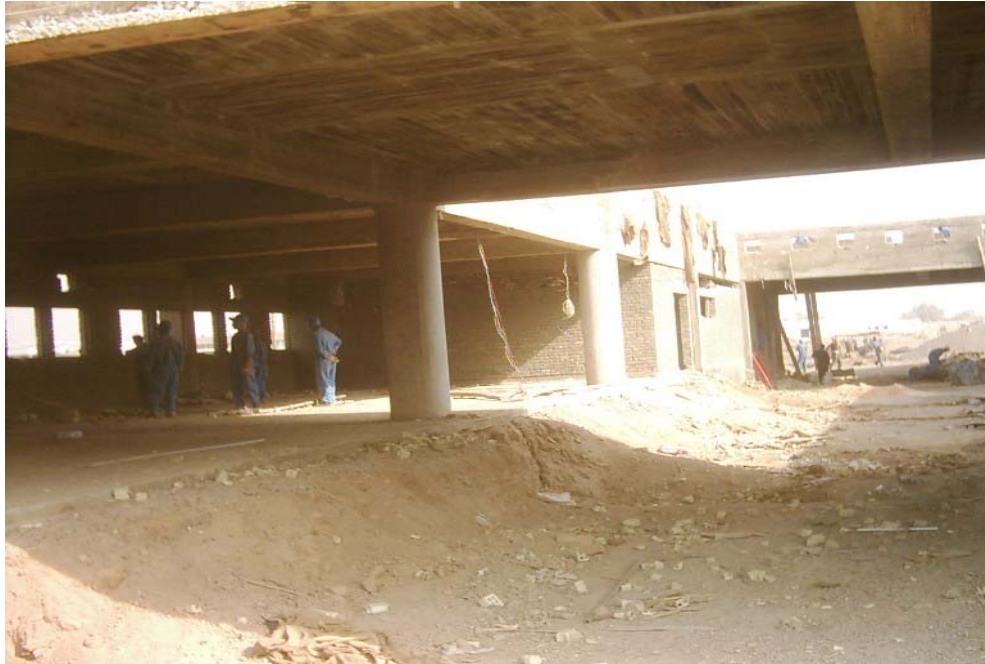
**Site Photo 51. QAR daily report photo of interior of central laundry facility from the 26 November 2005 daily QA report (Photo courtesy of the USACE)**

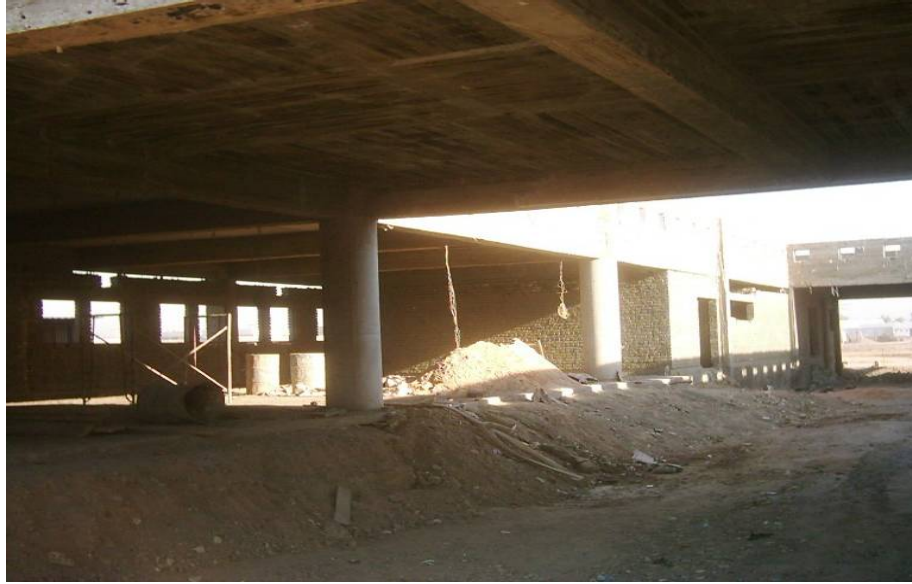
**Site Photo 52. QAR daily report photo of interior of central laundry facility (Photo courtesy of the USACE)**

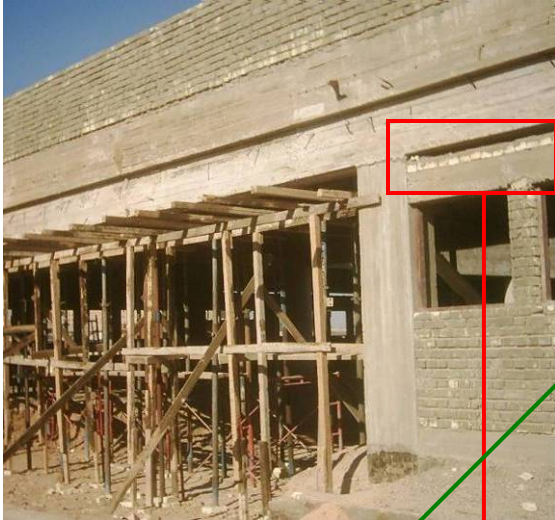
In some cases, the daily QA report provided photographs of poor construction work; yet the narrative did not document the deficiency. For instance, one daily QA report included a photograph of poor concrete quality beneath a lintel (Site Photos 56-58); however, the narrative daily report did not mention this problem nor does it mention if the QAR brought this problem to the contractor's attention. Instead of documenting the deficiencies and proposing potential corrective actions, the daily QA report simply stated "No activity" on that particular day for the laundry facility. By review of the daily QA reports, we were unable to determine if the contractor corrected this problem. It appears that the QAR did not receive proper training to identify poor workmanship issues.

Site Photo 56. QAR provided photograph of poor construction (Photo courtesy of the USACE)

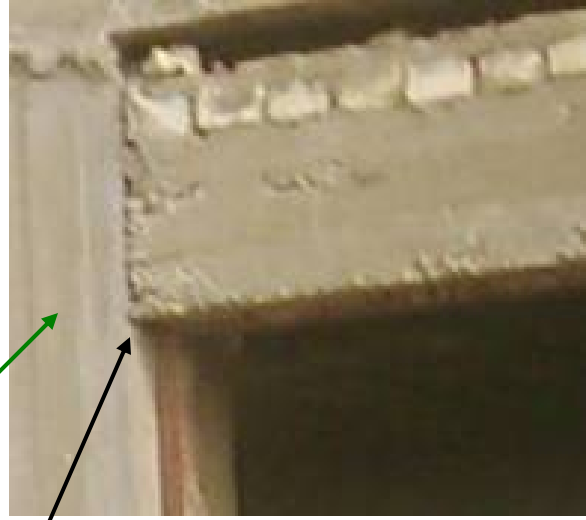
Site Photo 57. Enlarged portion of Site Photo 58

The USACE GRC Project Engineer did not effectively review the daily reports and monitor the performance of the LN QA engineers. The LN QAR periodically provided the USACE GRC Project Engineer photographic evidence of poor concrete workmanship (Site Photo 57), yet there is no indication that the Project Engineer tried to correct this issue. Further, the USACE Project Engineer and Resident Engineer did not effectively monitor performance of the LN QAR. The Project Engineer and Resident Engineer at a minimum should have periodically reviewed the LN QC and LN QA daily reports to determine the progress of the projects and the quality of the contractor's work. It does not appear that either the Project Engineer or the Resident Engineer thoroughly reviewed the daily reports. For example, the daily QC reports documented construction deficiencies; while the daily QA reports did not. On 19 September 2005, the daily QC report for the instructors' barracks stated:

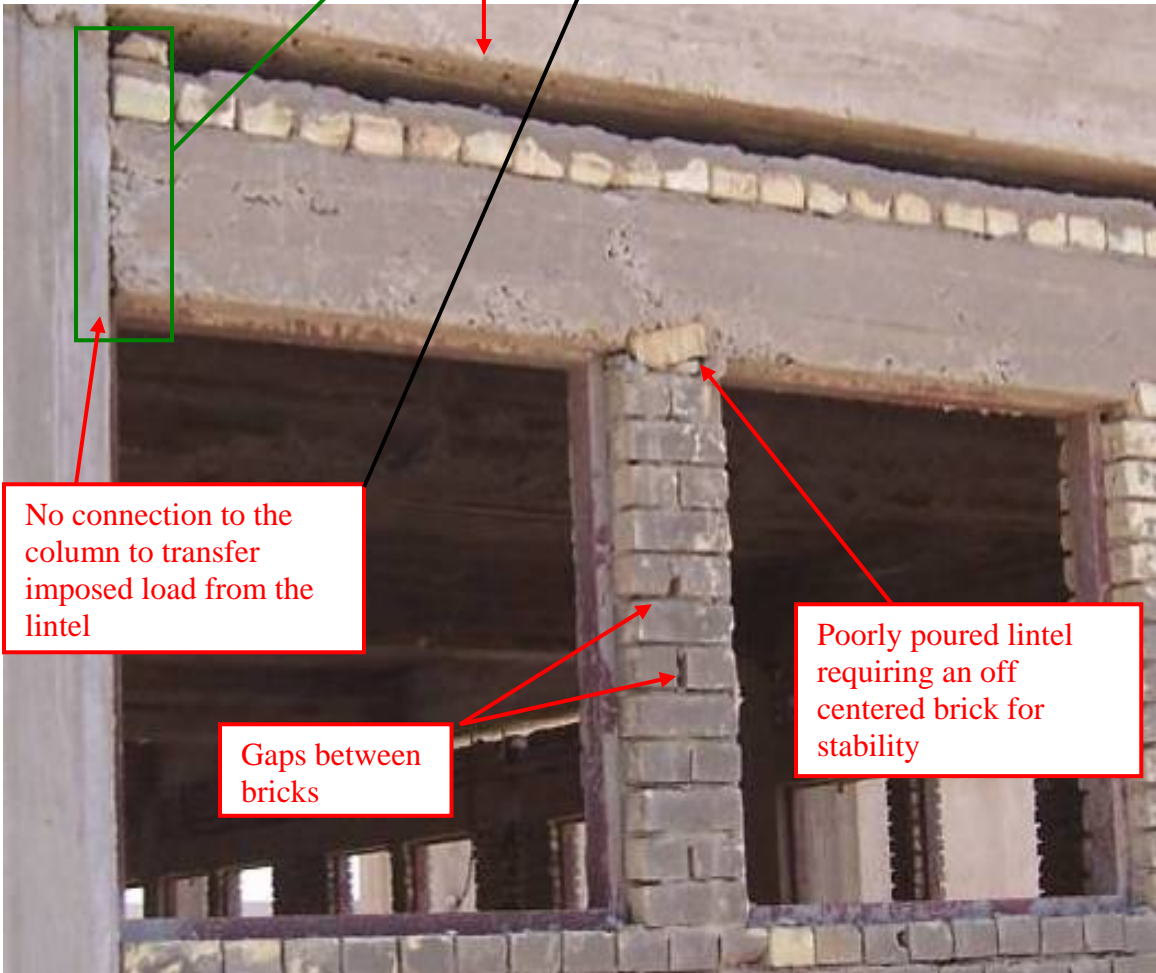
Site Photo 58. Enlarged section of Site Photo 56, detailing poor construction practices

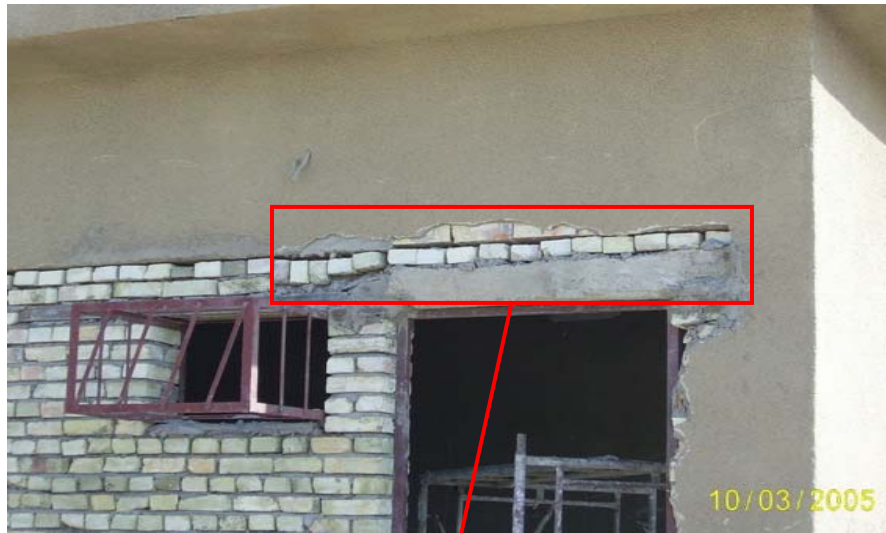
In one instance, photographic evidence of poor lintel and brick work was brought to the attention of the Project Engineer (Site Photos 59 and 60). This photograph was located in the GRC project file with the caption "Armory warehouse bad lential."

Site Photo 59. QAR provided photograph with caption “Armory warehouse bad lintel” (Photo courtesy of the USACE)

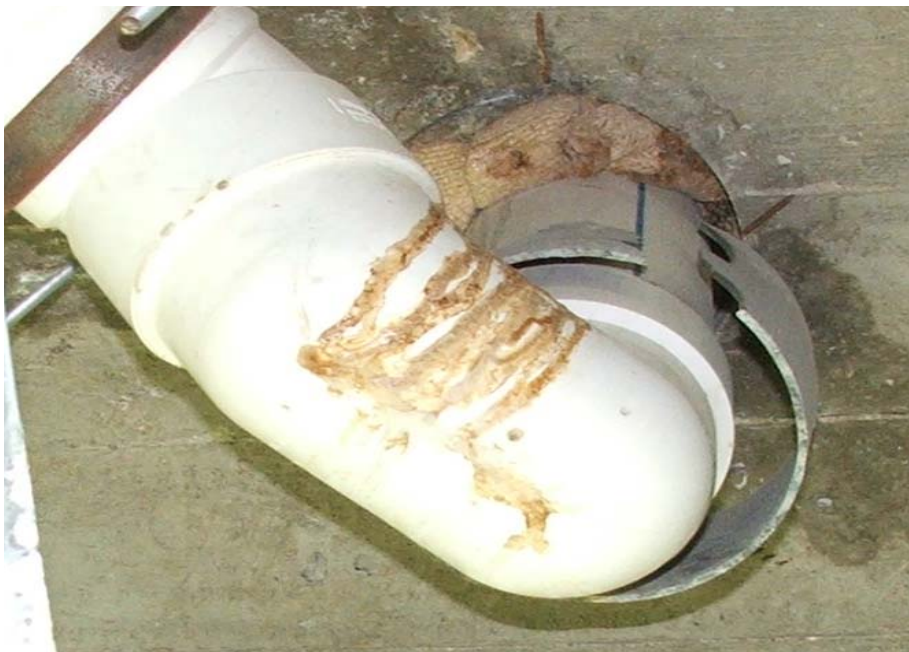
As part of its close out documentation, Parsons provided GRD with its testing results. According to Parsons' documentation for the cadet barracks buildings, the PPR (Polypropylene Random – pressure piping for hot and cold water system) pipes, sewer pipes, and rain water pipes were separately tested. The PPR test consisted of start and stop atmospheric pressures of 6.0 bar, or approximately 87 pounds per square inch (psi) (1 bar = 14.50377 psi), for 48 hours, with no reported water leakage. The sewer pipe test consisted of plugging the pipe openings and filling the pipes with water for 48 hours; there was no reported water leakage. The testing procedure for the rain water pipes was identical to the sewer pipe test, with no reported water leakage. According to the plumbing test log, cadet barracks buildings A, B, C, and D were tested and there was no water leakage. After considering the non-industry standard plumbing fittings were used in the cadet barracks bathrooms (Site Photo 62), the poor joint sealant work done by the subcontractor (Site Photo 63), and the end result of the plumbing deficiencies (Site Photo 64), we question Parsons' test results.

**Site Photo 63. Example of poor sealing technique used by the contractor**
