**BAGHDAD POLICE COLLEGE  
BAGHDAD, IRAQ**

**SIGIR PA-06-078.2**

**SIGIR PA-06-079.2**

SUBJECT: Report on Project Assessments of Reconstruction Work Performed Under Task Orders 06 and 29 at the Baghdad Police College, Baghdad, Iraq (Report Numbers SIGIR PA-06-078.2 and PA-06-079.2)

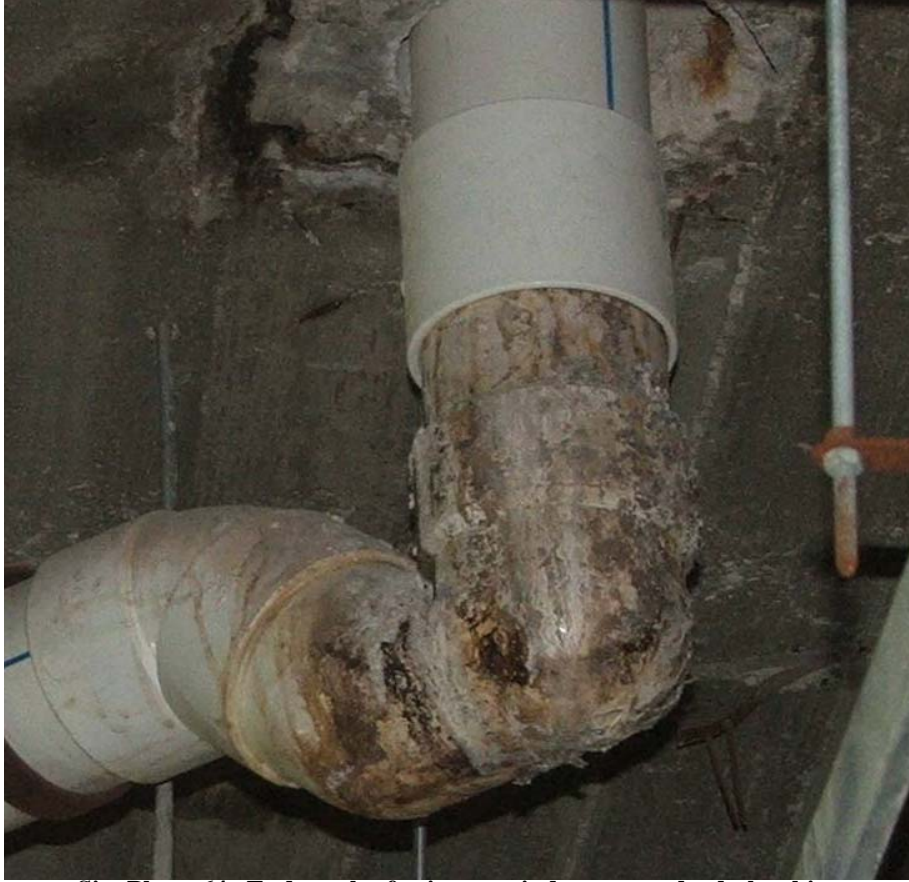
As part of its close out documentation, Parsons provided GRD with its testing results. According to Parsons' documentation for the cadet barracks buildings, the PPR (Polypropylene Random – pressure piping for hot and cold water system) pipes, sewer pipes, and rain water pipes were separately tested. The PPR test consisted of start and stop atmospheric pressures of 6.0 bar, or approximately 87 pounds per square inch (psi) (1 bar = 14.50377 psi), for 48 hours, with no reported water leakage. The sewer pipe test consisted of plugging the pipe openings and filling the pipes with water for 48 hours; there was no reported water leakage. The testing procedure for the rain water pipes was identical to the sewer pipe test, with no reported water leakage. According to the plumbing test log, cadet barracks buildings A, B, C, and D were tested and there was no water leakage. After considering the non-industry standard plumbing fittings were used in the cadet barracks bathrooms (Site Photo 62), the poor joint sealant work done by the subcontractor (Site Photo 63), and the end result of the plumbing deficiencies (Site Photo 64), we question Parsons' test results.

**Site Photo 64. End result of using non-industry standard plumbing fixtures and not sealing pipes correctly**

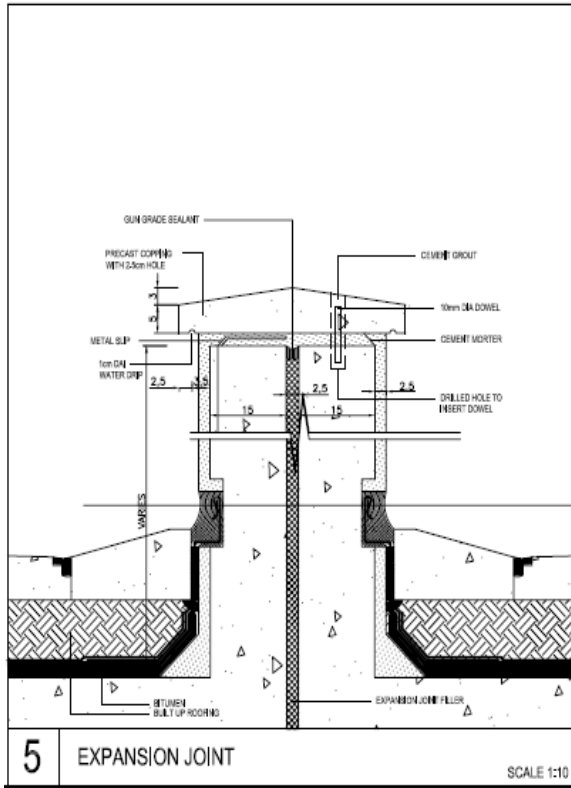
Similar to the instructors' barracks, we discovered significant expansion cracks on the interior and exterior of the language instructors' barracks (Site Photos 69 and 70). Parsons' as-built drawings required a specific type of expansion joint system for floor, interior wall, ceiling, exterior wall, and roof (Figure 7). The as-built drawings submitted show a very specific prefabricated joint system. We found little or no evidence of designed joint systems in place to protect the building from vertical and horizontal movement. When comparing the building's construction and damage to the as-built drawings submitted by Parsons, it is apparent that the as-built drawings do not reflect the actual construction done.

**Figure 6. Contractor's as-built drawing**

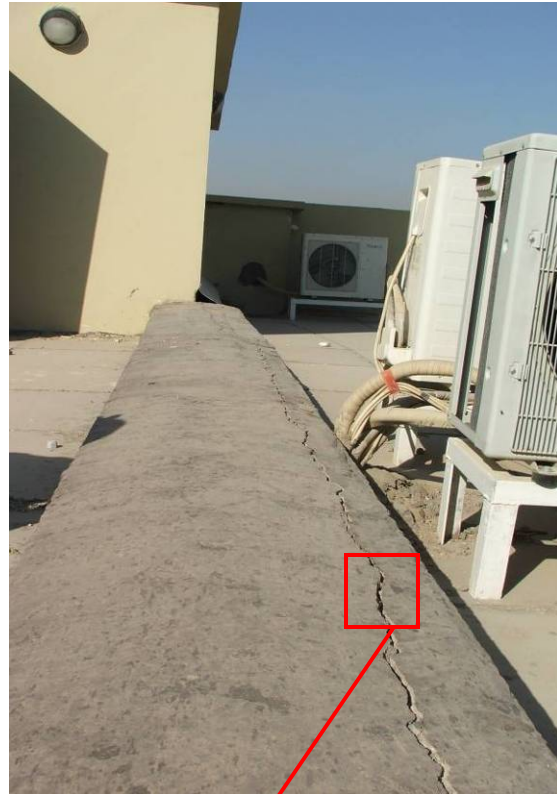
**Site Photo 67. Exterior expansion crack**

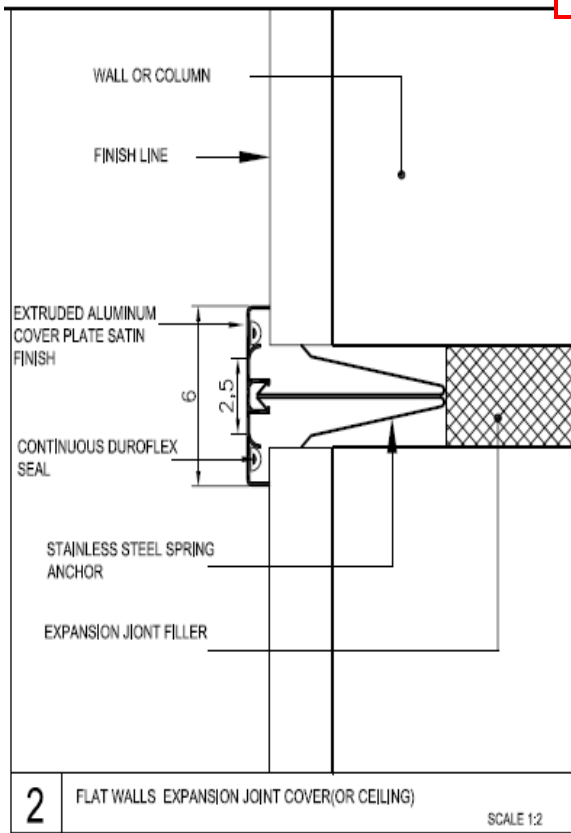
**Figure 7. Contractor's as-built drawing**

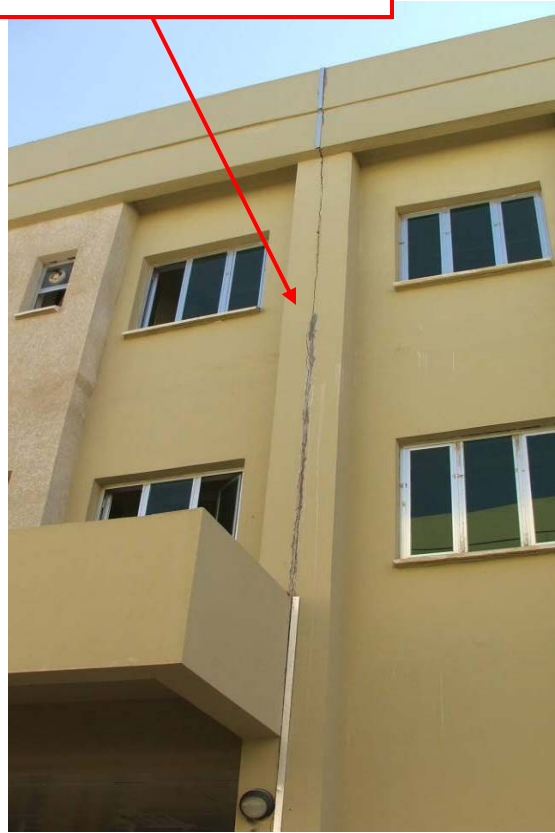
Major expansion crack on front side of building (absence of engineered joint)

**Site Photo 69. Exterior expansion crack**

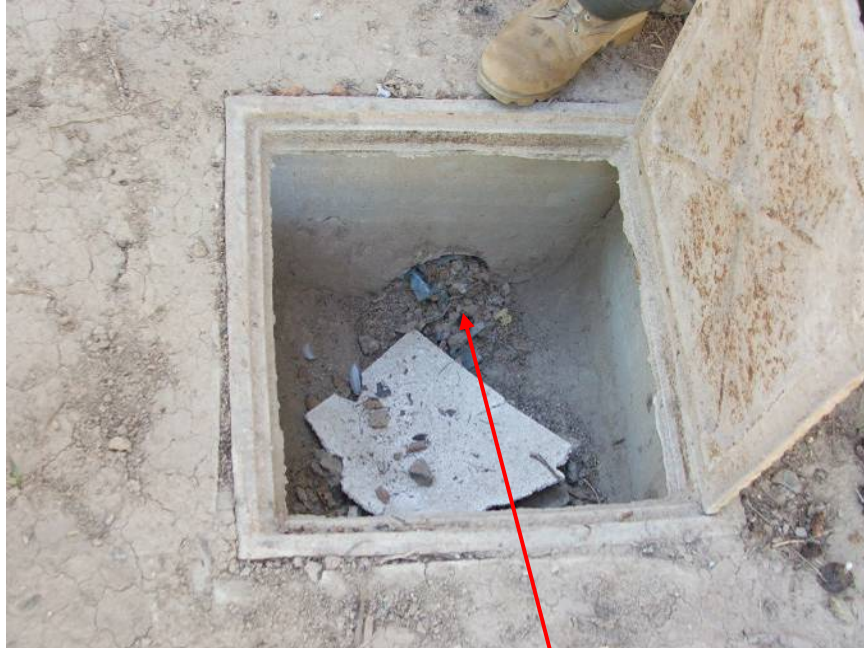
Finally, for the ablation unit, the as-built drawings submitted by the contractor indicate the facility is connected to the main water and sewage networks (Figure 8); however, during our initial site visit, we verified the facility was not connected to either the main water or sewage networks (Site Photo 71). The connection to the main water and sewage networks was not completed until late November 2006 and was completed by another contractor.

**Site Photo 71. 10 November 2006 site visit, documenting ablation unit not connected to the sewer network.**

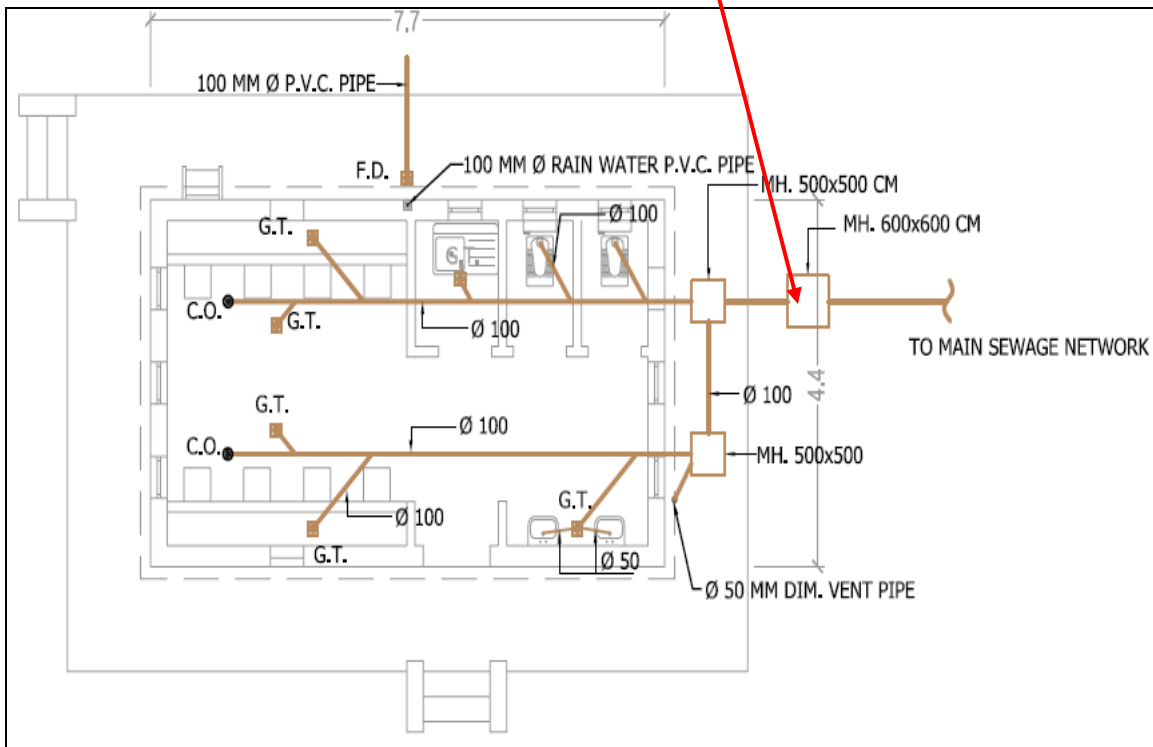
**Figure 8. Contractor's as-built drawing for ablation unit, which indicates connection to main water and sewage networks.**

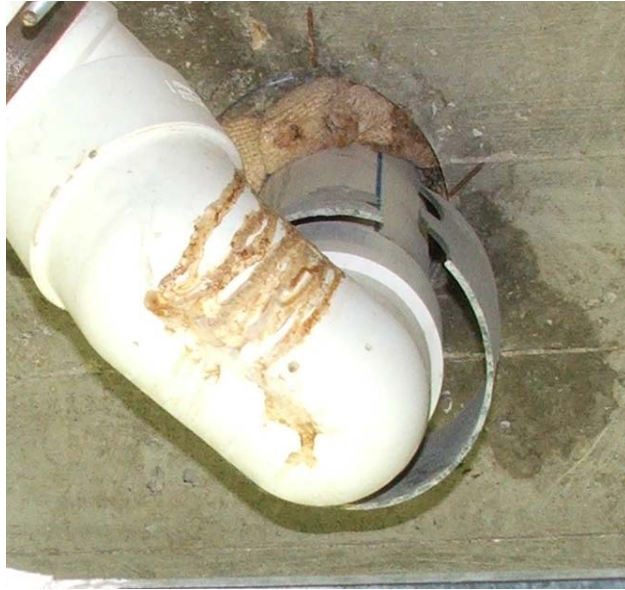
**Site Photo 78. Example of poor sealing technique used by the contractor during initial construction**

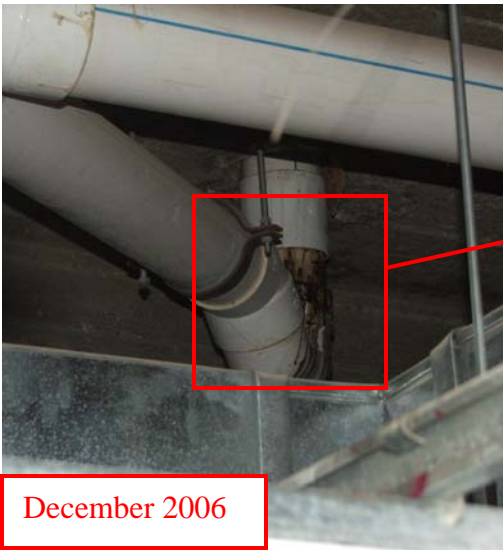
**Site Photo 80. Leaking waste water from poorly sealed pipes**

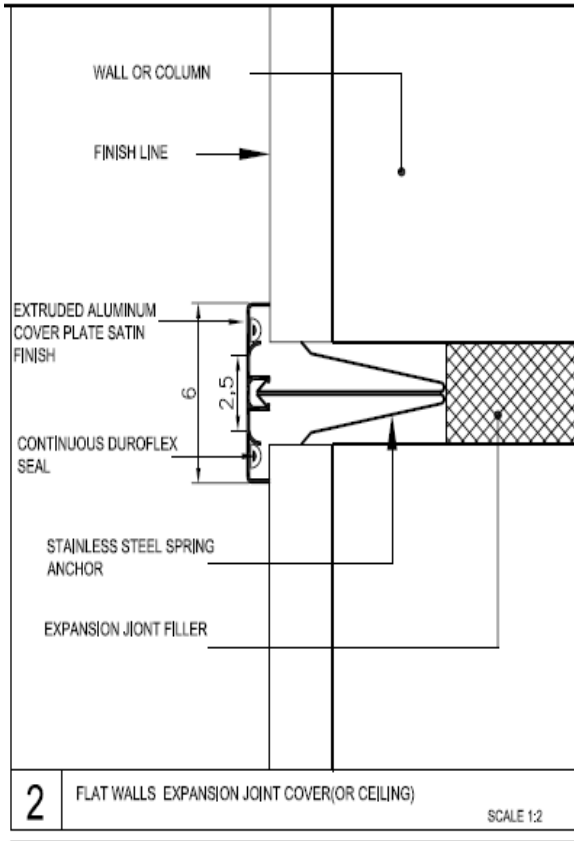
The contractor's as-built drawings, in our opinion and in GRD's own assessment, are not complete and accurate. For example, the as-built drawings for the instructors' barracks buildings show a very specific prefabricated joint system (Figure 9). We found little or no evidence of designed joints in place to protect the building from vertical and horizontal movement. Not only did the instructors' barracks suffer from significant interior and exterior expansion cracks (Site Photos 82 and 83) and runs the risk of reducing the buildings' life expectancy, equally troubling is the fact the GRD does not know if the contractor was paid for installing the prefabricated joint system claimed in the as-built drawings. The government already paid Parsons for inaccurate as-built drawings (since the as-built drawings reference prefabricated expansion joints which are not present on the buildings) and quite possibly paid Parsons for the installation of the prefabricated joint system.

**Figure 9. Contractor's as-built drawing**

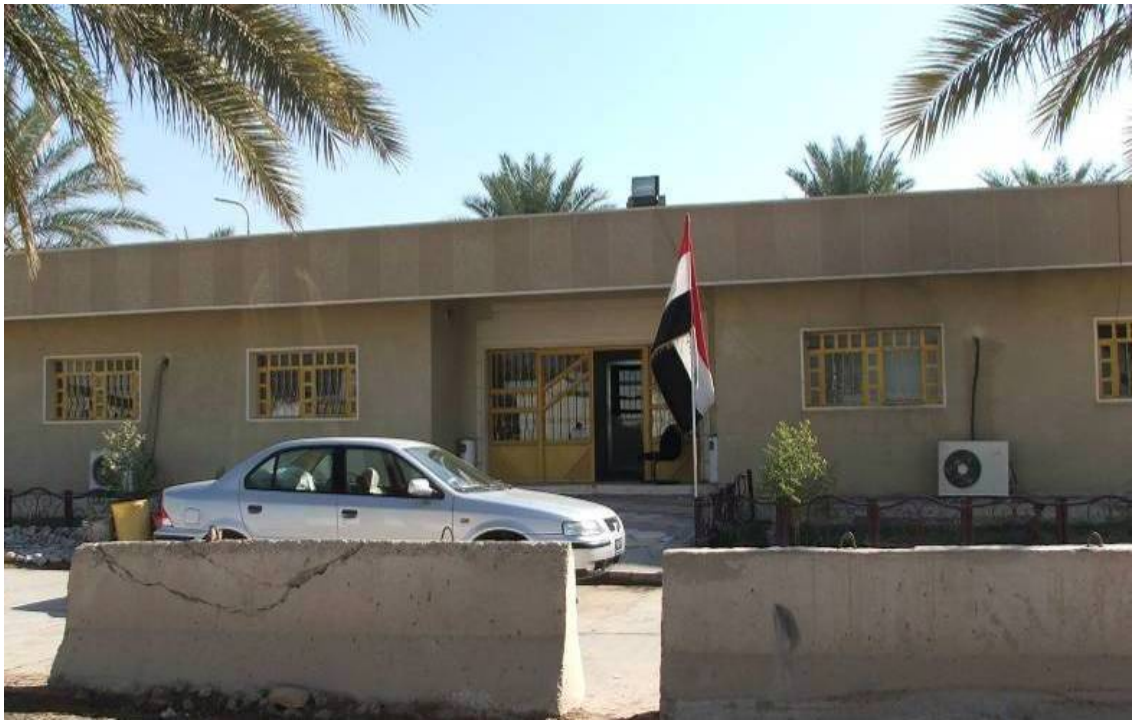
BPC representatives stated it was rehabilitated because it did not look similar to the other existing buildings at the BPC. Site Photos 84 and 85 show typical existing BPC buildings; while Site Photo 86 shows the exterior of the security office. We visited the security office and it appears to have been rehabilitated on the interior and exterior (Site Photos 87 and 88). Site Photos 89 and 90 show significant damage to the building’s exterior and sidewalk and large amounts of standing sewer water. However, as a result of not requiring and reviewing detailed contractor invoices, it is unknown what construction/rehabilitation the contractor allegedly performed on this building, which will

**Site Photo 86. Front view of the BPC security office**

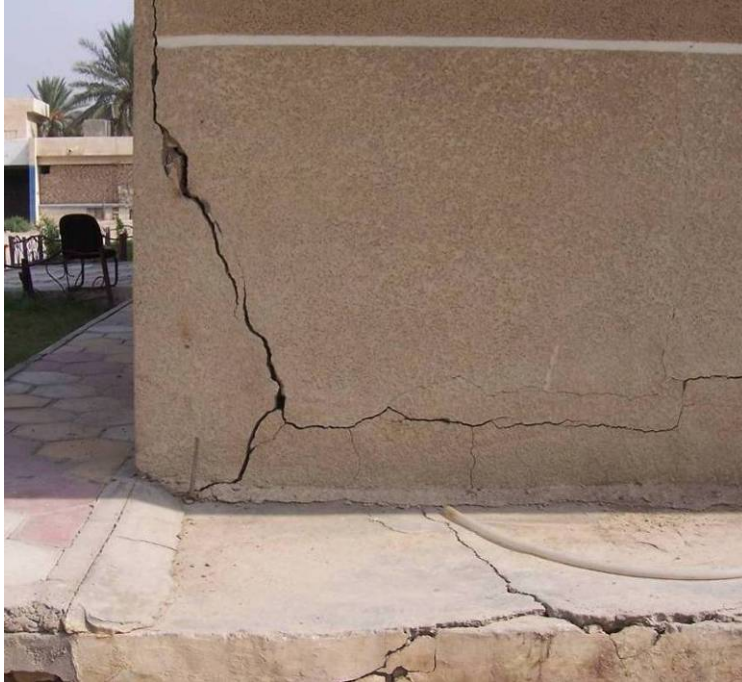
**Site Photo 89. Substantial cracks in the exterior of the building and side walk**

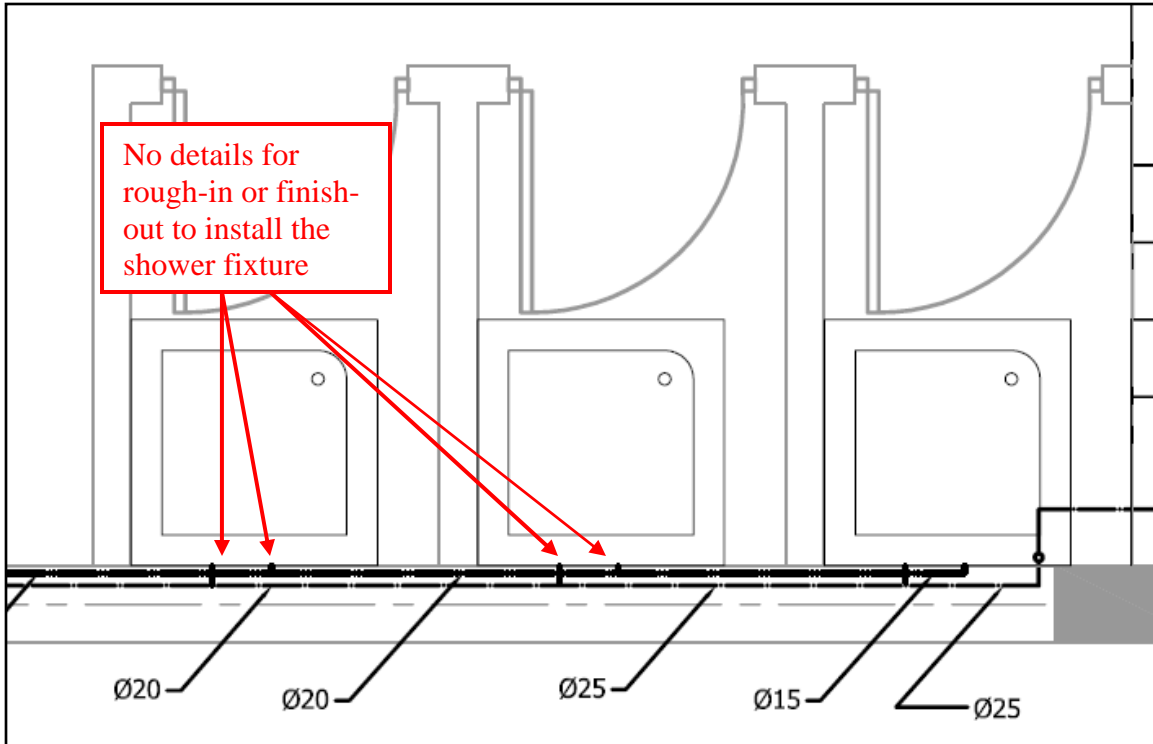
Detailed design drawings for the rough-in and finish-out of the plumbing fixtures were not provided by the contractor. Instead the drawings were generic and did not specify the distance that the hot and cold water lines should extend beyond the wall (i.e. rough-in) for the plumber to connect to the shower faucet and head (Figure 10). In addition, the drawings do not provide an enlargement of one shower as an example to provide specific installation details, such as the type of plumbing fixtures to use (i.e. finish-out). Without detailed design drawings, the subcontractor does not have adequate guidance to properly install the water lines and plumbing fixtures.

Figure 10. Contractor design for installation of hot and cold water lines for cadet barracks showers

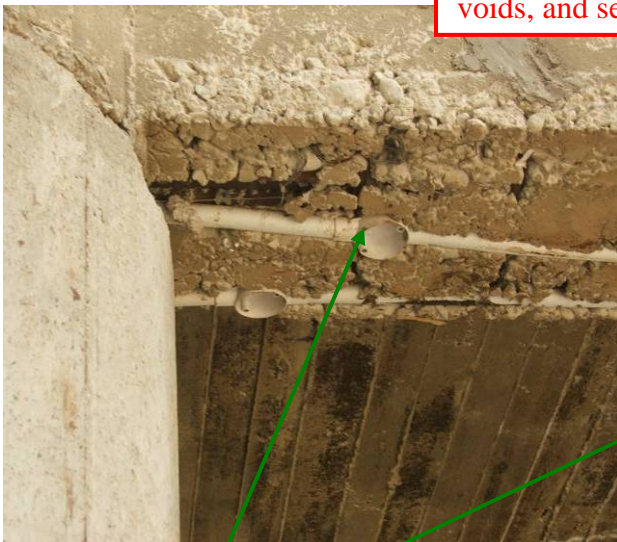
Site Photo 92. Concrete segregation and electrical conduit exposure

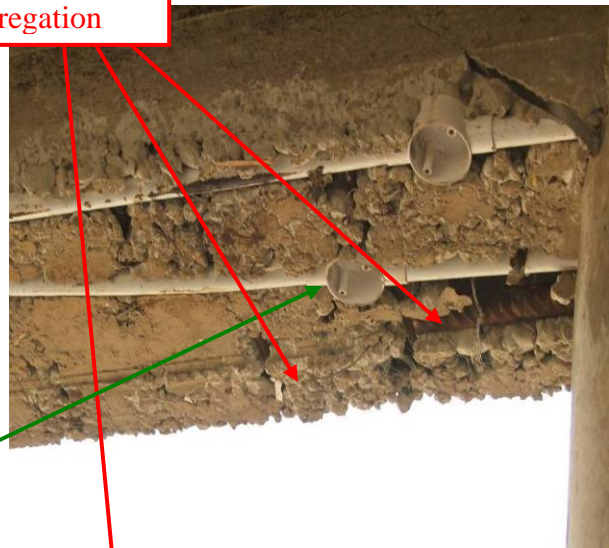
Site Photo 93. Concrete segregation and electrical conduit exposure

Electrical conduit exposure

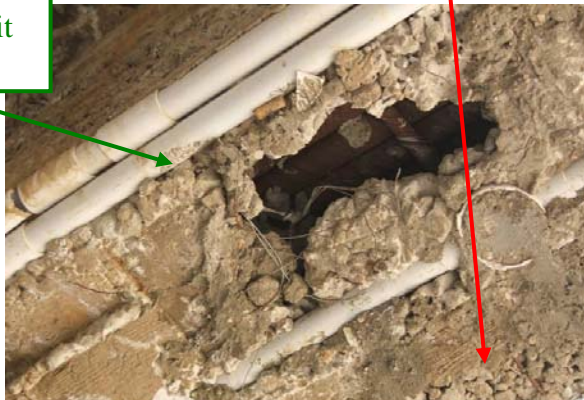
Site Photo 94. Concrete voids and electrical conduit exposure

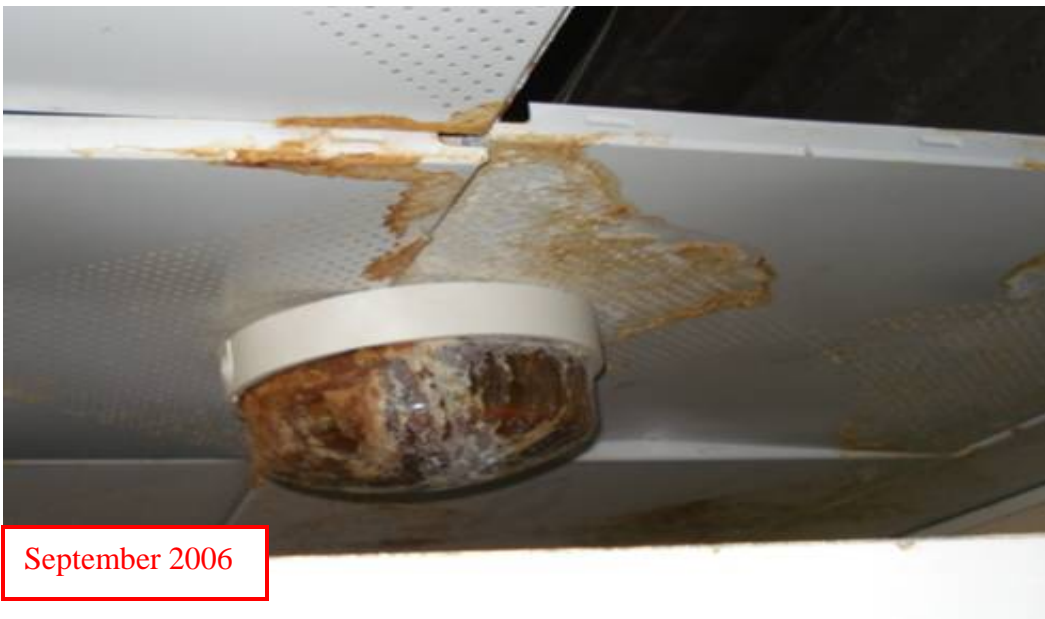
Upon close examination of multiple light fixtures in November 2006, the substance we saw (Site Photo 97) appeared to be quite similar in appearance to the urine and fecal matter we witnessed in our initial site visit (Site Photo 98). In addition, the GRD comments do not address the substance on the outside of the light fixtures. Again, this substance appears to be very similar to the substance we witnessed on the outside of the lighting fixtures on our first site visit.

**Site Photo 98. Urine-filled light fixture in cadet barracks bathroom from original construction**

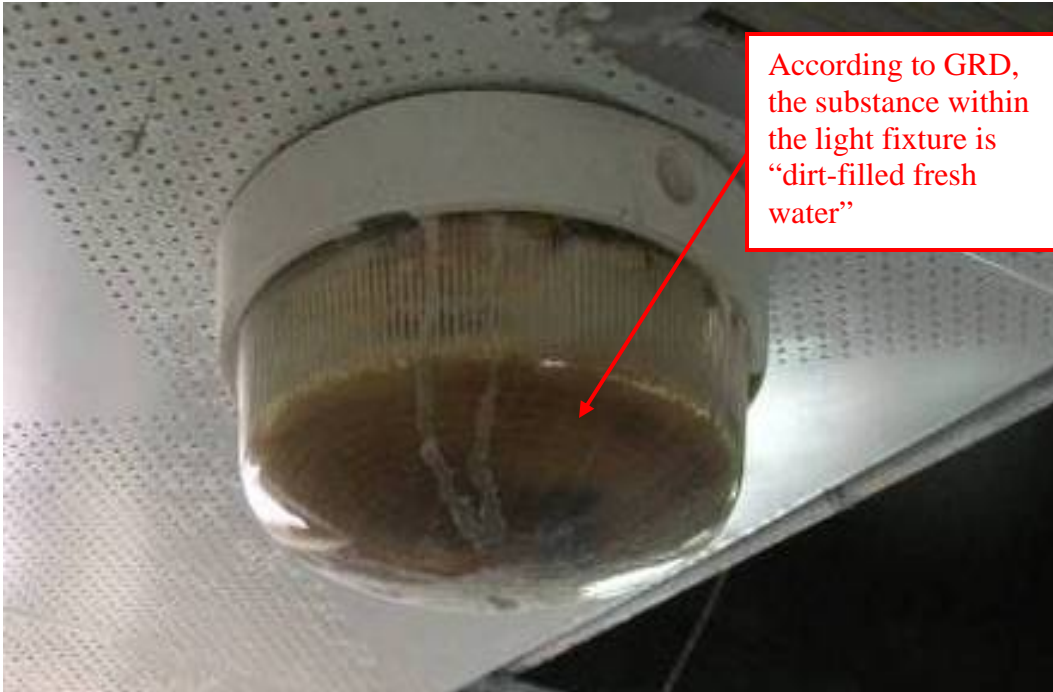
Further, even if GRD is correct that it is not urine and fecal matter within the light fixture, the fact that the substance is only "dirt-filled fresh water" is still extremely problematic. The large collection of liquid within the light fixture certifies a significant plumbing problem, regardless of whether the substance is urine and fecal matter or fresh water. Site Photo 99 shows just how "dirty" the fresh water at the BPC is. There is no explanation from GRD regarding how this "fresh water" became so "dirt-filled." Either the BPC is providing dirty fresh water for the cadets to use or the water has become contaminated in the distribution system.

According to GRD, the substance within the light fixture is “dirt-filled fresh water”

**Site Photo 99. Light fixture with the cadet barracks bathroom (November 2006)**

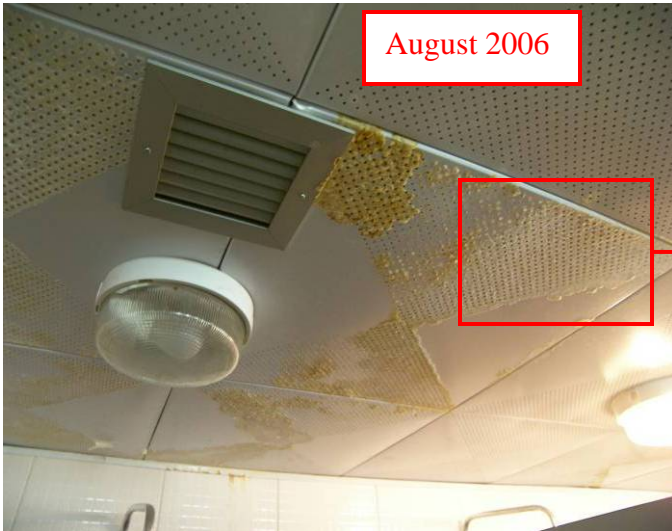
Site Photo 100. Urine stain on second floor ceiling

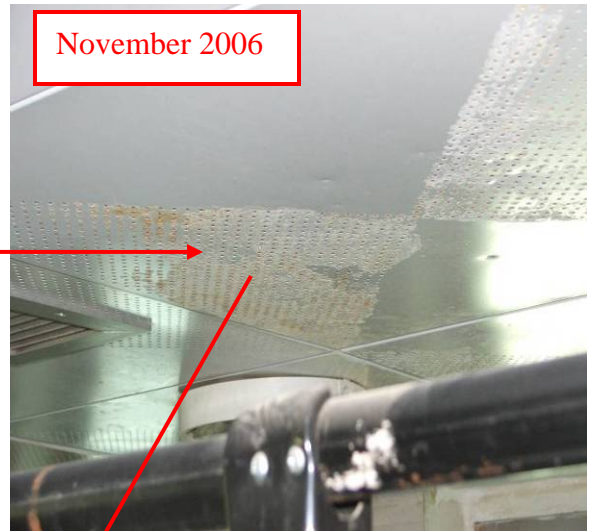
Finally, we do not find any validity to GRD’s claim that the “crystallized deposits shown in photo 181 are salt deposits from fresh water leaking through the concrete floor above.” First of all, when comparing a current photo (Site Photo 101) of the ceiling panel damage to a photo from our original site visit, which the GRD concurred was crystallized urine deposits (Site Photo 100), the damage appears to be identical. It must be noted that the damage in the original site visit photo is more substantial because the plumbing issues had been on going for several months, while the damage from November 2006 occurred in the “reworked/repared” plumbing that had only been used for a few weeks.

Similar to the GRD's claim that the light fixtures were not full of urine and fecal matter but only "dirt-filled fresh water," even if we agree that the ceiling panel damage is salt deposits from the fresh water, this is an extremely important issue for the GRD to address. If the fresh water provided to the BPC contains this concentration of salt, the cadets are being exposed daily to a potentially hazardous situation.

Site Photo 101. Urine stain on second floor ceiling (photo referred to in GRD comments)

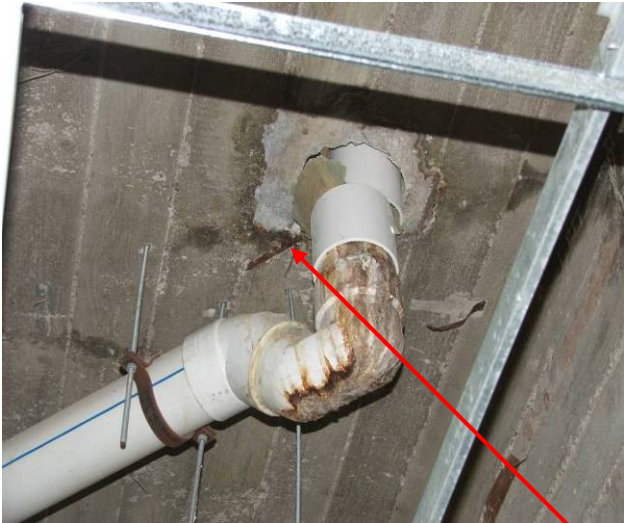
In a previous inspection report, we identified significant plumbing issues within the cadet and instructors' buildings<sup>11</sup>. The suspended ceilings of the cadet barracks buildings were removed to show us water damage. We identified segregation, honeycombing, and voids in the structural concrete members as well as exposed reinforcement bars (Site Photos 104-108).

**Site Photo 104. Cadet barracks concrete work**

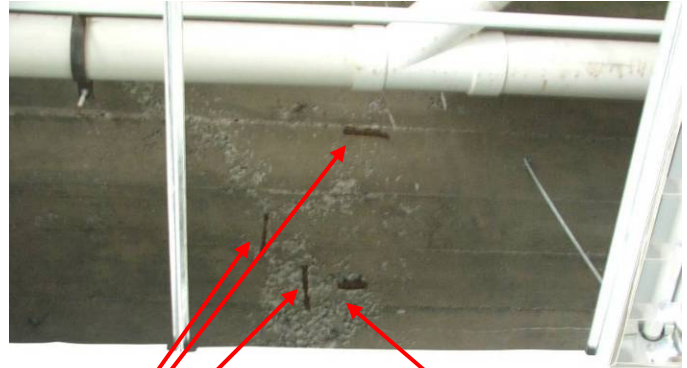
**Site Photo 105. Cadet barracks concrete**

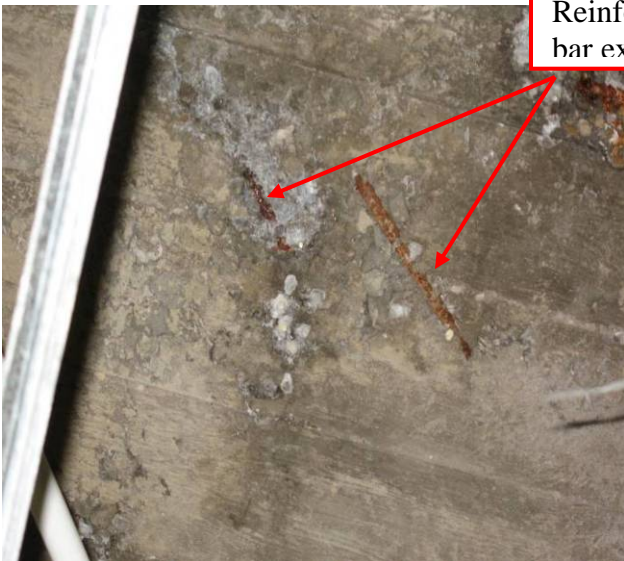
Reinforcement bar exposure

**Site Photo 106. Cadet barracks concrete work**

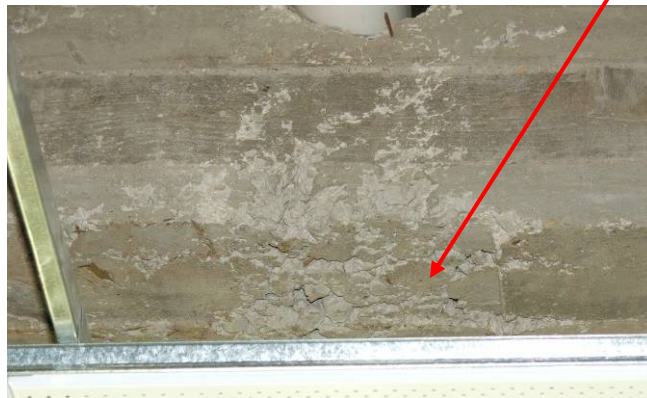
**Site Photo 108. Cadet barracks concrete work**

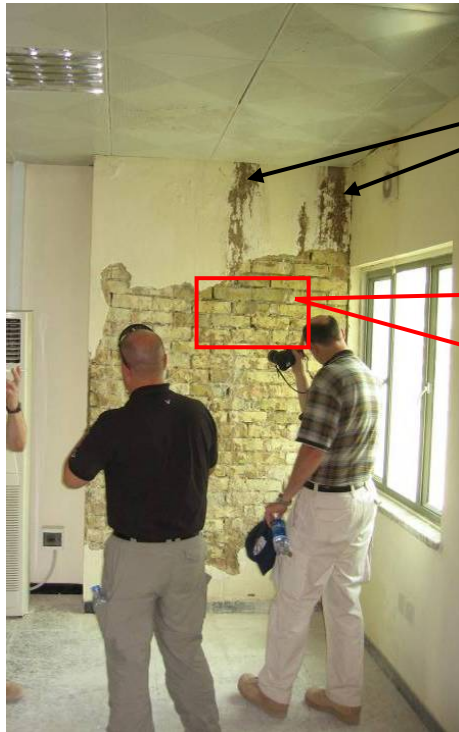
In the ground floor common area, we witnessed the effects of leaking water from the top two floors (Site Photo 109). The water damage to the walls was so extensive that the plaster had to be removed. When the plaster was removed, we identified evidence of poor quality brick and masonry work of the non-load bearing walls, such as broken pieces of brick and spaces between the bricks filled with small chips of material (Site Photo 110).

**Site Photo 109. Water damage to cadet barracks ground floor common area**

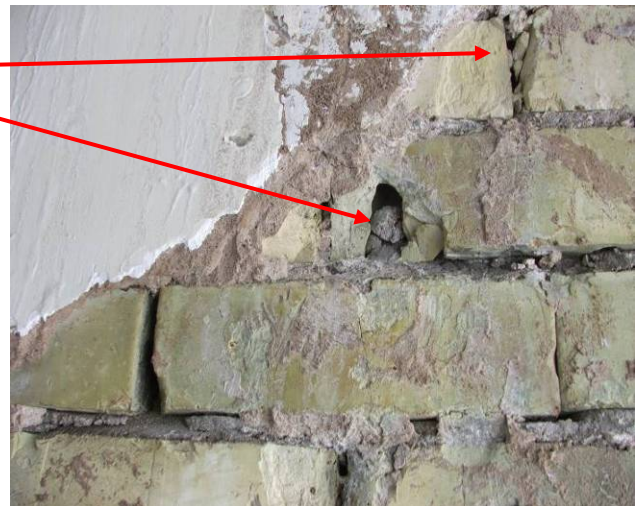
**Site Photo 110. Close-up view of brickwork from Site Photo 109**

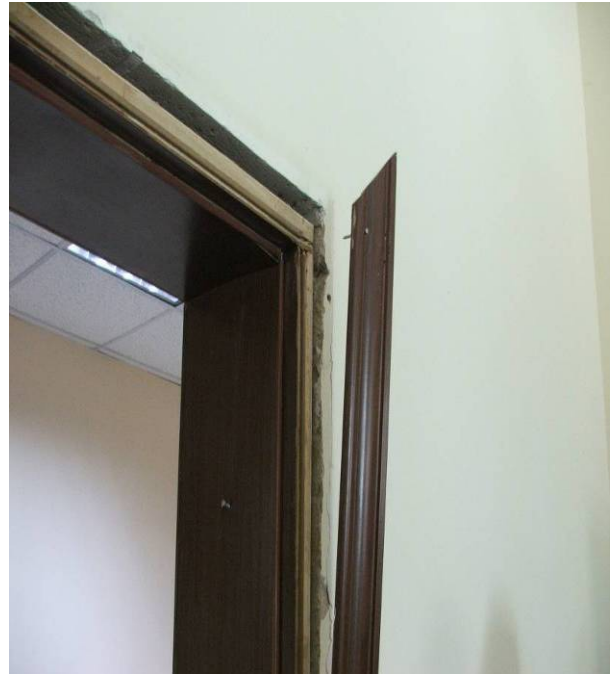
Each multiple occupancy cadet bedroom was approximately 5.5 meters (m) wide by 6.5m long and consisted of six bunk beds housing 12 cadets (Site Photo 111). Inside each room were a ceiling fan, two windows, two ceiling lights, and a split air conditioning unit. We identified poor construction techniques employed for the door frames (Site Photo 112). The first and second floor communal bathrooms consisted of 11 urinals (Site Photo 113), one dressing/changing room, two western and eight eastern-style toilets (Site Photo 114), 10 showers, and nine sinks (Site Photo 115). During our site visit, we noticed problems with the bathroom fixtures, such as low quality sinks and sink fixtures, shower fixtures and assemblies, and hoses (Site Photo 116), which resulted in broken fixtures and leaks (Site Photos 117 and 118).

**Site Photo 112. Poor door frame installation**

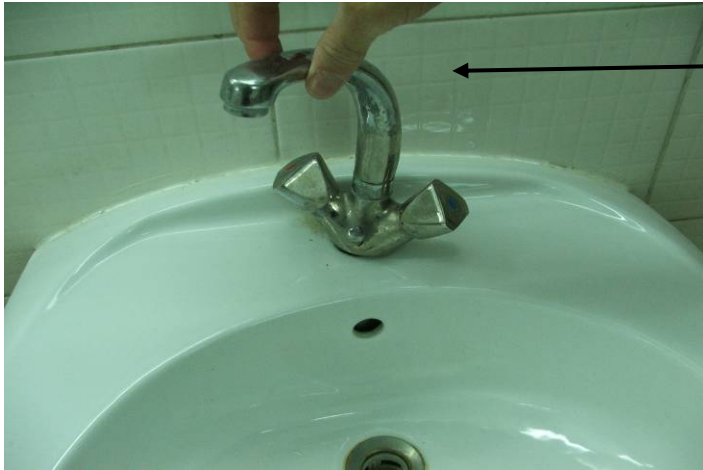
Faucet not securely attached and moved by hand

**Site Photo 116. Example of low quality sink fixtures**

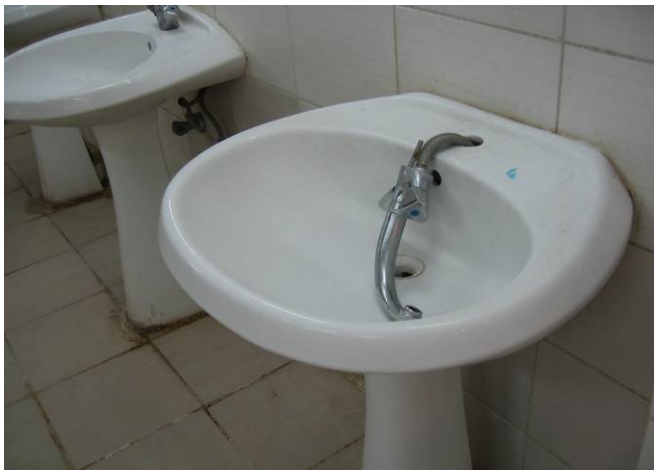
**Site Photo 117. Broken sink fixture**

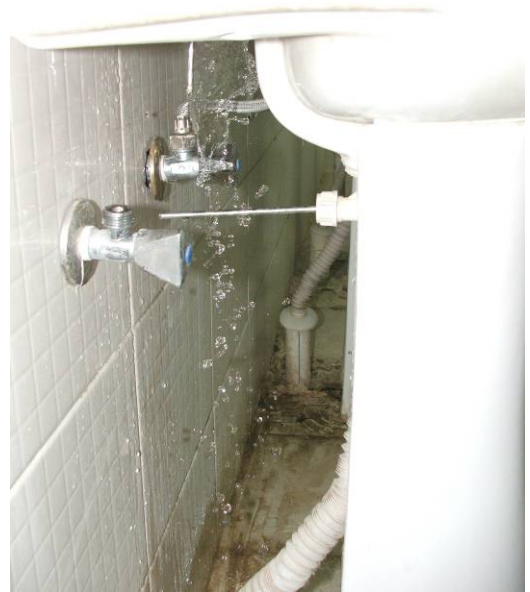
**Site Photo 118. Leaking water**

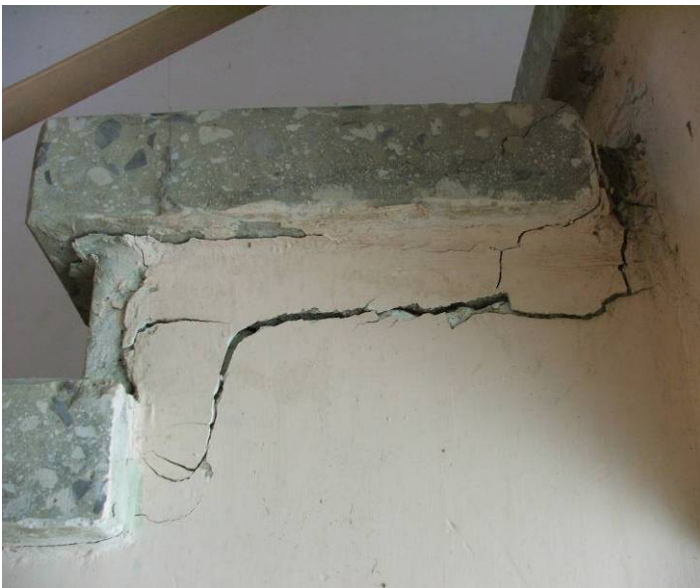
Finally, we identified structural deficiencies with the staircase; specifically the de-lamination of one step (Site Photo 120) and a large crack of another staircase (Site Photo 121). Underneath the staircase, we identified what appear to be stress cracks (Site Photos 122 and 123).

**Site Photo 120. De-lamination of staircase step**

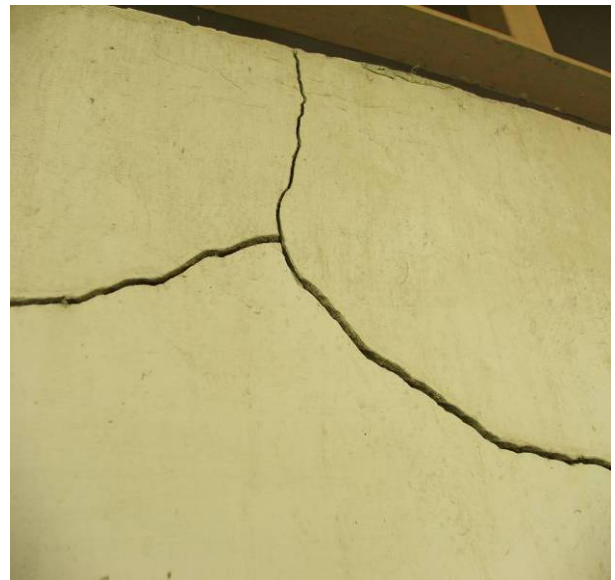
**Site Photo 121. Staircase crack**

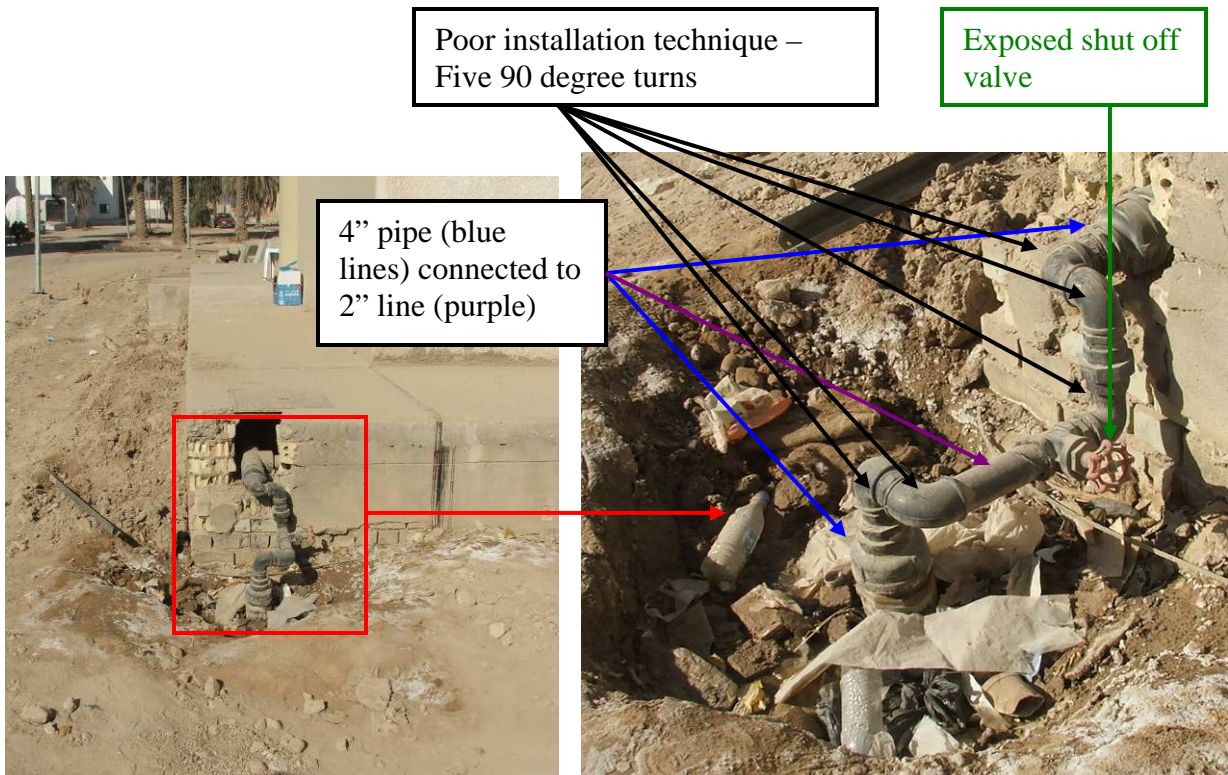
Prior to entering the building, we identified the main water line connection (Site Photo 125). This water line connection is poorly installed. It has five separate 90 degree turns from the pipe exiting the ground to the line in the foundation (Site Photo 126); the pipes and shutoff valve are exposed to the elements (i.e., water and sun, which will ultimately lead to rust), and the pipes are not covered to reduce the chance of damage from vehicle traffic (since the pipe line is close to the street). According to GRD's independent assessment, the "...standard method of construction is to secure the shut off valve inside a cast iron box with cast iron cover." Finally, the main water line connection is peculiar since multiple sized pipes are utilized. Specifically, there is a reduction from the 4" main pipe to a 2" pipe and then expanding to a 4" pipe (Site Photo 126).

**Site Photo 125. Main water line connection for instructors' barracks**

**Site Photo 126. Close-up view of main water line**

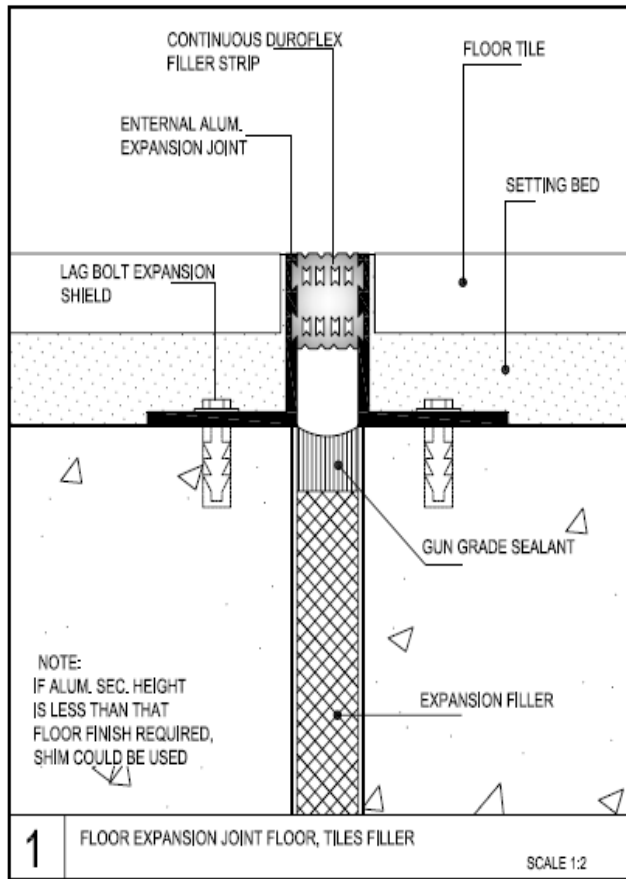
**Figure 11. As-built drawing for expansion joint**

More importantly, we discovered significant expansion cracks on the interior and exterior of the buildings. The contractor submitted as-built drawings claiming to have installed a specific type of expansion joint system for the floor, interior wall, ceiling, exterior wall, and roof. The as-built drawings submitted show a very specific prefabricated joint system. The materials and methods to install each type of joint require a high level of skill, experience, and understanding; however, from the expansion cracks we verified, it appears the contractor did not have the skill level, experience, and understanding to adequately install the expansion joints.

Expansion joint not installed as claimed in as-built drawings

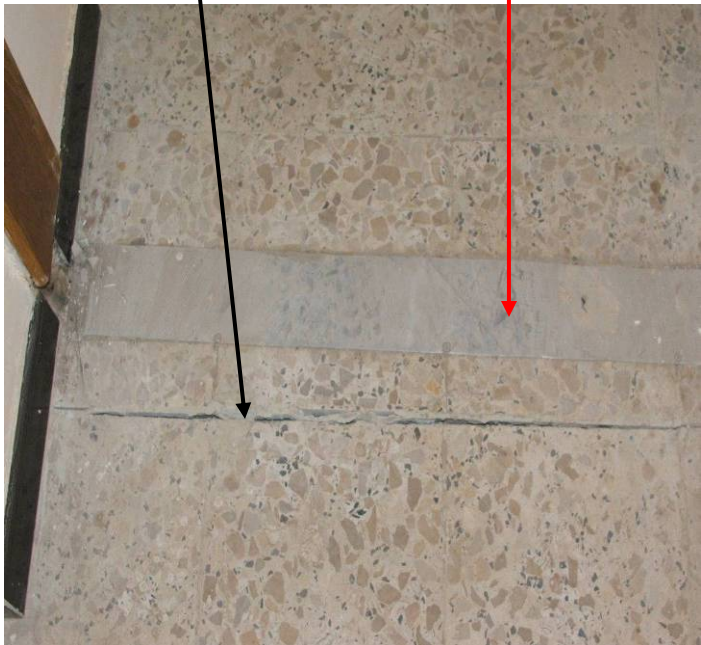
We found little or no evidence of designed joints in place to protect the building from vertical and horizontal movement. Properly designed and correctly installed joint systems are capable of protecting buildings and structures from damage caused by thermal expansion and contraction as well as anticipated foundation movements. The damage we identified is a direct result of not properly installing the expansion joints according to the as-built drawings (Figures 11 and 12 and Site Photos 132-135). The absence of properly installed expansion joints could potentially result in further damage to the buildings' interior and exterior, as well as, significantly reduce the buildings' life expectancy.

Expansion crack caused by not installing expansion joint correctly

**Site Photo 132. Interior expansion crack**

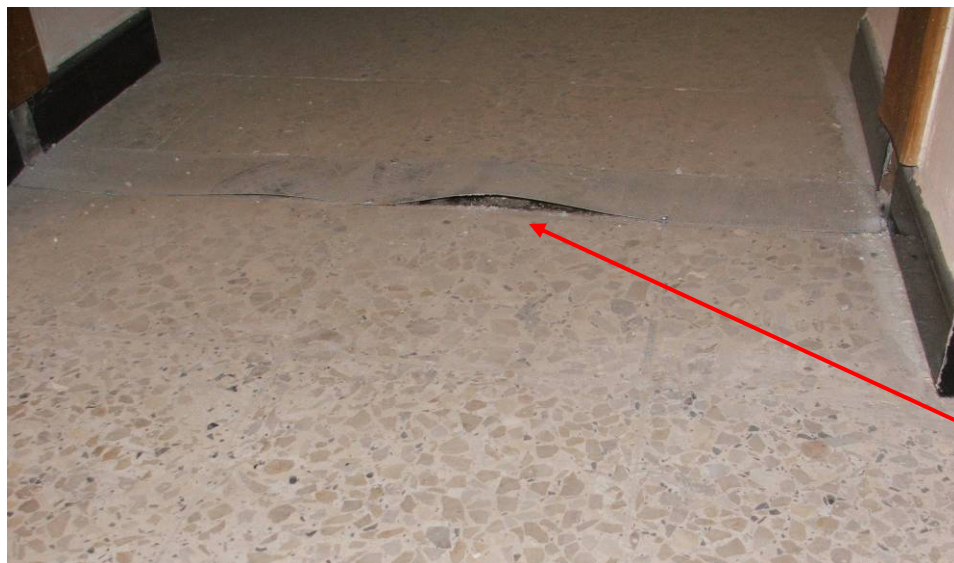
Expansion crack from not using the correct material

**Site Photo 133. Interior expansion crack in the instructors' barracks**

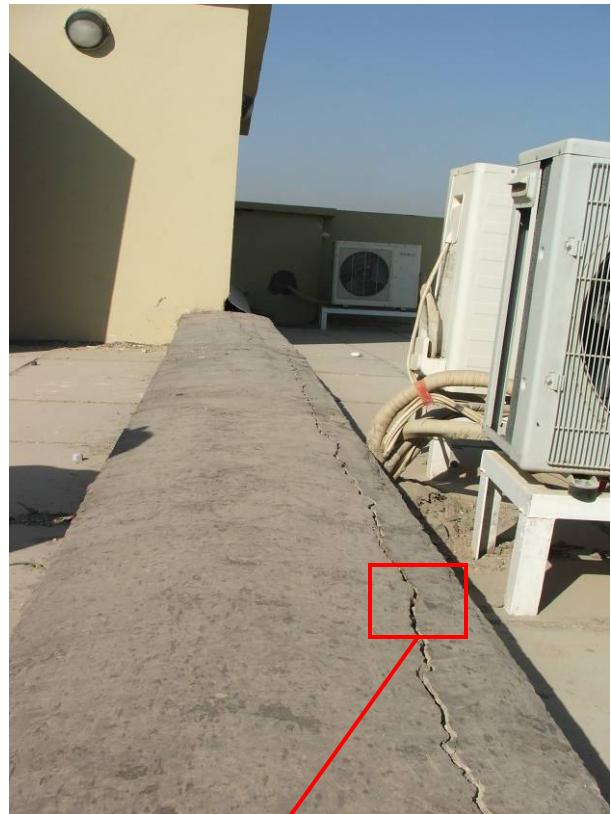
Site Photo 134. Expansion crack on roof

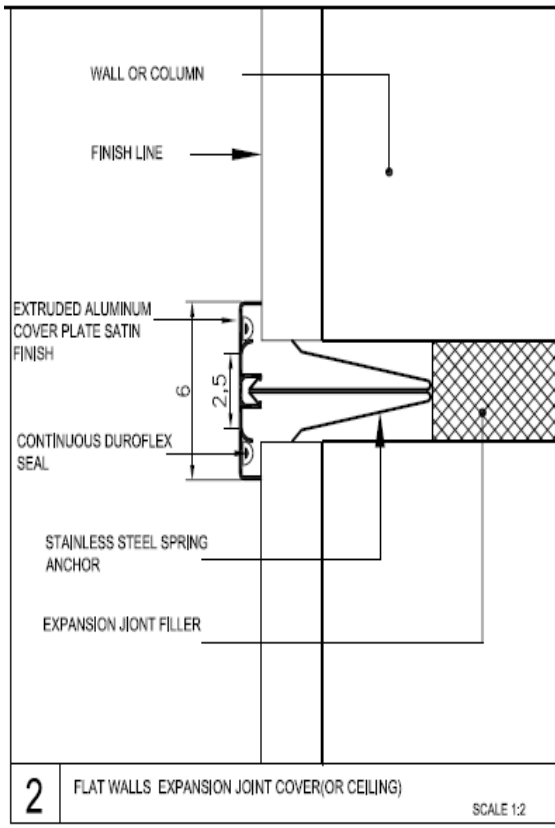
**Figure 13. As-built drawing for expansion joint**

Similar to the instructors' buildings, we discovered significant expansion cracks on the interior and exterior of the buildings. The contractor's as-built drawings required a specific type of expansion joint system for the floor, interior wall, ceiling, exterior wall, and roof. The as-built drawings submitted show a very specific prefabricated joint system. The materials and methods to install each type of joint require a high level of skill, experience, and understanding; from the expansion cracks we verified, it appears the contractor did not have the skill level, experience, and understanding to adequately install the expansion joints.

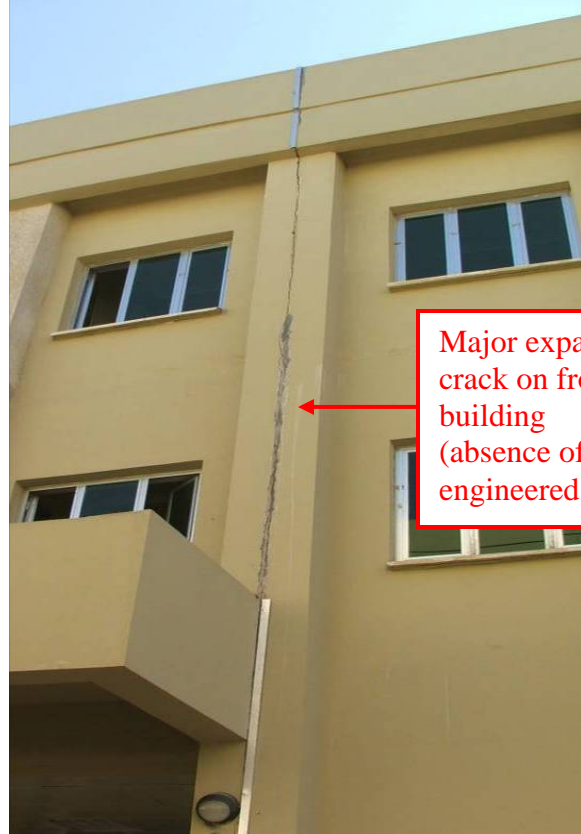
We found little or no evidence of designed joints in place to protect the building from vertical and horizontal movement. Properly designed and correctly installed joint systems are capable of protecting buildings and structures from damage caused by thermal expansion and contraction as well as anticipated foundation movements. The damage we identified is a direct result of not installing the expansion joints according to the design drawings (Figure 13 and Site Photos 138 and 139). The lack of properly installed expansion joints could potentially result in further damage to the buildings' interior and exterior, as well as, significantly reduce the buildings' life expectancy.

Major expansion crack on front of building (absence of engineered joint)

**Site Photo 138. Exterior expansion crack**
