**BAGHDAD POLICE COLLEGE  
BAGHDAD, IRAQ**

**SIGIR PA-06-078.2**

**SIGIR PA-06-079.2**

SUBJECT: Report on Project Assessments of Reconstruction Work Performed Under Task Orders 06 and 29 at the Baghdad Police College, Baghdad, Iraq (Report Numbers SIGIR PA-06-078.2 and PA-06-079.2)

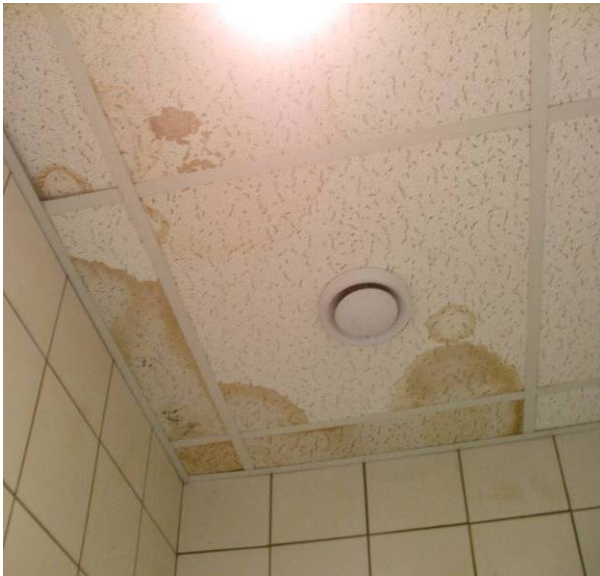
In the ground floor male bathroom area, we witnessed the effects of leaking water from the top floor (Site Photo 141). The classroom plumbing issues apparently were similar to the problems experienced in the cadet and instructors' barracks – poor installation practices coupled with defective pipes and fittings.

**Site Photo 141. Example of water damage**

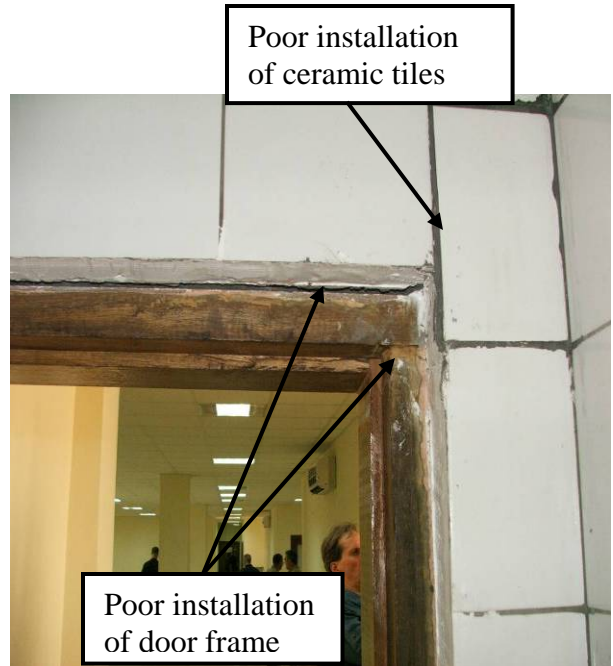
In addition, we identified evidence of poor and/or improper installation of door frames and ceramic tiles, specifically in the bathroom areas (Site Photo 142).

**Site Photo 142. Example of poor installation**

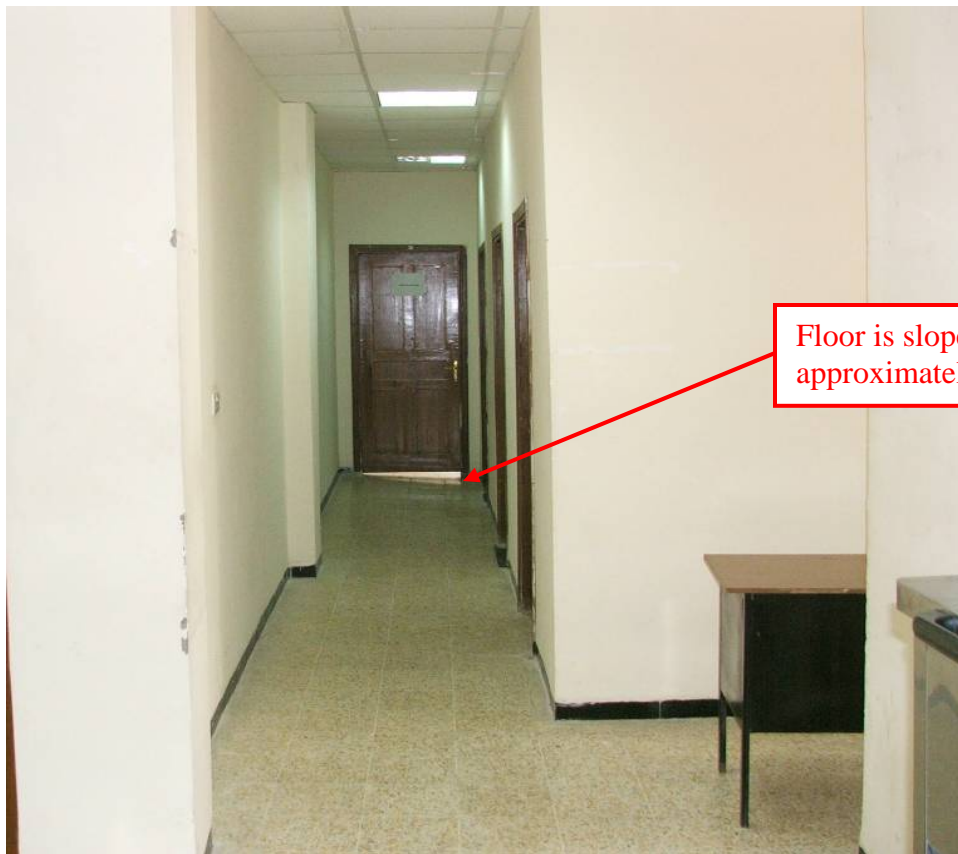
Further, the ground floor of Classroom E was not flat (Site Photo 143). The floor sloped downward to the right when approaching the female bathroom.

**Site Photo 143. Poor construction of the first floor in Classroom E**

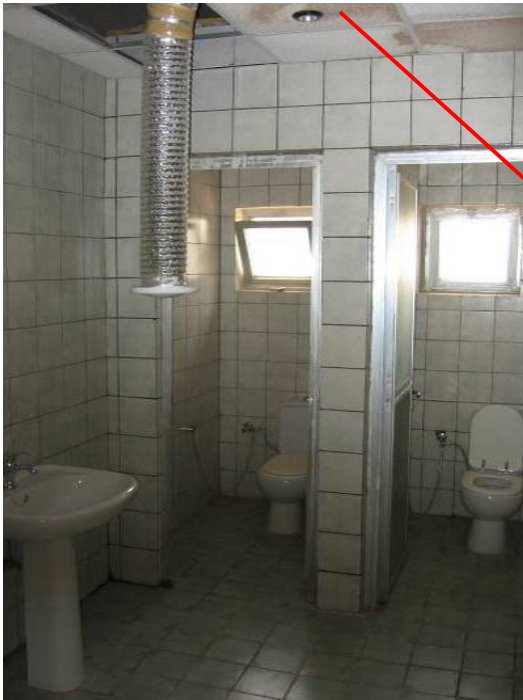
**Site Photo 150. Water damage on ceiling panel**

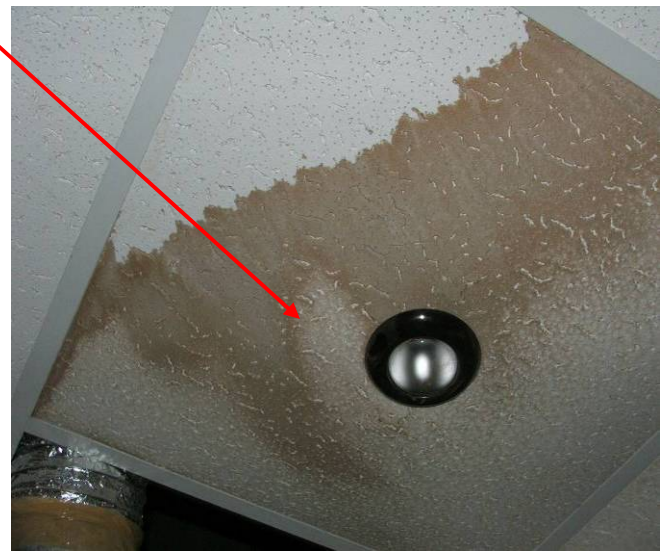
**Site Photo 151. Close-up view of water damage**

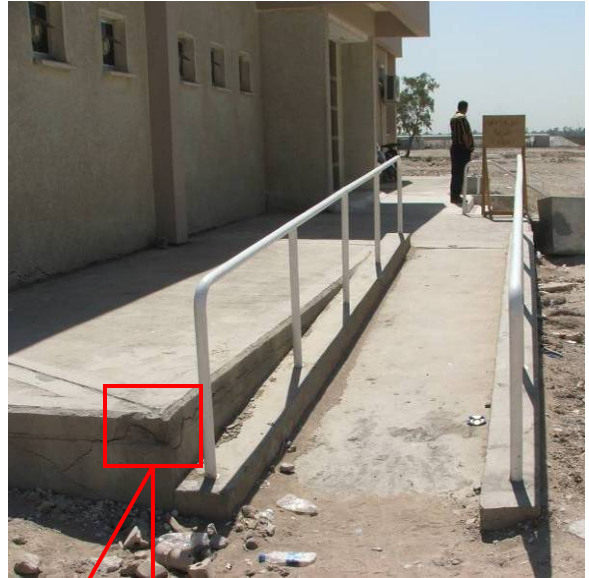
The library and archive building is a single-story concrete structure (Site Photo 152), which is currently being used as a badge office. The design drawings called for and the contractor provided a handicapped ramp in the front of the building (Site Photo 153). The interior of the building consisted of several small rooms and one male and female water closet. We did not observe any problems or defects in any of the building's interior; however, we did observe some concrete defects near the handicapped ramp (Site Photo 154).

**Site Photo 153. Defective concrete work**

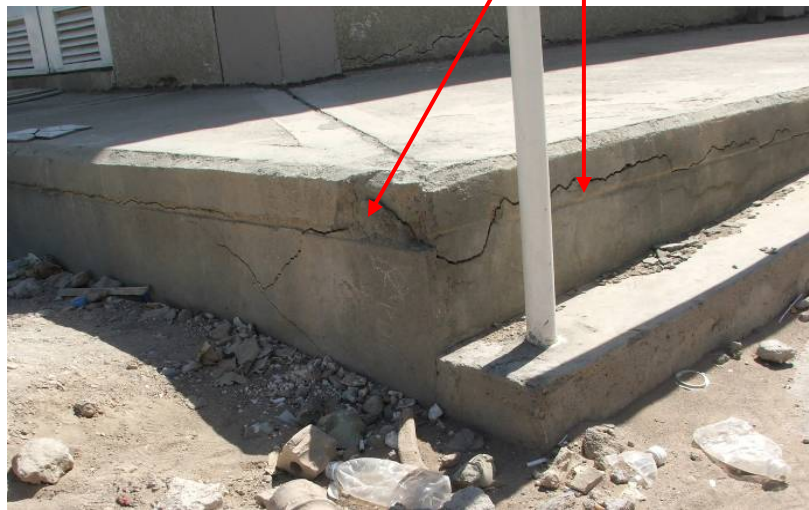
**Site Photo 154. Close-up view of Site Photo 153**

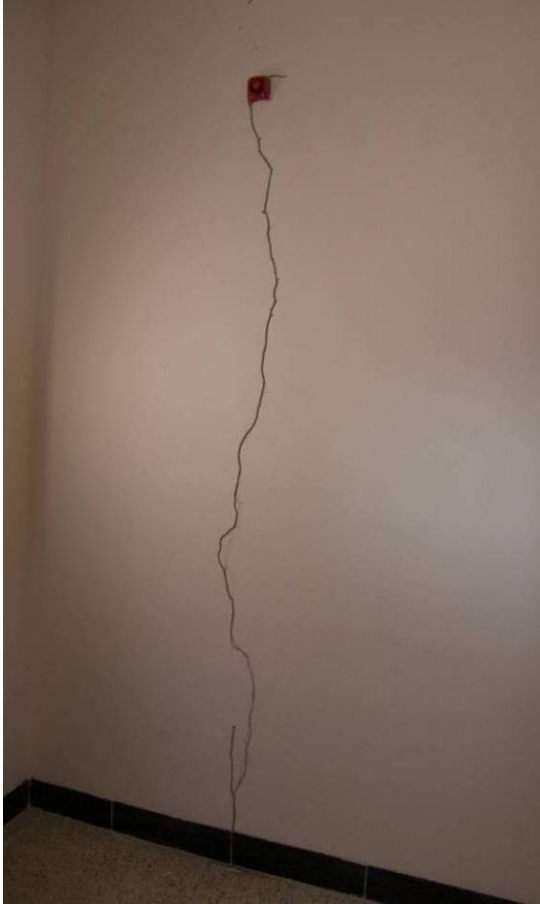
**Site Photo 157. Example of termite damage to interior wall**

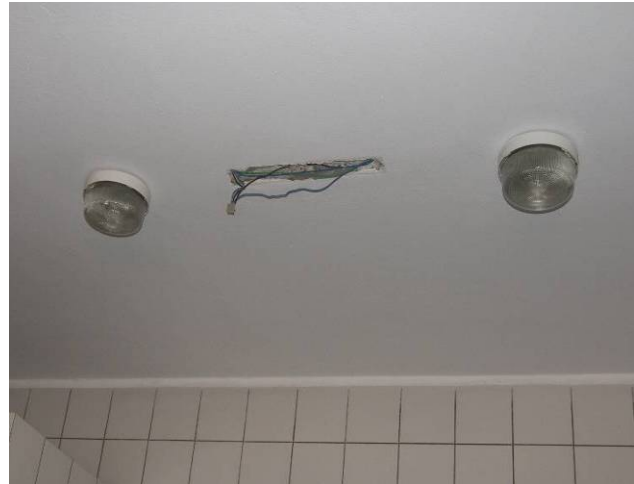
**Site Photo 158. Poor installation of light fixture**

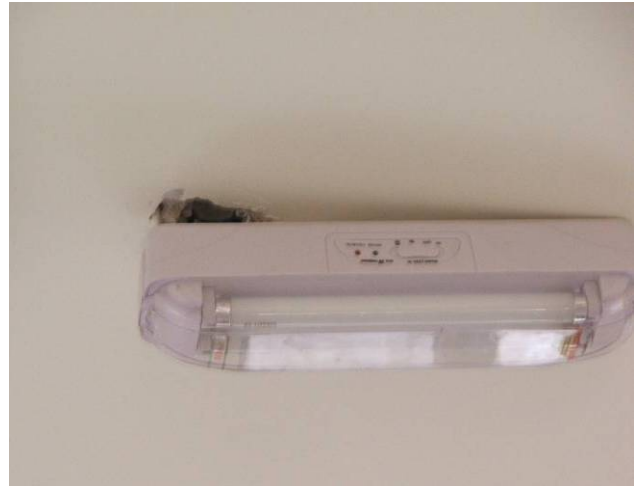
**Site Photo 159. Poor installation of light fixture**

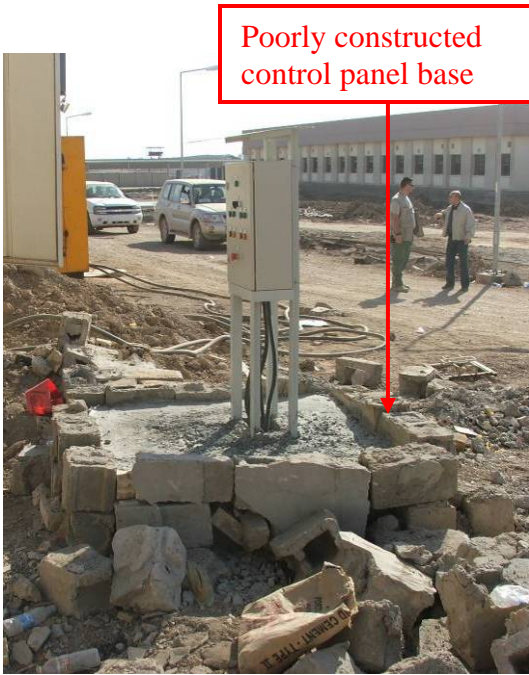
The new contractor recommended, and GRD agreed, to upgrade to a dual pump design. On our last visit on 8 December 2006, we verified the installation of a dual pump design. The construction of the pump station was of poor quality. The control panel base was

rudimentary and there was no protection for the control panel from the elements, such as extreme summertime heat, rain, wind, dust, and dirt (Site Photos 161 and 162). In addition, an elevated sewer manhole was created by pouring concrete on a used manhole ring over the existing hole (Site Photo 163). PVC pipe carrying the electrical wires was partially covered with concrete; however, the entire length of the PVC pipe was not covered, which leaves it vulnerable to damage from the elements (Site Photo 164).

**Site Photo 161. Dual pump station control panel base**

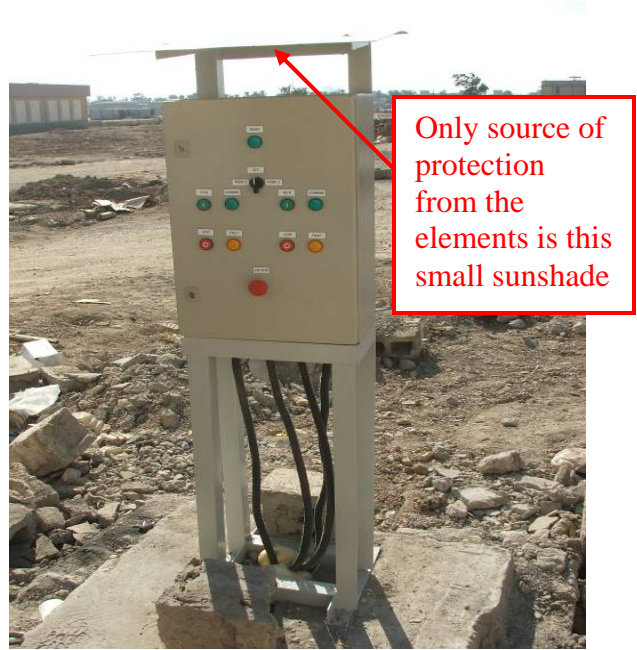
**Site Photo 162. Dual pump station control panel**

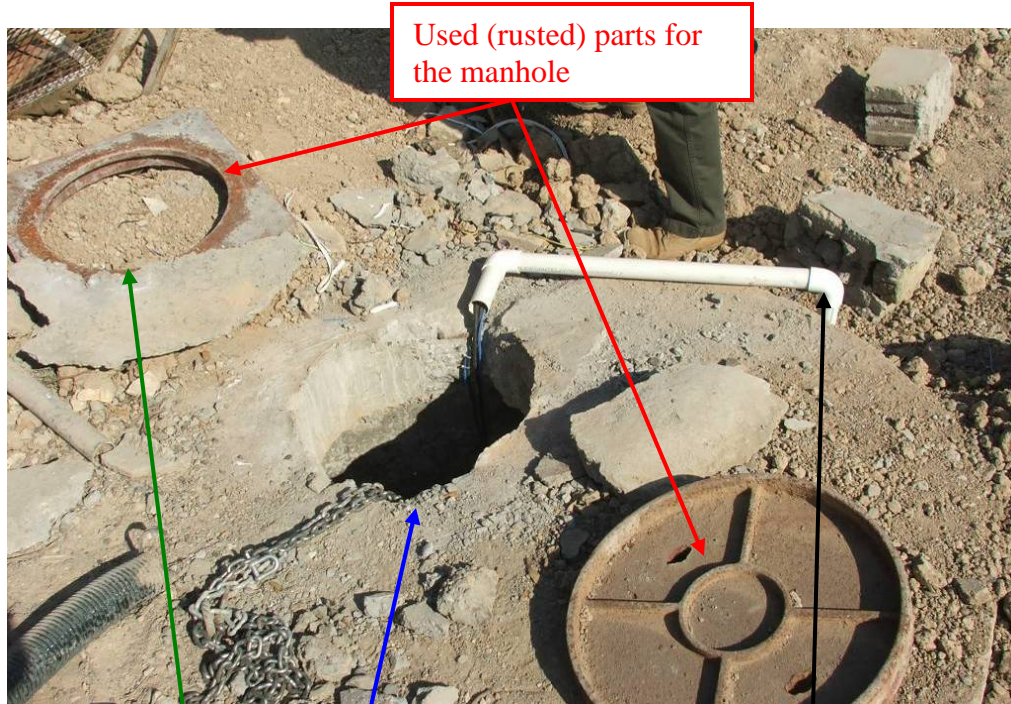
Site Photo 163. Sewer manhole as of 1 December 2006

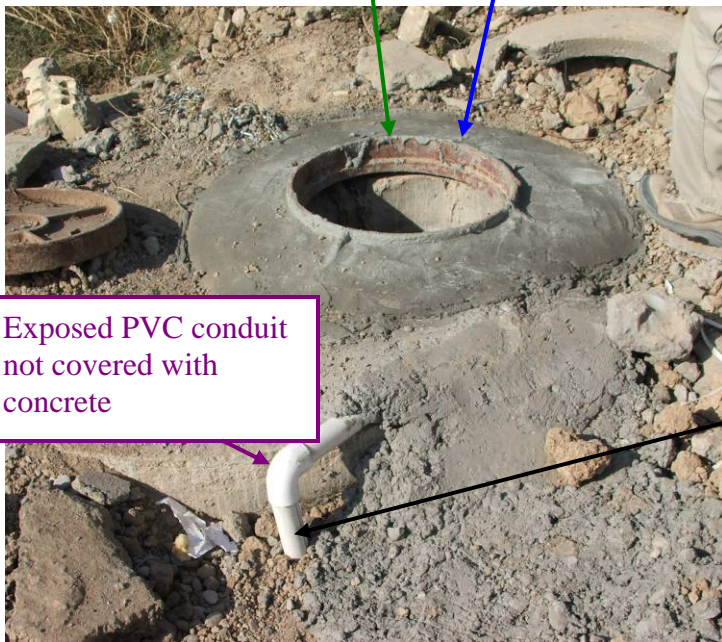
Site Photo 164. New elevated manhole as of 8 December 2006

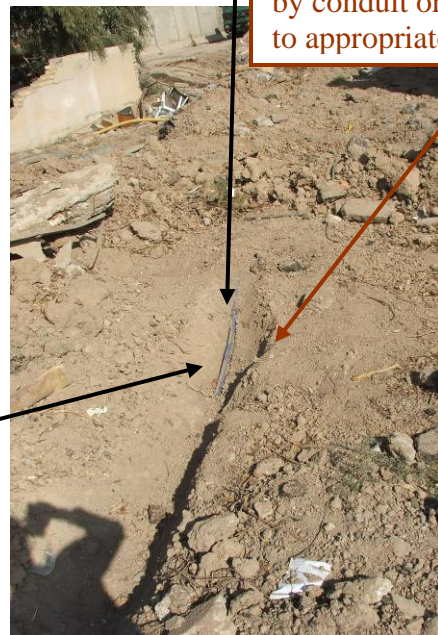
Further, the contractor poorly connected the electrical power wires to the pump station. From the power source to the base of the manhole, the electrical power wires were not placed in a conduit nor were the buried wires placed an appropriate depth under ground (Site Photo 165). At the time of the visit, the pump station appeared to be full of test water (Site Photo 166). BPC representatives stated the USACE GRD had informed them that the new pump station was currently ready for use. However, it did not appear to us to be operational. On 19 December 2006, we met with BPC representatives who stated the new pump station did not work because the contractor had not installed the correct type of pump. A pump which grinds the sewer solids had not been installed as necessary in order for the pump station to be operational. Consequently, the range administration building, a \$1.2 million facility, which the USACE GRC stated was ready for occupancy in June 2006, still could not be used.

Site Photo 165. Exposed electrical power lines to pump station

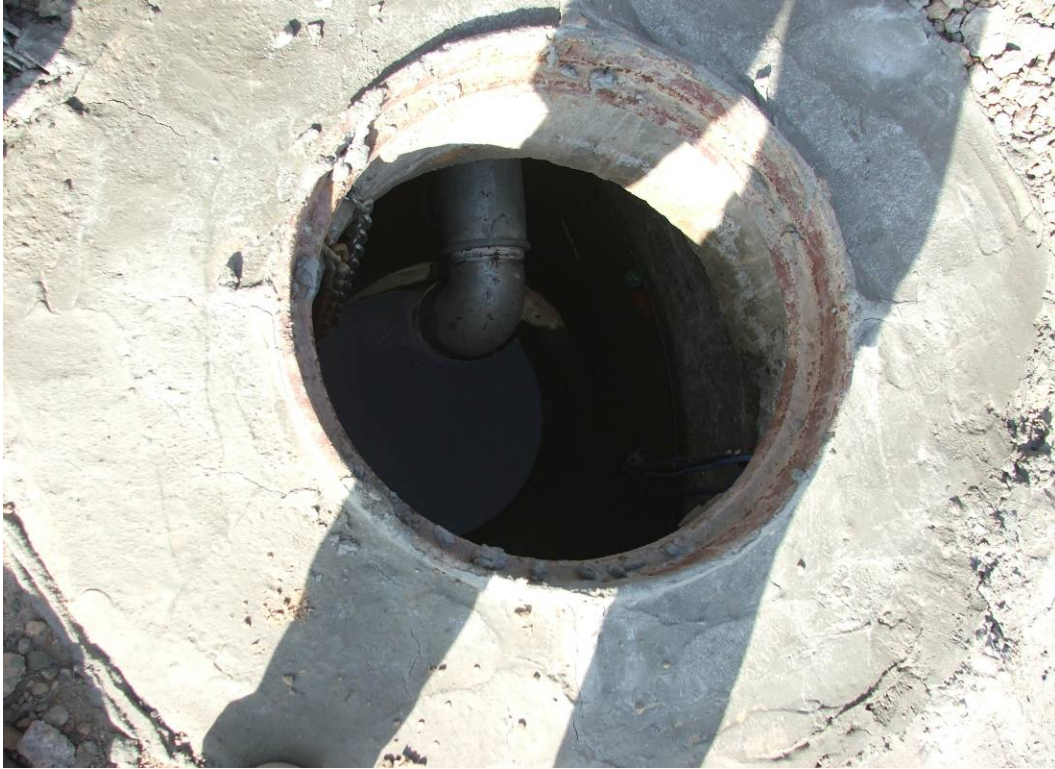
As a result of poor oversight by the GRC, Parsons either designed or constructed the building's sewer system below the academy's sewer system; and the contractor's new installation of a pump station was of "poor quality and unreliable design." However, the contractor was paid for the design and construction of both the building and the pump station. Further, a continuing lack of oversight by GRD allowed the new contractor to install an incorrect type of pump, which has caused additional delays to the use of the range administration building.

**Site Photo 166. New constructed dual pump station, which is not operational due to the installation of the incorrect type of pump**

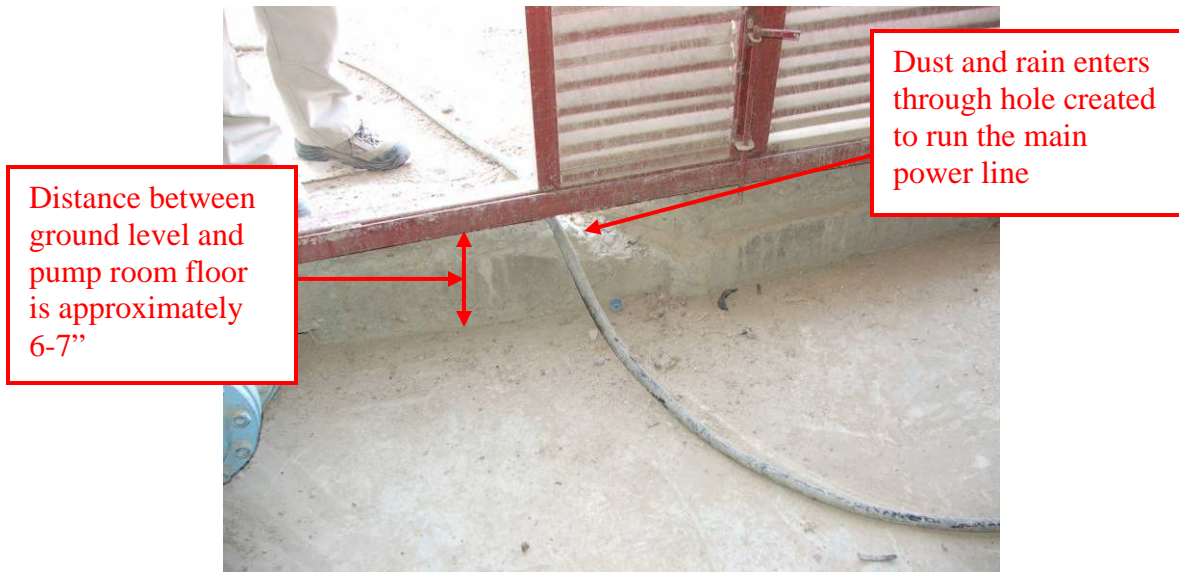
We observed limited operation of the water storage tank, which appeared to be functional. However, access to both the control room and to the top of the tank for operational functions is not adequate. The control room supporting the critical operation of this tank is below normal ground level, increasing the potential of heat, dust, and rainwater entering the room (Site Photo 174). During our site visit, we found the pump room to be extremely dusty and dirty; specifically the floor and pumps (Site Photo 175). In addition, we found the electrical wires on the pump room floor (Site Photo 176). During the rainy season, the likelihood of water entering the room through the hole for the power cable and ruining the electrical wires is exponentially increased. We did not observe any floor drains or pumps to remove water from the control room. Finally, with the pump room floor approximately 6-7" below ground level, it will be extremely difficult to keep the room clean.

Site Photo 174. Pump room is below the college ground level

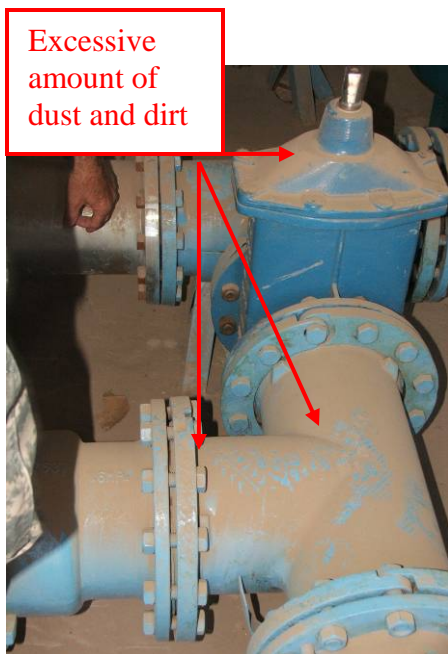
Site Photo 175. Dirt within the pump room

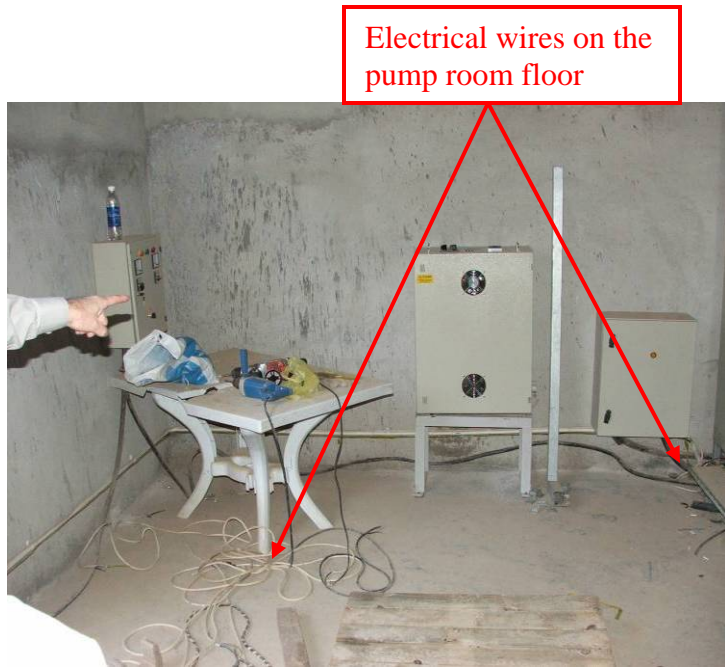
We were unable to inspect the entire plumbing and electrical systems, but they appeared to be in place. The main power supply cable was brought into this room by punching a hole under the door frame and was left on the floor to energize the pumps, motors, and control panel. We also noticed the cables providing signals to the pumps, motors, and valves from the control panel on the floor. In the event of water entering the pump room, there is the potential for significant damage to the support equipment, high pressure water main, and power generator. This would lead to a cutoff of water to the entire BPC campus for an extended period of time for repairs.

Site Photo 176. Electrical wires on the ground

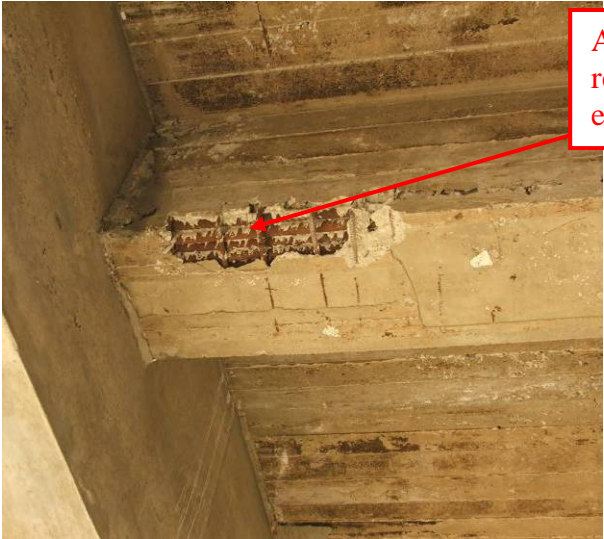
- areas of severe reinforcement bar exposure on the surface of the load-bearing reinforced concrete ceiling beams (Site Photos 178-180)
- areas of severe concrete segregation, honeycombing, and voids (Site Photos 181-183)
- poor quality brick masonry workmanship (Site Photos 184-187)

Site Photo 179. Reinforcement bar exposure

- Inadequate concrete cover for reinforcing steel and improperly embedded electrical conduit “potentially lends to spalling, de-lamination and reinforcing steel corrosion, which ultimately could cause structural failure.”
- Inadequate cover for reinforcing steel may “create a condition in which the reinforcing steel is subject to corrosive action from the humidity and chemical-use associated with laundry facility operations. Potential corrosion of the re-steel may lead to slab inability to bear roof load and eventual structural failure.”

- removing the existing concrete slab, performing the column and beam repairs, preparing the forms, and completing the elevated concrete placement
- considering a new truss design

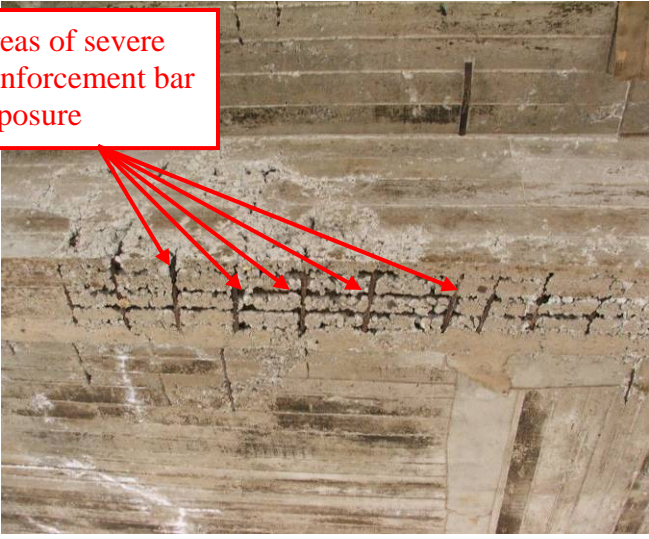
Areas of severe reinforcement bar exposure

Site Photo 180. Reinforcement bar exposure

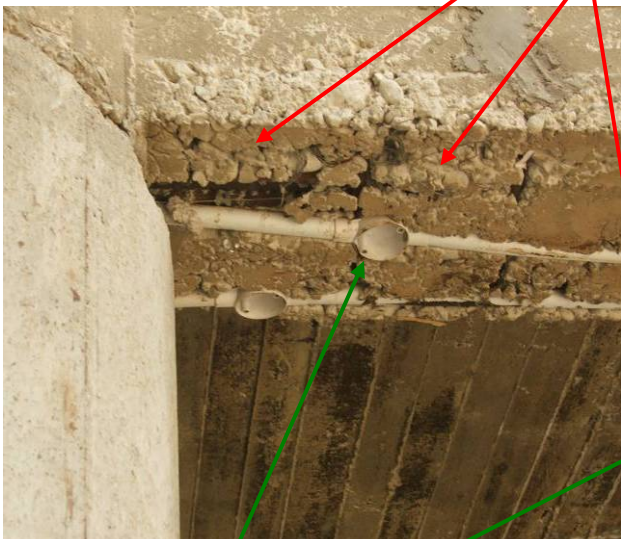
Areas of honeycombing, voids, and segregation

Site Photo 181. Concrete segregation and electrical conduit exposure

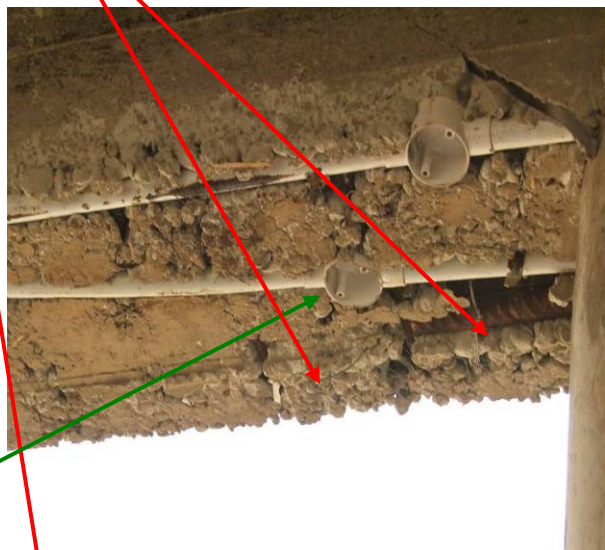
Site Photo 182. Concrete segregation and electrical conduit exposure

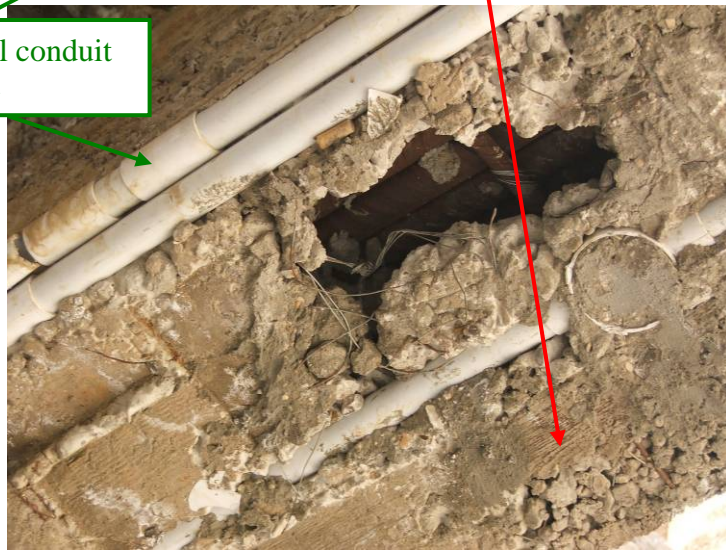
Electrical conduit exposure

Site Photo 183. Concrete voids and electrical conduit exposure

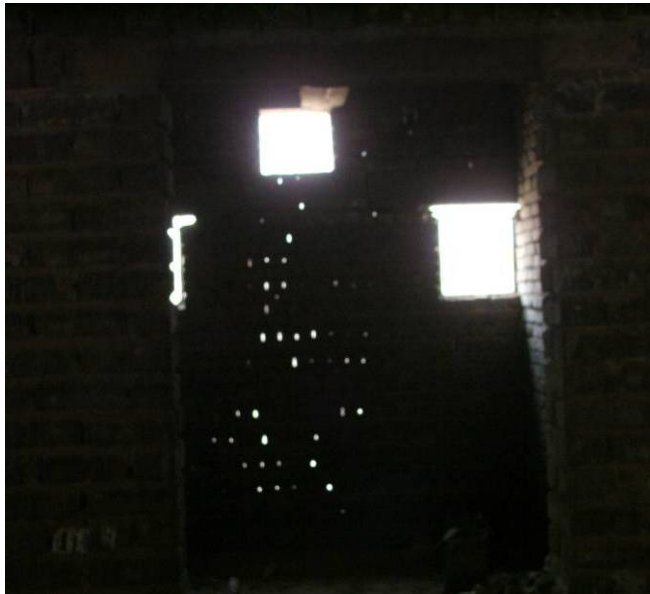
**Site Photo 184. Sunlight passing through gaps in wall**

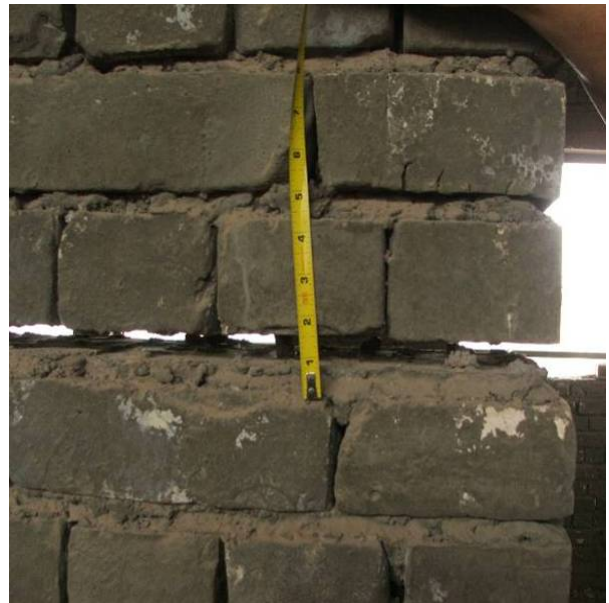
**Site Photo 185. One inch gap between bricks**

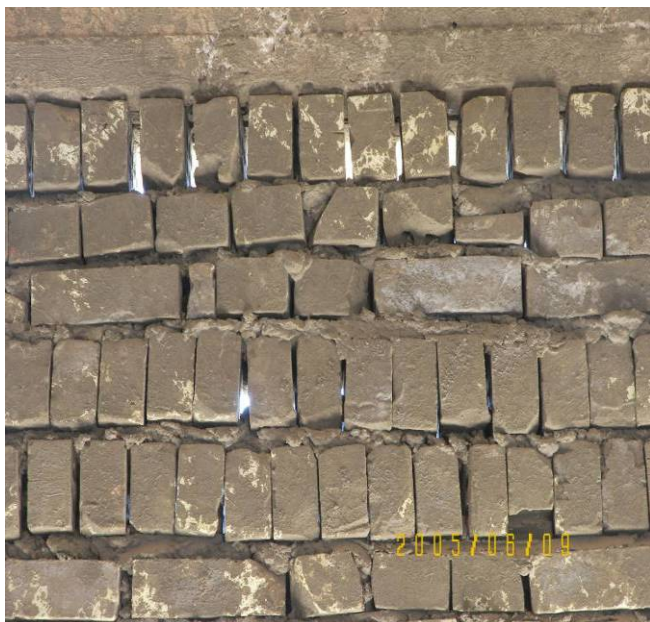
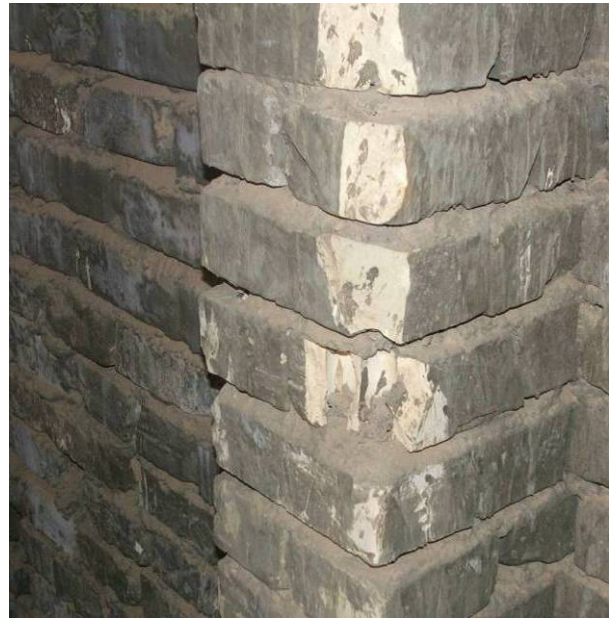
**Site Photo 186. Example of poor brick workmanship**

**Site Photo 187. Example of poor brick workmanship**

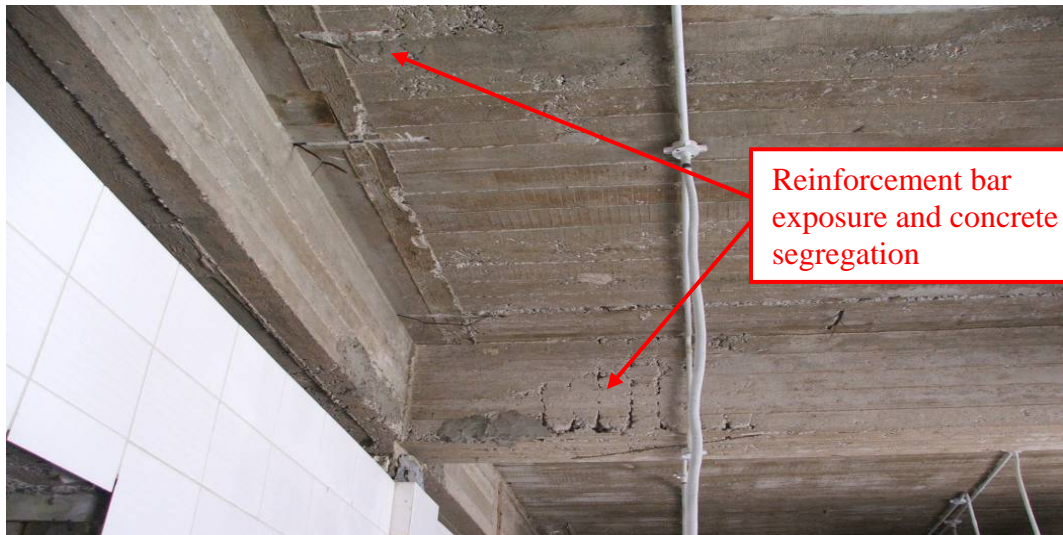
We viewed the dining facility in the condition it was left by Parsons – MNSTC-I’s contractor had not begun working on the facility. According to the design drawings, the dining facility was to be a single-story building with main seating area, male and female toilets, cashier areas, serving counter, staff room, and receiving area. However, the as-built drawings clearly state the size of the main seating area was sufficient for 1,440 people, not the 1,500 required by the TO. We verified that the floor and wall construction, and partial ductwork and electrical work had been completed (Site Photos 189-191). Parsons’ subcontractor left equipment and materials on site after the project was de-scoped (Site Photo 192). The new subcontractor will use the leftover material. We identified areas of reinforcement bar exposure and concrete honeycombs and segregation (Site Photo 193).

**Site Photo 193. Construction deficiencies within the indoor dining facility**

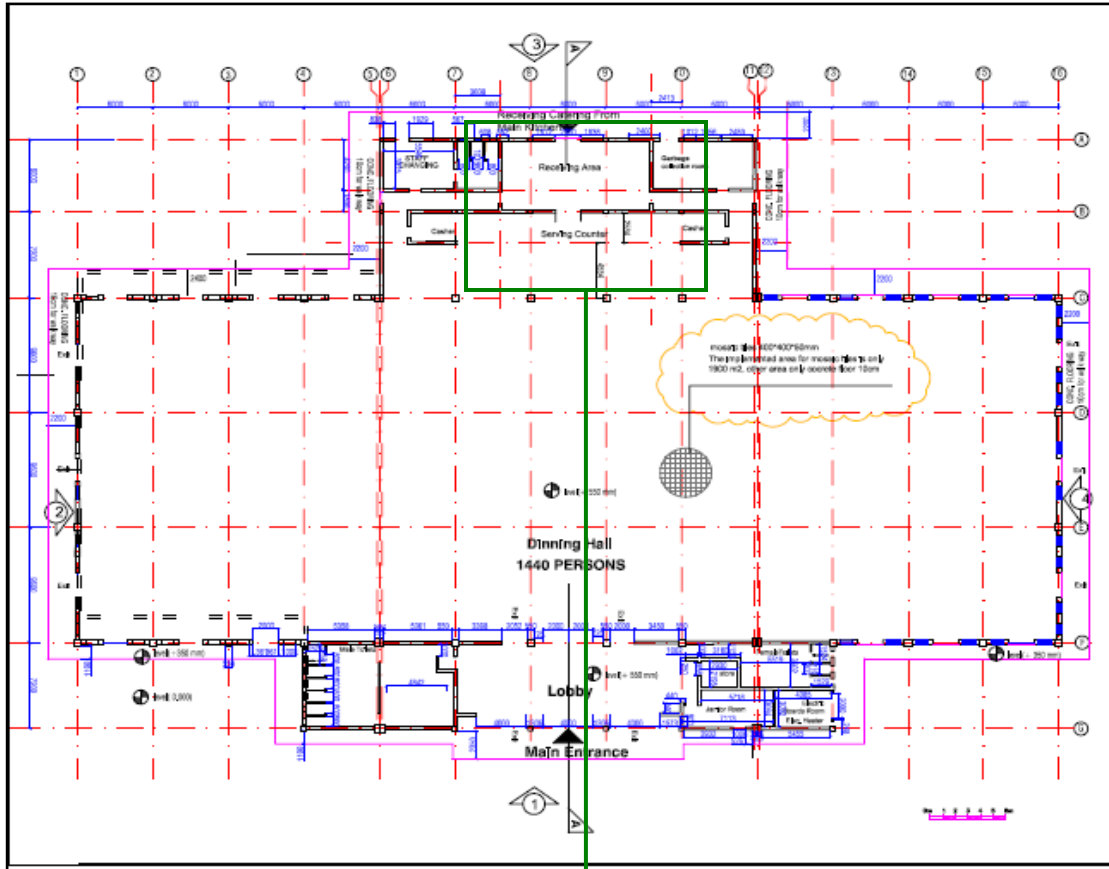
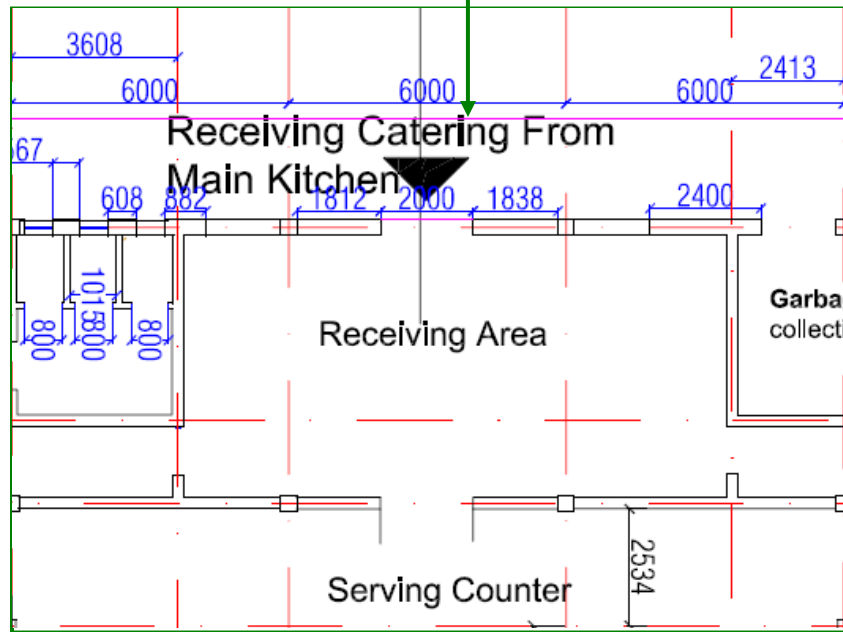
include the “attached” kitchen required by the TO. The government representative who reviewed Parsons’ design submittals did not mention the complete omission of the attached kitchen. GRD representatives, including the QAR did not realize the omission, either. GRD representatives believed the small room attached to the dining facility was the kitchen; however, this room is actually the receiving and servicing area for the dining facility (Site Photo 194 and Figures 14 and 15). No comment or clarification regarding this issue was raised at the time of design review. When the dining facility is completed, food will have to be brought in from the existing kitchen located on the BPC grounds. GRD representatives are now attempting to locate funding to construct a kitchen for the dining facility.

Figure 14. As-built drawing for the dining hall with no attached kitchen

Figure 15. Enlarged view of the area GRD thought was the attached kitchen, which turned out to be the receiving area

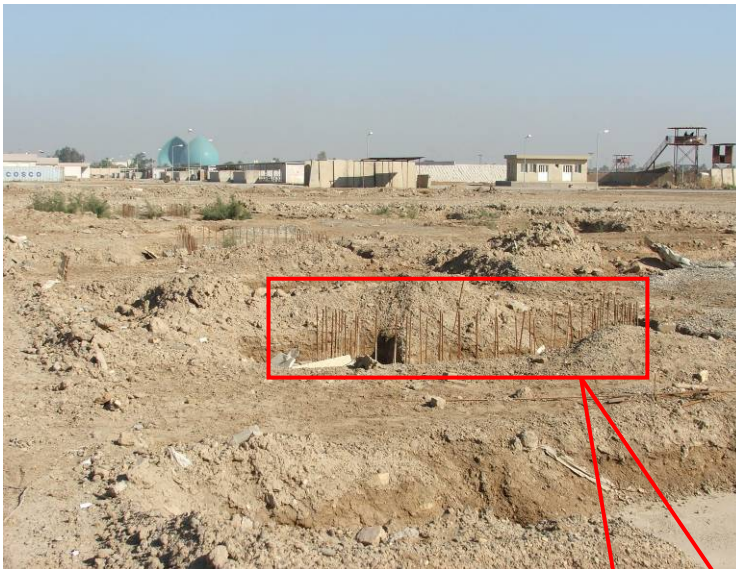
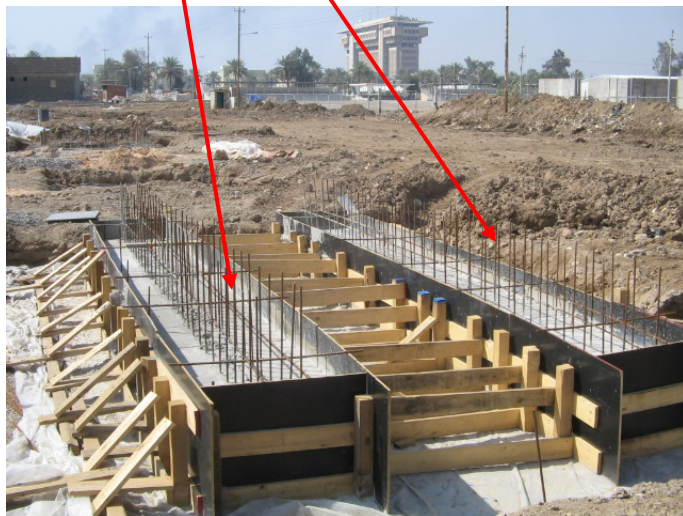
TO 06 required the construction of a physical training (PT) field, complete with pull-up bars, mats, etc. According to BPC representatives, the PT field was excavated and a foundation with reinforcement bars was partially completed. GRD officially de-scoped this project and it was not completed. The foundation was partially covered with dirt; however, a portion of the reinforcement bar still extends beyond the dirt covering (Site Photos 197 and 198). BPC representatives are concerned about the safety of its cadets and instructors, specifically a cadet/instructor tripping over an exposed reinforcement bar and impaling himself. When GRD de-scoped this project, the responsibility for correcting the potential safety hazard of exposed reinforcement bars transferred from Parsons and GRD to the BPC officials.

**Site Photo 197. Foundation for PT field with exposed reinforcement bars extending beyond the ground**

**Site Photo 198. PT field foundation with reinforcement bars**

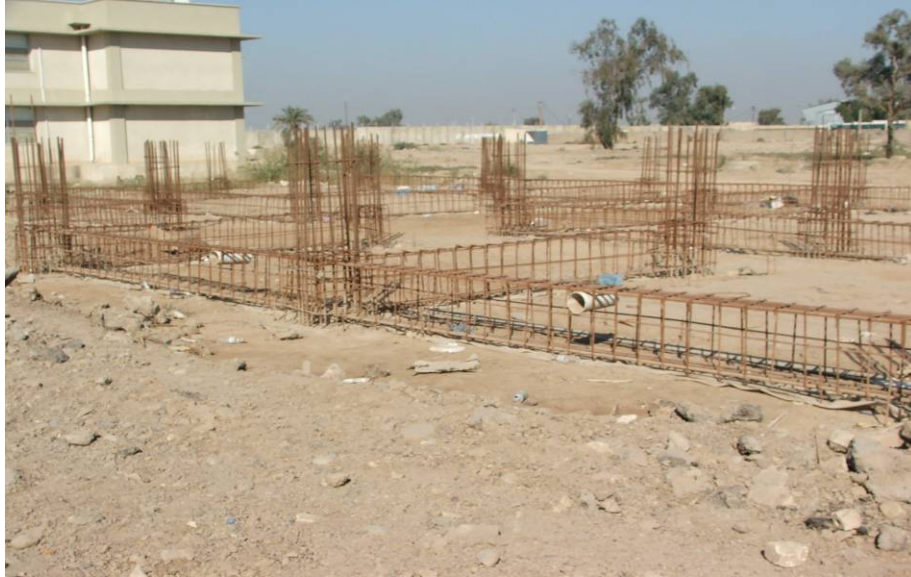
TO 29 required the contractor to design, construct, and equip a 100-person weight training room with lockers, showers, free weights, and total fitness machines. According to BPC representatives, the contractor began the foundation work then the project was de-scoped (Site Photo 199). Similar to the PT Field, BPC representatives are concerned about the fact that the de-scoped project left exposed reinforcement bars on the campus, with the responsibility for correcting the problem left to the BPC.

**Site Photo 199. Partially completed weight training room, with reinforcement bar exposure**

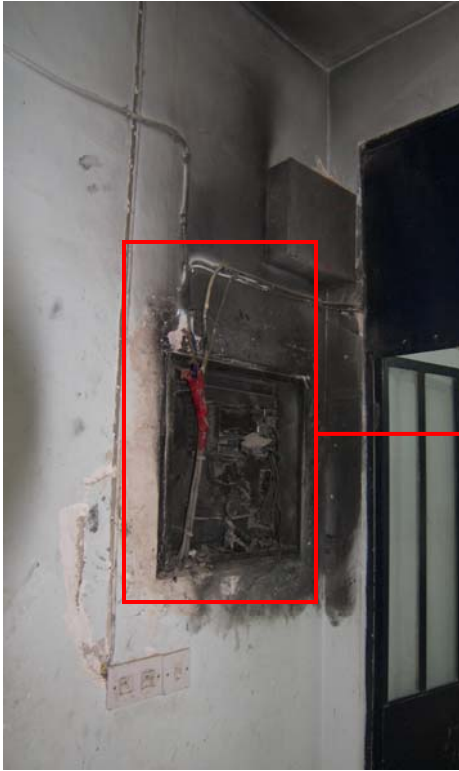
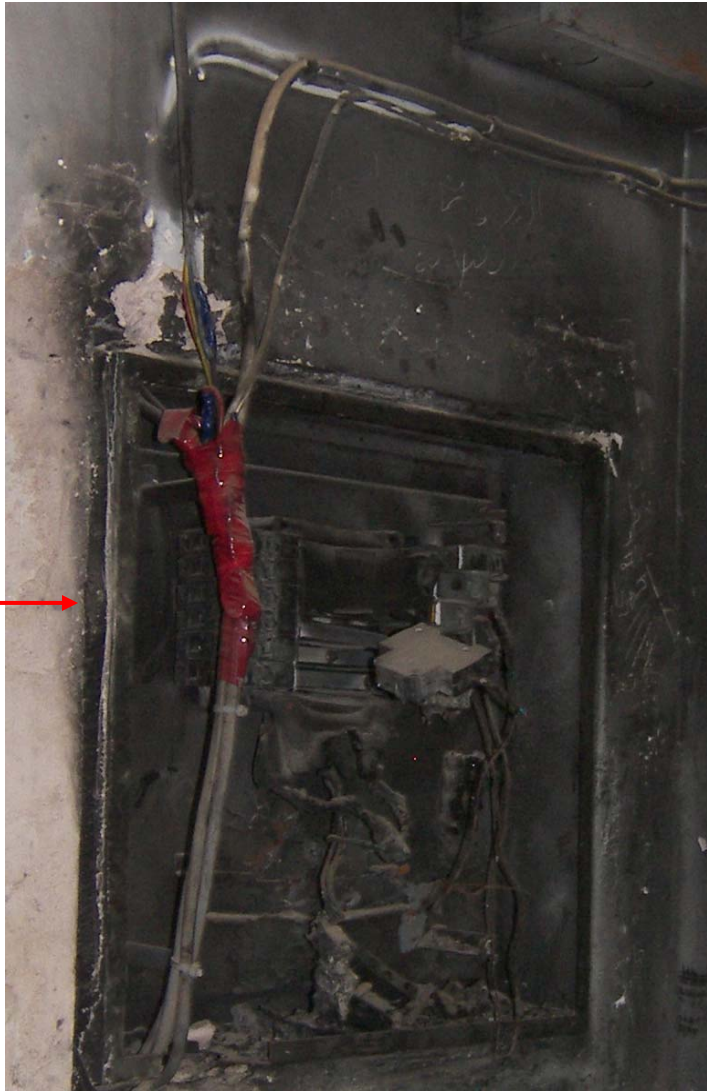
We observed old multiple service lines connected to the existing main power feed without any required power panel or circuit breakers. Circuit breakers provide safety to people and equipment by offering the opportunity of a mechanical shut down from the surge in incoming power as well as over loading the branch circuit. However, the safety and appropriateness of the electrical work is questionable. For example, the contractor failed to use a circuit breaker and instead wired the incoming heavy amp line directly to the lower amp lines, which significantly increases the chance of an additional electrical fire.

**Site Photo 200. “Emergency” electrical work performed by Parsons**

**Site Photo 201. Close-up view of Site Photo 200.**

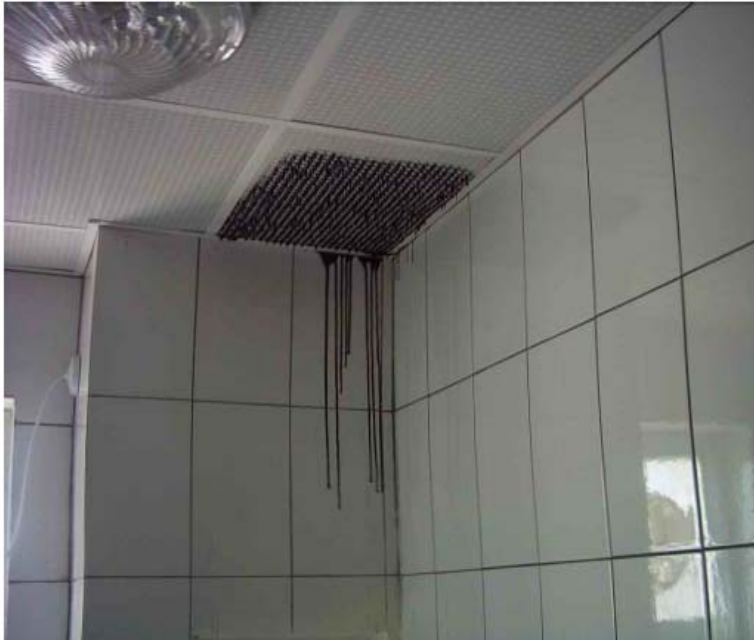
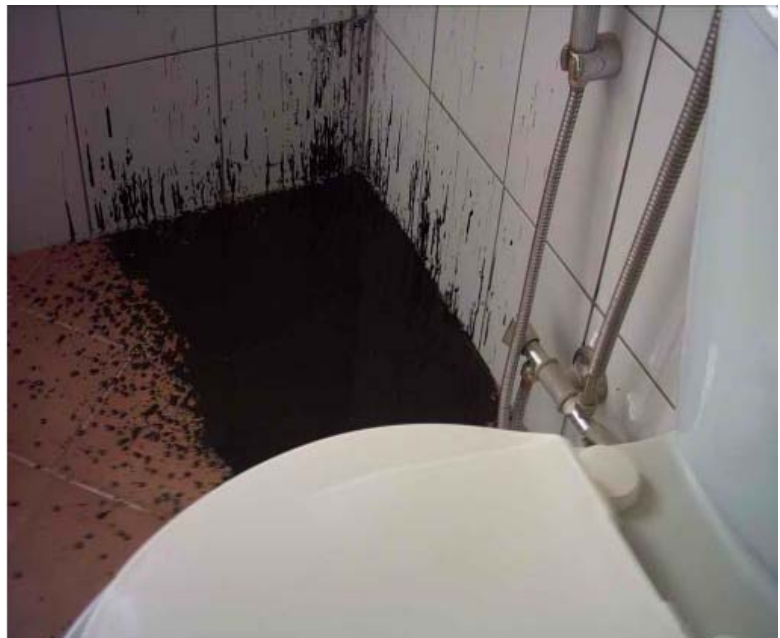
The results of the assessment report documented the “improper installation of roof flooring” for all classroom buildings, range control building, library, instructor barracks, language instructor barracks, forensic lab building, workshop building, and motor pool building. Specifically, “most of the roof mastic areas need to be repaired, maintained and corrective action must be taken to slope the concrete tiles [and] the drain openings.” GRD representatives confirmed that the roofs were poorly constructed for most BPC buildings. Poor mastic work is shown in Site Photo 202; while the end result of the poor work is shown in Site Photos 203 and 204.

**Site Photo 203. Interior damage caused by leaking tar**

**Site Photo 204. Interior damage caused by leaking tar**

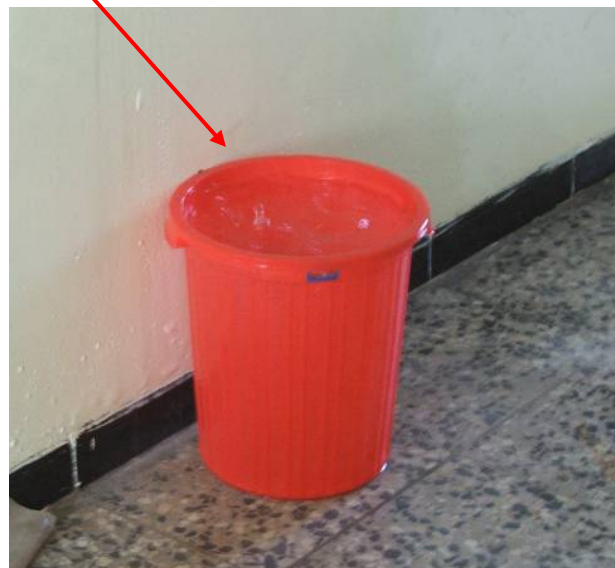
We visited the BPC on 10 November 2006 to verify the work accomplished on the cadet barracks buildings. We immediately noticed water on the ground floor common area (Site Photo 205). We observed water leaking from the ceiling (Site Photos 206 and 207) at approximately the same pace as documented in our previous report. We also noticed leaking water in the same locations on the pipes (Site Photos 208 and 209). [NOTE: the waste water damage to the current pipes is less than the damage from our original site visit; however, the current pipes had only been used for a few weeks.] BPC cadets stated the water had been leaking for approximately 4-5 days by the time of our visit. The cadets put a bucket under an open section of the false ceiling to capture leaking water (Site Photos 210 and 211).

**Site Photo 211. Close-up of bucket full of leaking water**

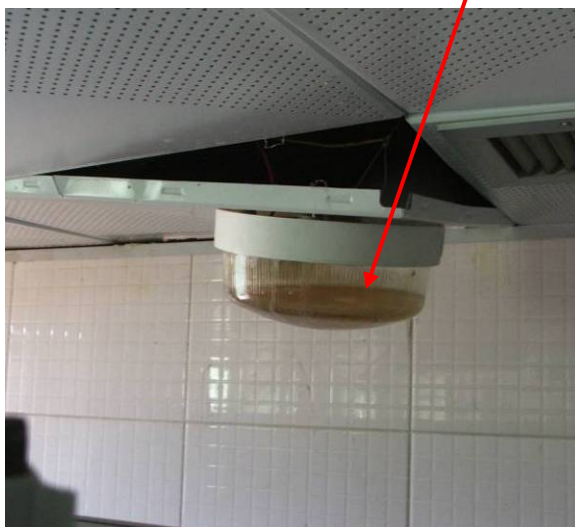
Finally, we do not find any validity to GRD’s claim that the “crystallized deposits shown in photo 181 are salt deposits from fresh water leaking through the concrete floor above.” First of all, when comparing a current photo (Site Photo 101) of the ceiling panel damage to a photo from our original site visit, which the GRD concurred was crystallized urine deposits (Site Photo 100), the damage appears to be identical. It must be noted that the damage in the original site visit photo is more substantial because the plumbing issues had been on going for several months, while the damage from November 2006 occurred in the “reworked/repared” plumbing that had only been used for a few weeks.

We continued our visit to the barracks first floor bathroom where we found more evidence that the subcontractor had not properly corrected the previously identified plumbing deficiencies. In some instances, it does not appear the subcontractor even replaced ceiling lights and false ceiling panels (Site Photos 212-215). Several ceiling lights were full of urine and fecal matter and corroded on the outside, which appeared to be more than a few weeks old; while the crystallized urine stains on the false ceiling panels appeared to be similar to the panels that were seen on our first visit to the BPC. However, BPC representatives were told by the GRD and the subcontractor that the entire barracks were complete. Not only were the upstairs bathrooms not complete, in some cases, potential hazards existed. For example, above the showers, live wires are dangling through exposed areas of the false ceiling with light fixtures filled with urine and water leaking from the sewer pipes (Site Photos 216 and 217).

**Site Photo 214. Urine-filled ceiling light**
