**BAGHDAD POLICE COLLEGE  
BAGHDAD, IRAQ**

**SIGIR PA-06-078.2**

**SIGIR PA-06-079.2**

SUBJECT: Report on Project Assessments of Reconstruction Work Performed Under Task Orders 06 and 29 at the Baghdad Police College, Baghdad, Iraq (Report Numbers SIGIR PA-06-078.2 and PA-06-079.2)

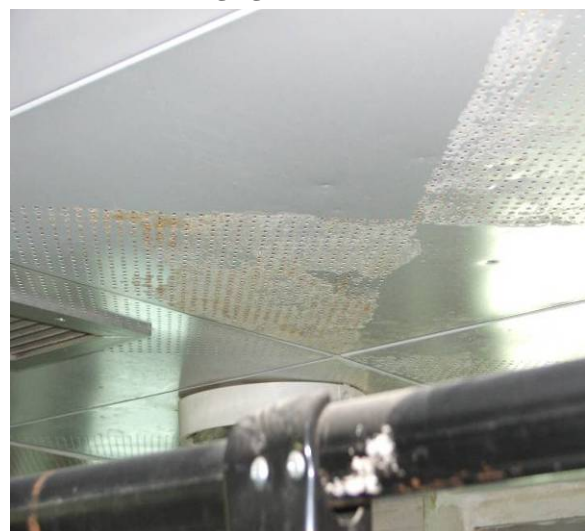
We continued our visit to the barracks first floor bathroom where we found more evidence that the subcontractor had not properly corrected the previously identified plumbing deficiencies. In some instances, it does not appear the subcontractor even replaced ceiling lights and false ceiling panels (Site Photos 212-215). Several ceiling lights were full of urine and fecal matter and corroded on the outside, which appeared to be more than a few weeks old; while the crystallized urine stains on the false ceiling panels appeared to be similar to the panels that were seen on our first visit to the BPC. However, BPC representatives were told by the GRD and the subcontractor that the entire barracks were complete. Not only were the upstairs bathrooms not complete, in some cases, potential hazards existed. For example, above the showers, live wires are dangling through exposed areas of the false ceiling with light fixtures filled with urine and water leaking from the sewer pipes (Site Photos 216 and 217).

**Site Photo 215. Crystallized urine stains on ceiling panels**

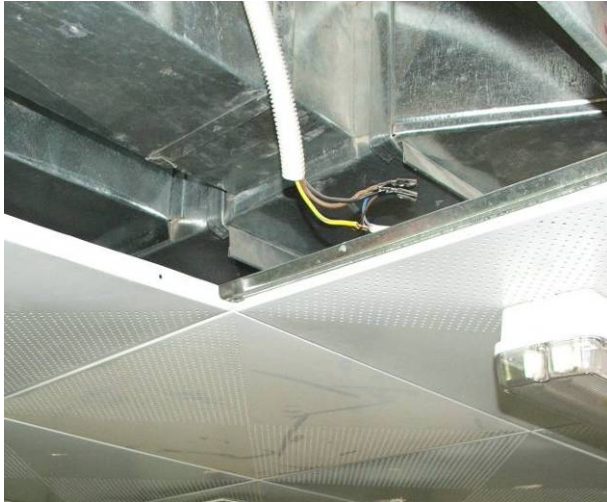
**Site Photo 216. Wires taped together**

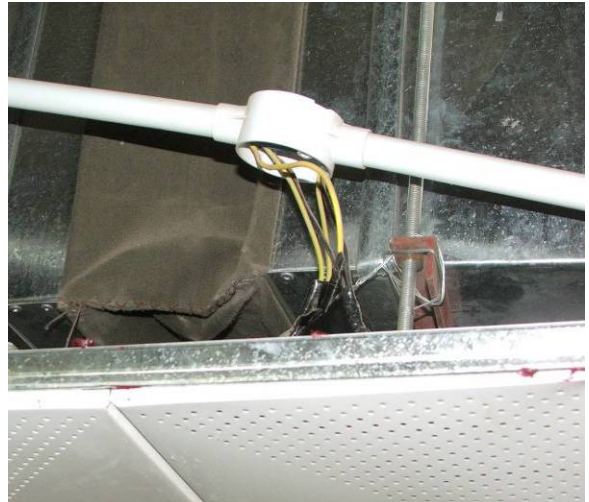
**Site Photo 217. Wires taped together**

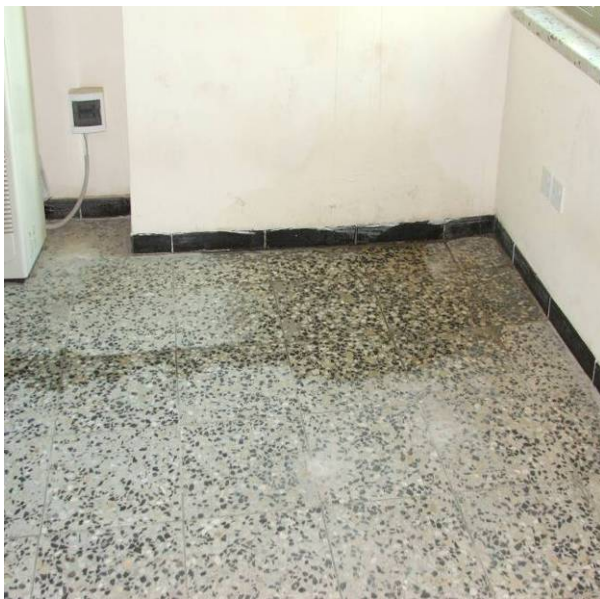
In another barracks building, we identified water leakage on a smaller scale than the previous barracks building. However, we noticed damage from the water leakage on the floors (Site Photos 218 and 219), walls, doorframes, and doors (Site Photos 220 and 221).

**Site Photo 218. Water damage on the floor of the cadet barracks**

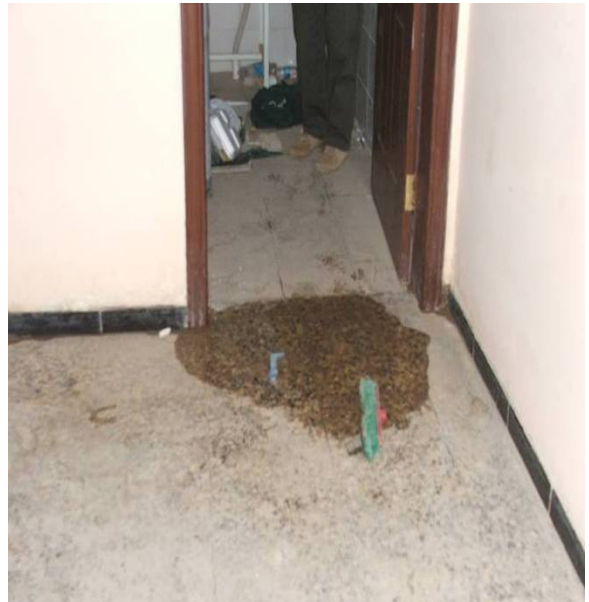
**Site Photo 219. Additional water damage in cadet barracks**

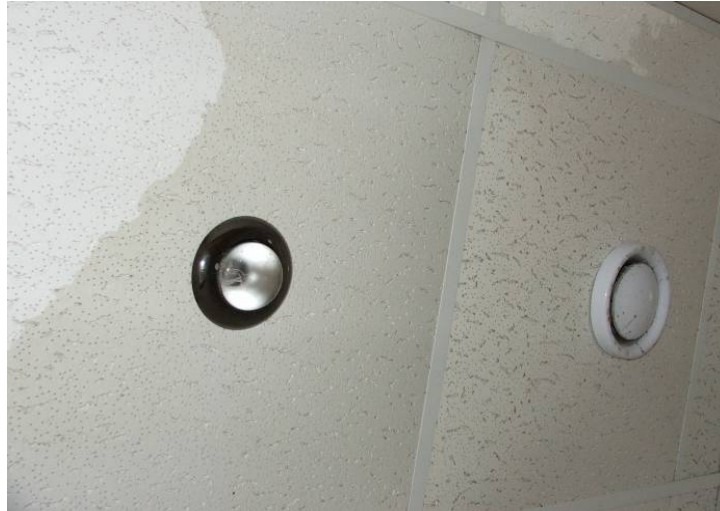
Earlier in this report, we documented damage from water leakage, poor door installation, and the ground floor sloping downward to the right in Classroom Building E. We visited Classroom Building E on 10 November 2006 to review the work completed by the subcontractor. The plumbing issues in the male bathroom appeared to have been corrected; however, in the female bathroom we witnessed evidence of water leakage on the false ceiling panels (Site Photo 222) and where the false ceiling panels collapsed and sent debris and water to the floor (Site Photos 223 and 224).

**Site Photo 222. Water damage on ceiling panels**

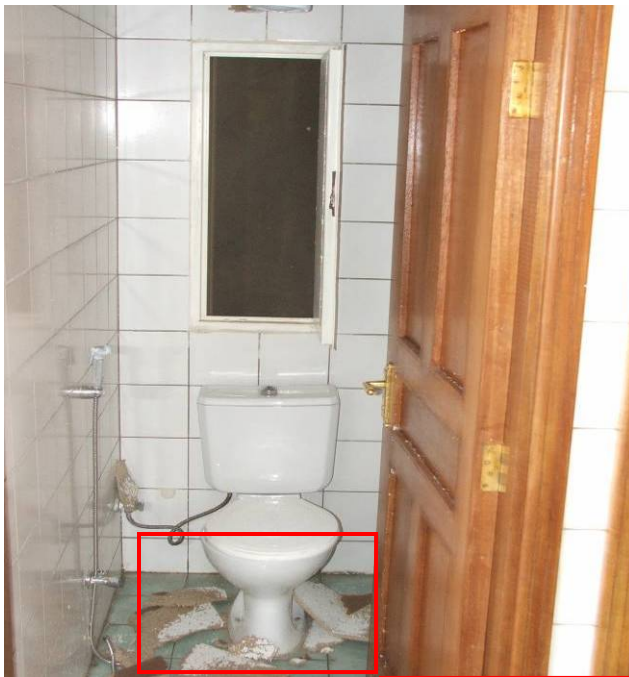
**Site Photo 223. Damaged ceiling panels that fell to the ground**

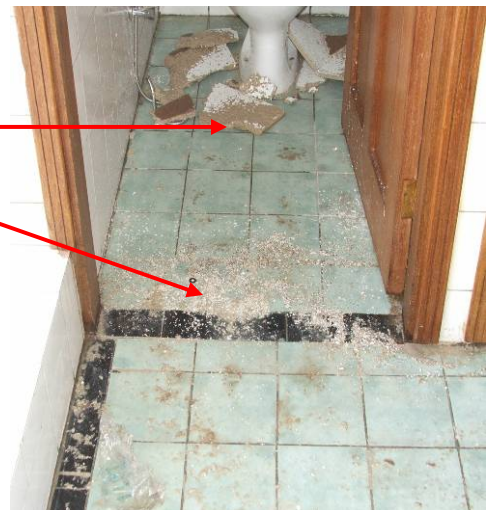
**Site Photo 224. Close-up of Site Photo 223**

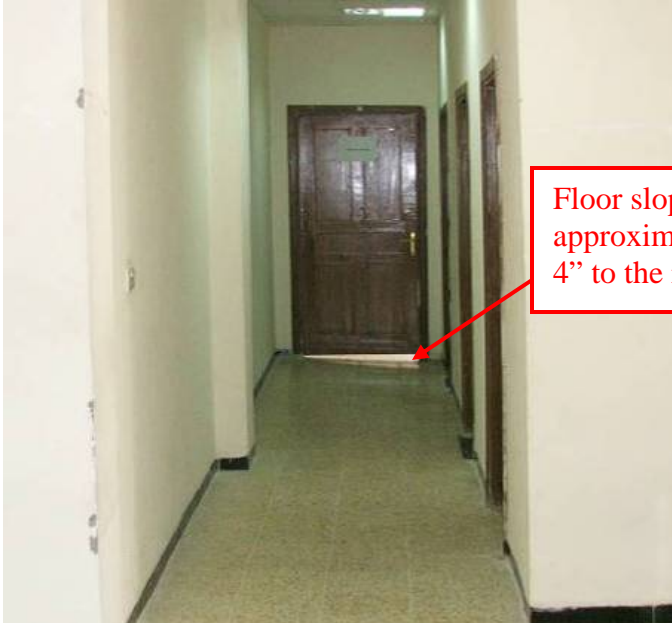
The subcontractor replaced the ground floor to correct the downward slope earlier identified (Site Photos 225 and 226). The new floor did not have the significant downward slope; however, the subcontractor did not correct the poor doorframe installation. The doorframe was originally constructed when the floor sloped and no corrective actions were taken to adjust the doorframe. Consequently, the door does not properly shut (Site Photo 227).

Floor sloped approximately 4" to the right

Site Photo 225. View of sloped floor in Classroom E

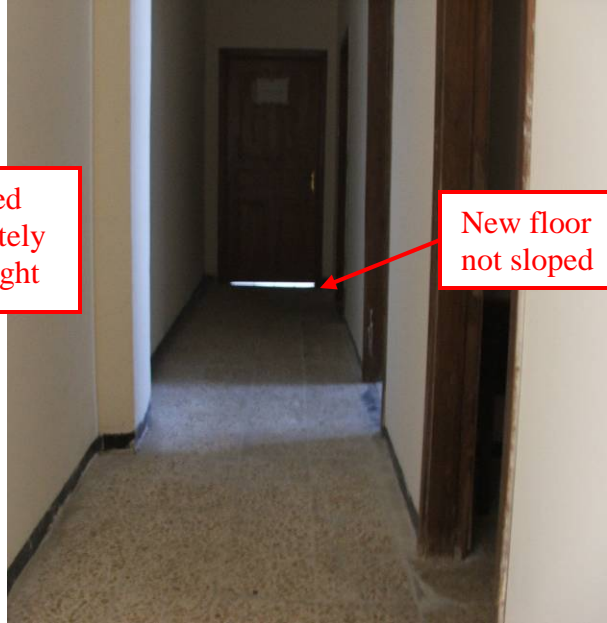
New floor not sloped
