BAGHDAD INTERNATIONAL AIRPORT
POWER SYSTEM ENHANCEMENT
BAGHDAD, IRAQ

SUSTAINMENT ASSESSMENT

SIGIR PA-07-097
APRIL 26, 2007

Baghdad International Airport Power System Enhancement Baghdad, Iraq

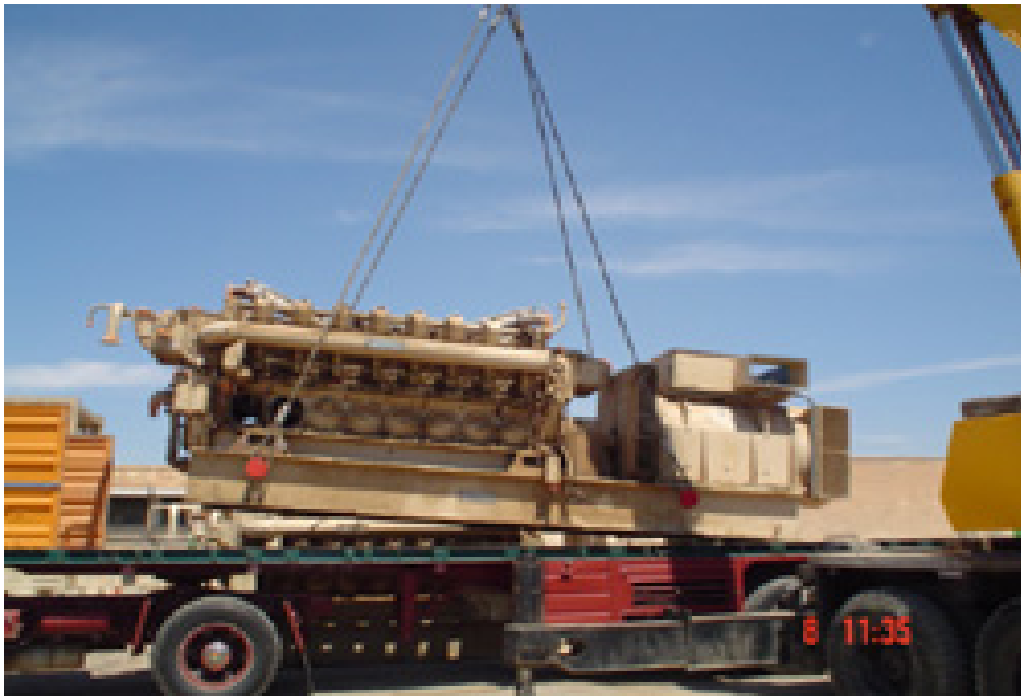
Site Photo 1. Existing Cockrill generator removal (Photo provided by USAID)

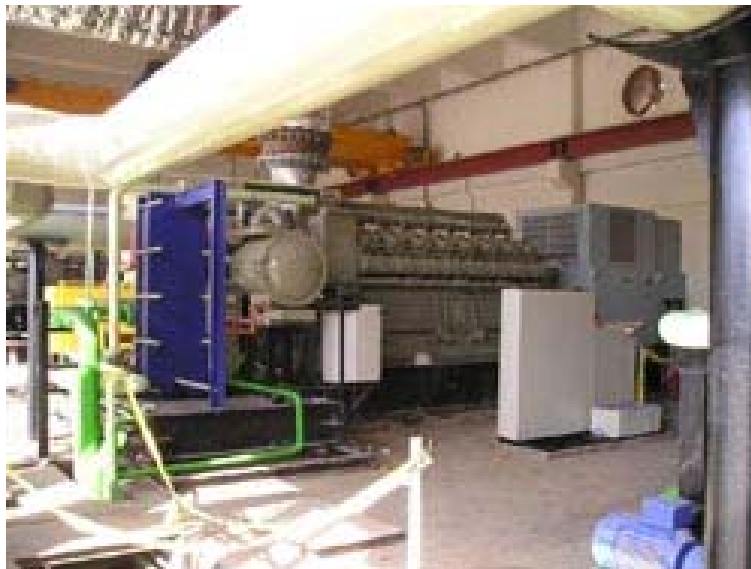
The contractor was to install and commission three new diesel generators. The contractor installed three General Electric (GE) generator sets, each approximately 2.9 MW, shown in Site Photo 3.

Site Photo 3. GE generator (Photo provided by USAID)

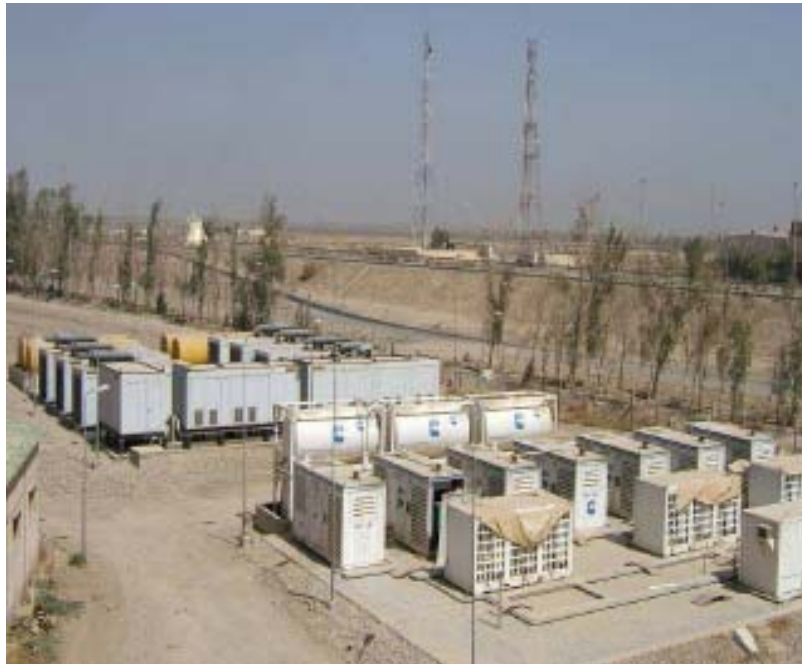
JO 03-008 stated that the contractor was to improve operations and maintenance access to the existing seven Cummins containerized diesel generator sets, while providing a control interface to the site master control. The contractor provided seven new Cummins generator sets, each approximately 0.85 MW. Site Photo 4 shows the aerial view of the seven Cummins generator sets, and Site Photo 5 shows the Cummins generator sets from the ground.

Site Photo 4. Seven Cummins generators (Photo provided by USAID)

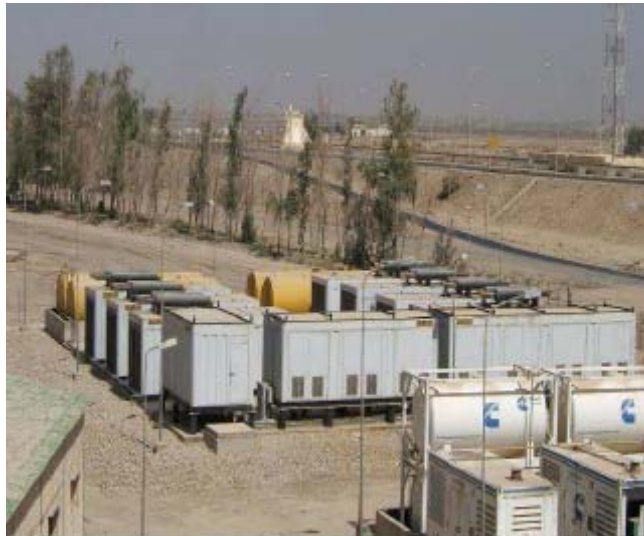
In addition, the contractor was to purchase, ship, install, and connect to the existing 11 kV system the seven new Caterpillar containerized diesel generator sets. The aerial view of the Caterpillar generator set and the contractor's site layout are shown respectively in Site Photo 6 and Figure 1. The contractor provided seven new Caterpillar generators sets, each approximately 1.02 MW.

Site Photo 6. Seven Caterpillar generators (Photo provided by USAID)

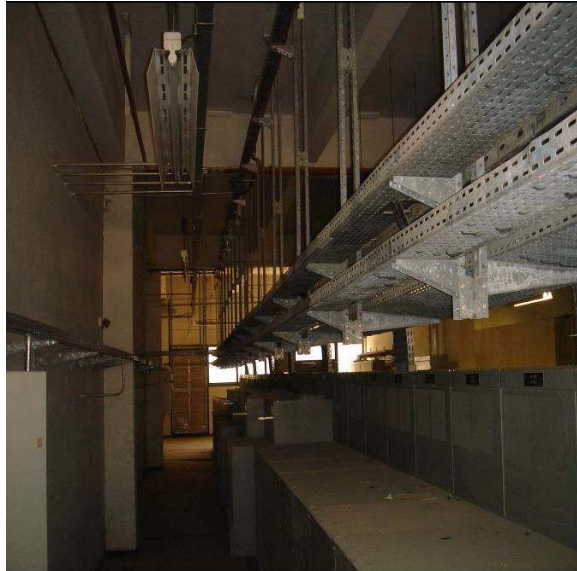
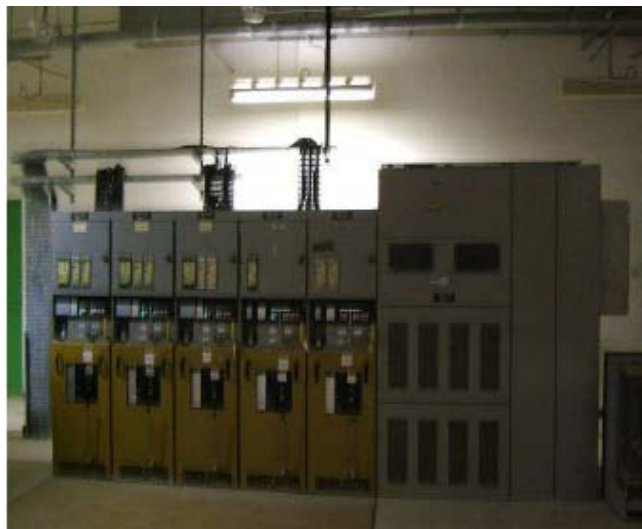
The contractor was to purchase, ship, install, and connect the existing 11 kilovolt (kV) system to the seven new containerized diesel generator sets. Site Photos 7 and 8, taken on 17 September 2005, show that the contractor provided 11 kV switchgear tray work and cables.

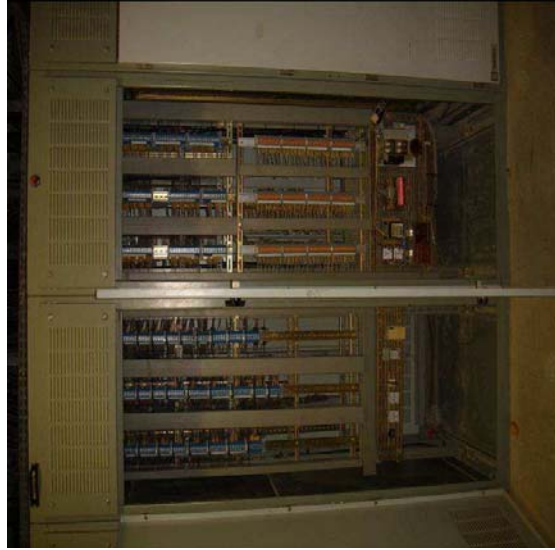
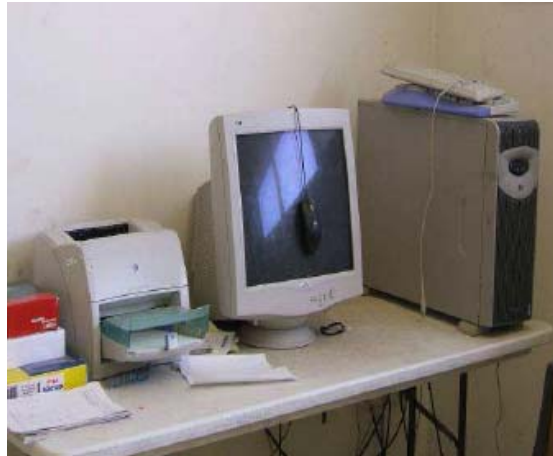
JO 03-008 stated that the contractor was to provide a system to monitor and control the generator load and capacity. Site Photos 9 and 10, show the contractor provided a Programmable Logic Controller (PLC) system.

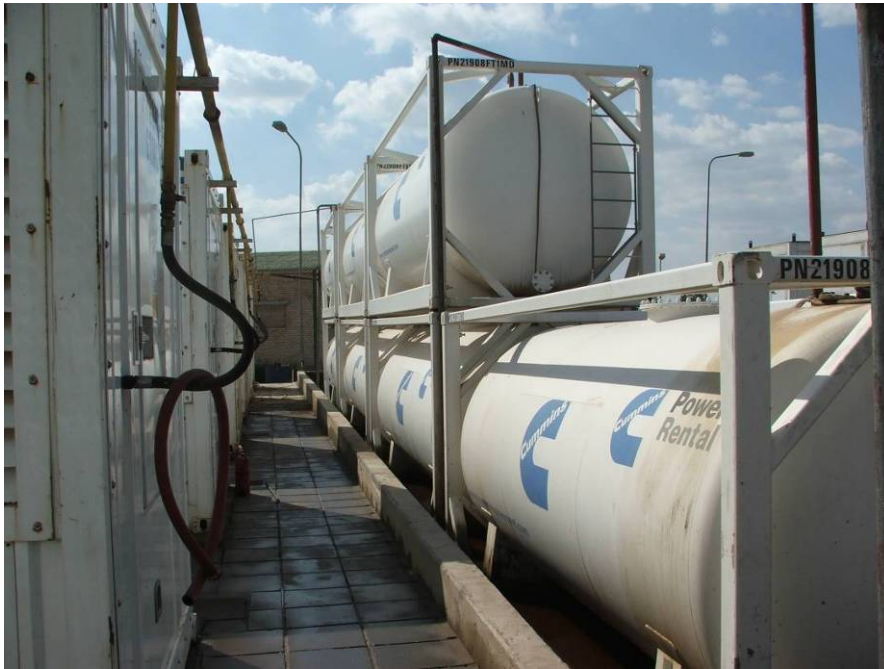
only) identify the Cummins generator set identification (ID) numbers. The Cummins generator area has its own fuel tanks, shown in Site Photo 32. Site Photo 33 shows one of the five Cummins generator sets that was not operational. The five Cummins generator sets are required to meet the electrical power requirement at the BIAP.

Site Photo 32. Cummins generator sets' fuel tanks
