WEST BAGHDAD INTERNATIONAL  
AIRPORT SPECIAL FORCES BARRACKS  
BAGHDAD, IRAQ

SUSTAINMENT ASSESSMENT

**SIGIR PA-07-100**  
**APRIL 24, 2007**

## West Baghdad International Airport Special Forces Barracks Baghdad, Iraq

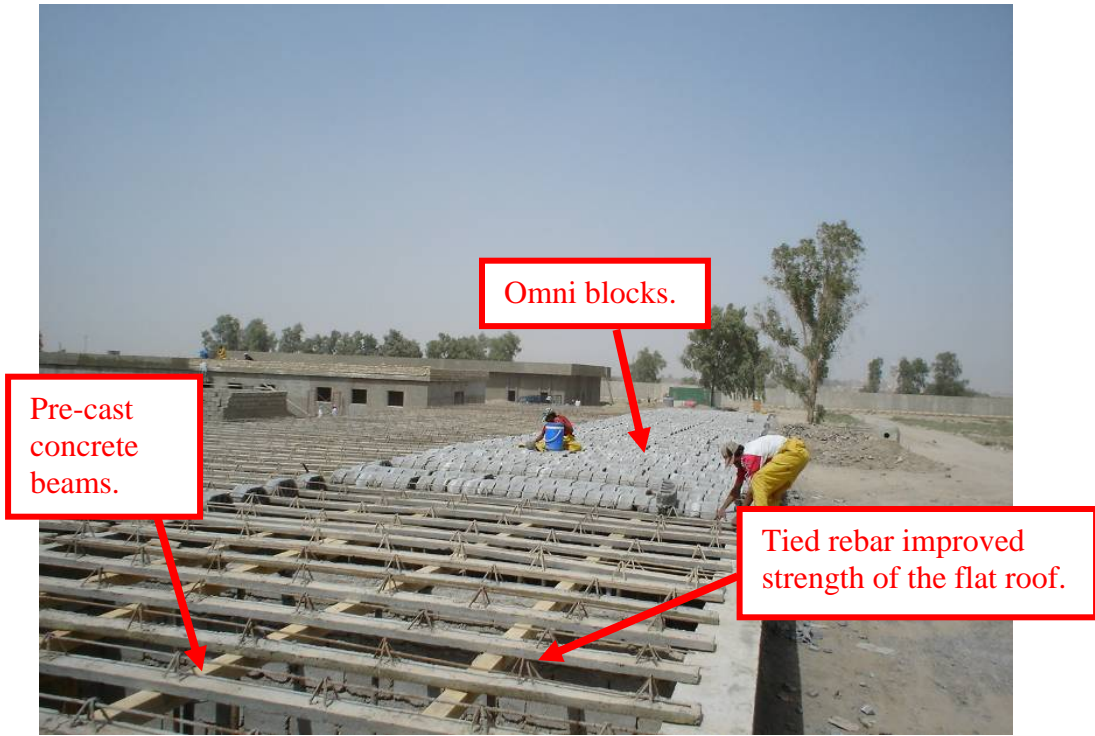
USACE Construction Progress Photos 5 and 6 illustrate stages of the construction of a barrack's roof. In USACE Construction Progress Photos 5, workers placed prefabricated "Omni" blocks on evenly spaced steel reinforced concrete beams to fabricate the roof's support structure system with tied rebar between beams. Subsequently, the roof's solid flatwork concrete was cast and clean dirt and sand was placed atop the flatwork casting and leveled before steiger plates (concrete tile) were laid in place. Overall, beam spacing and "Omni" block placement appeared even, straight and uniform.

**USACE Construction Progress Photo 5. “Omni” blocks were placed on evenly spaced concrete beams.**

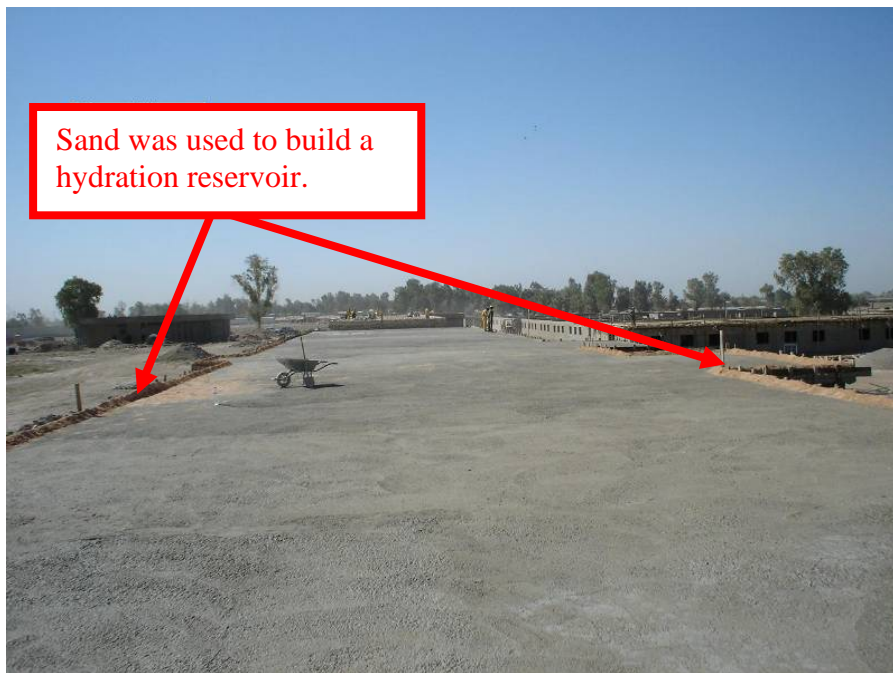
USACE Construction Progress Photo 6 taken 12 June 2005 shows the completed flatwork casting on the Senior NCO Barracks. June is a hot month in Iraq and flatwork concrete cast/placed in such conditions can dry and cure too rapidly. To slow down the drying process, sand was used to build a hydration reservoir of water above recently cast concrete.

**USACE Construction Progress Photo 6. Each Company Barracks roof was over 14,000 sq. ft.**

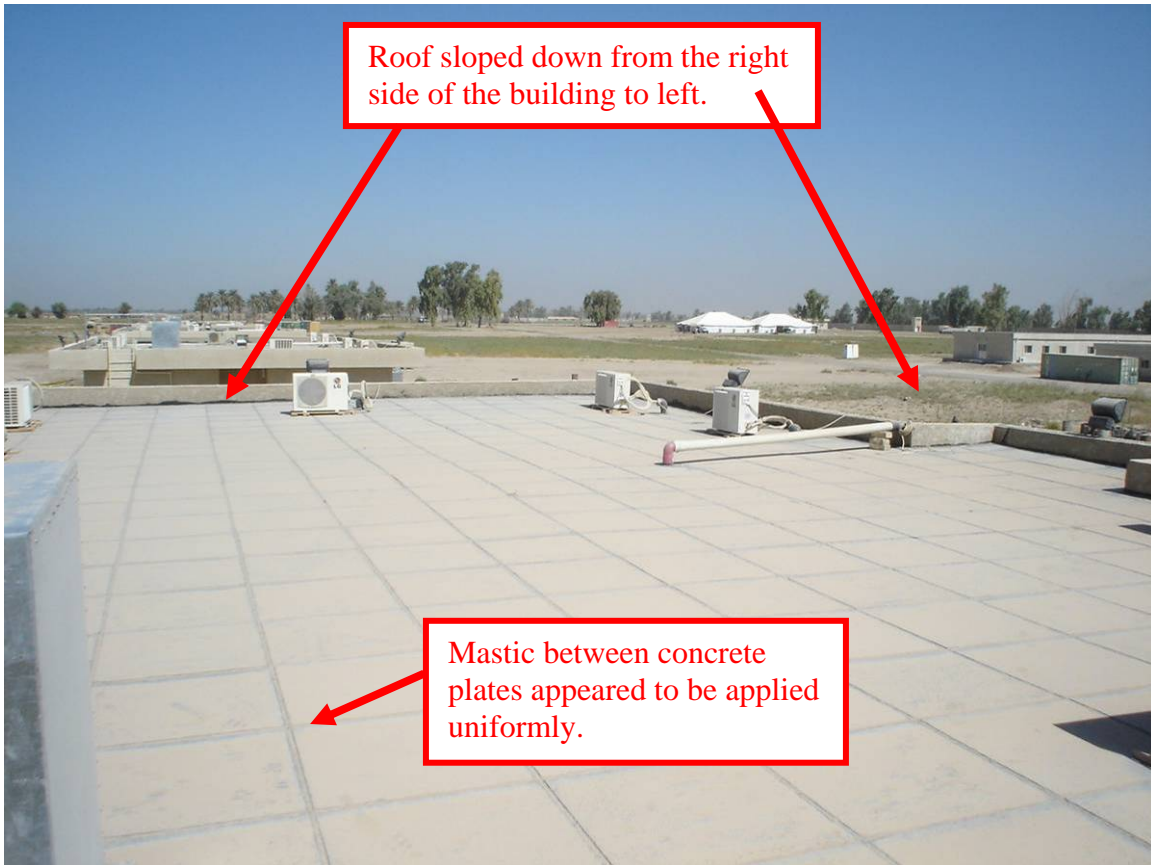
A completed roof on one of the six barracks included in the project is shown in USACE Construction Progress Photo 7. Concrete plates appear to have been properly placed and uniformly sealed with mastic to prevent leaks.

**USACE Construction Progress Photo 7. Roofs were sloped to facilitate drainage.**

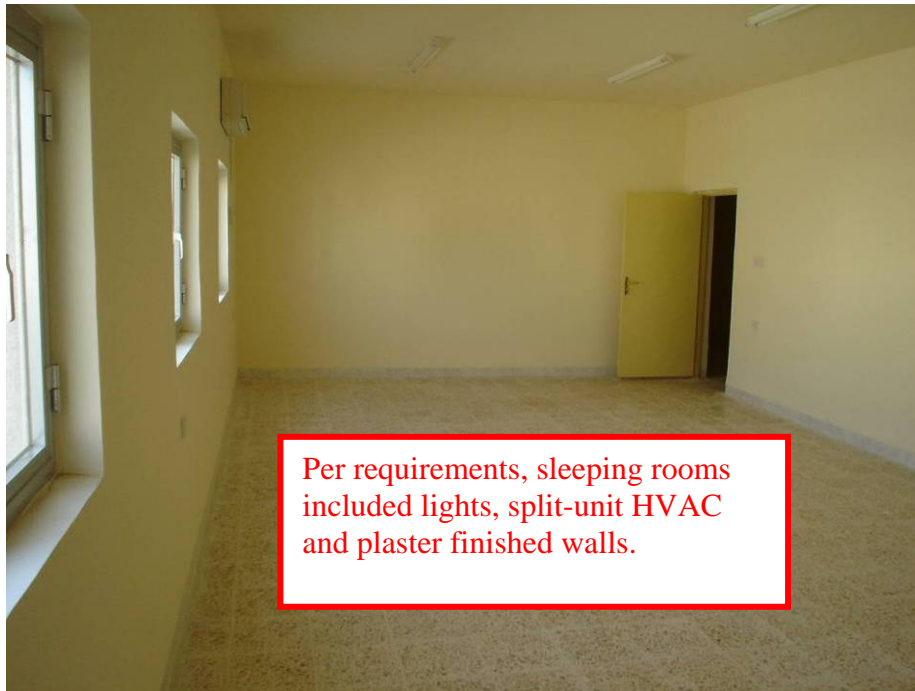
USACE Construction Progress Photos 8 and 9 illustrate that the interiors of the barracks were completed in a manner that met SOW requirements. Specifically, USACE Construction Progress Photo 8 shows lighting, interior plaster and split-unit through-wall HVAC. USACE Construction Progress Photo 9 shows that the bathroom included sinks with mirrors and sinks and eastern style latrines and showers.

Per requirements, sleeping rooms included lights, split-unit HVAC and plaster finished walls.

**USACE Construction Progress Photo 8. Example of a Company barracks sleeping room.**

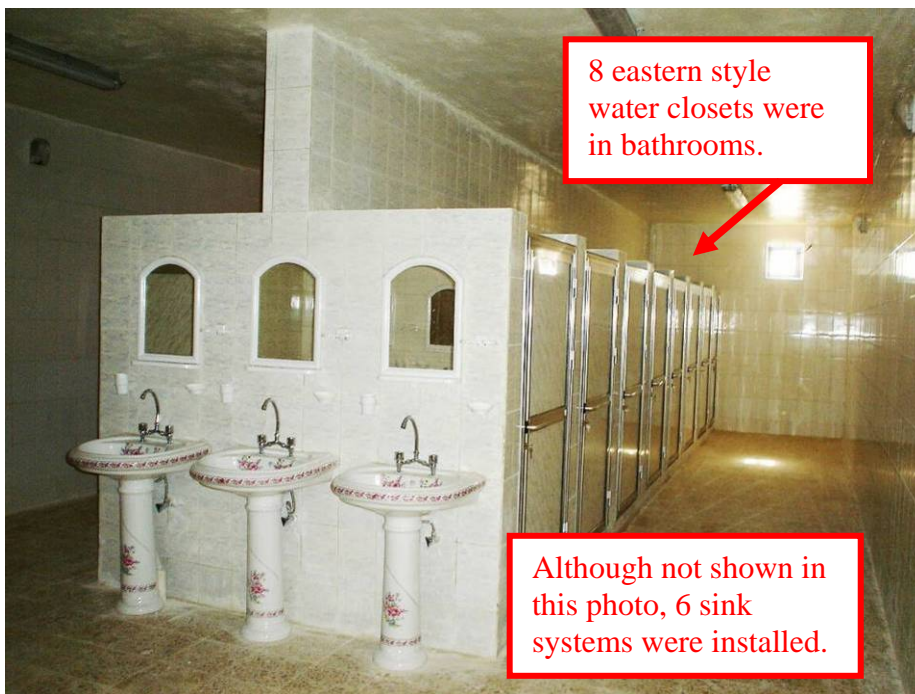
8 eastern style water closets were in bathrooms.

Although not shown in this photo, 6 sink systems were installed.

**USACE Construction Progress Photo 9. Bathrooms included required sinks and eastern style water closets.**
