MAHALLA 824 SEWER COLLAPSE PROJECT
UNDER THE COMMANDER'S EMERGENCY RESPONSE PROGRAM
BAGHDAD, IRAQ

SIGIR PA-07-112
JANUARY 16, 2008

SUBJECT: Report on the Rehabilitation of the Mahalla 824 Sewer Collapse Project in
the Doura governorate of Baghdad, Iraq (Report Number SIGIR PA-07-112)

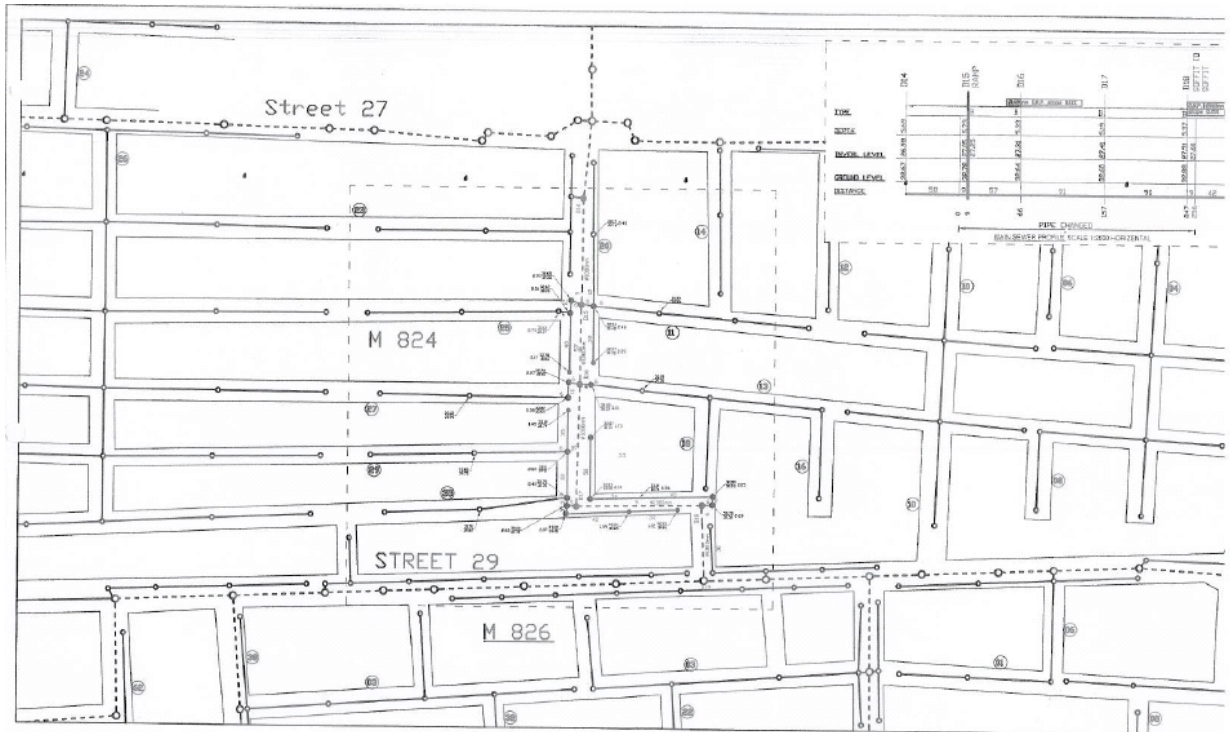
Figure 1: Mahalla 824 Sewer network layout (Courtesy of USACE)

The description of the facility (pre-construction) was based on information obtained from the contract and the USACE project file. The Mahalla 824 Sewer Collapse Project is located in the Doura governorate of Baghdad, Iraq. The Doura area has been neglected for decades, and the collapsed sewer main created a huge pond of standing sewage. Figure 1 illustrates the Mahalla 824 Sewer project area, and Site Photos 1 and 2 show the pond of sewage.

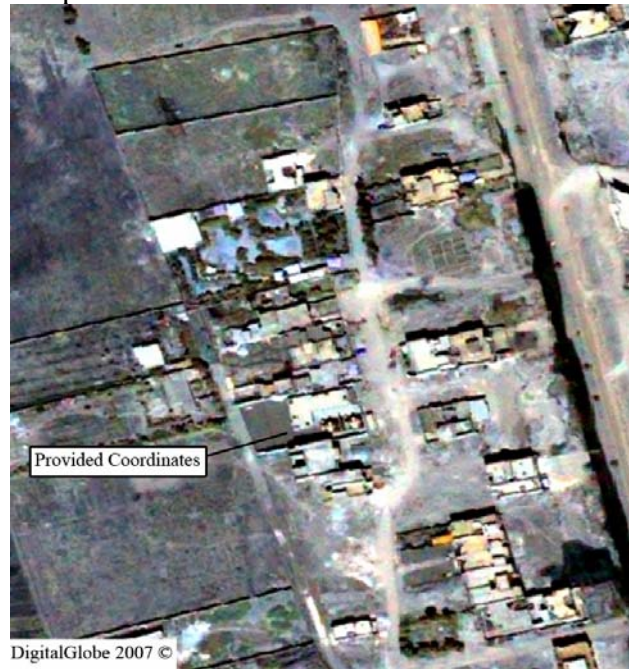
Aerial Image 1. Aerial overview denoting provided geo-coordinates of the Mahalla 824 Sewer.

At the time of our assessment, official security representatives could not escort the assessment team to the project site because of increased insurgent activity in the area. Therefore, our project assessment relied solely on information obtained from the contract files, emails with the USACE and aerial imagery (Aerial Image 1). Information contained in the contract files included the Contract, Contract documentation, contract modifications, Statements of Work, the design package (drawings and specifications), quality control reports, quality assurance reports, construction progress photos, safety plan, and invoices.
