**33-KILOVOLT POWER LINE
NASSRIYA, IRAQ**

**SIGIR PA-08-127
JULY 22, 2008**

SUBJECT: Report on Construction of the 33-Kilovolt Power Line, Nassriya, Iraq (Report
Number SIGIR PA-08-127)

33-Kilovolt Power Line, Nassriya, Iraq

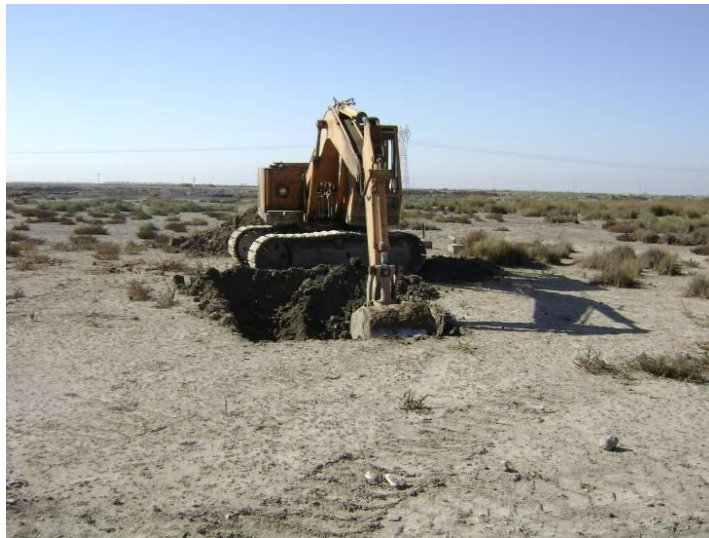
Site Photo 3. Excavation for tower foundation (Courtesy of the USACE))

At the time of our site visit, the contractor had not completed the 33-kV power line or the service road (Site Photo 2), which provides access to the towers. For example, the contractor was still excavating tower foundation sites (Site Photo 3), forming up the tower foundations (Site Photo 4), erecting tower bases (Site Photo 5), pouring the concrete base of the towers (Site Photo 6), vibrating concrete base towers (Site Photo 7), finishing the concrete for the tower bases (Site Photo 8), curing the concrete of the tower bases (Site Photo 9), and delivering aggregate to the site (Site Photo 10).
