**HADITHA GENERAL HOSPITAL**  
**UNDER THE ECONOMIC SUPPORT FUND PROGRAM**  
**HADITHA, IRAQ**

**SIGIR PA-08-132**  
**JANUARY 23, 2009**

## Haditha General Hospital Under the Economic Support Fund Program Haditha, Iraq

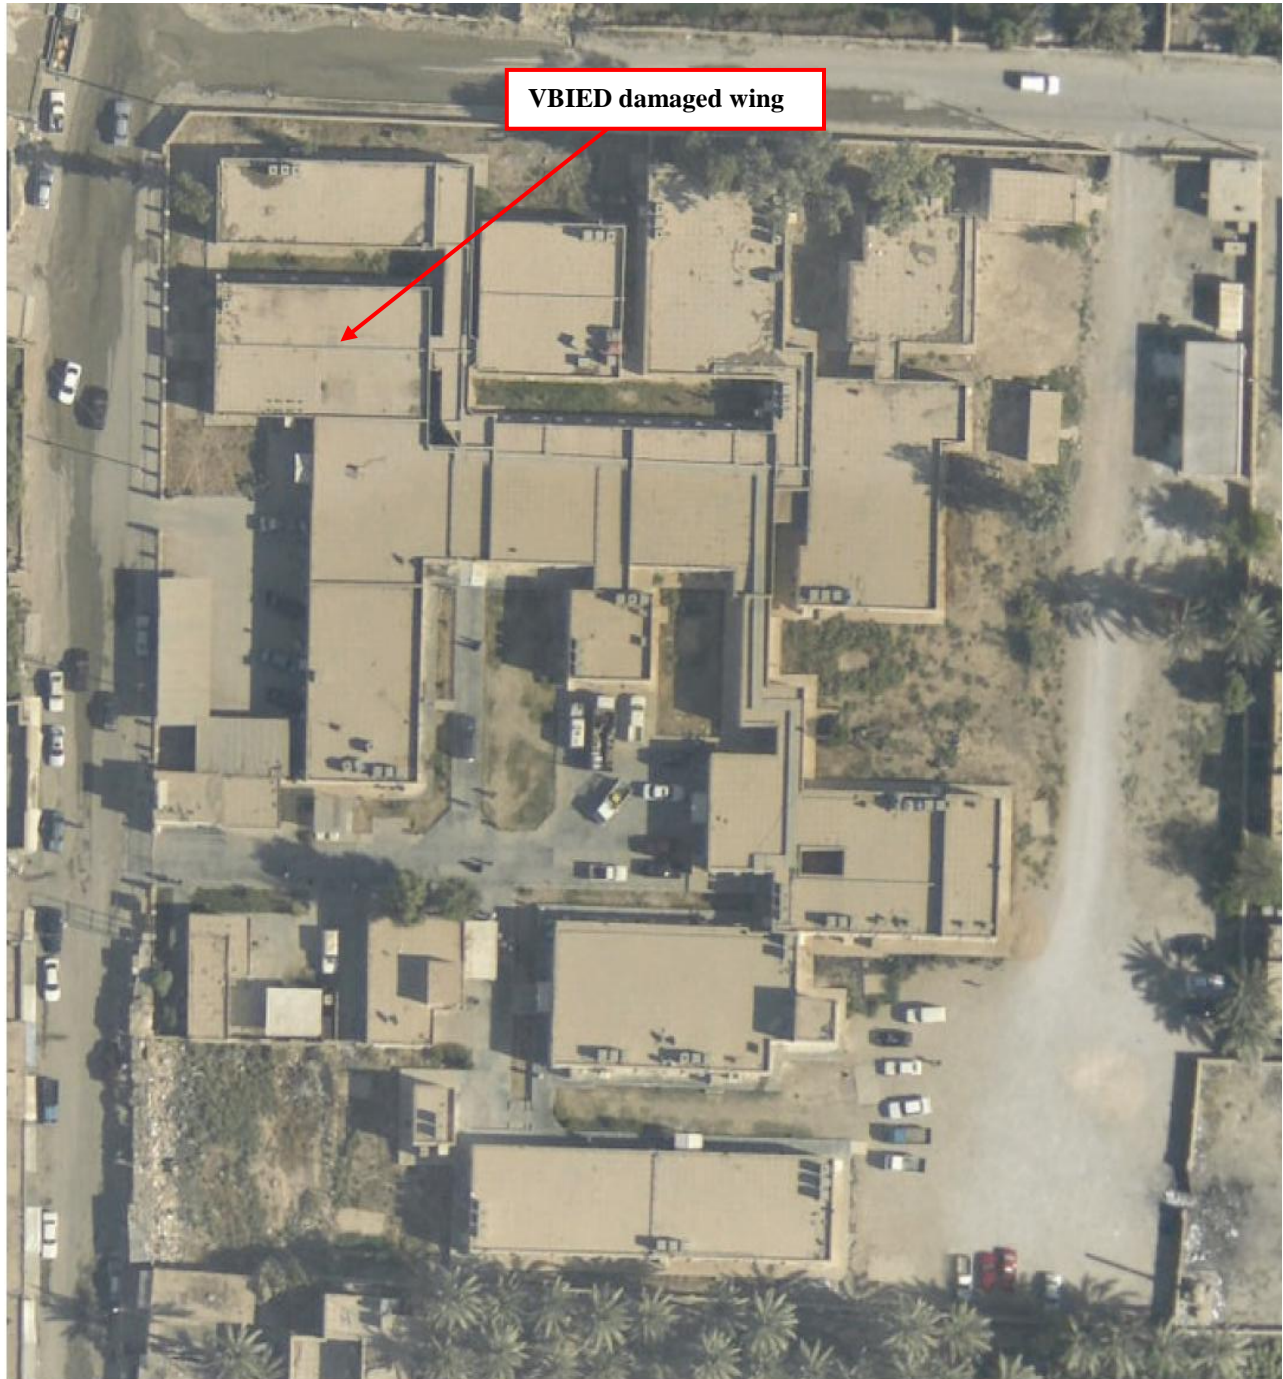
The hospital, located in the heart of the city, is a sprawling single-story complex spread out over a city block about 500 meters on each side (Figure 1). It consists of eight interconnected wings, which were built at different times. The complex also includes two other clinic buildings, storage, morgue, ambulance garage, housing, guardhouse, and generators. A large area on the eastern side of the complex allows for possible expansion.

**Figure 1. Aerial photo of the Haditha General Hospital  
(Courtesy of USACE)**

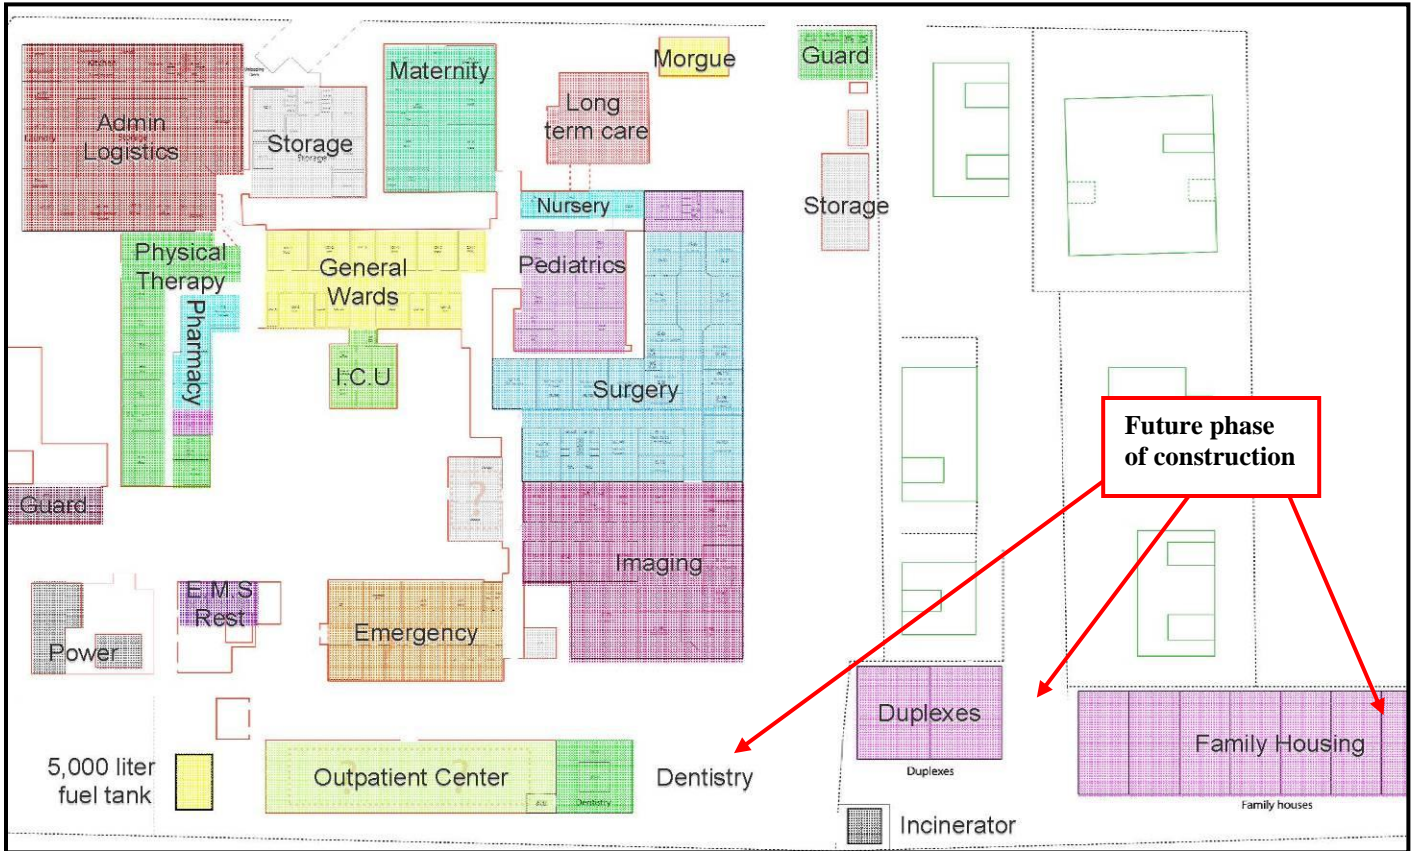
The modification to the contract required the demolition of the VBIED damaged wards of the hospital as well as the existing surgery wing. The VBIED wards would be replaced by a new two-story administration and logistics building which will house the laundry, kitchen and consolidated storage on the first floor, with administration and laboratory on the second floor. The surgical wing will include three operating rooms and their supporting facilities as well as five new four bed-surgical recovery wards, three female and two male. The imagery wing will include ultrasound, x-ray and CT scanner equipment, as well as all supporting facilities.

**Figure 2. Illustration of Haditha General Hospital after completion of renovation and construction**
