**REHABILITATION OF THE SUROOR
ELEMENTARY SCHOOL
UNDER THE ECONOMIC SUPPORT FUND
HUSSEINIYA, IRAQ**

SUSTAINMENT ASSESSMENT

**SIGIR PA-08-135
APRIL 7, 2009**

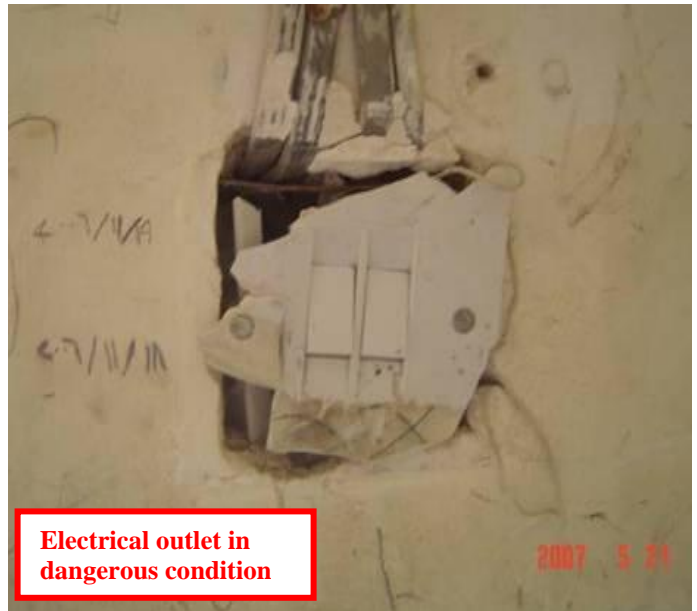
The school is located in the Husseiniya village near Baghdad, Iraq. The school was in a state of major disrepair from years of neglect and failure to maintain adequate upkeep. Site Photos 1 and 2 document the poor condition of the school prior to renovation. The school's electrical system was unsafe, the plumbing system unusable, the restrooms unsanitary, and overall the school was unsafe.

Site Photos 1 and 2. Suroor Elementary School prior to renovation (Courtesy of GRC)

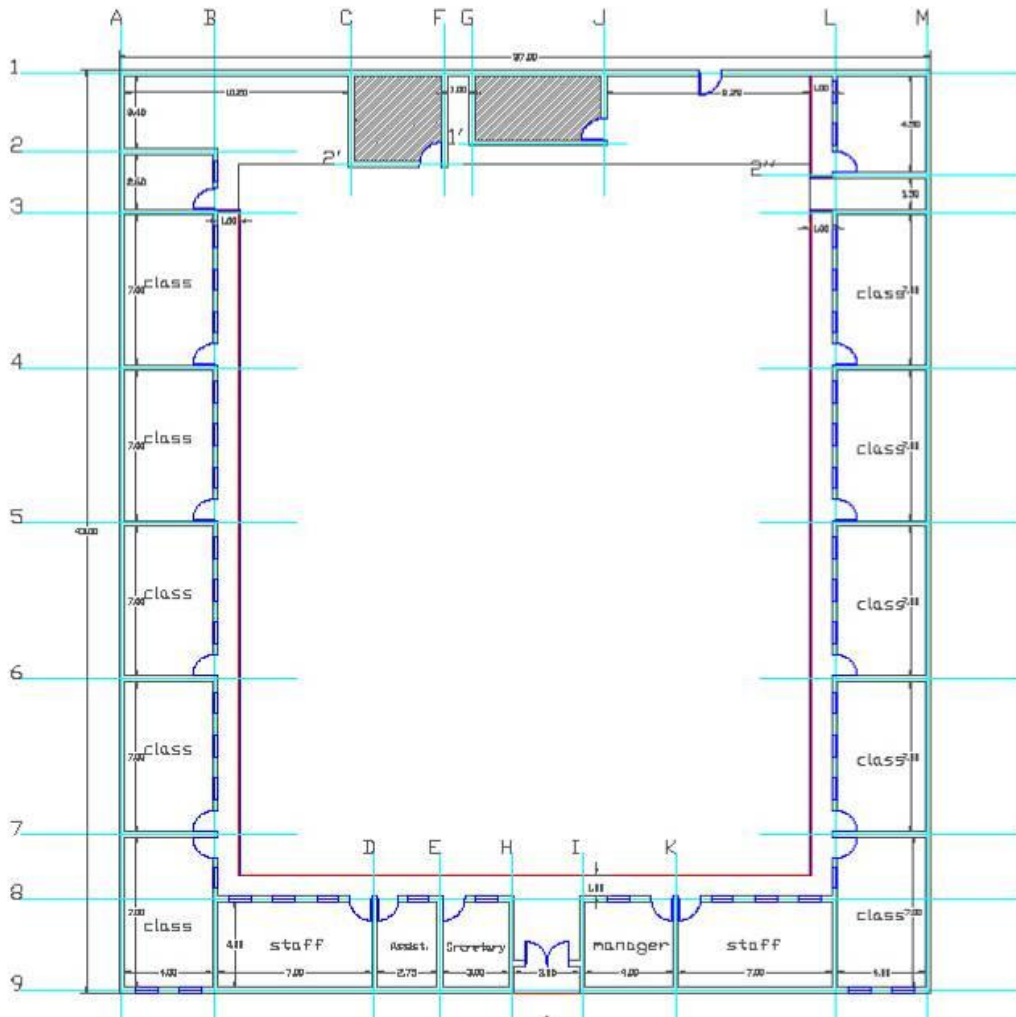
The architectural plans show the layout of 10 classrooms, 2 staff rooms, and administration areas (Figure 2). While the contractor’s submittals included good details of the electrical distribution system, our review concluded that the design submittals did not appear adequate for the renovation project because of the omission of details such as elevations, plumbing, and storm drainage.

Figure 2. Architectural layout of the school after renovation (Courtesy of GRC)

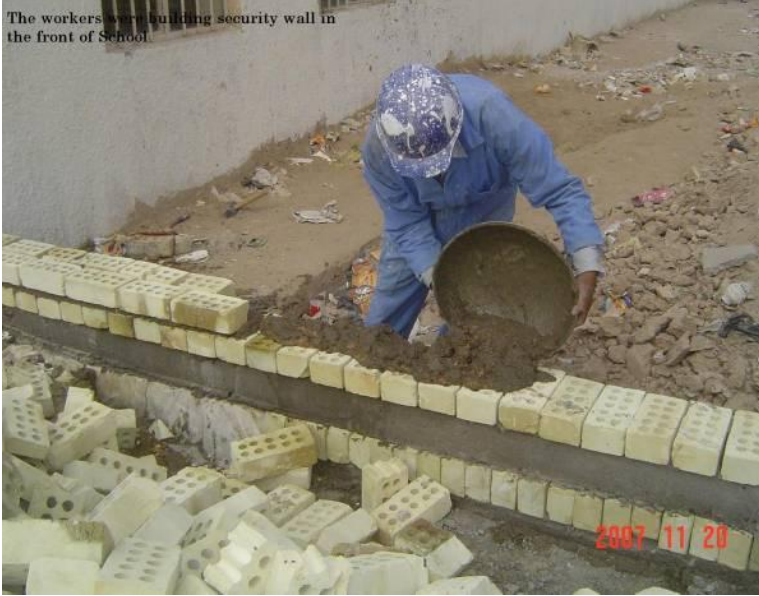
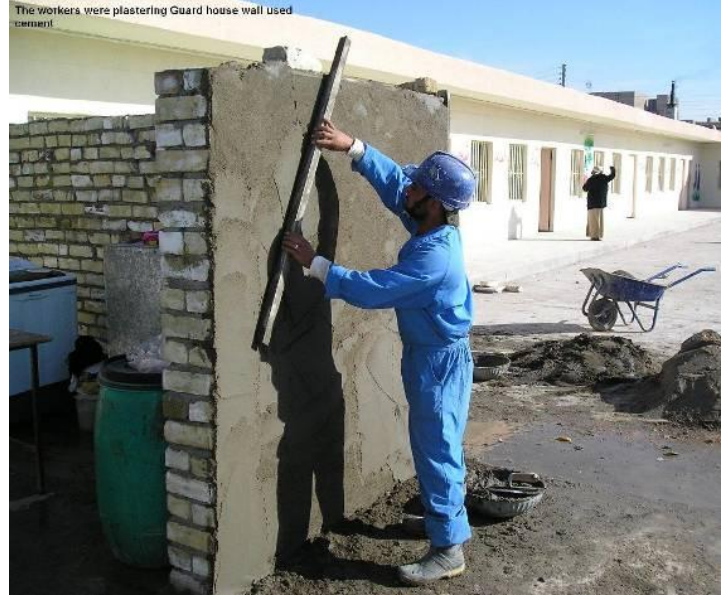
Site Photos 3 and 4 document the construction of the security wall and guard house wall, respectively.

Site Photos 3 and 4. Construction of the security wall and guard house wall (Courtesy of GRC)
