**RENOVATION OF THE KHANDEK
INTERMEDIATE SCHOOL
UNDER THE ECONOMIC SUPPORT FUND PROGRAM
YOUSEFIYA, IRAQ**

SUSTAINMENT ASSESSMENT

**SIGIR PA-08-136
APRIL 21, 2009**

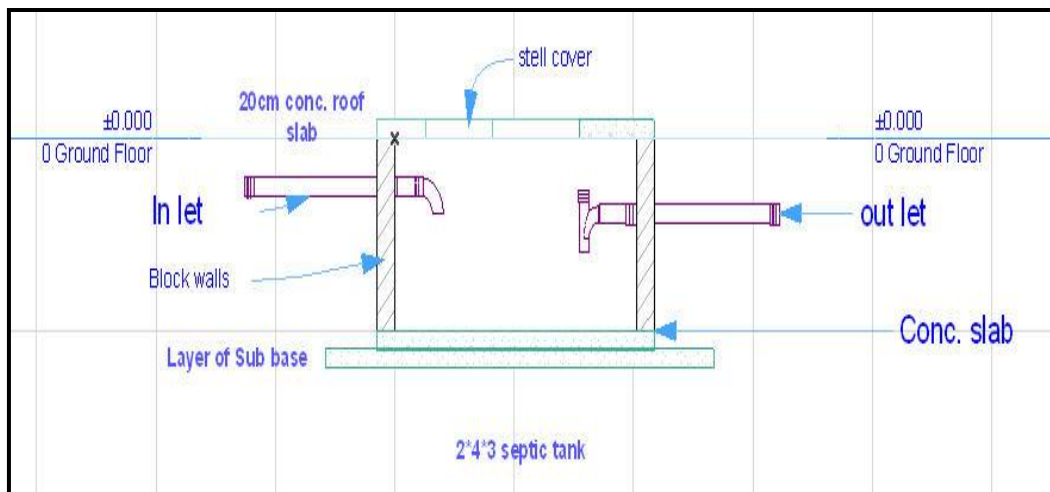
Figure 2. Septic tank section (Courtesy of GRC)

It does not appear that venting of the sanitary plumbing in the buildings was part of the design. The absence of vent piping through the roof of the building indicates that venting was not constructed. Figures 2 and 3 indicate a central vent in the septic holding tank, which would prevent the buildup of sewer gas in the plumbing system. Due to the expected low volumes of flow from the plumbing fixtures, the lack of venting should not excessively impact the capacity of the restroom.

The septic holding tank indicates that the outlet of the tank flows to an absorption area. The location and configuration of the absorption was not indicated in the design. It is unclear if this system is intended to treat sewage and promote absorption into the soil, or if the tank(s) function as holding tanks to be pumped out on a regular basis.

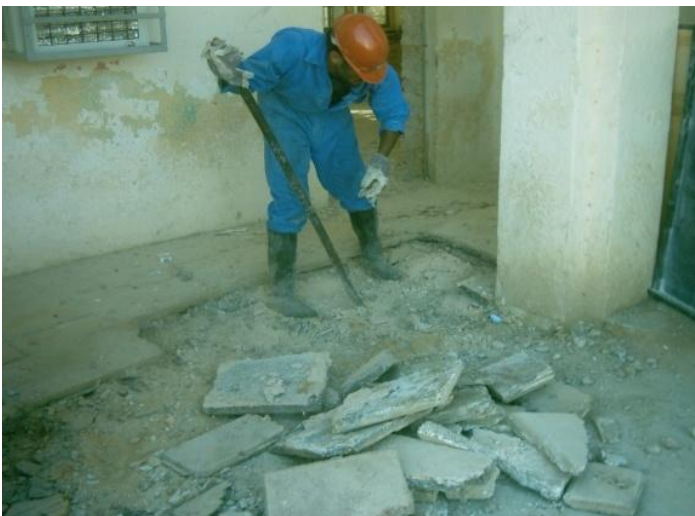
Site Photos 3 and 4 document various construction work activities at the school, such as the demolition of existing tiles, installation of new lighting, and new foundation and formwork construction.

Site Photo 3. Demolition of tiles (Courtesy of GRC)

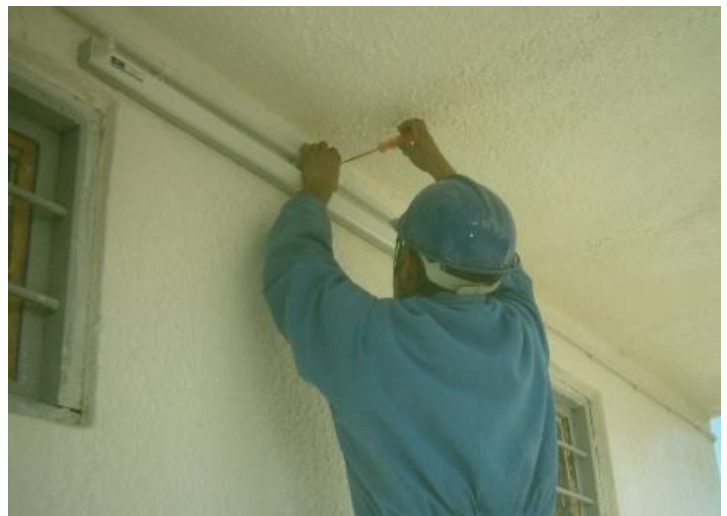
Site Photo 4. New lighting installation (Courtesy of GRC)
