**HAI TISEEN PRIMARY HEALTHCARE CENTER  
TAMEEM PROVINCE, IRAQ**

**SUSTAINMENT ASSESSMENT**

**SIGIR PA-08-158  
APRIL 16, 2009**

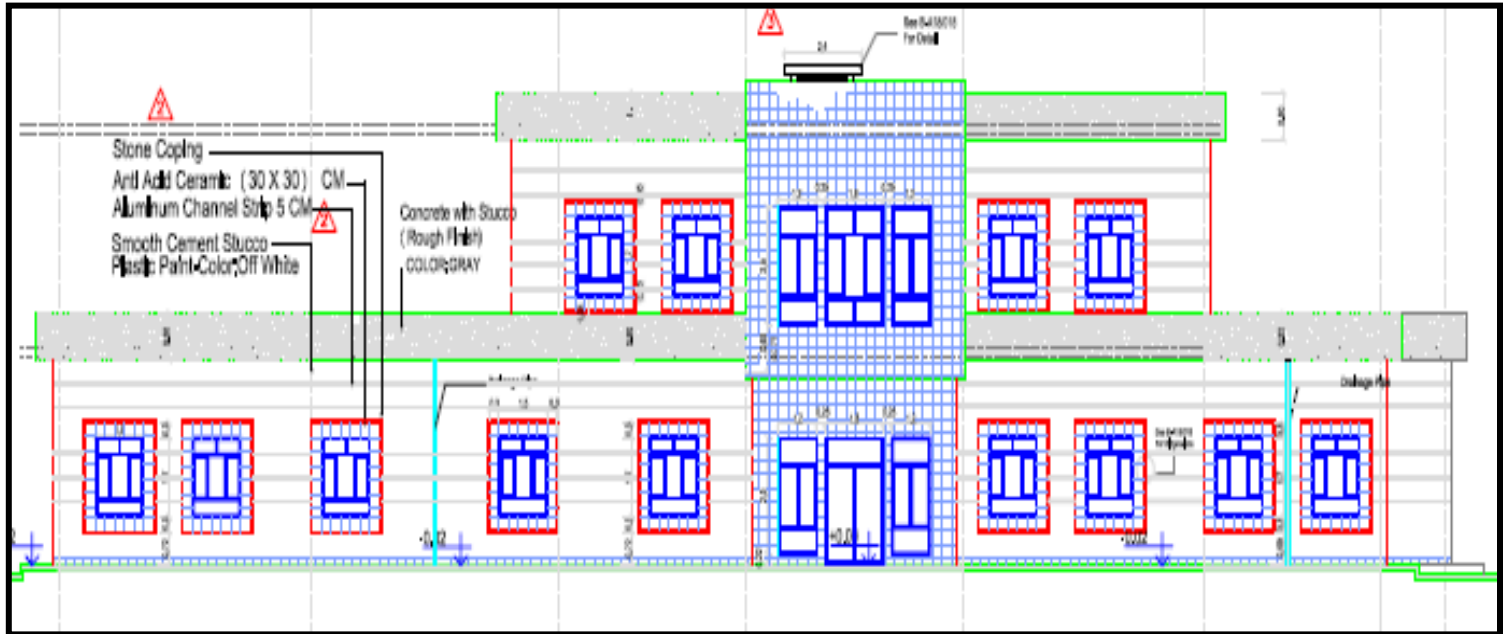
**Figure 2. Detailed design drawing frontal view of PHC exterior**  
(Courtesy of GRN)

Parsons presented GRD with a consistent design for all Type B PHCs. Parsons previously submitted 30%, 65%, 95%, and 100% design drawings and specifications to GRD for review and approval. Parsons' design drawings for a Type B facility included architectural, structural, mechanical, plumbing, and electrical plans. For example, the architectural design drawings included detailed exterior views of the facility (Figure 2).
