**RABEAA POINT OF ENTRY  
SCREENING FACILITY  
RABEAA, IRAQ**

**SIGIR PA-09-173  
JANUARY 11, 2010**

## Rabeaa Point of Entry Screening Facility

### Summary of Report: PA-09-173

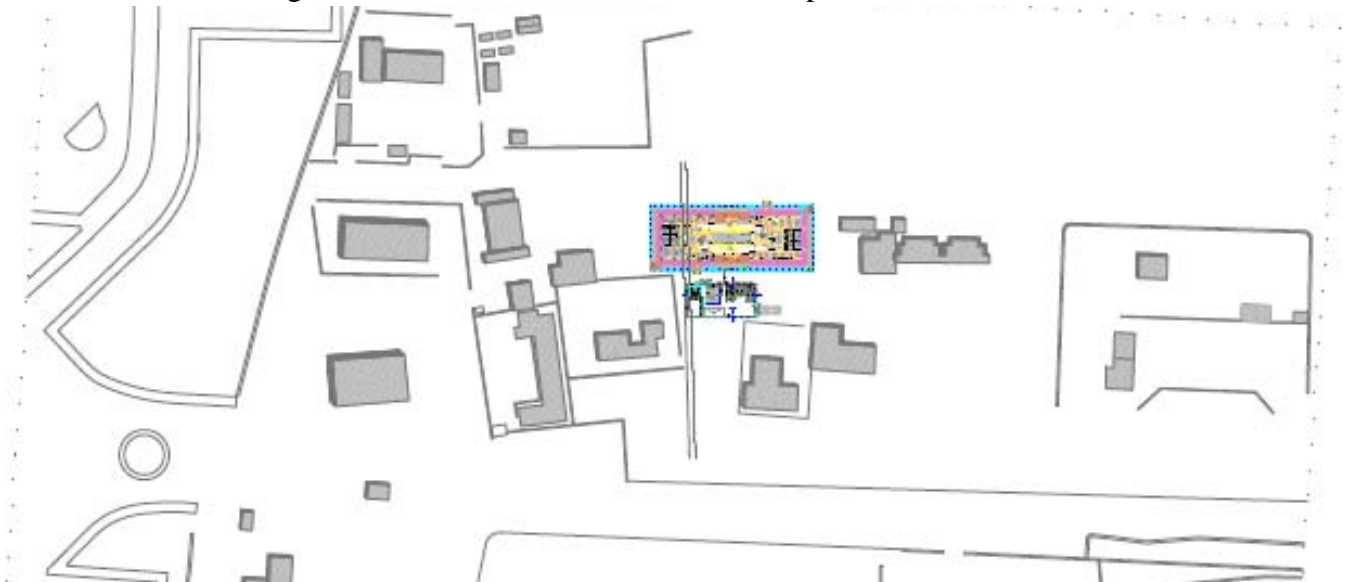
**Figure 1. Civil site plan (Courtesy of USACE)**

The civil design package included more architectural plans than civil drawings and the actual civil site plan (Figure 1) lacked details on topography, roadways, parking, and other typical site plan requirements. A primary concern was the lack of any drainage plan in the civil site plan. The contractor noted in the geotechnical report that drainage could contribute to future foundation problems.

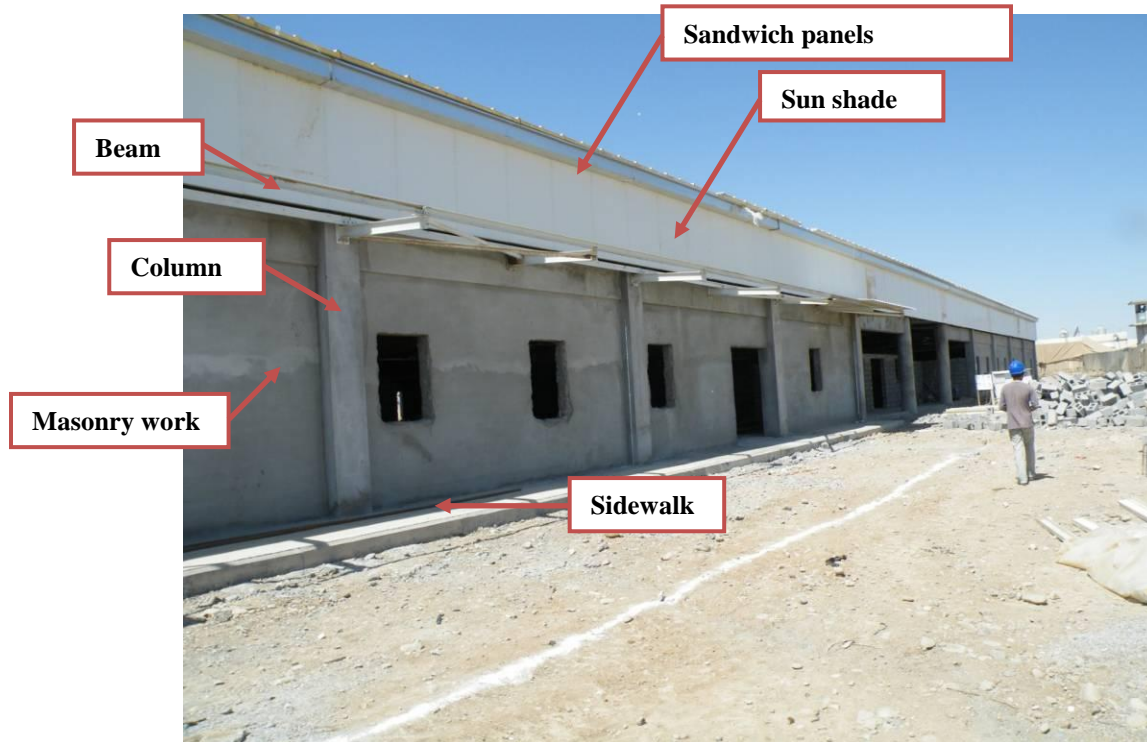
**Site Photo 1. Exterior construction of the screening building**

At the time of the site assessment, the exterior frame of the screening building was constructed (Site Photo 1). SIGIR observed the construction of the sandwich panels, sun shade, beam, columns, masonry, and sidewalk of the screening building. The interior of the screening building was not complete. The interior walls of the screening area were partially constructed.

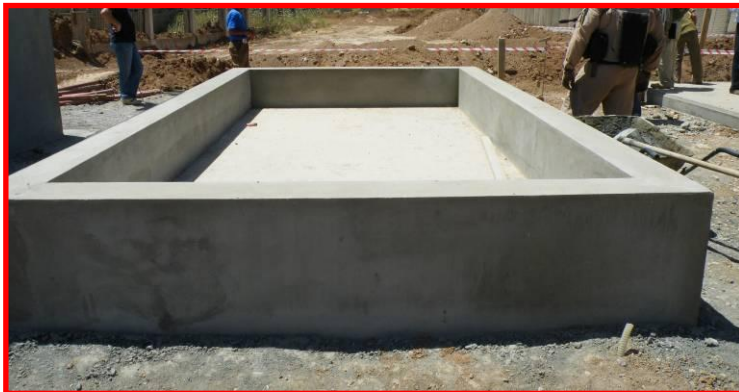
Site Photo 3. Fuel tank base

At the time of the site assessment, SIGIR noted that the contractor installed the generator on the generator pad (Site Photo 2), constructed the fuel tank base (Site Photo 3), and constructed the pump room (Site Photo 4).

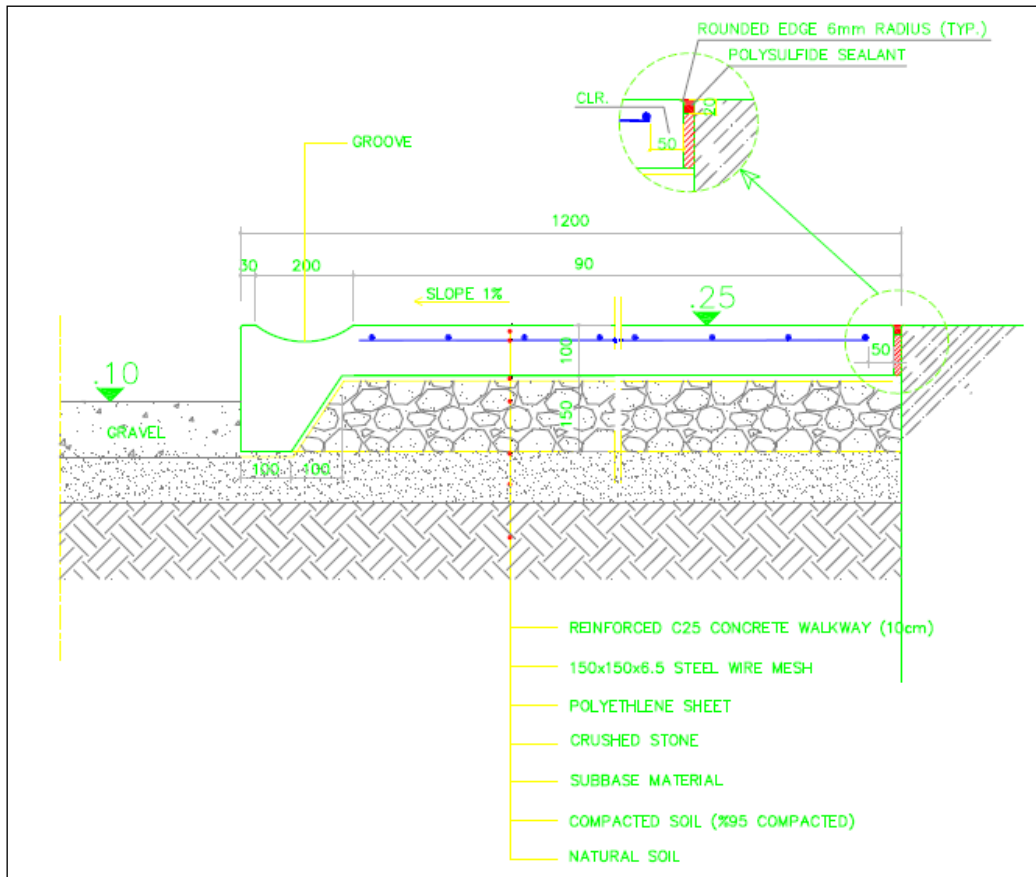
Figure 5. Sidewalk detail per the 100% design drawings (Courtesy of USACE)

At the time of the site assessment, the exterior sidewalk was partially constructed; the construction was determined to be lacking an isolation joint next to the building, control joints, and a 200mm groove (Site Photo 9). Both the isolation joint and the groove were included in the 100% drawings submitted for approval (Figure 5). The control joints (contraction joints) were required every 1.2 meters (m) per a special note on the plans.

- a. Improper jointing and unlevel construction of the concrete floor slab and cracking of the thin mortar overlay.
- b. Exterior sidewalk construction that was lacking control joints, a 200mm groove, and isolation joints next to the building.
- c. Construction of the raised concrete pad of the water pump house floor that was not square and did not allow for access to one exterior wall.

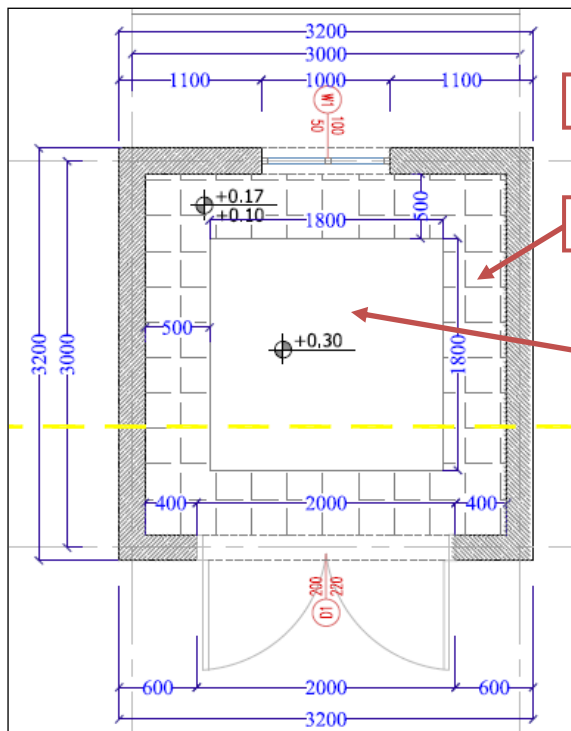
Figure 6. 100% Water pump room floor plan drawing (Courtesy of USACE)

Although the construction of the water pump house was partially completed, SIGIR noted that the construction of the raised concrete pump pad was not constructed in accordance with the drawings (Figure 6 and Site Photo 10). Specifically, the raised floor as submitted on the plans was a 1.8m square raised concrete pad. The actual construction of the raised concrete pad was not configured in a square and did not allow for access against one exterior wall. Once the booster pumps are placed on the concrete pad, the access to the electrical control panel could be impeded. The original design allowed for unimpeded access all around the raised pump pad.
