HAMMAM AL ALIL DIVISION TRAINING
CENTER
MOSUL, IRAQ

SIGIR PA-09-174
JANUARY 7, 2010

Summary of Report: PA-09-174

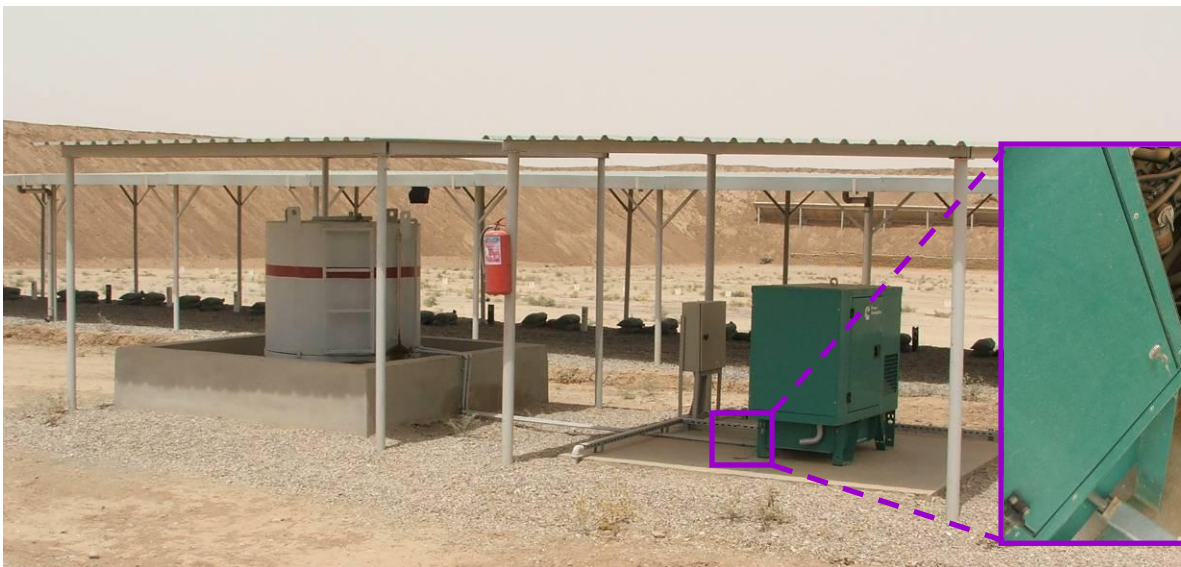
During the site assessment, SIGIR verified that the generator was present at the multi-purpose small arms range. The contractor constructed a concrete pad and sunshade for the generator. The generator was enclosed in a metal enclosure and a fuel tank was placed in a concrete spill containment structure (Site Photo 11).

Site Photo 11. Sunshade with generator & fuel tank

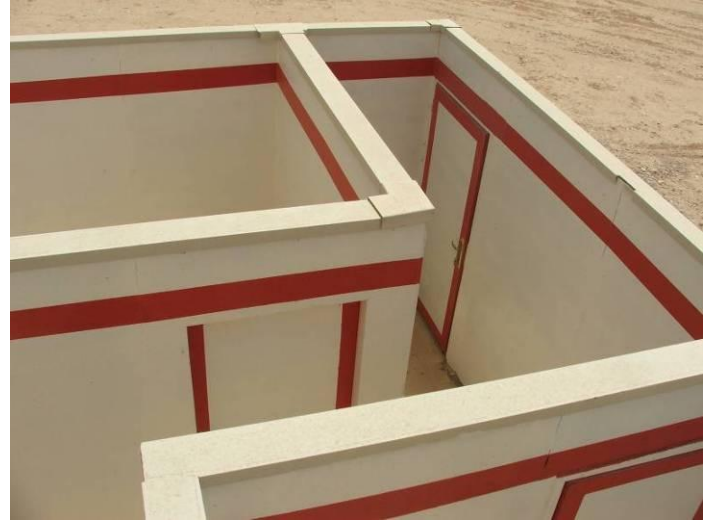
No significant cracking or displacement of the slab was observed, although minor shrinkage and cracking were present, which indicates poor curing practice. However, the minor shrinkage and cracking should not affect the structural integrity of the slab. The training structures utilized modular, panelized construction with bolted connections between the panels. The training structures were constructed without a roof. The panels were arranged to provide rooms and corridors with some panels containing entry doors (Site Photo 14).

Site Photo 14. MOUT facility interior

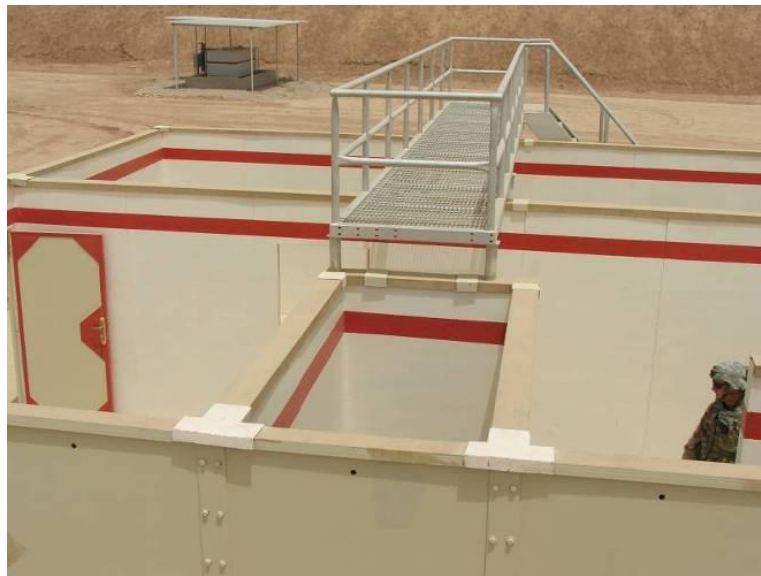
Observation platforms were constructed above the training structures (Site Photo 15). The platforms consisted of galvanized steel framing, open grate steel deck, and handrails. The steel framing for the platform was supported on the training structure's wall panels.

Site Photo 15. Observation platform

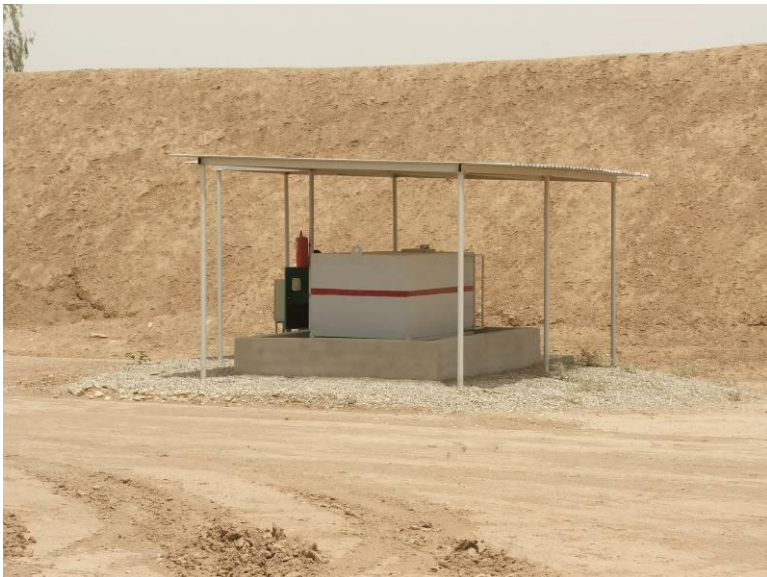
SIGIR verified that the generator was present at the MOUT facility. The contractor constructed a concrete pad and sunshade for the generator. The generator was enclosed in a metal enclosure and a fuel tank was placed in a concrete spill containment structure (Site Photo 16).

Site Photo 16. Sunshade with generator and fuel tank
